NARRATIVE REPORT FORM

Facility Name: Glenwood Drive and Walker Road

| Purpose: Oversight of Weekly gauging of potable wells and recovery wells on Glenwood Drive and respond to residential complaint at [redacted], Washington Crossing | | | | | |

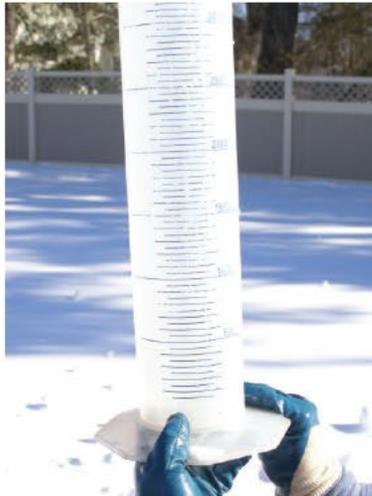
- The well was screened with a PID and gauged with the absorbent sock in
- After the sock was pulled, GES estimated it to be 50% saturated and placed into a metal container.
- The well was bailed and poured into the graduated cylinder.
- The amount of recovered LNAPL was estimated to be around 10mL
- The well was gauged a second time.
- An LNAPL sample was collected at 10:07.
- The LNAPL and water mixture was poured into a metal bucket.
- A new absorbent sock was installed in the well.

Recovered LNAPL and water from [redacted] potable well
2-9-26 @ 10:02

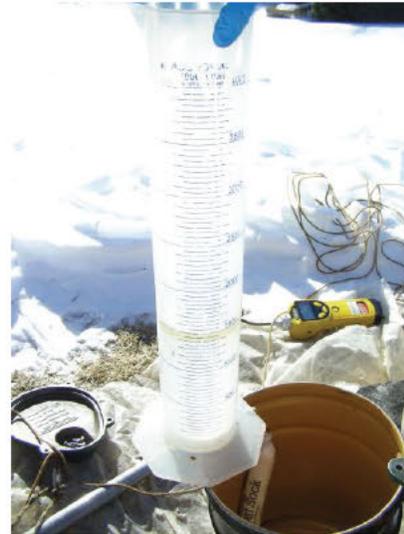
- The well was screened with a PID and gauged.
- The well was bailed and poured into the graduated cylinder.
- The amount of recovered LNAPL was estimated to be around 40mL
- The well was gauged a second time.
- A LNAPL sample was collected at 10:53
- The LNAPL and water mixture was poured into a metal bucket.

Bailed water and LNAPL from potable well at [redacted]
2-9-26 @ 10:51

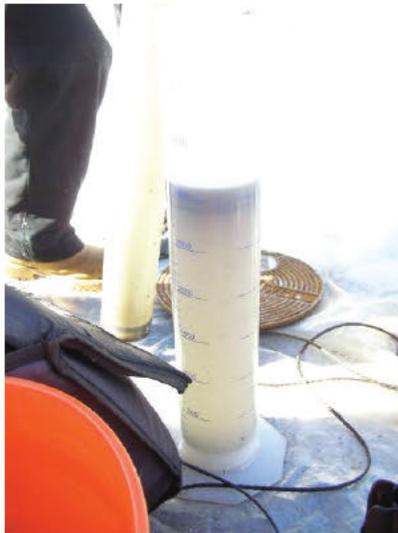
- The well was screened with a PID and gauged with the skimmer still in the well.
- The skimmer was pulled, observable measurable LNAPL was present.
- The well was bailed and poured into the graduated cylinder There was 220mL of LNAPL bailed along with water.
- The depth to LNAPL and water was gauged for a second time.
- A LNAPL sample was collected at 11:10.
- The water and LNAPL mixture was emptied into a metal bucket.
- The skimmer was wrapped in black contractor trash bags. This was due to RETTEW performing tests on the recovery well on Tuesday February 10, 2026.
- An absorbent sock was placed in the well to collect any LNAPL that might accumulate overnight.

Recovered LNAPL and water from recovery well RW-2
2-9-26 @ 11:04

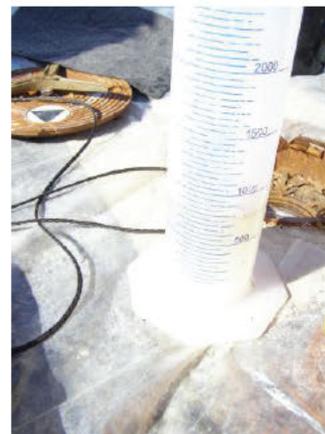
- The well was screened with a PID and gauged with the skimmer still in the well.
- The skimmer was pulled, and it was estimated that there was approximately 20mLof LNAPL present after it was poured into the graduated cylinder.
- The depth to LNAPL and water was gauged for a second time.
- A LNAPL sample was collected at 11:33.
- The water and LNAPL mixture was emptied into a metal bucket.
- The skimmer was placed back in the recovery well.

Amount of LNAPL recovered from recovery well RW-3
2-9-26 @ 11:30

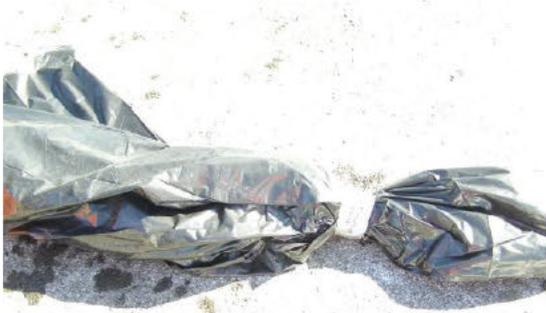
Skimmer recovered from recovery well RW-2 wrapped in contractor bags
 2-9-26 @ 11:16

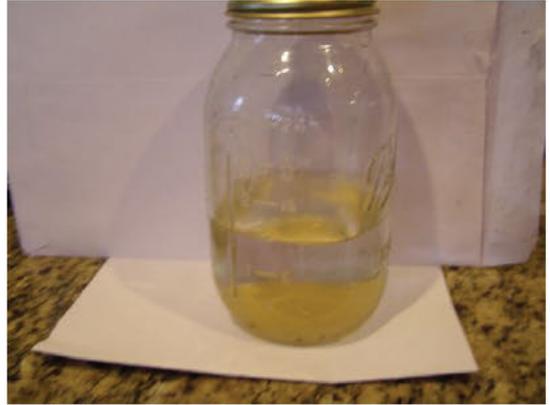
I was given permission to enter the residence. I was shown the water in a Ball jar that was collected from the kitchen sink last Wednesday, February 4, 2026. It was light yellow in color and then I opened the jar to determine if there was an odor. There was a sweet/floral smell.

Water from kitchen faucet collected on 2-4-26 at [REDACTED]
 2-9-26 @ 12:26
