NARRATIVE REPORT FORM

Facility Name: Glenwood Drive & Walker Road

The purpose of today's site visit was to observe drilling of monitoring well 18-DD on Glenwood Drive between Walker and Spencer Road (see map).

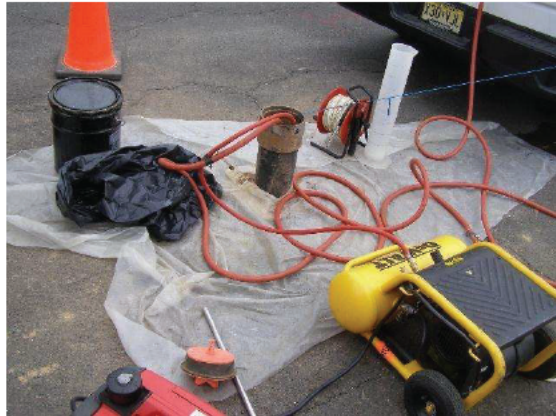
Wells B and C were finished the week prior and there was a GES crew pumping well B to measure any fuel that recharged (see photo 1). By the end of the day there was minimal fuel recovery from Well B.

Photo 1: Pumping of Well-B
 Source: Olivia Budnovitch, 4/22/26

DEP stayed onsite to observe drilling until they reached 42 feet below ground surface. Before departing, DEP checked in with the GES crew pumping Well-B to see if there were any changes, no new fuel accumulation was reported.

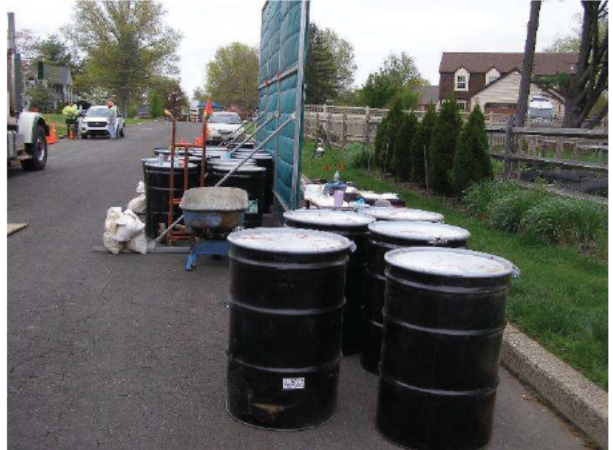
The Professional Geologist from GES monitored PID readings closely throughout drilling and made notes of significant features. The water and rock fragment byproduct was loaded into drums and sealed (see photo 2). The drums were also periodically screened with a PID.

Photo 2: Drum storage and sound barrier
 Source: Olivia Budnovitch, 4/22/26

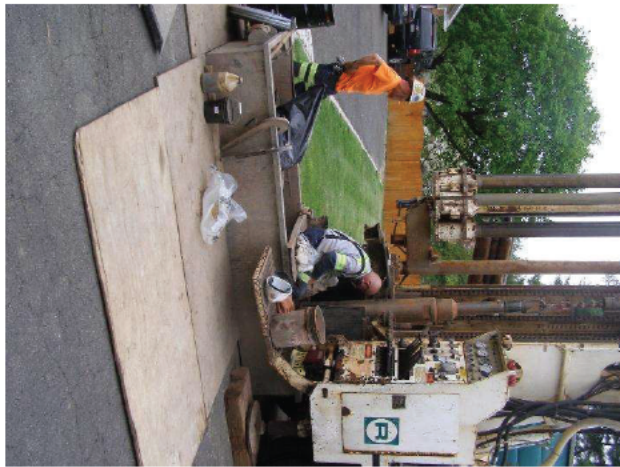
From 12:00 to 14:00 supplies were set up and the drill rig was positioned (see photo 3). Because of the telescoping design construction of the well, Summit needed to set the temporary casings and place bentonite between the two outer casings to keep them in place during drilling.

Photo 3: Drill rig placement
 Source: Olivia Budnovitch, 4/22/26

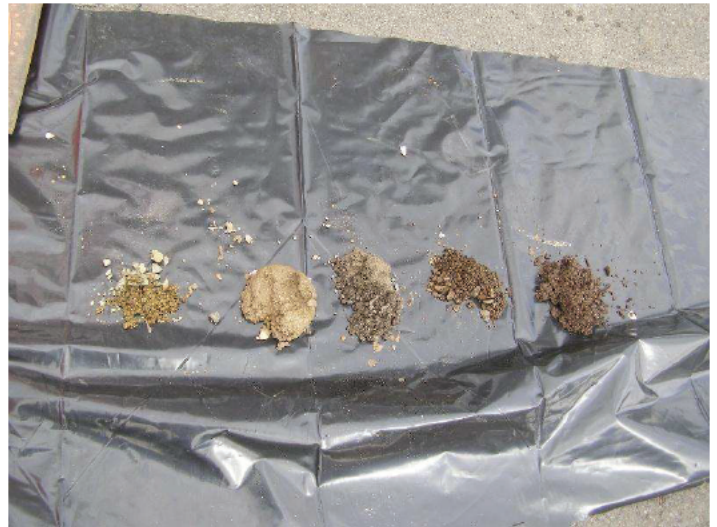
Drilling started at 14:05. Soil and rock chips were collected at 5-foot intervals starting at 10 feet below ground surface (see photo 4). Odors were observed intermittently throughout drilling. PID readings ranged from 8.5ppm to 160.8ppm. The highest PID readings were detected at 20 feet below ground surface. Hard bedrock was encountered at approximately 24 feet below ground surface, and a fracture was encountered at approximately 34 feet below ground surface.

Photo 4: Soil and rock fragments collected during drilling
 Source: Olivia Budnovitch, 4/22/26
