**NARRATIVE REPORT FORM**

Facility Name: Glenwood Drive and Walker Road

Primary Facility ID: 881609 \_\_\_\_\_

Inspection Date: 3-16-26		Inspection Time: 8:52am:		Lat/Long:																																																																			
Program: ECB		<input type="checkbox"/> Storage Tanks		<input type="checkbox"/> HSCA																																																																			
				<input checked="" type="checkbox"/> LRP																																																																			
Owner Name: Energy Transfer			Inspection ID:		Site ID:																																																																		
Facility Location (911) Address: Glenwood Drive and Walker Road Washington Crossing, PA 18977				Municipality: Upper Makefield Twp.																																																																			
				County: Bucks																																																																			
Responsible Official Name: Brad Fish				Responsible Official Address:																																																																			
Title: Senior Environmental Specialist Emergency Response & Remediation				100 Green Street Marcus Hook, PA 19061

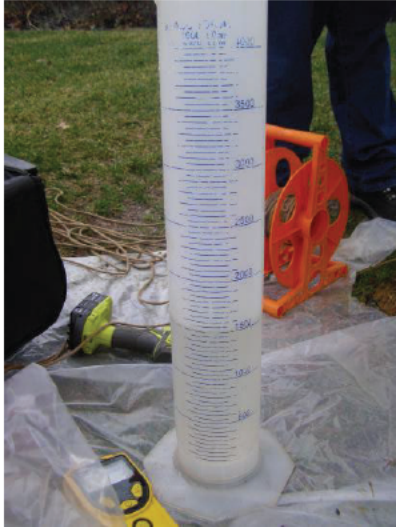
- The well was gauged before and after it was bailed.
- The bailed water LNAPL was placed into a graduated cylinder,
- There was a sheen on the bailed water.
- A LNAPL sample was collected at 9:12.

Water from [redacted] potable well  
 3-16-26 @ 9:13
