**NARRATIVE REPORT FORM**

Facility Name: Glenwood Drive and Walker Road

Primary Facility ID: 881609 \_\_\_\_\_

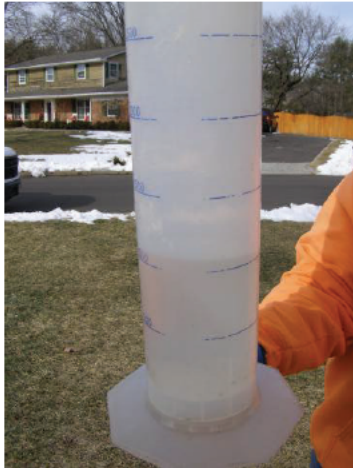
- ██████████:
- The well was gauged before and after it was bailed.
  - Approximately 1,050 mL of water was bailed (removed) and was then transferred to the metal bucket.
  - There was no obvious sheen, but small globules of LNAPL could be seen floating on the top.

Water from [redacted] potable well  
 3-2-26 @ 9:19

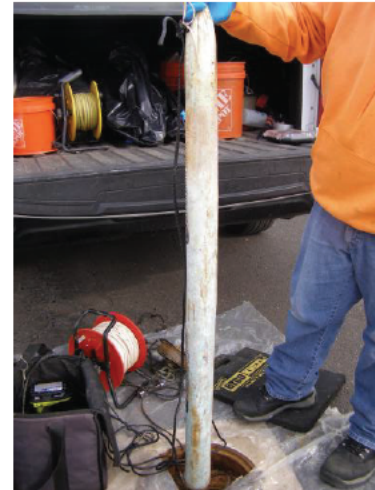
- An absorbent sock had been placed in the well, no skimmer.
- The well was gauged before and after the sock was removed.  
GES estimated the absorbent sock to be 60% saturated.
- The removed sock was placed into the metal bucket, and a new sock was installed.

Pulled absorbent sock from recovery well RW-2 in Glenwood Drive  
 3-2-26 @ 9:35

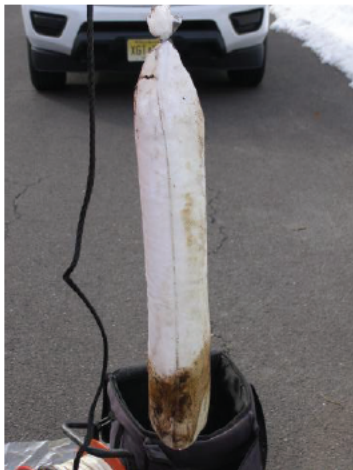
- An absorbent sock had been placed in the well, no skimmer.
- The well was gauged before and after the sock was removed.  
GES estimated the absorbent sock to be 60% saturated.
- Originally the sock was not replaced, but I was informed by GES that it was going to be replaced.

Pulled absorbent sock from recovery well RW-3 in Glenwood Drive  
 3-2-26 @ 9:49

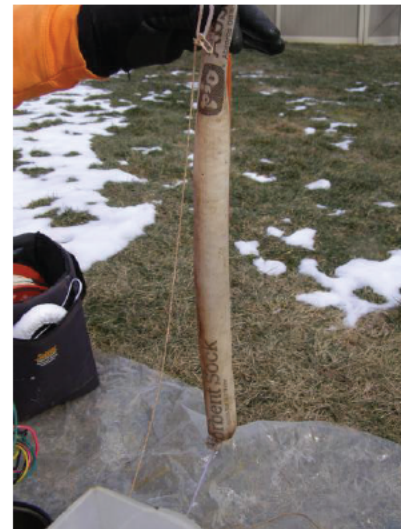
- ██████████:
- The potable well had the depth to water gauged with the absorbent sock in the well.
  - GES estimated the saturation of the absorbent sock to be 100% and was placed into a metal bucket.
  - A new absorbent sock was placed in the well.

Recovered absorbent sock from the potable well at [redacted]  
 3-2-26 @ 9:54
