NARRATIVE REPORT FORM

Facility Name: Glenwood Drive and Walker Road

Inspection Date: 3-23-26		Inspection Time: 8:53 am:		Lat/Long:	
Program: ECB		<input type="checkbox"/> Storage Tanks		<input type="checkbox"/> HSCA	
				<input checked="" type="checkbox"/> LRP	
Owner Name: Energy Transfer			Inspection ID:		Site ID:
Facility Location (911) Address: Glenwood Drive and Walker Road Washington Crossing, PA 18977				Municipality: Upper Makefield Twp.	
				County: Bucks	
Responsible Official Name: Brad Fish				Responsible Official Address:	
Title: Senior Environmental Specialist Emergency Response & Remediation				100 Green Street Marcus Hook, PA 19061	
Responsible Official Telephone: 610-859-6297					
Email Address: bradford.fish@energytransfer.com					
Entities Present:					
DEP – Rebecca Flannery					
GES – Devin Graham, Mark FeLong, Matt Lyon, Matt Moraller, and Kevin Troutman					
Purpose: Oversight of Weekly gauging of Potable Wells and recovery wells on Glenwood Drive and LNAPL investigation

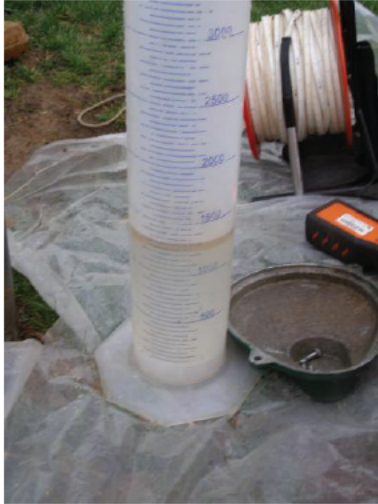
- ██████████:
- The well was gauged before and after it was bailed.
 - The well was bailed and poured into the plastic graduated cylinder.
 - An approximate 50 mL of LNAPL with well water was observed in the graduated cylinder.
 - A LNAPL sample was collected at 9:16 and the rest of the cylinder was poured into a metal bucket.

Water and LNAPL from [redacted] potable well
 3-23-26 @ 9:11

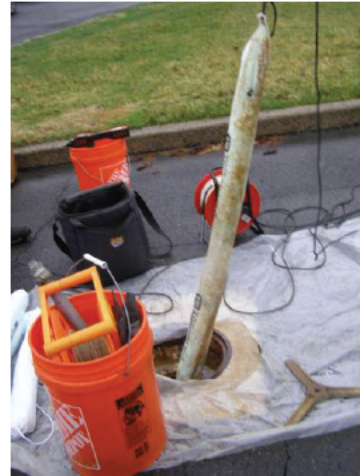
- An absorbent sock had been placed in the well, no skimmer.
- The well was gauged before and after the sock was removed. GES estimated the absorbent sock to be 5% saturated.
- The same sock was placed back into the recovery well.

Pulled absorbent sock from recovery well RW-2 in Glenwood Drive
 3-23-26 @ 9:33

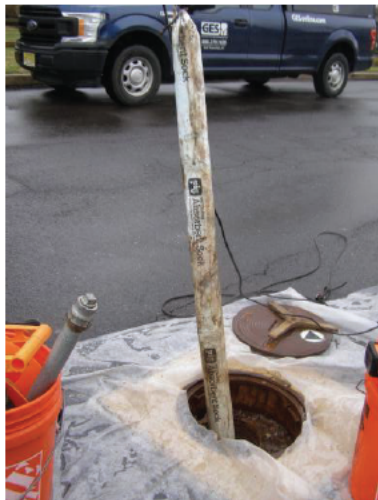
- An absorbent sock had been placed in the well, no skimmer.
- The well was gauged before and after the sock was removed. The sock appeared to be completely dry and was placed back into the well after the 2nd gauging.

Pulled absorbent sock from recovery well RW-3 in Glenwood Drive
 3-23-26 @ 9:45

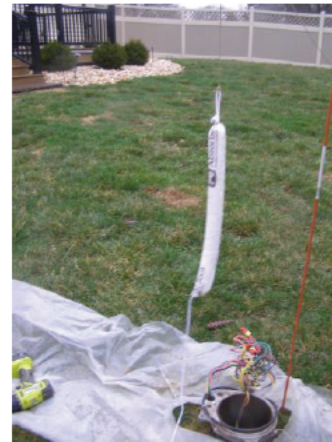
- ██████████:
- The potable well had the depth to water gauged with the absorbent sock in the well.
 - GES observed that it was fairly dry and after the 2nd gauge, was placed back into the well.

Recovered absorbent sock from the potable well at [redacted]
 3-23-26 @ 9:53

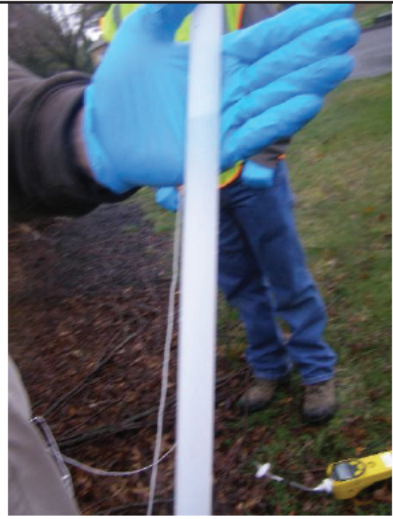
Image 001: [REDACTED]

- All the bailed water was placed into a bucket to be disposed of later.
- Photos of each bailer was taken at each residence (Photo Log below)
- Residents at ██████████ and ██████████ and ██████████ observed the activity.
