NARRATIVE REPORT FORM

Facility Name: Glenwood Drive & Walker Road

Primary Facility ID: 881609

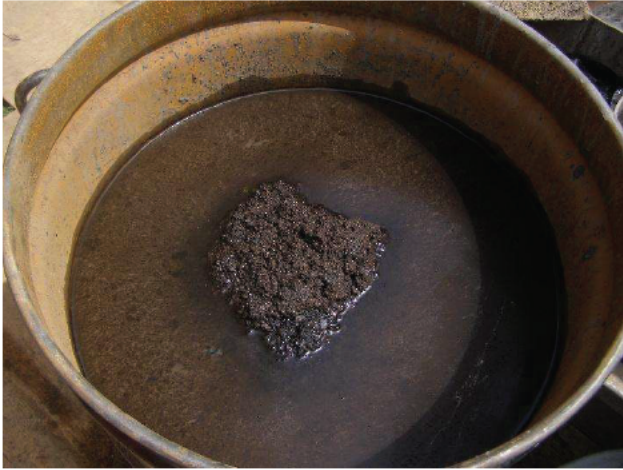
Photo 1: Oily water in storage drums

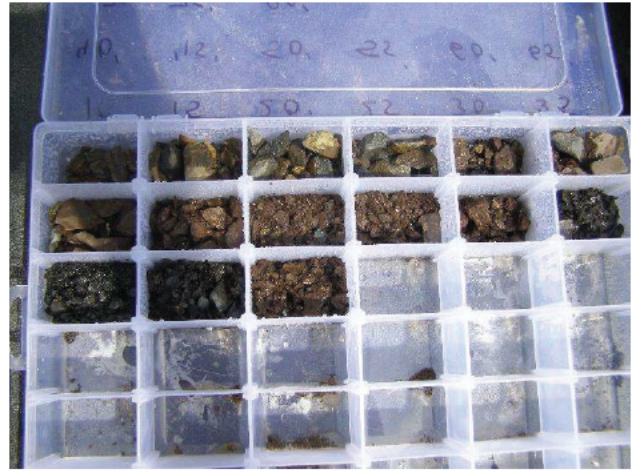
The drilling objective today was to advance the borehole from 70 feet bgs to 80 feet bgs. During drilling rock chips were collected in five-foot intervals at 75 feet bgs and 80 feet bgs (photo 2). Petroleum odors were noted throughout drilling. GES was monitoring the drilling area with a PID and MultiRae for VOC readings. GES reported that odors and PID readings were notably higher during the first 70 feet of drilling. PID readings ranged from 123.3-283.3 ppm with the most elevated readings occurring at 11-14 feet bgs and 62-67 feet bgs. After the borehole was advanced to 80 feet bgs, PID readings at the top of the casing were 296.2ppm. Additionally, there was fuel apparent in the storage drums used to collect water and rock chips during drilling (photo 1). GES also noted that there was oily water floating in the catch basin at the start of the day today. After drilling was finished for the day, the Summit crew began setting the casing so it could set overnight.

Photo 2: Rock chips collected from 5-foot intervals during drilling

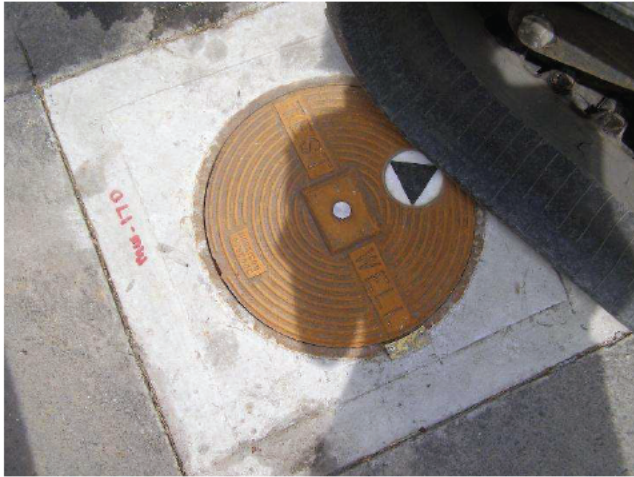
DEP arrived onsite at 10:02. Upon arrival sound barriers were placed on both sides of drilling to shield the adjacent residences. There was a GES crew performing periodic gauging of nearby potable wells and personnel from Rettew were surveying the newly installed and flush mounted wells on Glenwood Drive (photo 3&4). There was also a vacuum truck from ET onsite and Stantec was performing air monitoring. Drilling began at 10:00.

Photo 3: Flush mounting of MW-17DD

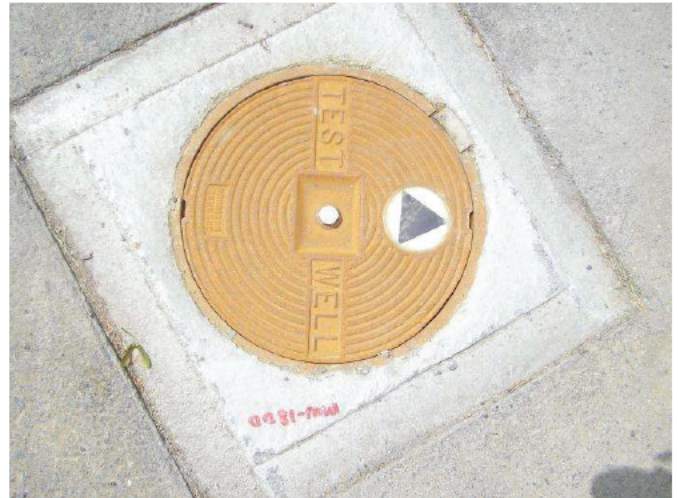
Photo 4: Flush mounting of MW-18DD
