Memo

To: Mr. Dustin Armstrong (DEP)
From: Timothy Uhler (GES)
Frank DiGnazio, P.G. (GES)
cc: Russ Devan, P.G. (DEP)
Joshua Crooks (DEP)
Date: January 7, 2022
Re: Technical Memorandum
GTAC 7-1-343 – Nockamixon TCE Site
Nockamixon Township, Bucks County, Pennsylvania

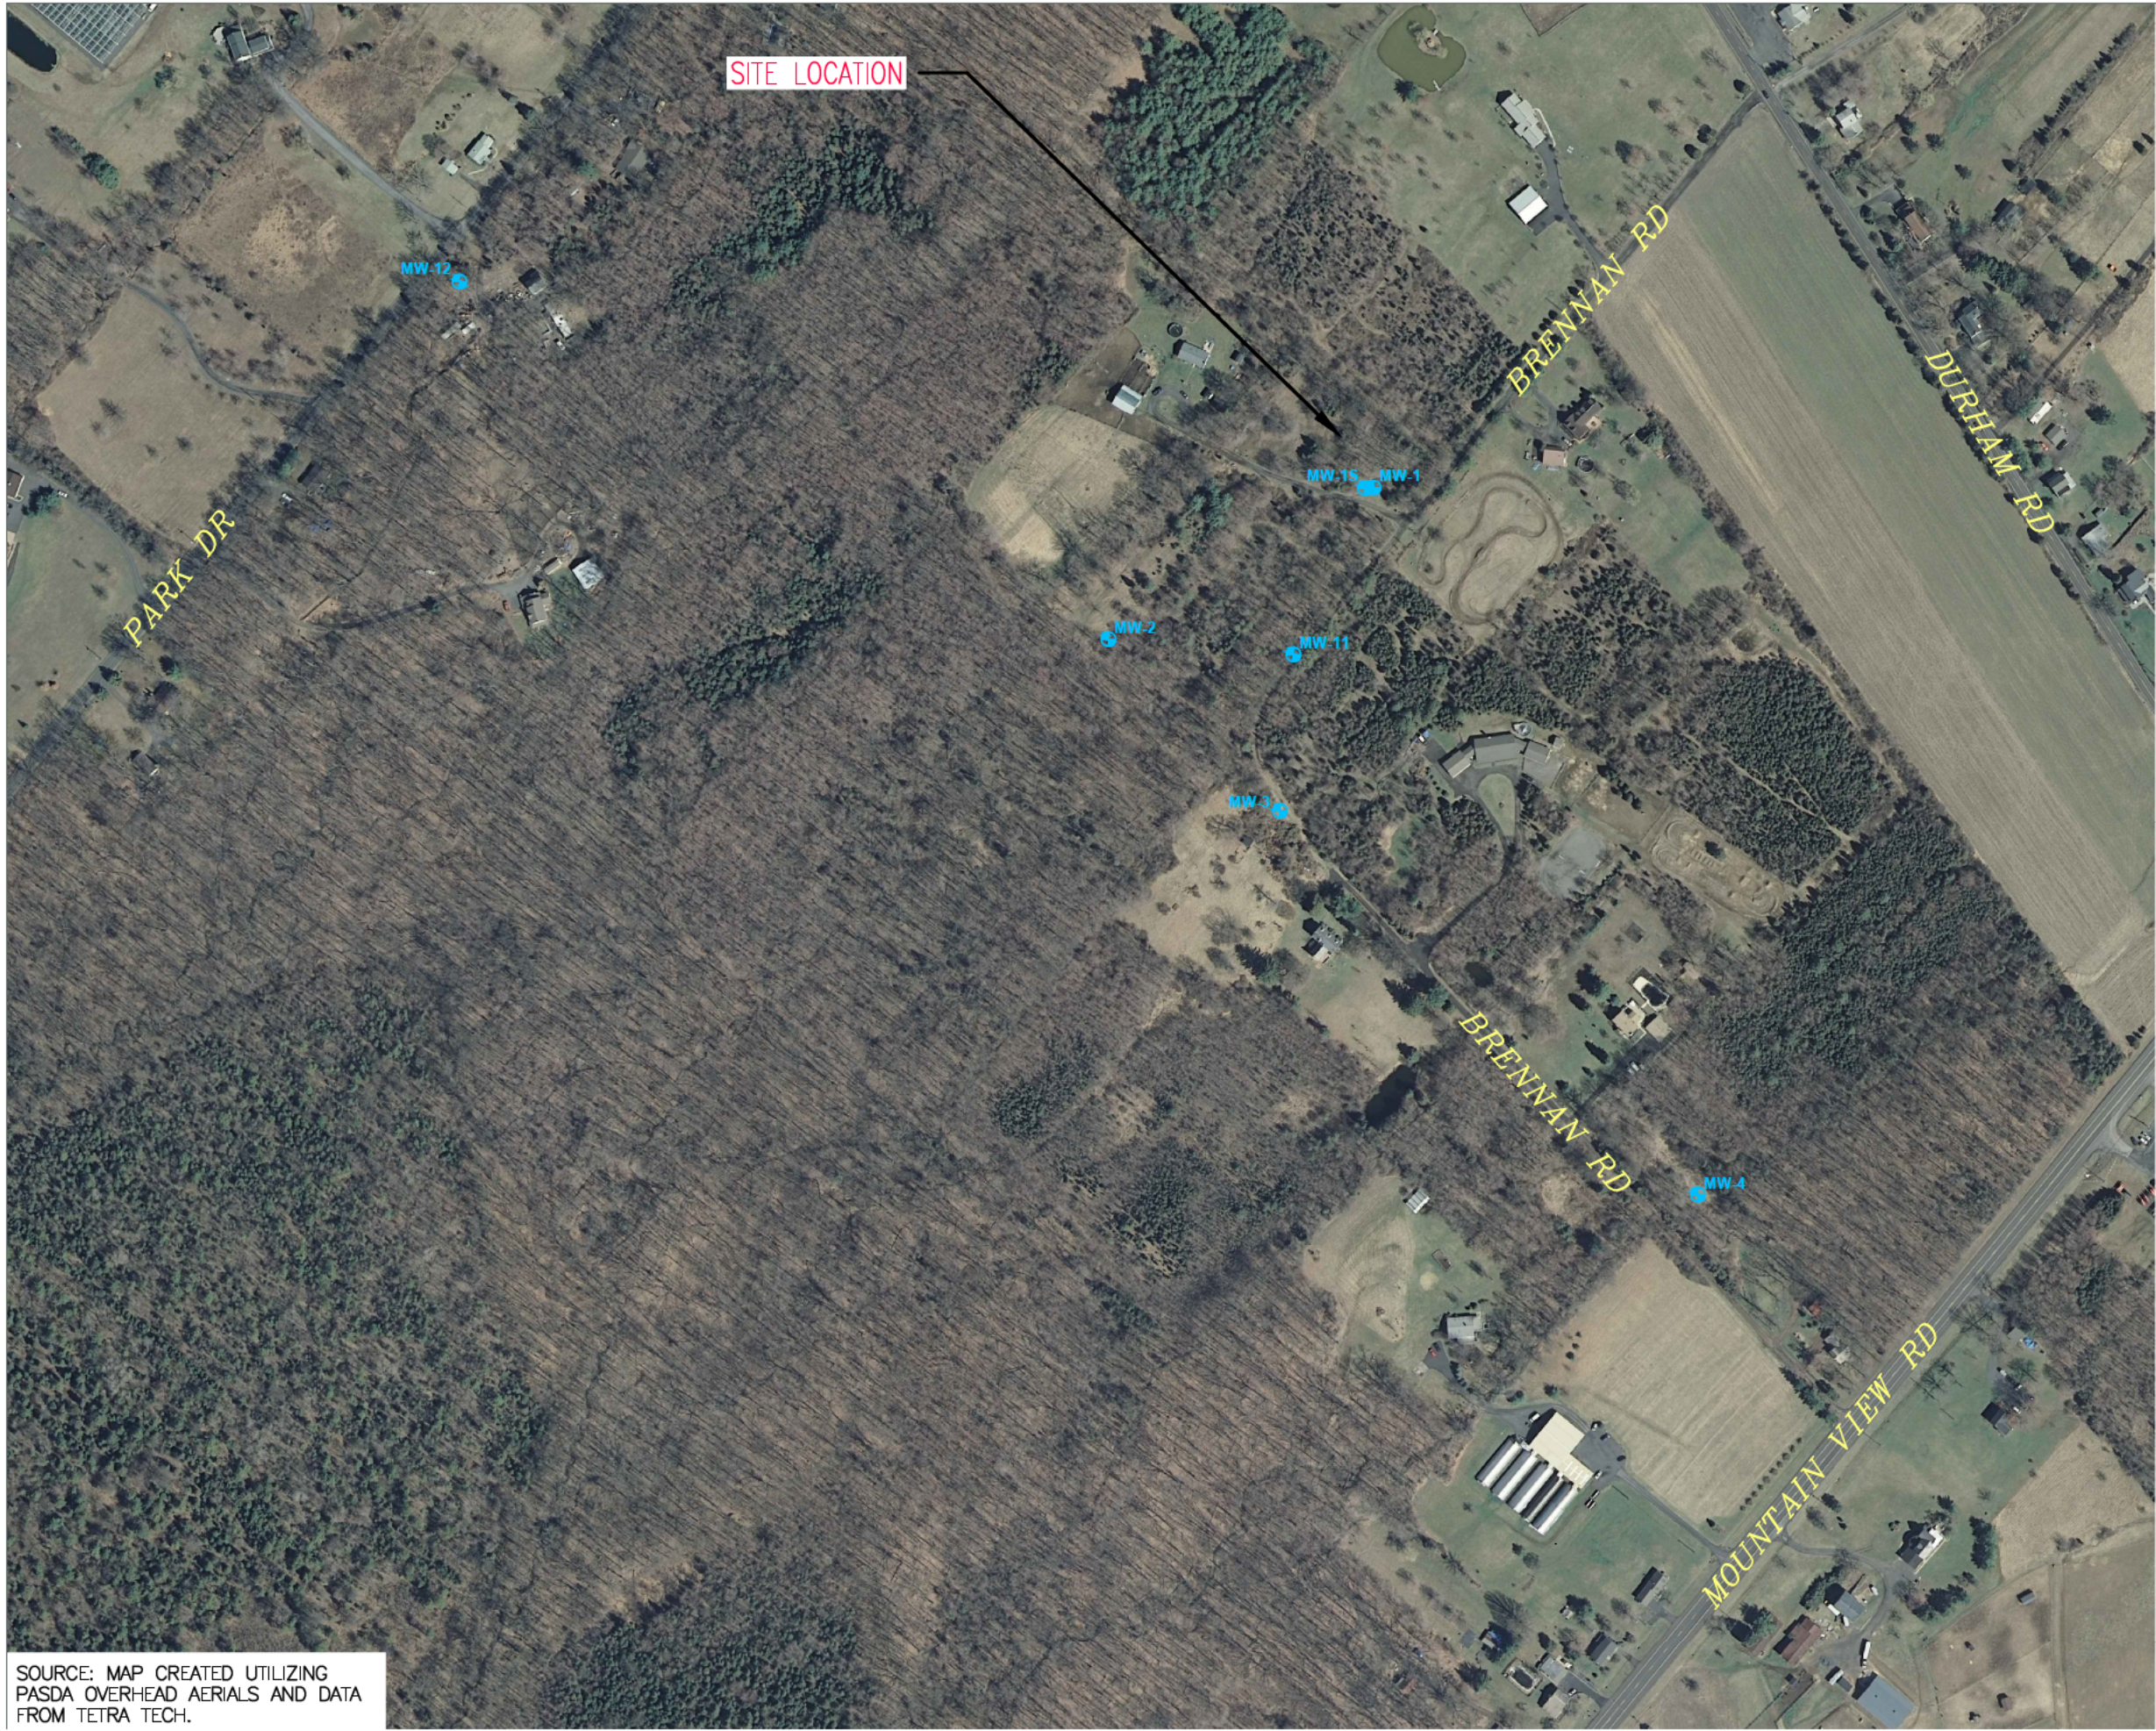
Figure 2 – Site Map

SOURCE: MAP CREATED UTILIZING
PASDA OVERHEAD AERIALS AND DATA
FROM TETRA TECH.

The Site area includes multiple residential and commercial properties located along Durham Road, Easton Road, Cord Road, Mountain View Drive, Tower Road, Brennan Road, and Park Drive West in Nockamixon Township, Bucks County, Pennsylvania. The source of the groundwater contaminant plume has been identified as a former 77.2-acre farm (Schulberger Farm) located on Brennan Road. The Site area is rural and comprises undeveloped land, farmland, residences, and businesses. A school is located on Durham Road and a quarry is located east of Easton Road. Nockamixon State Park is located to the west and southwest, and the Revere Chemical NPL Site is located northeast of the Site. A Site Location Map is included as **Figure 1** and a Site Layout Map is included as **Figure 2**.

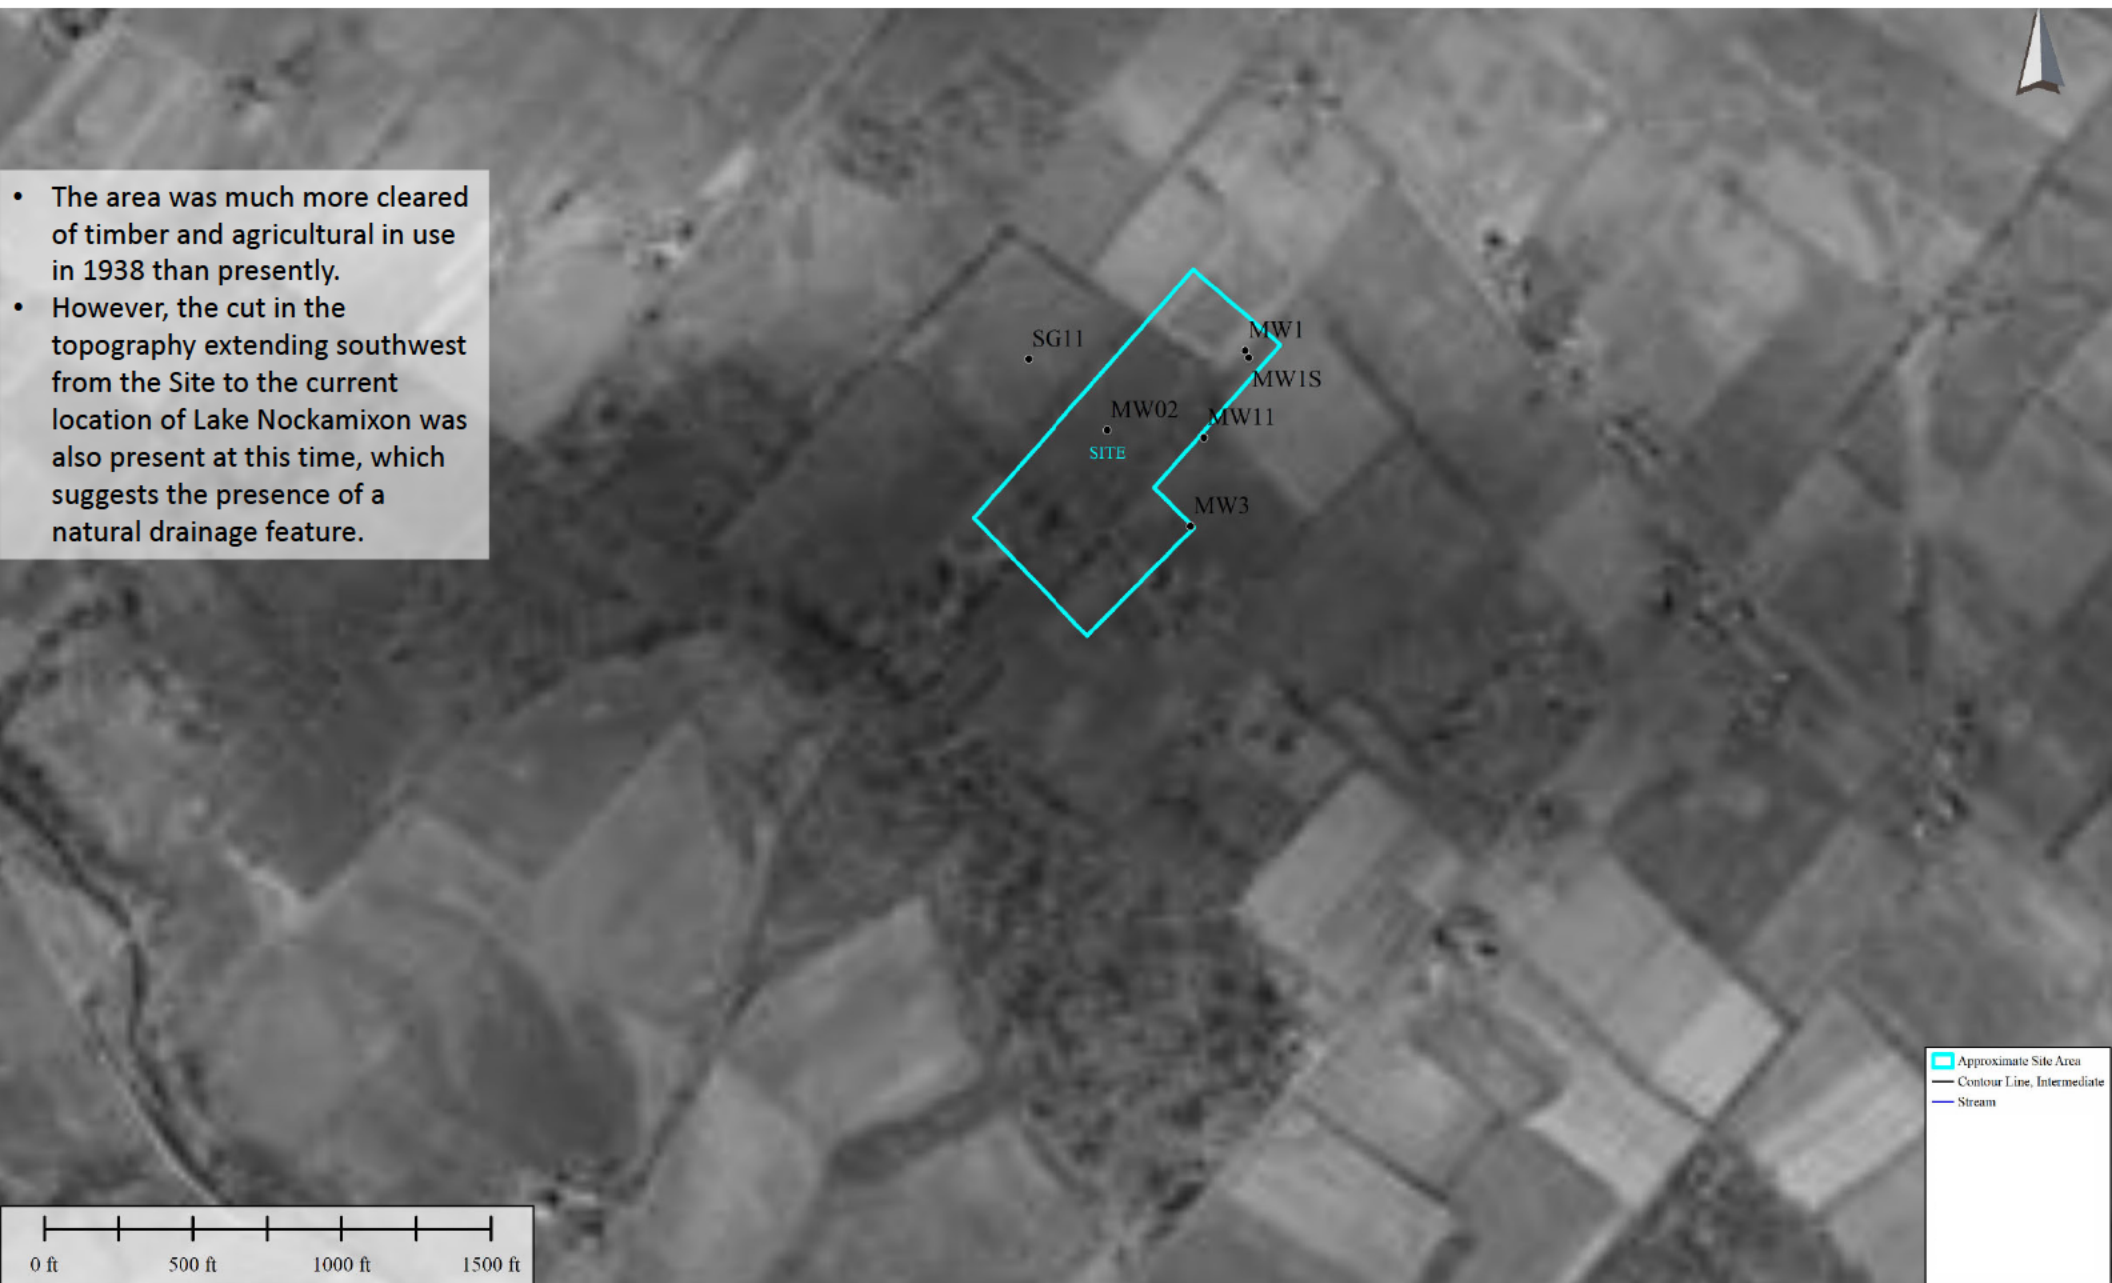
Figure 10 – LiDAR-Identified Linear Features Overlain on Historic 1938 Aerial Photograph

- The area was much more cleared of timber and agricultural in use in 1938 than presently.
- However, the cut in the topography extending southwest from the Site to the current location of Lake Nockamixon was also present at this time, which suggests the presence of a natural drainage feature.

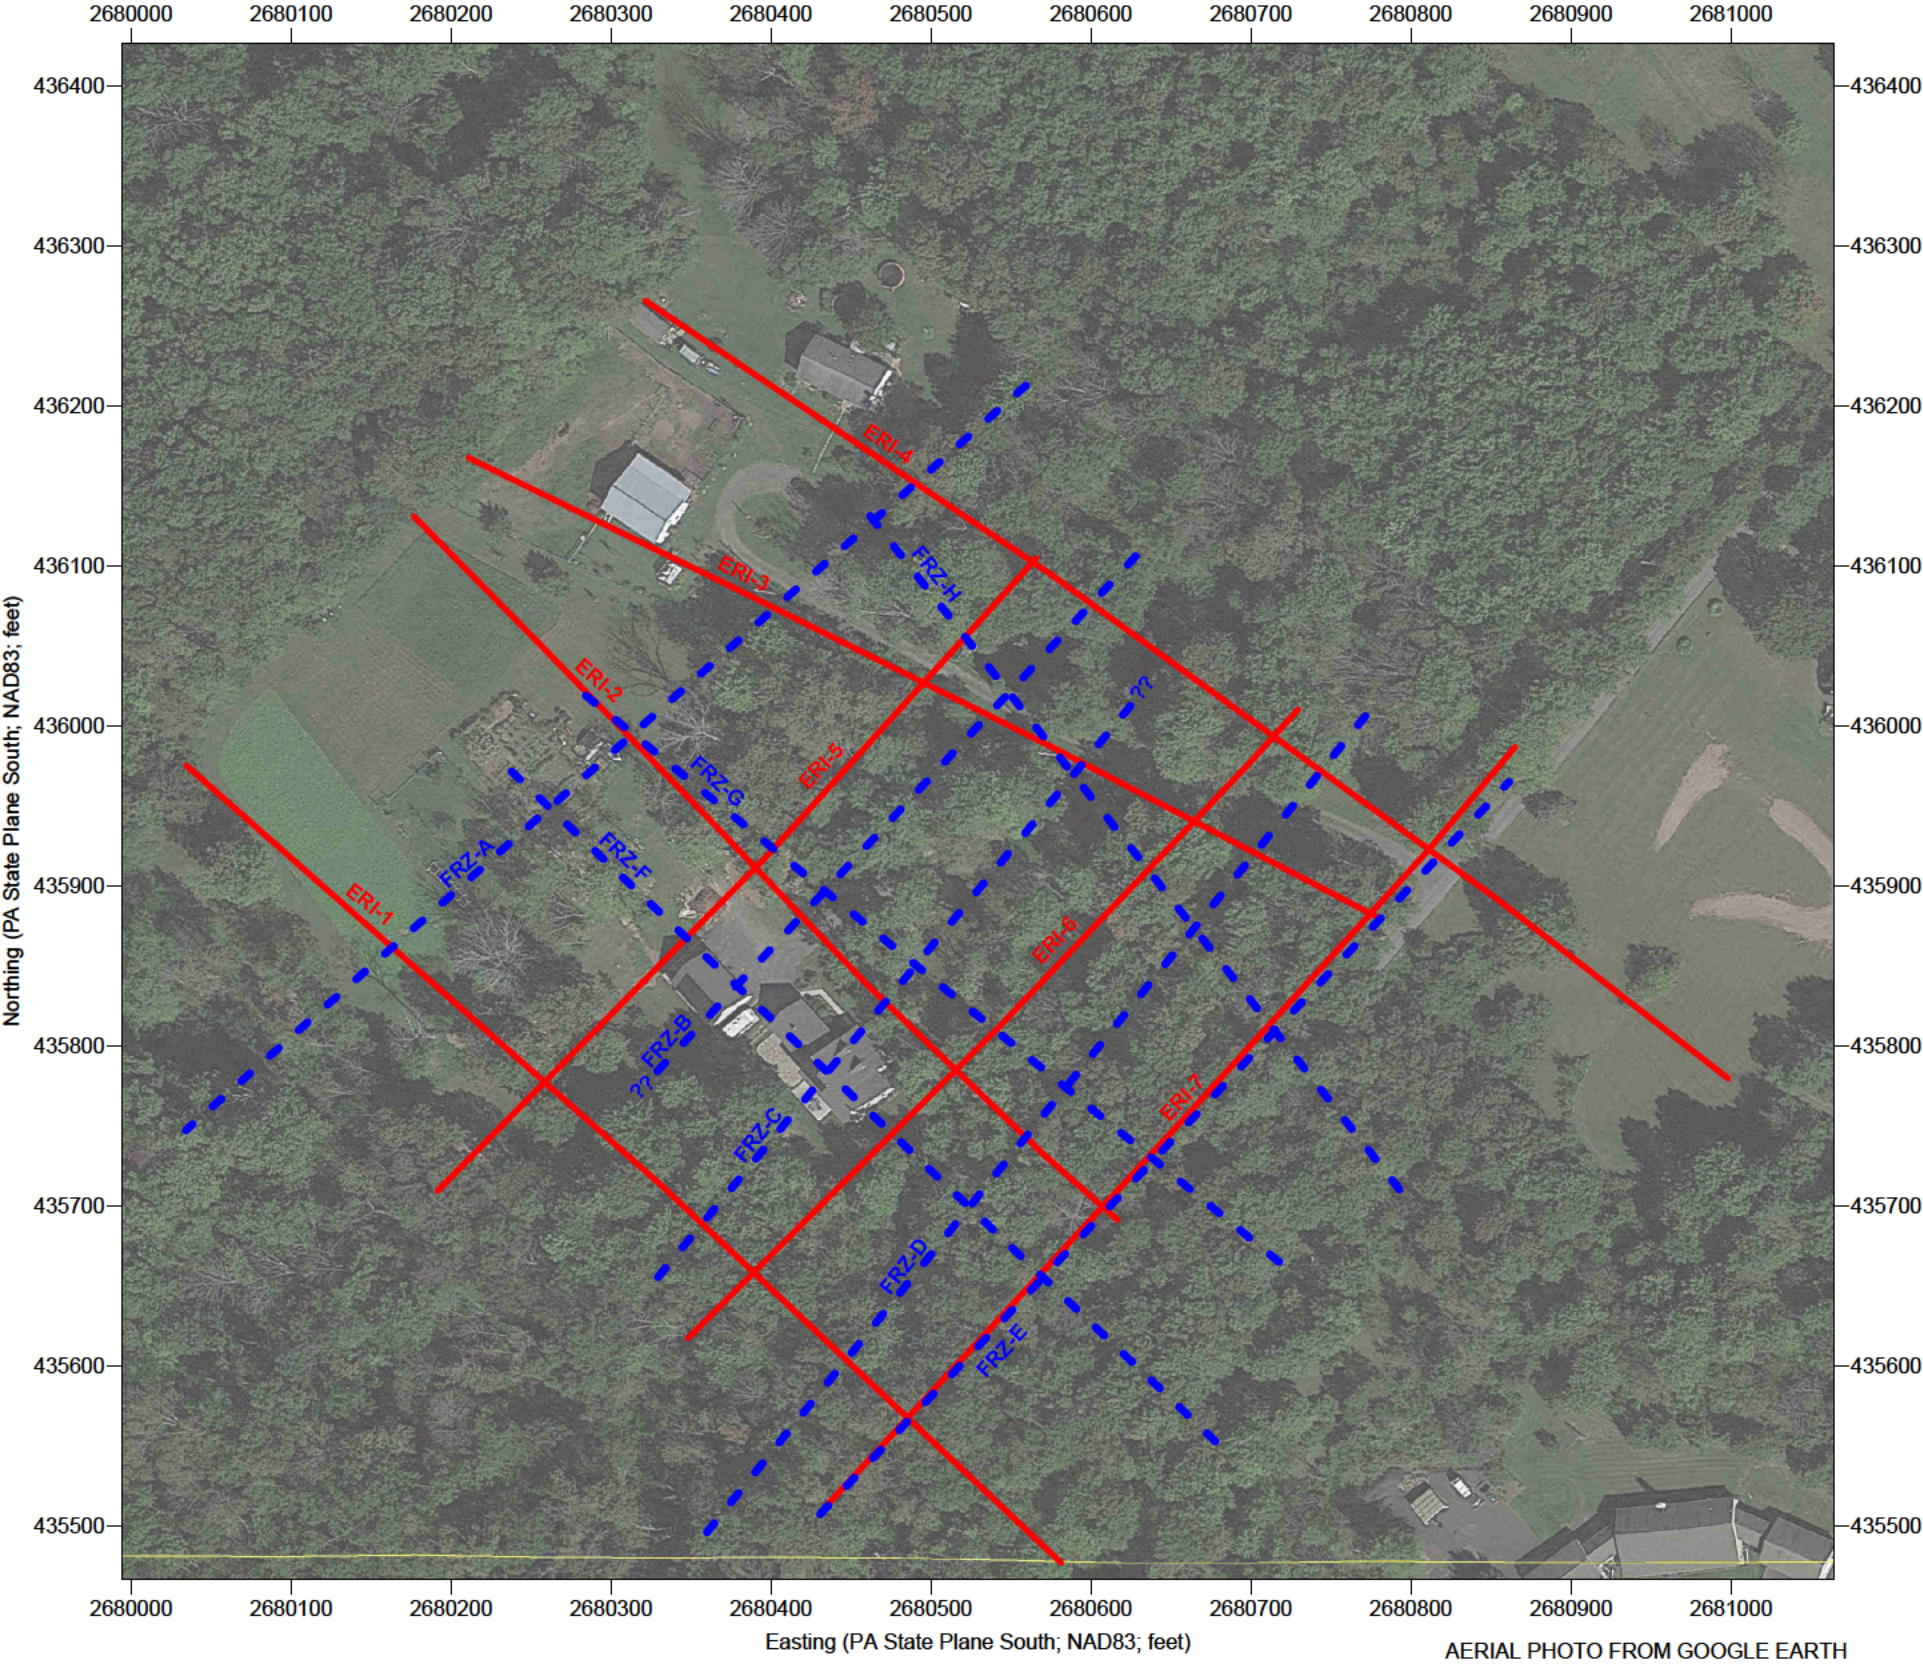
Potential Bedrock Fracture Zone
Interpreted from ERI Models

<div><div><div></div></div><div>ADVANCED GEOLOGICAL SERVICES</div></div> <div>3 MYSTIC LANE MALVERN, PA 19355 (610) 722-5500</div>		Electrical Resistivity Imaging Survey Line Location Plot	
AGS PROJECT #: 21-183-1		LOCATION: GTAC Nockamixon TCE Site Nockamixon, Pennsylvania	
DATE: June 30, 2021		CLIENT: Groundwater & Environmental Services	1
		ADVANCED GEOLOGICAL SERVICES, INC.	
		DRAWN BY: M. Young	APPROVED BY: DJ

Locations of northwest to southeast ERI profiles and interpreted fracture zones are shown on Figure 1. The individual ERI model profiles are shown on Figure 2 and 3. Five potential fracture zones were identified from northwest to southeast oriented profiles. Potential fractures FRZ-A through FRZ-E are shown on Figure 1 and on the individual ERI model profiles. These fracture zones are oriented southwest to northeast, approximately perpendicular to the resistivity transects. The most prominent southwest to northeast fracture zone is FRZ-A which can be identified in all ERI northwest to southeast profiles, and being most prominent in profile ERI-3.

Three potential fracture zones were identified passing through profiles ERI-5, ERI-6, and ERI-7, the most prominent being FRZ-H (Figures 1 and 6). Fracture zones FRZ-F and FRZ-G are oriented approximately northwest to southeast, whereas fracture FRZ-H is oriented slight more
