# Memorandum

**Re:** Final Screening Evaluation Memorandum  
GTAC 7-1-343 – Nockamixon TCE Site  
Nockamixon Township, Bucks County, Pennsylvania

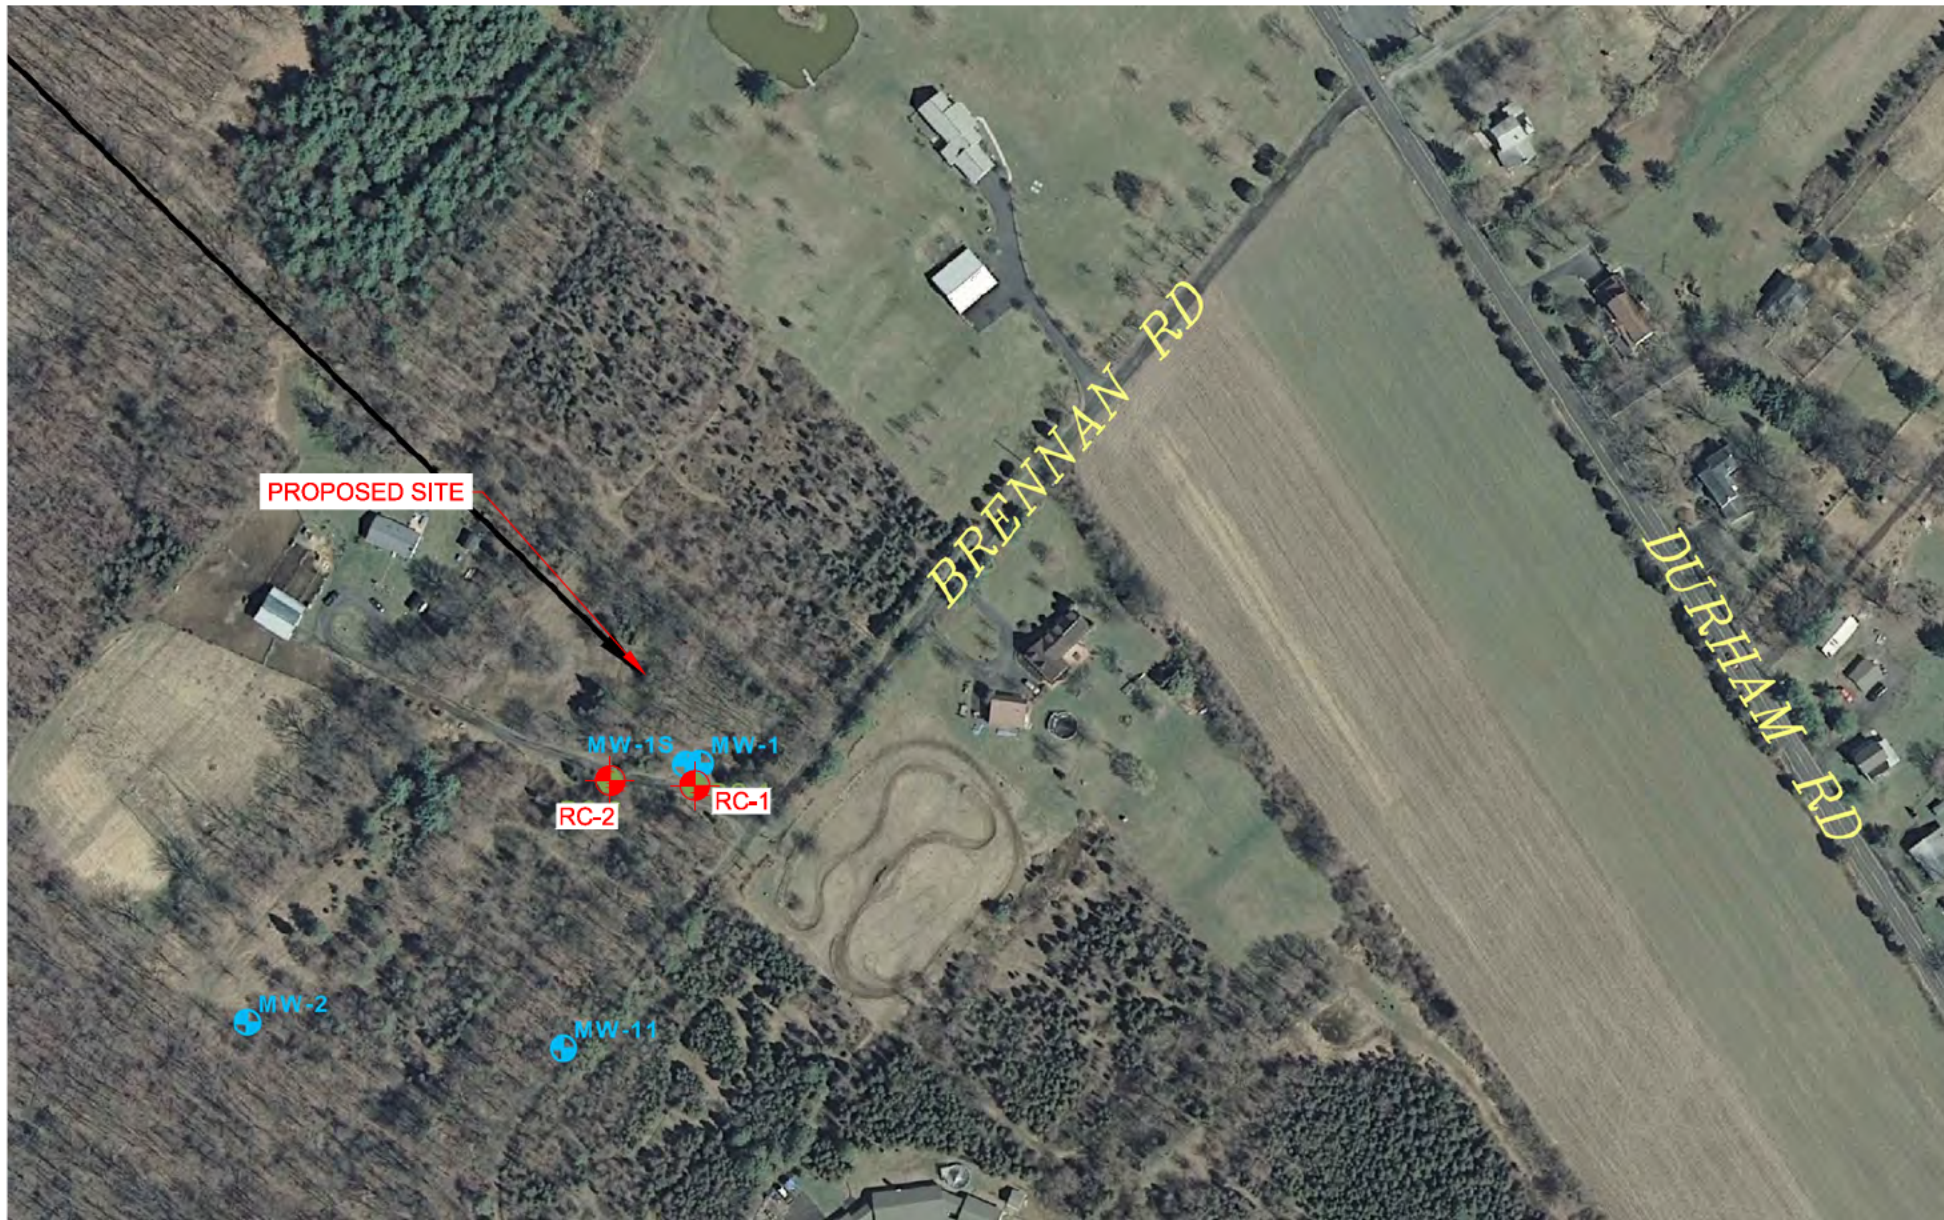
FIGURE 2. SITE GEOLOGIC MAP  
GTAC - NOCKAMIXON TCE SITE  
NOCKAMIXON TWP., BUCKS CO., PA

Per the USGS geologic maps (see Figure 2. Site Geologic Map), the site is underlain by of the Brunswick Formation (Trb), which consists of reddish-brown mudstone, siltstone, and shale, containing a few green and brown shale interbeds; red and dark-gray, interbedded argillites near base. A half mile northeast of the site is the geologic contact with the Lockatong Formations which is described as dark-gray to black, thick-bedded argillite containing a few zones of thin-bedded black shale; locally has thin layers of impure limestone and calcareous shale. Cores from the upper 15 ft of the rock are identified as gray to dark, bluish gray, calcareous argillite, which seems to more closely align with the description of the nearby Lockatong Formation rather than the Brunswick rocks. The overburden soils consist of stiff to hard, residual silt and clay with rock fragments, derived from advanced weathering of the argillite.

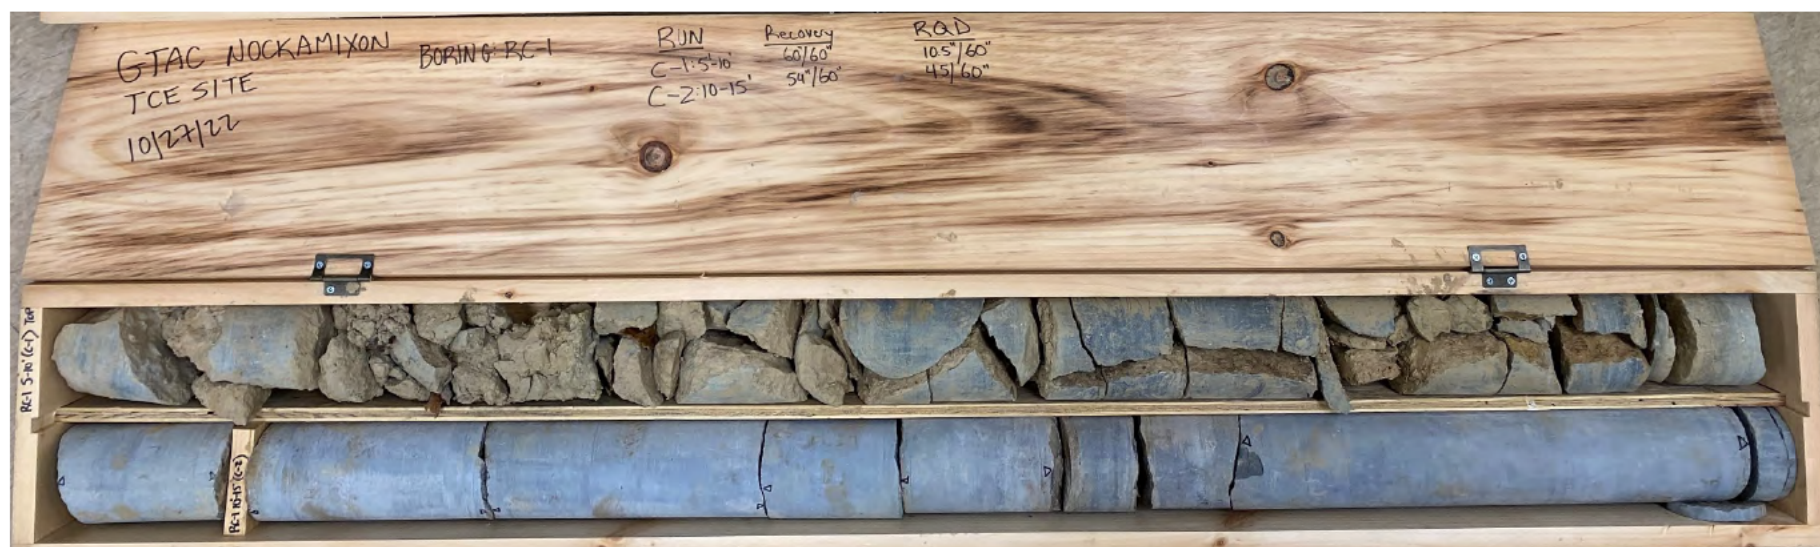
Photo 1. Cores of Boring RC-1

**Rock Mass Characterization.** The argillite rock was encountered at a depth of 5 ft. Based on our close visual examination of the cores from RC-1 and RC-2 and the laboratory measured unconfined compressive strength values, the upper 10 ft of the rock mass (to a depth of 15 ft below grade) is categorized into 2 layers that differ mainly in the fracturing and degree of weathering as follows.

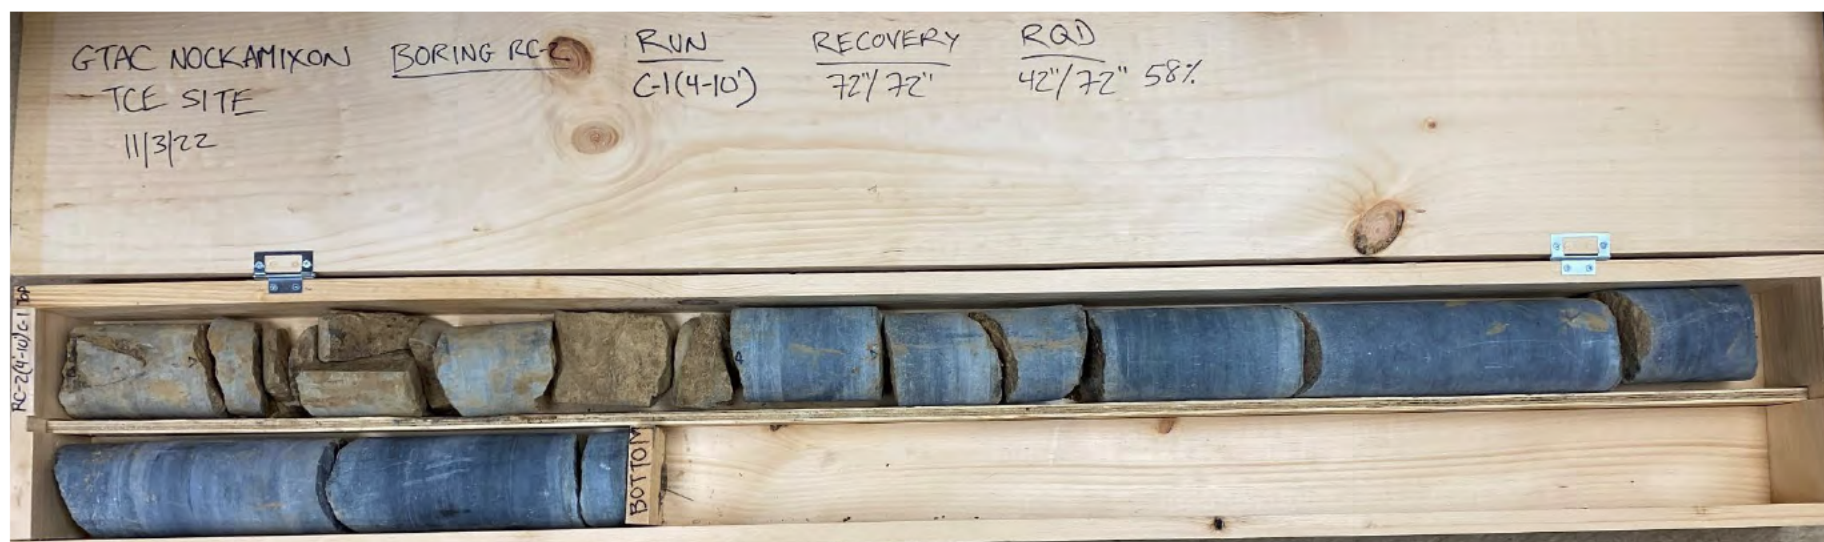
Photo 2. Cores of Boring RC-2

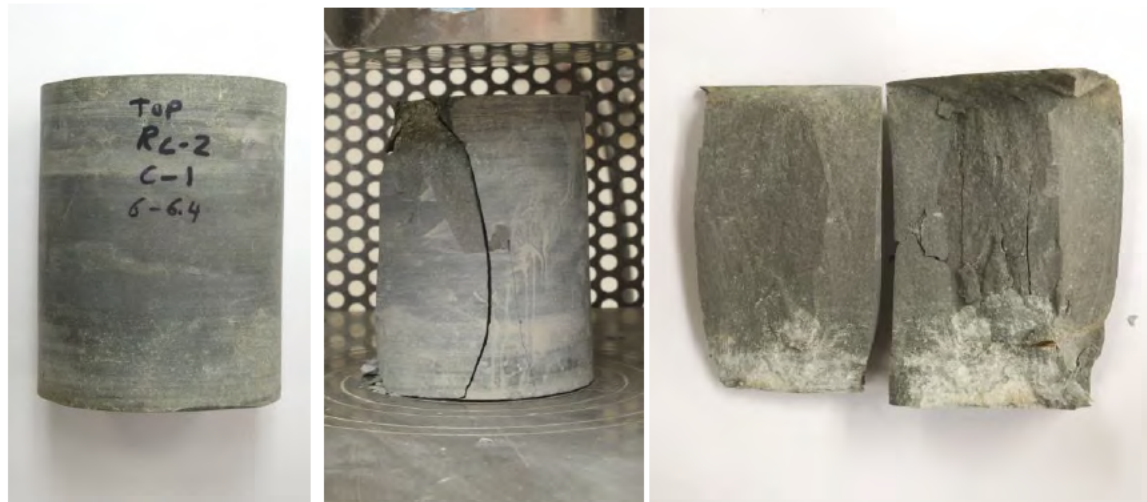
# ROCK UNCONFINED COMPRESSION TEST REPORT (ASTM D7012)

ID / Run	Depth	Diameter (in.)	Height (in.)	Unit weight (pcf)	Corrected Compressive Strength (psi)
RC-2 / C-1	6.0 - 6.4	3.32	4.64	162.2	12,173

GeoStructures performed unconfined compressive strength testing on 4 selected core specimens per ASTM D7012 for rippability assessment purposes. It is noted that 2 of the specimens did not reach the failure point and the tests were terminated at the machine's load capacity. The results and stress-strain curves are presented in Attachment B.

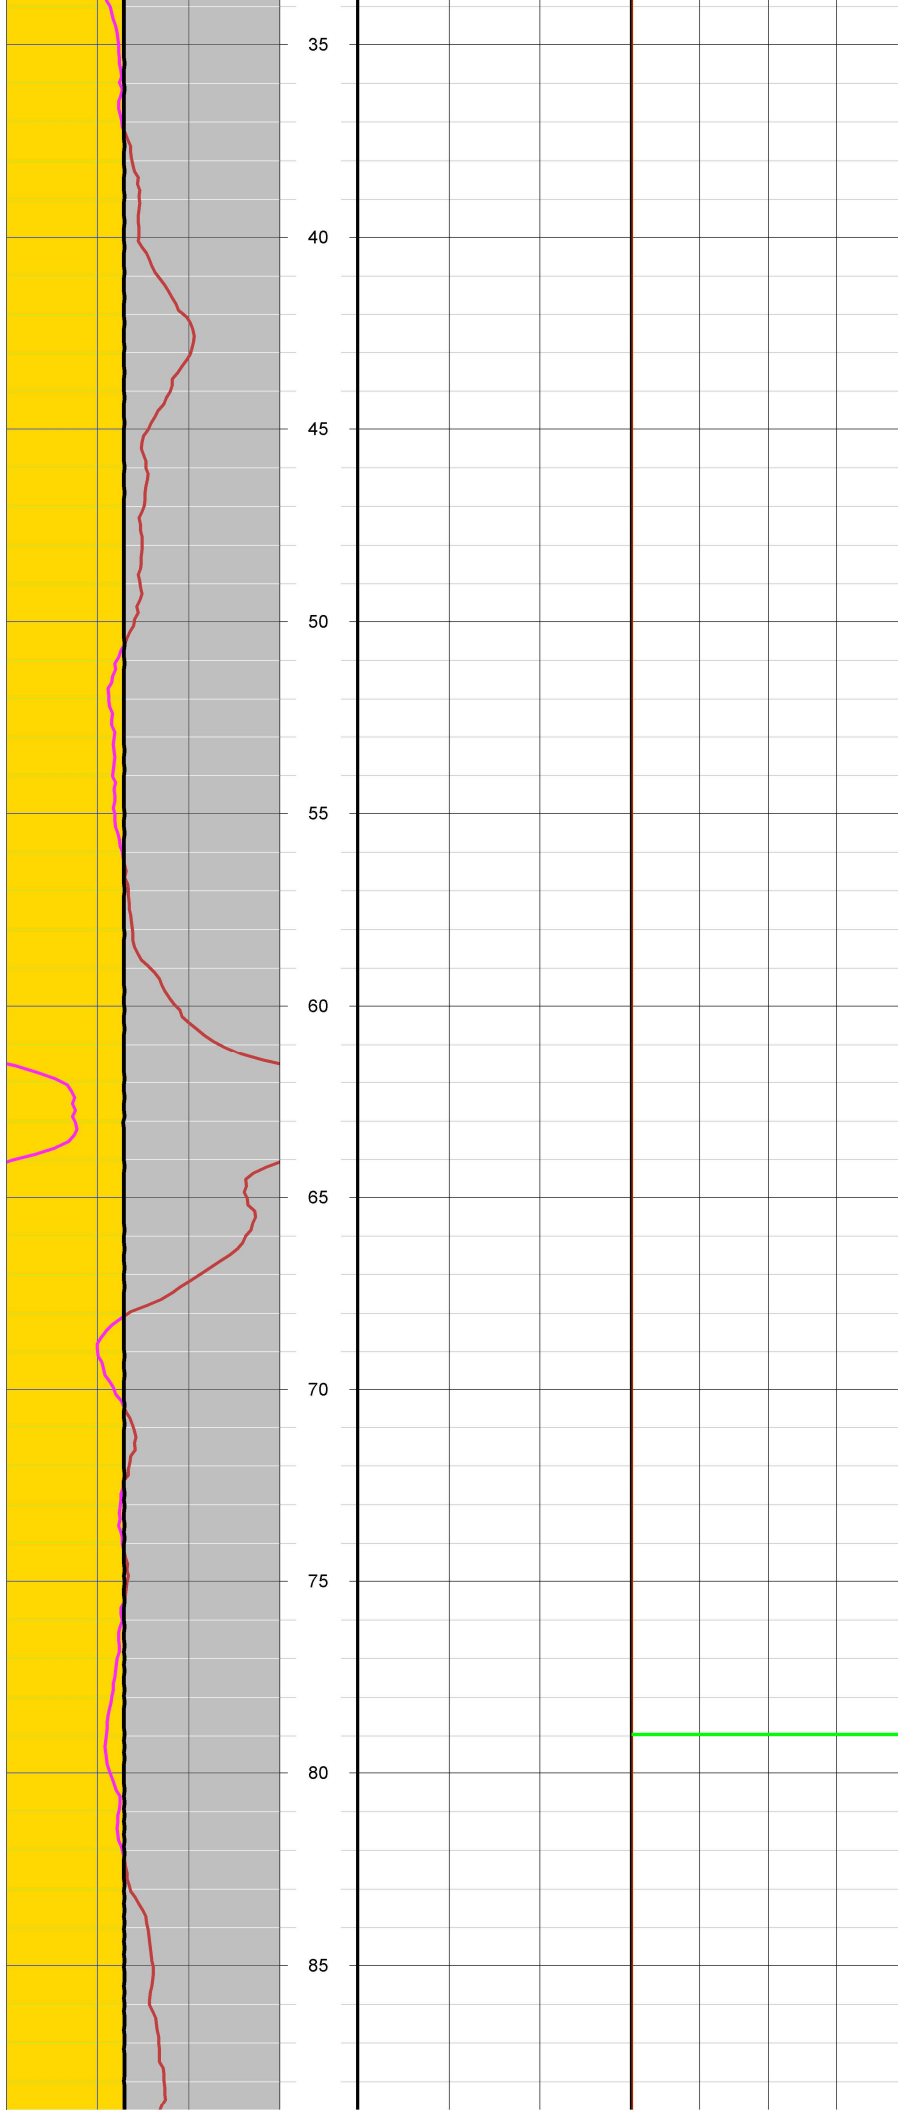
Depth Datum: Ground Surface  
Borehole Dia.: 5 in. (PQ core)  
Total Depth: 150 ft.  
Casing Type: Steel  
Casing Depth: approx. 5 ft.  
Casing Stickup Ht.: 2.25 ft. (temporary casing)  
Water Level: 97.5 ft.

**Remarks:** Structure Plot Colors: Green = Bedding plane, parting or fracture  
Magenta = Open joint or fracture  
Orange = partially open joint or fracture  
Gray = Filled joint or fracture  
Cyan = Discontinuous fracture

Geophysical logging results were evaluated to determine bedrock characteristics that will assist remedial option evaluation for source area groundwater. Additionally, GES and DEP reviewed the downhole geophysical logs and proposed discreet groundwater sampling intervals in each of the two rock core locations. These intervals were selected based on the identified water bearing fractures and will be used to determine vertical dispersion of the bedrock aquifer impacts and if any downward migration from the source area overburden may be occurring. A copy of the downhole geophysical results report prepared by AGS is included as **Attachment D**.

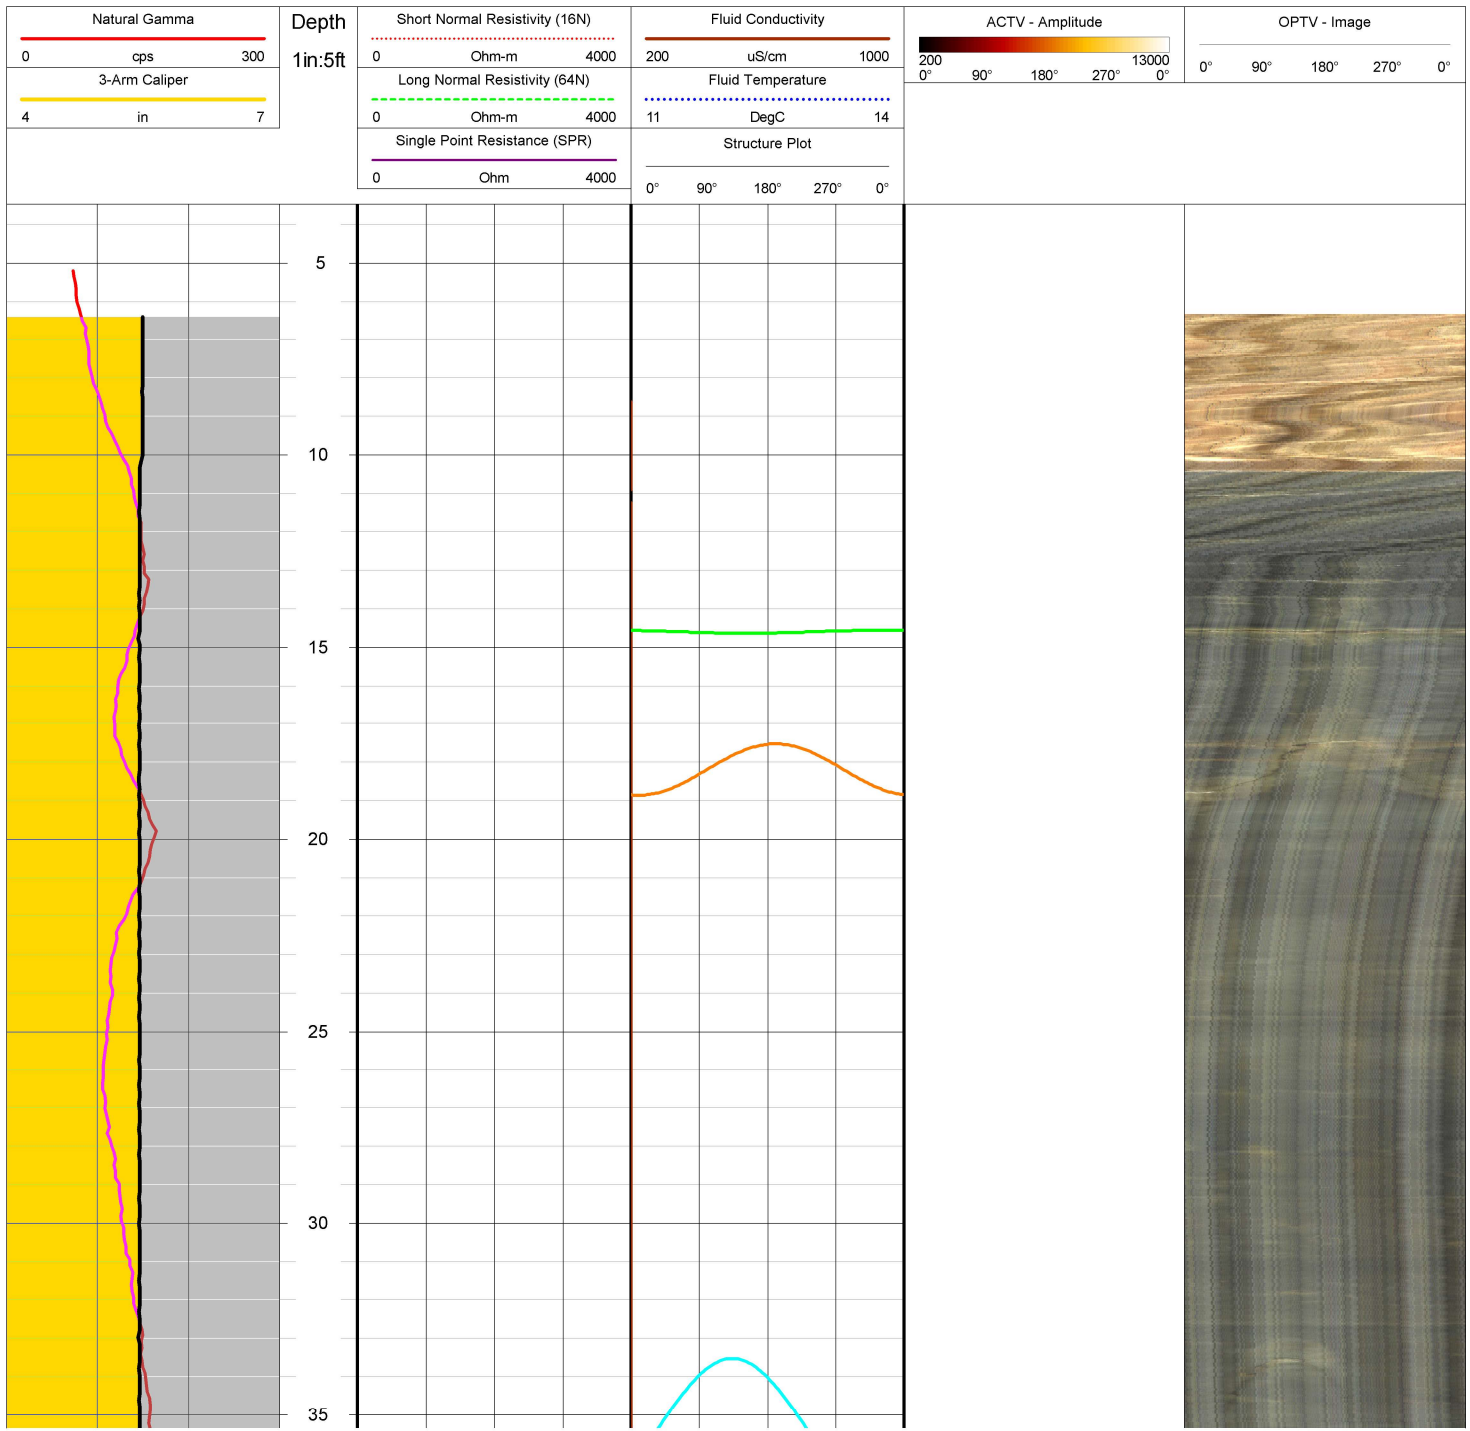
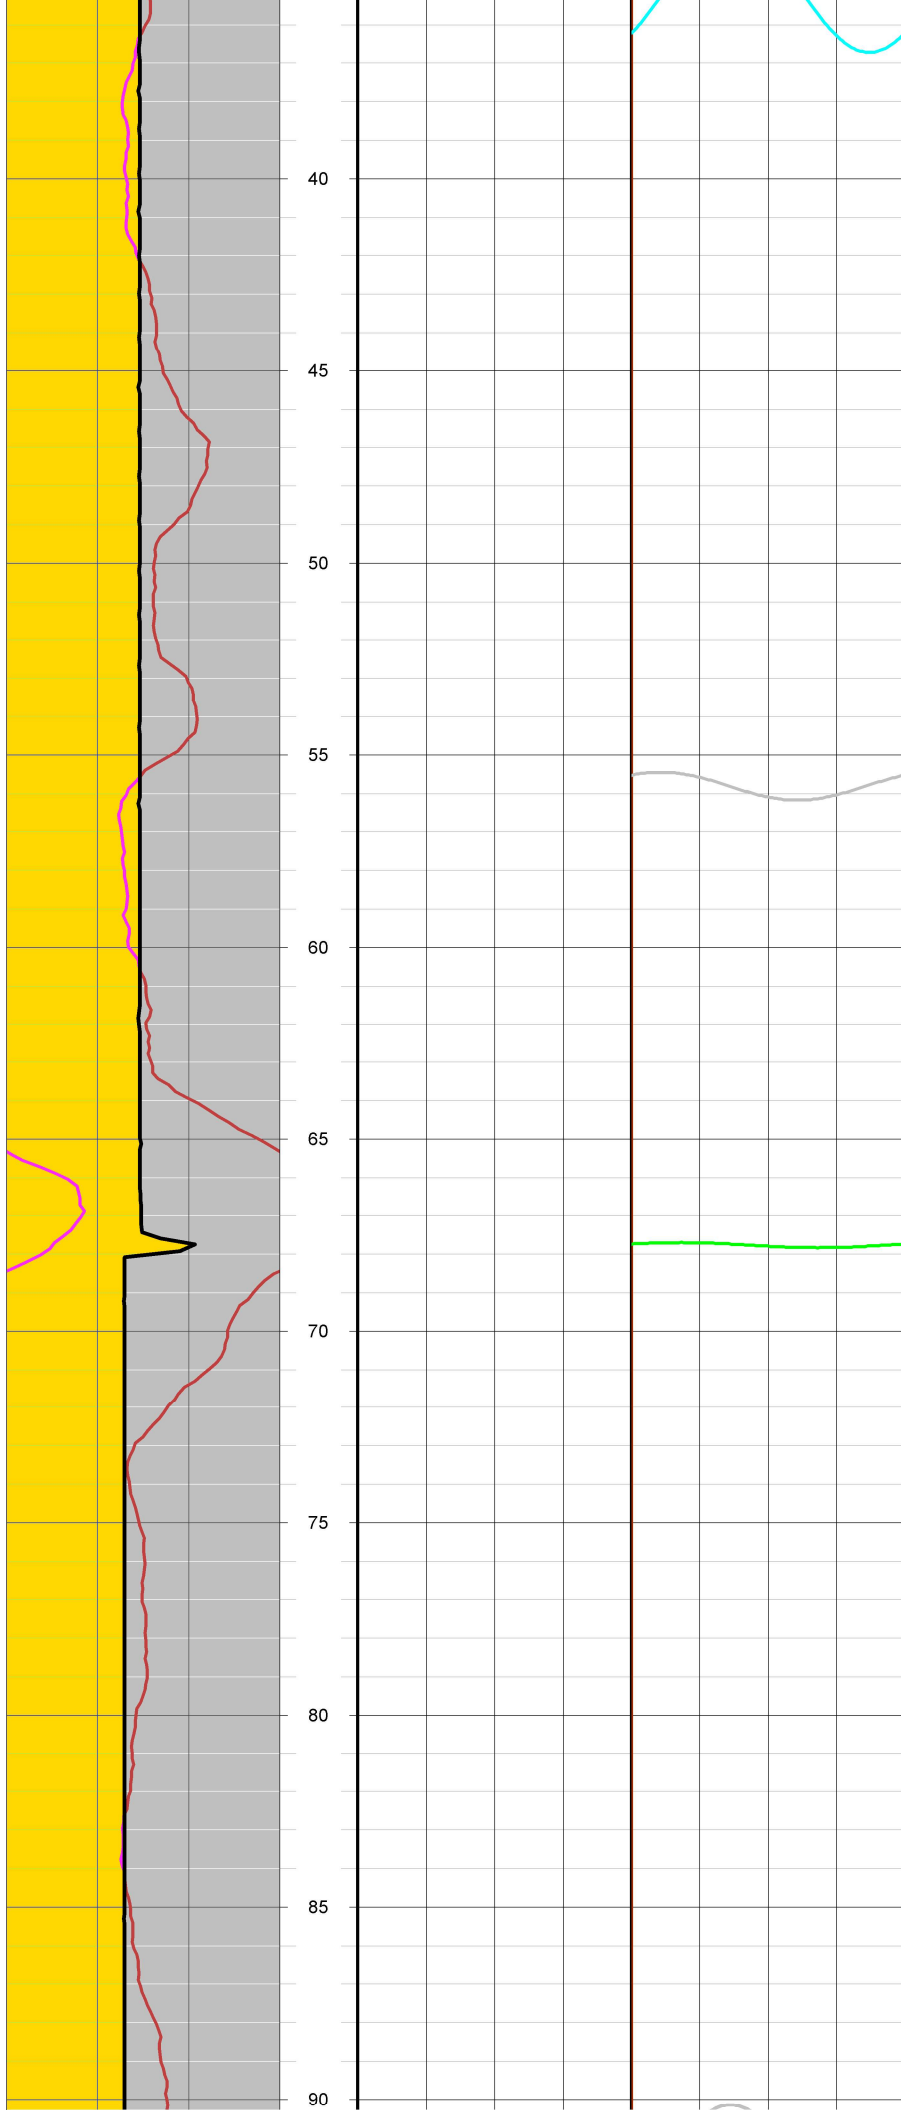
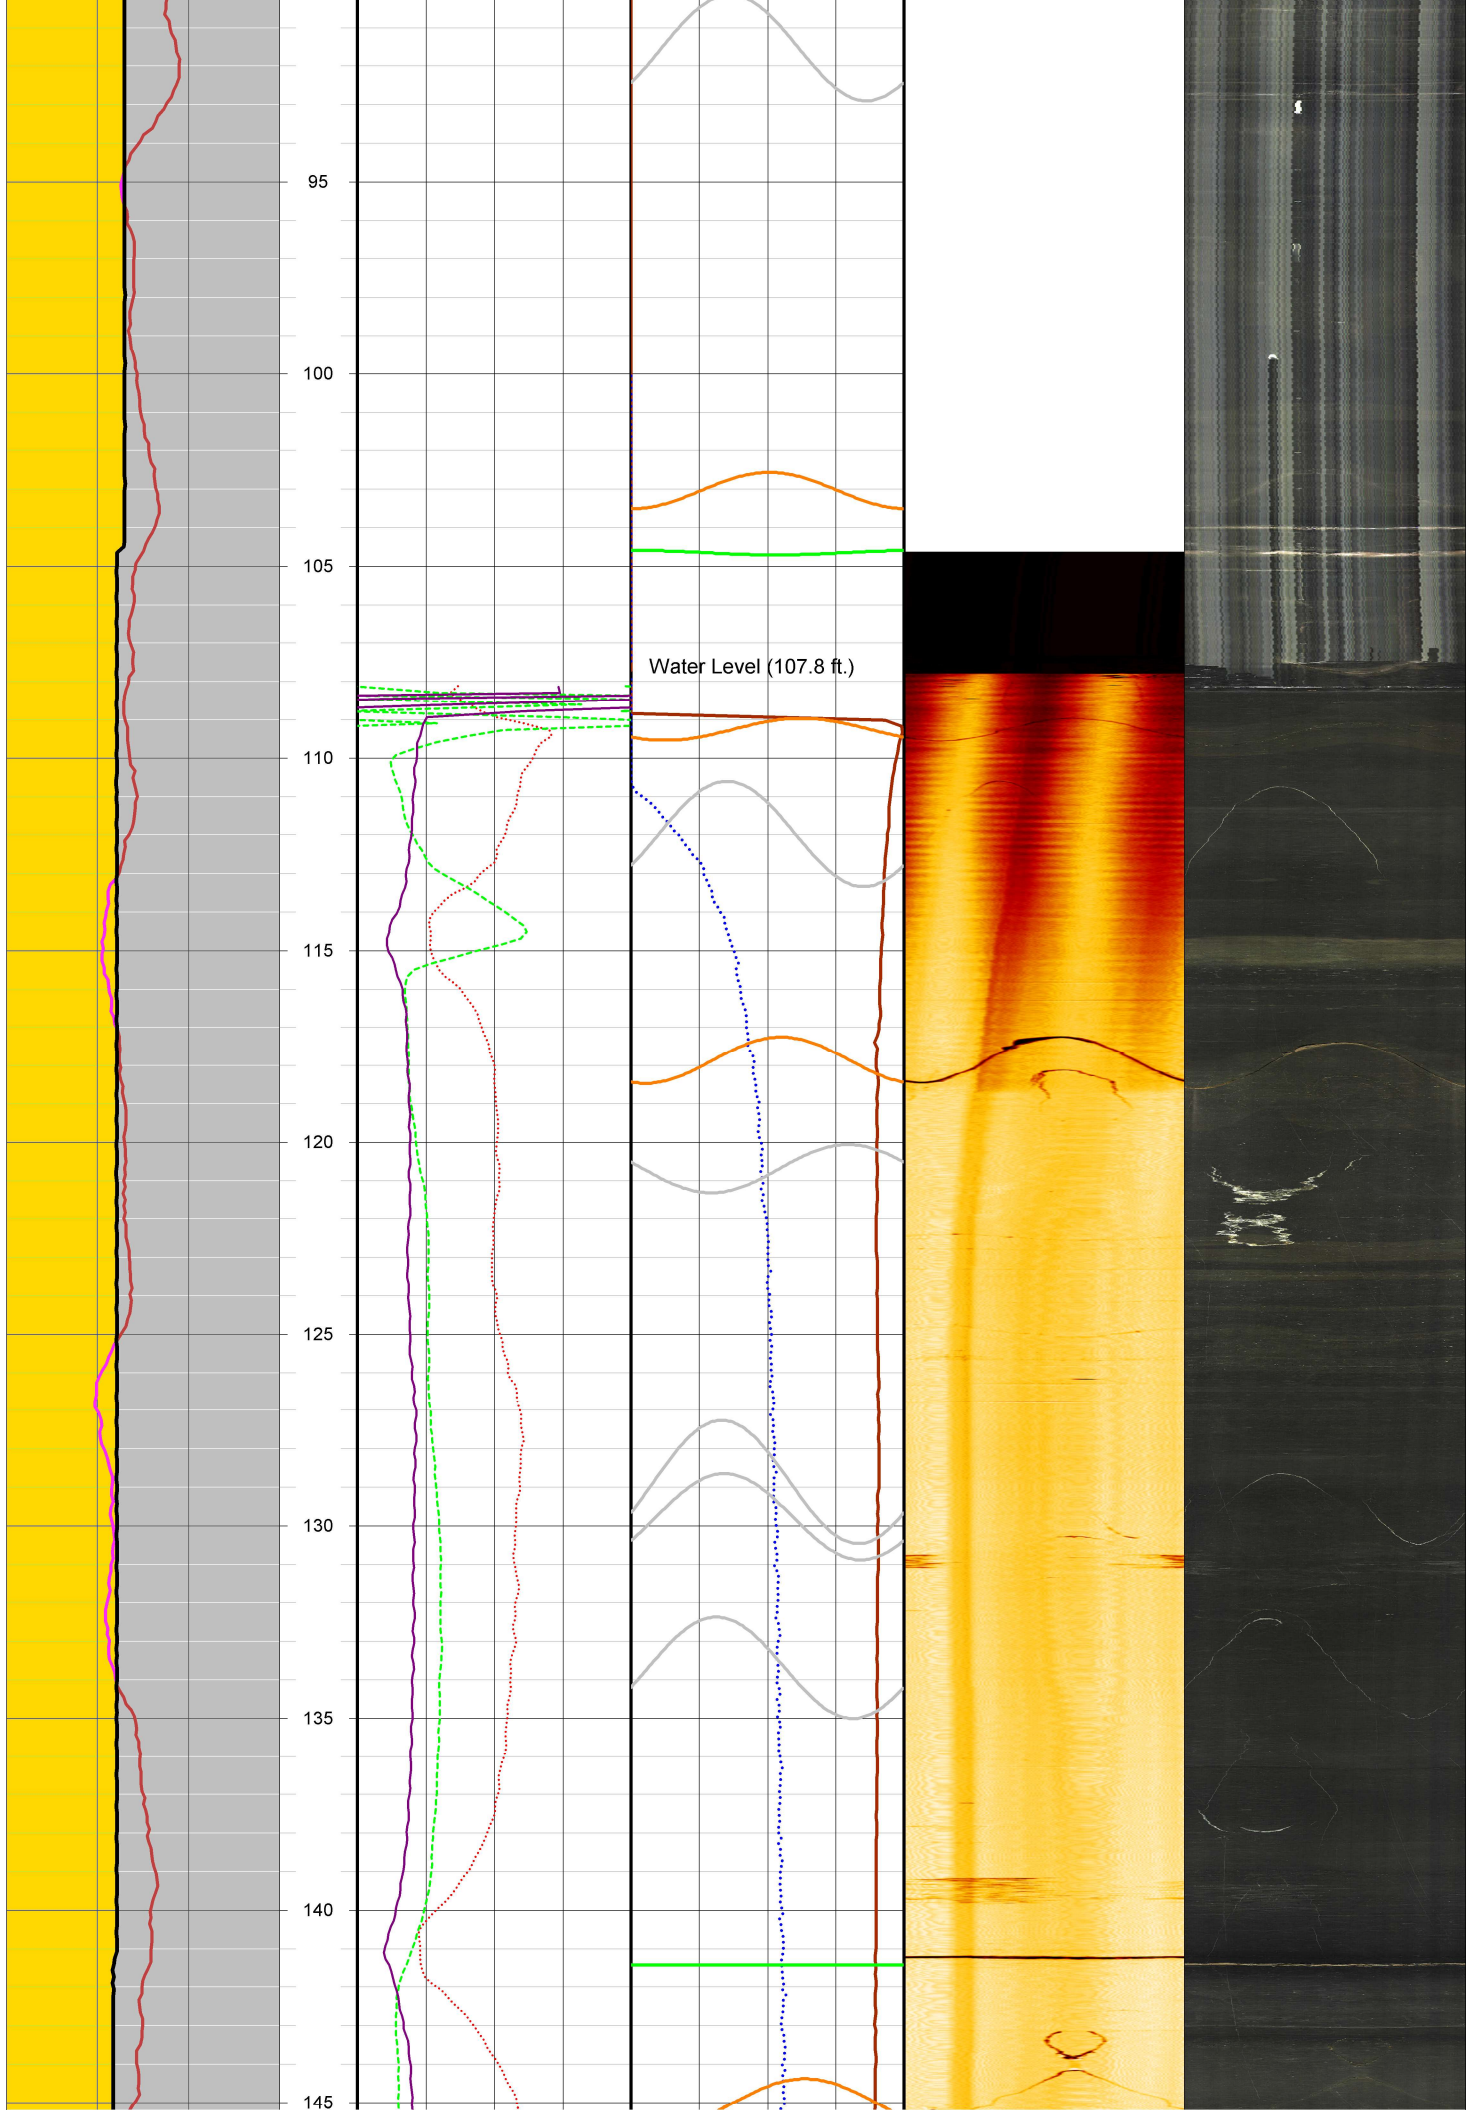
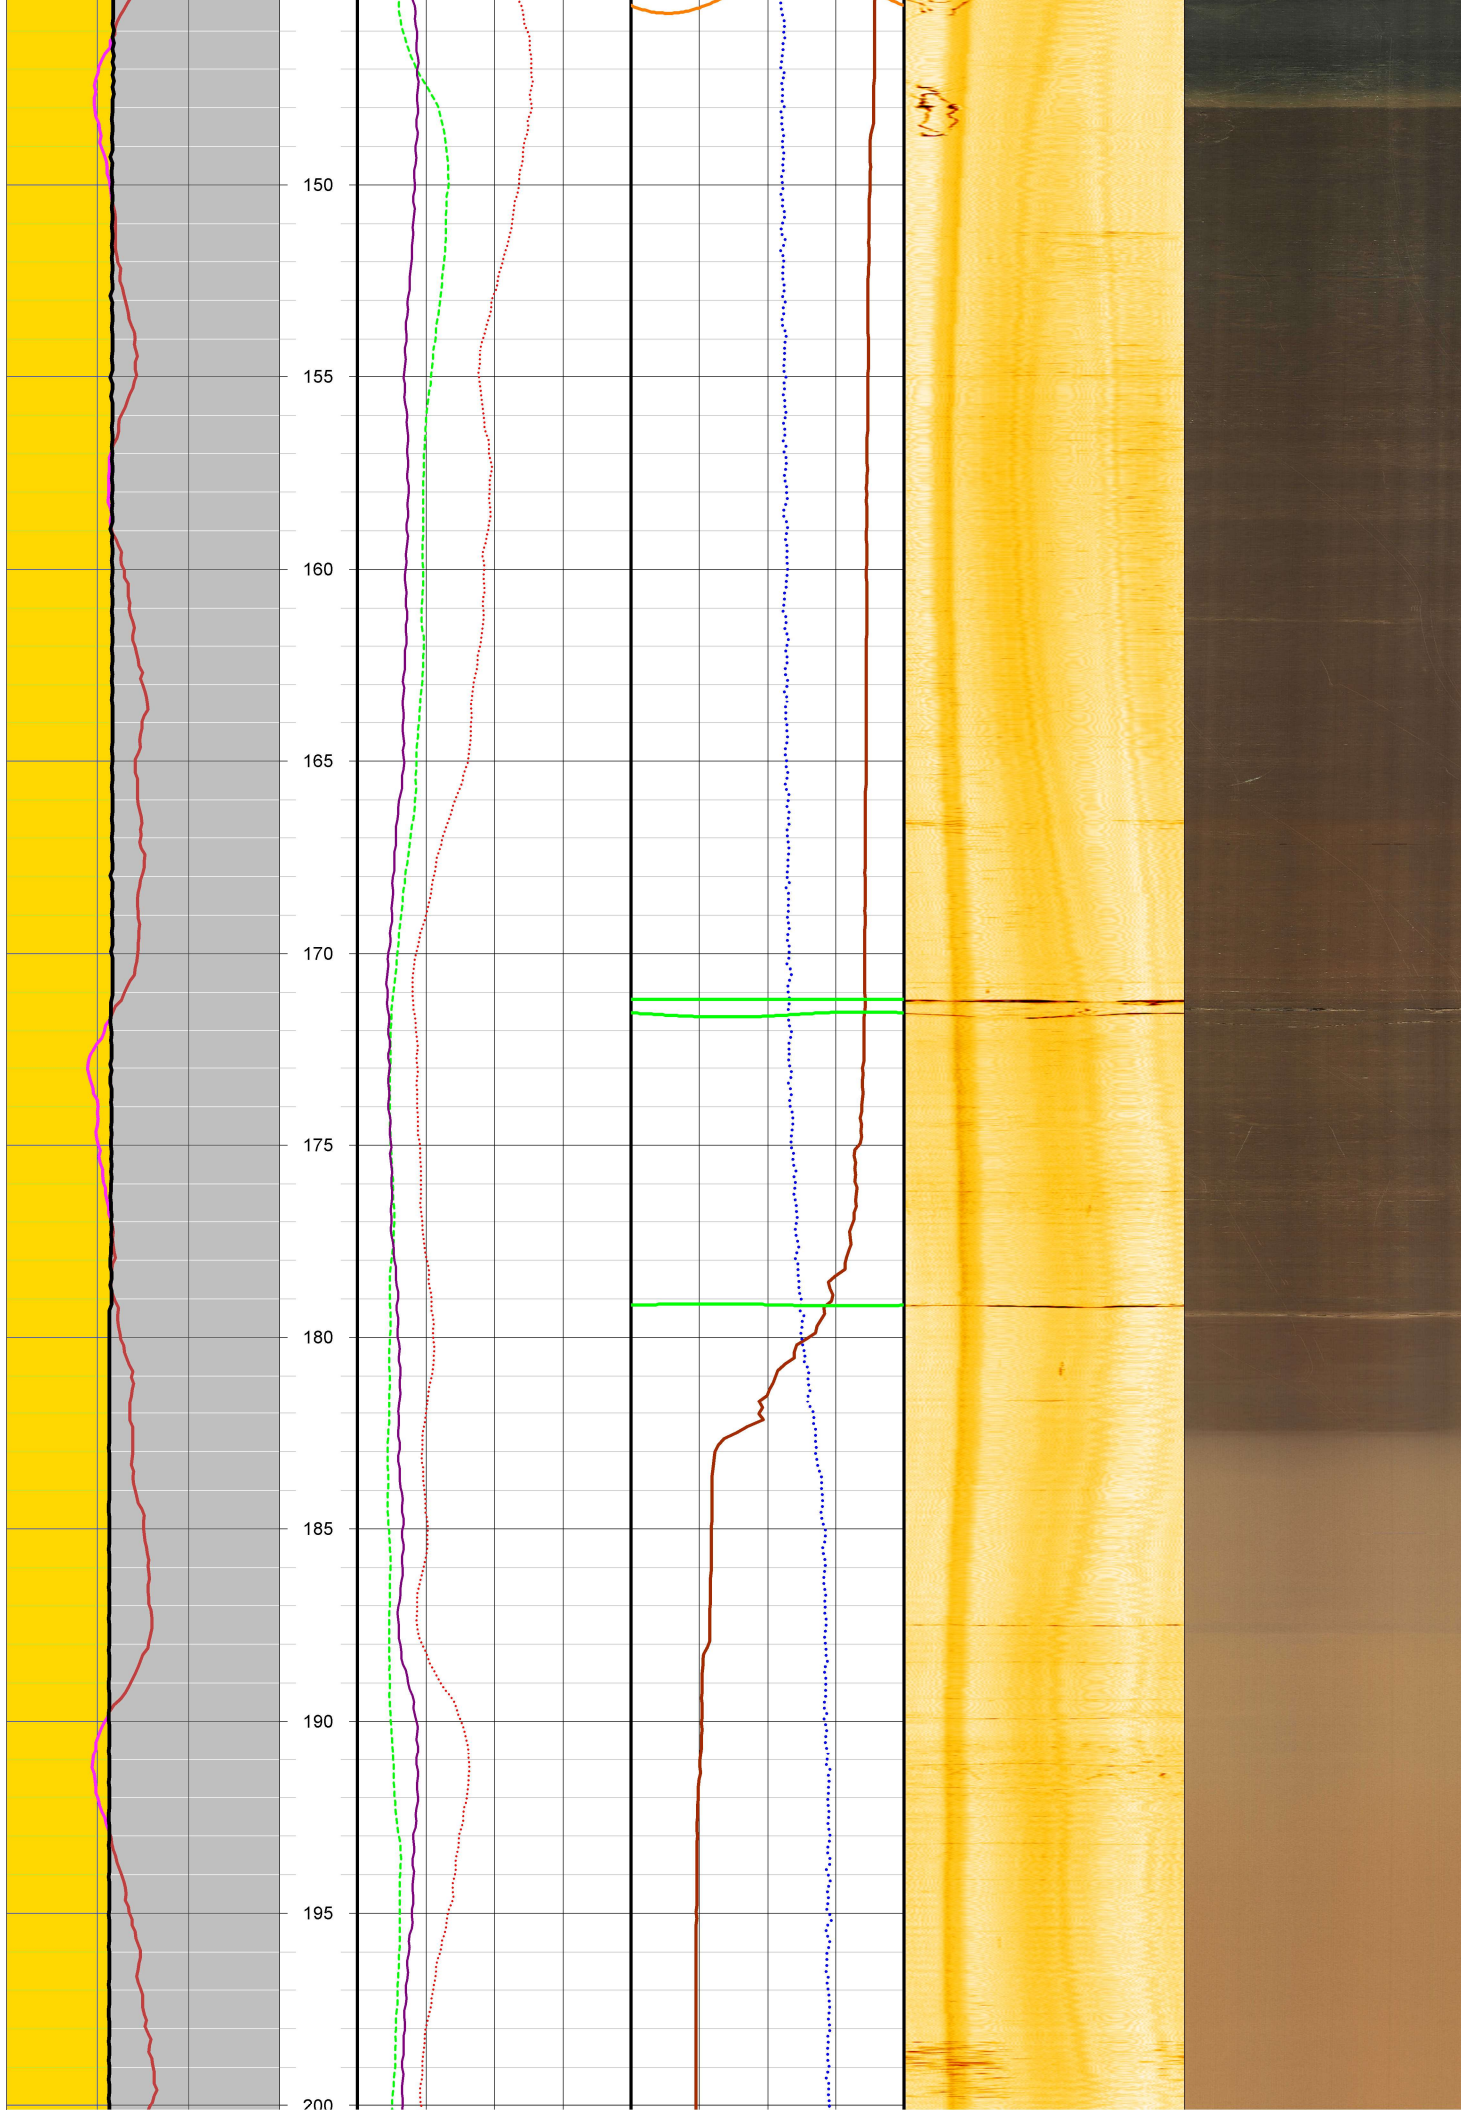
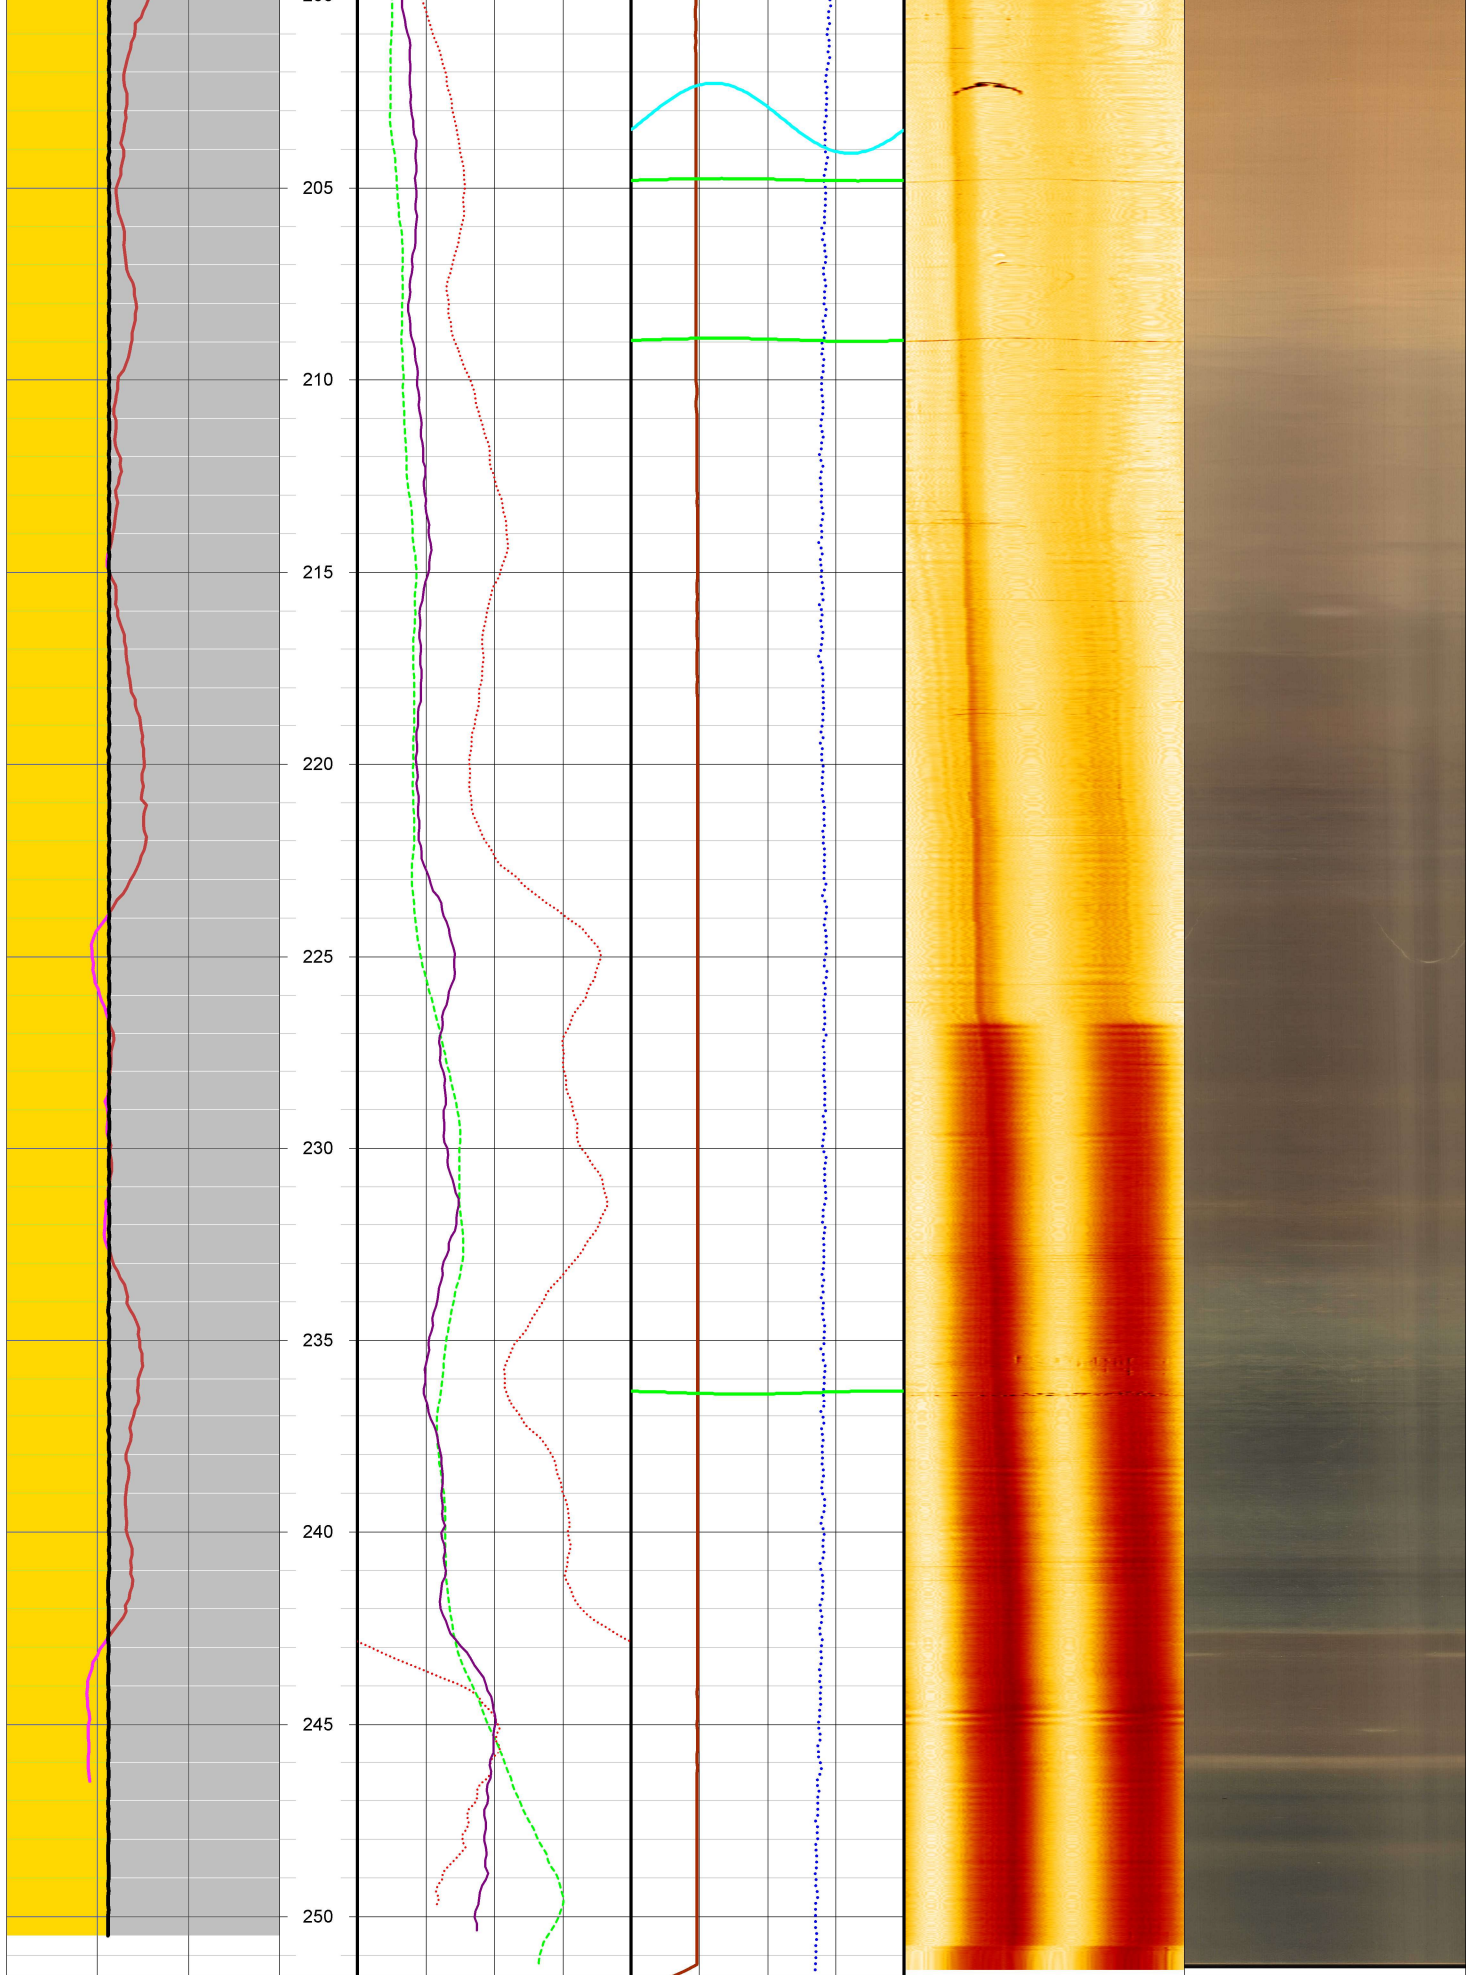
Depth Datum: Ground Surface  
Borehole Dia.: 5 in. (PQ core)  
Total Depth: 251 ft.  
Casing Type: Steel  
Casing Depth: approx. 10 ft.  
Casing Stickup Ht.: 1.4 ft. (temporary case)  
Water Level: 107.8 ft.

**Remarks:** Structure Plot Colors: Green = Bedding plane, parting or fracture  
Magenta = Open joint or fracture  
Orange = partially open joint or fracture  
Gray = Filled joint or fracture  
Cyan = Discontinuous fracture
