# Memorandum

**Re:** Final Screening Evaluation Memorandum  
GTAC 7-1-343 – Nockamixon TCE Site  
Nockamixon Township, Bucks County, Pennsylvania

Groundwater & Environmental Services, Inc. (GES) has prepared this Screening Evaluation Memorandum on behalf of the Pennsylvania Department of Environmental Protection (DEP) for the Nockamixon TCE Site (Site), located in Nockamixon Township, Bucks County, Pennsylvania. The purpose of this Screening Evaluation Memorandum is to: discuss the components and results of additional remedial investigation activities; detail the remedial technology screening evaluation and rough cost estimating effort; and make recommendations for future work at the Site based on the new information obtained from these studies.

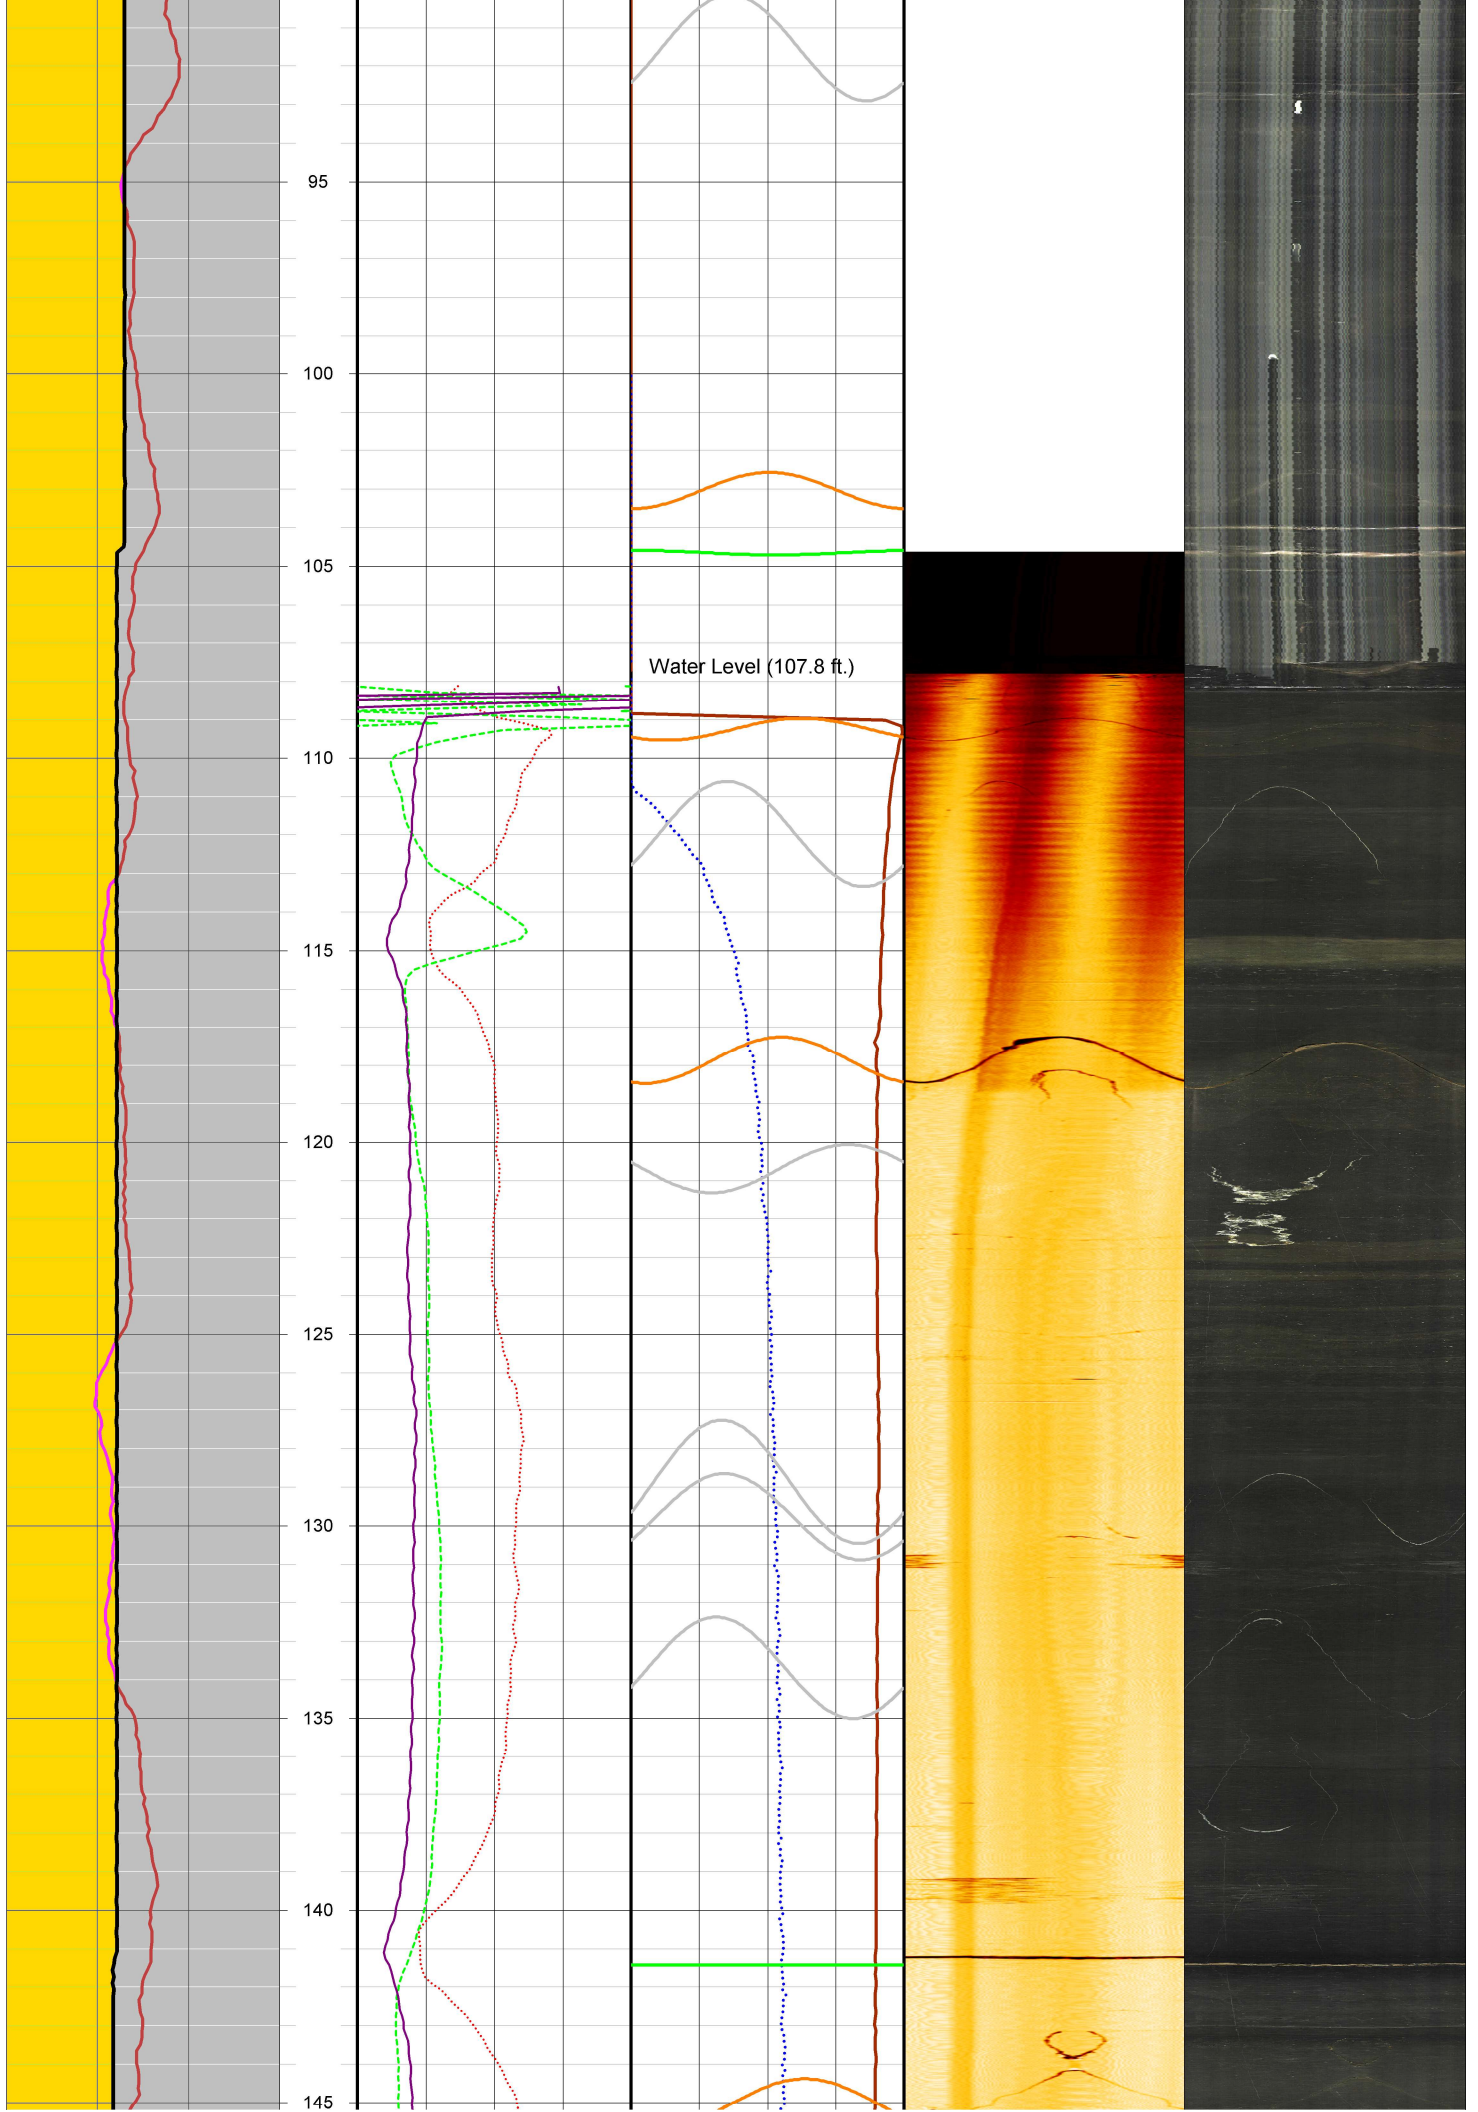
Depth Datum: Ground Surface  
Borehole Dia.: 5 in. (PQ core)  
Total Depth: 251 ft.  
Casing Type: Steel  
Casing Depth: approx. 10 ft.  
Casing Stickup Ht.: 1.4 ft. (temporary case)  
Water Level: 107.8 ft.

**Remarks:** Structure Plot Colors: Green = Bedding plane, parting or fracture  
Magenta = Open joint or fracture  
Orange = partially open joint or fracture  
Gray = Filled joint or fracture  
Cyan = Discontinuous fracture

Geophysical logging results were evaluated to determine bedrock characteristics that will assist remedial option evaluation for source area groundwater. Additionally, GES and DEP reviewed the downhole geophysical logs and proposed discreet groundwater sampling intervals in each of the two rock core locations. These intervals were selected based on the identified water bearing fractures and will be used to determine vertical dispersion of the bedrock aquifer impacts and if any downward migration from the source area overburden may be occurring. A copy of the downhole geophysical results report prepared by AGS is included as **Attachment D**.
