**Jenner Area Joint Sewer Authority STP, Boswell, PA**  
*Effluent probe installation & probe telemetry project.*

**SUMMARY**

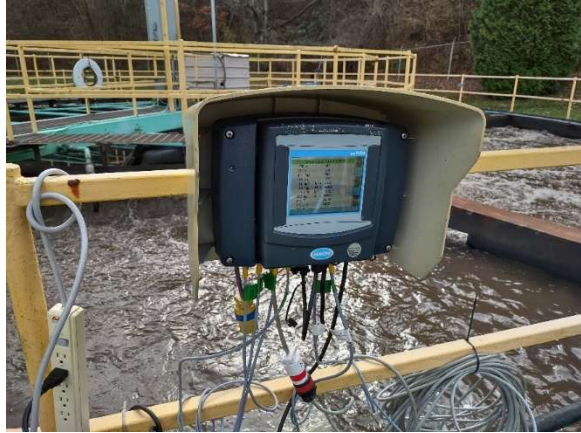
*Photo 2: temporary DEP probe controller*

Because there was delay in buying the extra parts, DEP lent a probe controller, cable, and data converter to Jenner. DEP felt it was vital to use the probes to stop the ammonia violations. The original plan was to install five probes at the effluent,

on installing the D.O. and ORP probes in each aeration tanks and tried reviving one pH probe by replacing its salt bridge and electrolyte solution. That probe was installed, but only its thermometer worked.

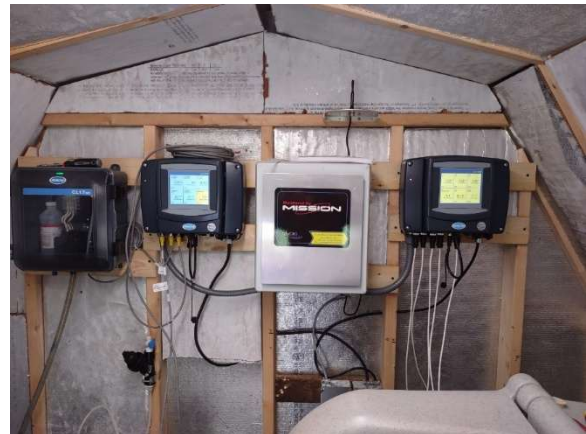
*Photo 3: Hach probe controllers, the CL17 TRC miniaturized lab, and the Mission Systems telemetry connection.*

DEP and the operators invited Hach to estimate the costs of installing and maintaining the remainder of the probes they had purchased. The estimate was much too high. The chief operator asked an operator from another plant for his opinion. This operator advised connecting the probes to Jenner's account with Mission Systems, an internet data hosting service monitoring Jenner's pumping stations. The operators contacted a part-time instrumentation technician who would install both the effluent and aeration tank probes in permanent conduit, and they bought a Mission Systems telemetry modem. The chief operator wanted to also connect the aeration D.O. probes to a variable frequency drive (VFD) for one of the blowers, to control aeration D.O., and bought a larger capacity motor, as well.

Work was completed in August 2025. The probes were connected to the telemetry device for easier data management and graphing, and the VFD came into service shortly later. The operators continue using gradual timer adjustments for ON/OFF aeration to cut down the amount of chemical and power they were using. Effluent ammonia, for the most part, remained under control. DEP staff retrieved their equipment on August 15.

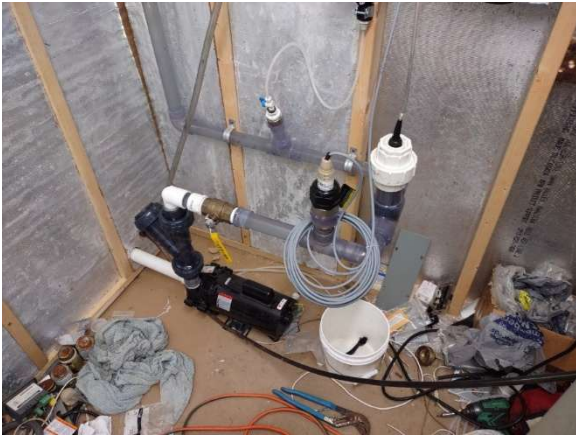
Effluent sampling and probe connections for continuous monitoring.

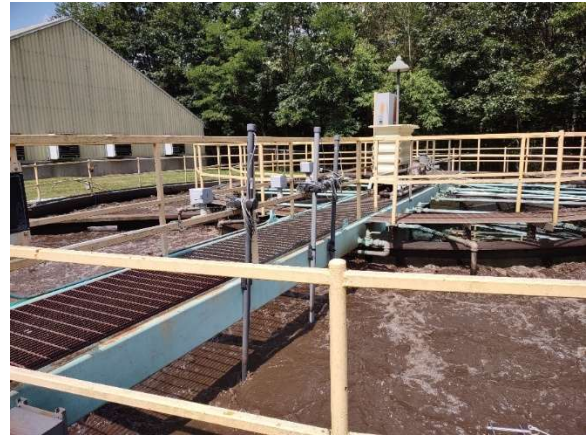
View of probes “permanently” installed by Jenner’s telemetry contractor

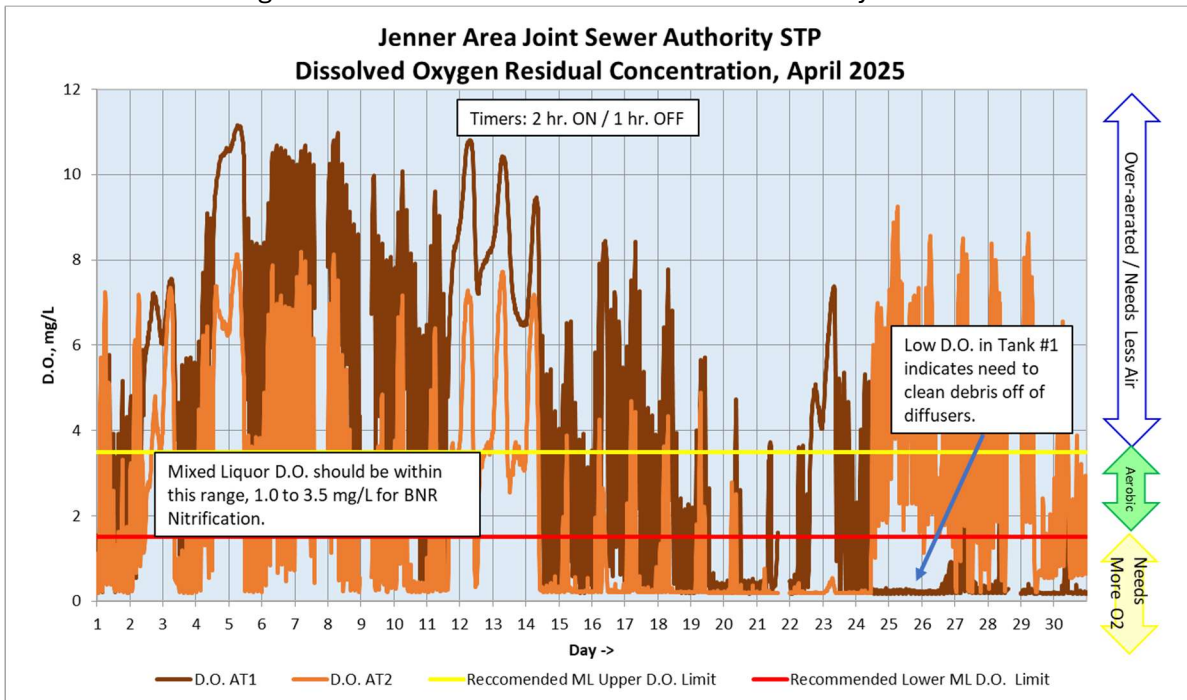
Example DEP monitoring graph showing need to clean Tank #2 diffusers from 4/25 onward.

After providing a copy of a computer program to manage the probe data, DEP wrote a spreadsheet to graph the daily data to make it easier for the operators to monitor the D.O. and ORP. Using the graphs, the operators were able to adjust aeration timers to favor removing ammonia and nitrate, gradually increasing aeration OFF time so long as ammonia remained low. Whenever D.O. appeared to be too low in only one of two aeration tanks, they knew they would have to clean debris off the air diffusers. The D.O. and ORP graphs helped them visualize what happened in the aeration tanks.
