# WATERSHED IMPLEMENTATION PLAN

April 2008

## West Branch of Antietam Creek Franklin County, Pennsylvania

Prepared by:  
RETTEW Associates, Inc.  
3020 Columbia Ave.  
Lancaster, PA 17603

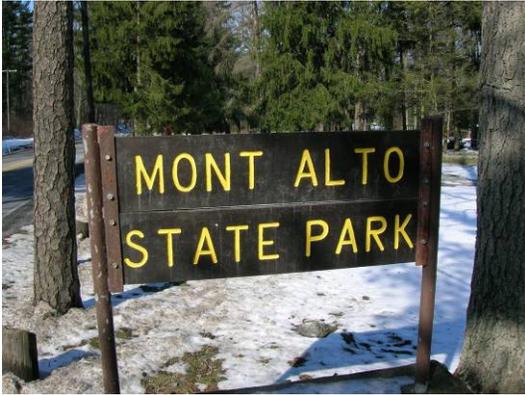
*Fig #1 - Location Map*

The West Branch of Antietam Creek is located in Franklin County, Pennsylvania near Waynesboro and Mont Alto. The West Branch comprises 41.4-square miles and is a drainage to Antietam Creek and ultimately the Potomac River. Pennsylvania municipalities occupying a portion of the West Branch include Guilford Township, Quincy Township, Washington Township, the Borough of Waynesboro, and the Borough of Mont Alto. The West Branch generally flows in a southerly direction from its headwaters in Mont Alto State Park to its

confluence with the East branch of Antietam Creek about 1.5-miles south of Waynesboro. Significant roadways within the West Branch include Route 997, Route 316, and Route 16. *See Fig #1 - Location Map below.*

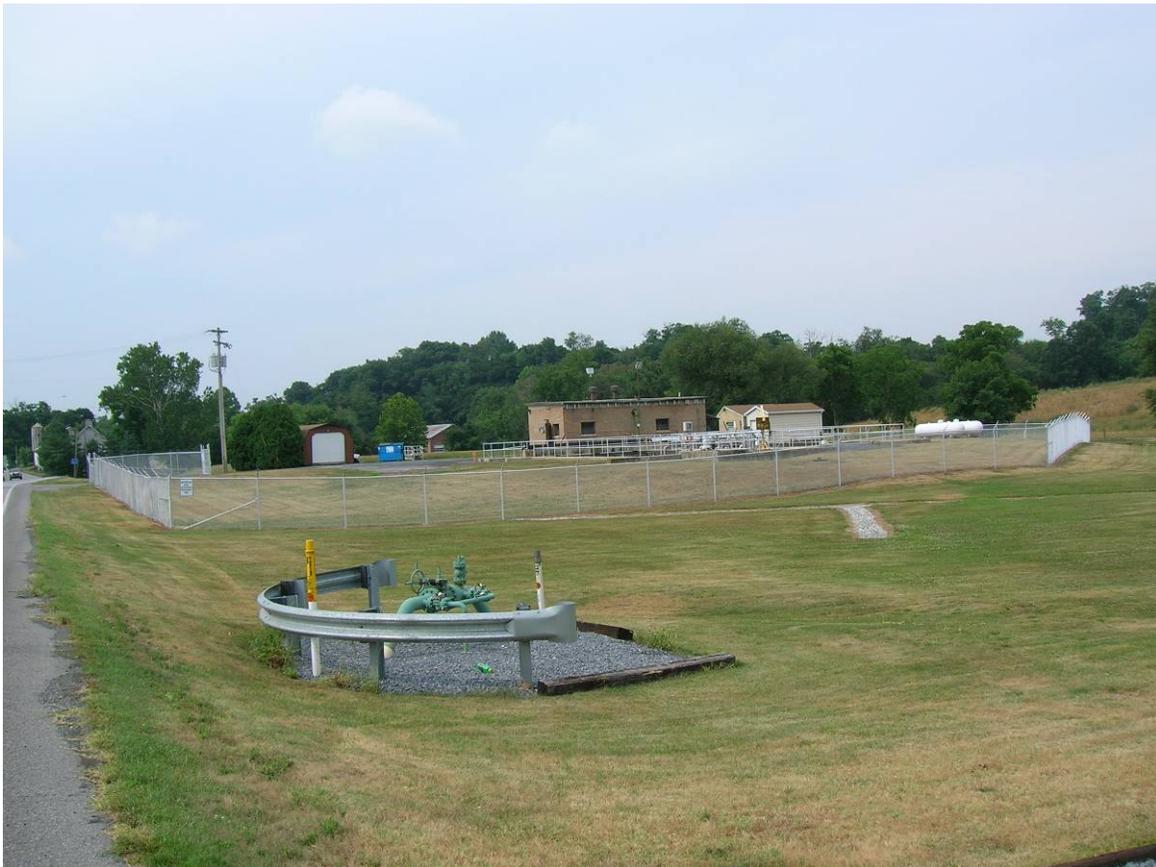
*Above – Sewage Treatment Plant along Rte. 997*

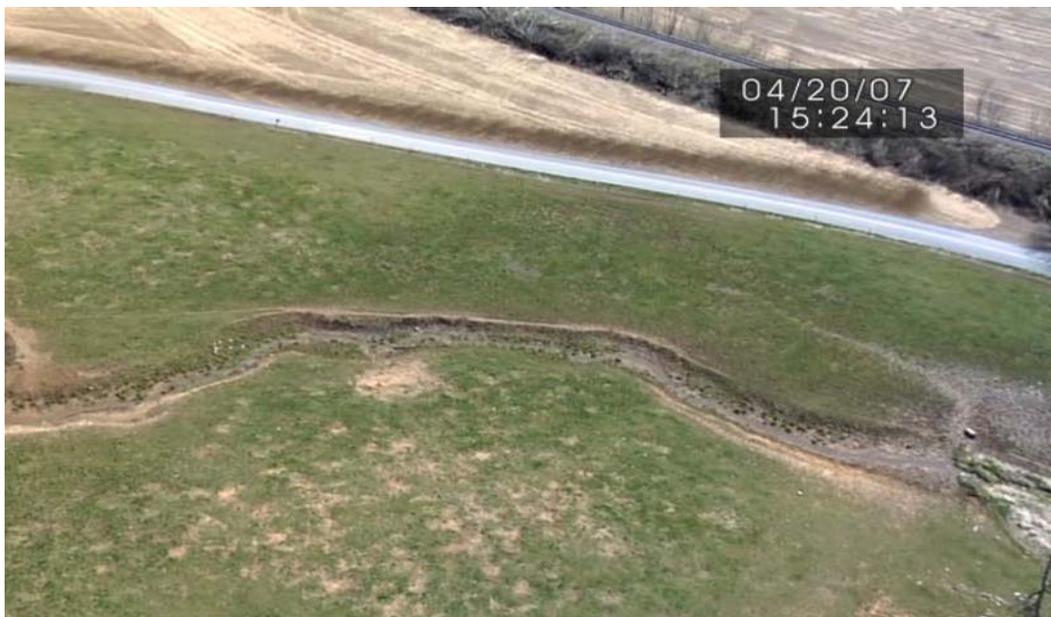
*Example of aerial footage clip*

Most aerial videoing took place from an altitude between 400 – 600 feet above the ground. The video was time coded and linked to a GPS unit so that site locations could be known and in turn linked to GIS programming for further analysis and planning.

After the flights were completed, collected video footage was post-processed. This involved dividing out the various sub-watersheds using the associated time code and collected GPS coordinates. Once adequately post-processed, the video footage was placed on a DVD disk for viewing at any time. All 62.44-miles of collected stream corridor video are on the DVD.
