Pennsylvania Wetland Replacement Project Monitoring Report Summer 2000

Summer 2000 Field Observations of Wetlands Restored with Funds from the Pennsylvania Wetland Replacement Project

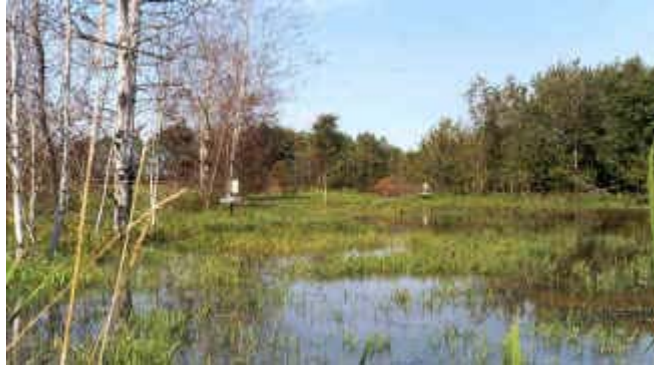
Waterfowl nesting structures in the Howard wetland.

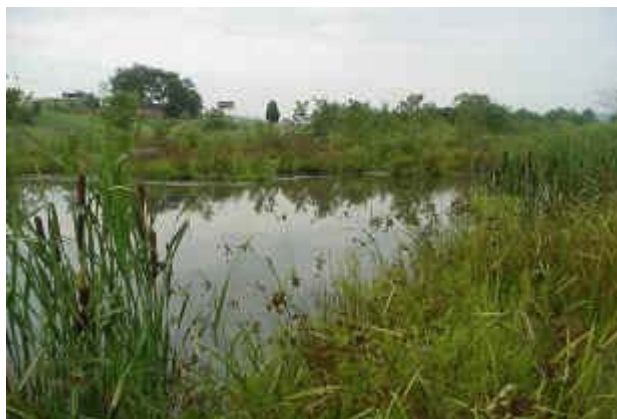
The Pennsylvania Wetland Replacement Project partnered with the U.S. Fish and Wildlife Service (USFWS) to restore this wetland. Plant materials provided by the Pennsylvania Wetland Replacement Project have helped Mr. Rusty Ryan meet his goal of attracting a variety of wildlife species. He has reported seeing over 140 different species of birds including waterfowl and wading birds.

The Ryan site in July 2000.

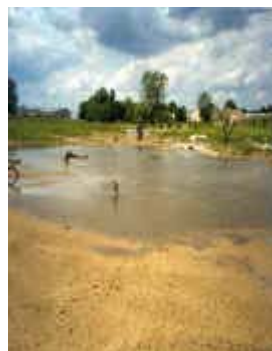
As part of a larger watershed restoration and protection effort by Warwick Township and the Lititz Run Watershed Alliance, the Pennsylvania Wetland Replacement Project was a financial partner to the project. This wetland is assimilating sediment and nutrients by managing a large percent of the stormwater flow in the Santo Domingo Creek. The photos below document the progress of the site from construction year one to construction year two, a trend that is becoming apparent.

Santo Domingo in
September 1999.

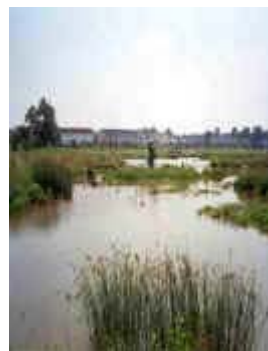
The same site in
July 2000.

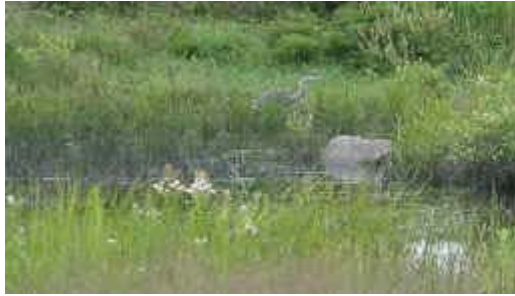
This USFWS-designed wetland restoration project, located in an abandoned sand and gravel mine, was completed in 1996. The goal of the project was to provide wildlife habitat. During the 2000 field visit, evidence of use by deer, waterfowl and songbirds was observed. While the site seems to be progressing slowly, there has been positive progress in every monitoring year.

Lake Naomi in July 2000.

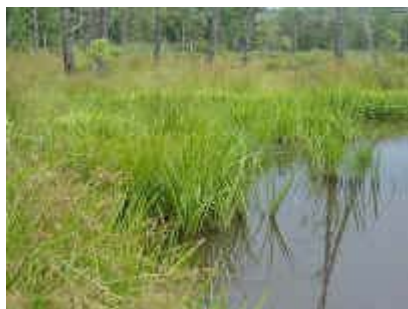
This restoration effort involved the removal of old fill from a peat bog. Wetland vegetation in bog communities is very unique and has covered approximately 30 percent of the site over the last two years. This is an excellent sign that over time native bog species will revegetate the entire site.

Vegetation has covered approximately

30% of the site over the last two years.

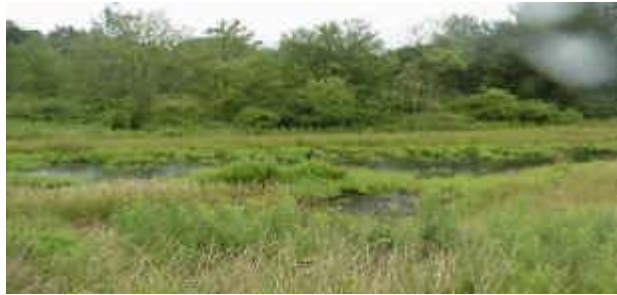
The progress of this site over the last year is remarkable. While some plants did not survive through the first two years, the photo below documents improved conditions this year. A remedial planting scheduled for 2000 was not necessary. Take note that this site was established adjacent to an existing scrub-shrub wetland. Habitat diversity and wildlife use are high. The owner reports several different species of waterfowl.

Vegetation has shown marked improvement in one year.
Photo from July 2000.

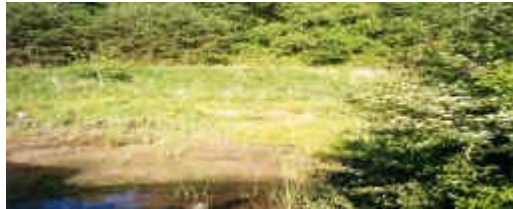
The series of three wetlands is vegetating nicely. The landowner's restoration goal was to expand woodcock habitat. Shrubs and trees provided by the Pennsylvania Wetland Replacement Project and planted by the landowner are thriving. The alders and pin oaks will provide resting and nesting cover. The emergent vegetation present at the site is also very healthy and diverse. The photos below document the changes in vegetation from 1999 to 2000.

Photo taken in May 1999.

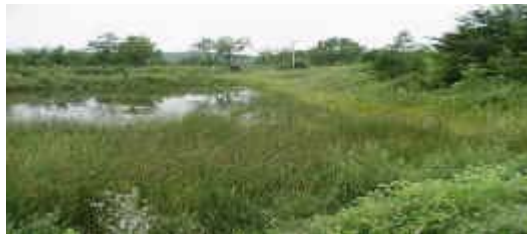
Photo taken in July 2000 in the same area as the above photo.

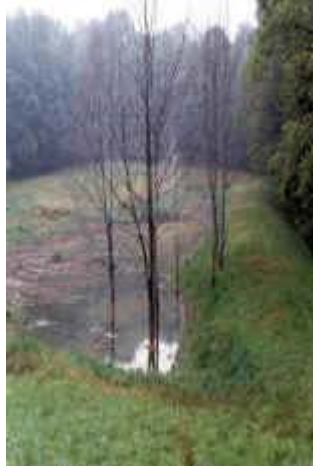
As the Environmental Education Center for Cambria County, this site was developed to create a variety of different aquatic habitats by restoring emergent wetlands adjacent to a pond. The project has been very successful (over 200 students have visited) and this year, on the day of the monitoring visit, Mr. Joe Emerick was training 30 school teachers.

The Emerick site in September 1998.

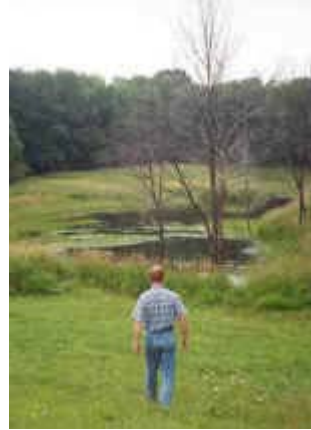
The site from the same vantage point in August 2000.

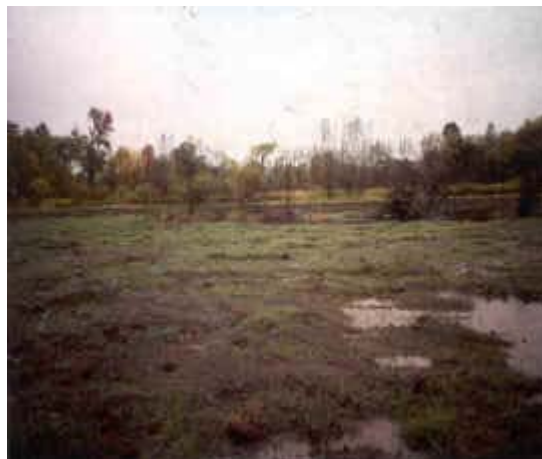
This site is another excellent example of wetland restoration. Ditches from the late 1950s or early 1960s were filled in and the site was seeded to provide a jumpstart and to compete with reed canary grass in the area. Currently, the vegetation on the site is healthy and robust and the area is seasonally saturated. The wetland is buffering the West Branch French Creek, a tributary to French Creek.

The Pfadt wetland restoration in early Fall 1998.

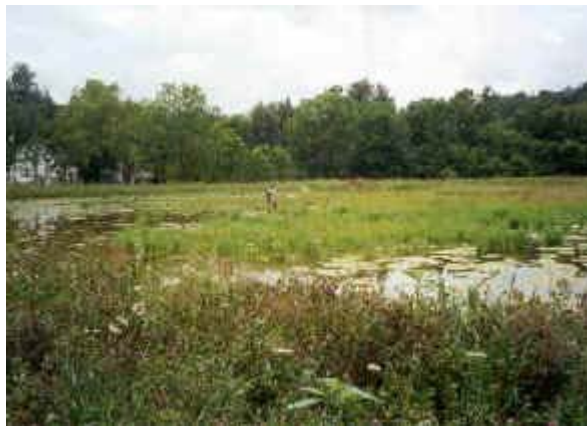
With the assistance of NRCS and the enthusiasm of the landowner, this old field has been restored to a wetland. The goal of the wetland is to attract reptiles and amphibians, an interest of the landowner. Spring 2001 will be the first real test of the wetlands attracting powers. Water levels are optimal and the vegetation is progressing nicely.

The Steinberger wetland 11 months after construction.
