A Successful HSCA Funded Cleanup: Rose Valley TCE

Gamble Township, Lycoming County, PA

Rose Valley TCE Site

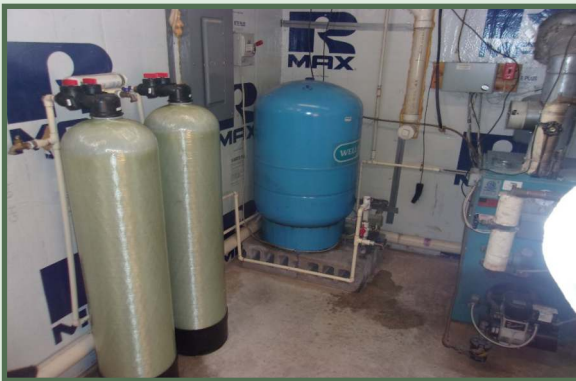
Impacted homes were supplied with whole house point-of-entry treatment systems with a primary and secondary carbon treatment vessel.

The six residents with TCE concentrations greater than 1 ppb were provided with bottled water until whole house point-of-entry water treatment systems were installed in May 2018. The drinking water at all of the homes with installed treatment systems has been regularly sampled to ensure the effectiveness of the systems in removing the TCE. The most recent samples were collected in December 2019, and confirmed that TCE was not present in the drinking water of any of the impacted homes after treatment. Homes with pre-treatment TCE concentrations above 25 ppb have been sampled quarterly, at a minimum, while homes with concentrations below 25 ppb are sampled biannually. Water samples were obtained from an unused drinking water well that is located adjacent to impacted properties on Kibbe Lane. The samples were obtained on October 1, and November 17, 2020. The analytical results indicated that TCE was present at concentrations above the SHS. Currently, no houses reside on the impacted property, and there is no indication that it will be used for residential purposes in the future. The property owner was notified by letter of the results and that the drinking water should not be used for consumptive purposes.

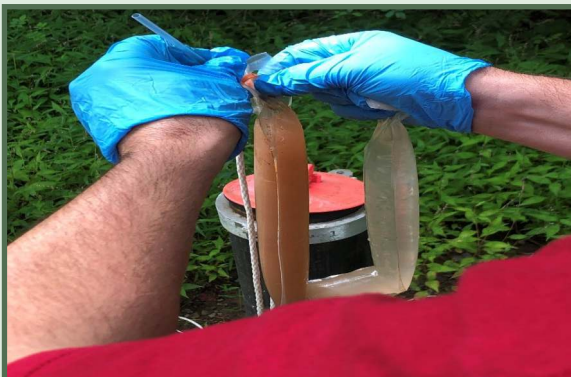
Monitoring wells were sampled with no-purge, passive, disposable plastic sleeve samplers to reduce costs.

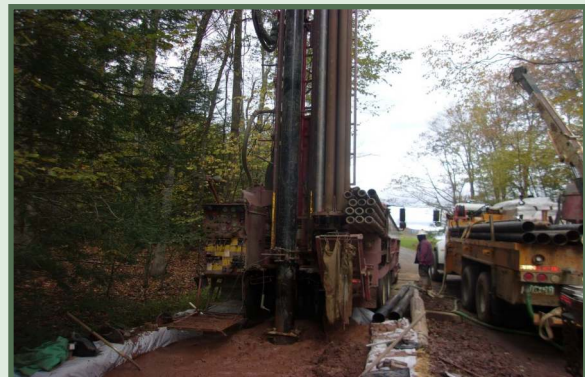
Installation of one of five groundwater monitoring wells.

Five groundwater monitoring wells were installed by a DEP contractor in the area of known groundwater contamination in October and November of 2018. The wells were first sampled by the contractor in late November of 2018. The analytical results indicated detections of TCE in three of the five wells. One well showed a TCE concentration of 174 ppb which is nearly 35 times higher than the SHS of 5 ppb. These wells

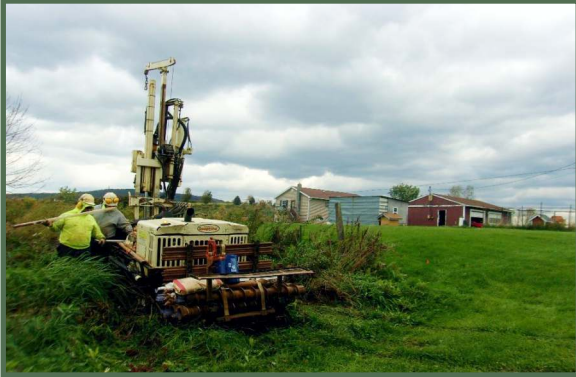
Direct push borings were advanced for soil characterization and piezometer installation in strategic locations.

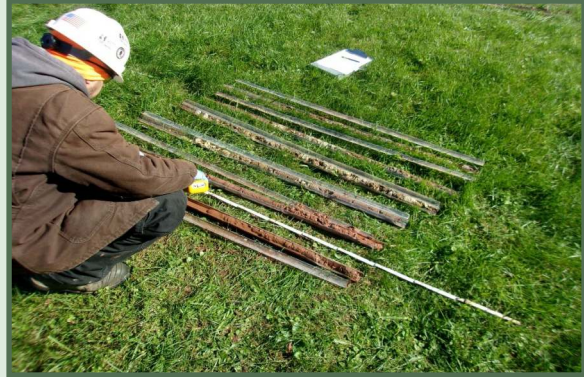
Soil from borings was screened with a photoionization detector for volatile organic compounds prior to sampling.

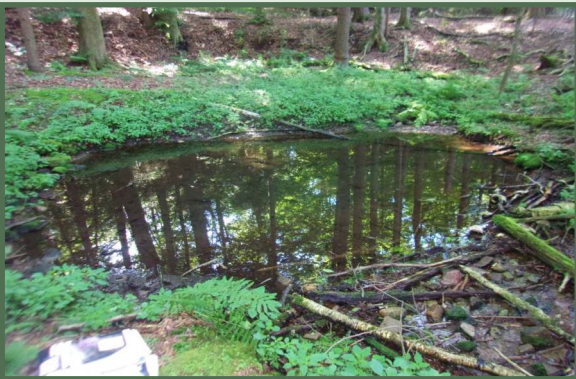
Groundwater spring was impacted with TCE at levels above the Act 2 Statewide health standard.

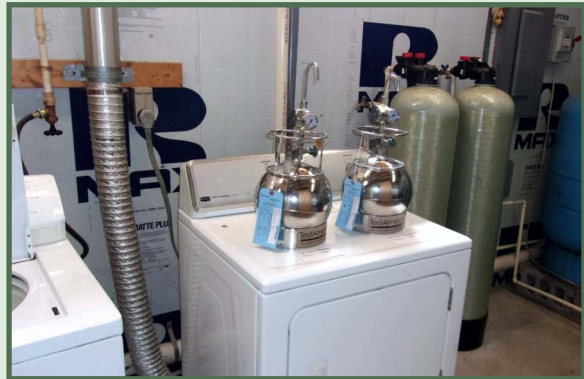
Air sampling was conducted at the impacted home to ensure that the vapor mitigation system was effective in removing TCE from the ambient air.

mitigation system and the results indicated that TCE vapors were no longer detected in the air. The home was resampled for indoor air quality again in 2021 and the results confirmed that the TCE level were below the VI screening value.

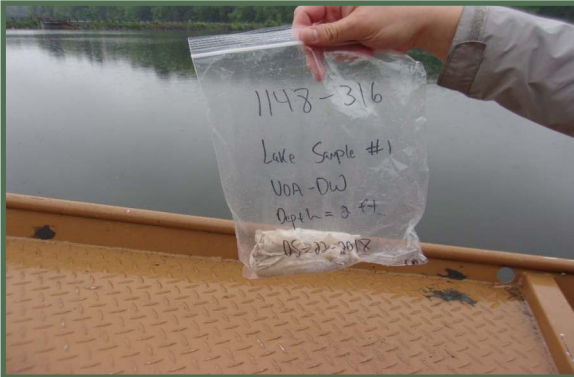
Rose Valley Lake was sampled by boat with the assistance of the Pennsylvania Fish and Boat Commission.

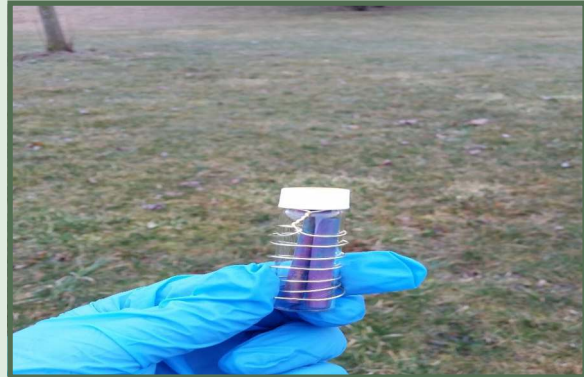
A passive soil gas sampler, prior to being placed in the ground in the area of highest contamination.

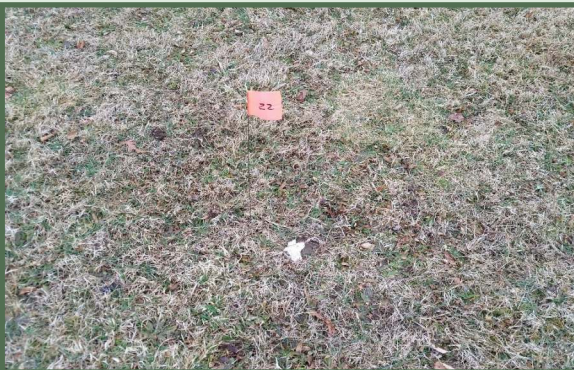
The passive soil gas samplers were covered in aluminum foil, marked with a flag, and then retrieved for analysis after 19 days. No TCE was detected at any of the sampling locations.
