Palmerton Zinc Pile Superfund Site Natural Resource Damage
Assessment

DRAFT Restoration Plan and Environmental Assessment

The Trustees of the Palmerton Zinc Pile Superfund Site

May 19, 2010

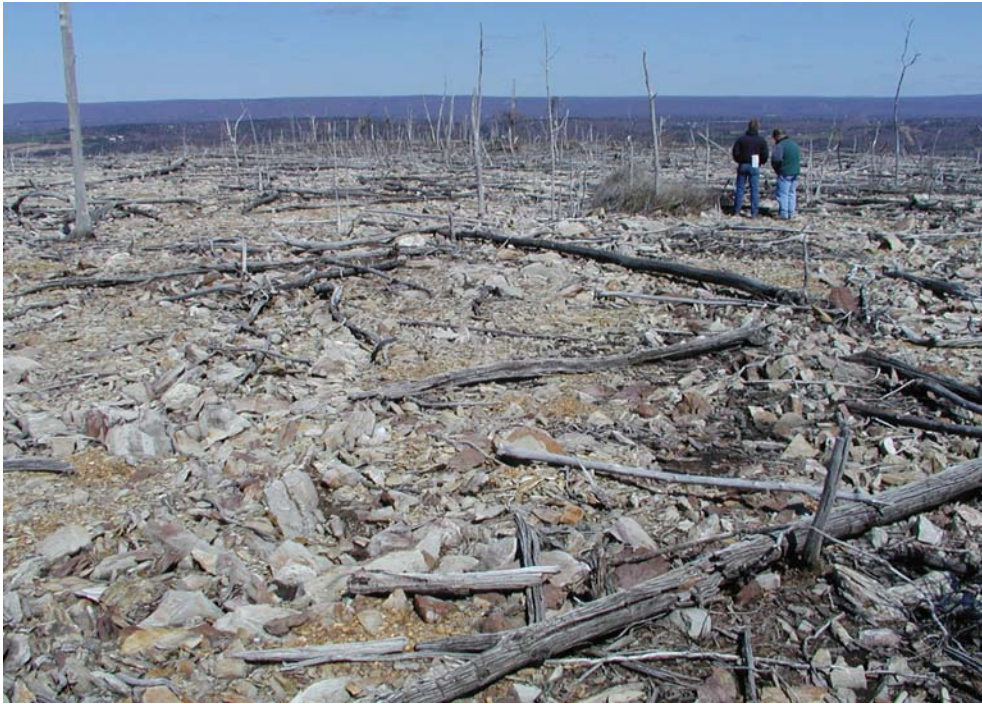
EXHIBIT 3-3 DEFORESTED LAND ON BLUE MOUNTAIN

As summarized in the Assessment Plan (Trustees 2006), numerous sources have documented the effects of Site-related metals at levels sufficient to cause injury to soils, vegetation, birds, mammals, and amphibians (EPA 2001, Beyer and Storm 1995, Storm et al. 1994, Storm et al. 1993, EPA 1993, Beyer 1988, Beyer et al. 1985, Beyer et al. 1984, Strojan 1978, Jordan 1975, Jordan and Lechevalier 1975, Nash 1975, Buchauer 1973). The Trustees conducted several additional studies from 2004 through 2008 to evaluate injury to the upland habitat resulting from Site-specific metals contamination. The results of a 2004 Trustee soil study showed that soil metal concentrations on over 3,000 acres of public land on Blue Mountain remained highly elevated at levels sufficient to cause injury to natural resources (Exhibit 3-4, Trustees 2007b). The habitat assessment included in this study indicated reductions in tree cover, tree seedlings, and leaf litter in the contaminated areas and found little sign of recovery in previously denuded areas. Follow-up greenhouse and field investigations further demonstrated the phytotoxic effects of soil metal levels, including losses in tree cover, tree seedlings, and forest structure (Beyer et al. 2010, Trustees 2008b). Based on current estimates, approximately 1,000 acres of public land remains deforested as a result of metals contamination.

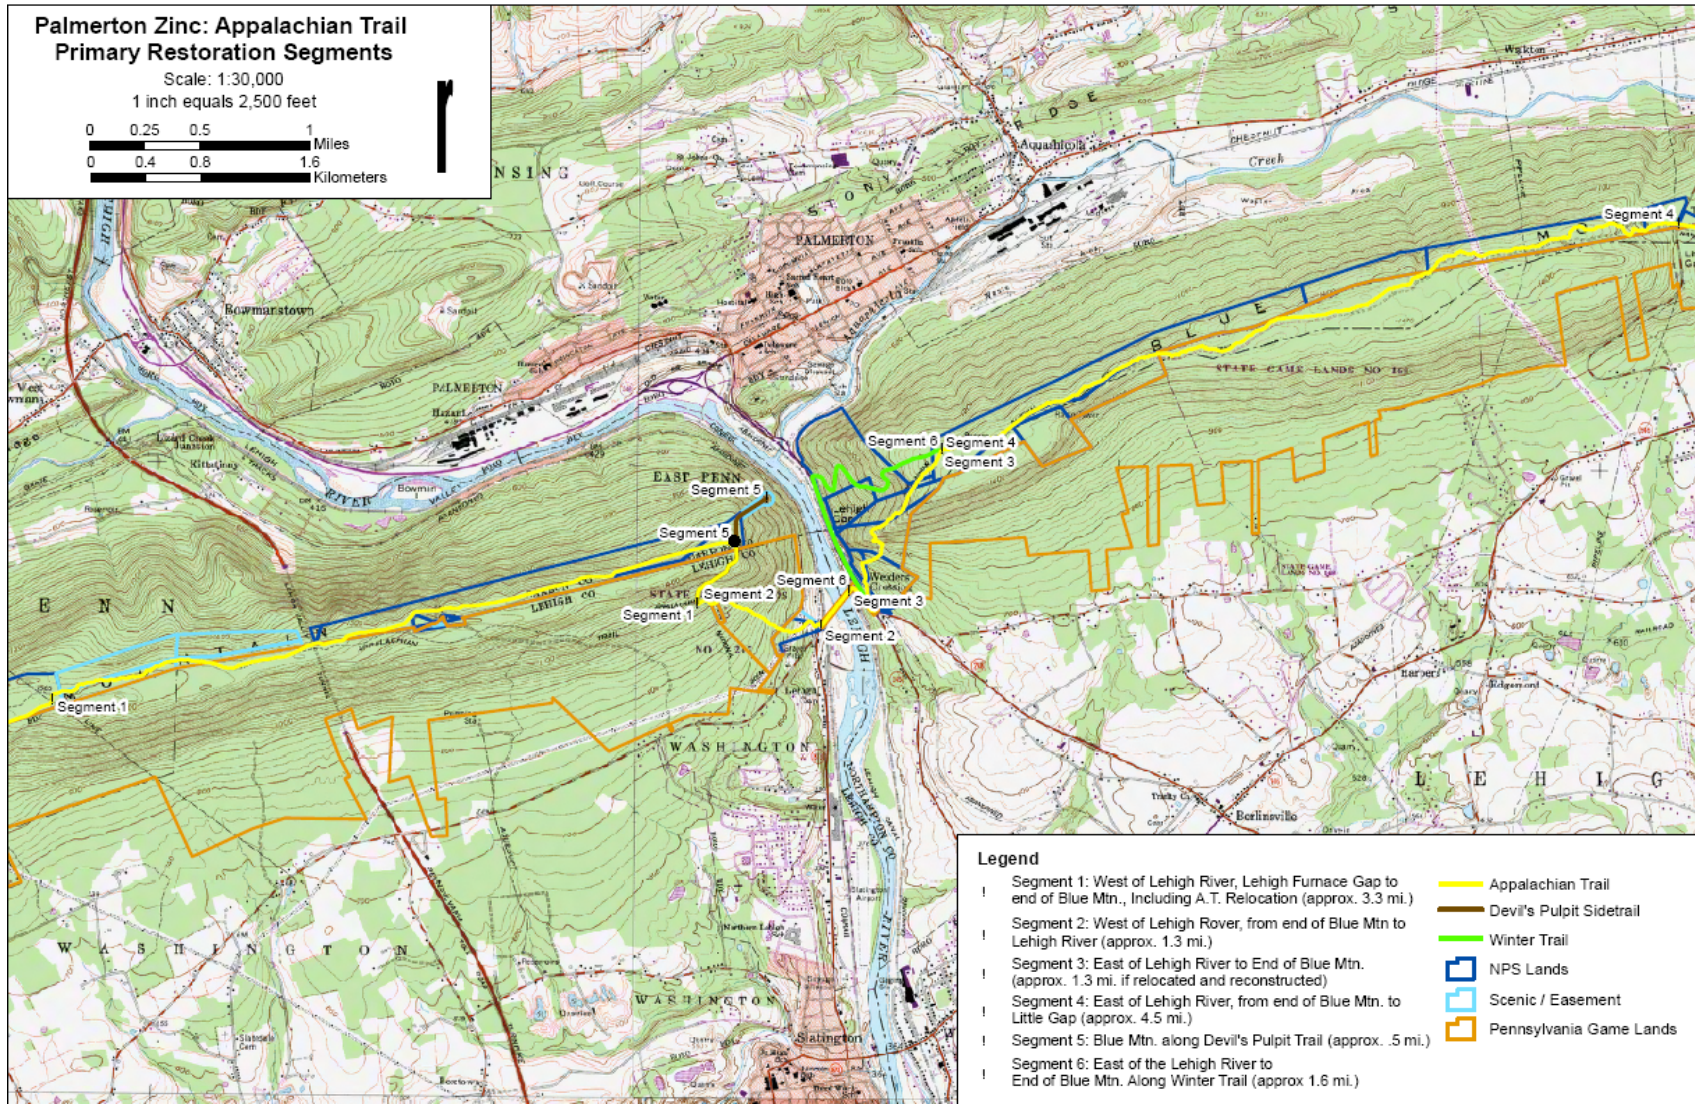
EXHIBIT B-1 MAP OF APPALACHIAN TRAIL PROPOSED PRIMARY REMEDIATION SEGMENTS

- Segment 4: East of Lehigh River (at Lehigh Gap), from the Winter Trail junction at the top of the west end of Blue Mountain to Little Gap (approximately 4.5 miles). As noted earlier in section 2.2.1, this segment is included in remedial activities and is not included in this Alternative.
