Figure 1.1 - Mined Extents - Bailey Mine

Extent of Mining During the 6th Assessment Period: 2,995 Acres

Total Extent of Mining at the End of 6th Assessment Period: 31,690 Acres

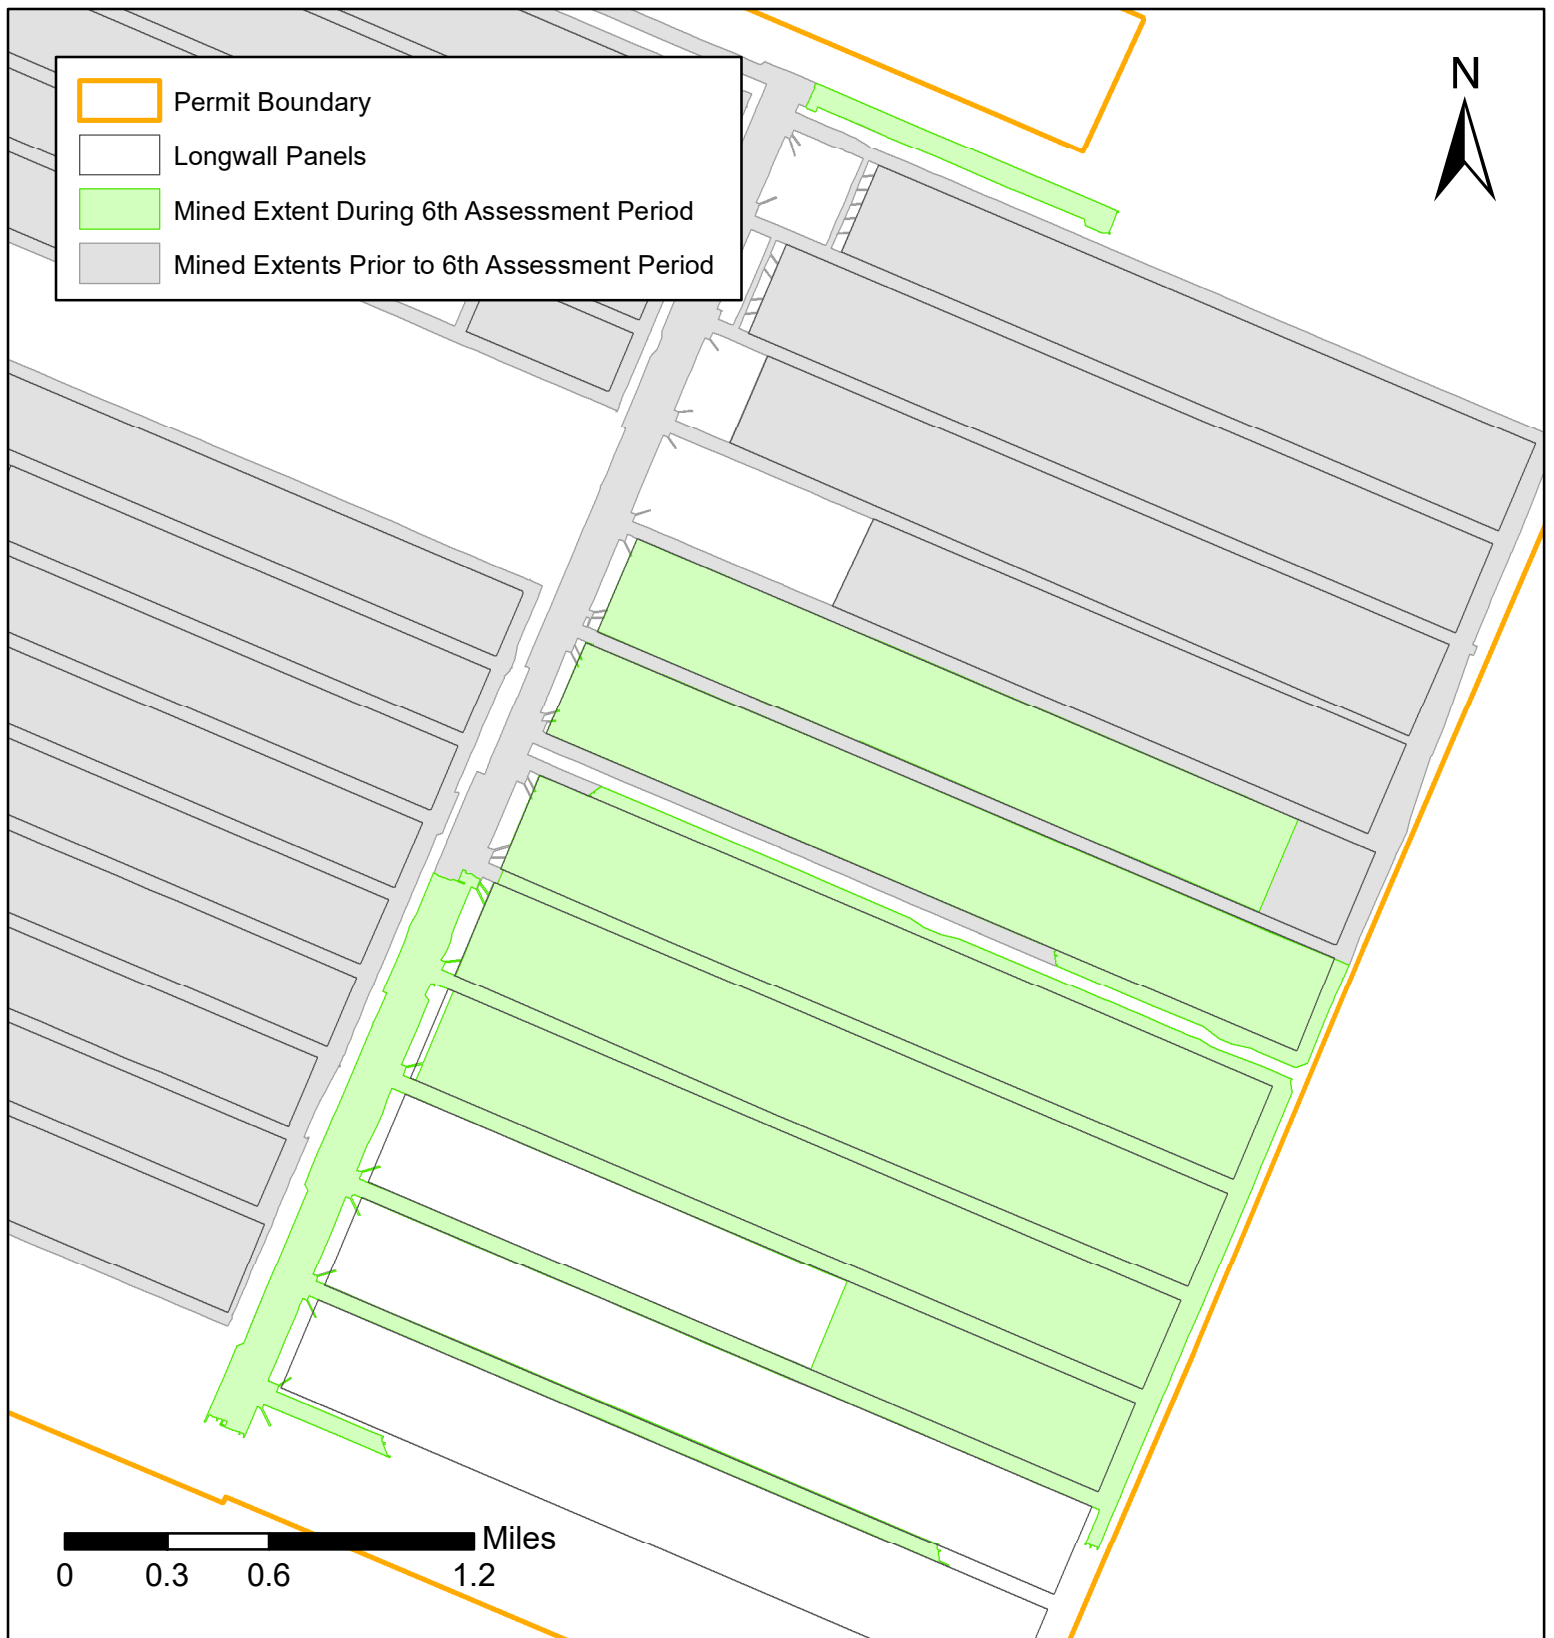
Figure 1.1.A - Mined Extents - Bailey Mine

Extent of Mining During the 6th Assessment Period: 2,995 Acres

Total Extent of Mining at the End of 6th Assessment Period: 31,690 Acres

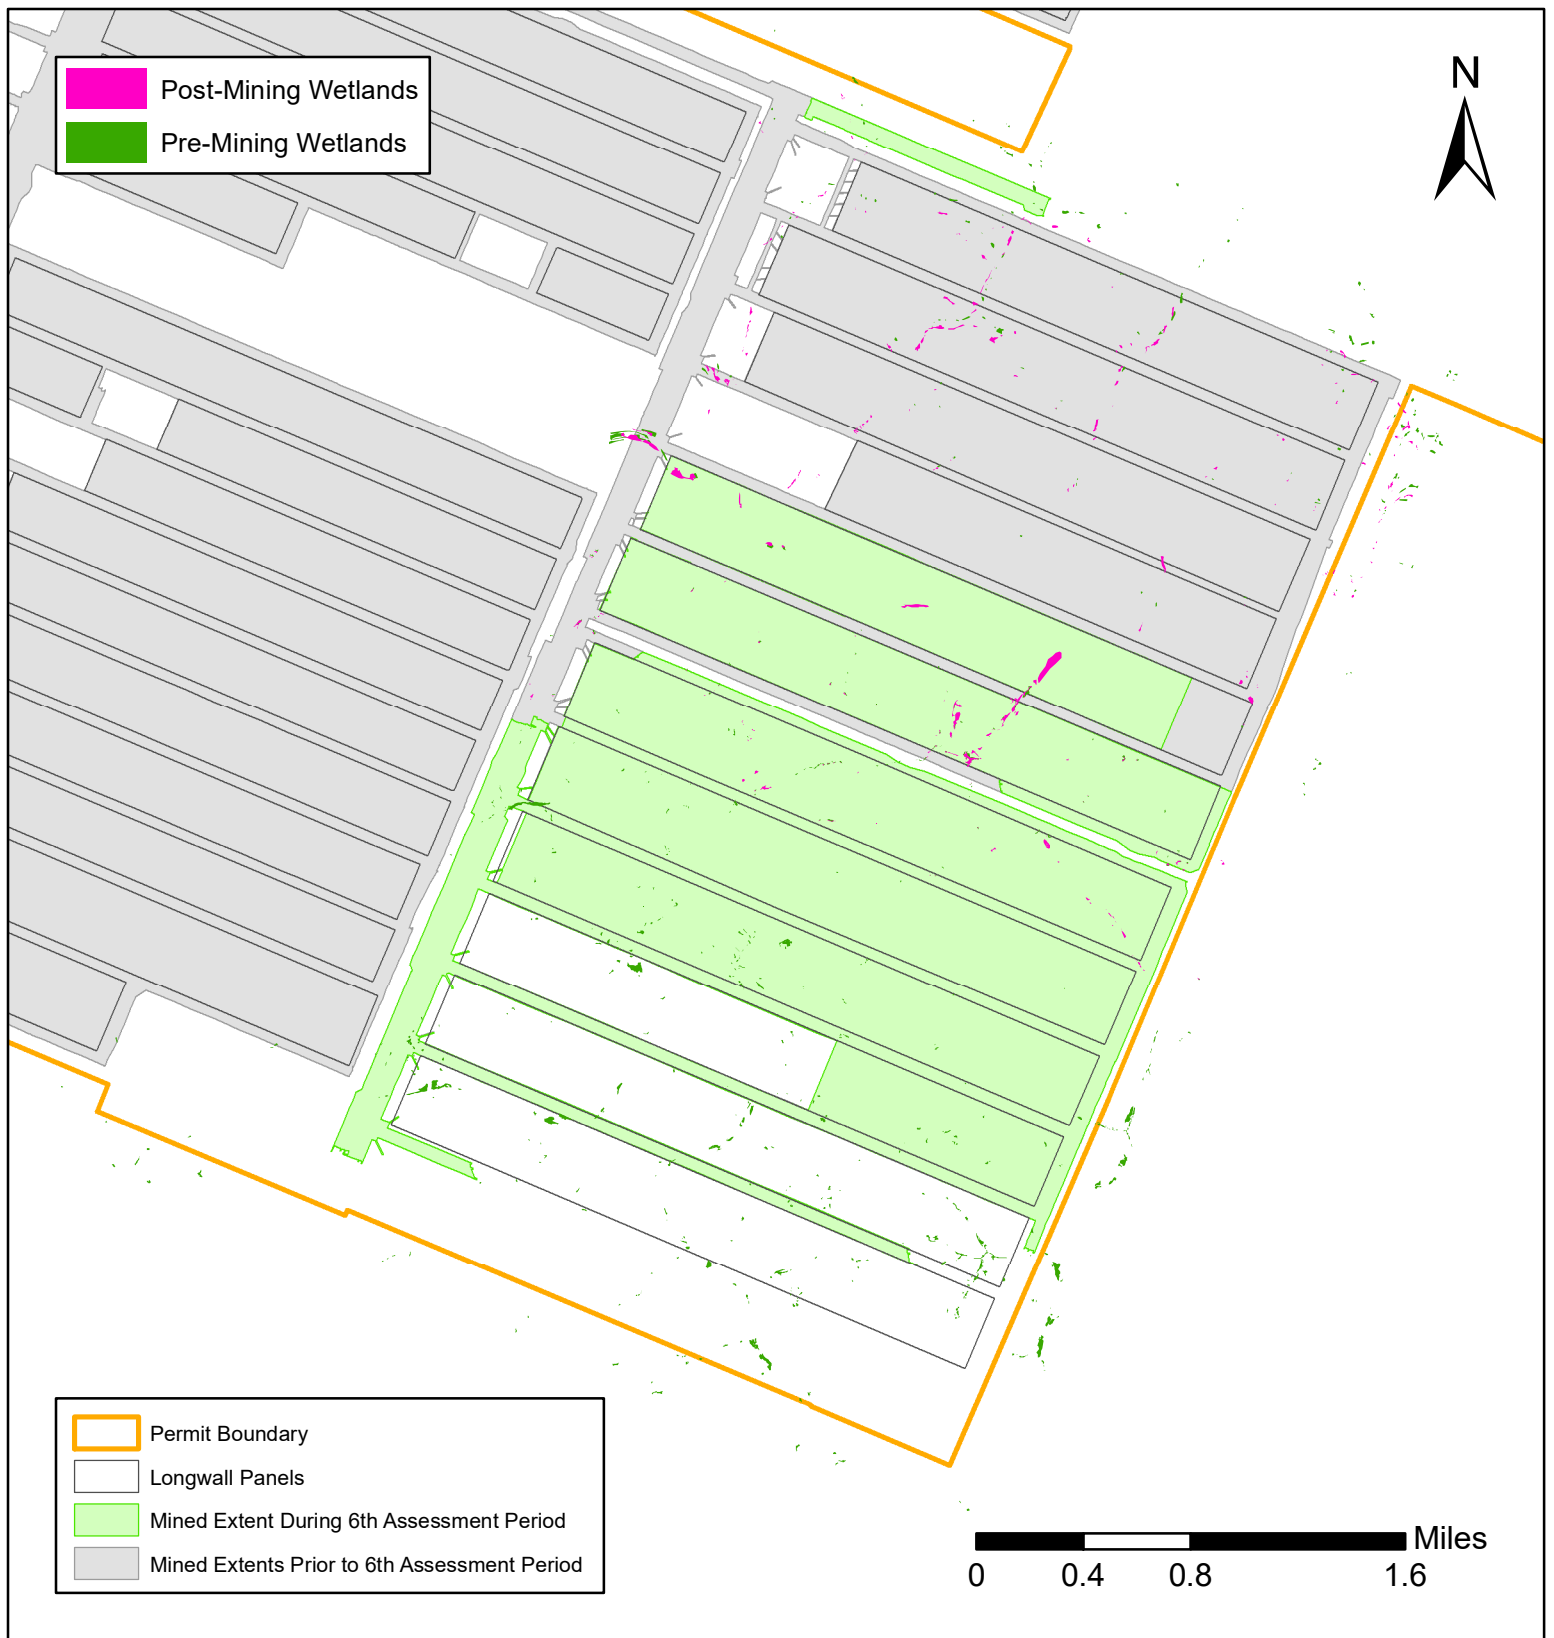
Figure 1.5 - Wetlands - Bailey Mine

Wetlands Undermined During 6th Assessment Period: 7.58 Acres

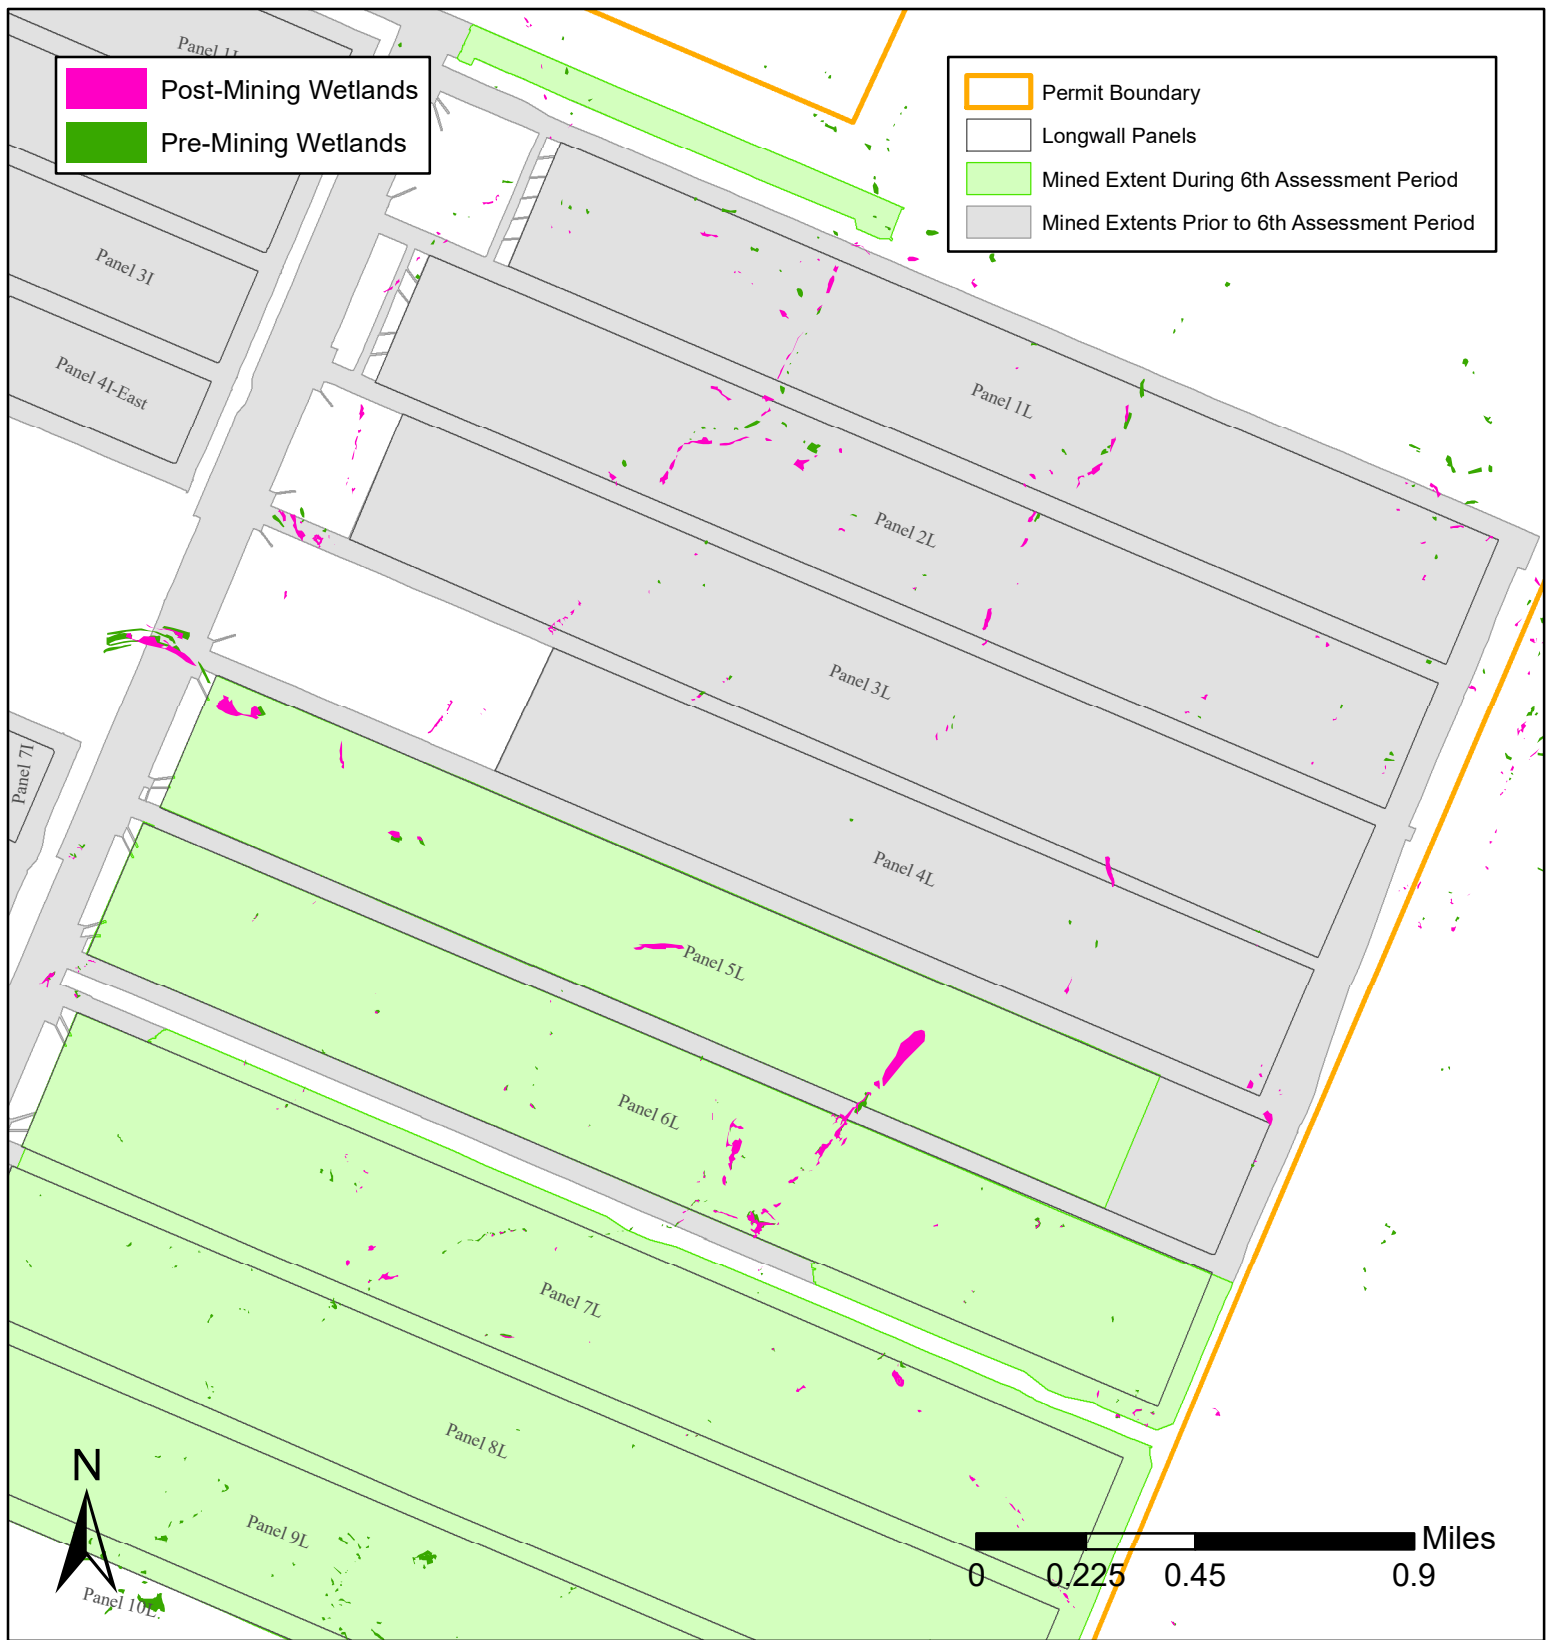
Figure 1.5.A - Wetlands - Bailey Mine

Wetlands Undermined During 6th Assessment Period: 7.58 Acres

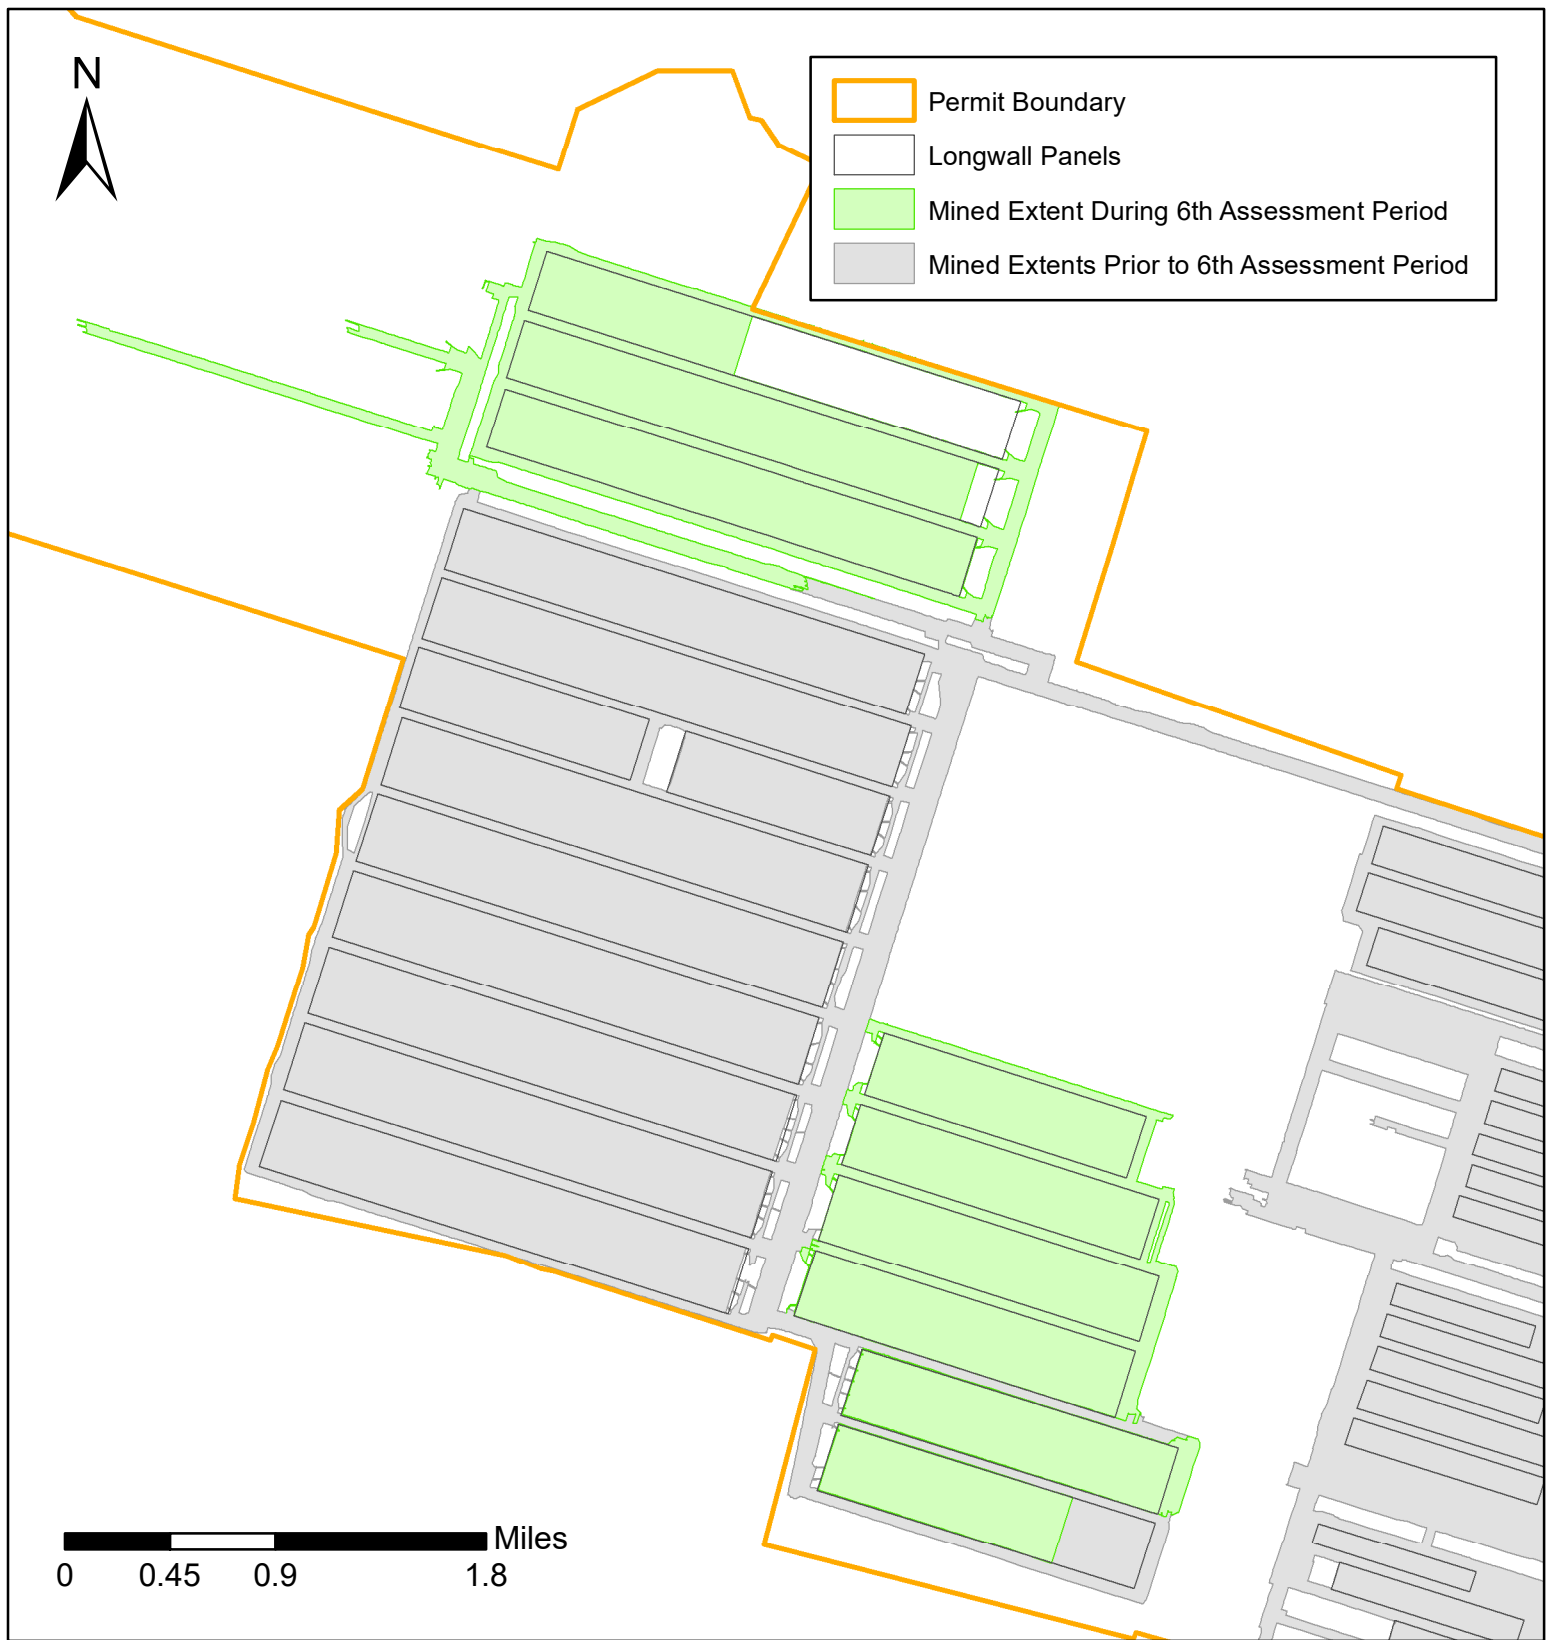
Figure 2.1.A - Mined Extents - Cumberland Mine

Extent of Mining During the 6th Assessment Period: 3,050 Acres
Total Extent of Mining at the End of 6th Assessment Period: 22,968 Acres

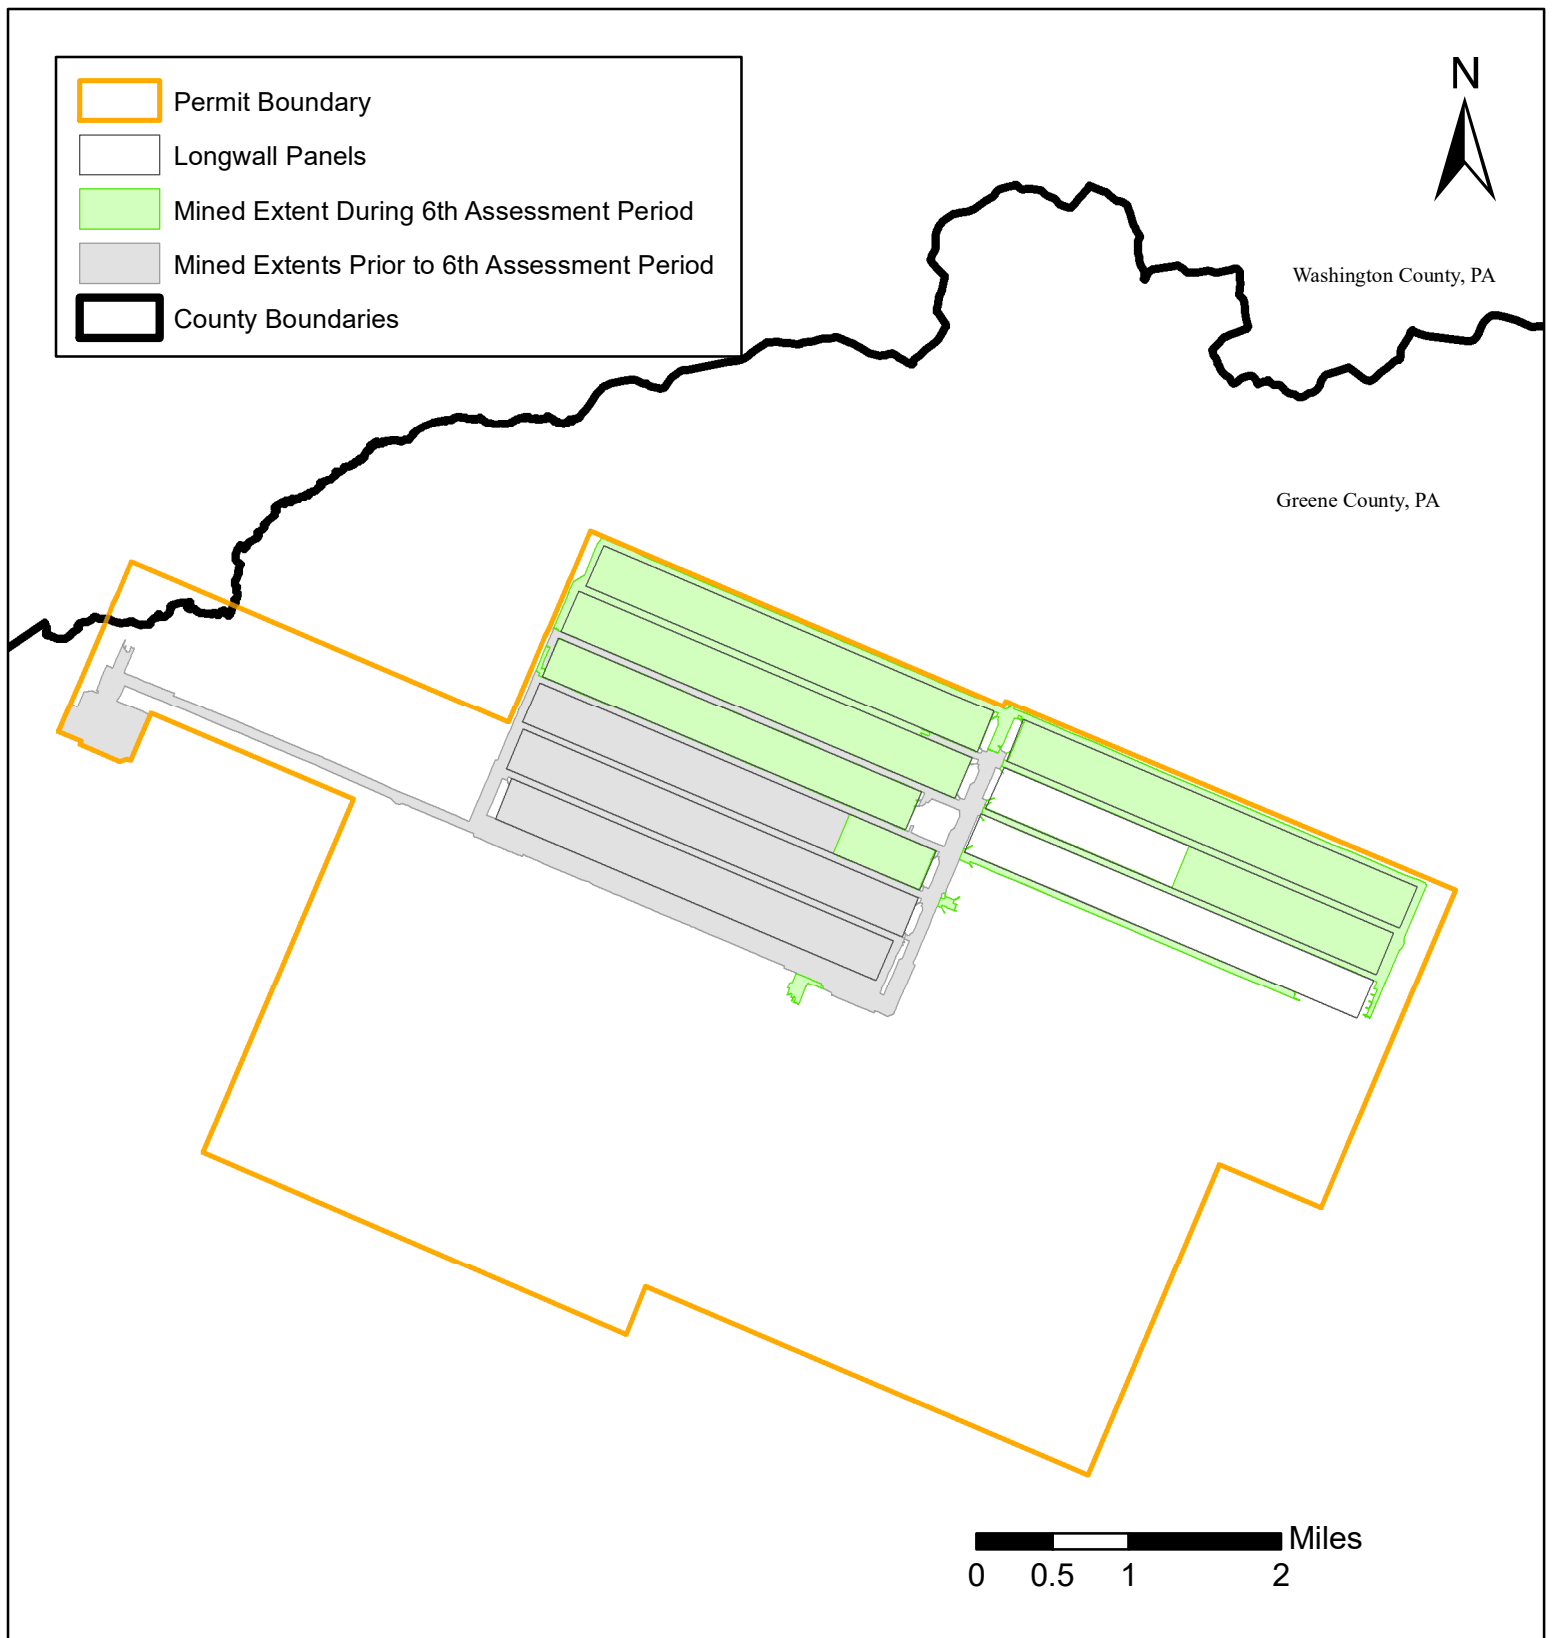
Figure 4.1 - Mined Extents - Harvey Mine

Extent of Mining During the 6th Assessment Period: 2,937 Acres
Total Extent of Mining at the End of 6th Assessment Period: 5,413 Acres

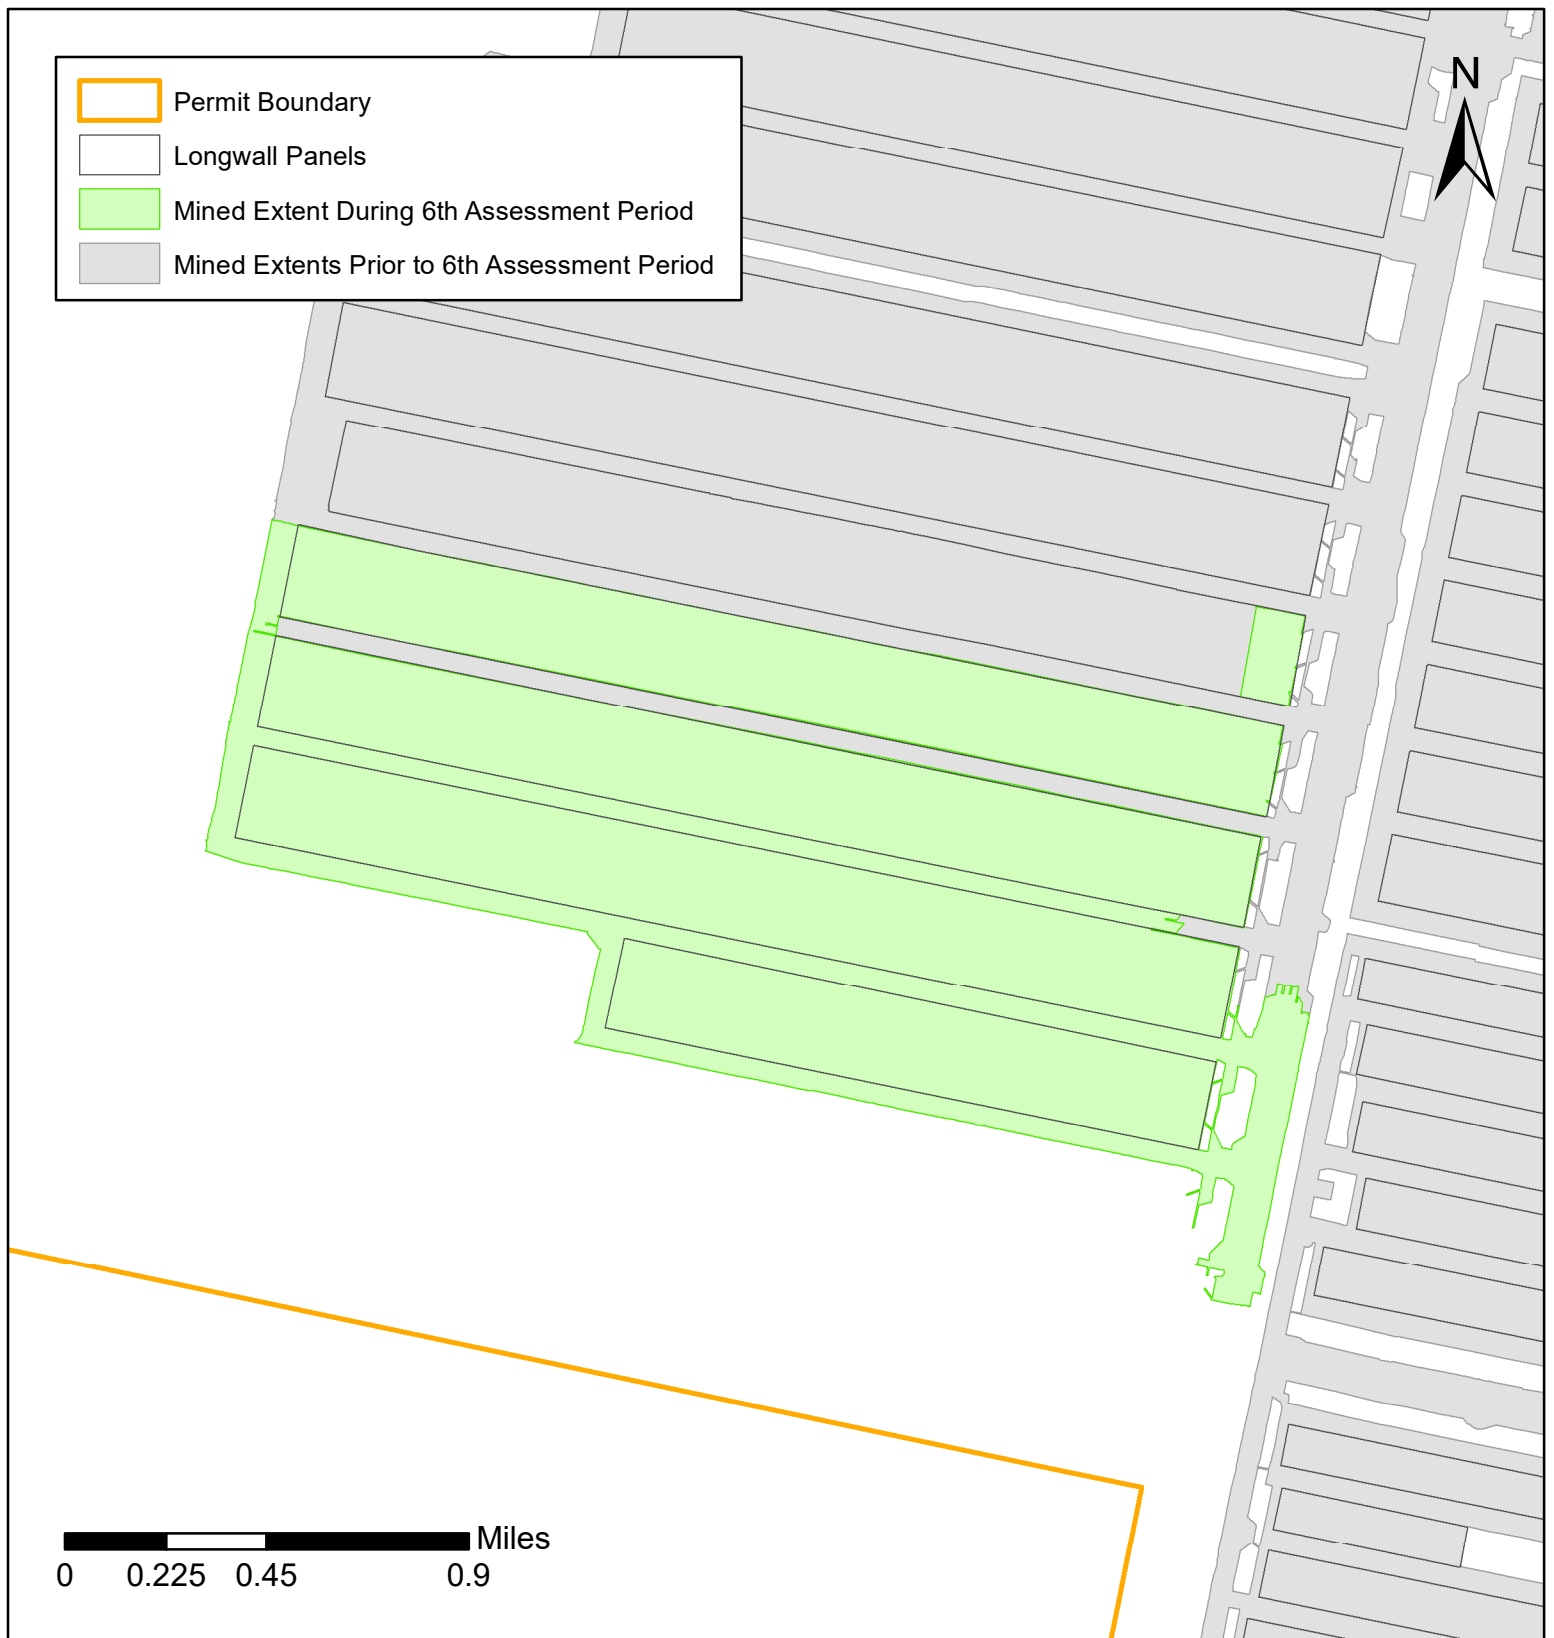
Figure 6.1.A - Mined Extents - Monongalia County Mine

Extent of Mining During the 6th Assessment Period: 1,340 Acres

Total Extent of Mining at the End of 6th Assessment Period: 18,766 Acres
