TRIP REPORT

Subject: Summary of Soil Infiltration Tests
Mt. Union Station
Sunoco PPP
Shirley Township, Huntingdon County, Pennsylvania

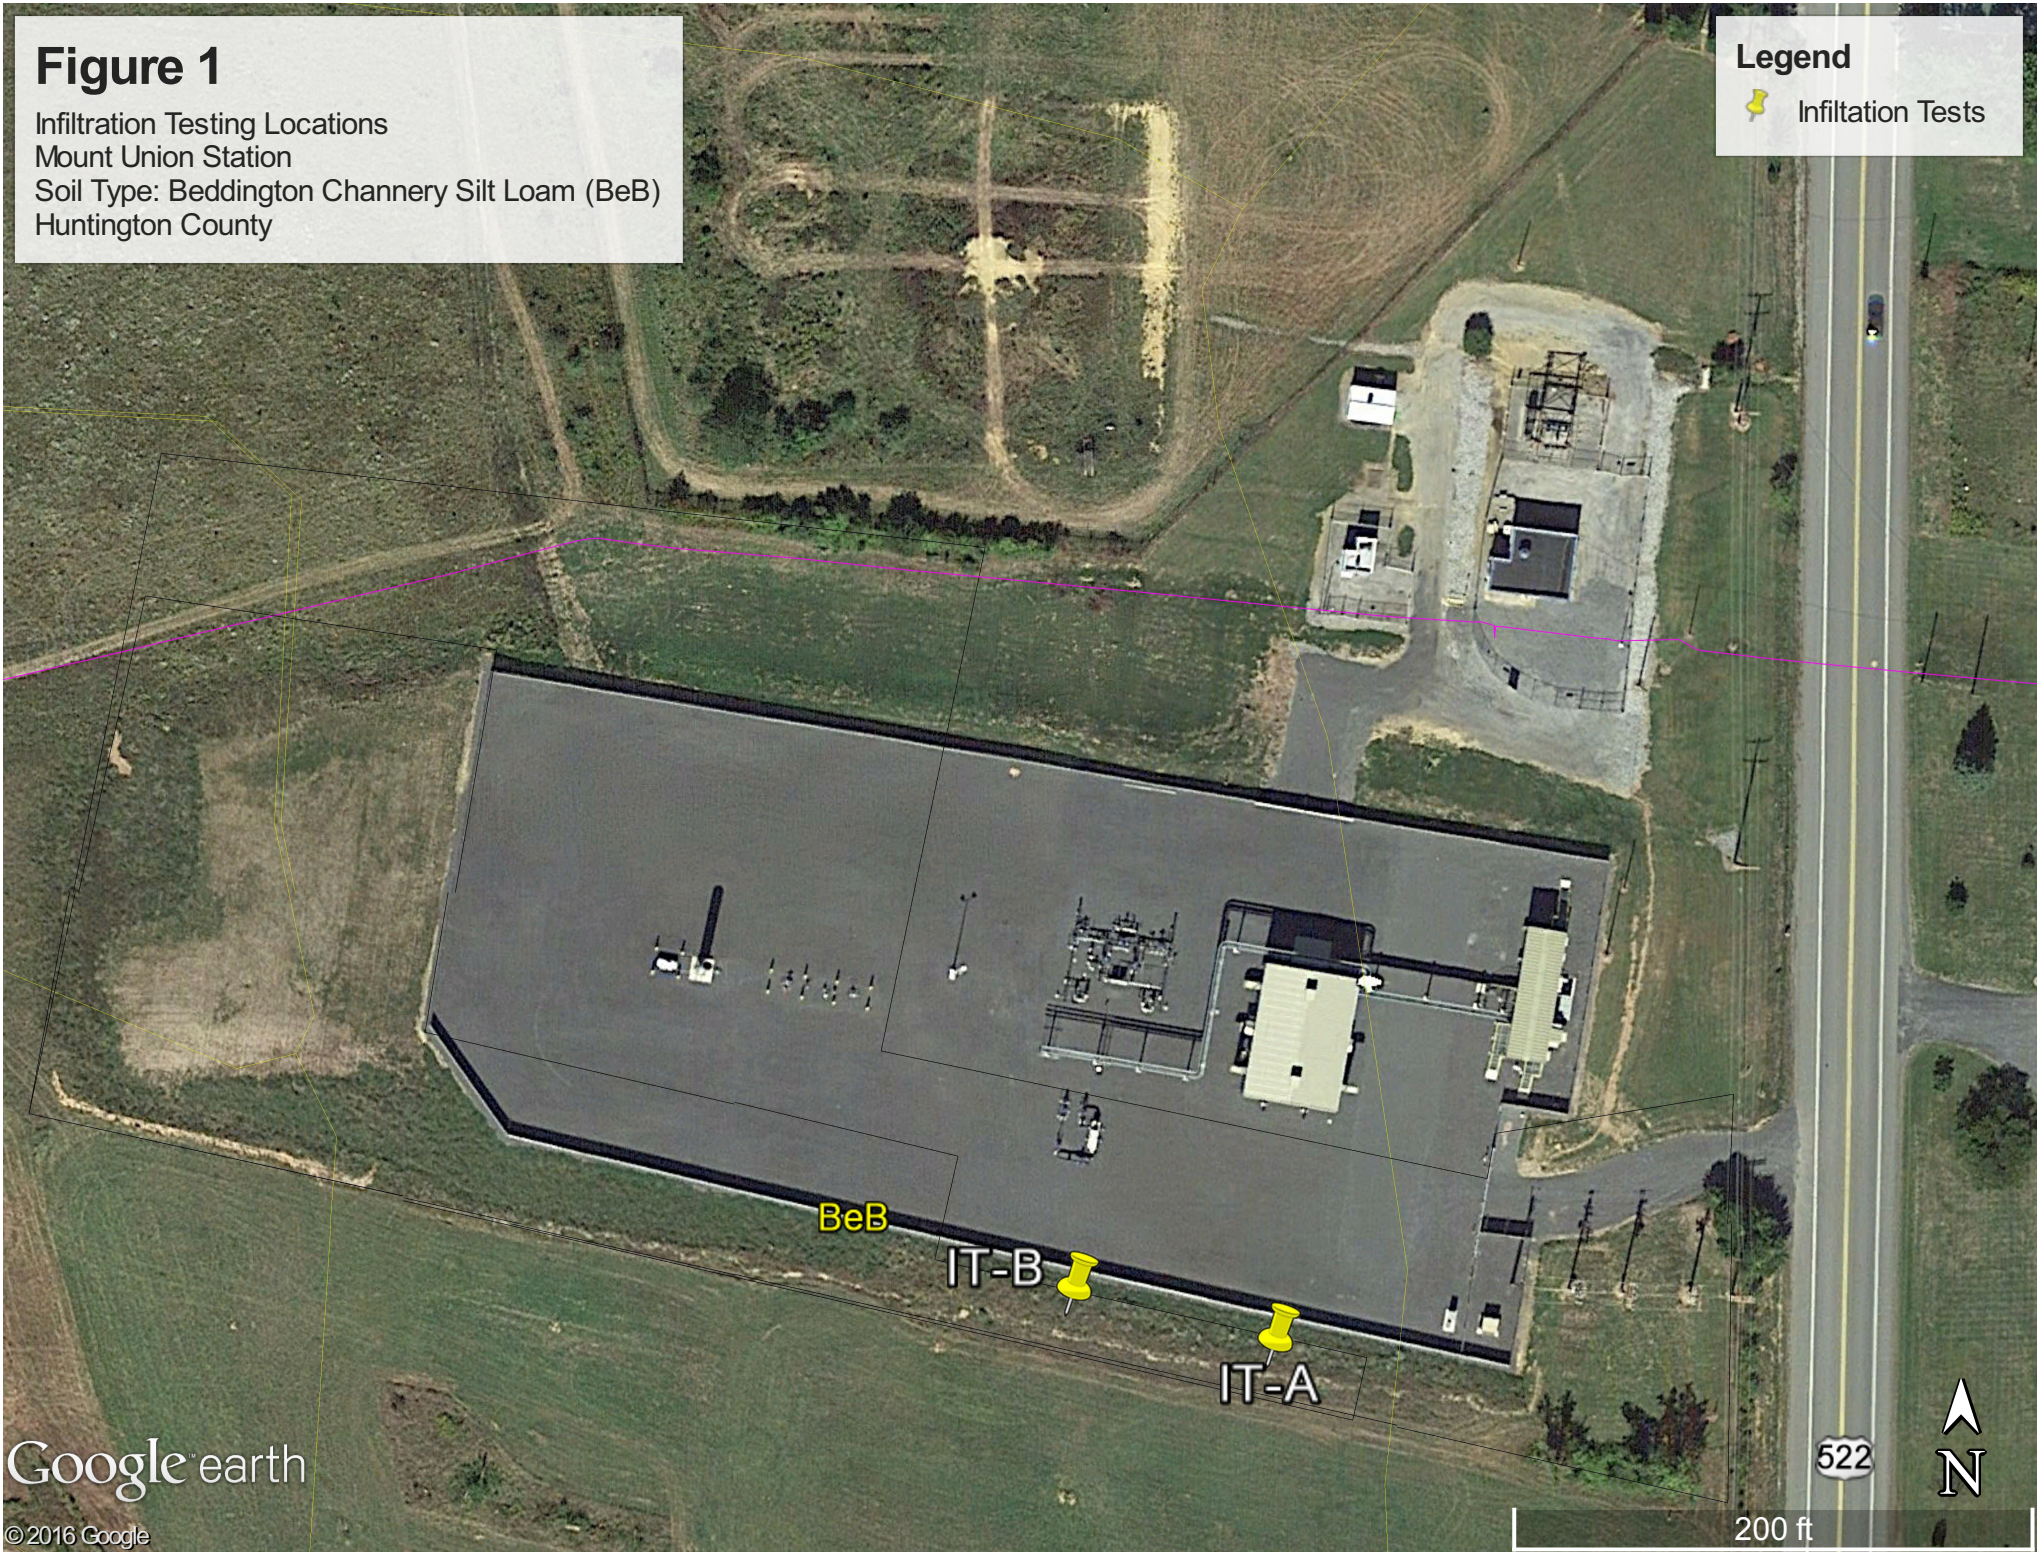
Figure 1

Infiltration Testing Locations
Mount Union Station
Soil Type: Beddington Channery Silt Loam (BeB)
Huntington County

This report presents the field data and results of double-ring soil infiltration tests conducted to support stormwater management system design. Two deep tests (IT-A and IT-B) were performed at the property. Test locations are listed by coordinates in World Geodetic System 84 (WGS 84) latitude and longitude format in Table 1, and locations are also illustrated on a figure attached to this report.
