To: Sunoco Pipeline L.P. (SPLP)
From: Tetra Tech
Subject: Wetland Cover Class Verification Technical Memorandum for the Pennsylvania Pipeline Project
Date: February 6, 2017

FIGURE 1
WETLAND LOCATION MAP
WETLAND 33D
PENNSYLVANIA PIPELINE PROJECT
MARINER EAST 2
SUNOCO PIPELINE L.P.
CUMBERLAND COUNTY, PA

Sunoco Pipeline, L.P.
Pennsylvania Pipeline Project
Wetland Cover Class Field Verification

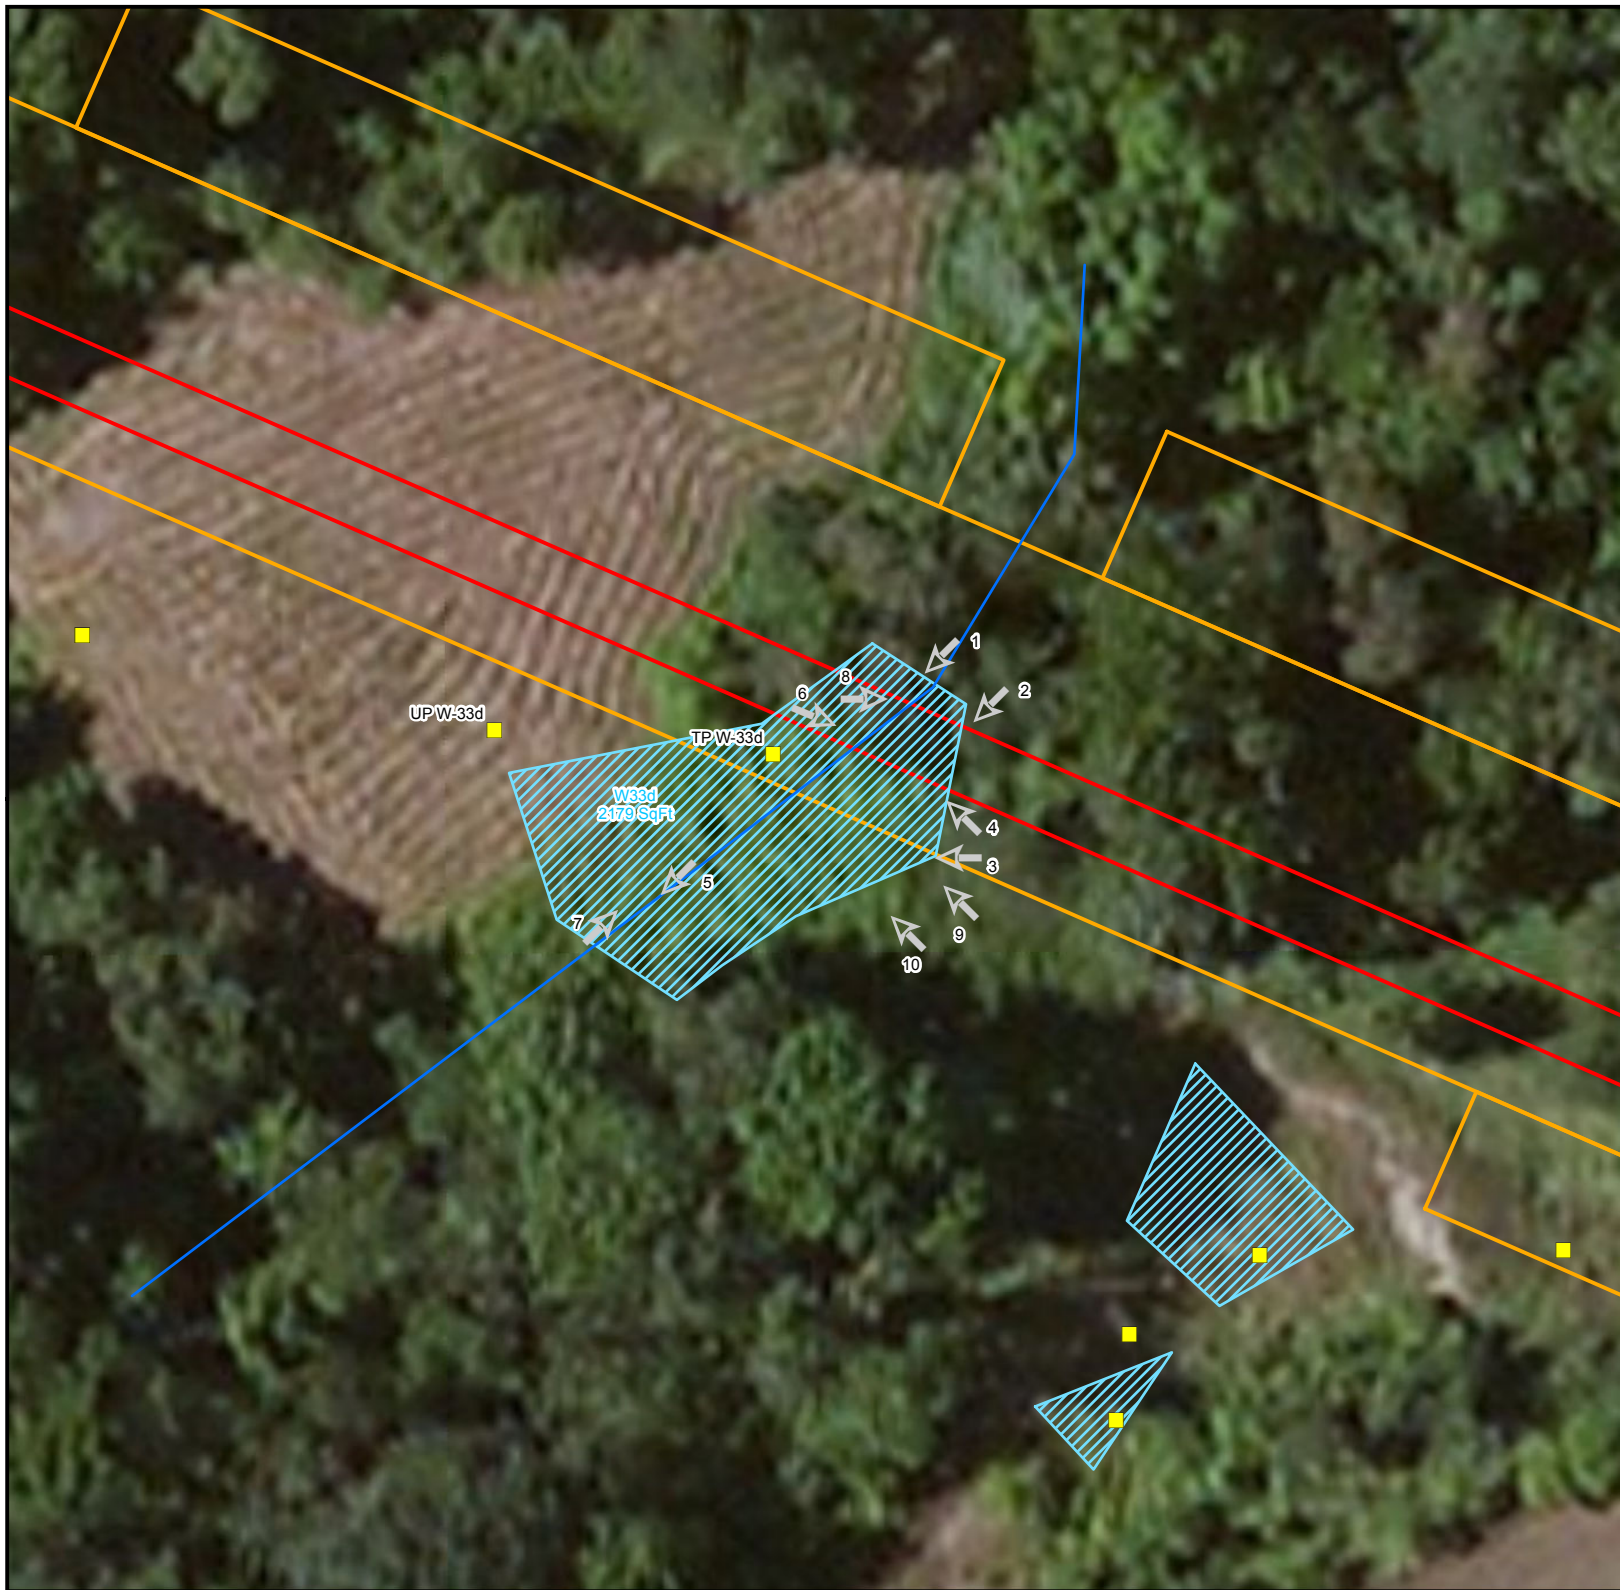
Wetland W33d was also verified in the field as having the correct Cowardin designation of PEM. As with wetland A49, aerial imagery indicated trees growing within the boundaries of wetland W33d. However, field inspection verified these trees were growing outside of the wetland along the boundary. A map of the wetland with photo locations is provided in Appendix A. Photographs representing the existing conditions can be found in Appendix B. Appendix C contains the wetland vegetation data sheet.

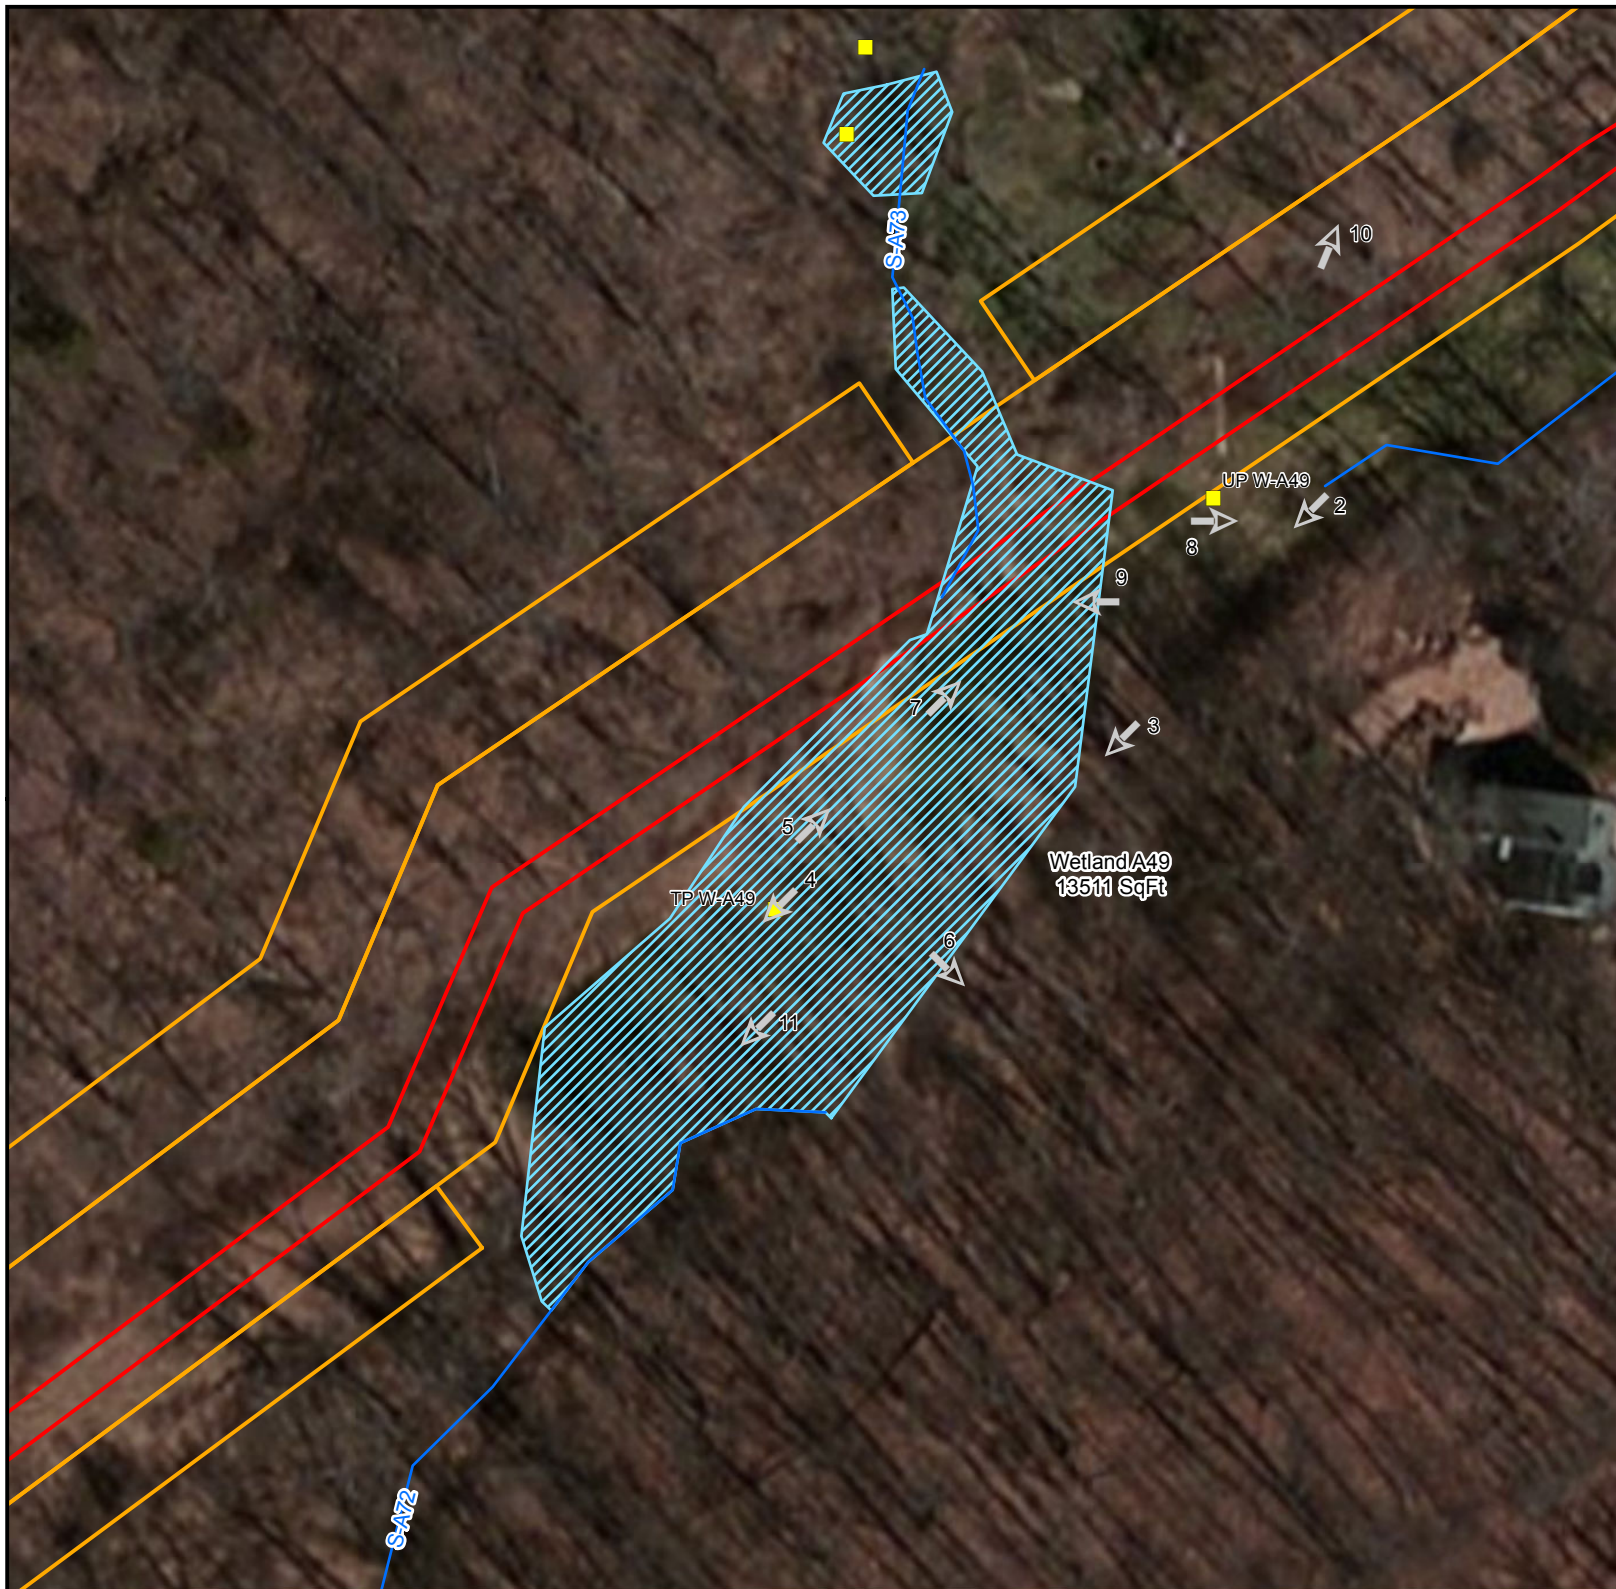
FIGURE 1
WETLAND LOCATION MAP
WETLAND A49
PENNSYLVANIA PIPELINE PROJECT
MARINER EAST 2
SUNOCO PIPELINE L.P.
BERKS COUNTY, PA

Wetland A49 was verified in the field as having the correct Cowardin designation of PEM. Aerial imagery indicates that there are trees growing within the wetland; however, the field visit verified that the trees and shrubs are actually outside the wetland, growing along the boundary with their associated canopy

overhanging the PEM wetland. A map of the wetland with photo locations is presented in Appendix A. Photographs representing the existing conditions can be found in Appendix B.

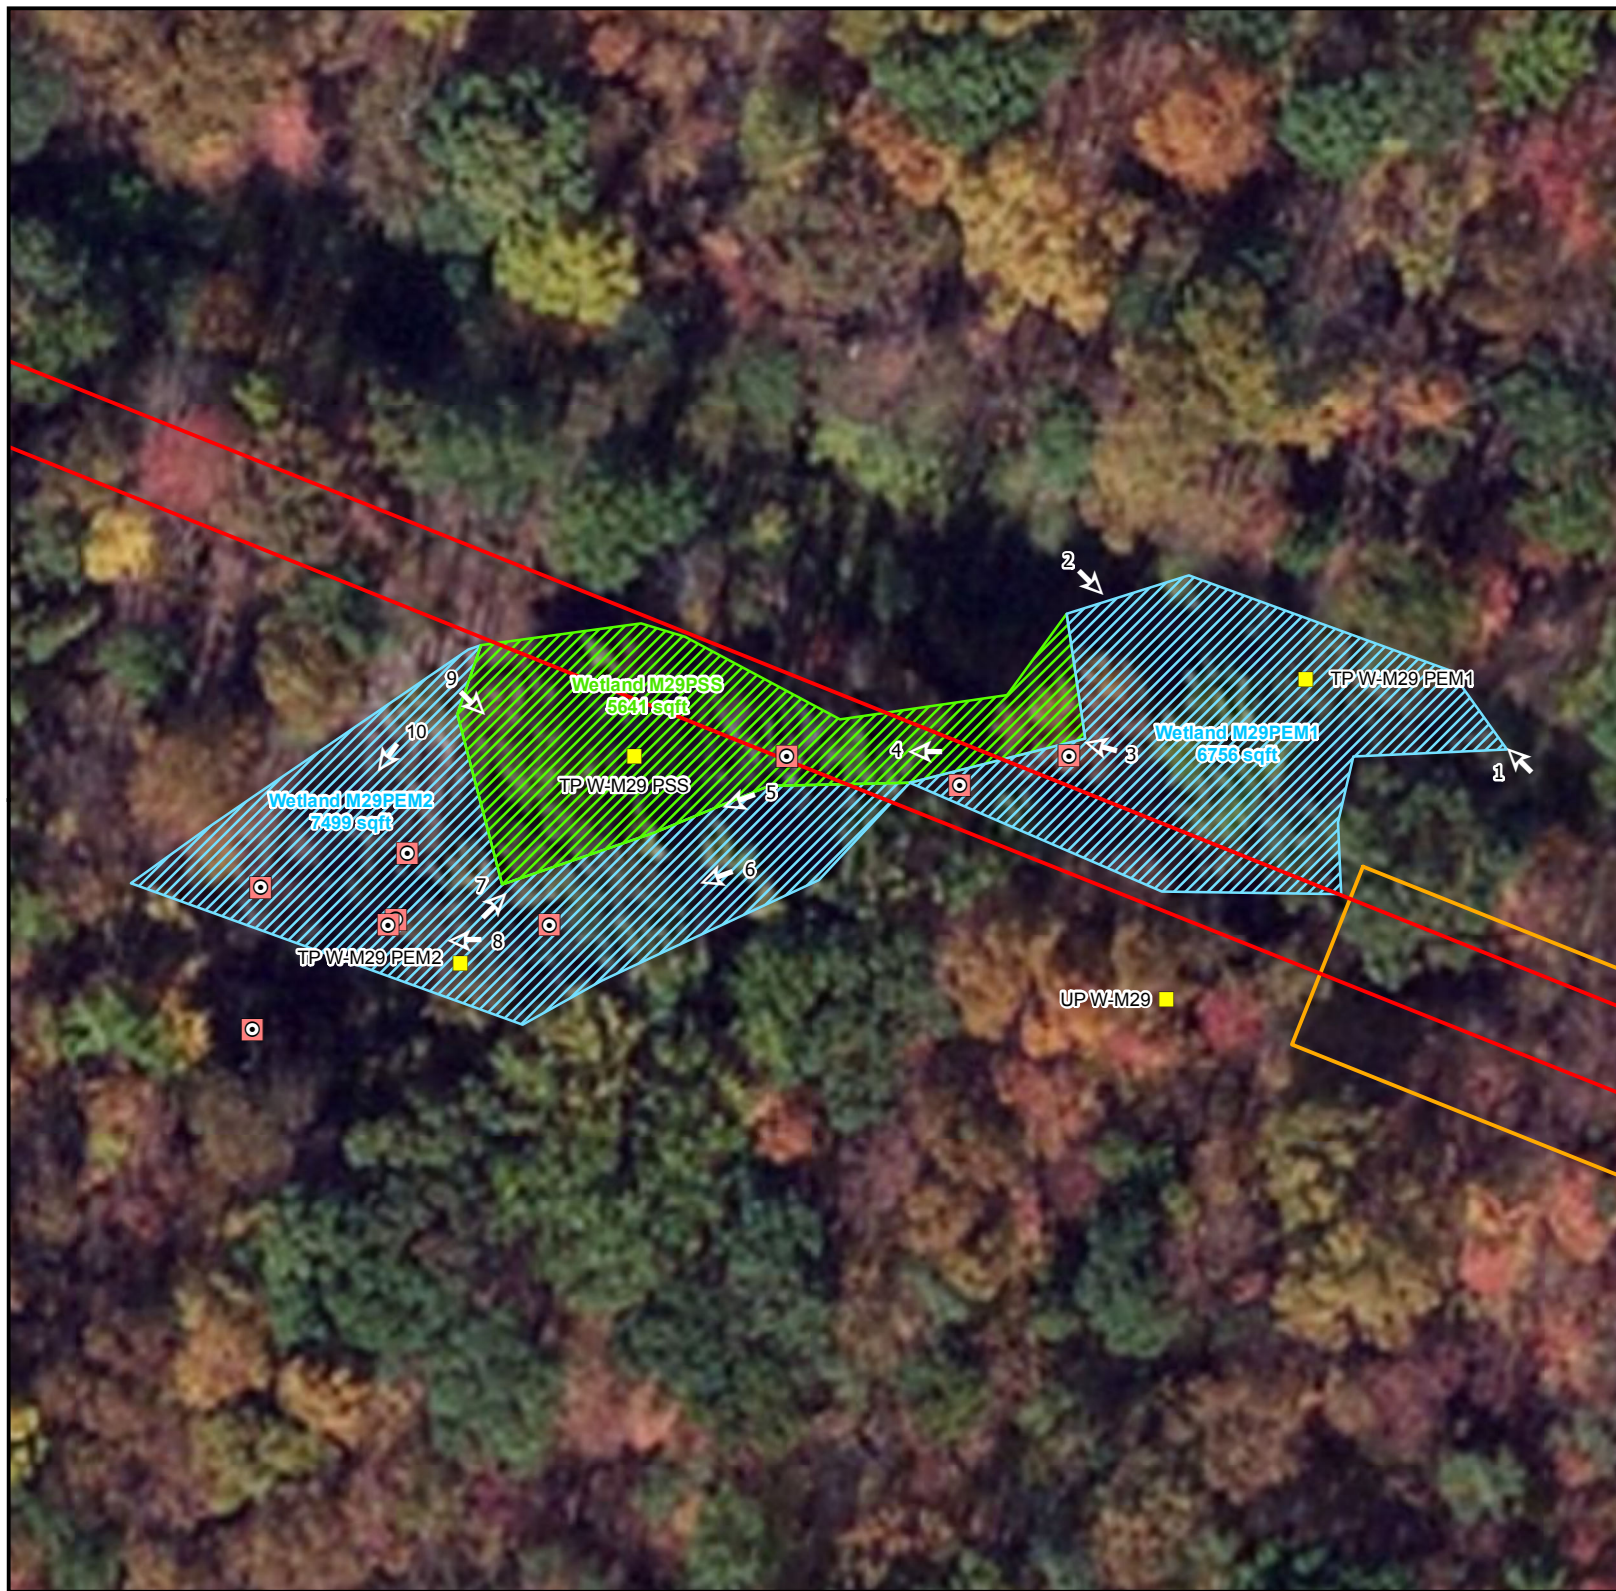
FIGURE 1
WETLAND LOCATION MAP
WETLAND M29
PENNSYLVANIA PIPELINE PROJECT
MARINER EAST 2
SUNOCO PIPELINE L.P.
BLAIR COUNTY, PA

The field inspection of Wetland M29 led to a portion of the wetland now being classified as PSS, rather than the entirety of it being PEM as previously documented. The wetland now has PEM1, PEM2, and PSS1 portions (Appendix A). This wetland was initially examined on June 28, 2014 after recent non-SPLP logging activities in the vicinity. Since the initial site visit, the site most likely has experienced natural succession and revegetation, resulting in the presence, or increased dominance, of shrub species within the previously PEM classified portion. A map of the wetland with photo locations is provided in Appendix A. Photographs that identify both the PEM and PSS portions of this wetland as seen during the field survey effort can be found in Appendix B. Appendix C contains the wetland vegetation data sheet. The resulting updates in impacts due to this cover class change have been carried throughout the various permit applications.

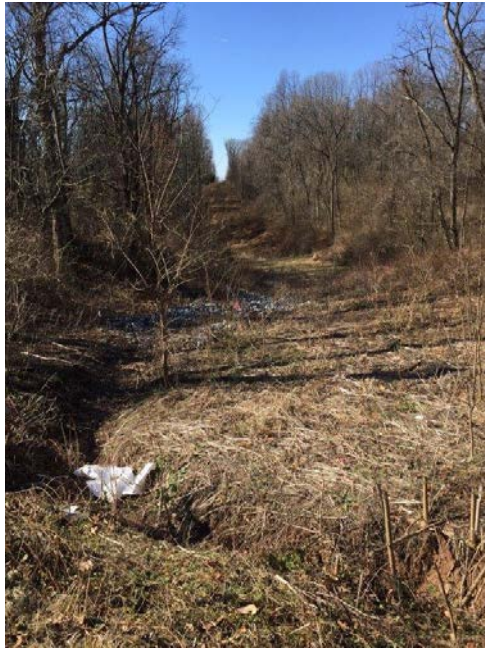
Photographer: P. Gaskins
Date: 2/04/2017
Photo No.: 1
Direction: SW

Comments: (Photo 1) View from Vinemont Rd - wetland A49 in background, note drainage ditch CLV43 in foreground.

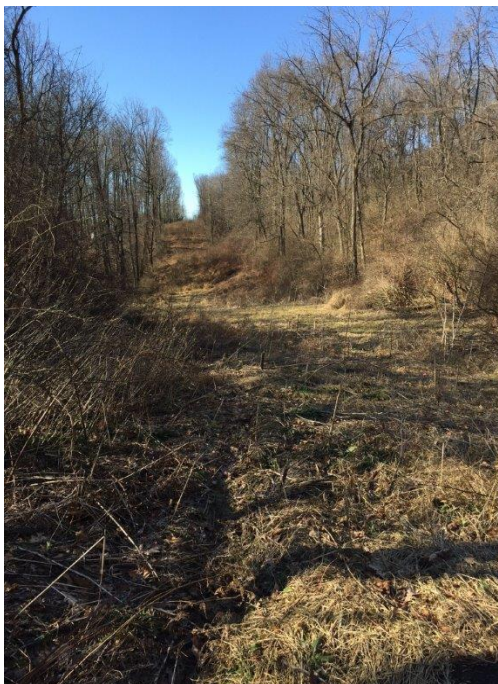
Photographer: P. Gaskins
Date: 2/04/2017
Photo No.: 2
Direction: SW

Comments: (Photo 2) View along ROW towards wetland A49.

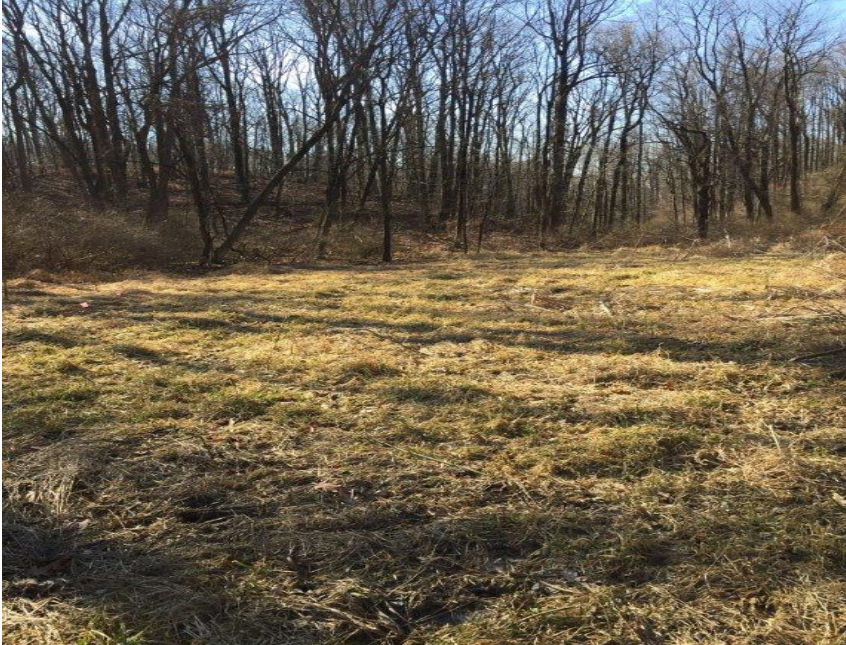
Photo No.: 3

Comments: (Photo 3) Wetland
A49 – PEM

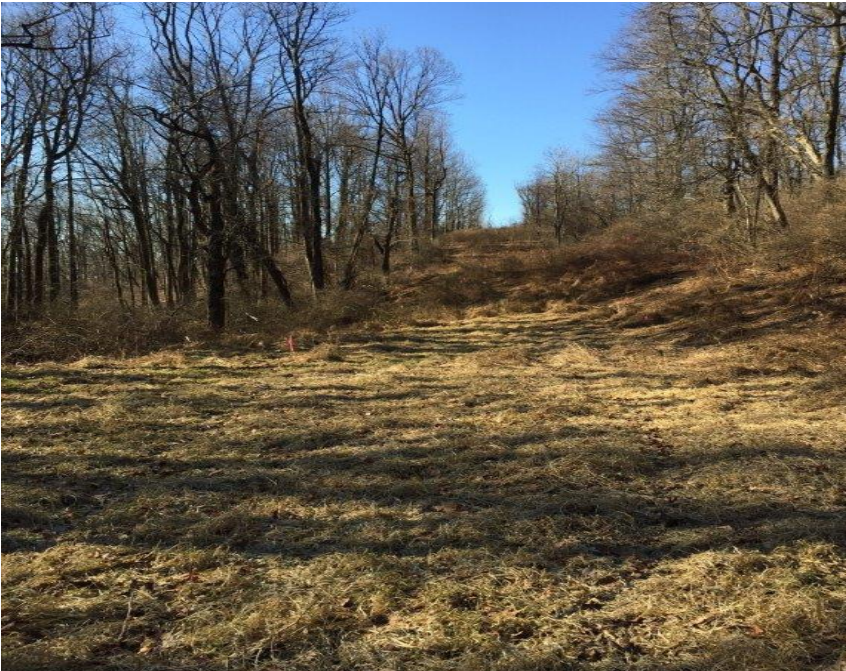
Photo No.: 4

Comments: (Photo 4) Wetland
A49 – view along ROW.

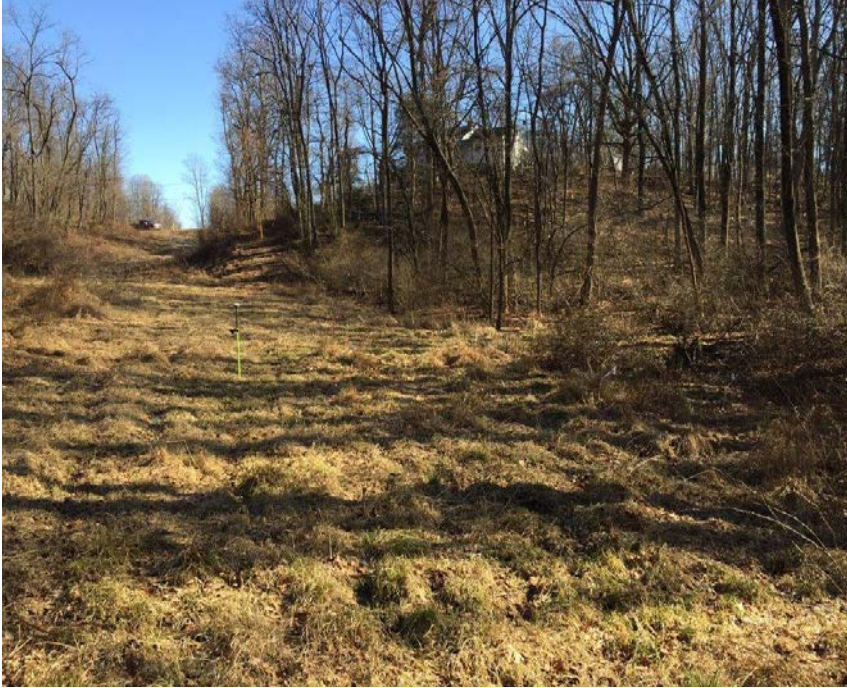
Photo No.: 5

Comments: (Photo 5) Wetland A49 – view along ROW towards Vinemont Rd.

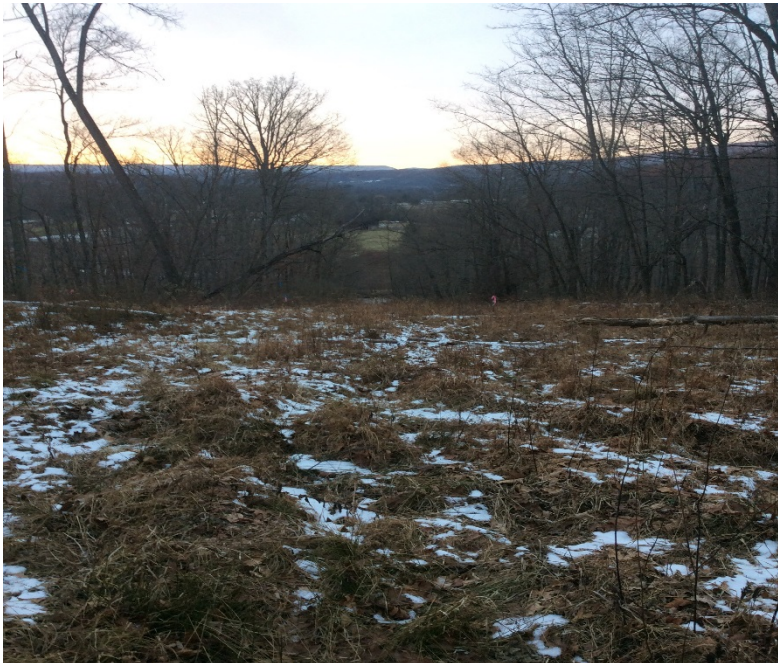
Photographer: K. McCluskey
Date: 2/04/2017
Photo No.: 12
Direction: W

Comments: PEM1 portion of
wetland M29 from Photo
Location 1.

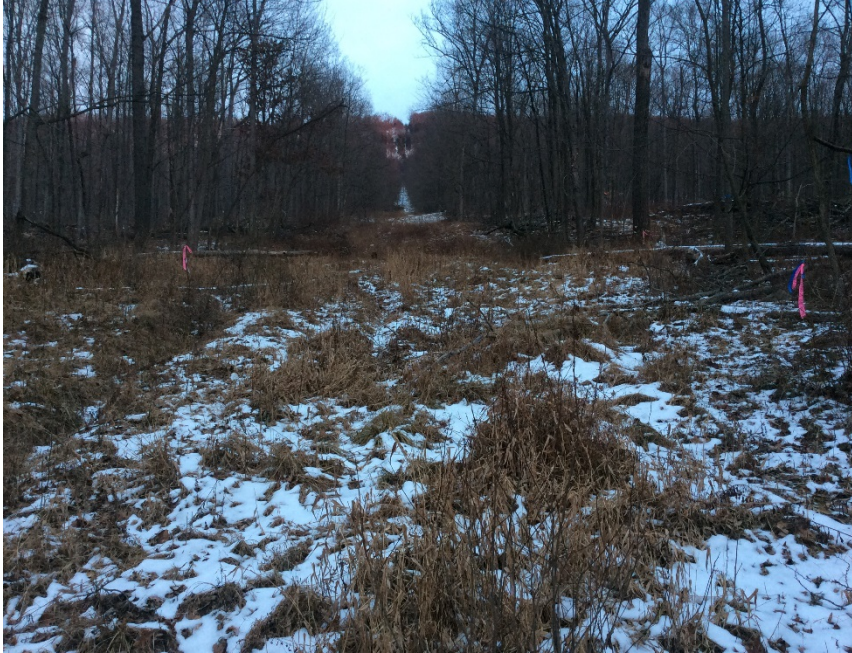
Photographer: K.McCluskey
Date: 2/04/2017
Photo No.: 13
Direction: E

Comments: PEM1 portion of wetland M29 from Photo Location 2.

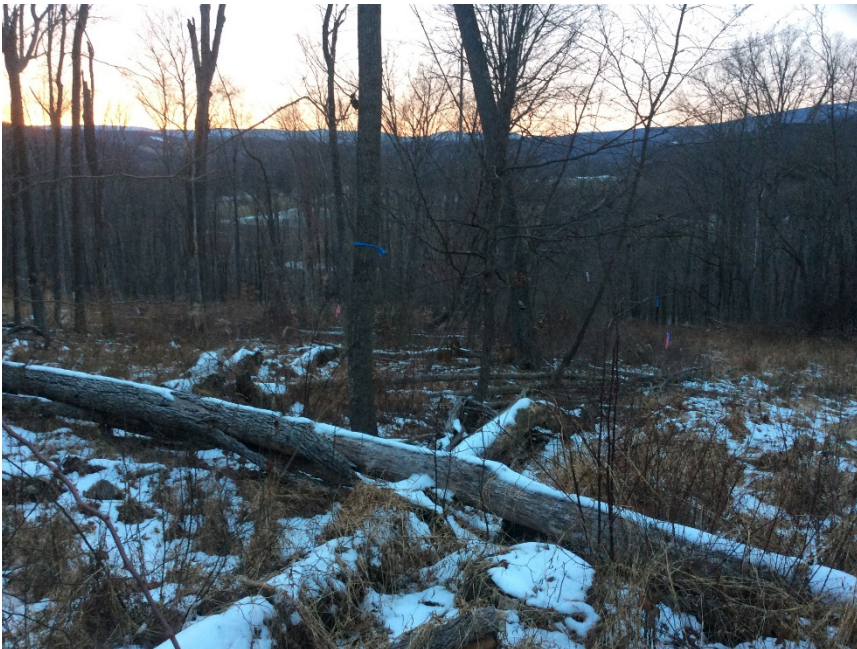
Photographer: K.McCluskey
Date: 2/04/2017
Photo No.: 14
Direction: W

Comments: PSS portion of wetland M29 from Photo Location 3.

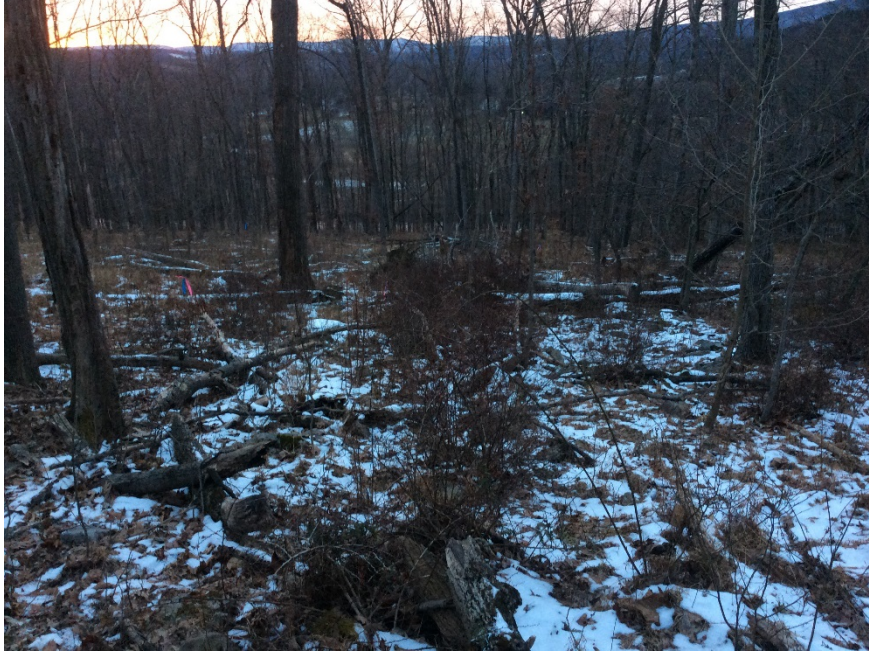
Photographer: K.McCluskey
Date: 2/04/2017
Photo No.: 15
Direction: W

Comments: PSS portion of wetland M29 from Photo Location 4.

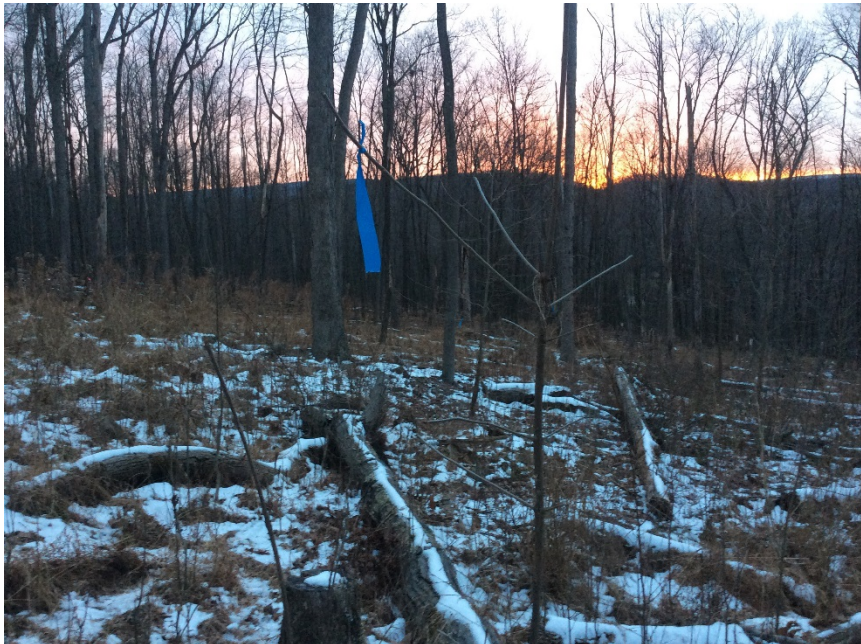
Photographer: K.McCluskey
Date: 2/04/2017
Photo No.: 16
Direction: SW

Comments: PEM2/PSS boundary of wetland M29 from Photo Location 5.

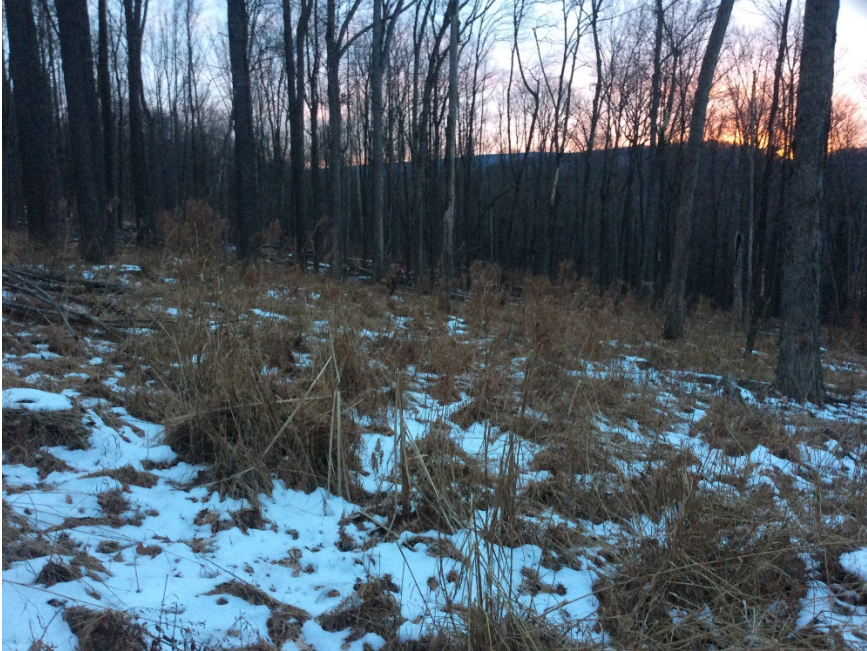
Photo No.: 17

Comments: PEM2 portion of
wetland M29 from Photo
Location 6.

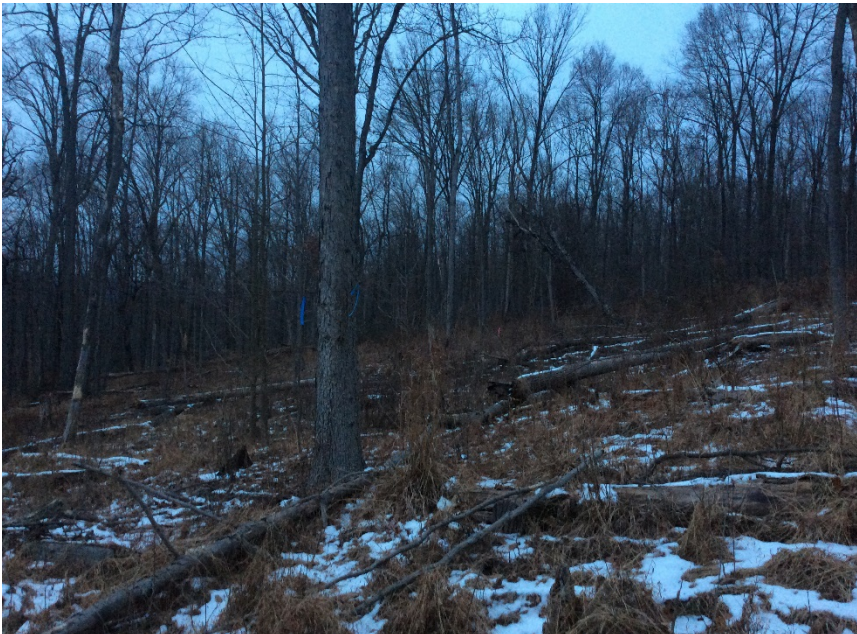
Photo No.: 18

Comments: PSS portion of
wetland M29 from Photo
Location 7.

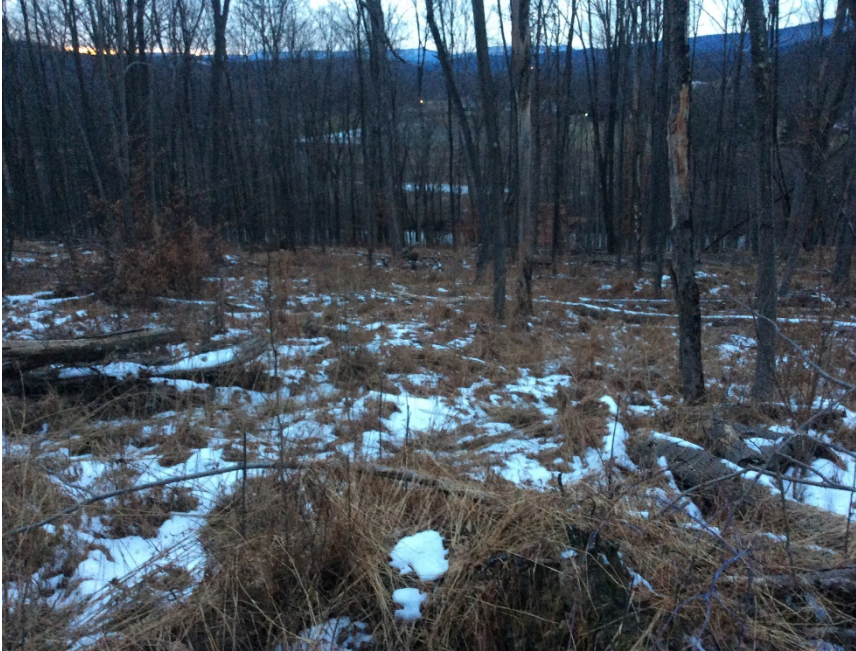
Photo No.: 19

Comments: PEM2 portion of wetland M29 from Photo Location 8.

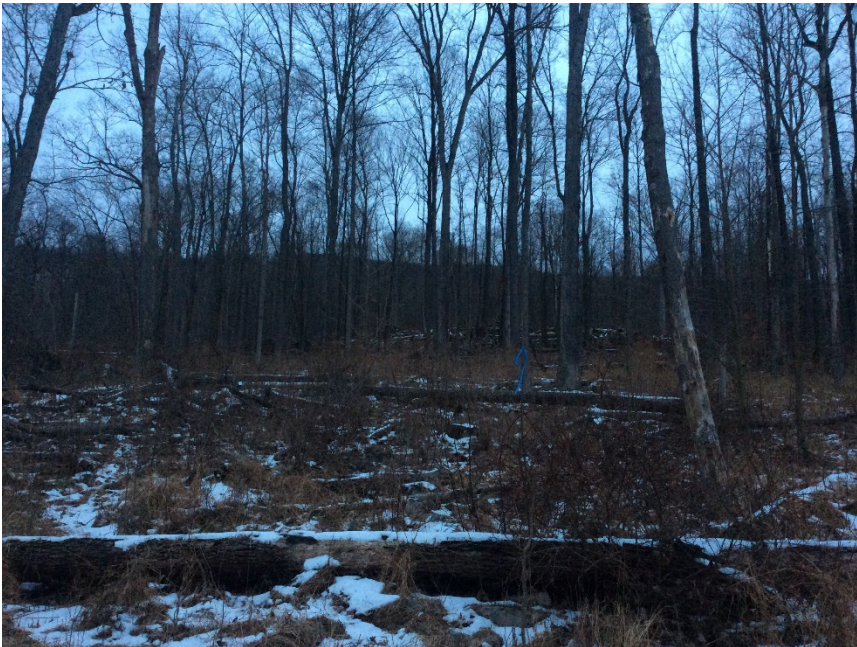
Photo No.: 20

Comments: PSS portion of wetland M29 from Photo Location 9.

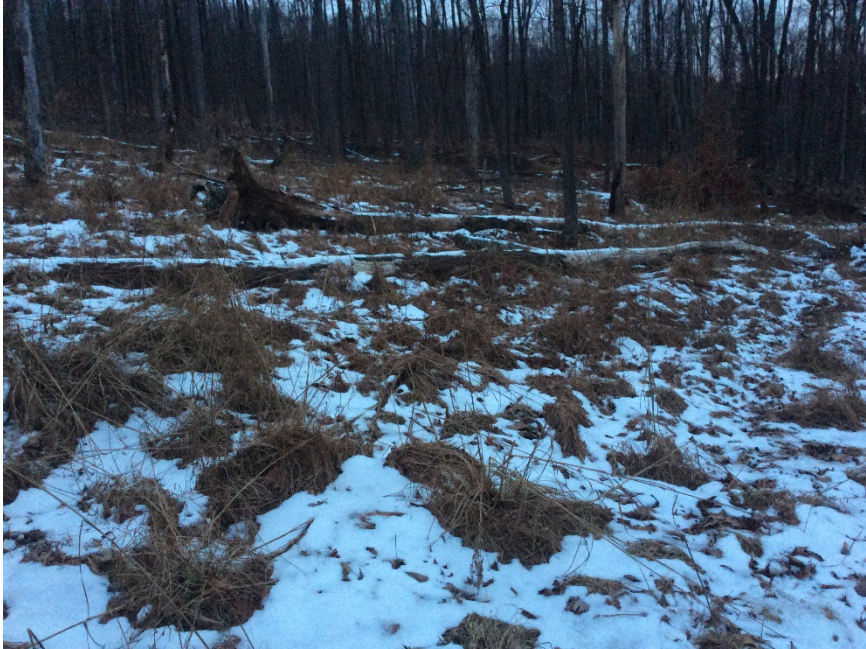
Photographer: K.McCluskey
Date: 2/04/2017
Photo No.: 21
Direction: SW

Comments: PEM2 portion of wetland M29 from Photo Location 10, note standing dead trees.

*Almost all of the trees that occur within this PEM portion of W-M29 are standing dead. There were only 2 large live trees within the PEM2 portion of W-M29. There were two shrub-sized striped maples, but these occur on the edge of the PEM/ PSS habitat boundary line.
