## **TRIP REPORT BOOT ROAD EFRD SITE – INFILTRATION TESTING**

**Table 1**  
**Summary of Infiltration Test Results**  
**Boot Road EFRD**  
**West Goshen Township, Chester County, PA**  
**Sunoco PPP**

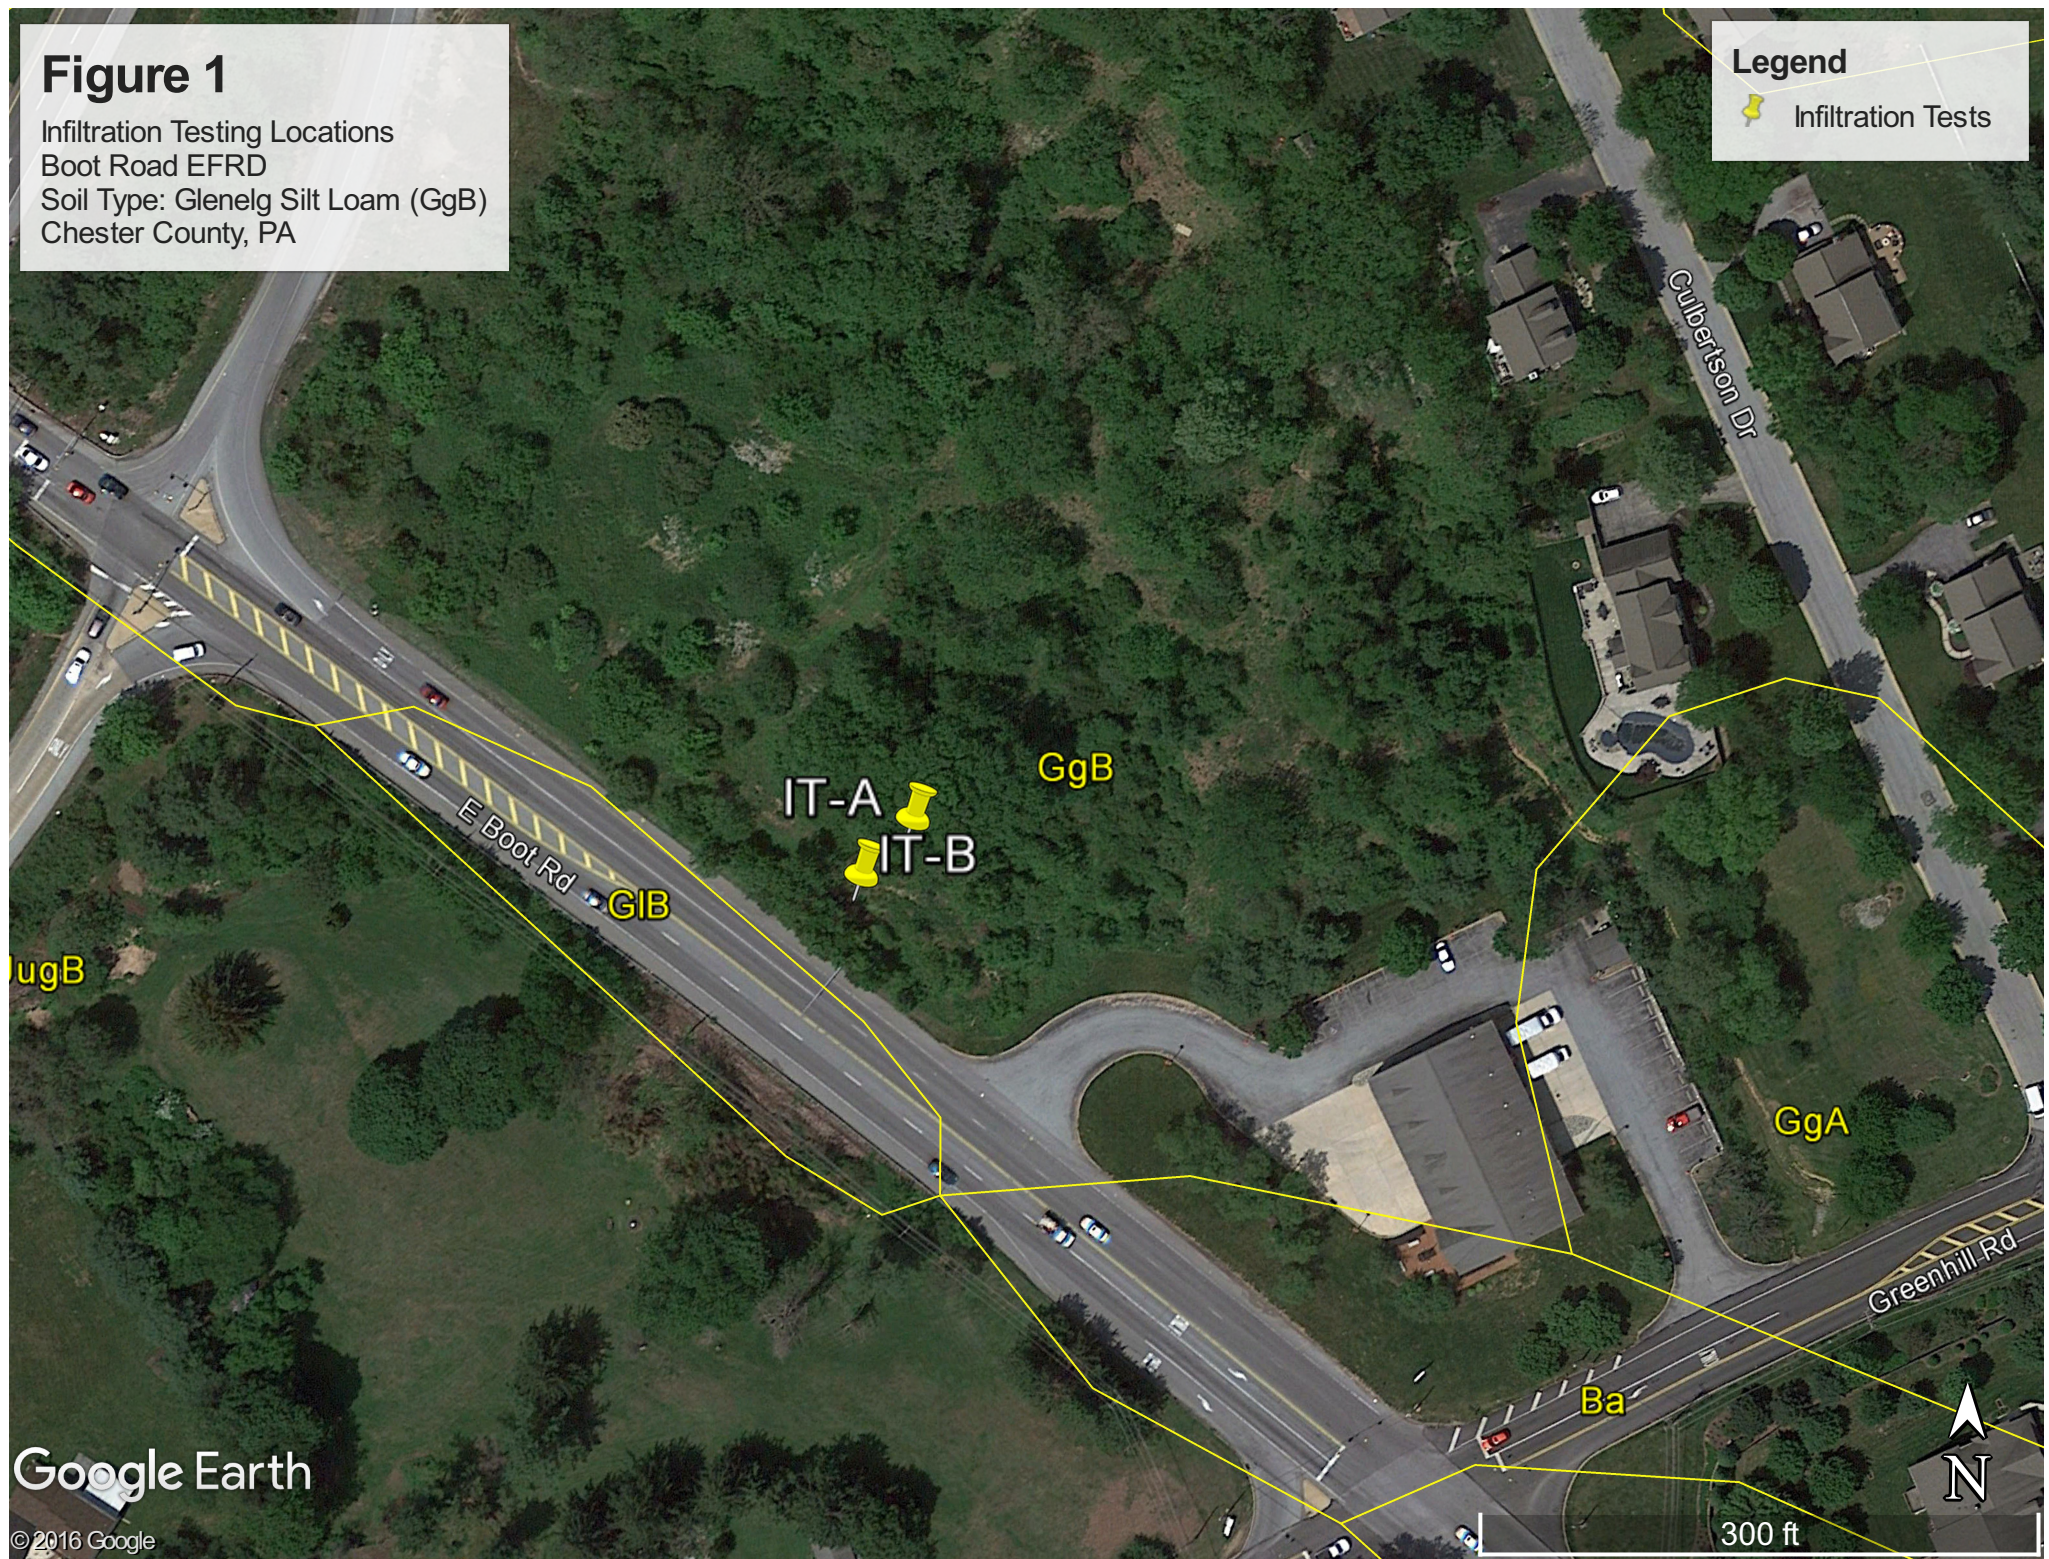
# Figure 1

Infiltration Testing Locations  
Boot Road EFRD  
Soil Type: Glenelg Silt Loam (GgB)  
Chester County, PA

This Trip Report presents the field data and results of double-ring soil infiltration tests conducted to support the design of a stormwater management system at the Boot Road EFRD site located in West Goshen Township, Chester County, Pennsylvania as part of the Pennsylvania Pipeline Project (PPP) for Sunoco Pipeline, LP. One deep and two shallow tests (IT-A and IT-B) were performed at the site. The test locations are listed by coordinates (latitude and longitude) in Table 1 and shown on the attached figure.

The infiltration tests were conducted by Ken McGill and Heather Rychlak of CH2M Hill, Inc., on October 6, 2016. The test locations were positioned in the field using a handheld, WAAS-enabled GPS unit. Table 1 provides the coordinates of the test locations. All three tests were located in a grassy field, approximately 50 feet northeast of East Boot Road.
