Geotechnical Engineering Services Data Report

Schuylkill River Pipe Replacement Project
Chester and Montgomery Counties, Pennsylvania

File No. 15556-032-00

February 8, 2023

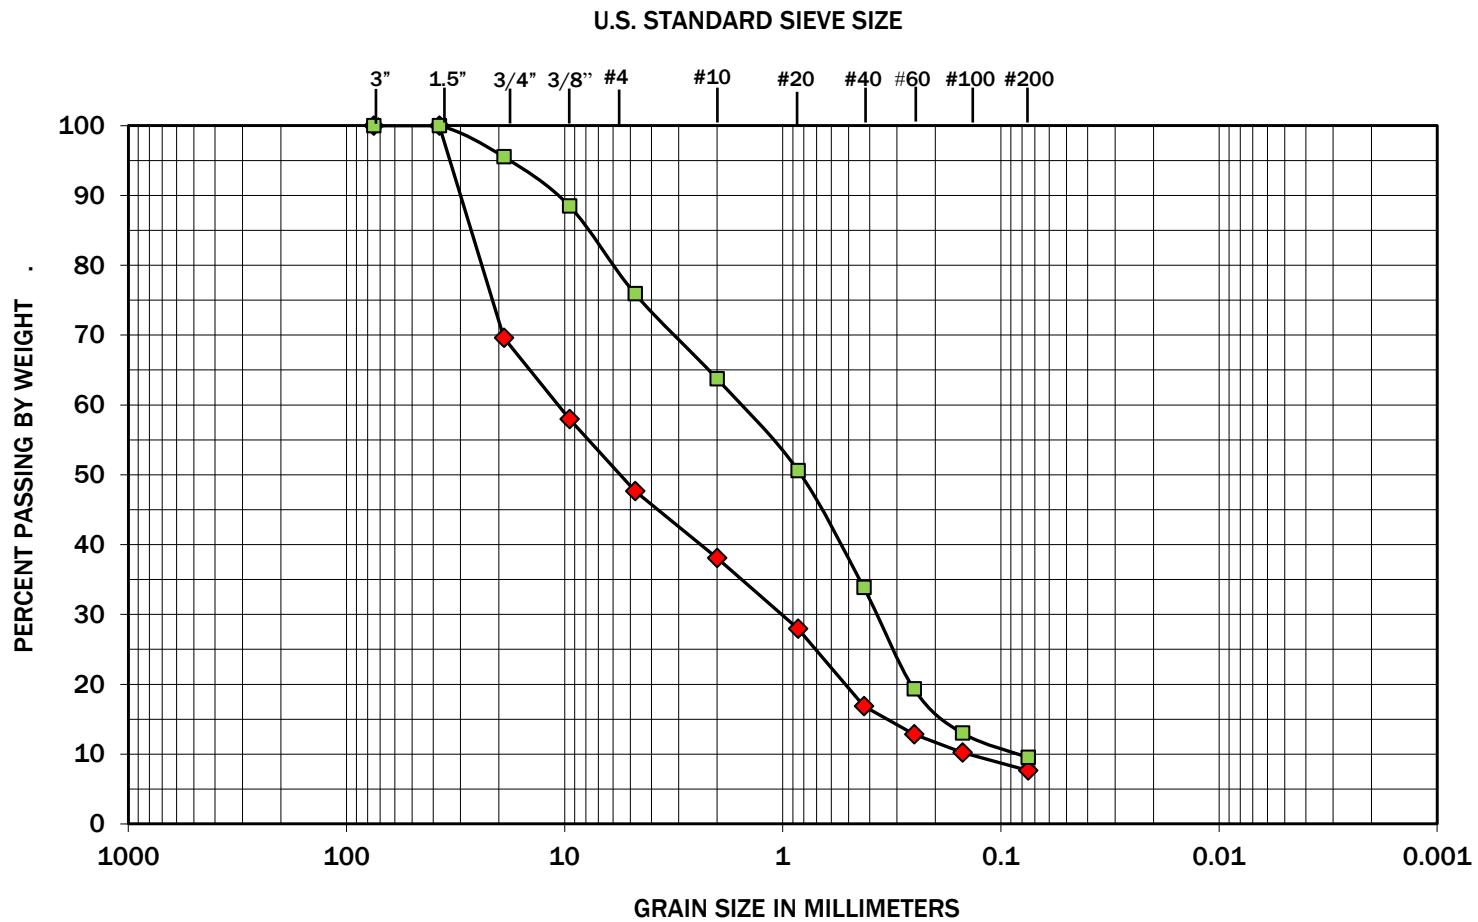
Figure A-5

Symbol	Boring Number	Sample Depth (feet)	Moisture Content (%)	Gravel (%)	Sand (%)	Fines (%)	Soil Description (USCS)
◆	SR-1	15	10.1	52.3	40	7.7	Brown poorly graded gravel with silt and sand (GP-GM)
■	SR-2	15	15.0	24.1	66.4	9.5	Reddish brown well-graded sand with silt and gravel (SW-SM)

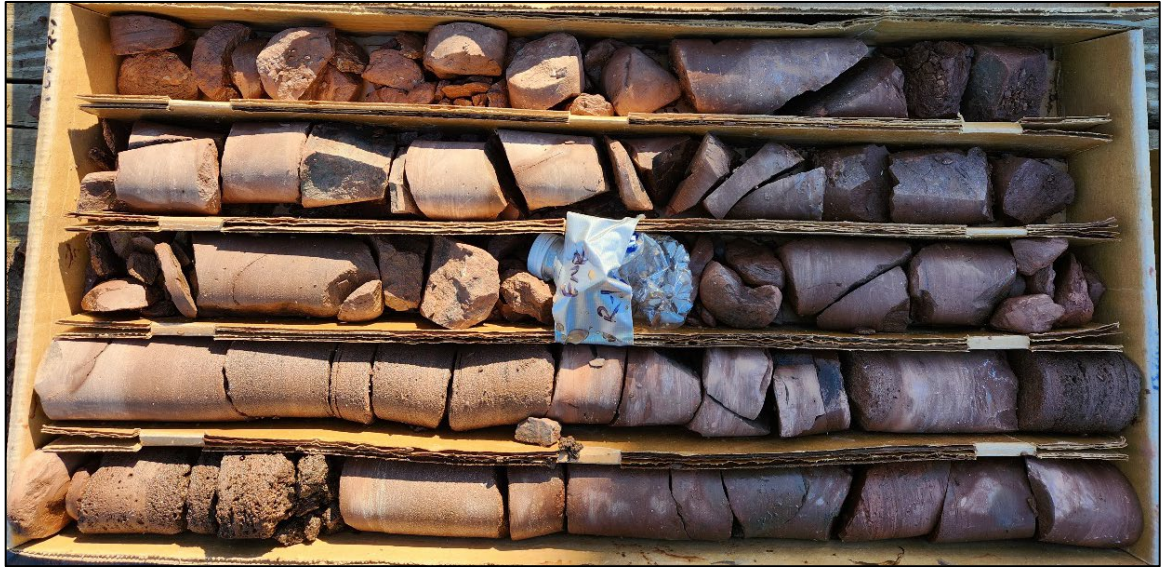
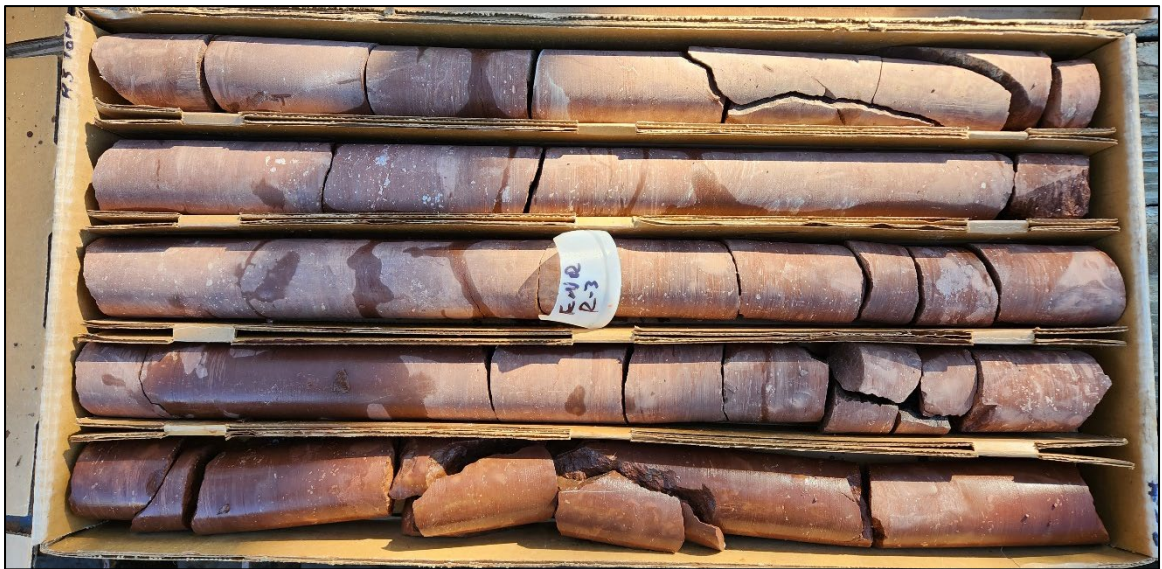
Figure A-6

SR-1: 20.0' to 30.0'

SR-1: 30.0' to 40.0'

Rock Core Photographs

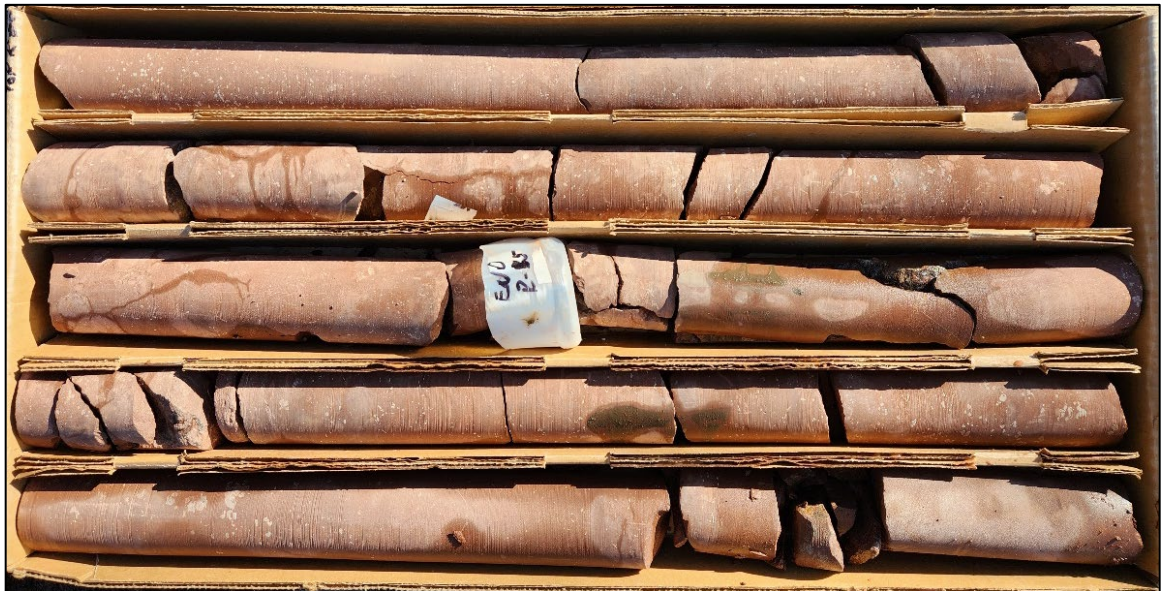
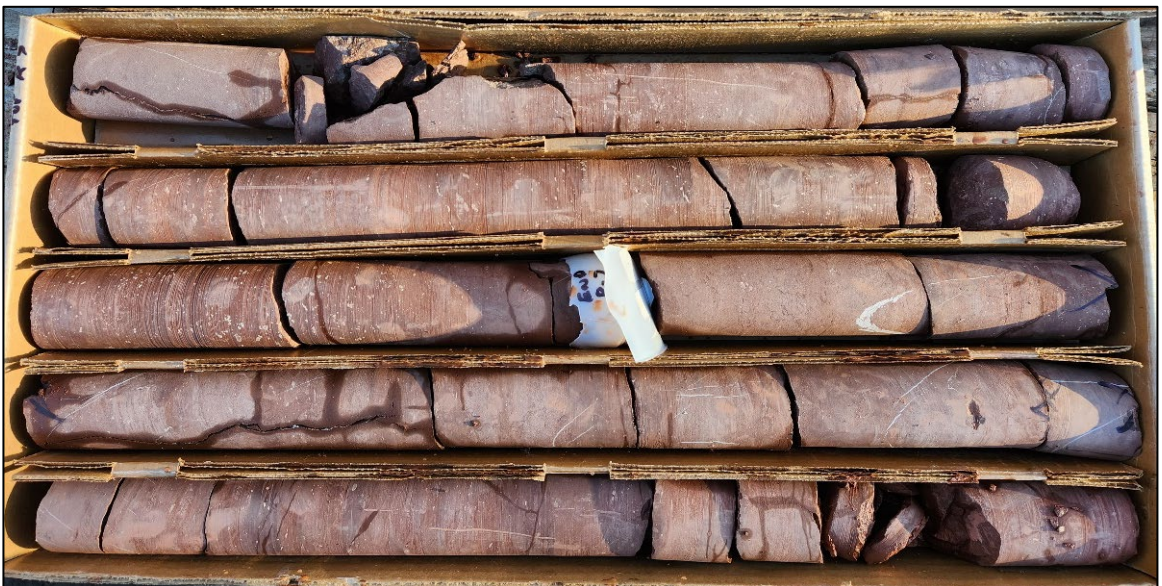
Figure A-7

SR-1: 40.0' to 50.0'

SR-1: 50.0' to 60.0'

Rock Core Photographs

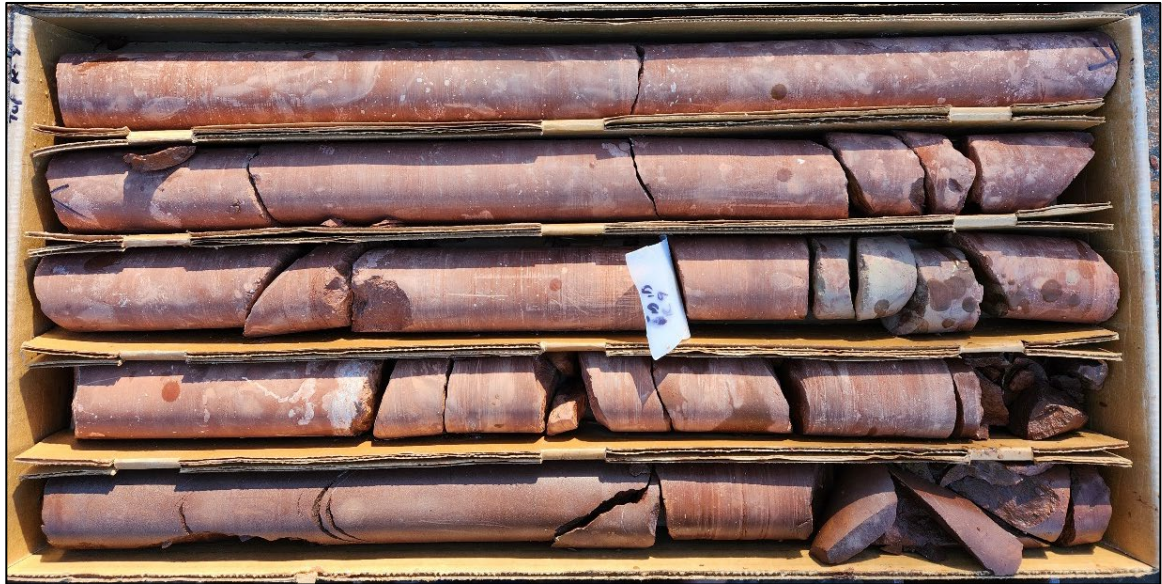
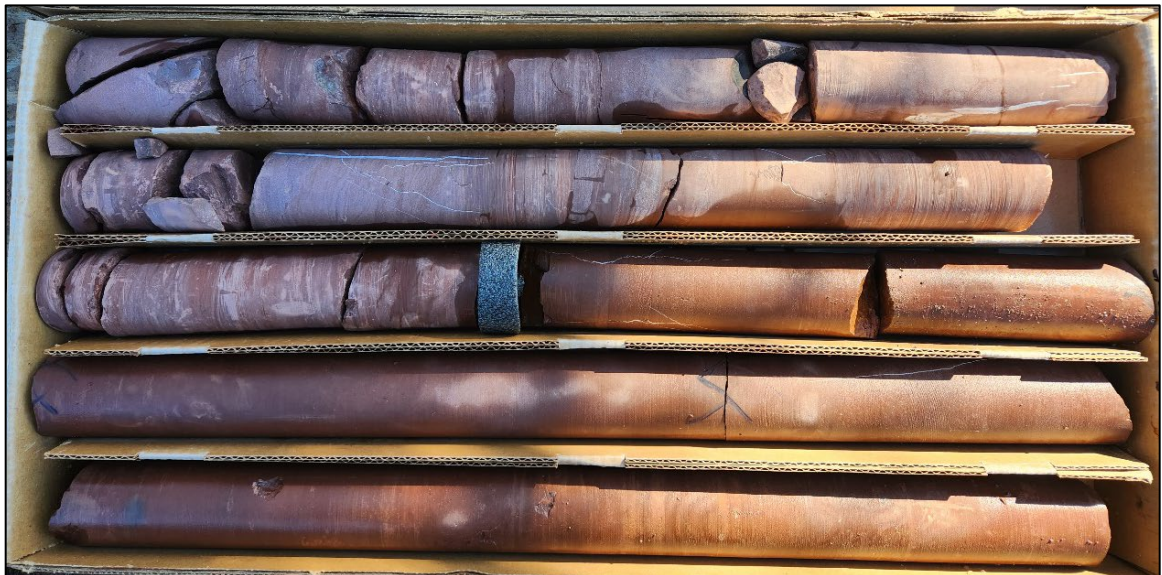
Figure A-8

SR-1: 60.0' to 70.0'

SR-1: 70.0' to 80.0'

Rock Core Photographs

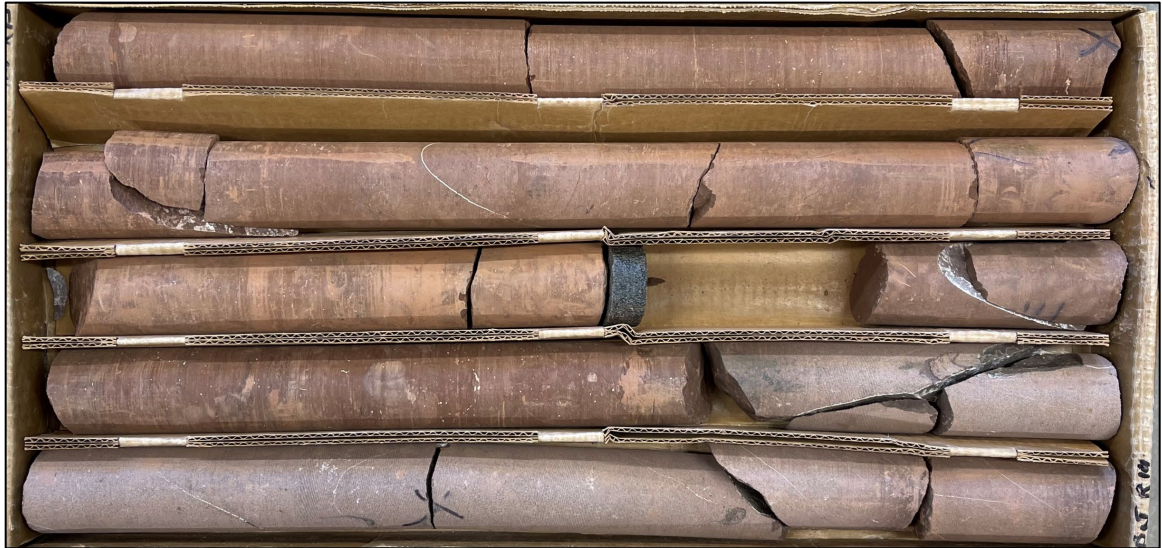
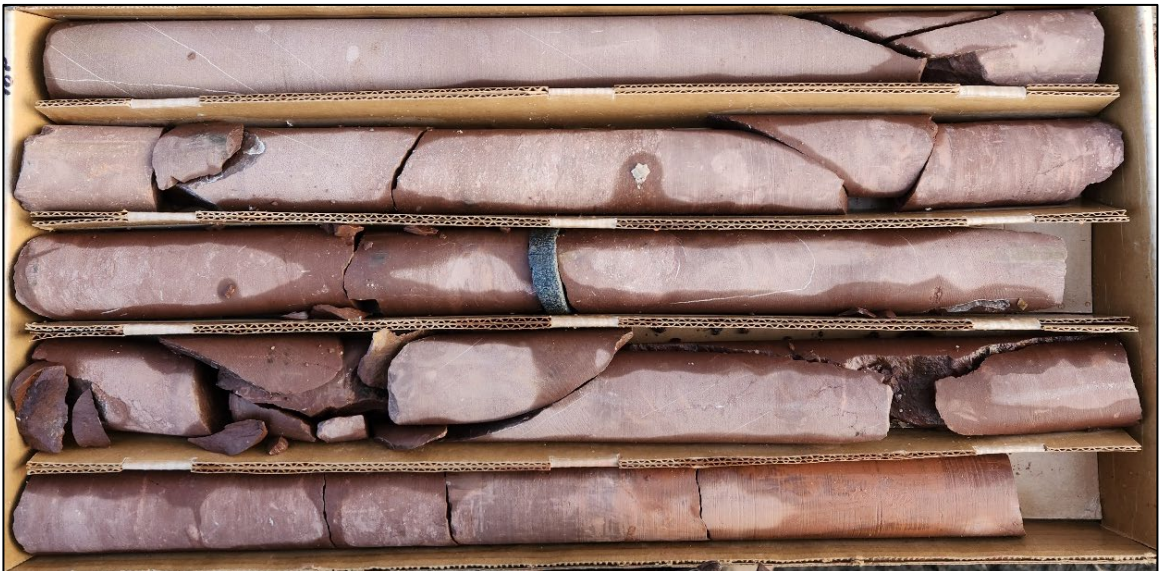
Figure A-9

SR-1: 80.0' to 90.0'

SR-1: 90.0' to 100.0'

Rock Core Photographs

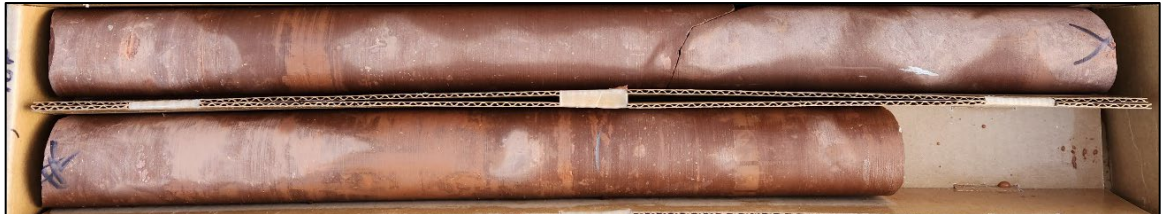
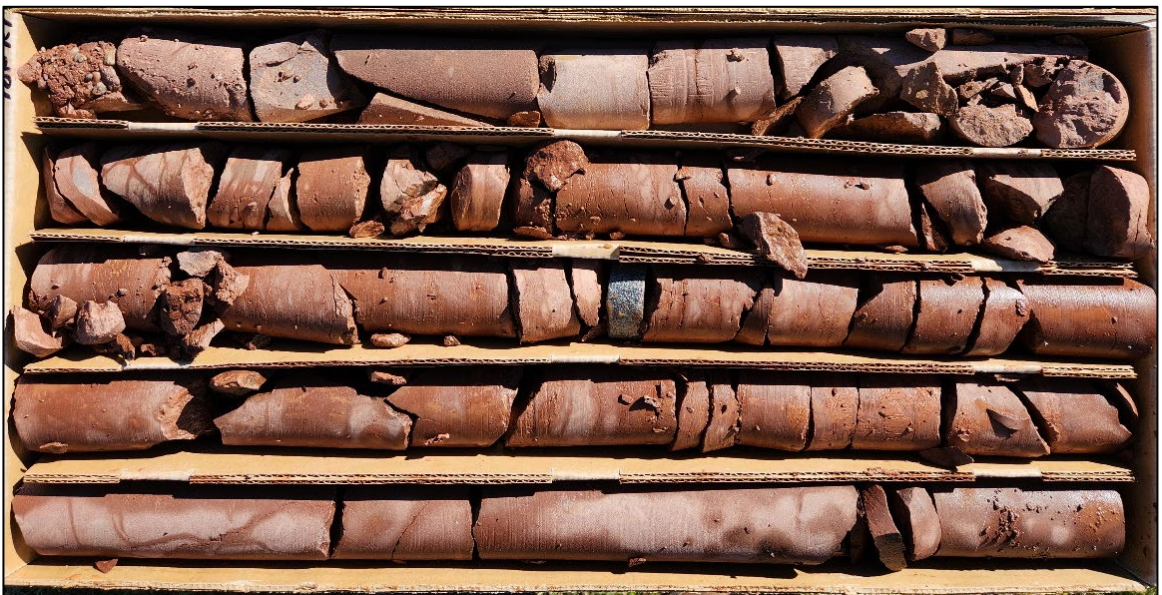
Figure A-10

SR-1: 100.0' to 103.0'

SR-2: 19.0' to 29.0'

Rock Core Photographs

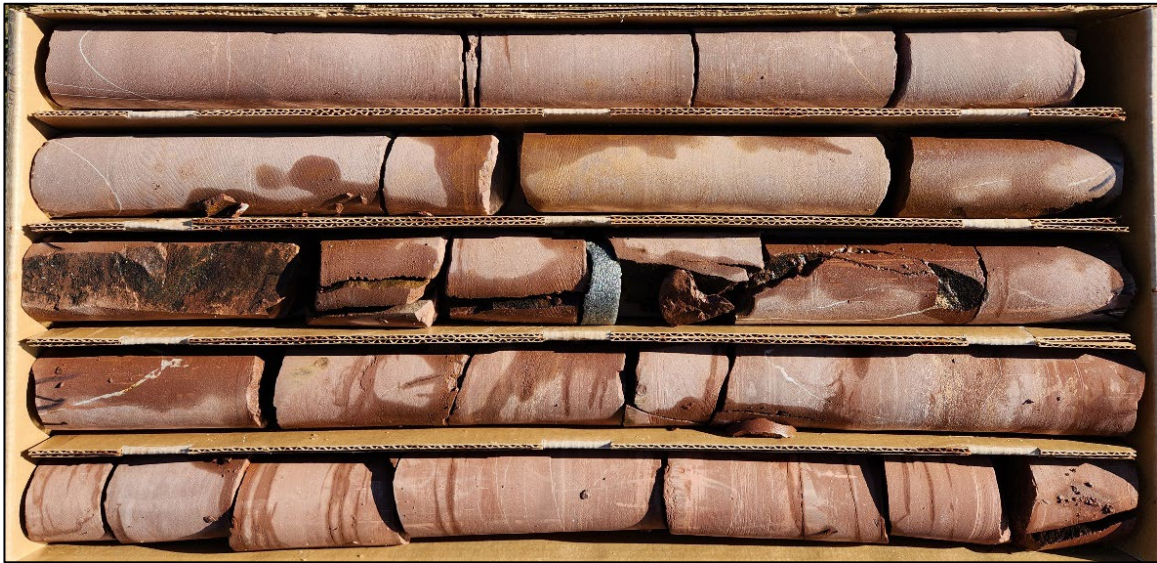
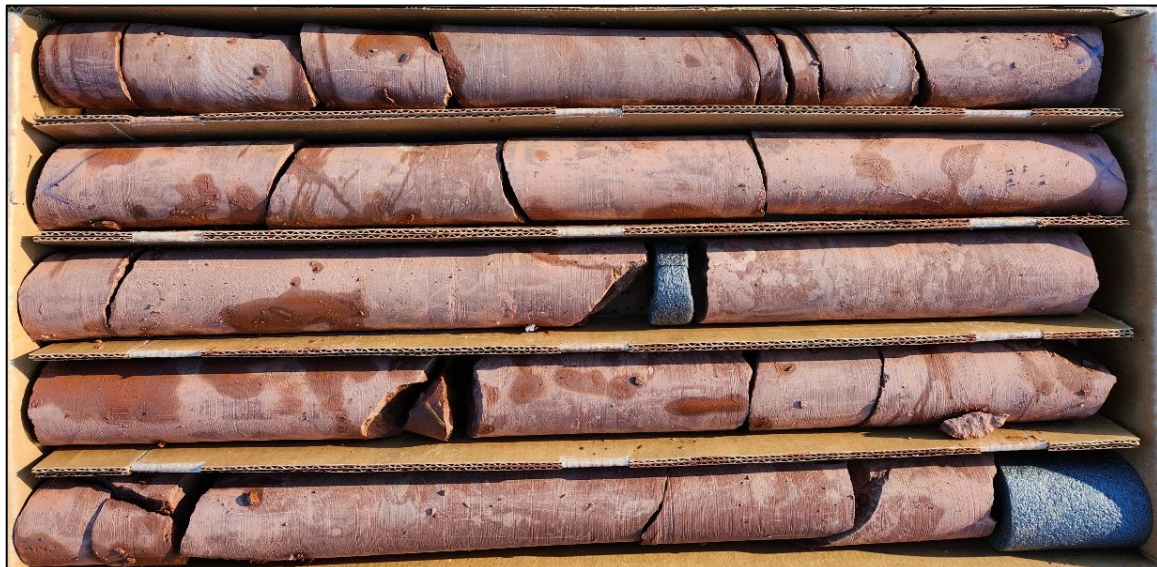
Figure A-11

SR-2: 29.0' to 39.0'

SR-2: 39.0' to 49.0'

Rock Core Photographs

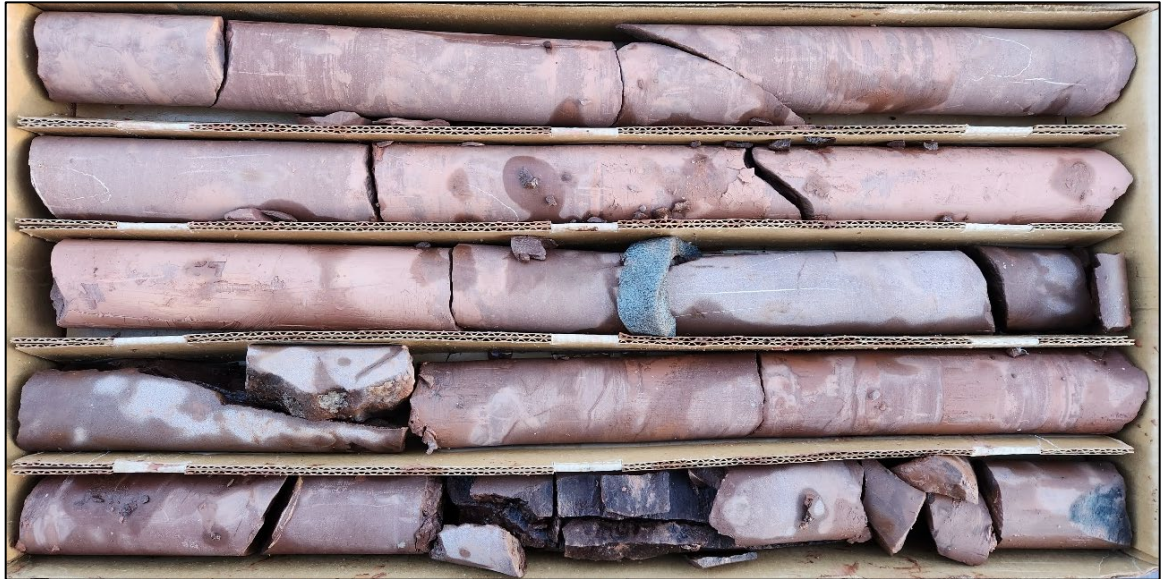
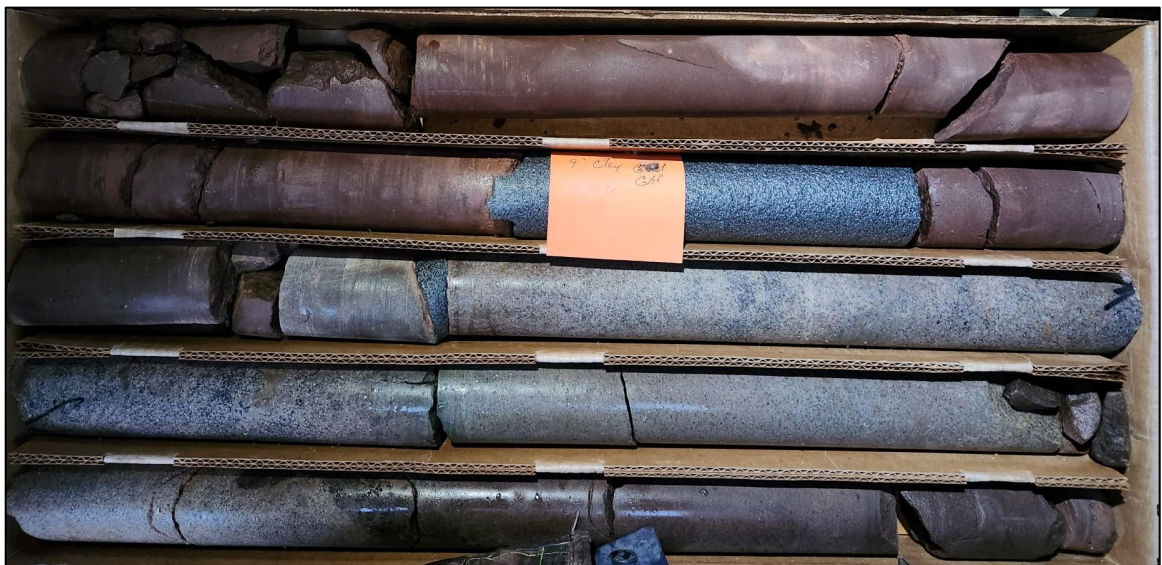
Figure A-12

SR-2: 49.0' to 59.0'

SR-2: 59.0' to 69.0'

Rock Core Photographs

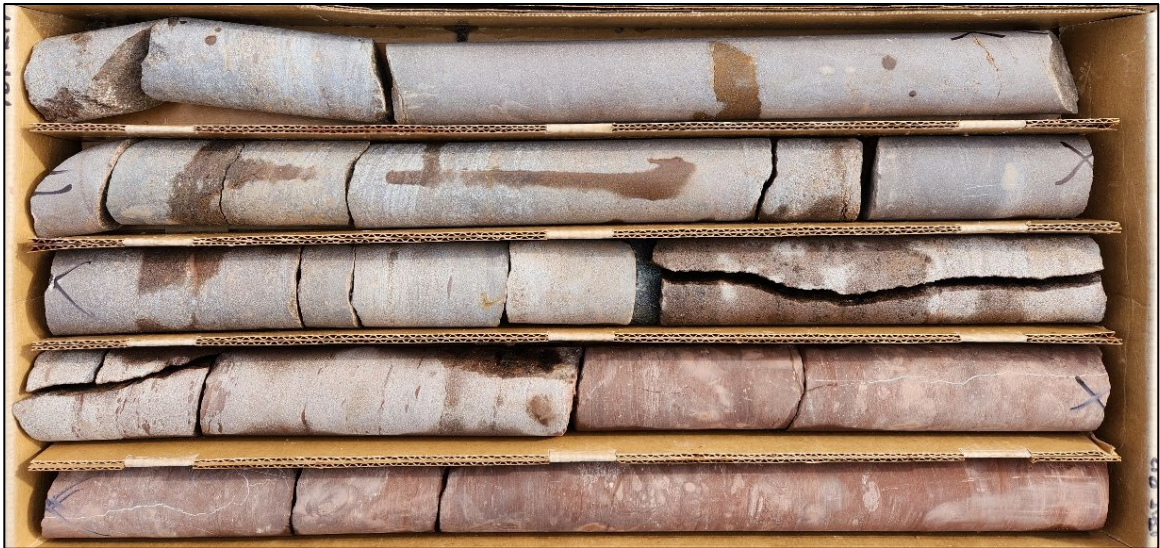
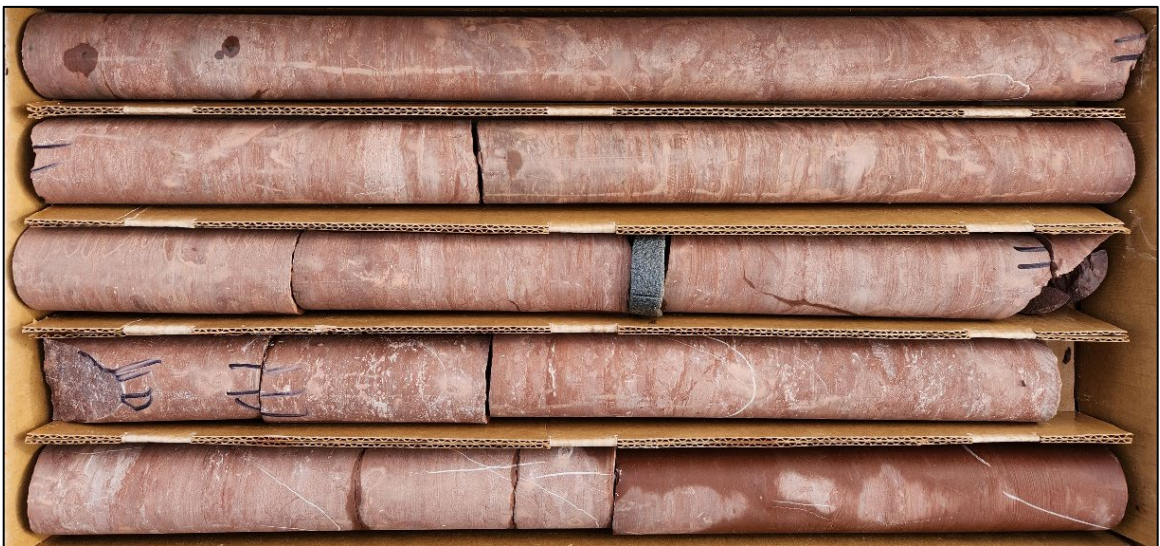
Figure A-13

SR-2: 69.0' to 79.0'

SR-2: 79.0' to 89.0'

Rock Core Photographs

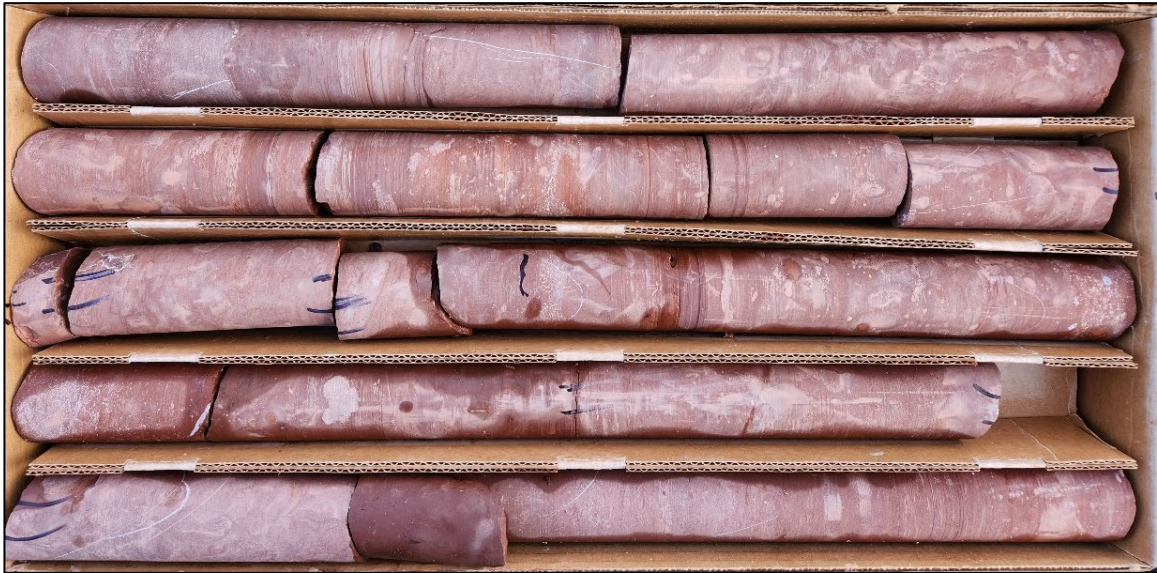
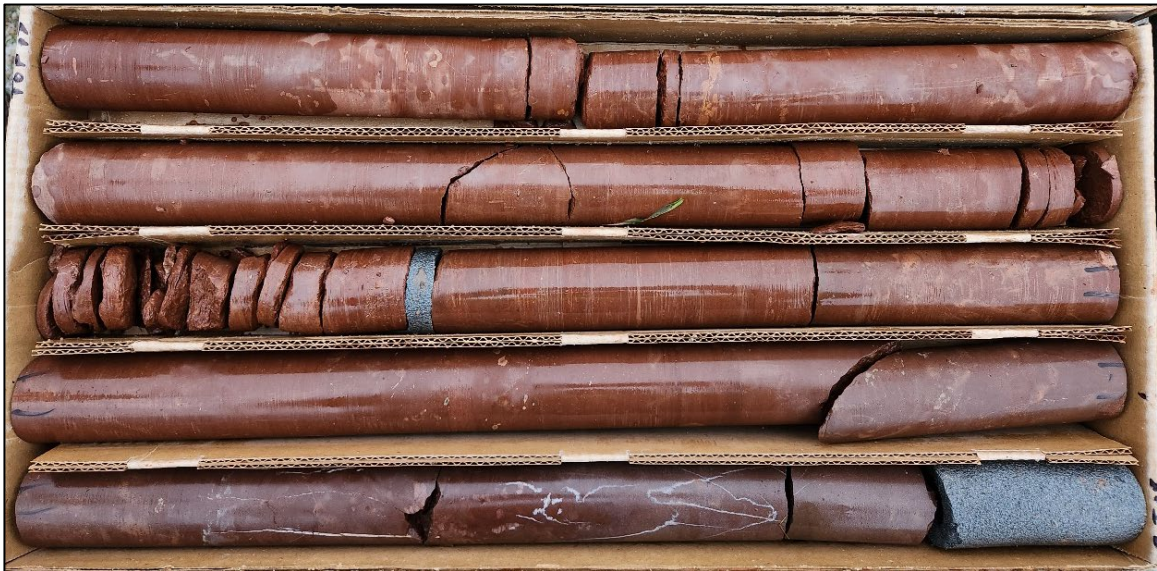
Figure A-14

SR-2: 89.0' to 99.0'

SR-2: 99.0' to 109.0'

Rock Core Photographs

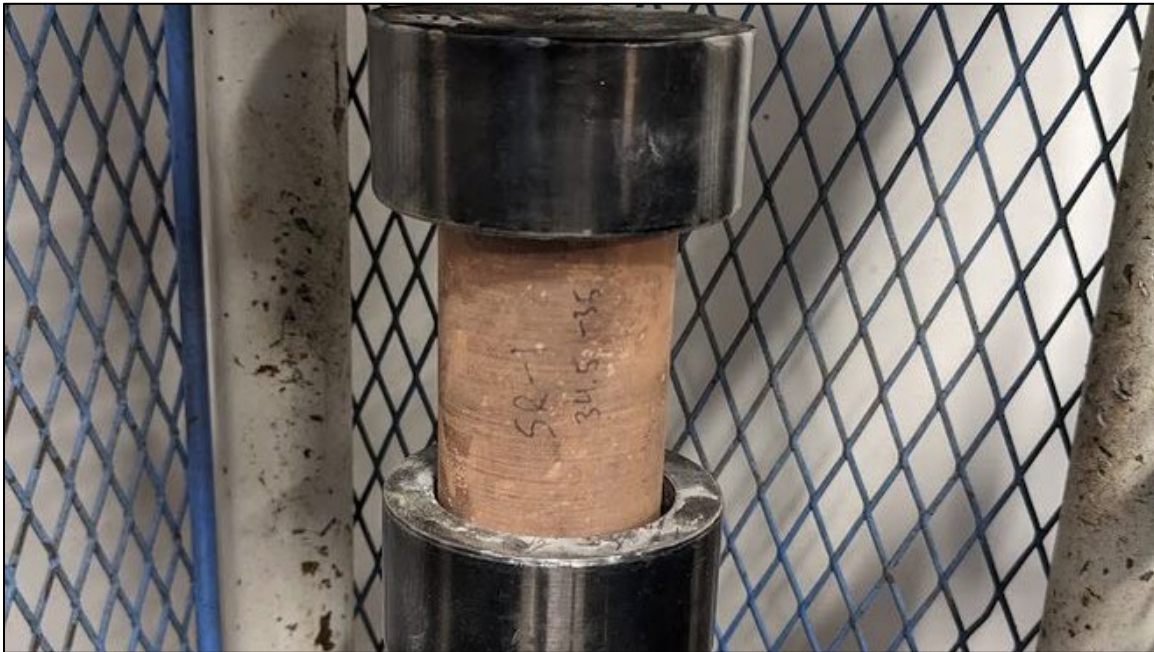
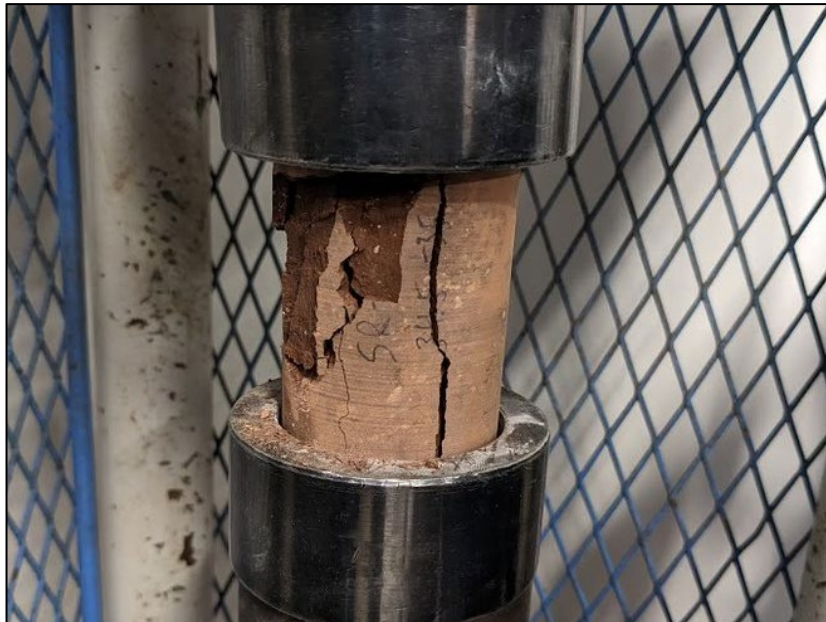
Figure A-16

SR-1: 34.5' to 35.0', before break

SR-1: 34.5' to 35.0', after break

Avg. Diameter, in.	1.968
Avg. Length, in.	4.506
Area, in ²	3.04
Load at failure, lbs.	13,740
Unc. Comp. Strength, psi	4,517
Dry Unit Weight, pcf	169.8

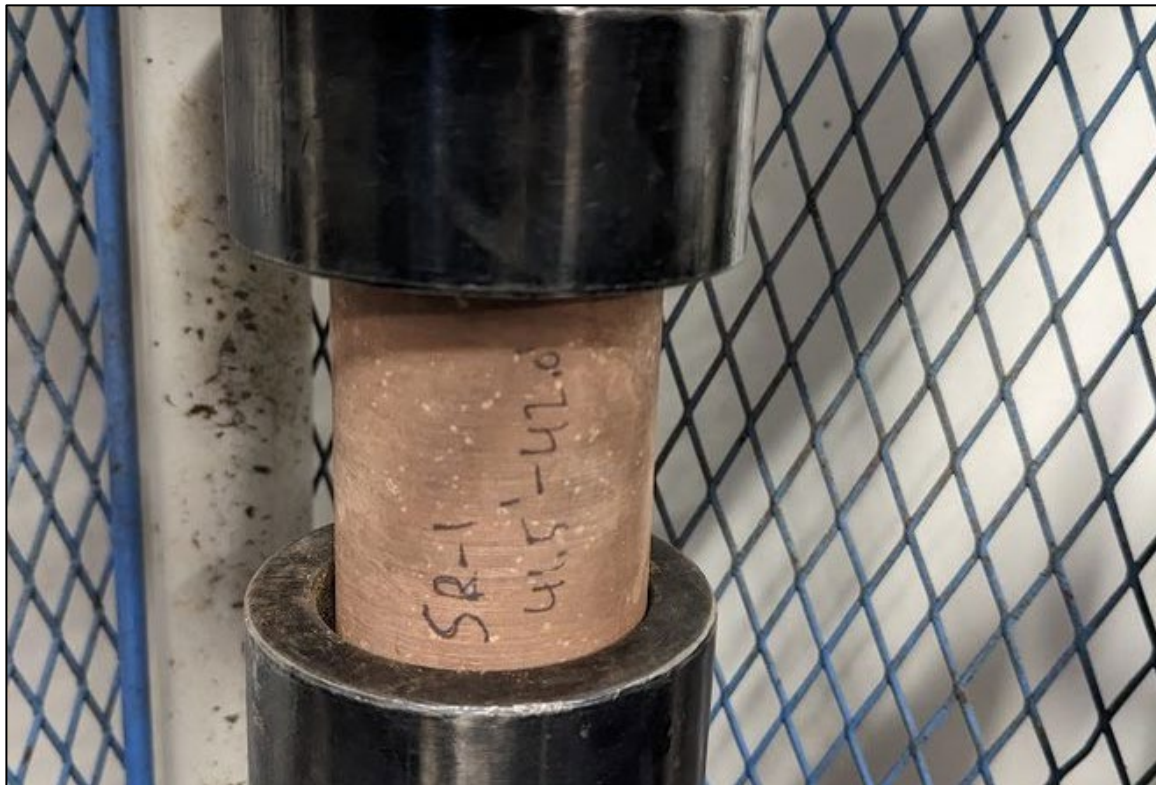
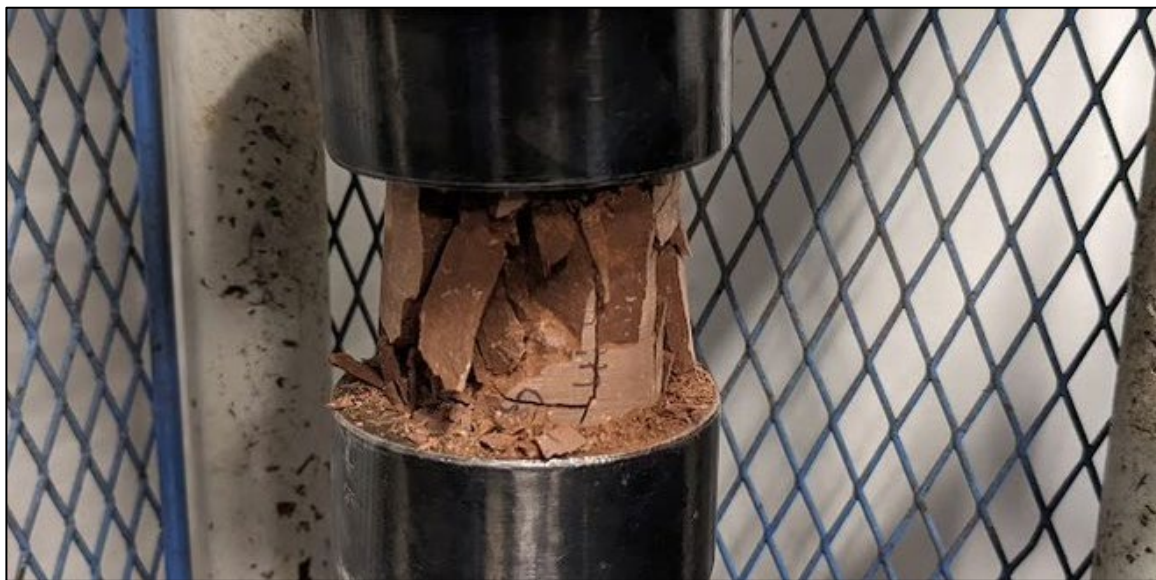
Figure A-17

SR-1: 41.5' to 42', before break

SR-1: 41.5' to 42', after break

Avg. Diameter, in.	1.965
Avg. Length, in.	4.225
Area, in ²	3.03
Load at failure, lbs.	21,000
Unc. Comp. Strength, psi	6,925
Dry Unit Weight, pcf	172.0

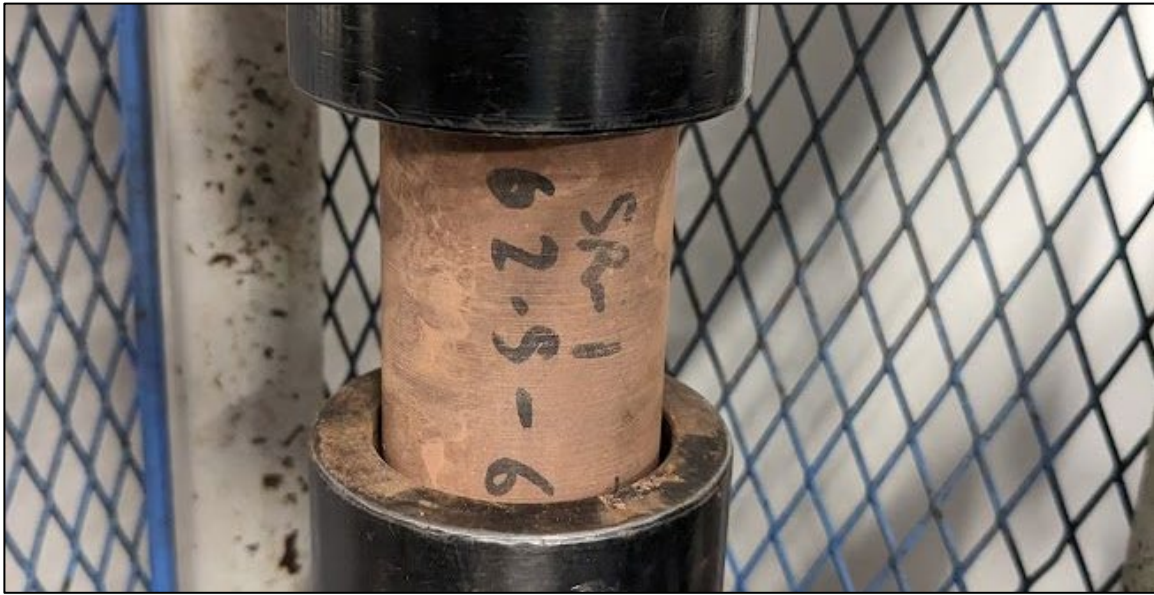
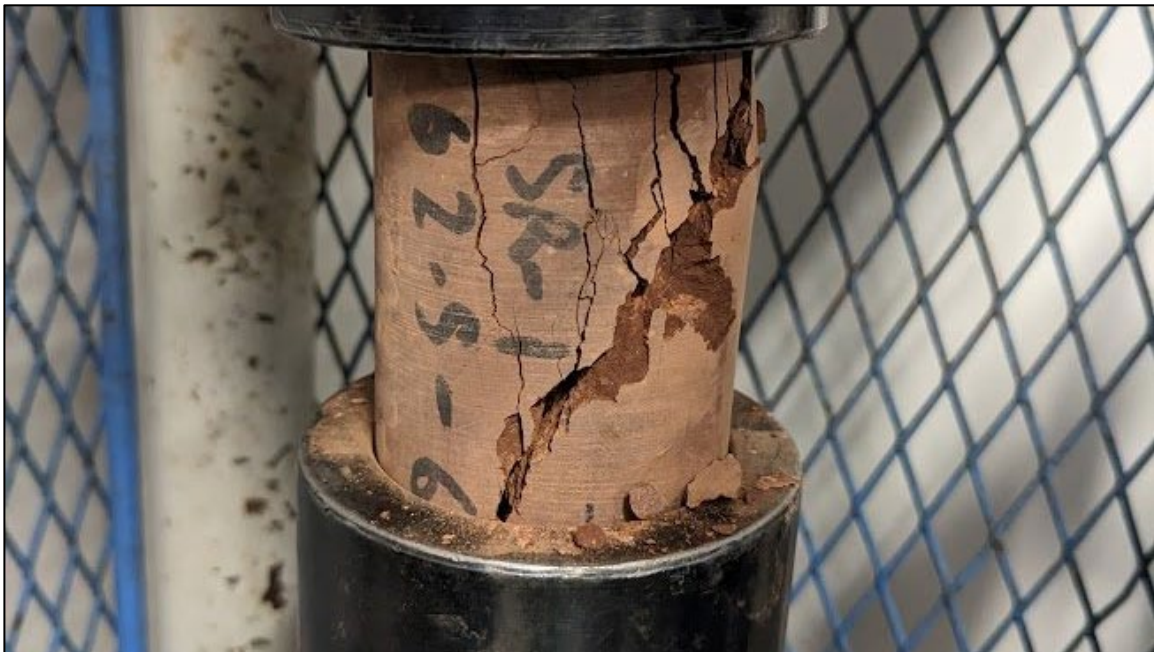
Figure A-18

SR-1: 62.5' to 63', before break

SR-1: 62.5' to 63', after break

Avg. Diameter, in.	1.995
Avg. Length, in.	4.518
Area, in ²	3.12
Load at failure, lbs.	21,160
Unc. Comp. Strength, psi	6,772
Dry Unit Weight, pcf	164.2

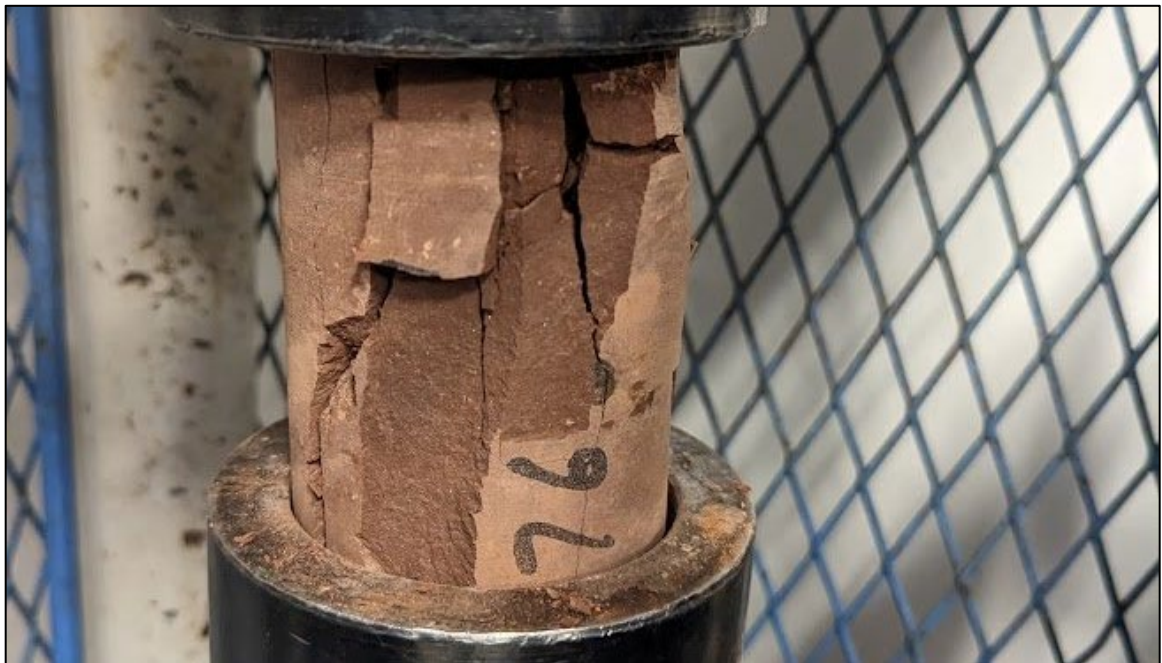
Figure A-19

SR-1: 76.5' to 77.0', before break

SR-1: 76.5' to 77.0', after break

Avg. Diameter, in.	1.977
Avg. Length, in.	4.569
Area, in ²	3.07
Load at failure, lbs.	39,380
Unc. Comp. Strength, psi	12,833
Dry Unit Weight, pcf	171.1

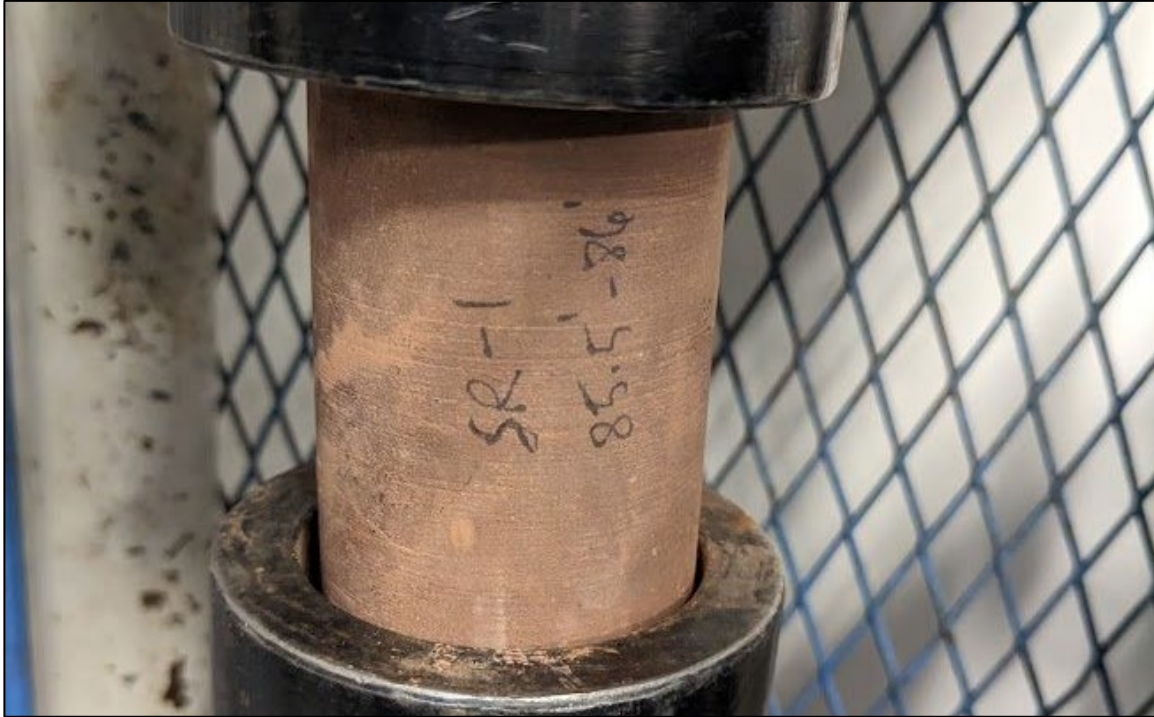
Figure A-20

SR-1: 85.5' to 86', before break

SR-1: 85.5' to 86', after break

Avg. Diameter, in.	1.968
Avg. Length, in.	4.499
Area, in ²	3.04
Load at failure, lbs.	22,480
Unc. Comp. Strength, psi	7,390
Dry Unit Weight, pcf	169.6

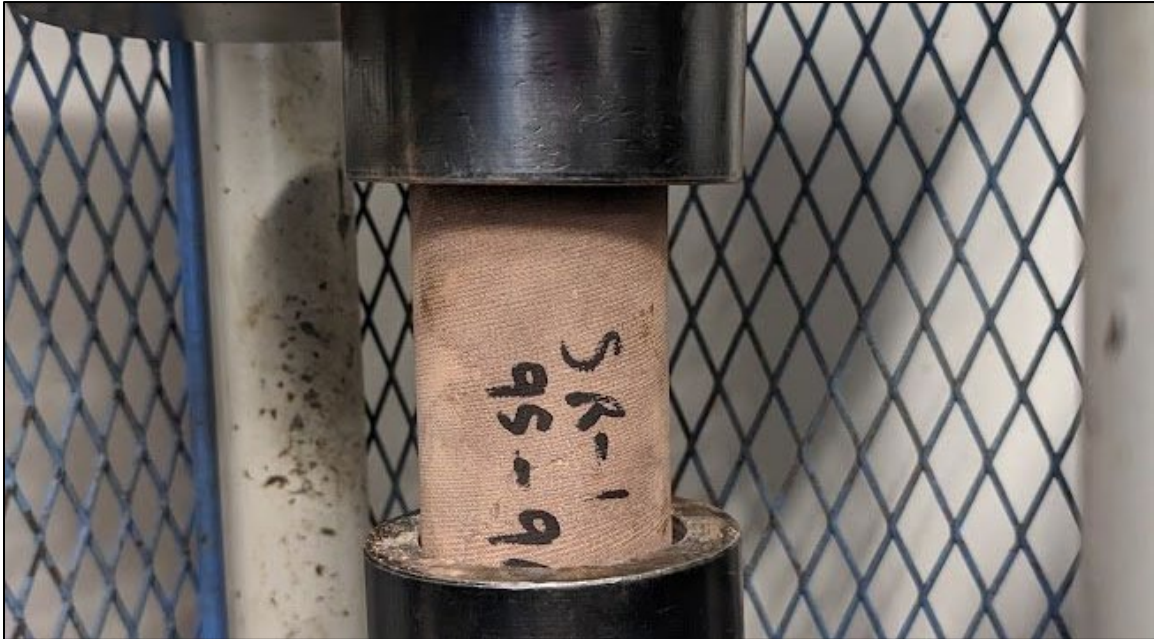
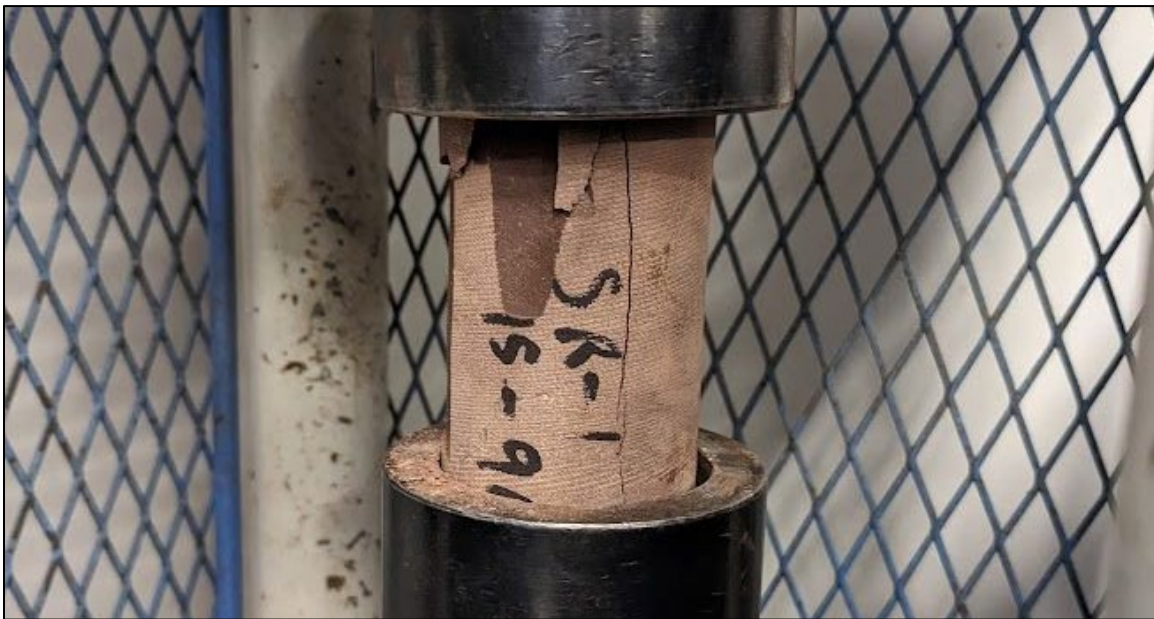
Figure A-21

SR-1: 95' to 95.5', before break

SR-1: 95' to 95.5', after break

Avg. Diameter, in.	1.985
Avg. Length, in.	4.749
Area, in ²	3.09
Load at failure, lbs.	20,130
Unc. Comp. Strength, psi	6,505
Dry Unit Weight, pcf	165.2

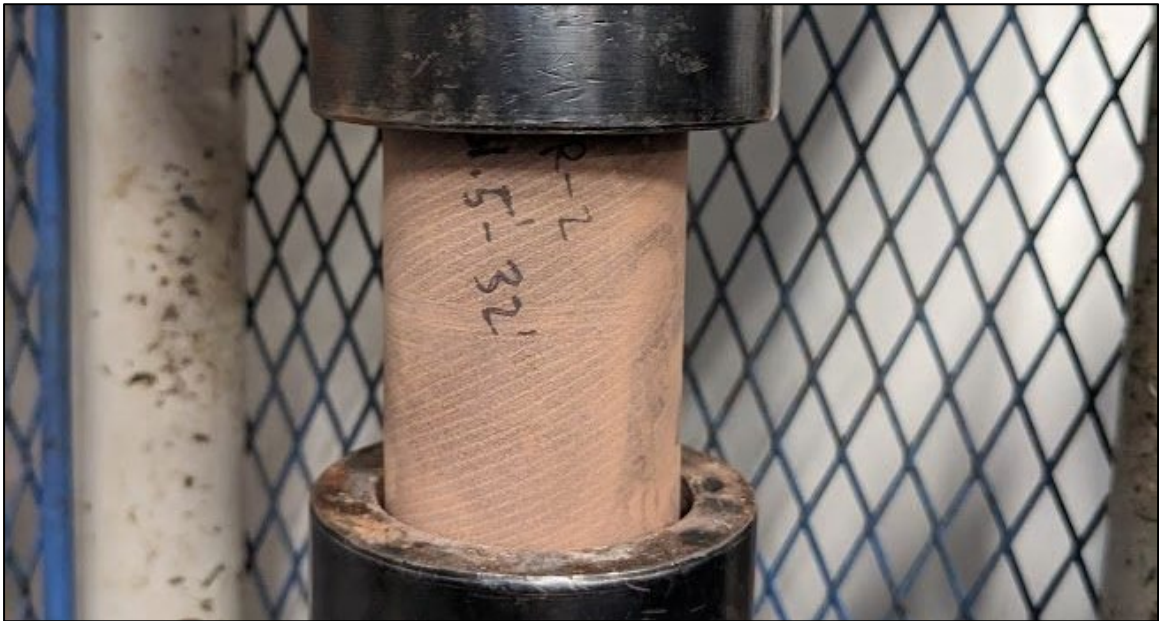
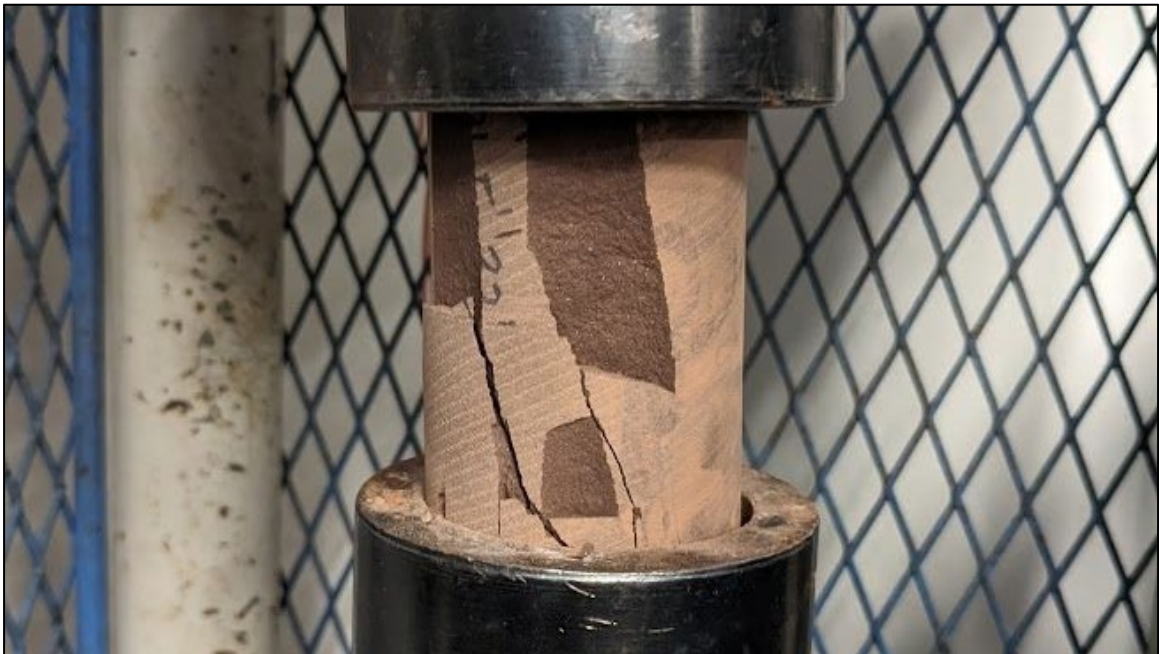
Figure A-22

SR-2: 31.5' to 32', before break

SR-2: 31.5' to 32', after break

Avg. Diameter, in.	1.979
Avg. Length, in.	4.485
Area, in ²	3.07
Load at failure, lbs.	27,490
Unc. Comp. Strength, psi	8,940
Dry Unit Weight, pcf	167.5
