Geotechnical Engineering Services Data Report

Schuylkill River Pipe Replacement Project
Chester and Montgomery Counties, Pennsylvania

File No. 15556-032-00

February 8, 2023

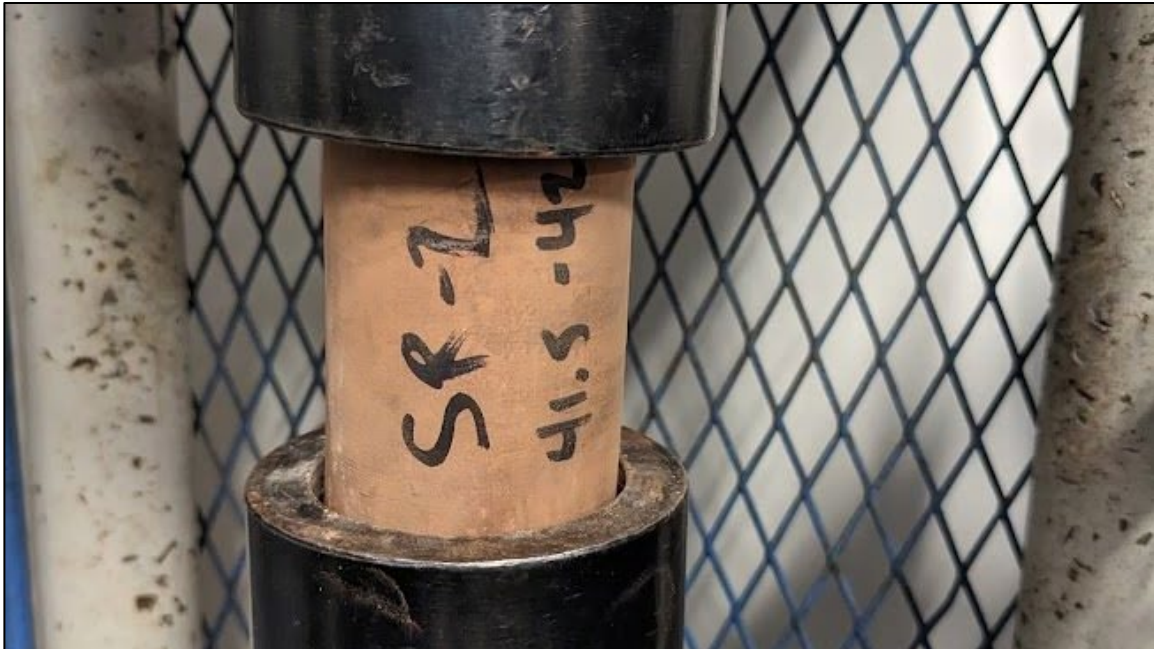
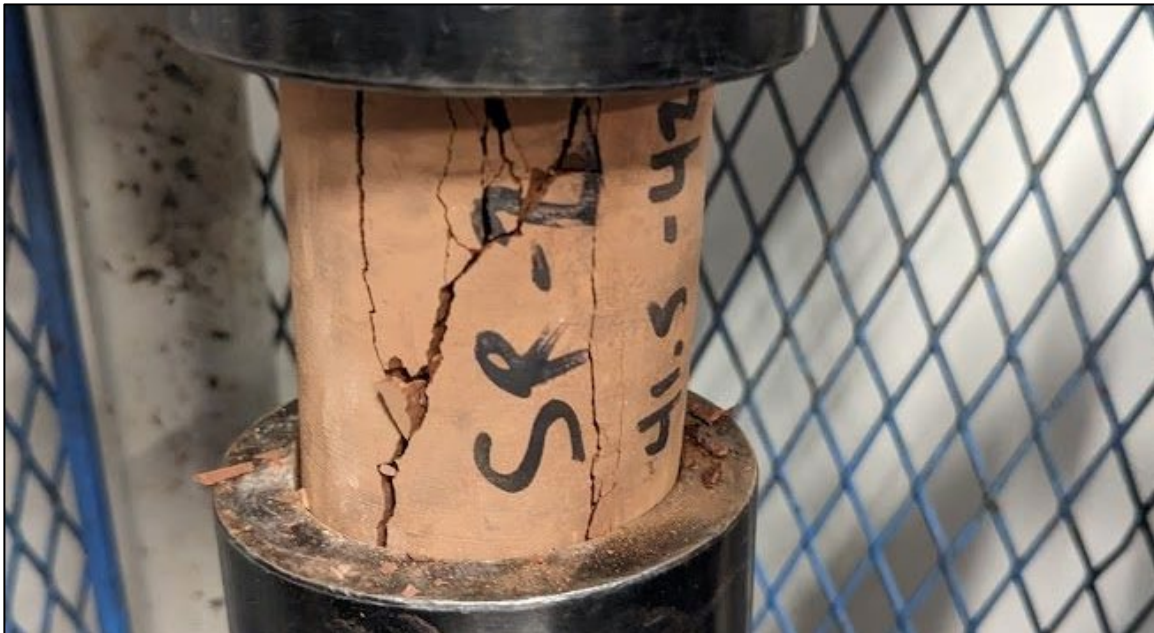
Figure A-23

SR-2: 41.5' to 42', before break

SR-2: 41.5' to 42', after break

Avg. Diameter, in.	1.976
Avg. Length, in.	4.355
Area, in ²	3.07
Load at failure, lbs.	20,160
Unc. Comp. Strength, psi	6,576
Dry Unit Weight, pcf	170.8

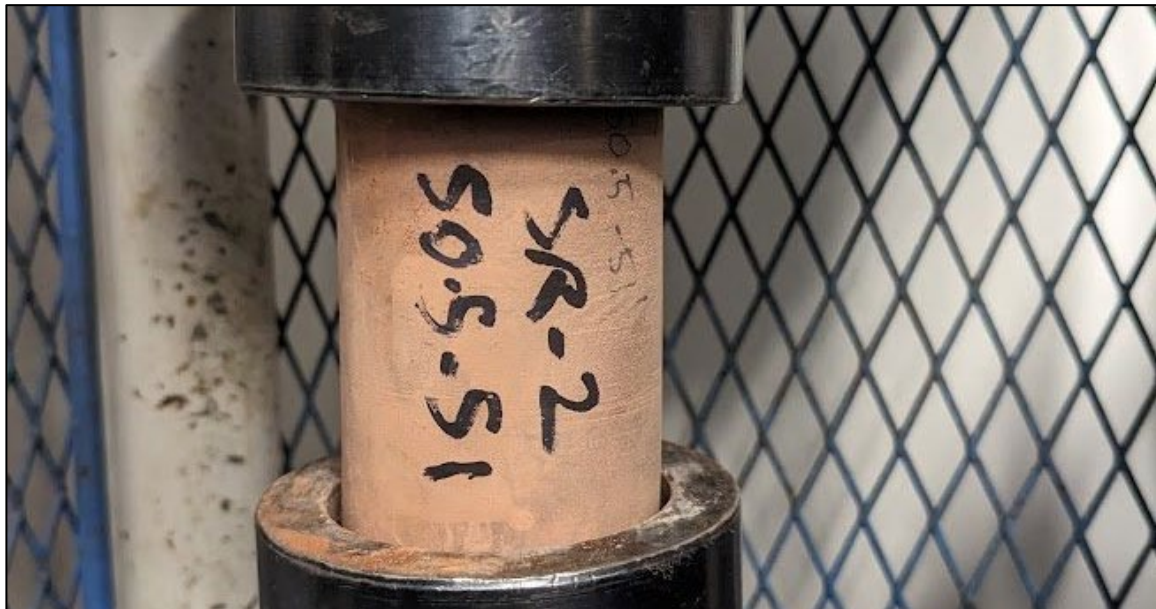
Figure A-24

SR-2: 50.5' to 51', before break

SR-2: 50.5' to 51', after break

Avg. Diameter, in.	1.992
Avg. Length, in.	4.400
Area, in ²	3.12
Load at failure, lbs.	23,420
Unc. Comp. Strength, psi	7,512
Dry Unit Weight, pcf	165.6

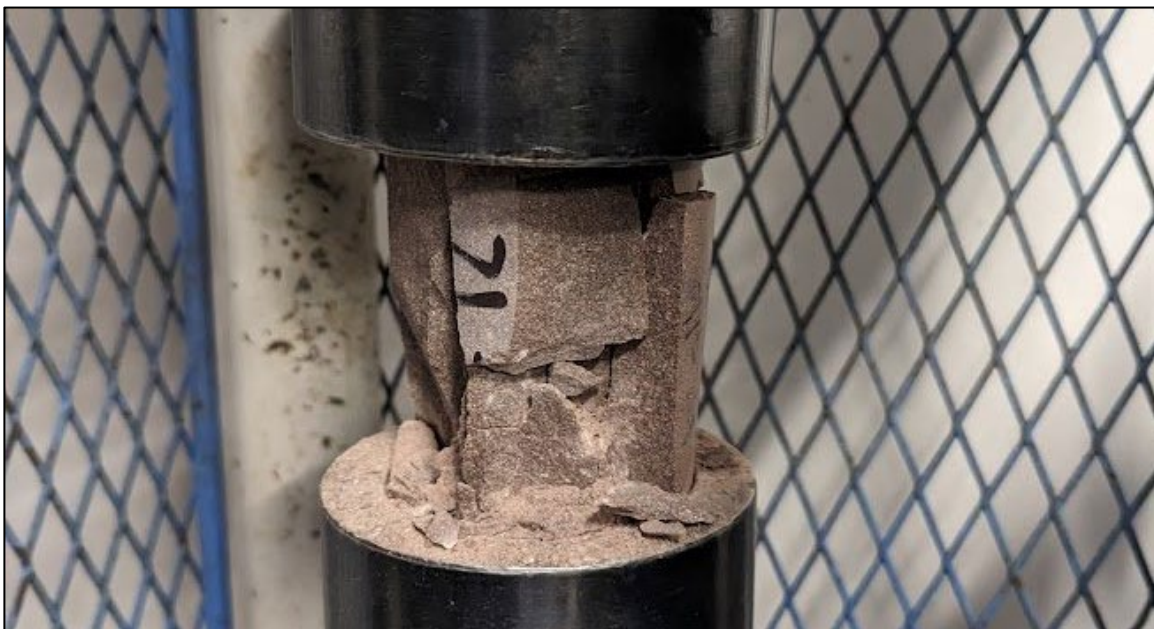
Figure A-25

SR-2: 71' to 71.5', before break

SR-2: 71' to 71.5', after break

Avg. Diameter, in.	1.983
Avg. Length, in.	4.502
Area, in ²	3.09
Load at failure, lbs.	71,690
Unc. Comp. Strength, psi	23,220
Dry Unit Weight, pcf	164.4

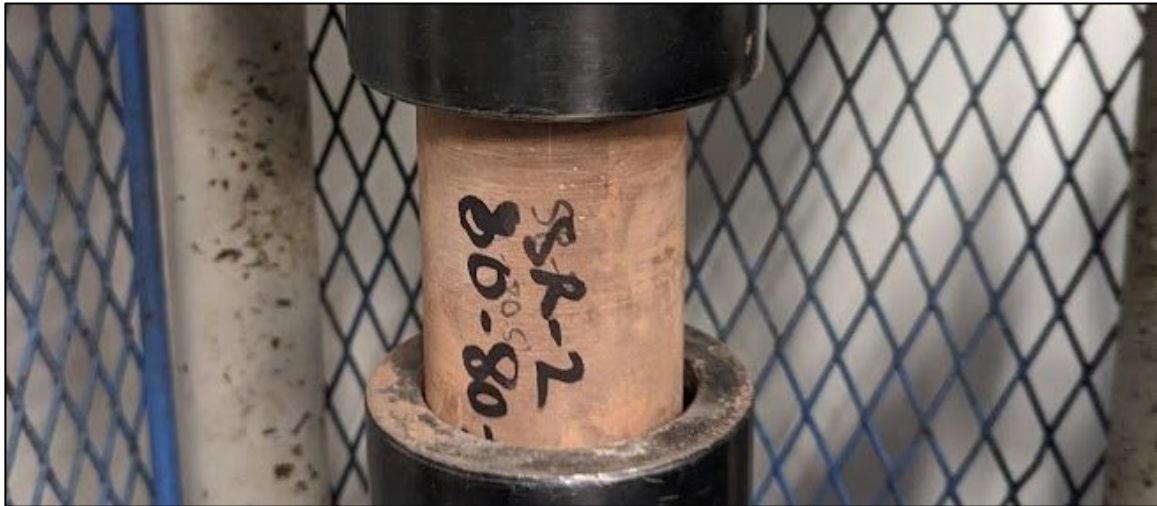
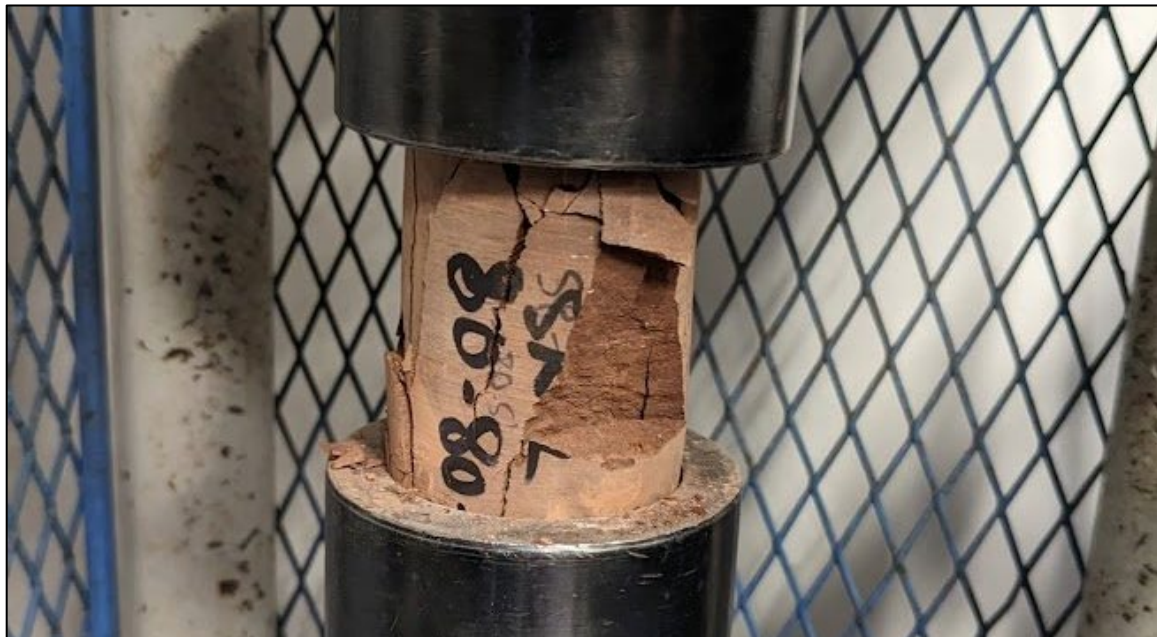
Figure A-26

SR-2: 80' to 80.5', before break

SR-2: 80' to 80.5', after break

Avg. Diameter, in.	1.962
Avg. Length, in.	4.480
Area, in ²	3.02
Load at failure, lbs.	19,960
Unc. Comp. Strength, psi	6,600
Dry Unit Weight, pcf	172.5

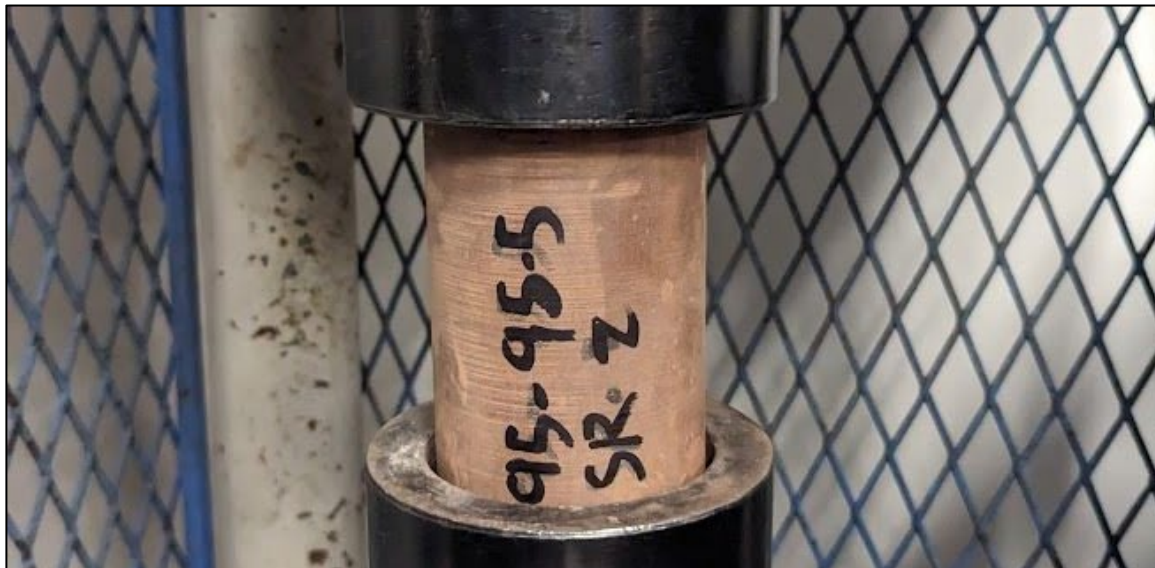
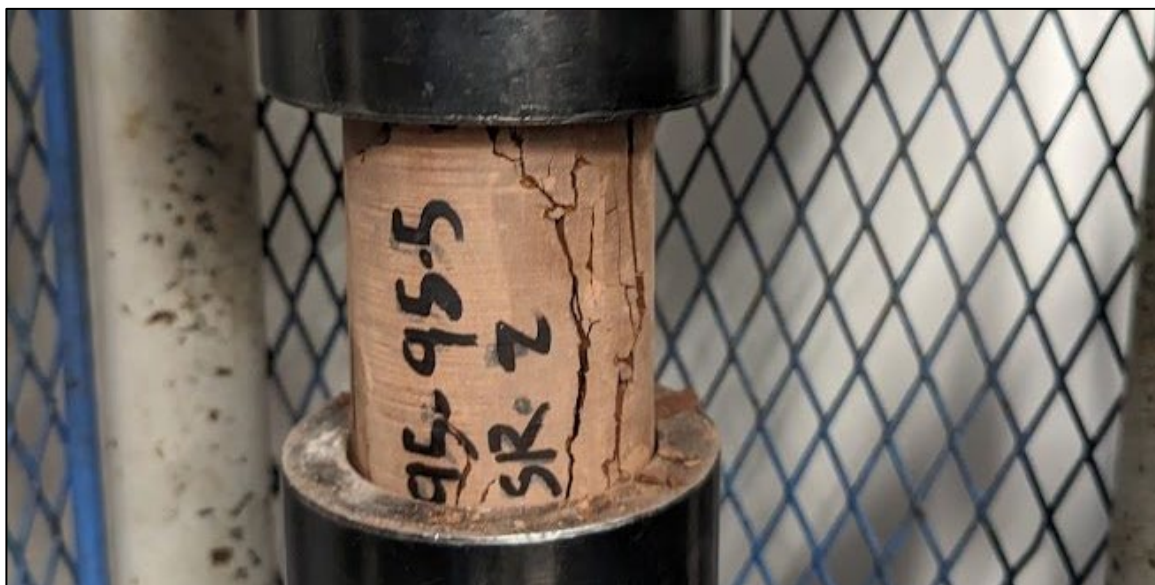
Figure A-27

SR-2: 95' to 95.5', before break

SR-2: 95' to 95.5', after break

Avg. Diameter, in.	1.982
Avg. Length, in.	4.513
Area, in ²	3.09
Load at failure, lbs.	15,780
Unc. Comp. Strength, psi	5,115
Dry Unit Weight, pcf	171.2

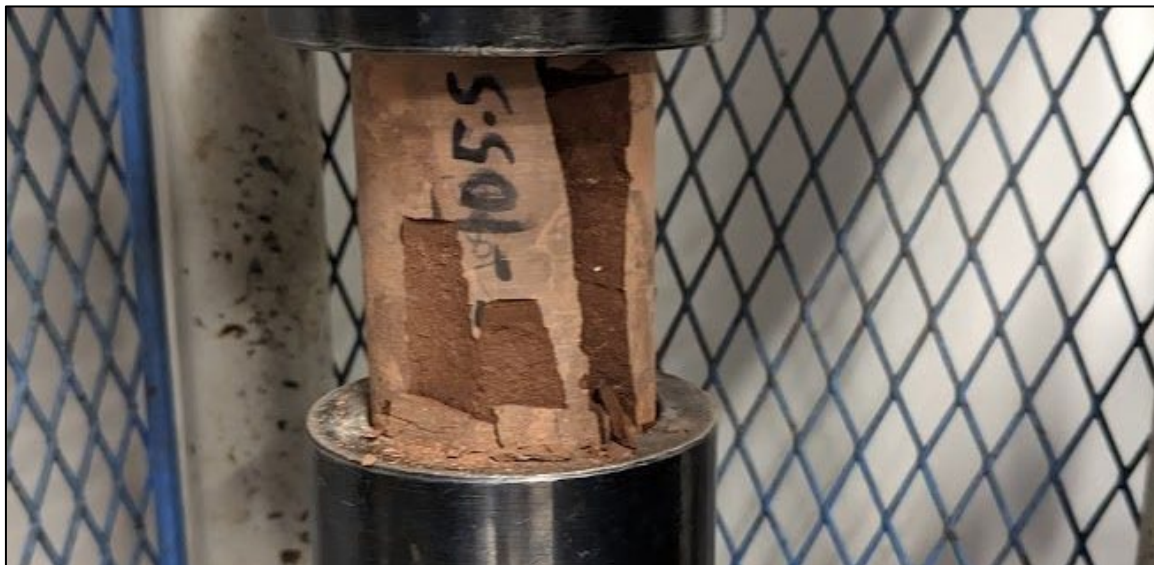
Figure A-28

SR-2: 105' to 105.5', before break

SR-2: 105' to 105.5', after break

Avg. Diameter, in.	1.977
Avg. Length, in.	4.692
Area, in ²	3.07
Load at failure, lbs.	13,010
Unc. Comp. Strength, psi	4,238
Dry Unit Weight, pcf	170.9

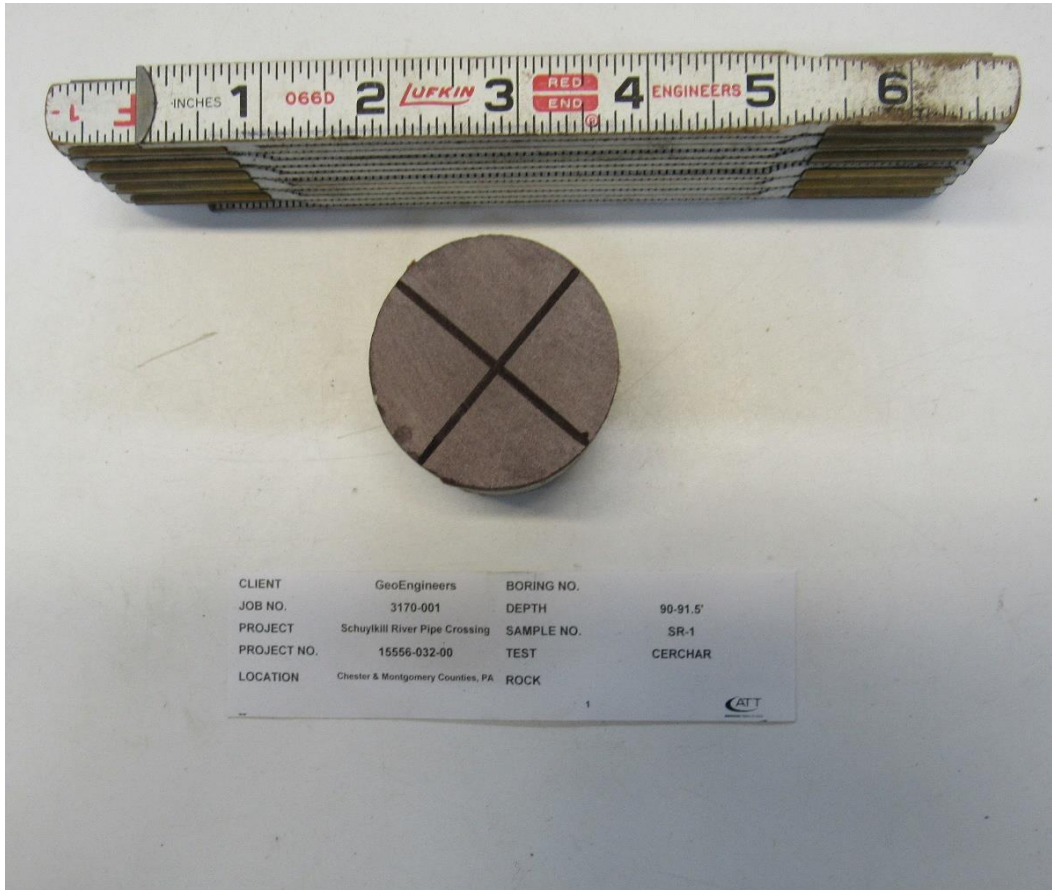
Before Picture

BORING NO. SR-1
DEPTH 90.0-91.5
SAMPLE NO. --
DATE SAMPLED --
DATE TESTED 02/03/23
TECHNICIAN HN
ROCK TYPE --

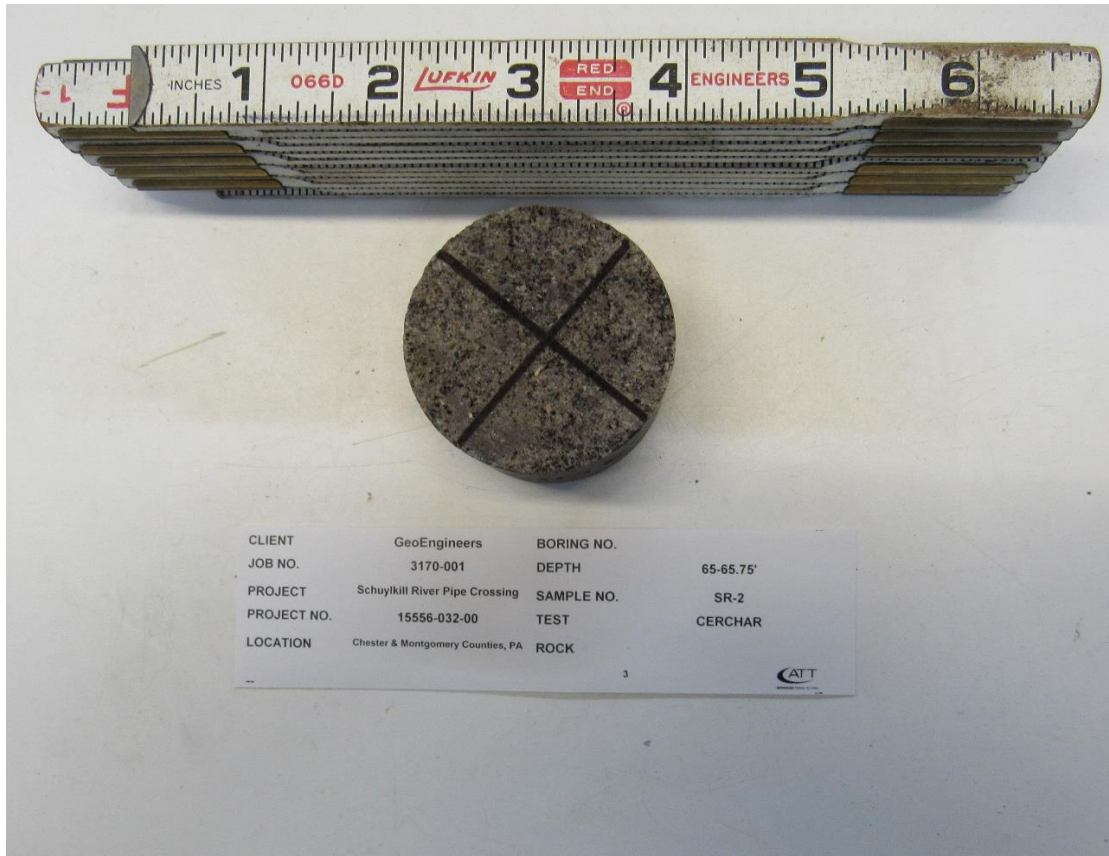
Before Picture

BORING NO. SR-2
 DEPTH 65.0-65.75
 SAMPLE NO. --
 DATE SAMPLED --
 DATE TESTED 02/03/23
 TECHNICIAN HN
 ROCK TYPE --

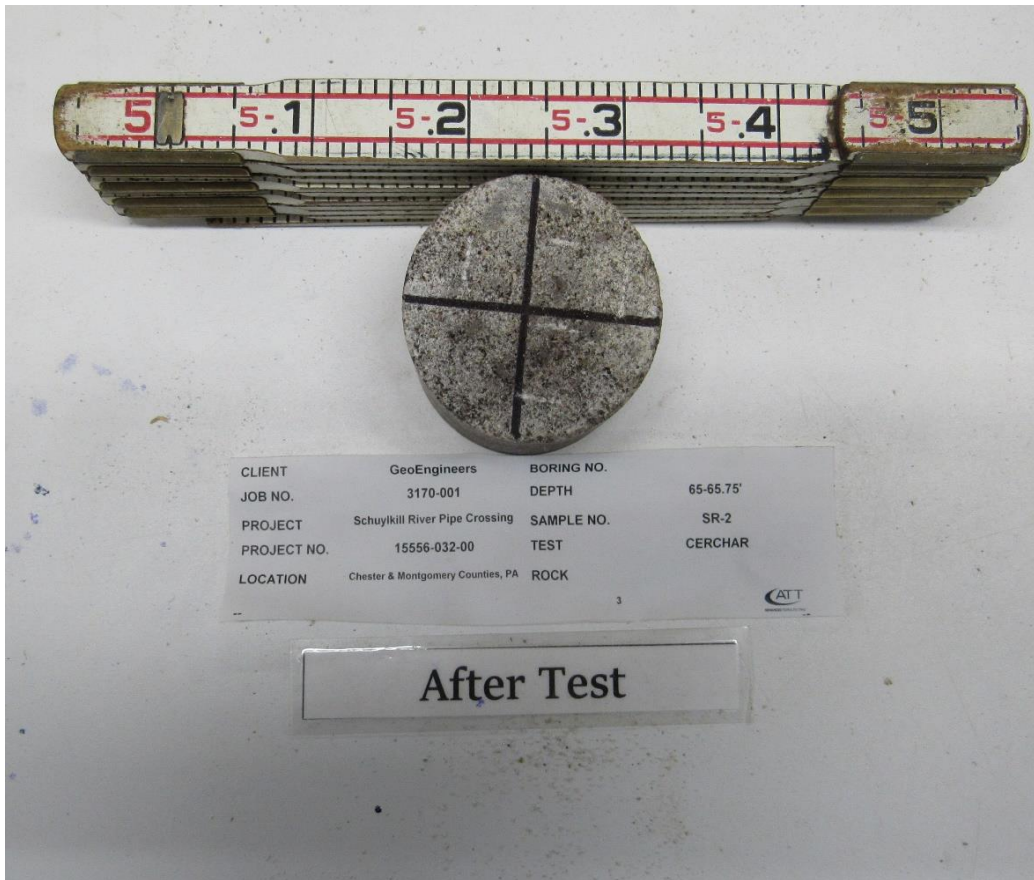
After Picture

BORING NO. SR-2
DEPTH 65.0-65.75
SAMPLE NO. --
DATE SAMPLED --
DATE TESTED 02/03/23
TECHNICIAN HN
ROCK TYPE --

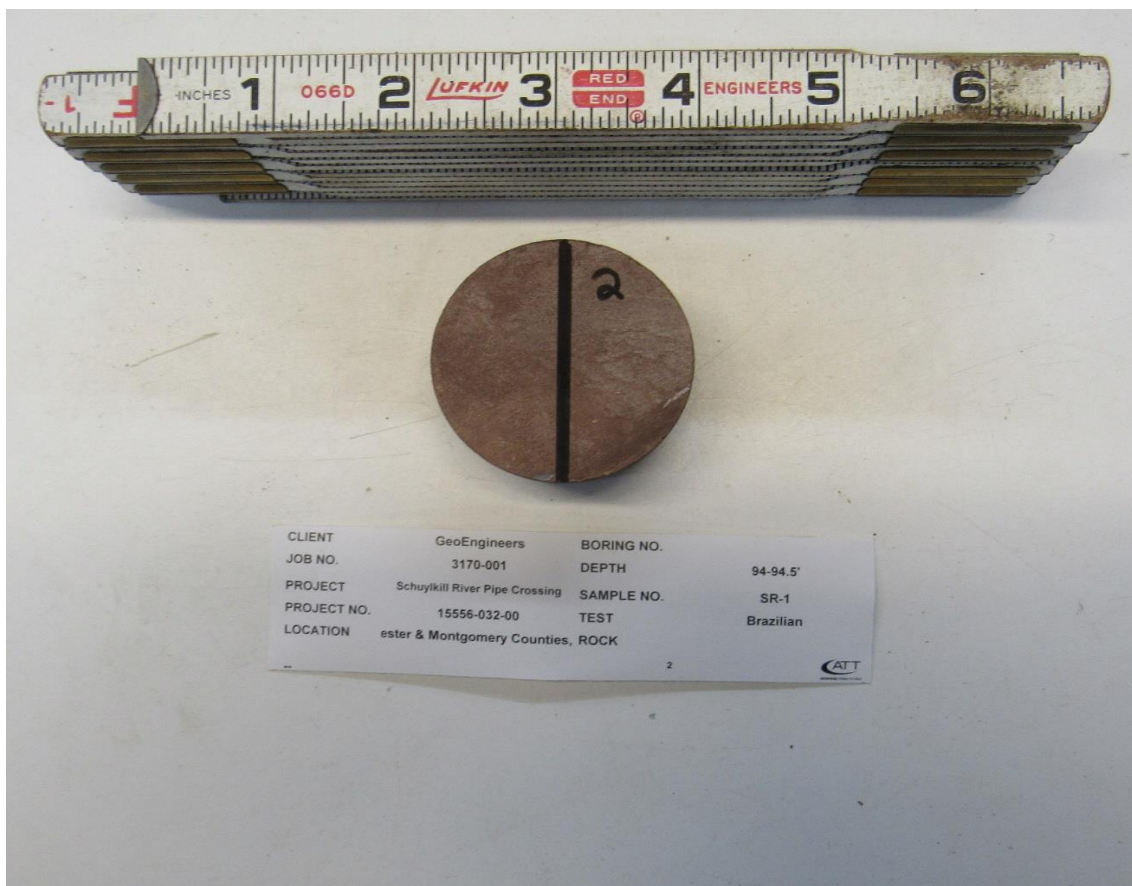
Before Picture

CLIENT	GeoEngineers	BORING NO.	
JOB NO.	3170-001	DEPTH	94-94.5'
PROJECT	Schuylkill River Pipe Crossing	SAMPLE NO.	SR-1
PROJECT NO.	15556-032-00	DATE SAMPLED	
LOCATION	Chester & Montgomery Counties, PA	DATE TESTED	02/02/23
		TECHNICIAN	DL
		ROCK TYPE

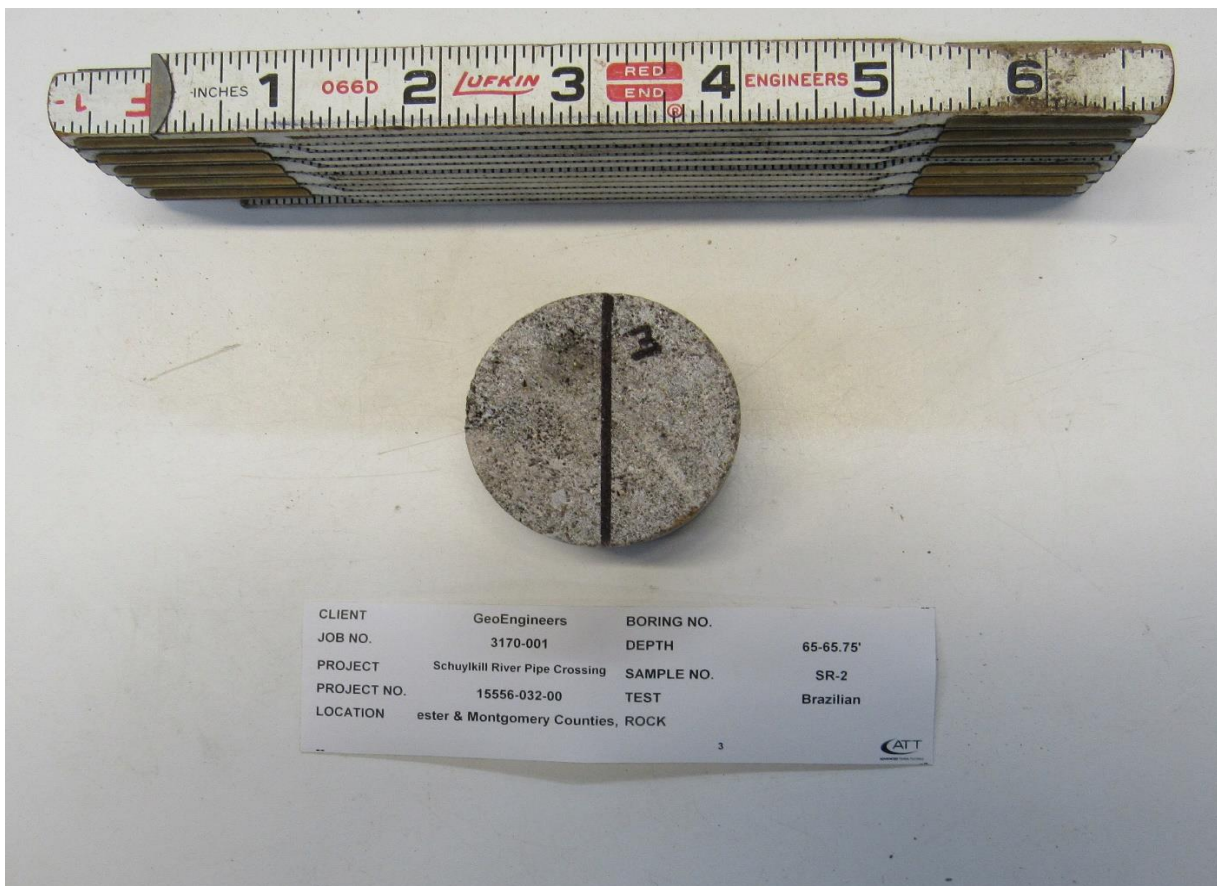
Before Picture

BORING NO.
 DEPTH 65-65.75'
 SAMPLE NO. SR-2
 DATE SAMPLED
 DATE TESTED 02/02/23
 TECHNICIAN DL
 ROCK TYPE

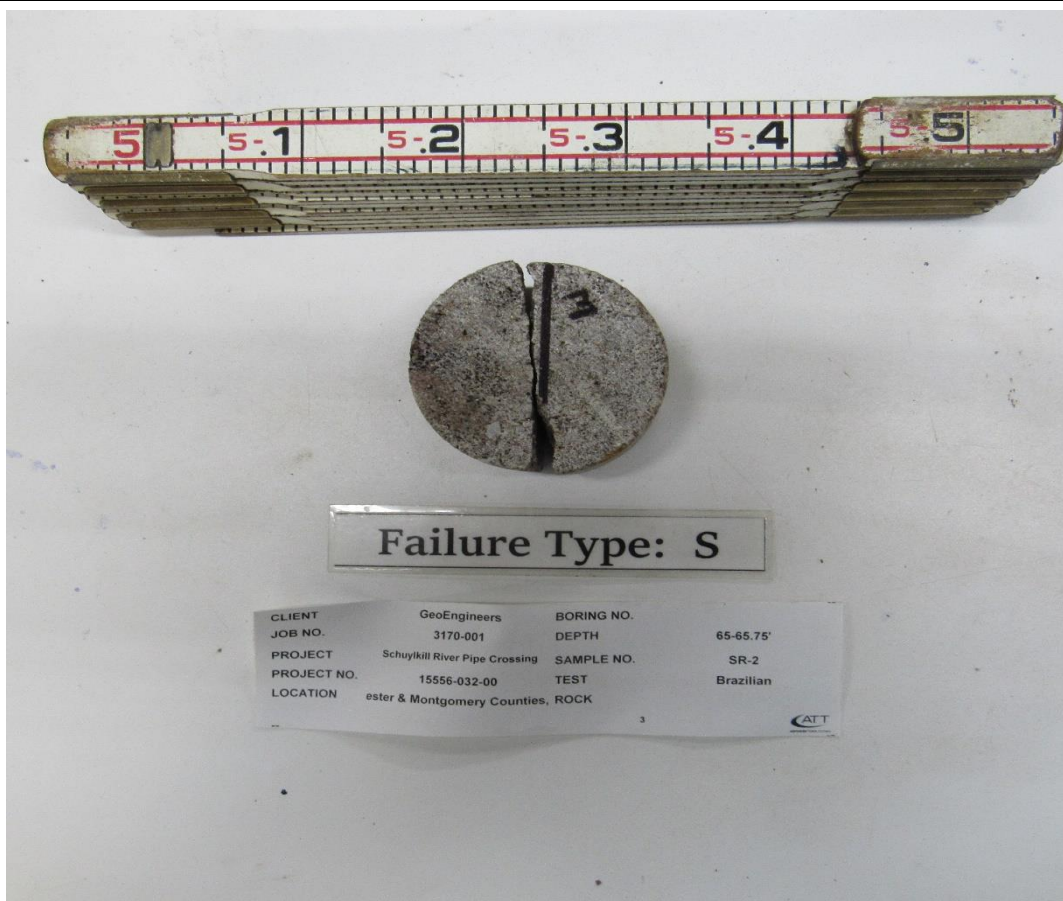
After Picture

BORING NO.
 DEPTH 65-65.75'
 SAMPLE NO. SR-2
 DATE SAMPLED
 DATE TESTED 02/02/23
 TECHNICIAN DL
 ROCK TYPE
