*Atlantic Sunrise Project – PA DEP Chapter 105 Joint Permit Application
Transcontinental Gas Pipe Line Company, LLC
Luzerne County*

Permittee Responsible Mitigation Plan for the Atlantic Sunrise Project – Luzerne County Briar Creek Mitigation Site

North Centre Township, Columbia County, Pennsylvania
Transcontinental Gas Pipe Line Company, LLC.

*Rev. 2
April 2017*

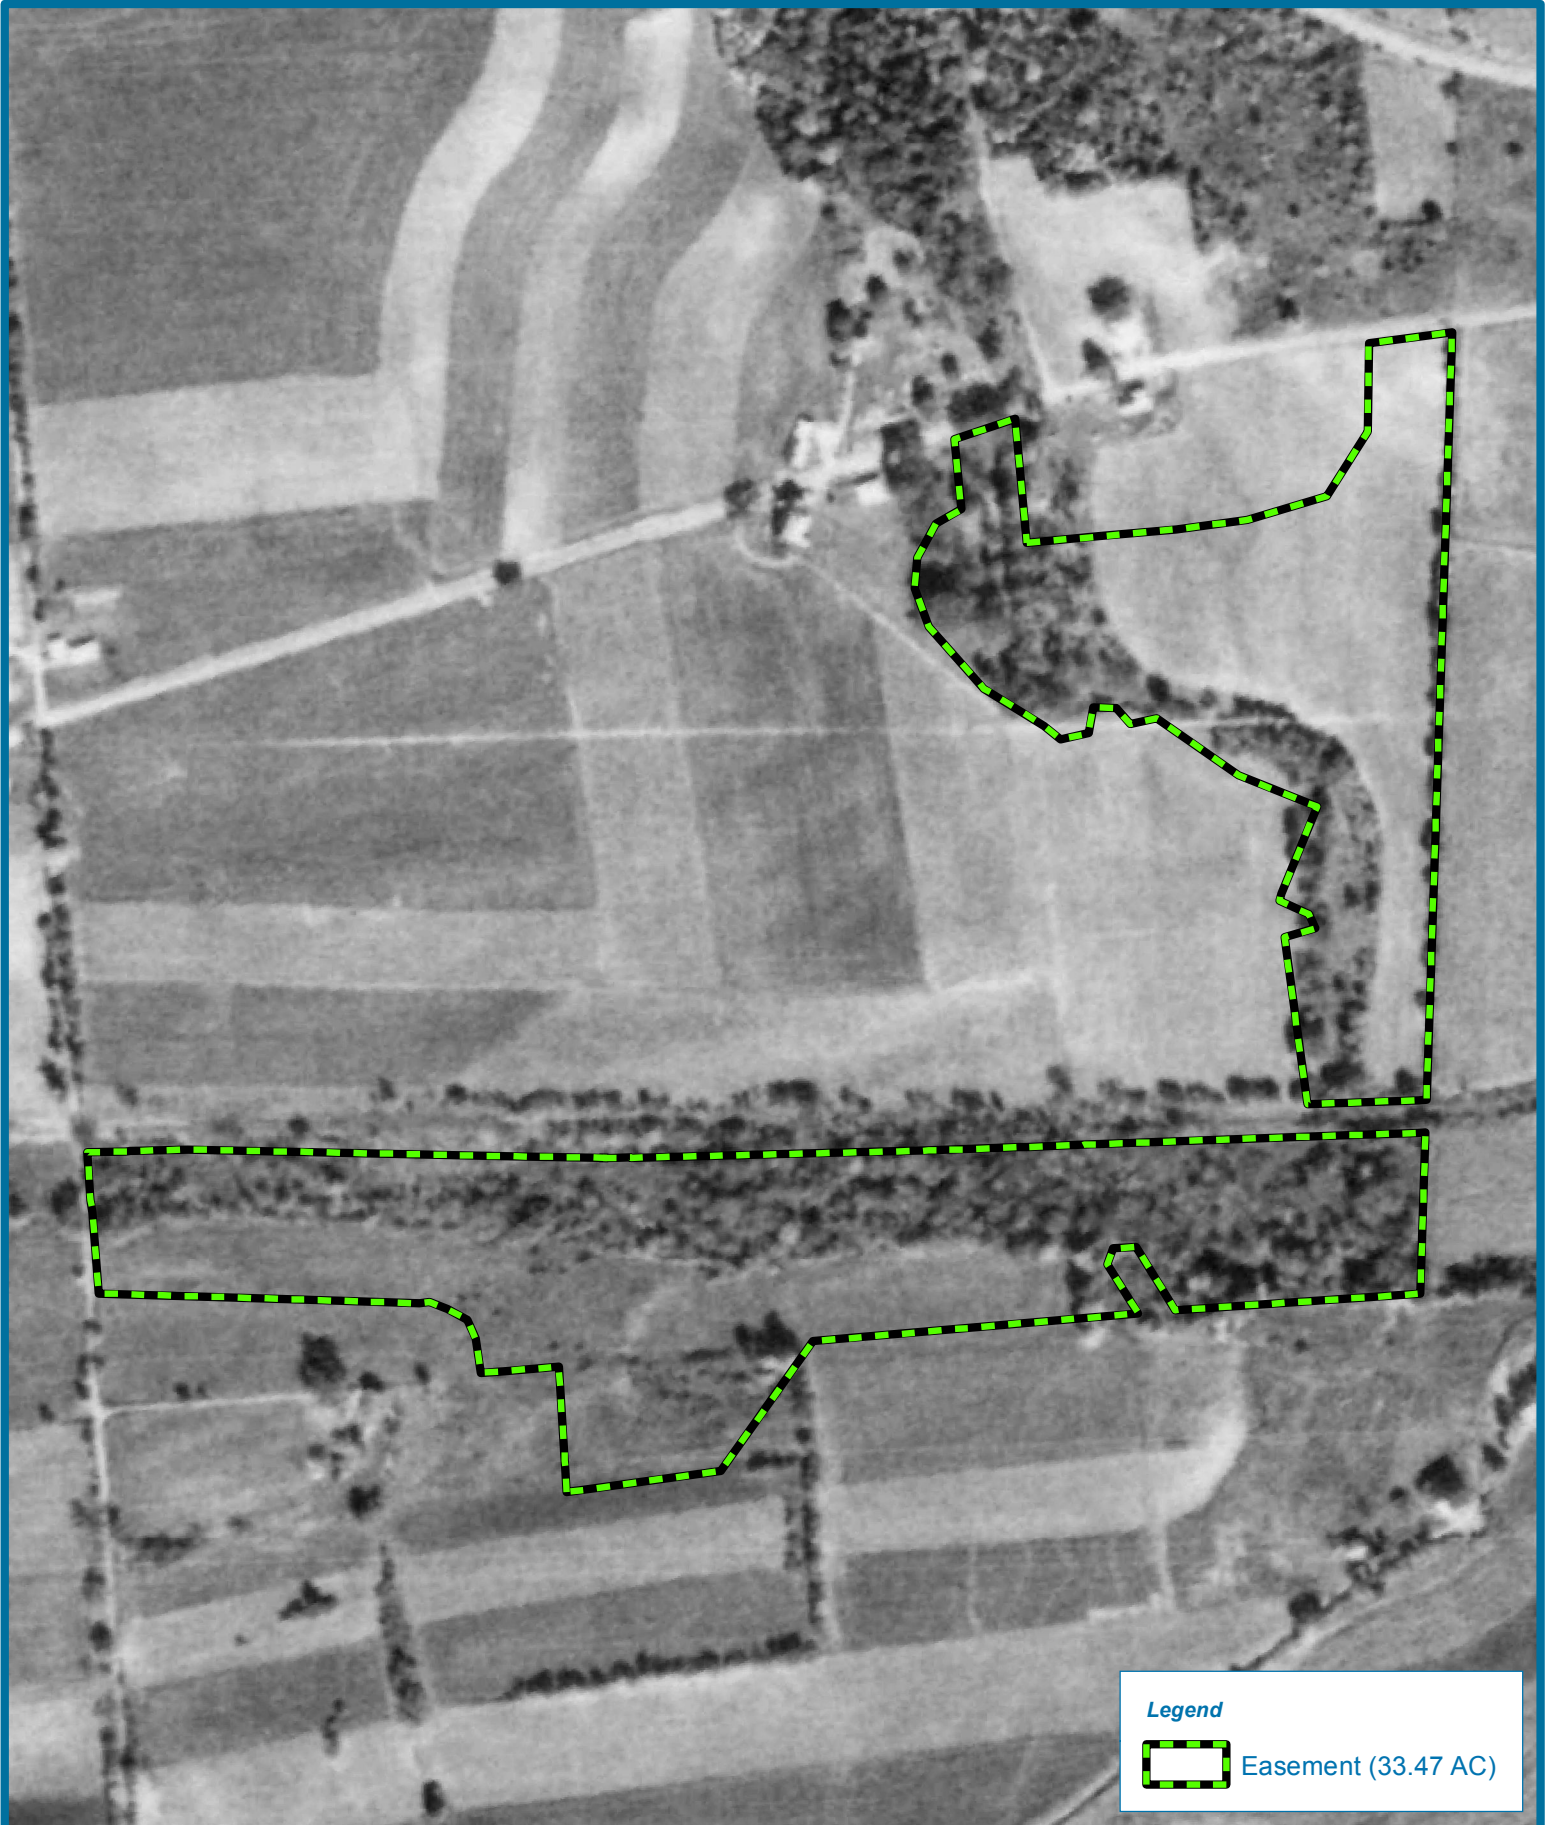
FIGURE 4C

ATLANTIC SUNRISE PROJECT
BRIAR CREEK MITIGATION SITE
1969 HISTORIC AERIAL*
