November 8, 2021  
Project C160860.03

**DEP File No. ESG830021001-00**  
**ESCGP-3**  
**National Fuel Gas Supply Corporation**  
**2021 FM120 Insertion Project**  
**Cameron, Elk, and Mckean Counties, Pennsylvania**

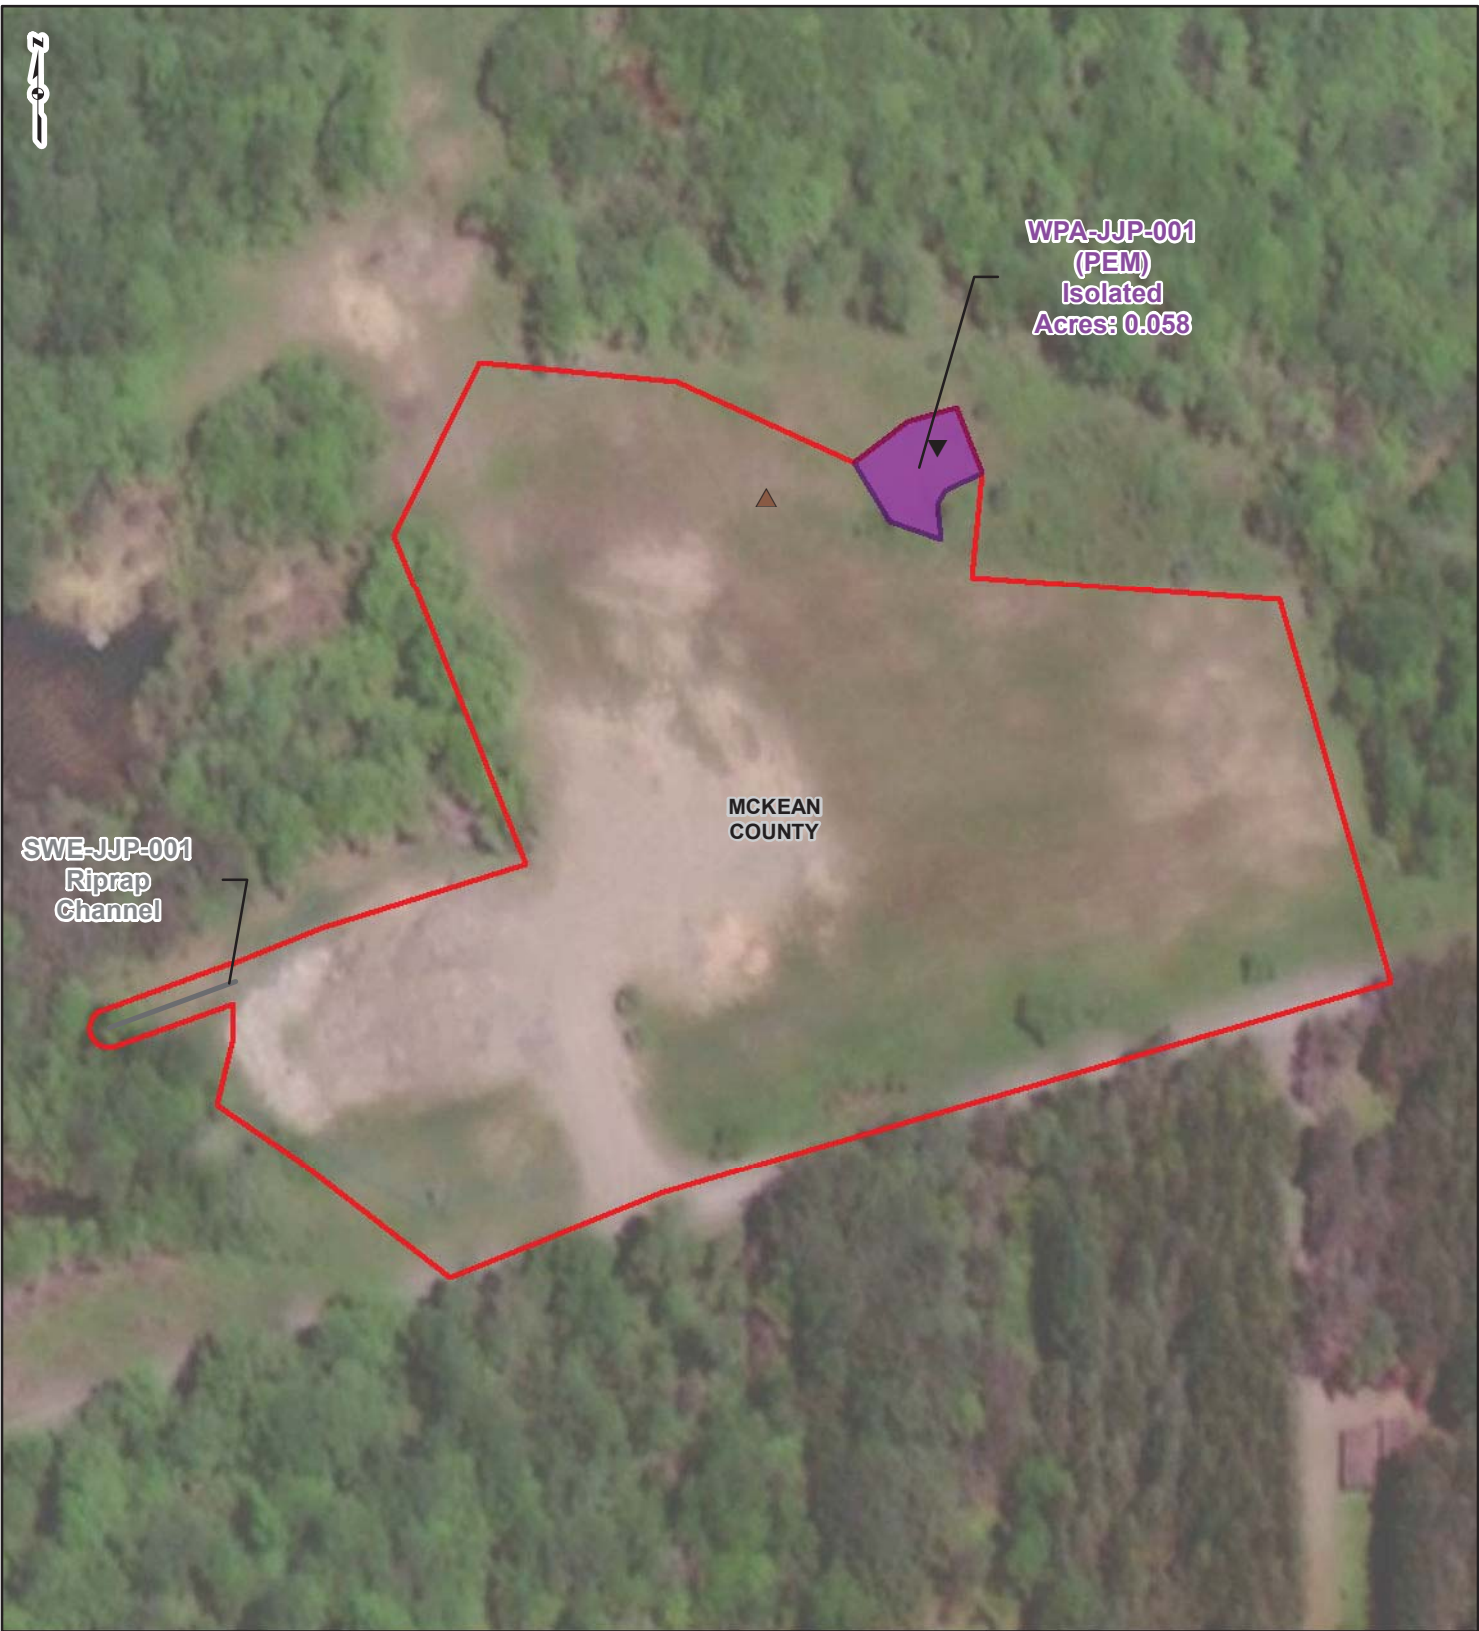
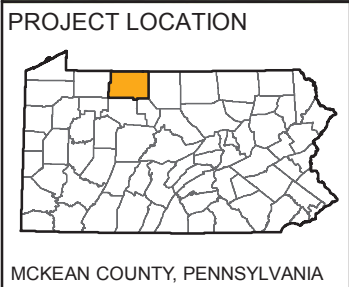
**FIELD MEMO MAP**

The specific site of the proposed laydown yard is an existing gravel lot that appears to have been recently used as a construction yard for an additional natural gas project within the local area. The previously disturbed portion of the existing gravel lot was outlined in degraded (ripped and overgrown with vegetation) erosional sock.

As instructed by Mr. Graham, the delineated study area boundary for the proposed laydown yard was established by taking GPS data points along the degraded erosion sock around the entire gravel lot.

One Paulustrine Emergent (PEM), isolated wetland was delineated within the north east end of the lot, abutting the study area boundary. The client explained that the final limit of disturbance would be able to remain at least 50 feet away from the wetlands' delineated boundary.

In addition, one stormwater erosional feature was delineated with the western section of the lot, just outside the study area boundary. The stormwater feature consisted of a riprap channel that was oriented to the open water area west of the lot as viewed on aerial mapping. The rip rap channel was completely dry and mostly vegetated with upland plant species at the time of survey, and no evidence of flow was observed within the channel.

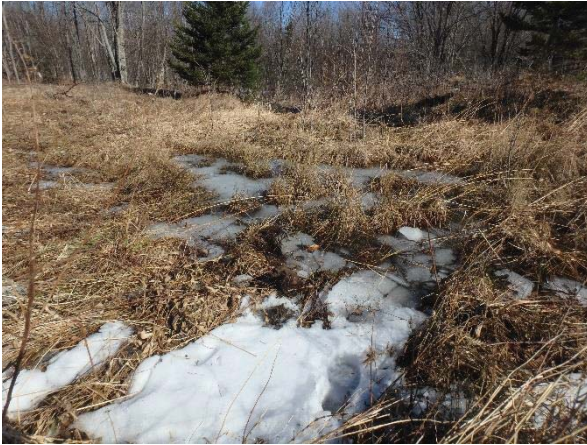
Wetland WPA-JJP-001, Facing North (3/15/19)

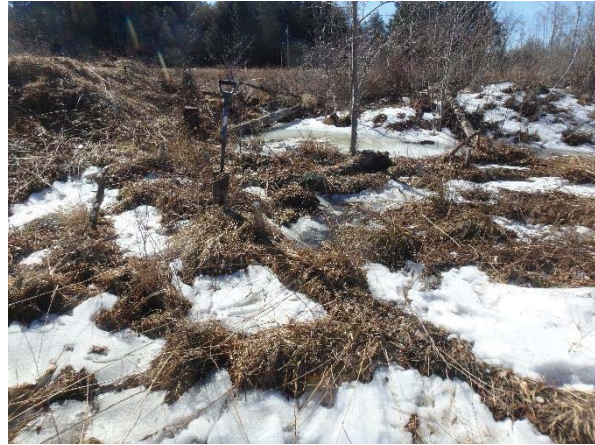
Wetland WPA- JJP -001, Facing South (3/15/19)

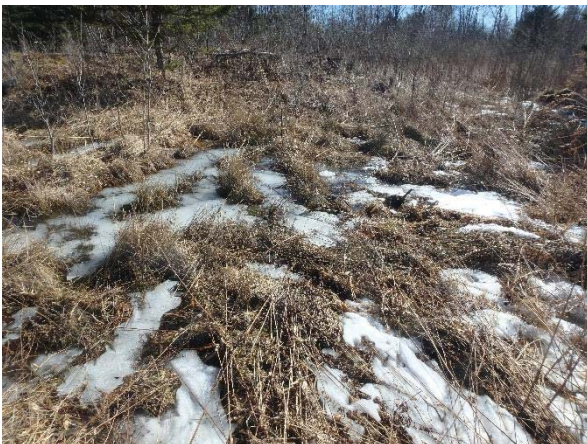
Wetland WPA- JJP -001, Facing East (3/15/19)

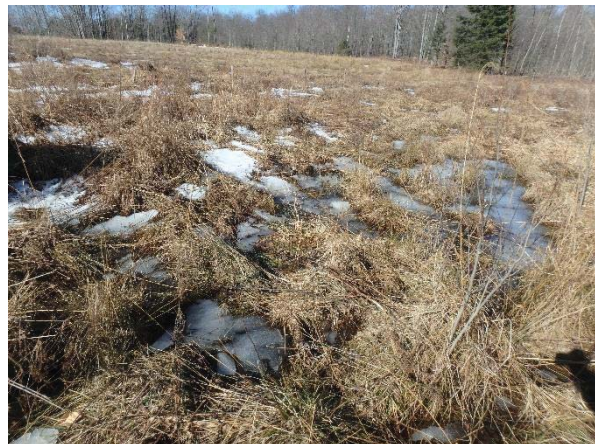
Wetland WPA- JJP -001, Facing West (3/15/19)
