**HORIZONTAL DIRECTIONAL DRILL ANALYSIS
BIDDLE DRIVE CROSSING
PADEP SECTION 105 PERMIT NO.: E15-862
PA-CH-0199.000-RD
(SPLP HDD No. S3-0360)**

This re-evaluation of the horizontal directional drill (HDD) installation is for a 20-inch diameter pipeline that traverses under Biddle Drive, Devon Drive, Valleyview Drive and Shoen Road in Uwchlan and West Whiteland Townships, Chester County, Pennsylvania, is in accordance with terms and conditions item 2 referencing Exhibit "2" of the Stipulated Order issued under Environmental Hearing Board Docket No. 2017-009-L (Order), August 10, 2017. Exhibit "2" provides the rationale of HDD re-evaluations which includes a variety of factors for identifying HDDs for reevaluation, not one which was dispositive. These factors include proximity to public and private water supplies, proximity to natural features (e.g. streams and wetlands) and the value of those natural features, proximity to man-made features (e.g. underground utilities and pipelines, railroad crossings), known impacts to rock from historic blasting, geologic conditions, depth of cover, and occurrence of inadvertent returns (IRs).

**ATTACHMENT 1
GEOLOGY AND HYDROGEOLOGICAL EVALUATION

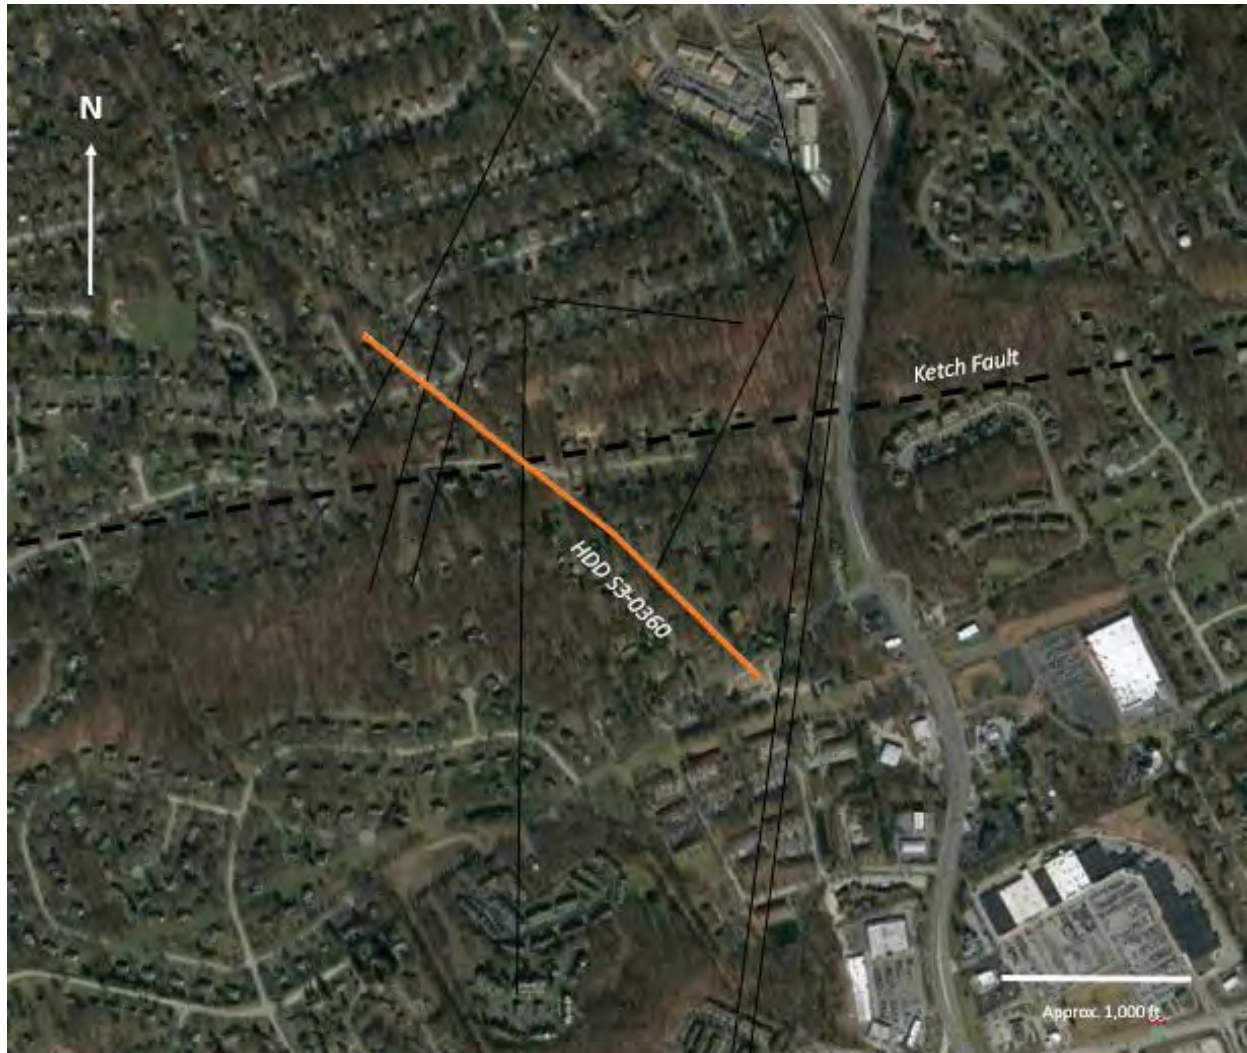
Figure 3. Fracture Trace Map (mod. from GoogleEarth™)

Fracture trace analysis for HDD S3-0360 was performed using aerial stereographic pairs flown in 1937. The proposed path of the proposed profile, mapped fracture traces, and a lineament are shown on **Figure 3** and on the proposed HDD profile in **Attachment A**. The alignment transects four of the mapped fracture traces and the Ketch Fault along the northwest half of the profile. All four fracture traces trend north-northeast and the one furthest to the southeast intersects the Ketch Fault along the HDD alignment at approximately Station 17+10. The other three fracture traces cross the alignment at approximately Stations 22+00, 24+20, and 26+10. These locations are potential zones of fracture concentration, weakness in bedrock, and preferential pathways for fluid migration (drilling fluid or groundwater). The southern end of a fifth, north-northeast trending fracture trace, is mapped within the alignment right-of-way (ROW) near Station 7+80 and a north-northeast trending lineament is mapped due east and south of the southeast entry/exit.

Note: Solid black lines indicate fracture traces and parallel lines east of HDD indicate a lineament.

Published geologic maps show a major left-lateral fault within the Chickies Formation, the Ketch (Gap) Fault, passes through the HDD S3-360 path along Township Line Road at approximately Station 17+10 on the proposed profile. In addition, the alignment transects four mapped fracture traces along the northwest half of the profile. All four fracture traces trend north-northeast and the one furthest to the southeast intersects the Ketch Fault along the alignment. The other three fracture traces cross the alignment at

approximately Stations 22+00, 24+20, and 26+10. These locations are potential zones of fracture concentration, weakness in bedrock, and preferential pathways for fluid migration (drilling fluid or groundwater). The southern end of a fifth north-northeast trending fracture trace is mapped within the alignment right-of-way (ROW) near Station 7+80 and a north-northeast trending lineament is mapped due east and south of the southeast entry/exit (see Attachment 1).

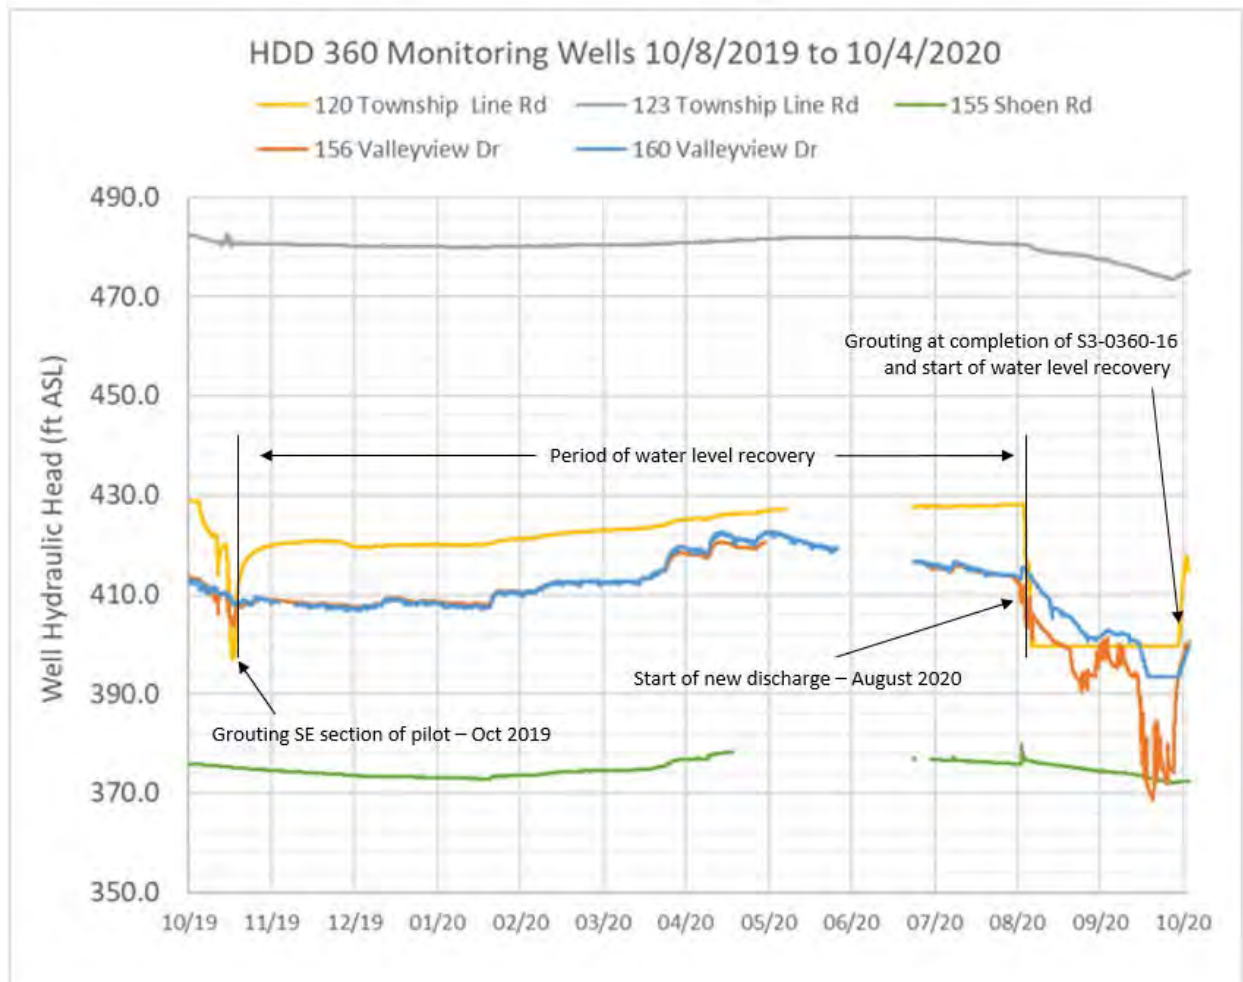
Figure 6. Groundwater Levels

A continuous water level monitoring system with remote access has been established at five former residential wells in the area to assess pre-drill conditions and monitor for potential water level impacts during drilling of both the 16-inch and 20-inch HDD at S3-0360 (see **Figure 4** for locations). Monitoring of the groundwater levels began in December 2017 and the data have been downloaded weekly. A real-time data logger was installed in the 160 Valleyview Drive monitoring well on October 18, 2019. The natural groundwater level fluctuations recorded until October 4, 2020 are shown on **Figure 6**.

As shown on **Figure 6**, water levels in the monitoring wells responded to HDD construction activity. During periods of active drilling, the water levels declined in response to a groundwater discharge at the southeast entry/exit. The southeast entry/exit for the P&Ps for both pipes is located at a lower elevation than the background water table, over approximately 2,450 feet of the 2,857-foot drill path (horizontal distance). As such, completion of the pilot borings for the 16-inch line created a groundwater discharge

A continuous water level monitoring system with remote access has been established at five former residential wells in the area to assess pre-drill conditions and monitor for potential water level impacts during drilling of both the 16-inch and 20-inch HDD at S3-0360. Monitoring of the groundwater levels began in December 2017 and the data have been downloaded weekly. A real-time data logger was installed in the 160 Valleyview Drive monitoring well on October 18, 2019. The water level monitoring data show normal water levels generally fluctuate between 405 and 430 ft amsl.

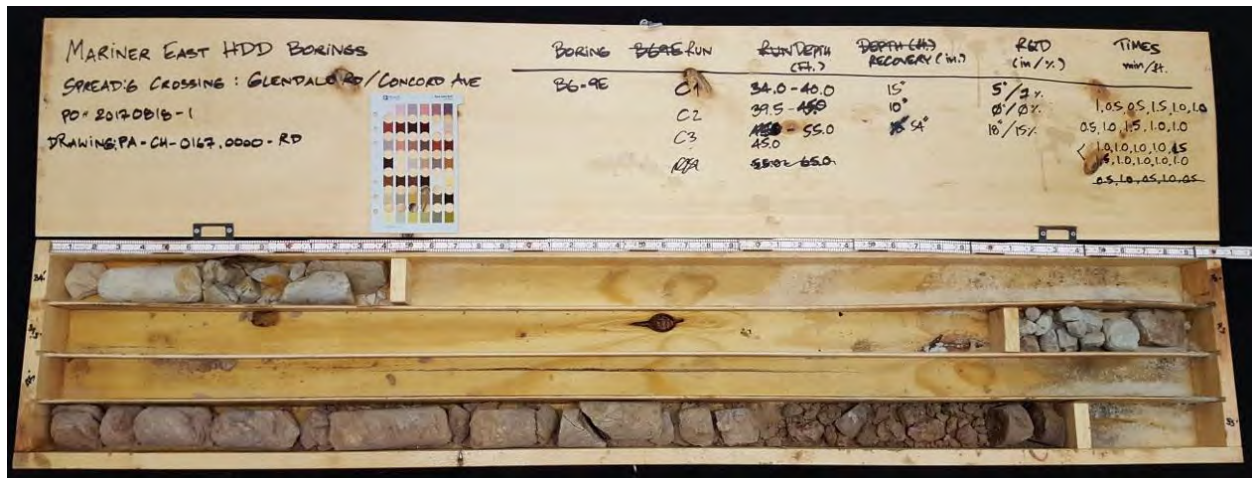
Photograph 1: B6-9E, Samples C-1 to C-3 (34 to 55 feet)

Terracon boring B6-9E was advanced on August 28-31, 2017, adjacent to the northwest entry/exit point. The surface elevation is listed on the log as approximately 574 ft amsl and the boring was installed to a depth of 140 feet or approximate elevation 434 ft amsl. The lowest elevation for the proposed profile is 279 ft amsl. Unconsolidated overburden observed at B6-9E was comprised of silty sand before split-spoon refusal at 34 ft bgs and the start of coring. Bedrock cores were logged as felsic gneiss and quartzite. Recoveries throughout the core were low with all but two ranging from 0 to 45 percent. The five-foot core from 100 to 105 ft bgs had a recovery of 80 percent and the three-foot core from 112 to 115 ft bgs had a recovery of 100 percent. RQD values were low throughout the cores, ranging from 0 to 27 percent. The boring log indicates that groundwater was encountered at a depth of 25 ft bgs.

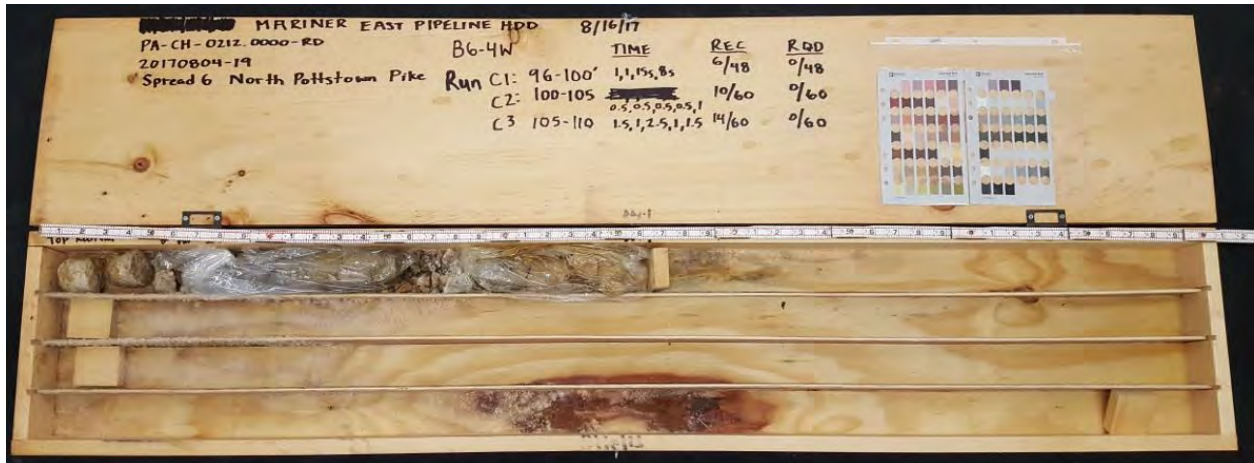
Photograph 1: B6-4W, Samples C-1 to C-3 (96 to 110 feet)

Boring B6-4W was advanced by Terracon on August 15-16, 2017, adjacent to the southeast entry/exit point. The surface elevation is listed on the log as approximately 353 ft amsl and the boring was installed to a depth of 130 feet or approximate elevation 223 ft amsl. The lowest elevation for the proposed profile is 279 ft amsl. Unconsolidated overburden observed at B6-4W was comprised of sandy clay with gravel and decomposed rock to the total depth of 130 ft bgs. Split spoon refusal was encountered at a depth of 96 ft bgs. Rock coring was performed from 96 to 110 ft bgs (elevation 257 to 243 ft amsl). Over this interval, core recovery was poor, ranging from 12.5 to 23 percent and rock quality RQD was zero percent. Terracon drill logs indicate the rock that was cored may have been a quartzite boulder. Split-spoon sampling was resumed from a depth to 110 ft bgs to the final depth of 130 ft bgs. Geologic mapping of this area indicates a geologic contact between the Harpers and Ledger Formations in the vicinity of the boring B6-4W. The Harpers Formation is a brownish gray phyllite and the Ledger Formation is a gray dolomite. However, these rock types were not observed in boring B6-4W. The log for B6-4W indicated that groundwater was not encountered.

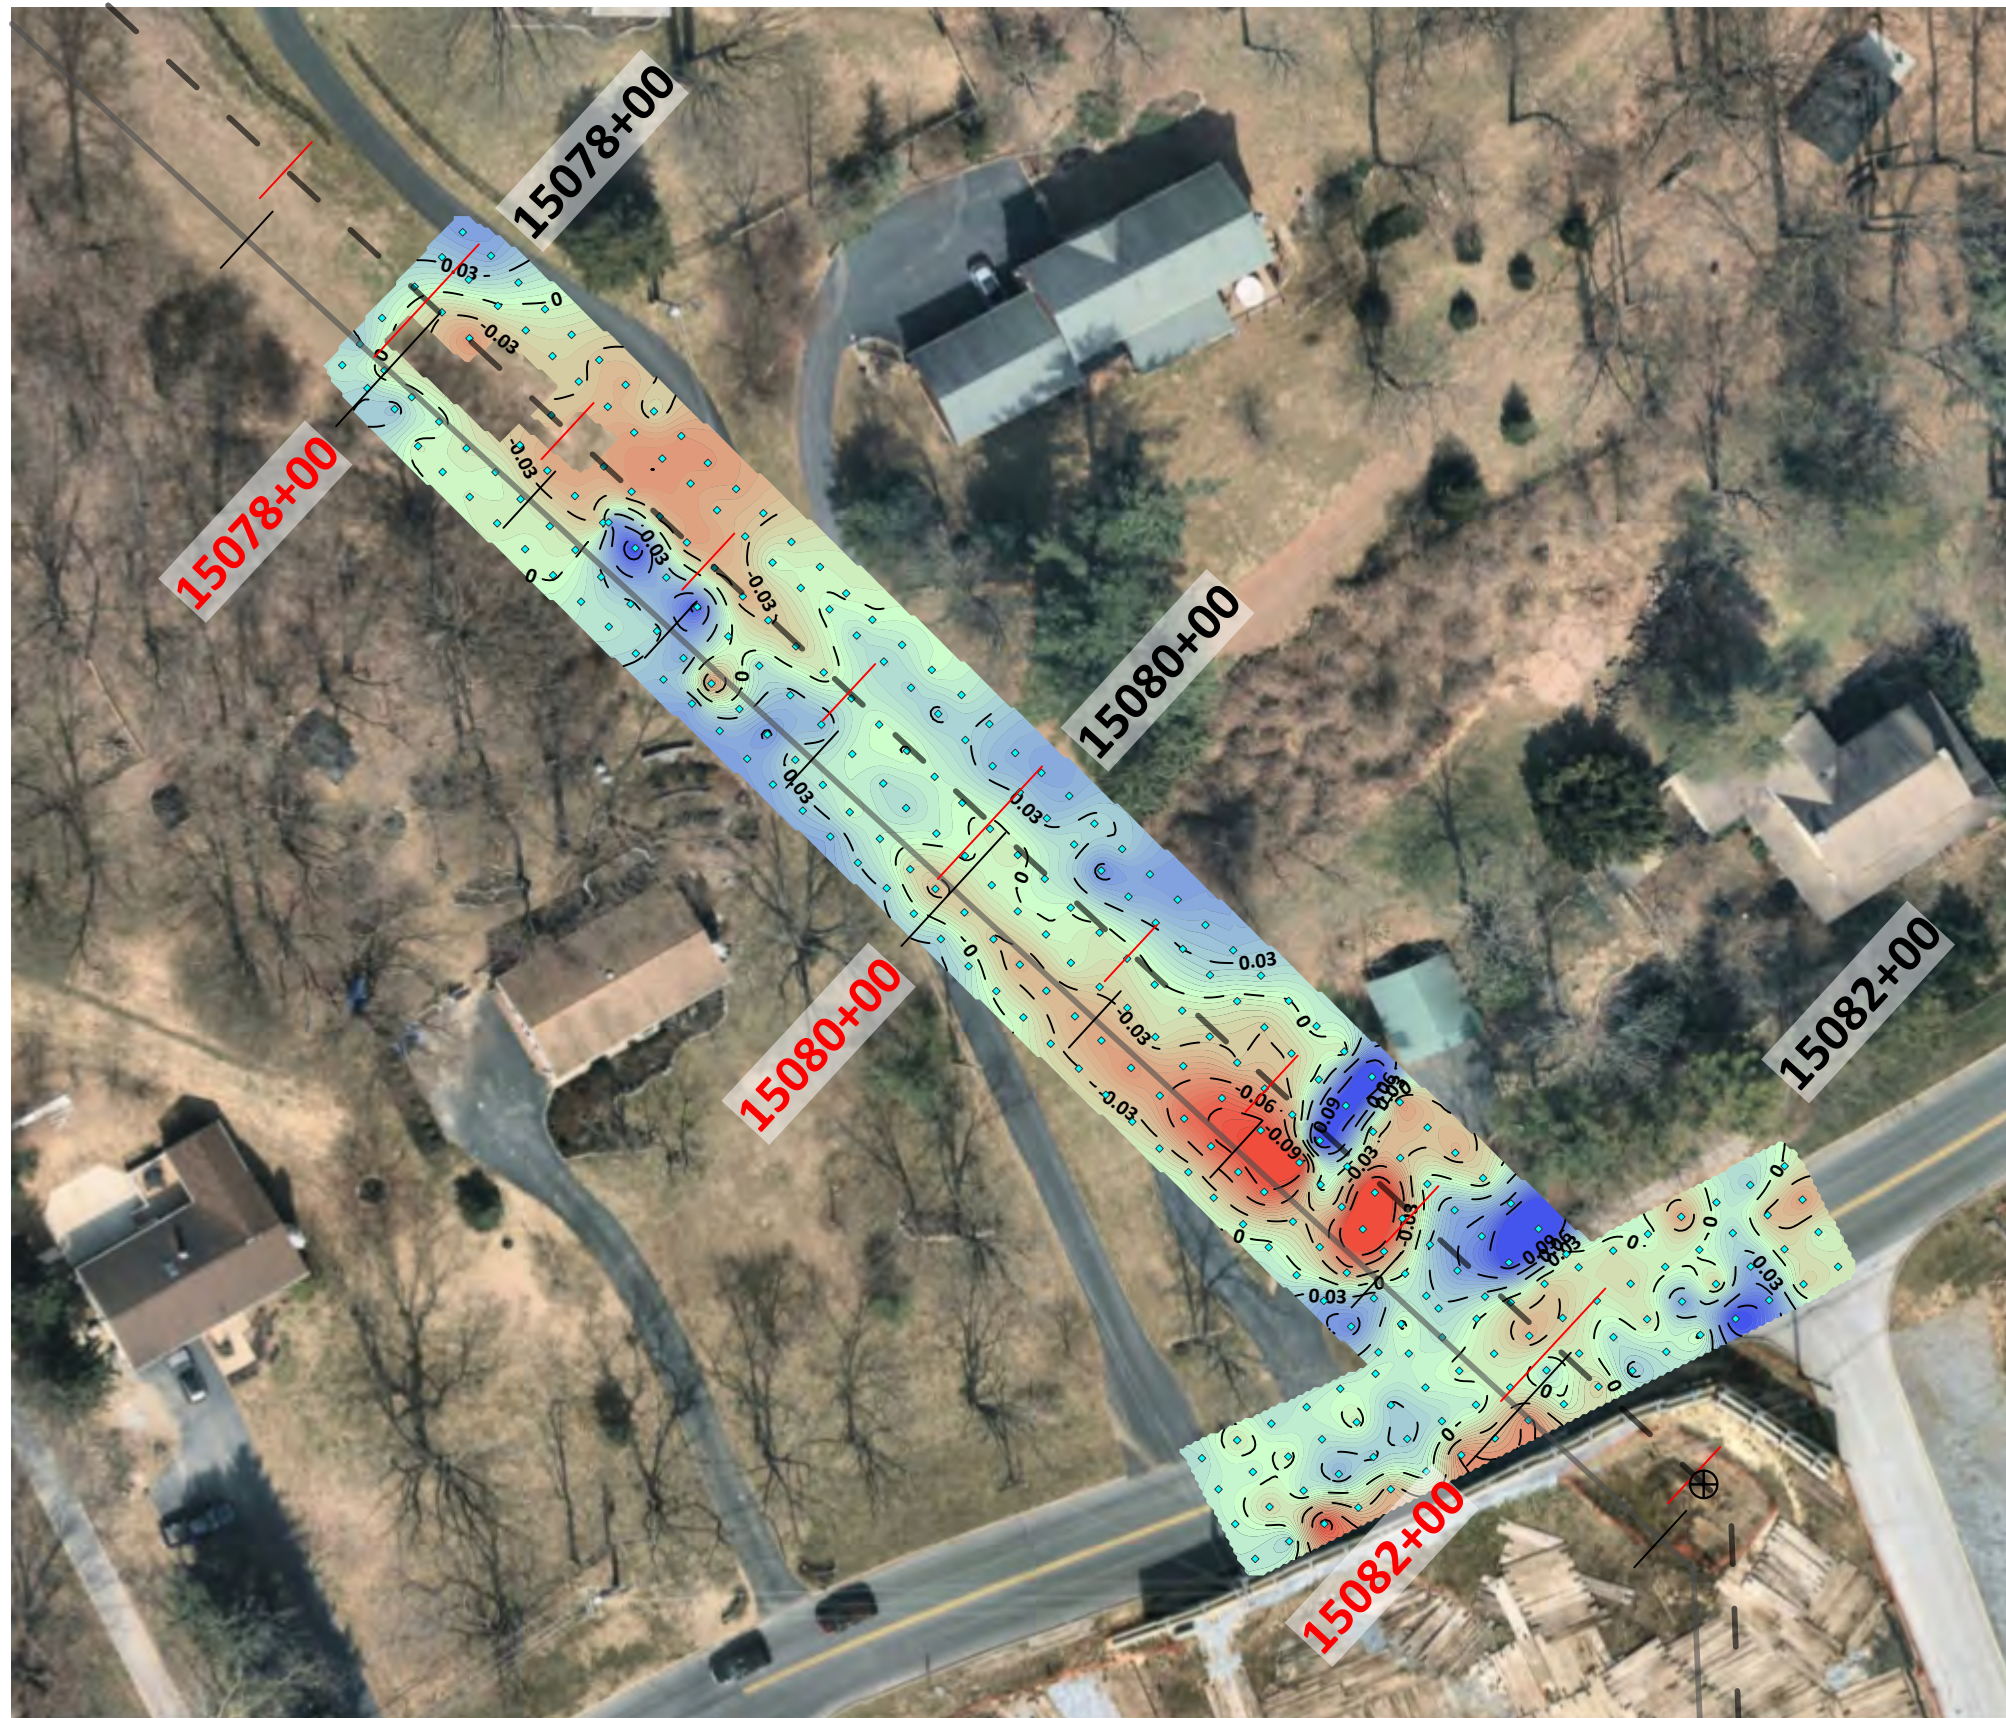
Figure 3: Residual Microgravity

Data from Scintrex CG-5 microgravity meter with complete Bouguer correction.

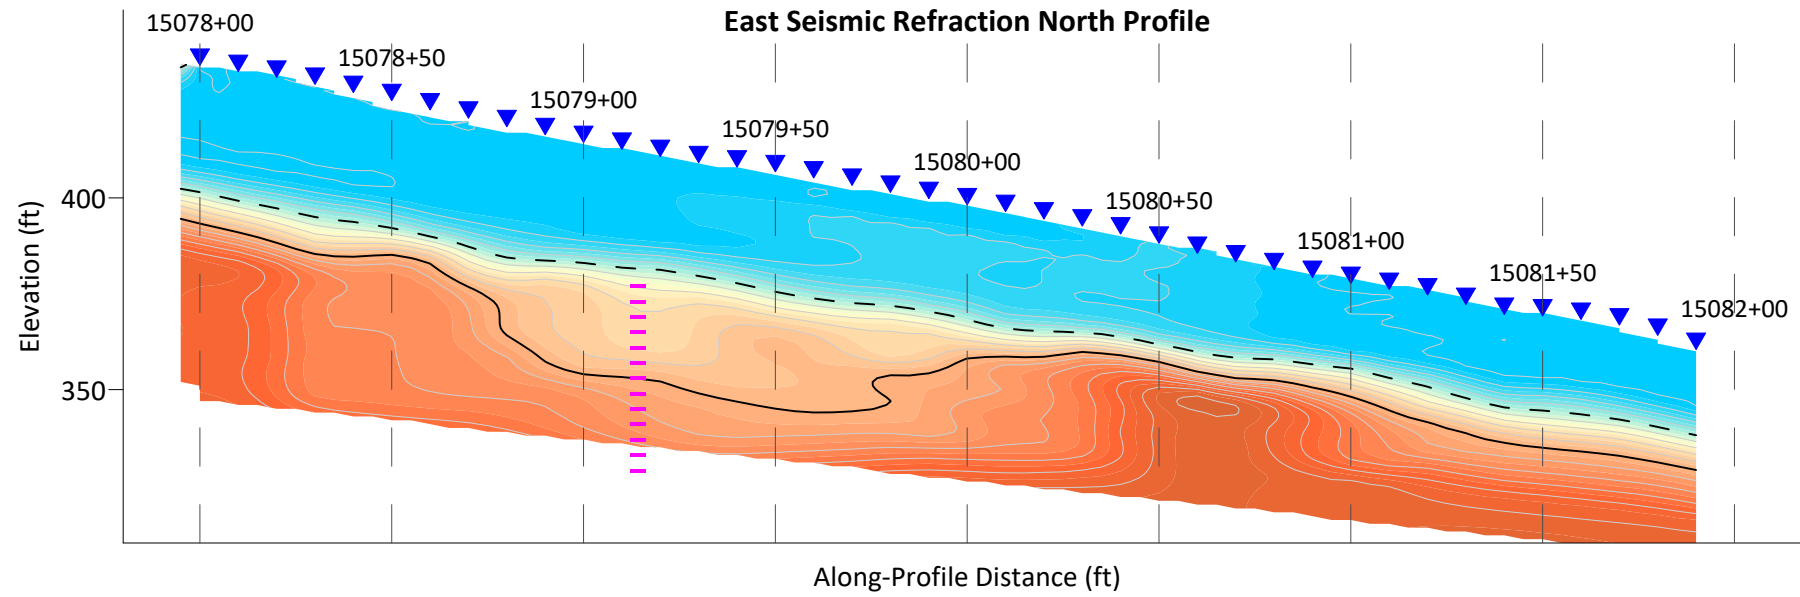
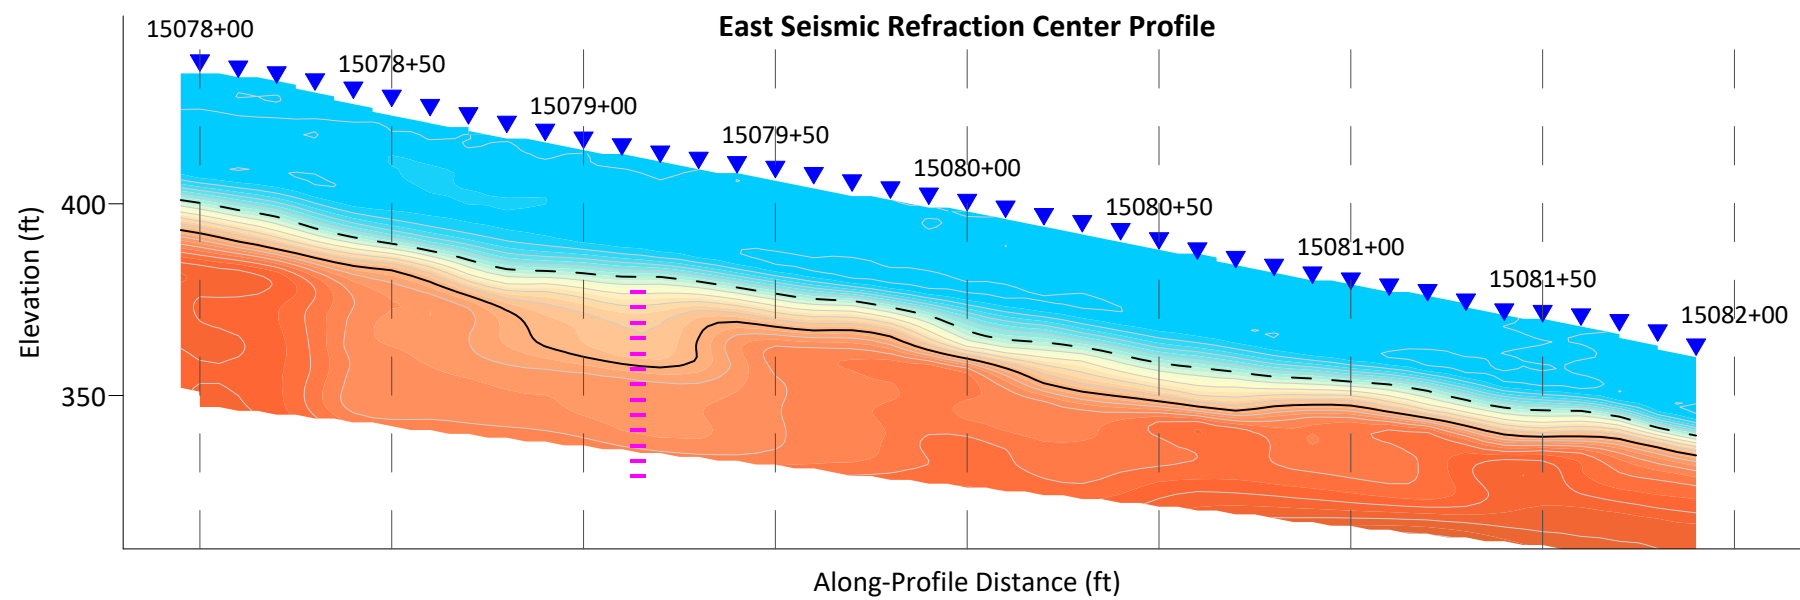
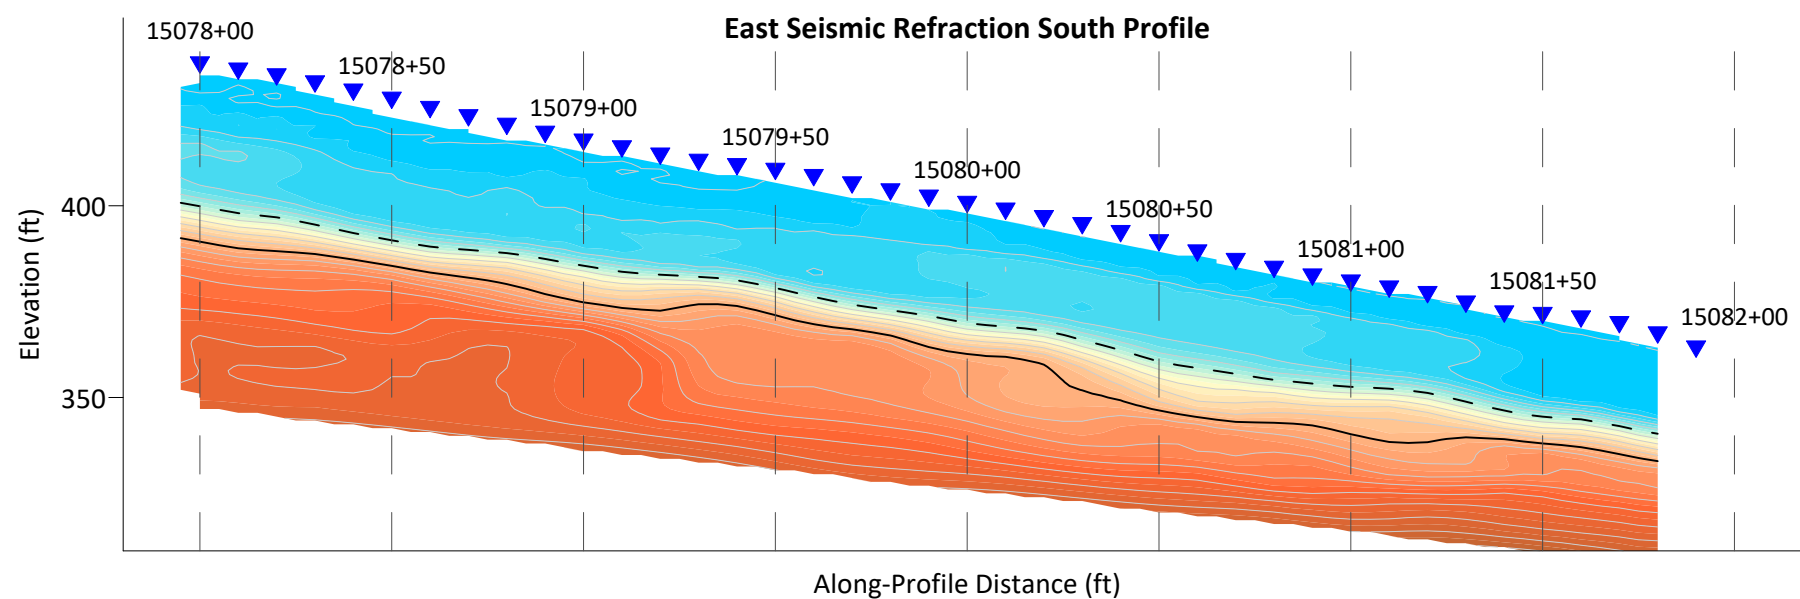
Figure 4: Seismic Refraction Profiles

- Possible Fracture Zone
- 16-inch HDD (from As-Built)
- 15338+00 Pipeline Station Number

Seismic data from Geometrics 24-channel Geode with 4.0 Hz geophones.

Rettew performed a geophysical survey in February 2020, covering approximately 400 feet of the southeast end of the proposed alignment for HDD S3-0360. Three different geophysical techniques were utilized to detect and delineate subsurface voids or low-density zones and provide a top of competent bedrock profile; including microgravity, seismic refraction and multi-spectral analysis (MASW), and electrical resistivity (ERI). The seismic refraction and MASW data indicate there is a soil mantle approximately 25 to 35 feet thick over the survey lines and a potential zone of bedrock fracturing at approximately Stations 3+40 on the proposed profile. The ERI profiles show deeper, electrically more conductive anomalies, below an inferred top-of-rock at approximately Stations 0+80, 3+05 and 4+10 on the proposed profile that may represent water- or clay-bearing fractures or weathered seams within bedrock. A zone of lower resistivities was reported occurring from approximately Station 0+50 to 1+00 extending from approximately where the proposed profile may emerge from rock near Shoen Road – where groundwater seepage has been observed.

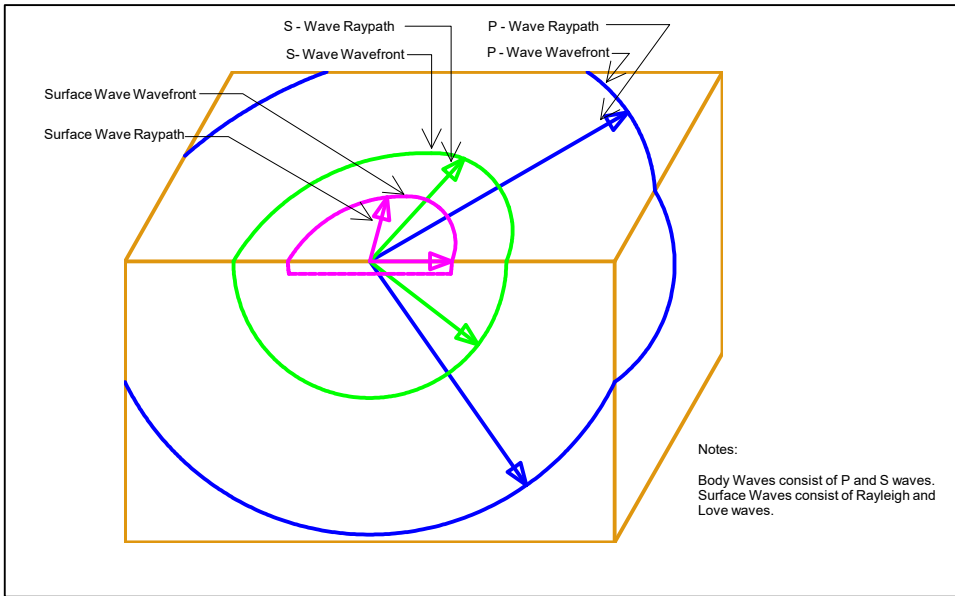
Figure SR-1

Seismic Wave Types

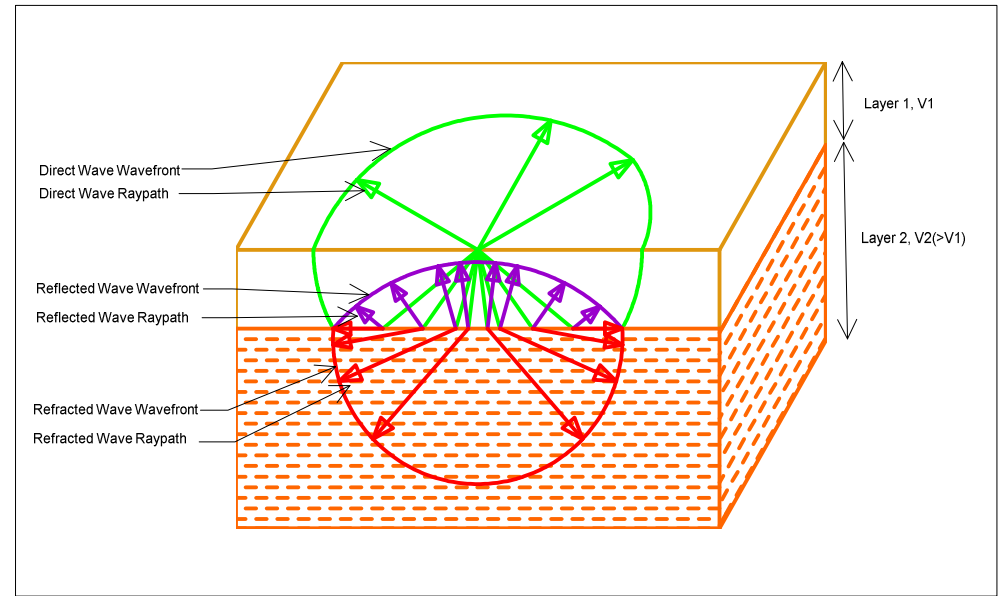
Figure SR-2

Effect of Layering
on Body Wave Raypath

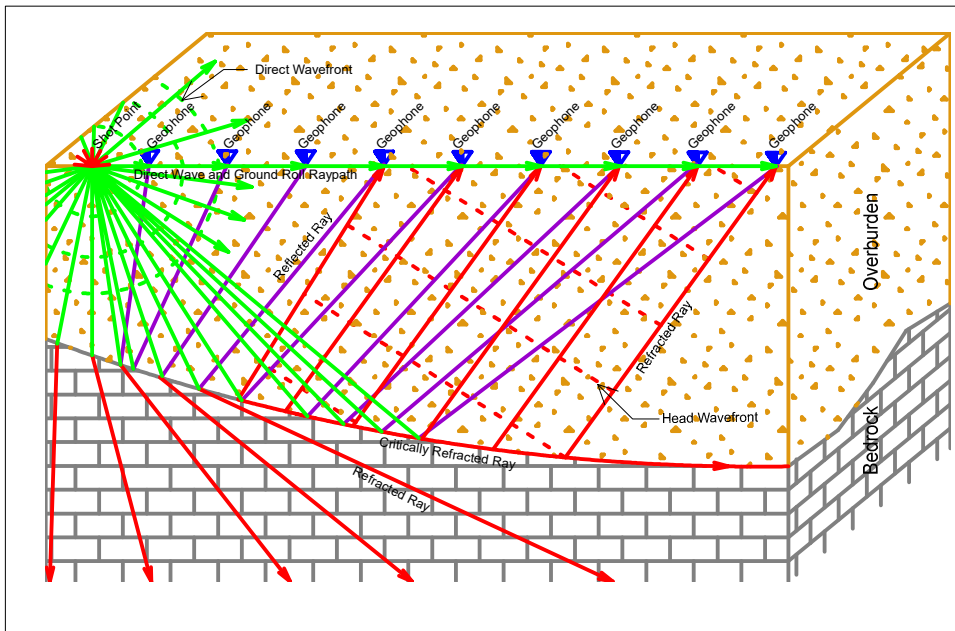
Figure SR-3

Seismic Ray Path Geometry

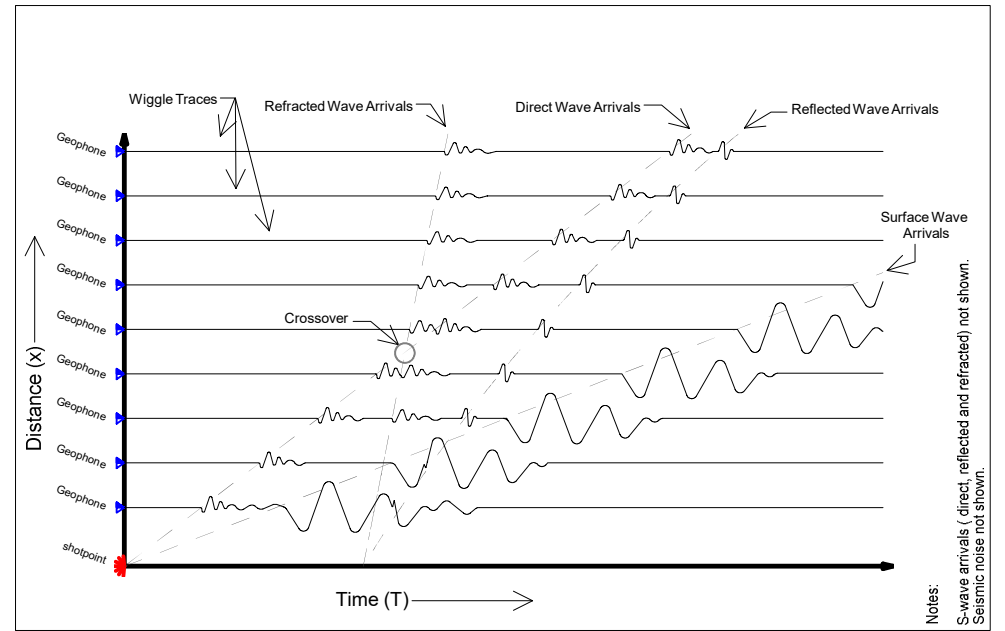
Figure SR-4

Idealized
Seismic Record
and T- X Graph

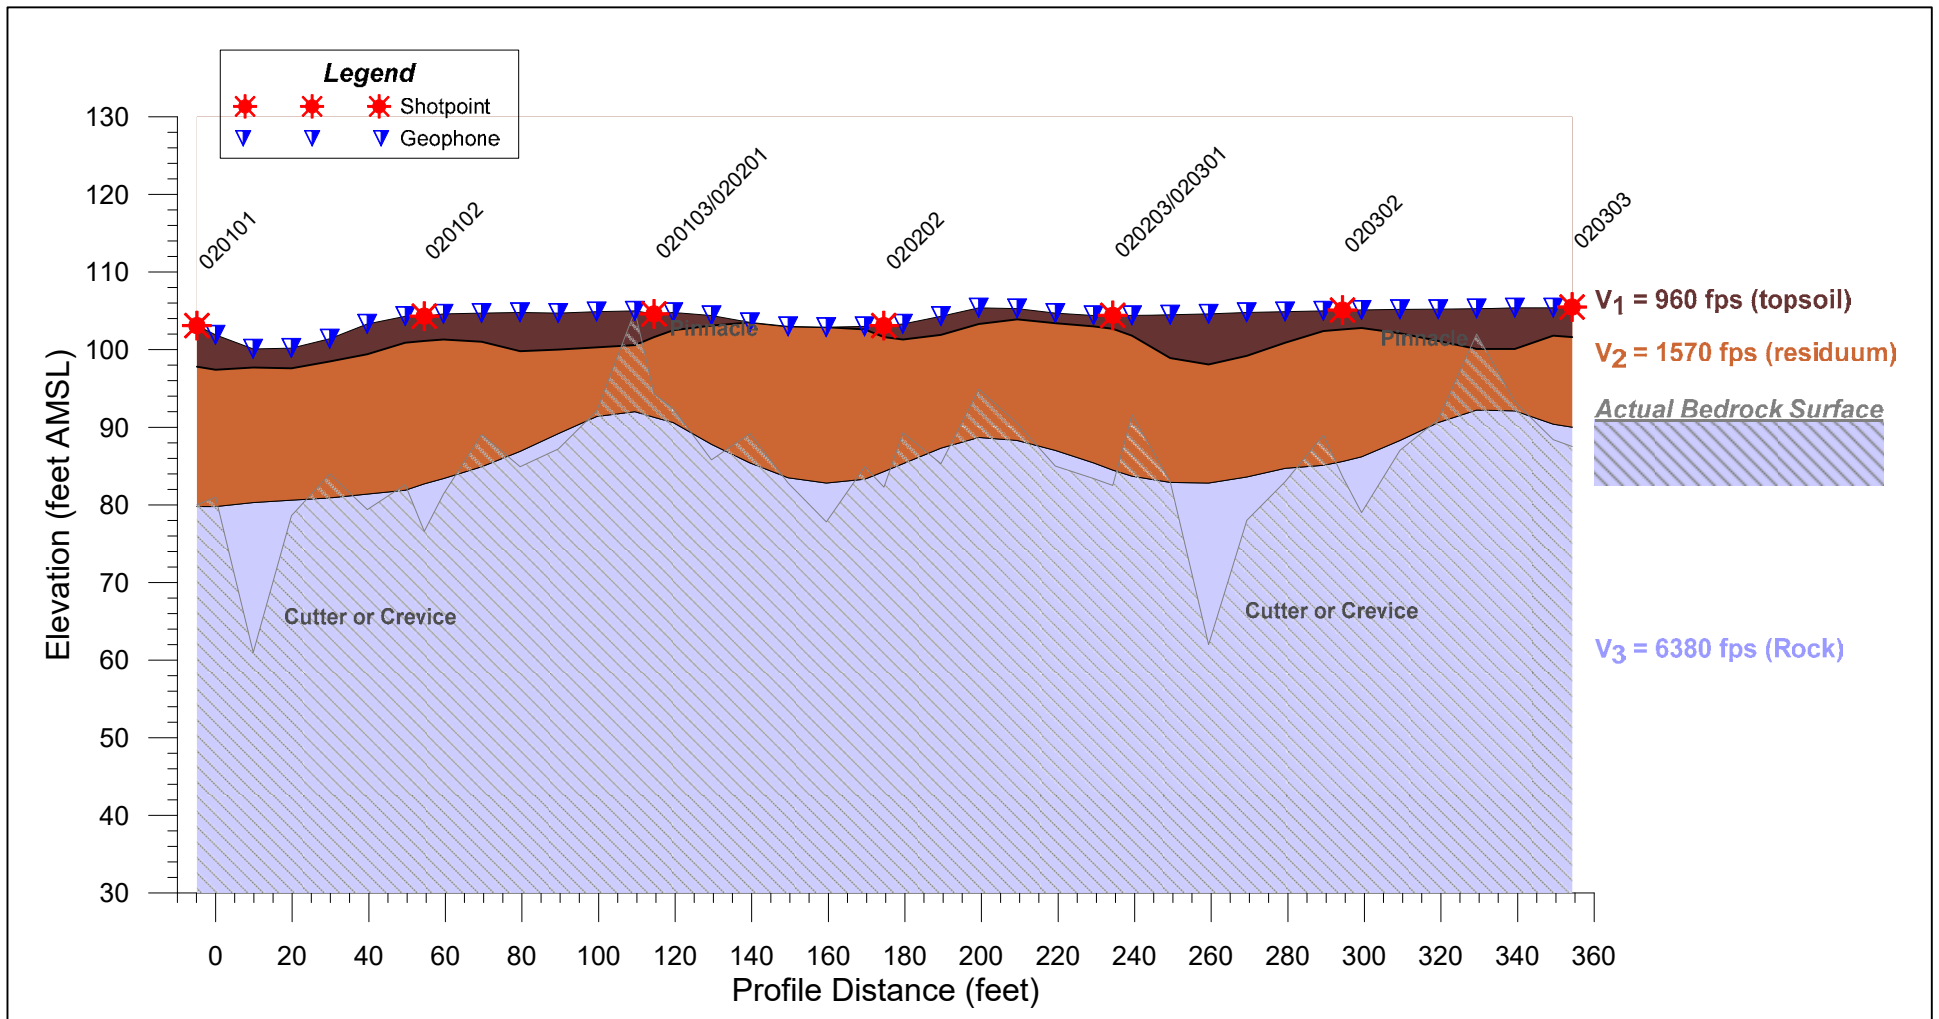
Figure SR-5

Example Karst Terrane Seismic Profile

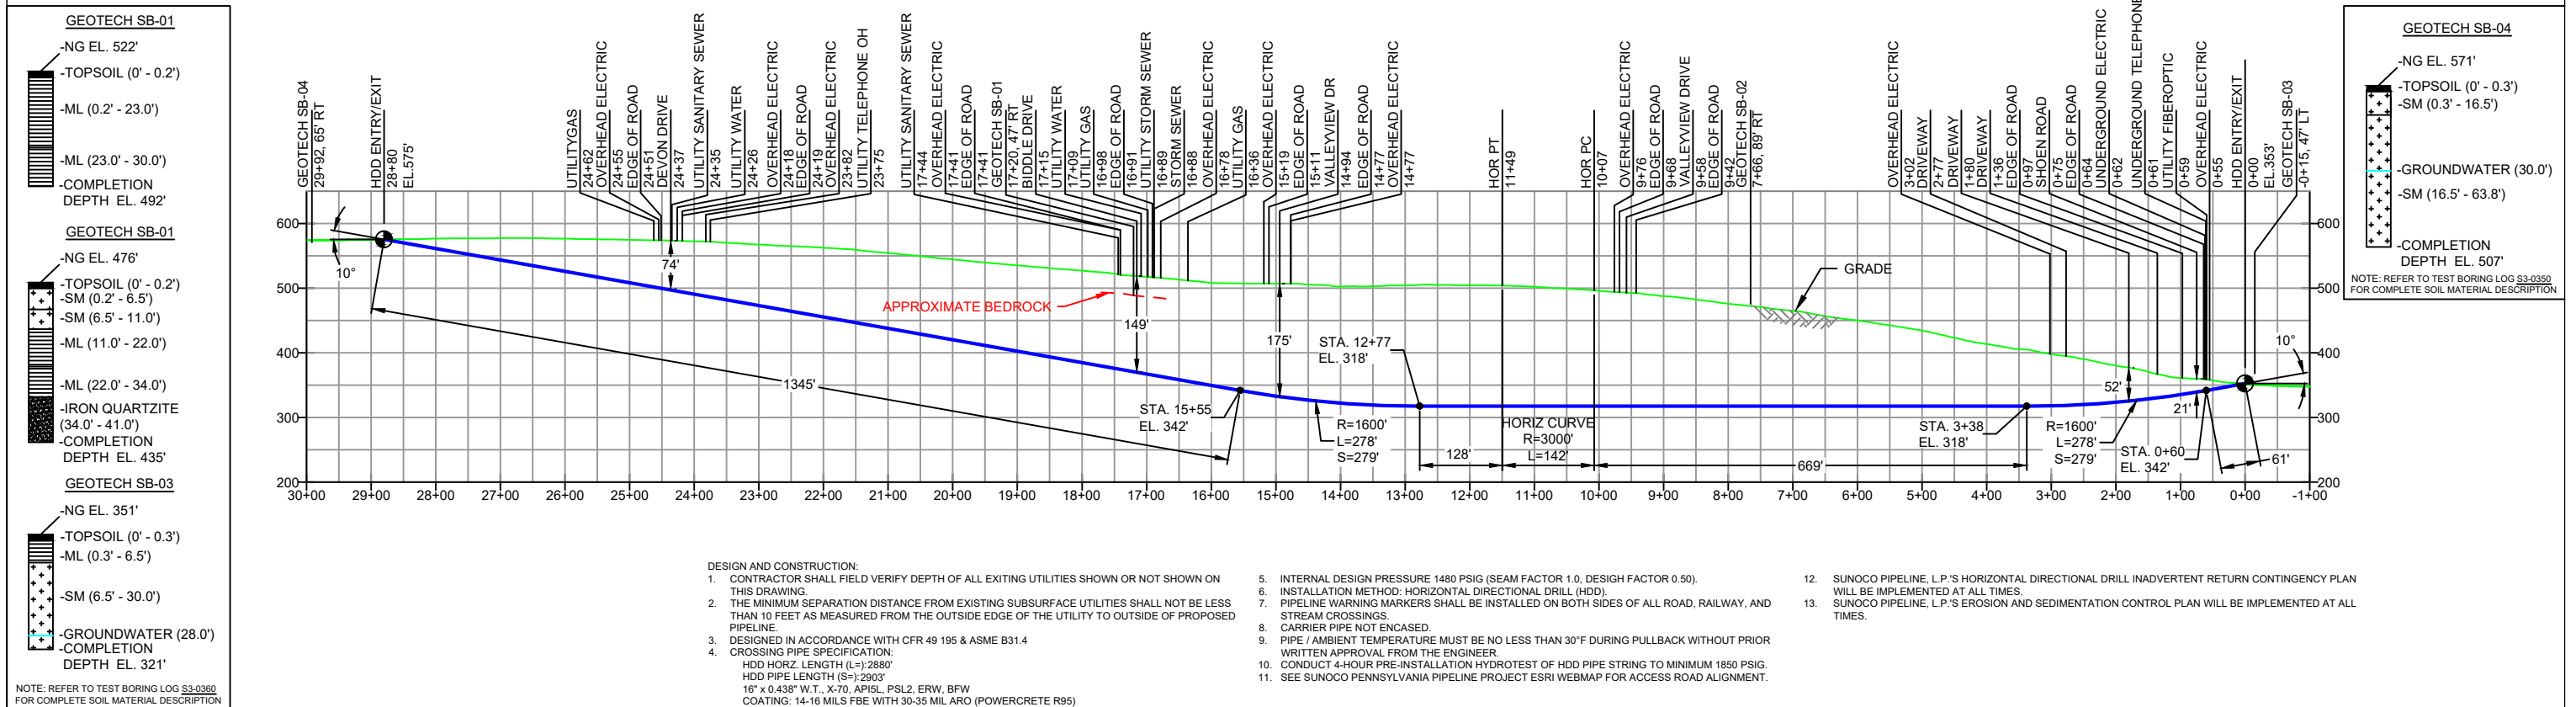
SCALE: 1"=250' DWG. NO: PA-CH-0199.0000-RD-16

PLAN VIEW

PROFILE VIEW

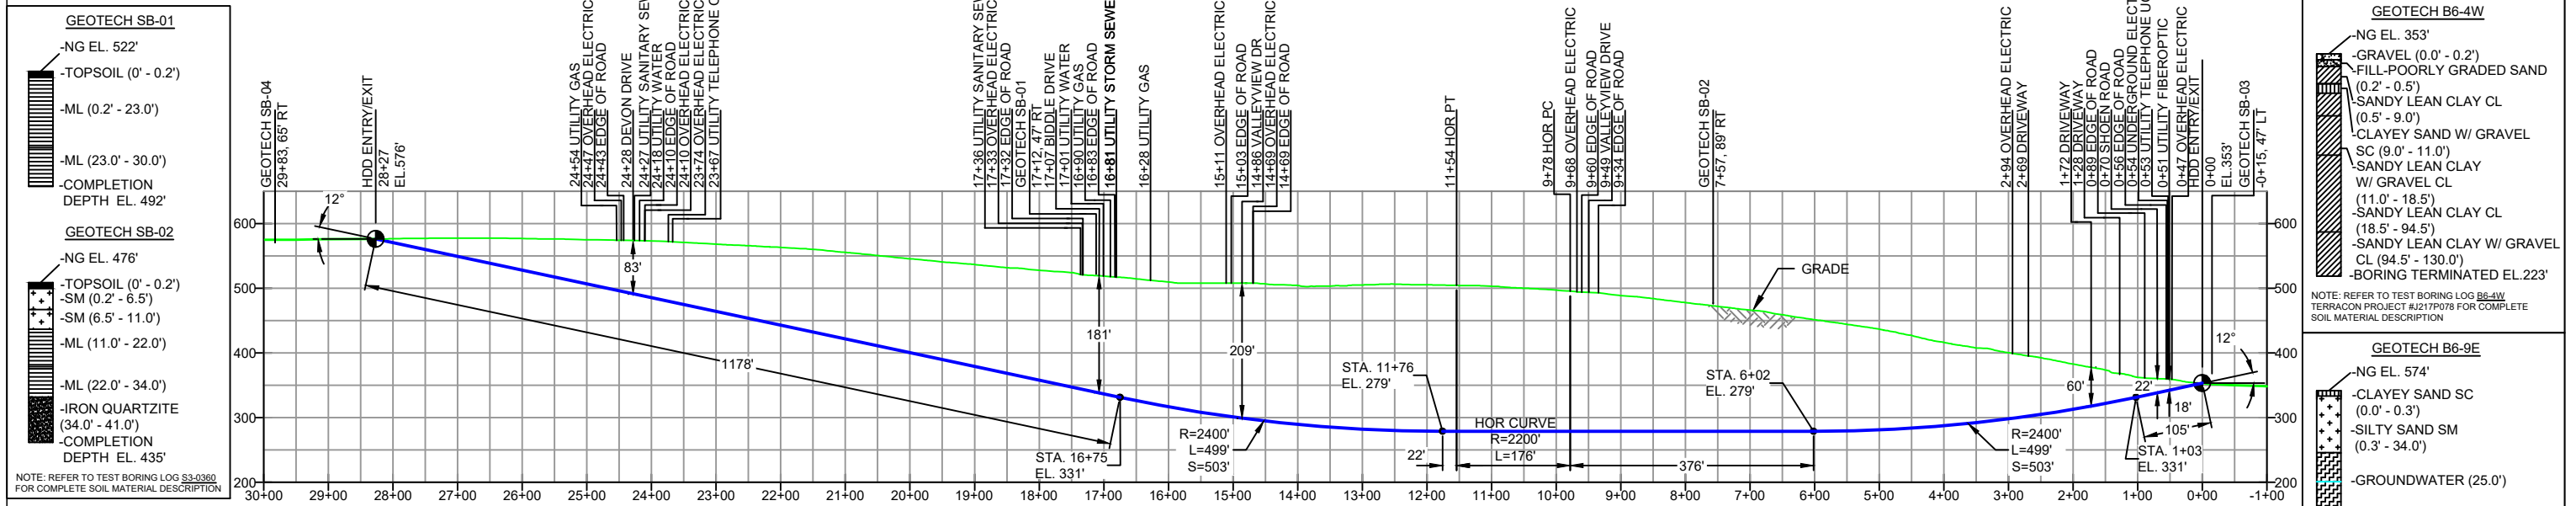
CHESTER COUNTY, PENNSYLVANIA - WEST WHITELAND & UWCHLAN TOWNSHIP
S3-0360

PROFILE VIEW
