**HORIZONTAL DIRECTIONAL DRILL ANALYSIS
BLACKLOG CREEK CROSSING
PADEP SECTION 105 PERMIT NO.: E31-234
PA-HU-0106.0000-RD-16
(SPLP HDD No. S2-0154-16)**

The 16-inch pipeline HDD is referred to herein as HDD S2-0154-16.

ORIGINAL HORIZONTAL DIRECTIONAL DRILL DESIGN SUMMARY: 16-INCH

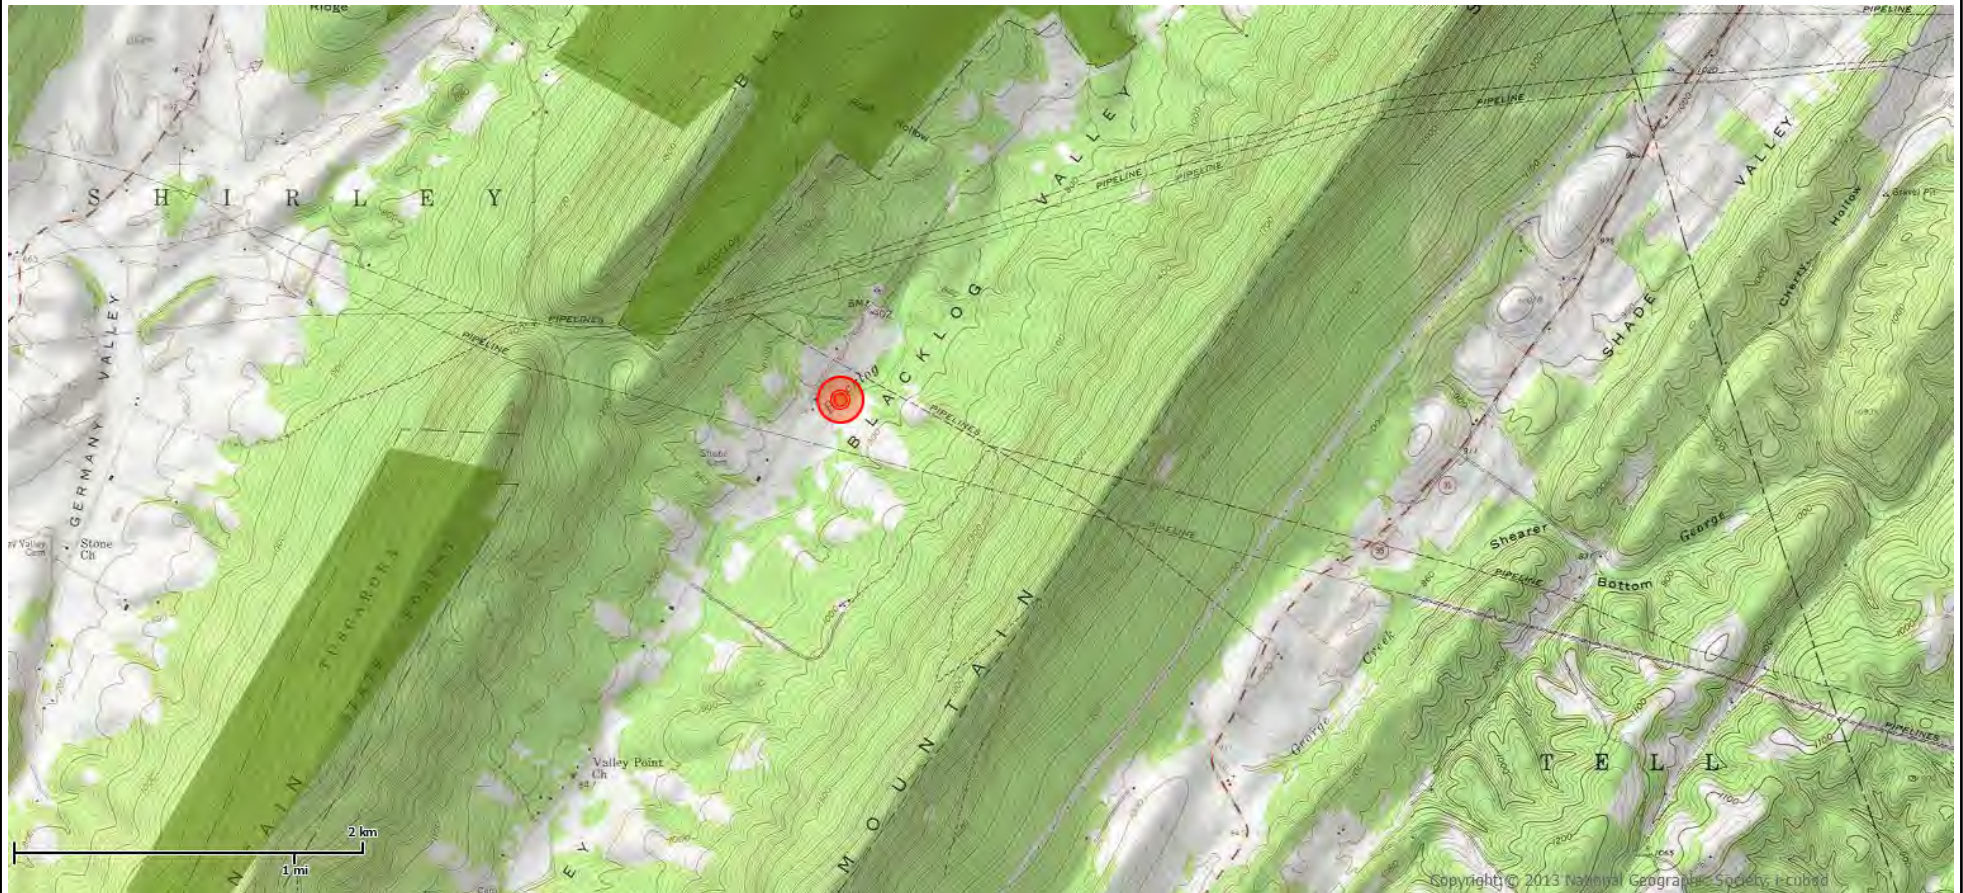
**FIGURE 2: Boring Location Plan
SR 2017 - PPP3
DPS PO #20170921
PSI Project # 08031074**

**GEO BORE #1
(150 FT)**

**GEO BORE #2
(150 FT)**

- **Boring B-01:** Stiff to very stiff, moist, lean CLAY (CL) with sand and trace shale fragments, medium dense, moist, clayey SAND (SC) with shale fragment, weathered sandy SHALE sampled as very dense, dry, poorly graded GRAVEL (GP). Auger refusal was encountered at approximately 15.2 feet bgs. Groundwater was not encountered.

- **Boring B-02:** Stiff, moist, sandy lean CLAY (CL) with trace shale fragments, weathered sandy SHALE sampled as very dense, dry, poorly graded GRAVEL (GP). Auger refusal occurred at approximately 15.4 feet bgs. Groundwater was not encountered.
