**HORIZONTAL DIRECTIONAL DRILL ANALYSIS
CAMPBELL CREEK/GEORGE CREEK CROSSING
PADEP SECTION 105 PERMIT NO. E31-234
PA-HU-0110.0000-SR-16
(SPLP HDD# S2-0155-16)**

This reevaluation of the horizontal directional drill (HDD) installation of a 16-inch diameter pipeline that traverses under George Creek, and wetland K-68 in Tell Township, Huntingdon County, has been completed in accordance with Condition No. 3 of the Stipulated Order issued under Environmental Hearing Board Docket No. 2017-009-L. Condition No. 3 stipulates, for HDDs initiated after the temporary injunction issued by the Pennsylvania Department of Environmental Protection (PADEP) Environmental Hearing Board on July 25, 2017, a reanalysis must be performed on HDDs for which an inadvertent return (IR) occurs during the installation of one pipe (20-inch or 16-inch diameter) where a second pipe will thereafter be installed in the same right-of-way (ROW).

The 20-inch HDD was initiated after July 25, 2017 and an IR occurred during its installation, thereby necessitating a reanalysis before the installation of the second pipe (16-inch) can commence. The installation of the 20-inch pipe is complete.

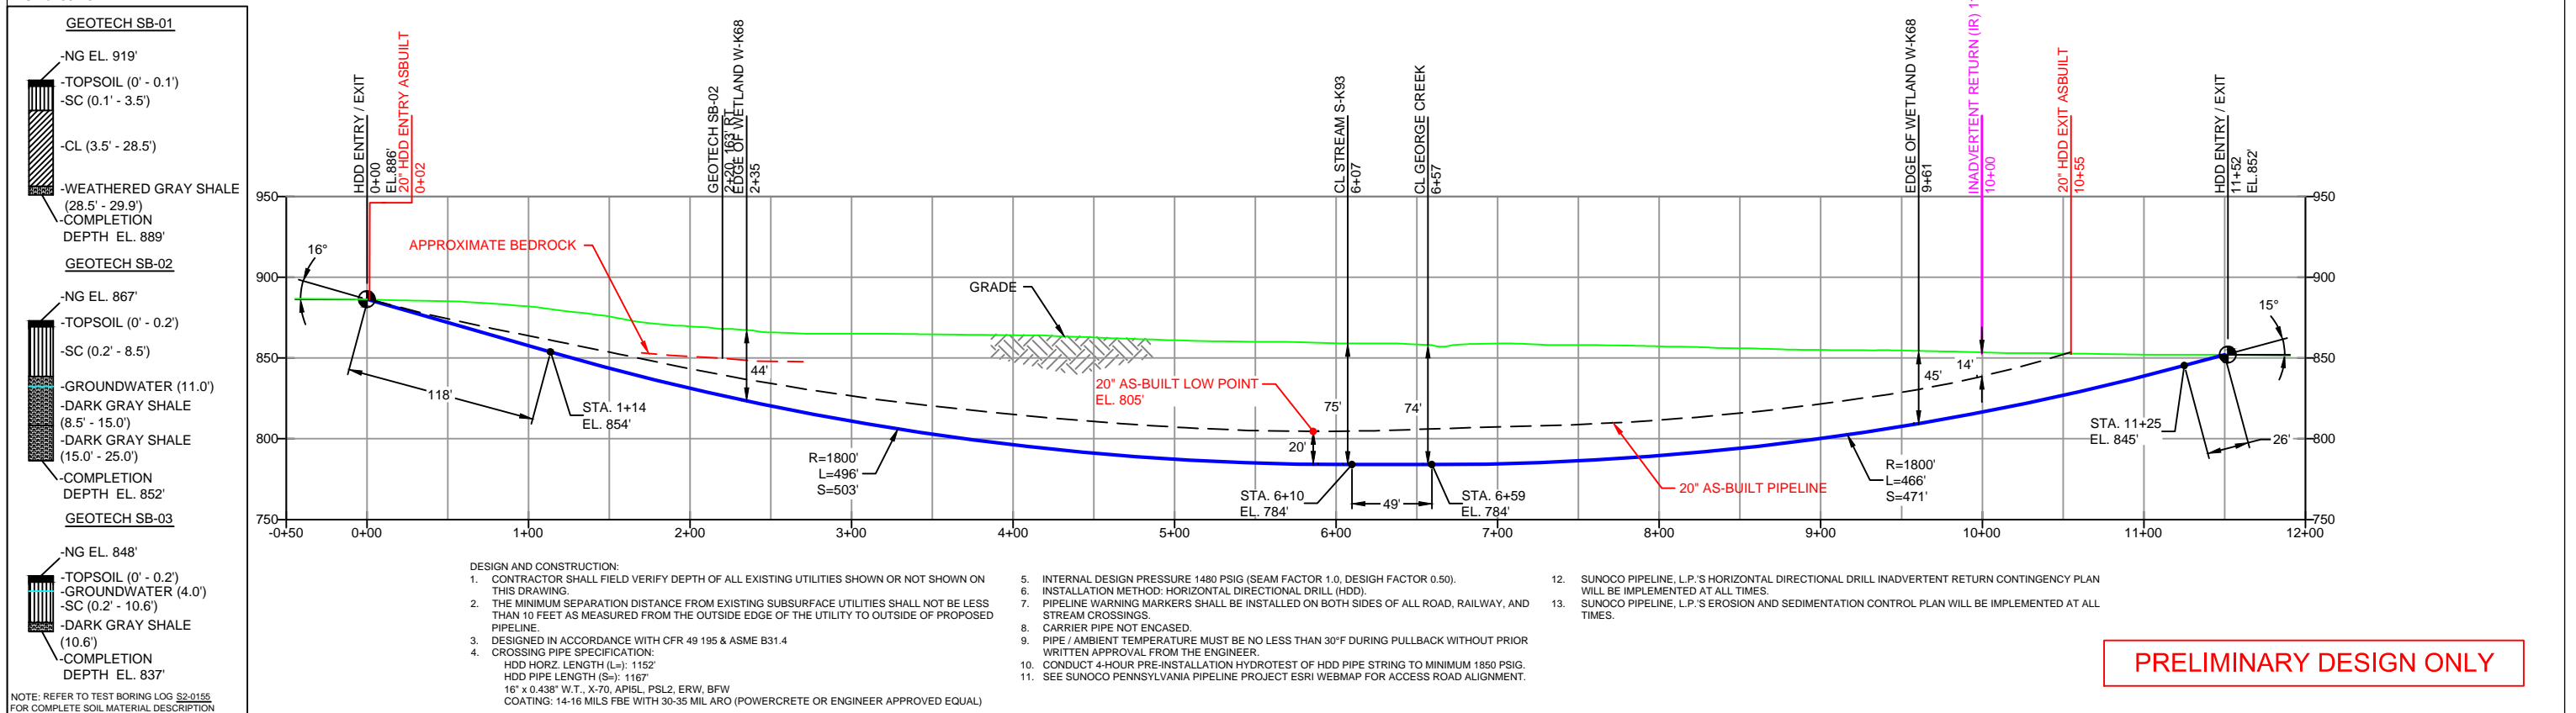
SCALE: 1"=100' DWG. NO. PA-HU-0110.0000-SR-16

PLAN VIEW
PROFILE VIEW

HUNTINGDON COUNTY PENNSYLVANIA, TELL TOWNSHIP
S2-0155-16

- Horizontal length: 850 foot (ft)
- Entry/Exit angle: 10 degrees
- Maximum Depth of cover: 38 ft
- Depth below wetland K-68: 3-15 ft
- Depth below George Creek: 38 ft
- Pipe design radius: 1,600 feet

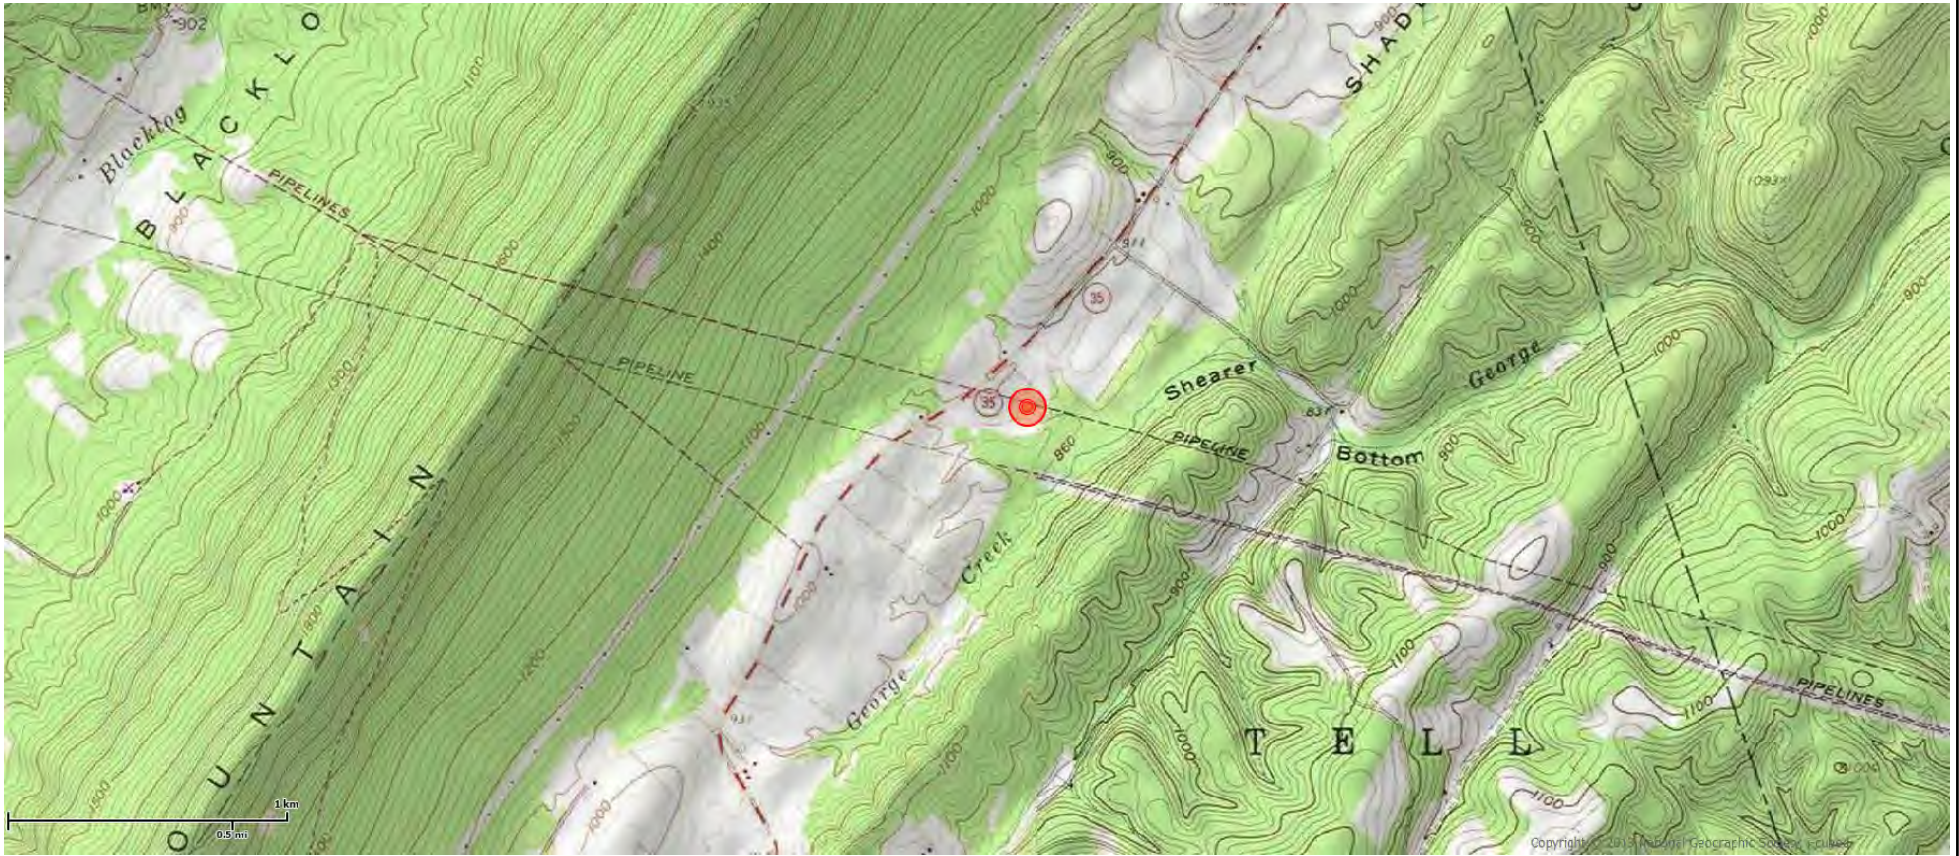
FIGURE 2: Boring Location Plan George Creek - PPP3 DPS PO # 20170922 PSI Project # 08031075

GEO BORE #1 (130 FT)

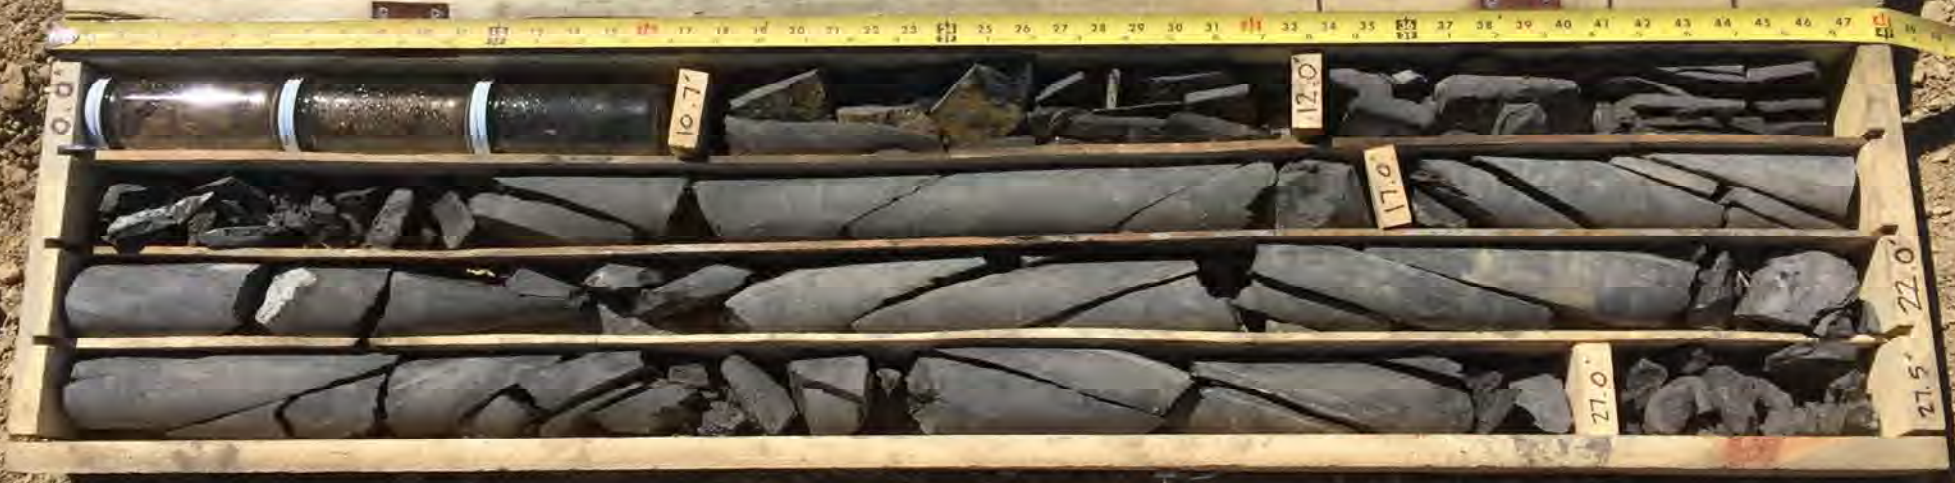
PSI Project # 08031075 DATE 9/26/17
BORING B-1 BOX 2 OF 9 DEPTH 27.5 FT TO 42.8 FT
SPREAD PPP # 3
MDD Common Name PA-HU-0110,000 SR

RUN	DEPTH	REC	RQD
R-5	27.0' - 32.0'	4.2'	0.4'
R-6	32.0' - 37.0'	4.9'	1.2'
R-7	37.0' - 42.0'	5.0'	2.4'
R-8	42.0' - 47.0'	5.0'	3.7'

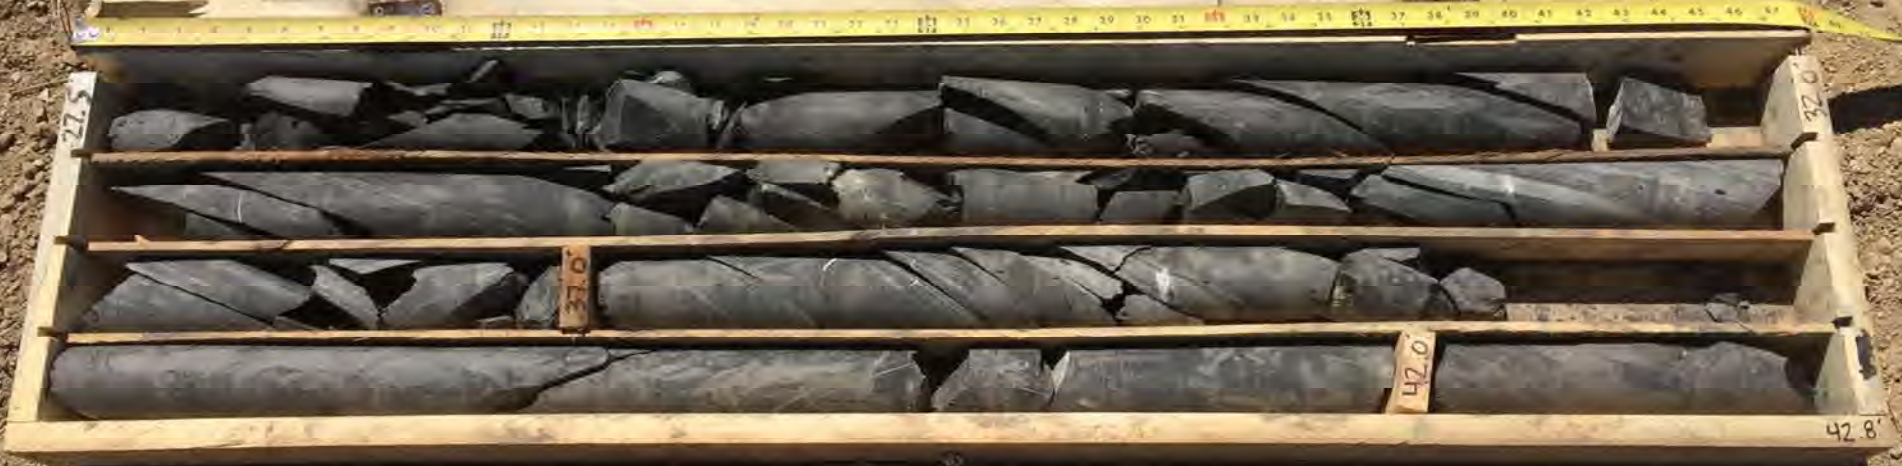
BORING B-1 BOX 3 OF 9 DEPTH 42.8 FT. TO 55.4 FT.

RUN	DEPTH	REC	RQD
R-8	42.0'-47.0'	5.0'	3.7'
R-9	47.0'-52.0'	4.9'	2.3'
R-10	52.0'-57.0'	5.0'	4.1'

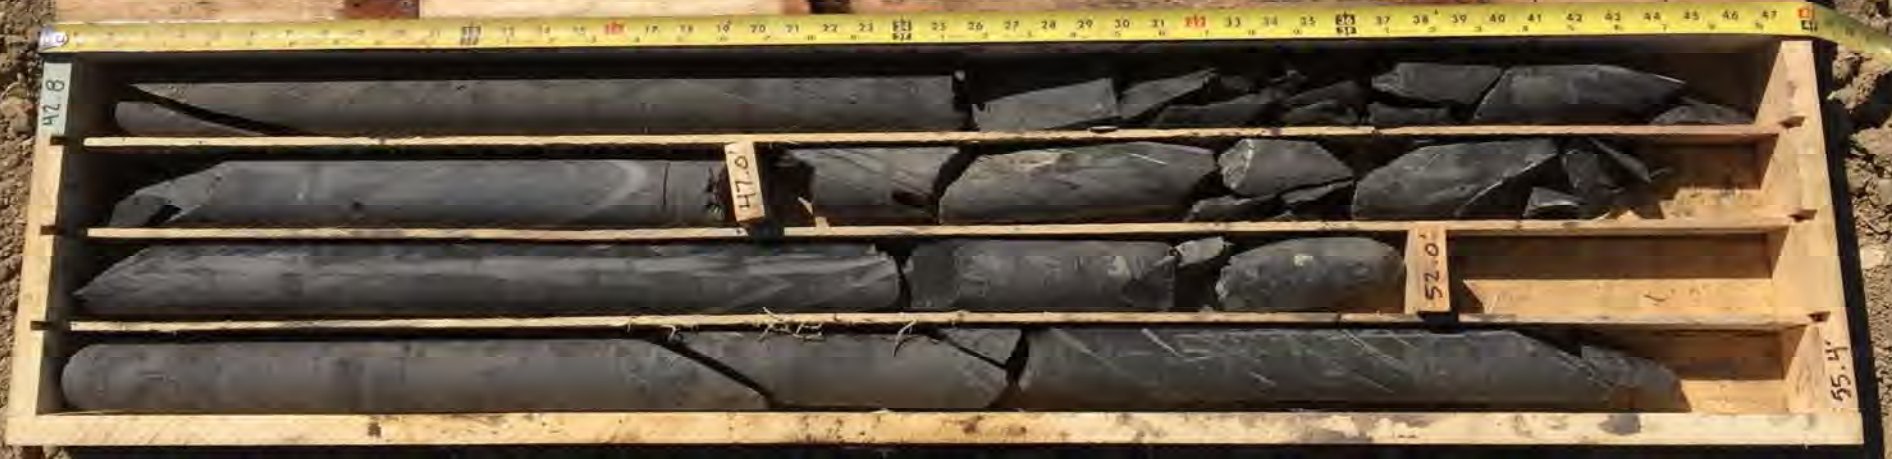
BORING B-1 Box 4 OF 9 DEPTH 55.4 FT TO 69.1 FT

R/W	DEPTH	REC	RQD
R-10	52.0' - 57.0'	5.0'	4.1'
R-11	57.0' - 62.0'	4.9'	1.0'
R-12	62.0' - 67.0'	5.0'	2.1'
R-13	67.0' - 72.0'	5.0'	4.7'

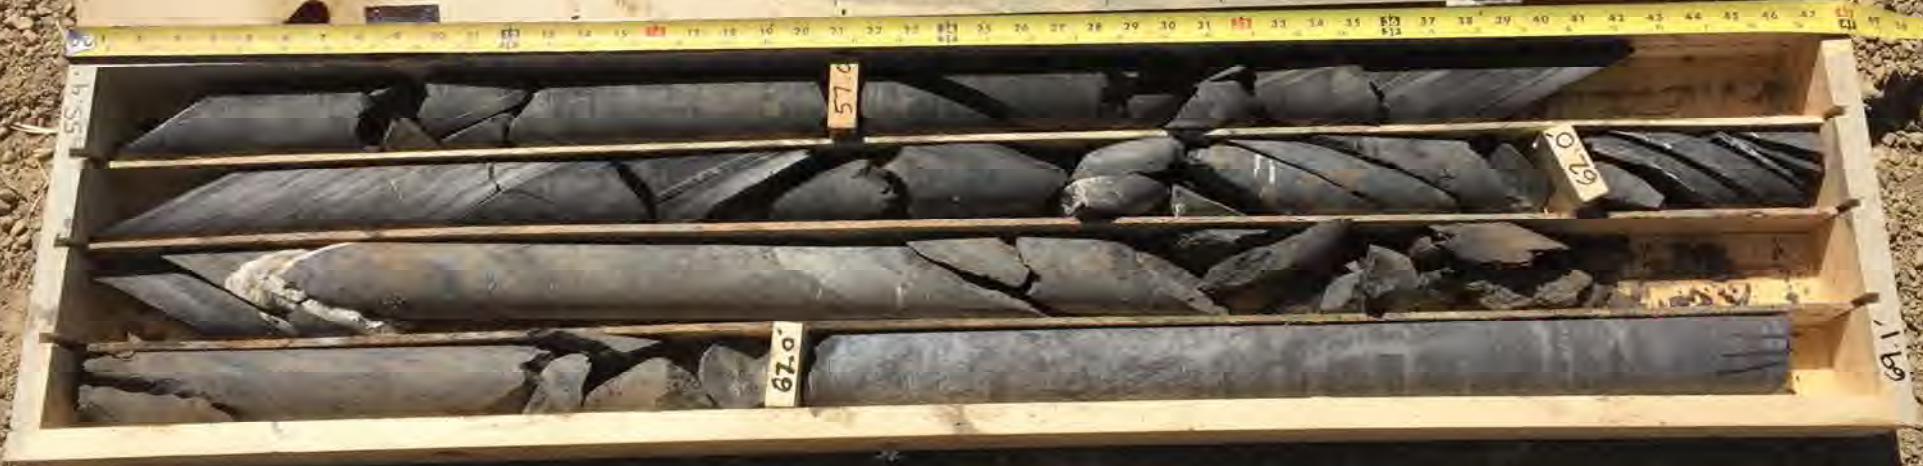
PSI Project # 08031075 DATE 9/27/17
 Boring B-1 Box 5 OF 9 DEPTH 69.1 FT. TO 83.3 FT.
 SPREAD PPP # 3
 HDD Common Name PA-HU-0110.0000 SR

RUN	DEPTH	REC	RQD
R-13	67.0' - 72.0'	5.0'	4.7'
R-14	72.0' - 77.0'	5.0'	4.1'
R-15	77.0' - 82.0'	5.0'	4.4'
R-16	82.0' - 87.0'	4.6'	1.9'

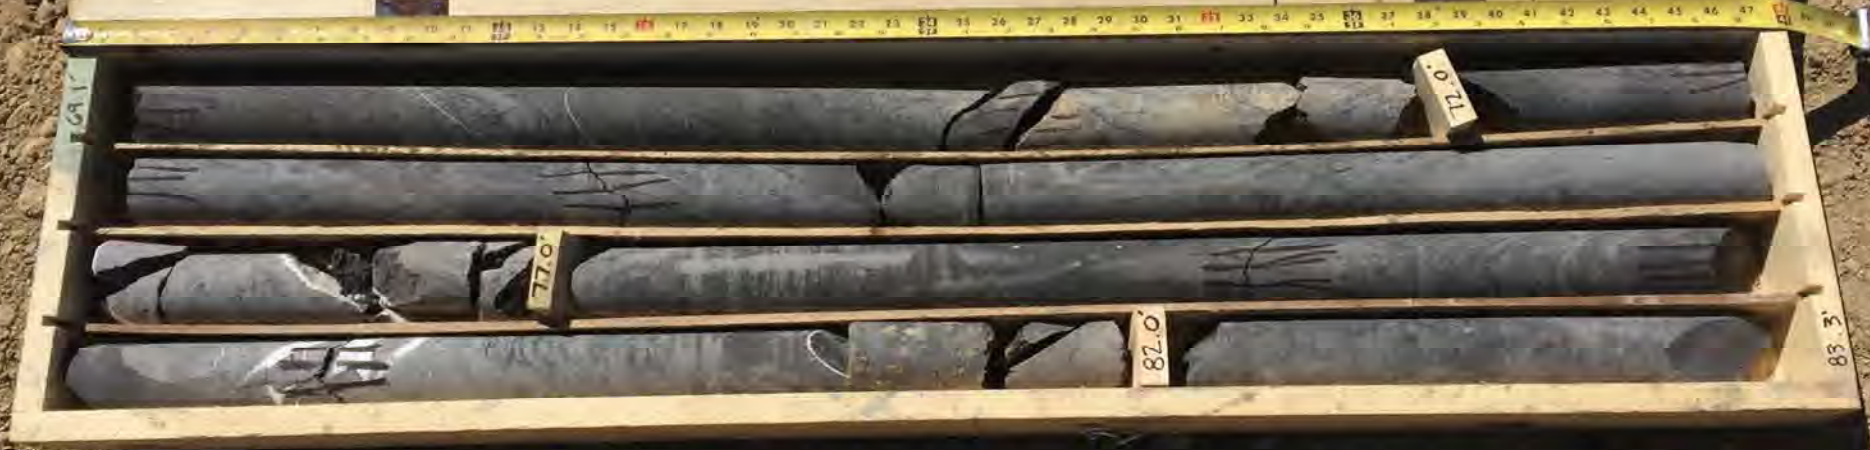
PSI Project # 08031075 DATE 9/27/17
 Boring B-1 Box 6 of 9 DEPTH 83.3 FT. TO 98.6 FT.
 SPREAD PPP # 3
 HDD Common Name PA-HH-0110.0000 SR

RUN	DEPTH	REC	RQD
R-16	82.0' - 87.0'	4.6'	1.9'
R-17	87.0' - 92.0'	5.0'	4.6'
R-18	92.0' - 97.0'	4.8'	3.5'
R-19	97.0' - 102.0'	5.0'	3.7'

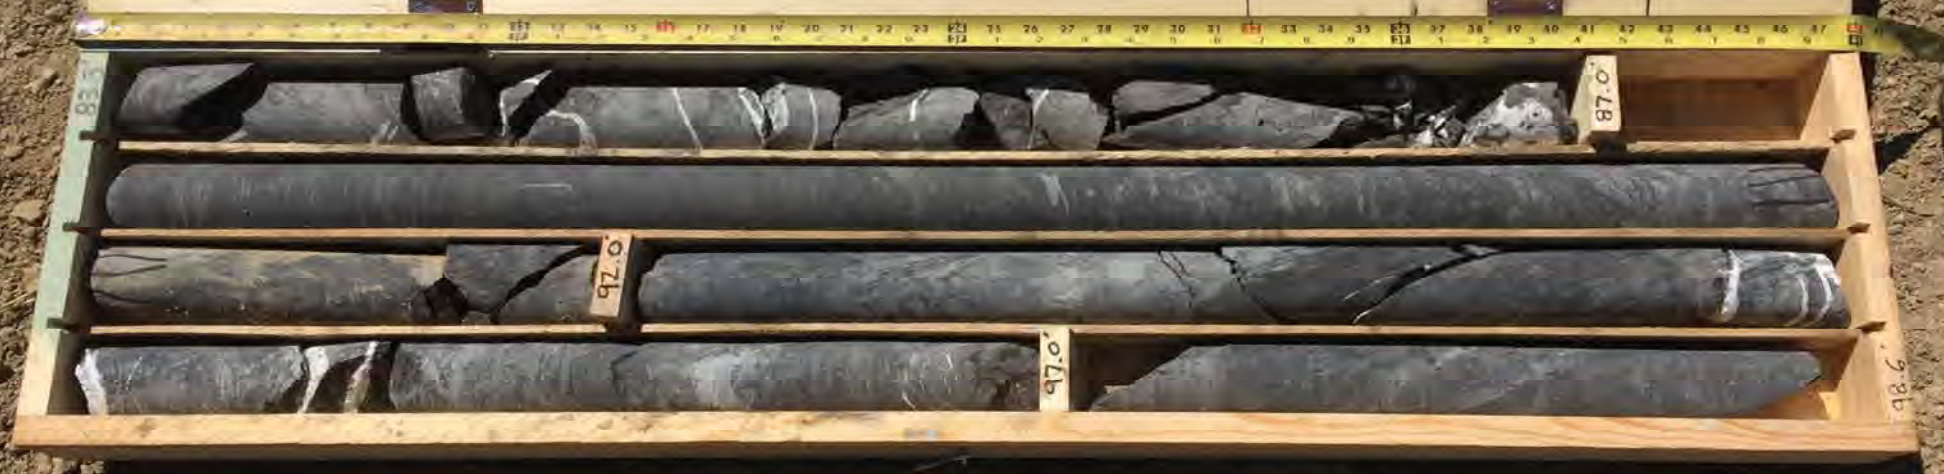
BORING B-1 Box 7 of 9 DEPTH 98.6 FT. TO 113.2 FT

RUN	DEPTH	REC	RQD
R-19	97.0' - 102.0'	5.0'	3.7'
R-20	102.0' - 107.0'	4.8'	3.7'
R-21	107.0' - 112.0'	5.0'	4.7'
R-22	112.0' - 117.0'	4.7'	4.0'

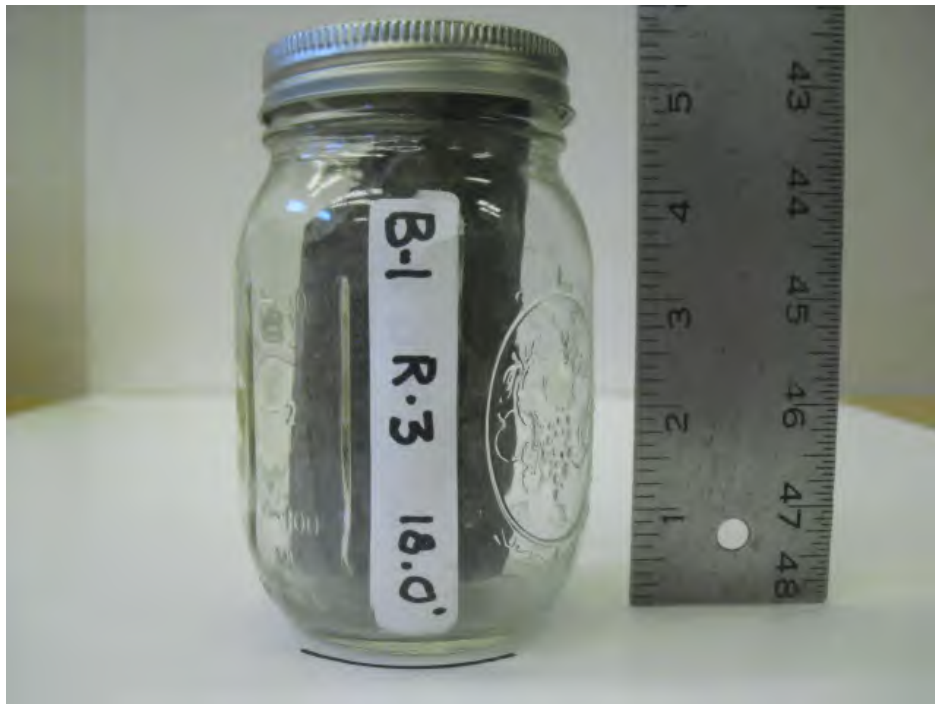
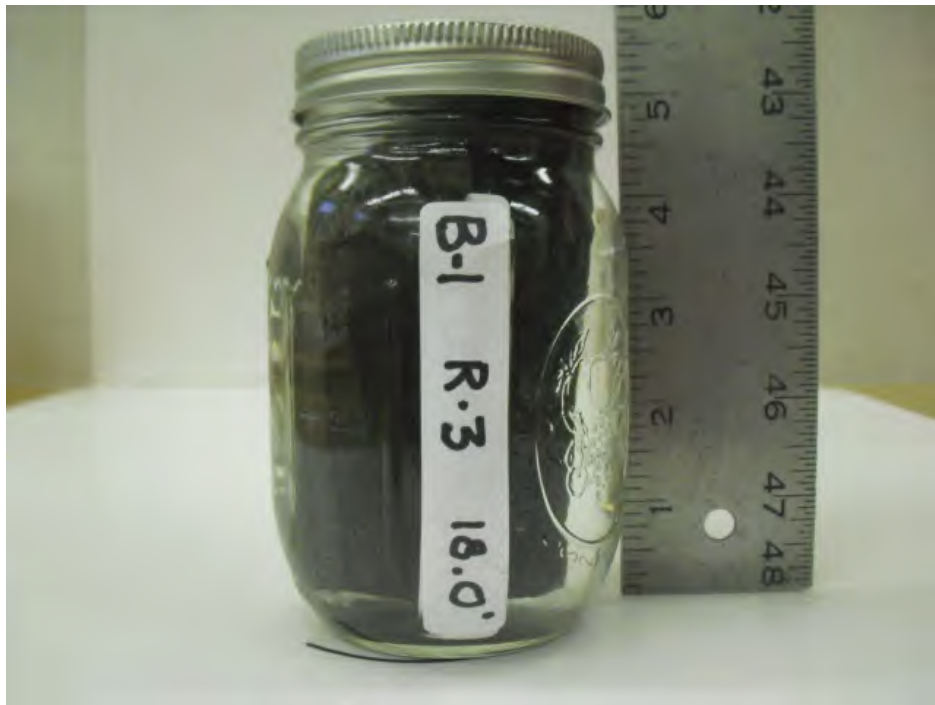
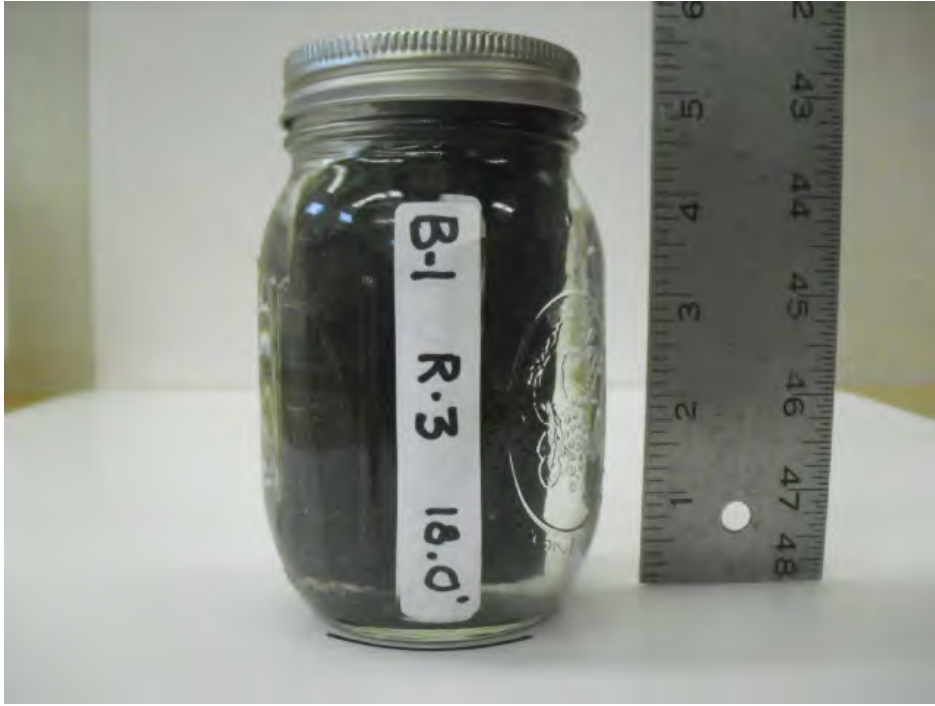
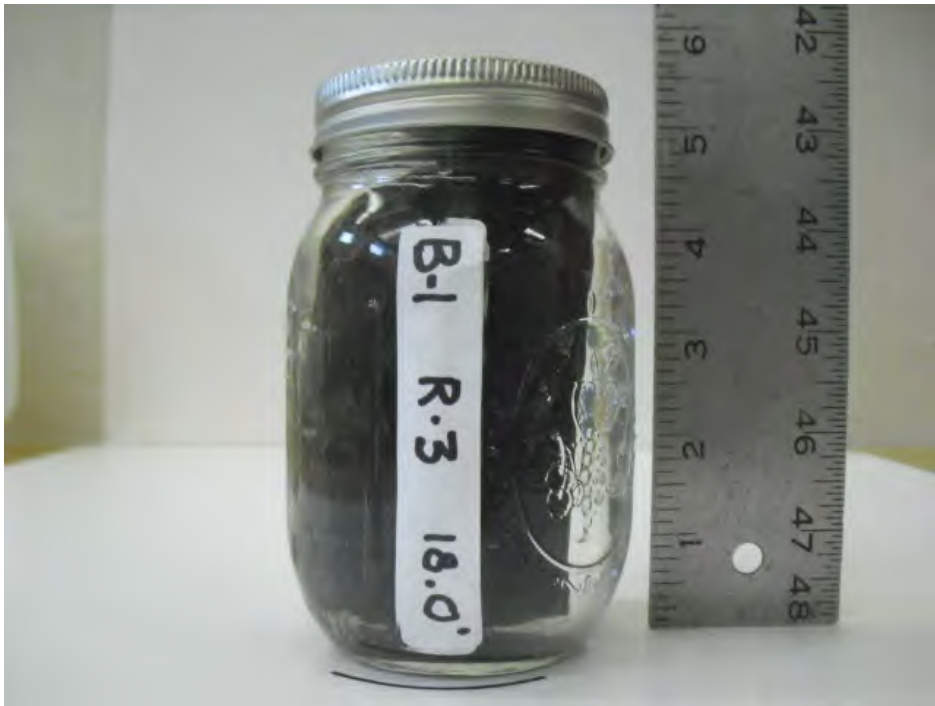
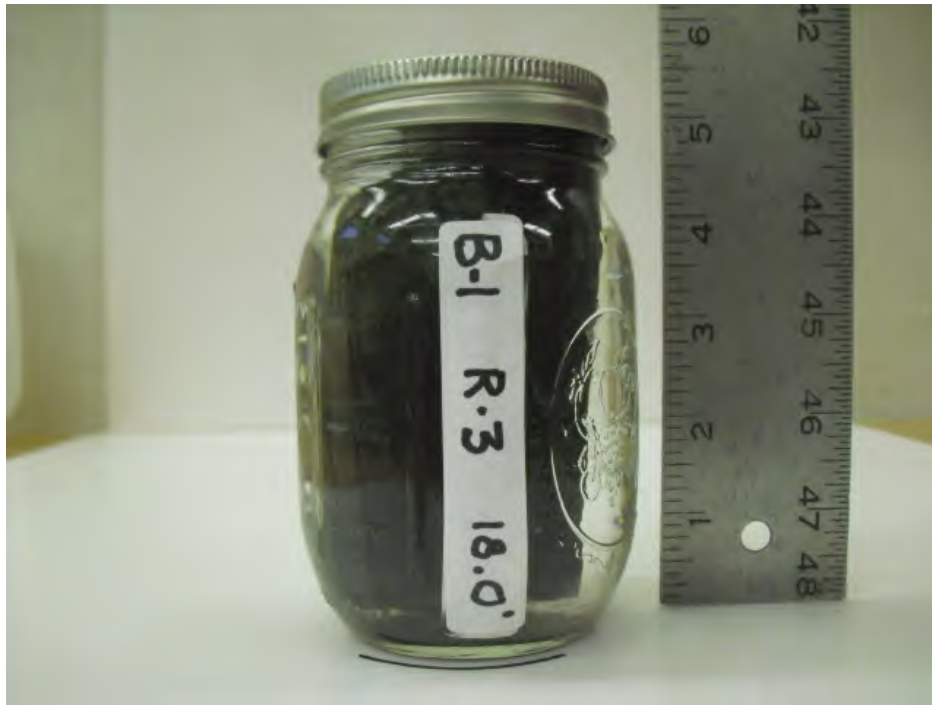
08031075 B-1 R-3 18.0'

2 Minute: Slake Index 6

4 Hour: Slake Index 6

8 Hour: Slake Index 6

24 Hour: Slake Index 6

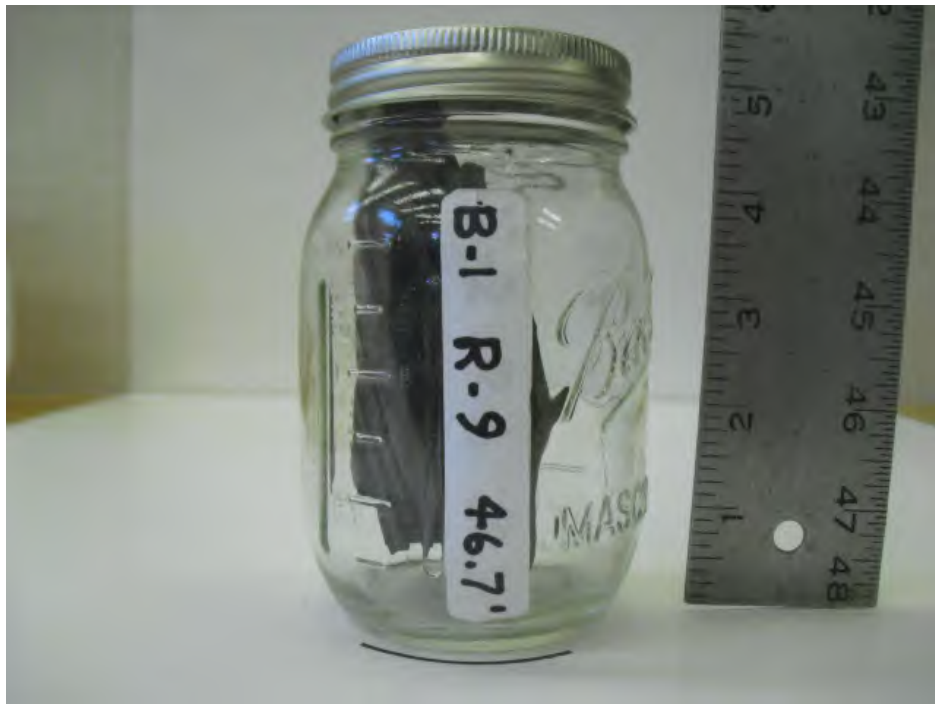
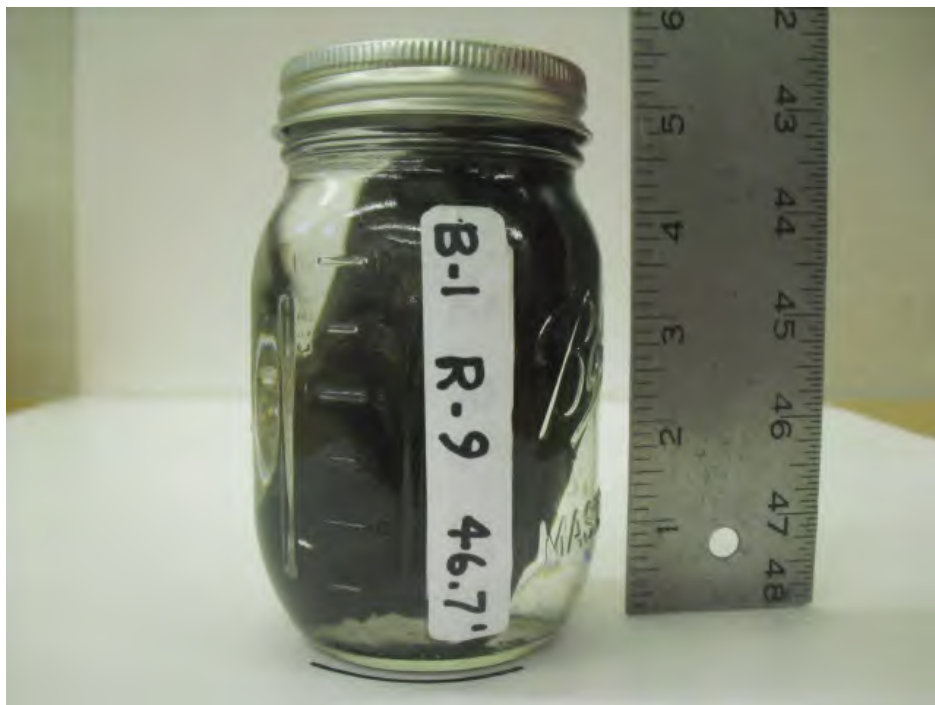
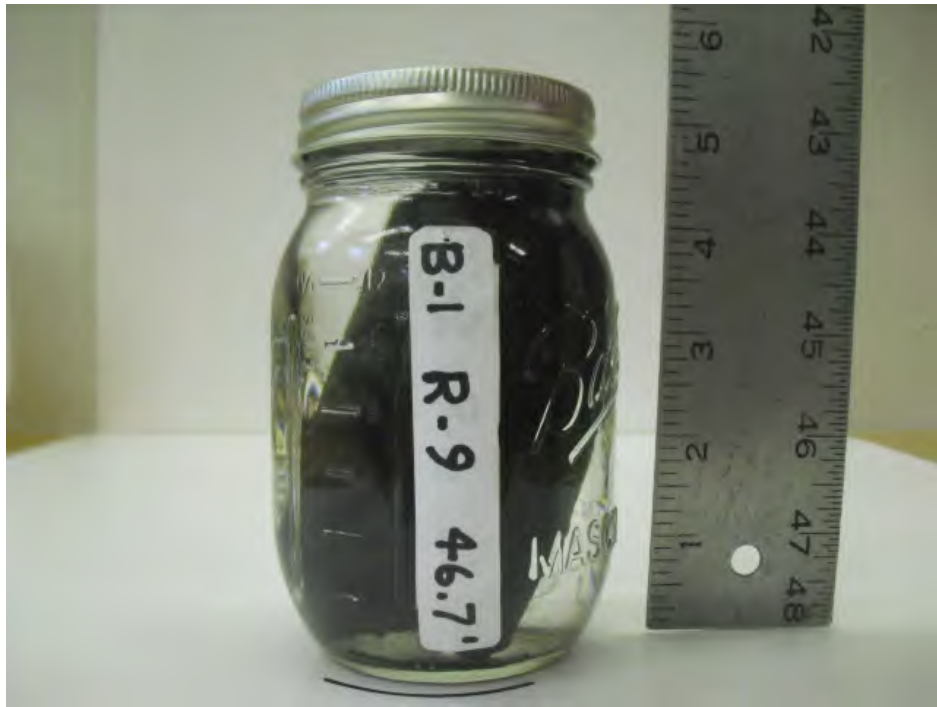
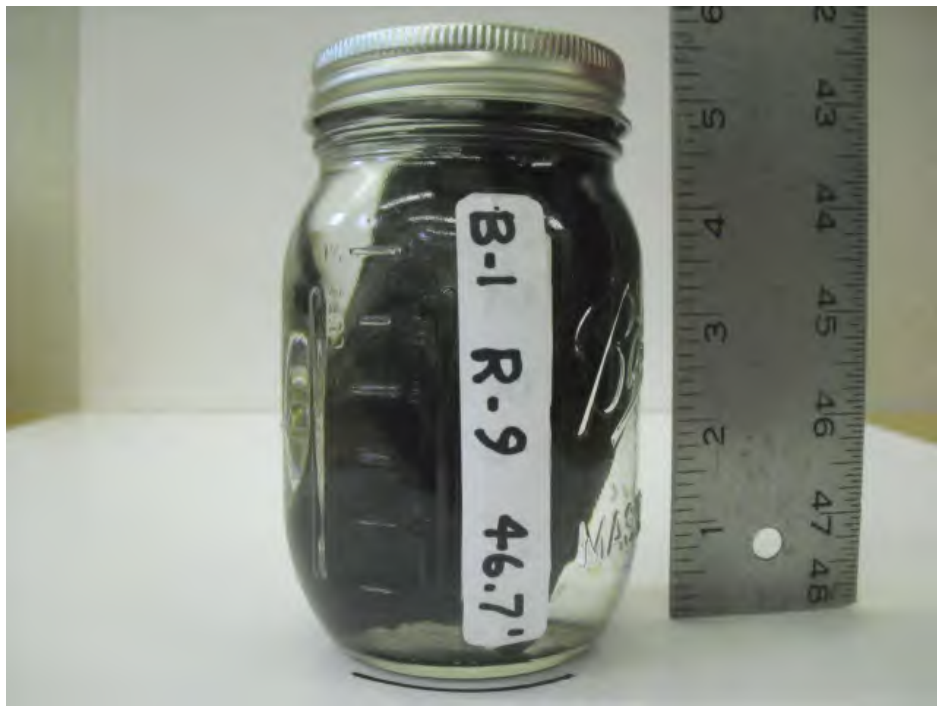
08031075 B-1 R-9 46.7'

2 Minute: Slake Index 6

4 Hour: Slake Index 6

8 Hour: Slake Index 6

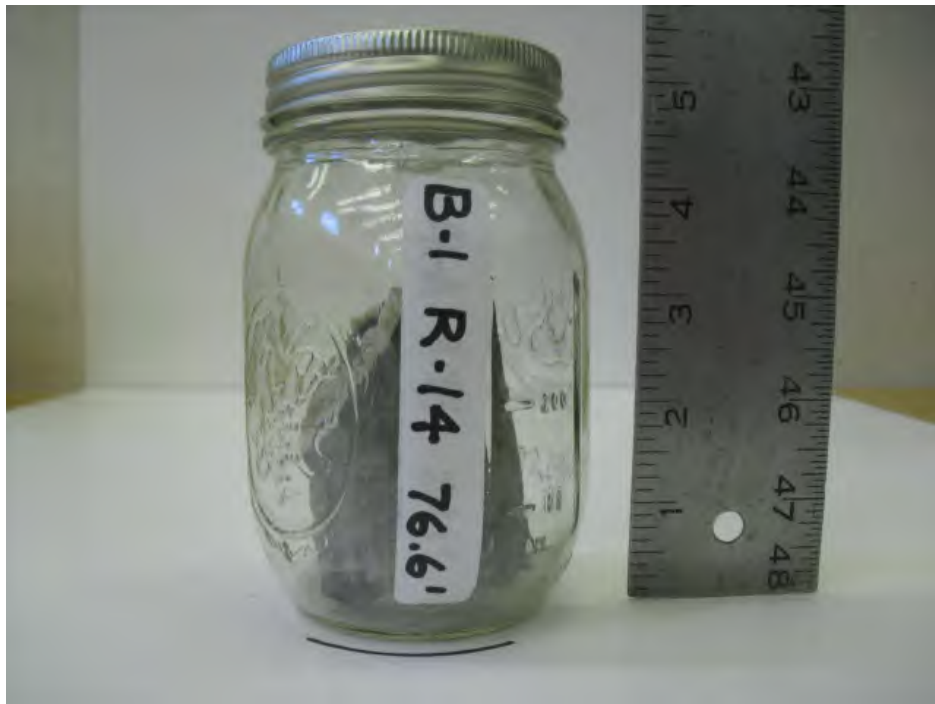
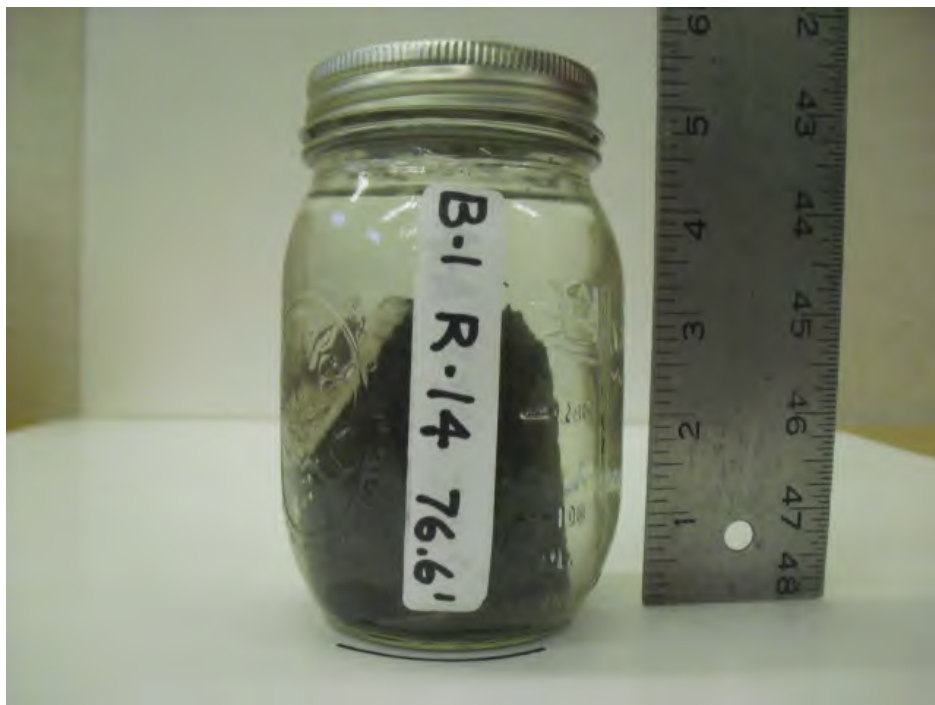
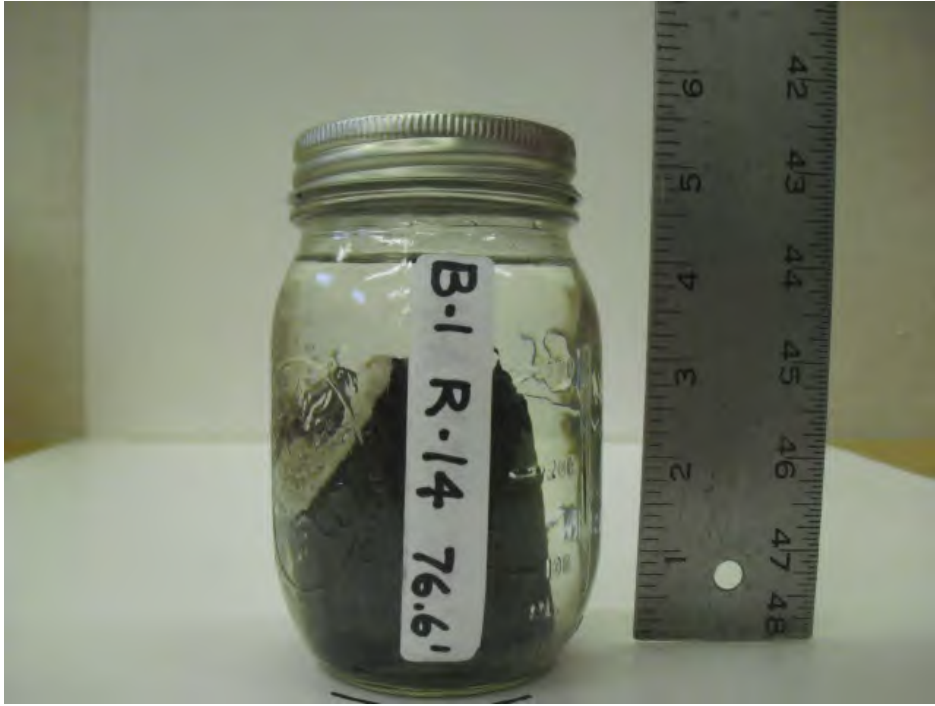
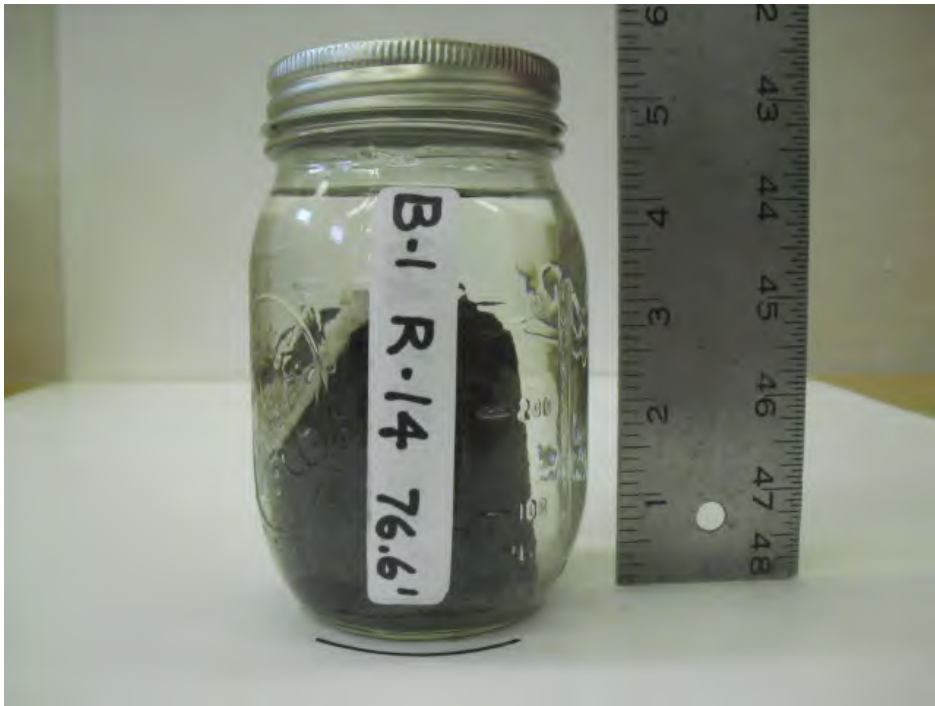
08031075 B-1 R-14 76.6'

2 Minute: Slake Index 6

4 Hour: Slake Index 6

8 Hour: Slake Index 6

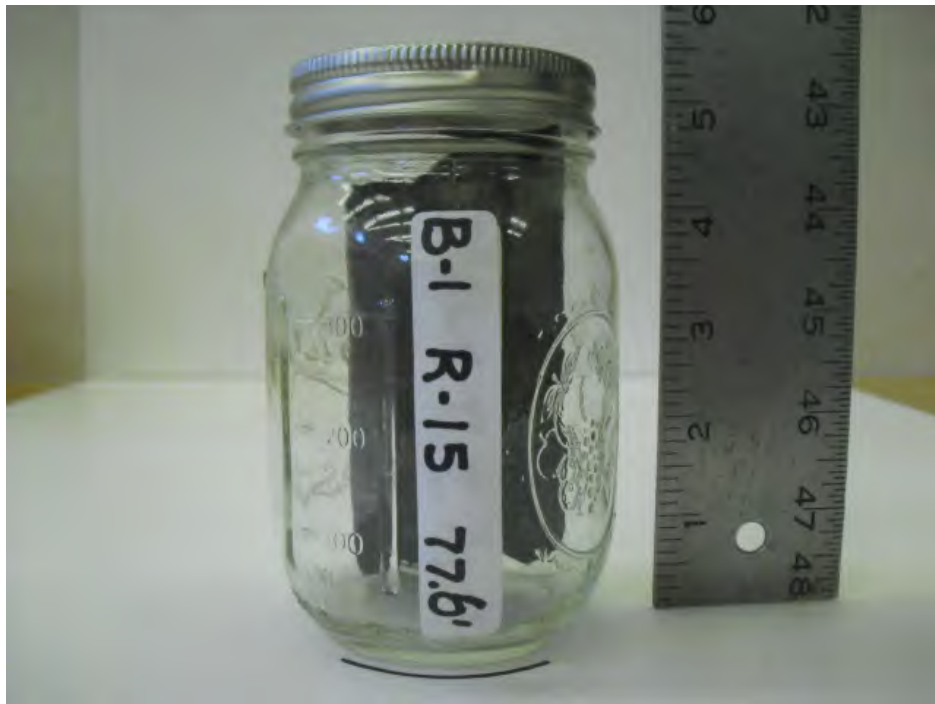
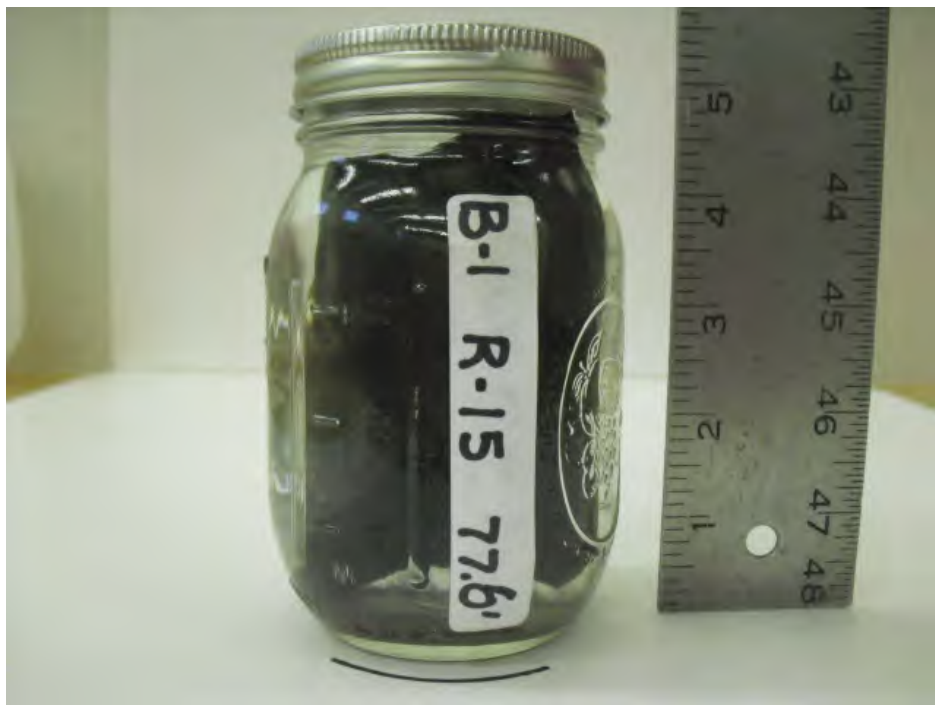
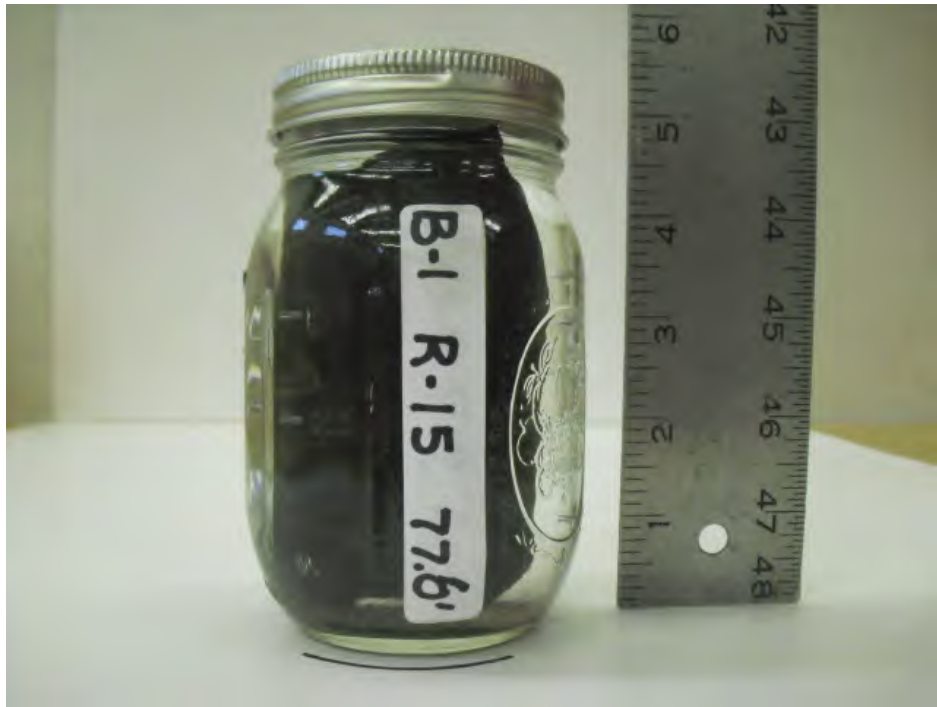
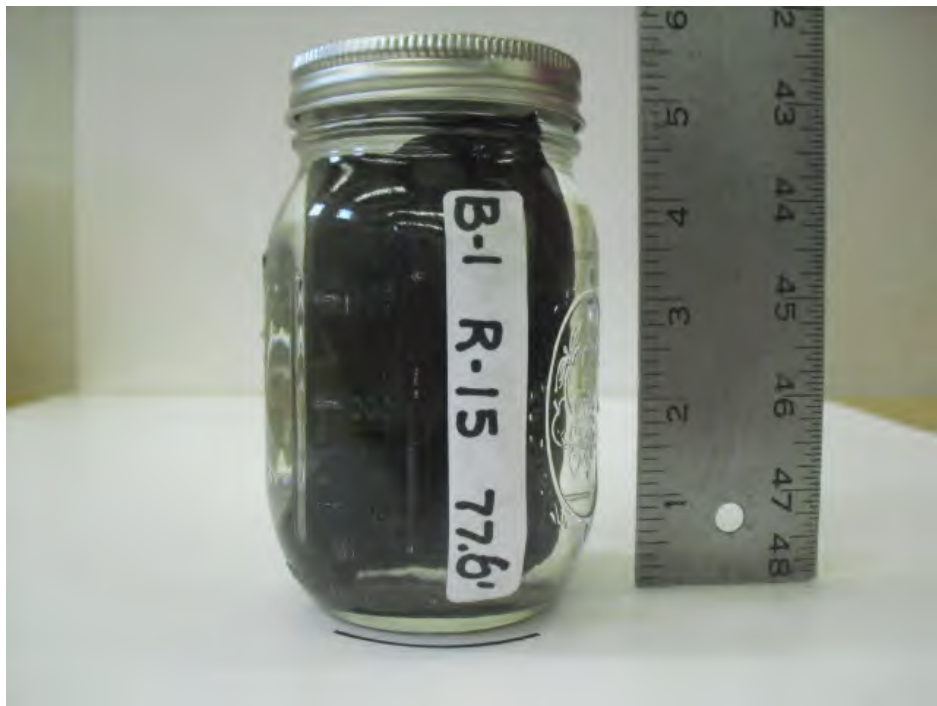
08031075 B-1 R-15 77.6'

2 Minute: Slake Index 6

4 Hour: Slake Index 6

8 Hour: Slake Index 6
