**HORIZONTAL DIRECTIONAL DRILL ANALYSIS
CAMPBELL CREEK/GEORGE CREEK CROSSING
PADEP SECTION 105 PERMIT NO. E31-234
PA-HU-0110.0000-SR-16
(SPLP HDD# S2-0155-16)**

This reevaluation of the horizontal directional drill (HDD) installation of a 16-inch diameter pipeline that traverses under George Creek, and wetland K-68 in Tell Township, Huntingdon County, has been completed in accordance with Condition No. 3 of the Stipulated Order issued under Environmental Hearing Board Docket No. 2017-009-L. Condition No. 3 stipulates, for HDDs initiated after the temporary injunction issued by the Pennsylvania Department of Environmental Protection (PADEP) Environmental Hearing Board on July 25, 2017, a reanalysis must be performed on HDDs for which an inadvertent return (IR) occurs during the installation of one pipe (20-inch or 16-inch diameter) where a second pipe will thereafter be installed in the same right-of-way (ROW).

The 20-inch HDD was initiated after July 25, 2017 and an IR occurred during its installation, thereby necessitating a reanalysis before the installation of the second pipe (16-inch) can commence. The installation of the 20-inch pipe is complete.

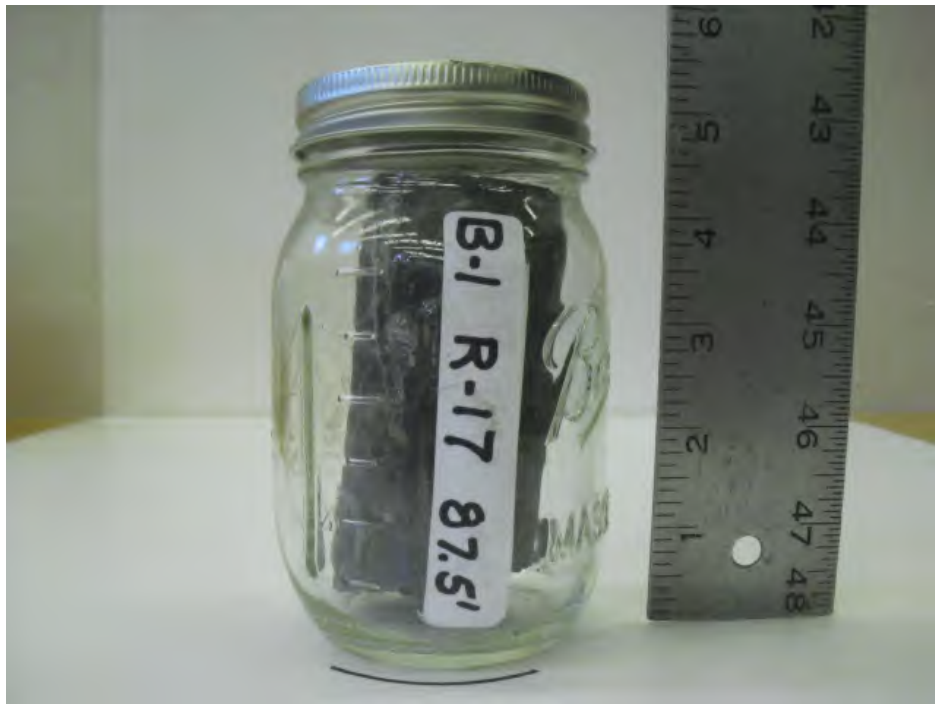
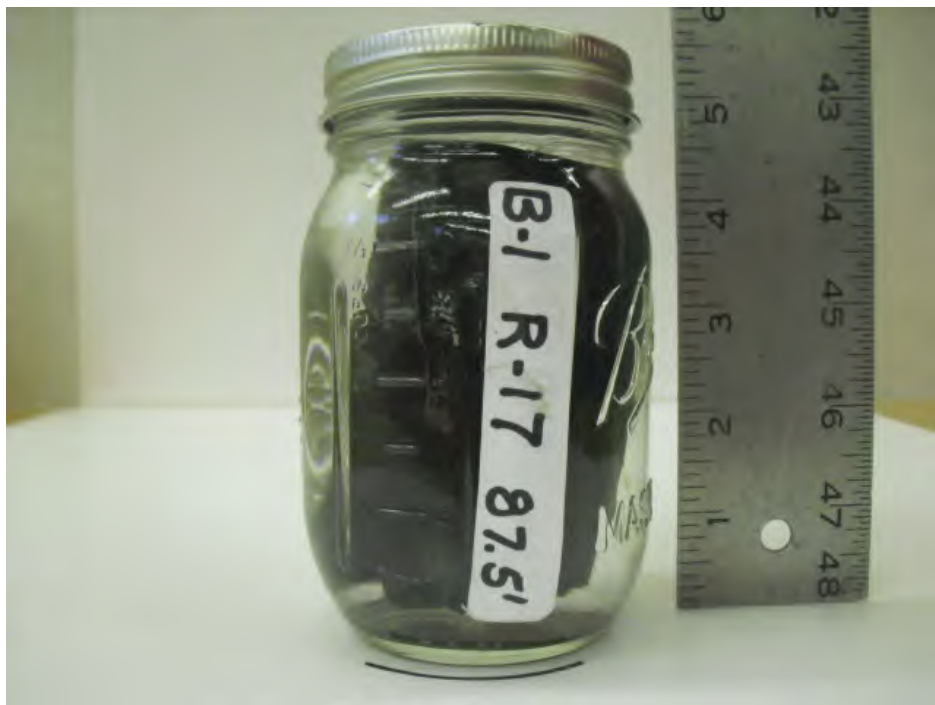
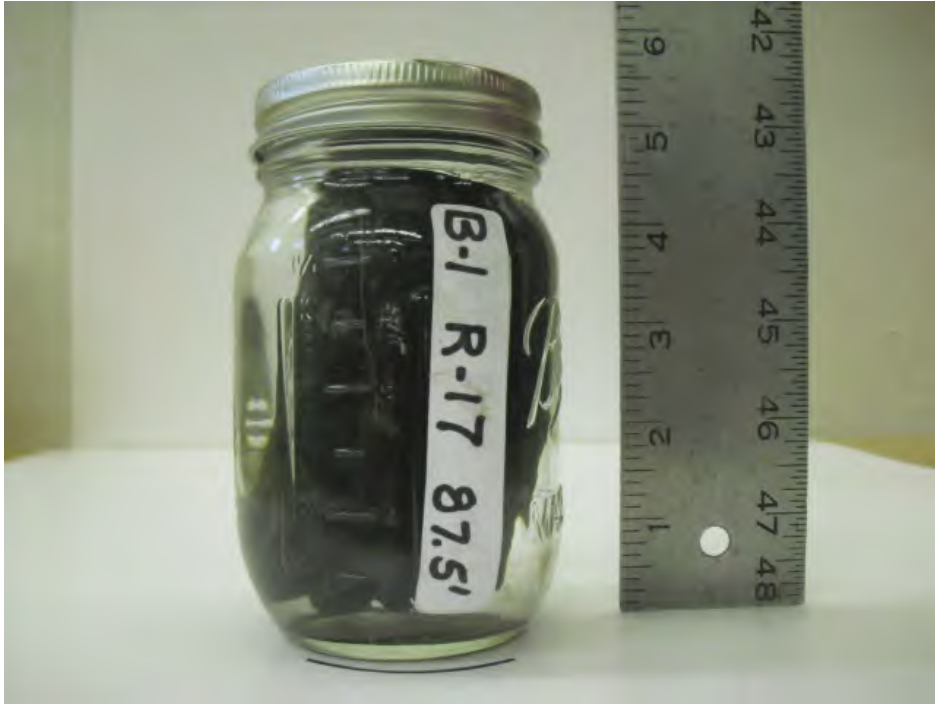
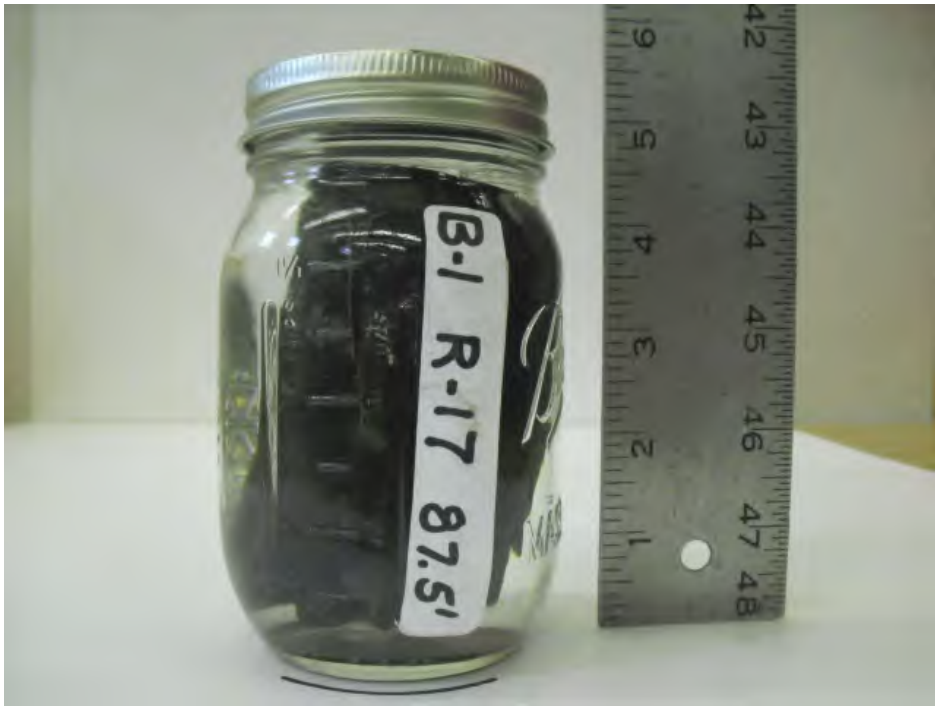
08031075 B-1 R-17 87.5'

2 Minute: Slake Index 6

4 Hour: Slake Index 6

8 Hour: Slake Index 6

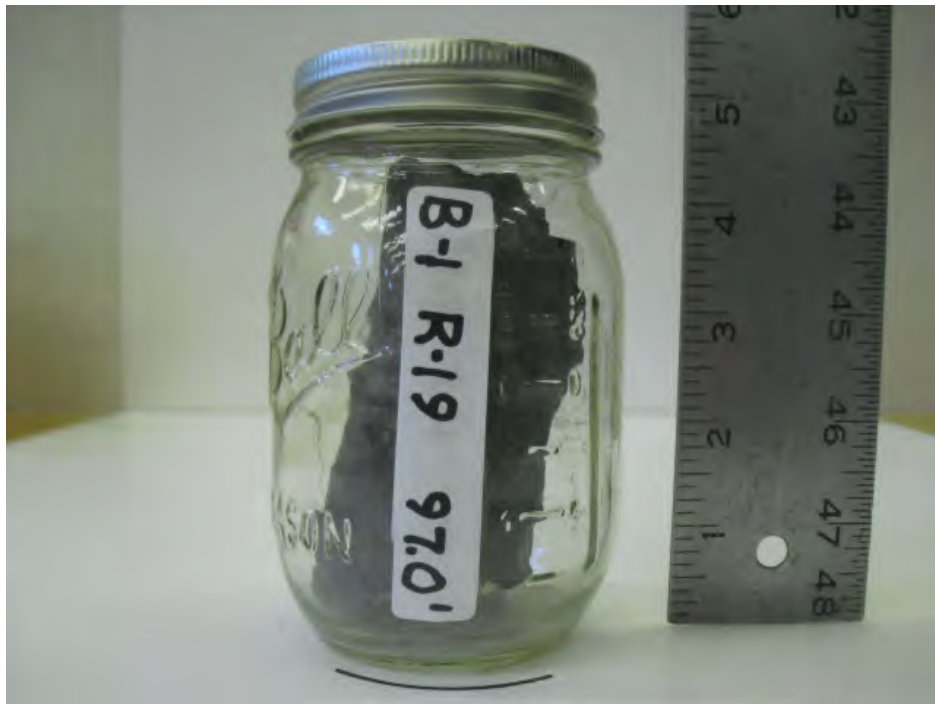
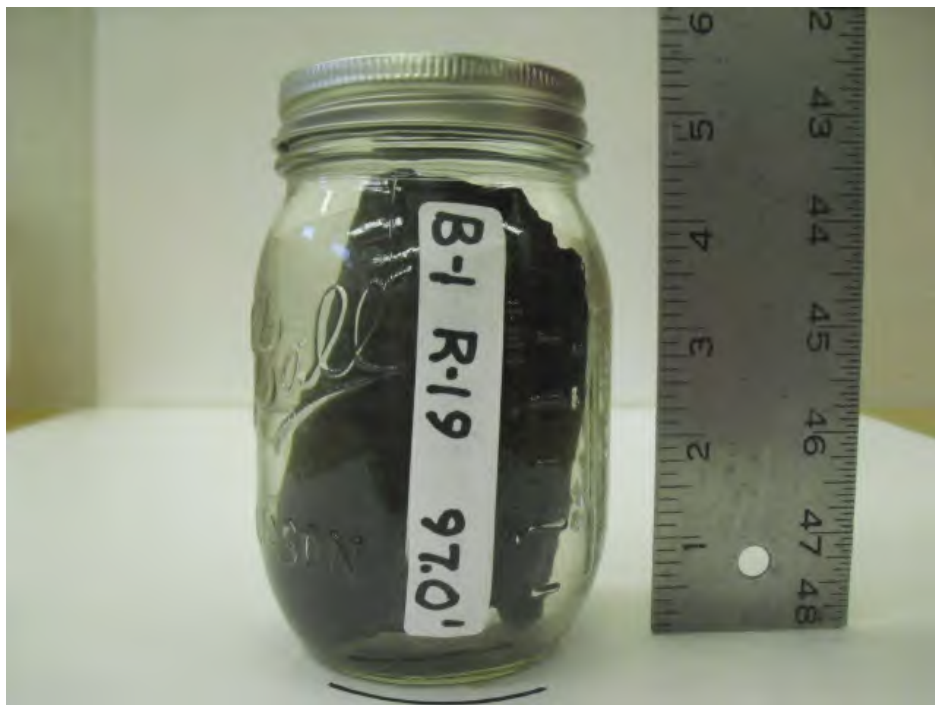
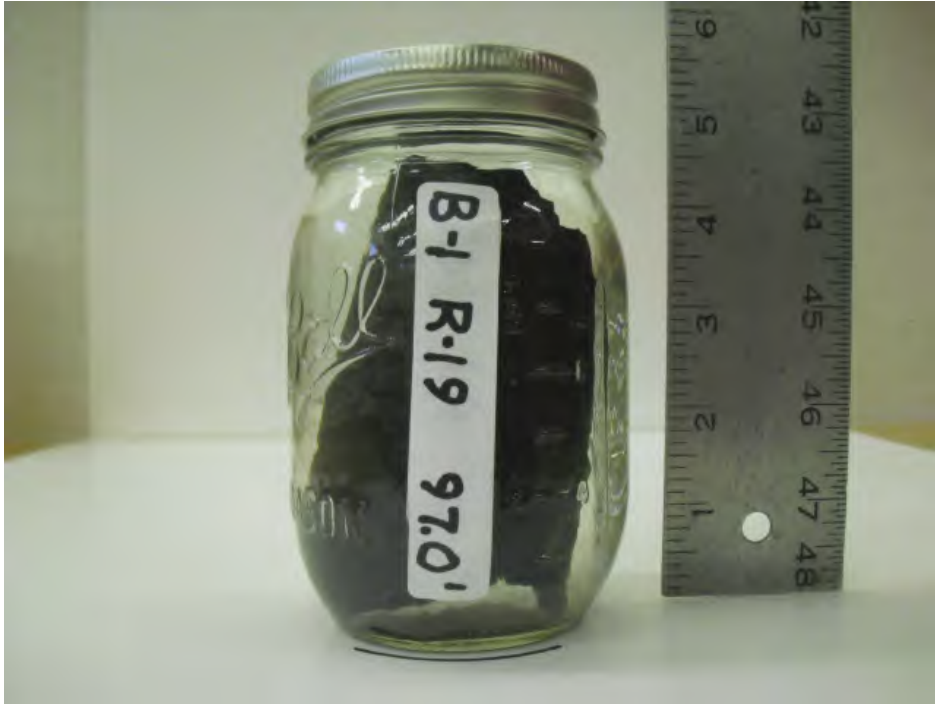
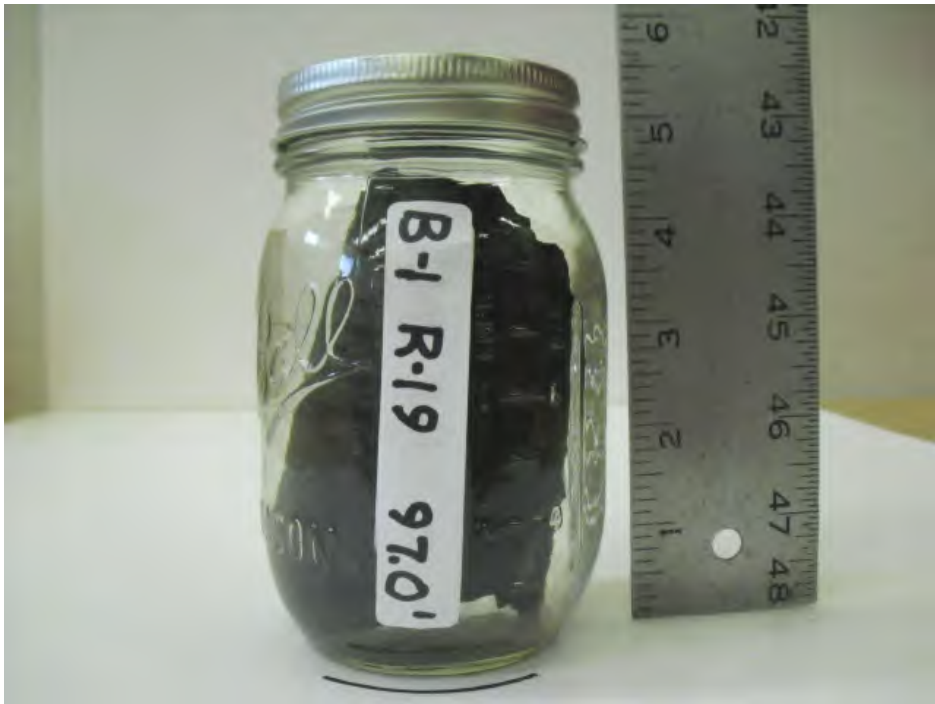
08031075 B-1 R-19 97.0'

2 Minute: Slake Index 6

4 Hour: Slake Index 6

8 Hour: Slake Index 6

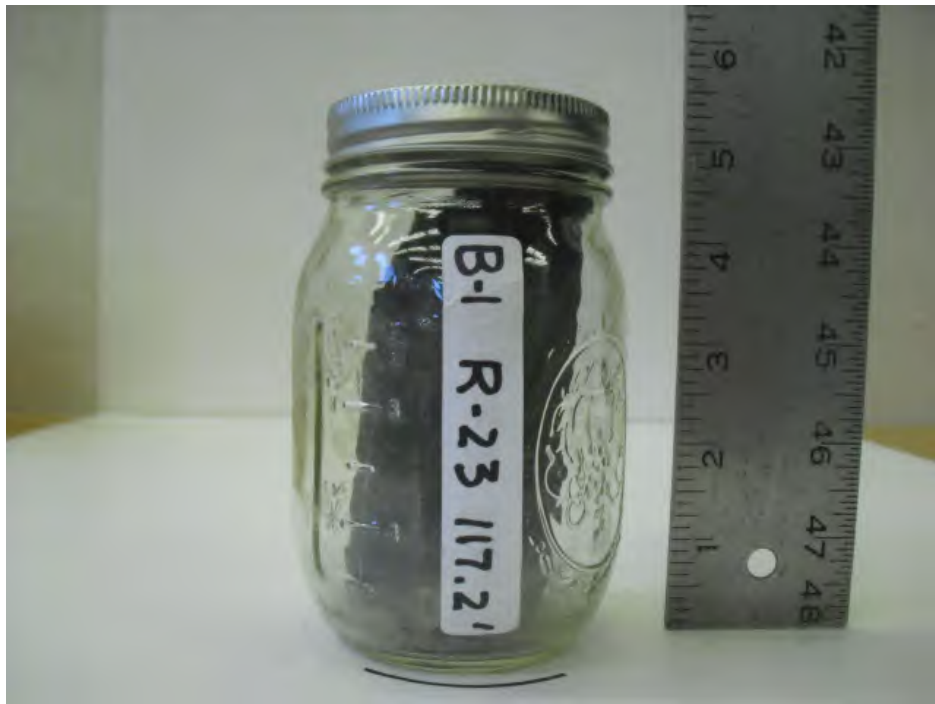
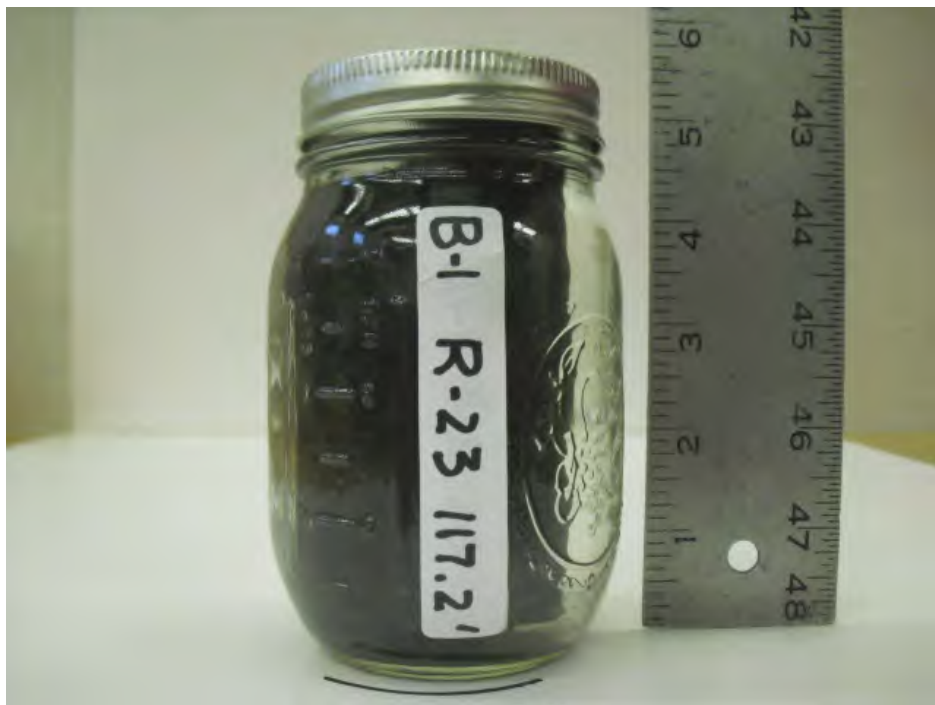
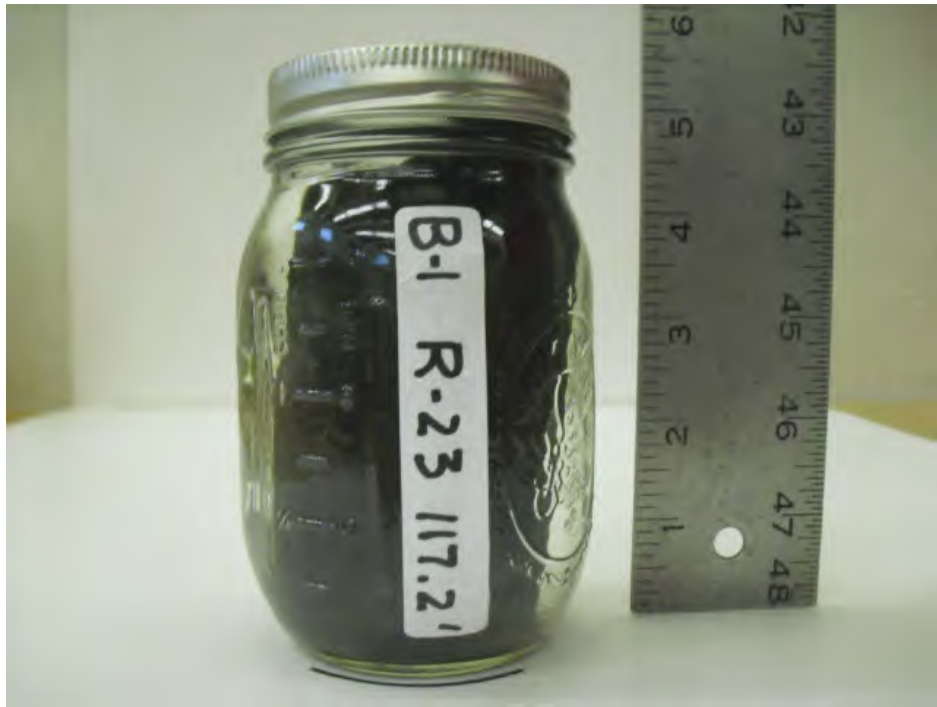
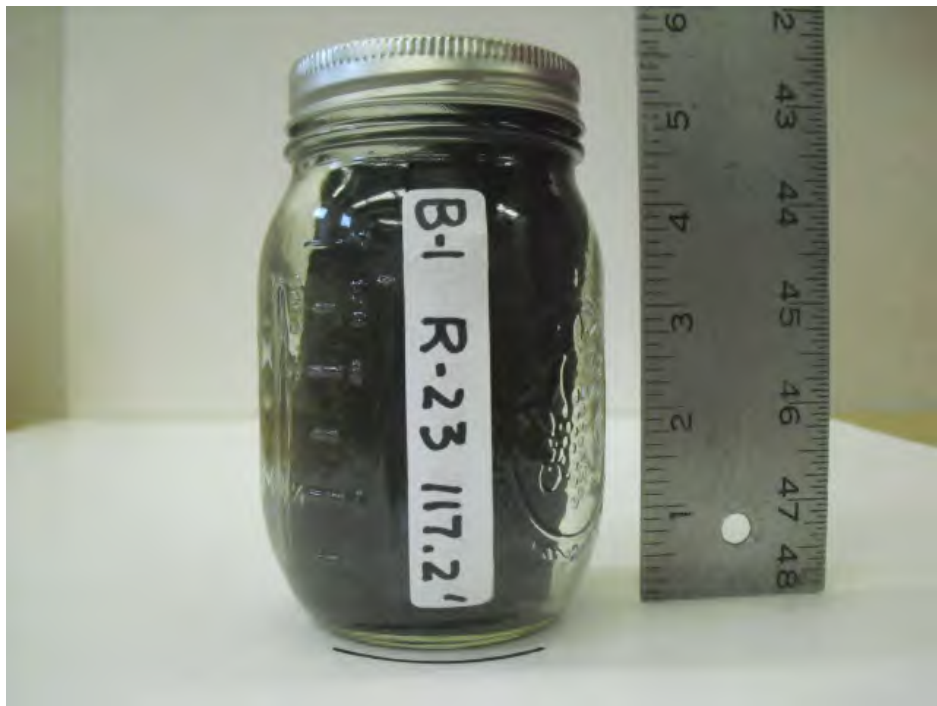
08031075 B-1 R-23 117.2'

2 Minute: Slake Index 6

4 Hour: Slake Index 6

8 Hour: Slake Index 6

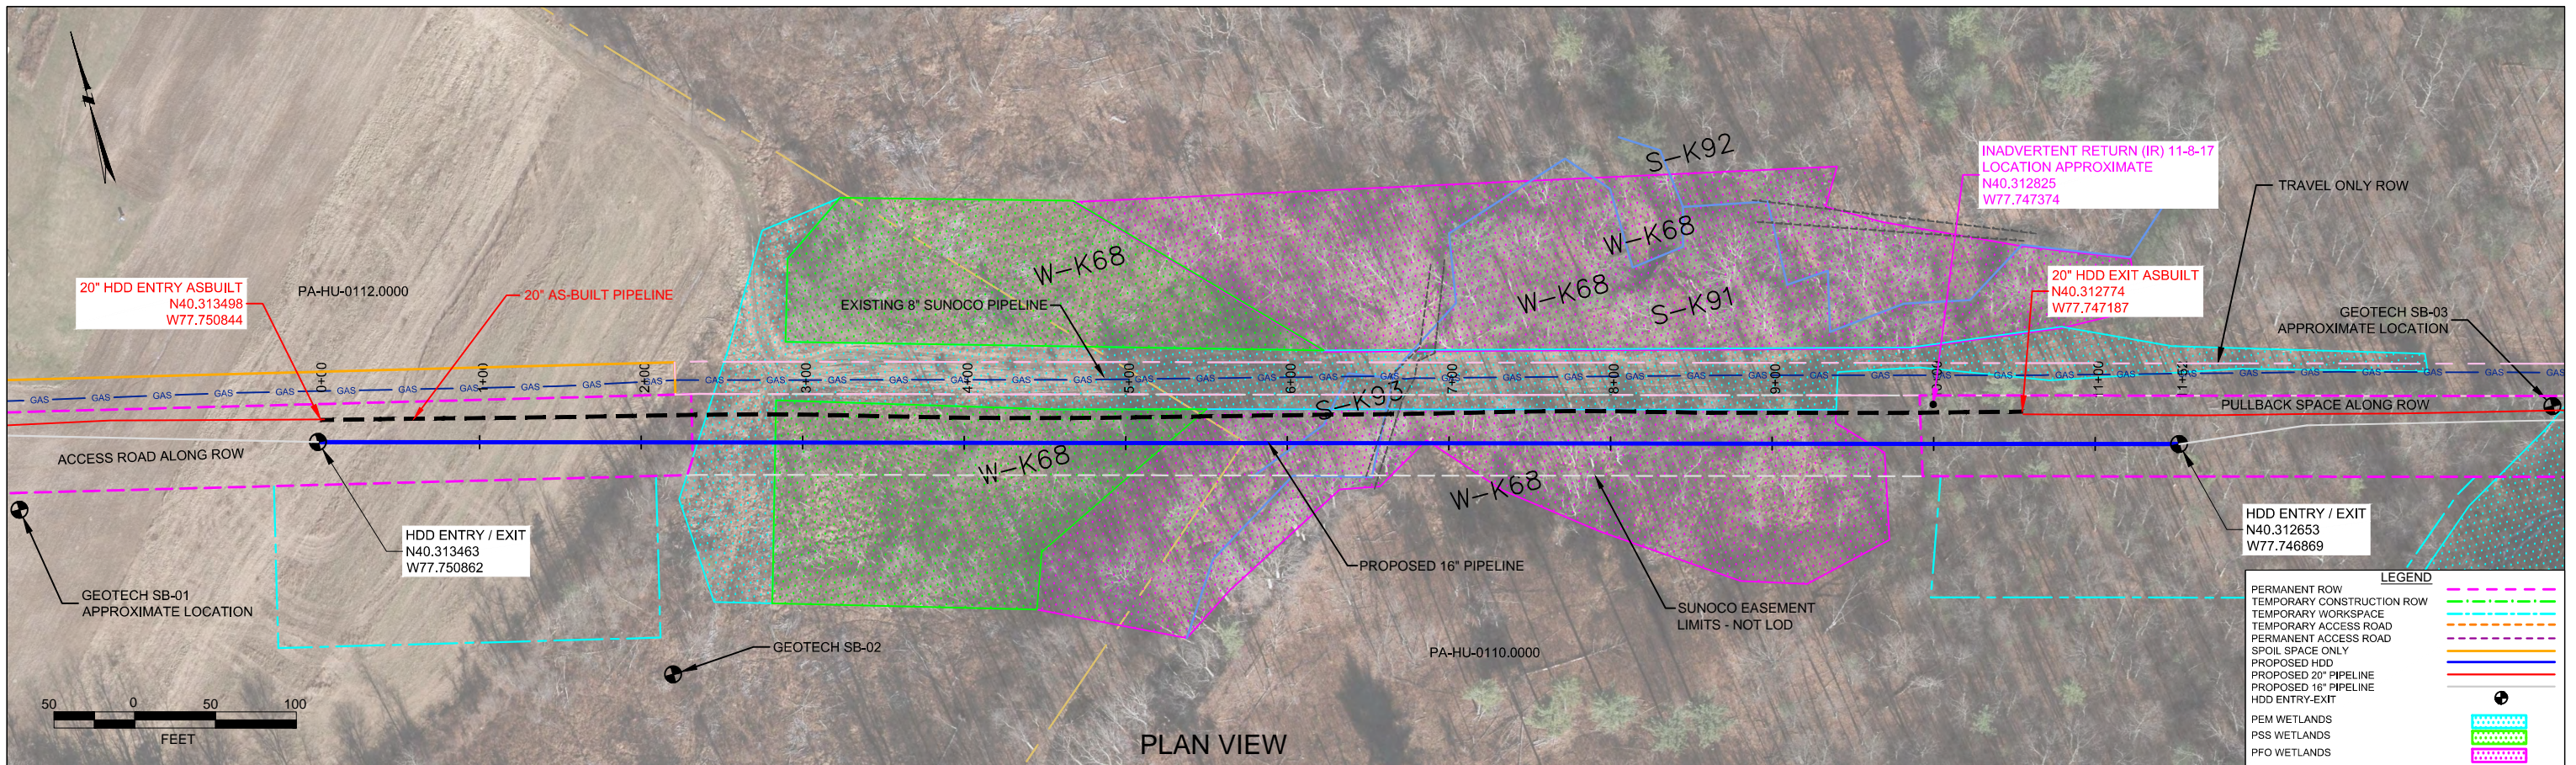
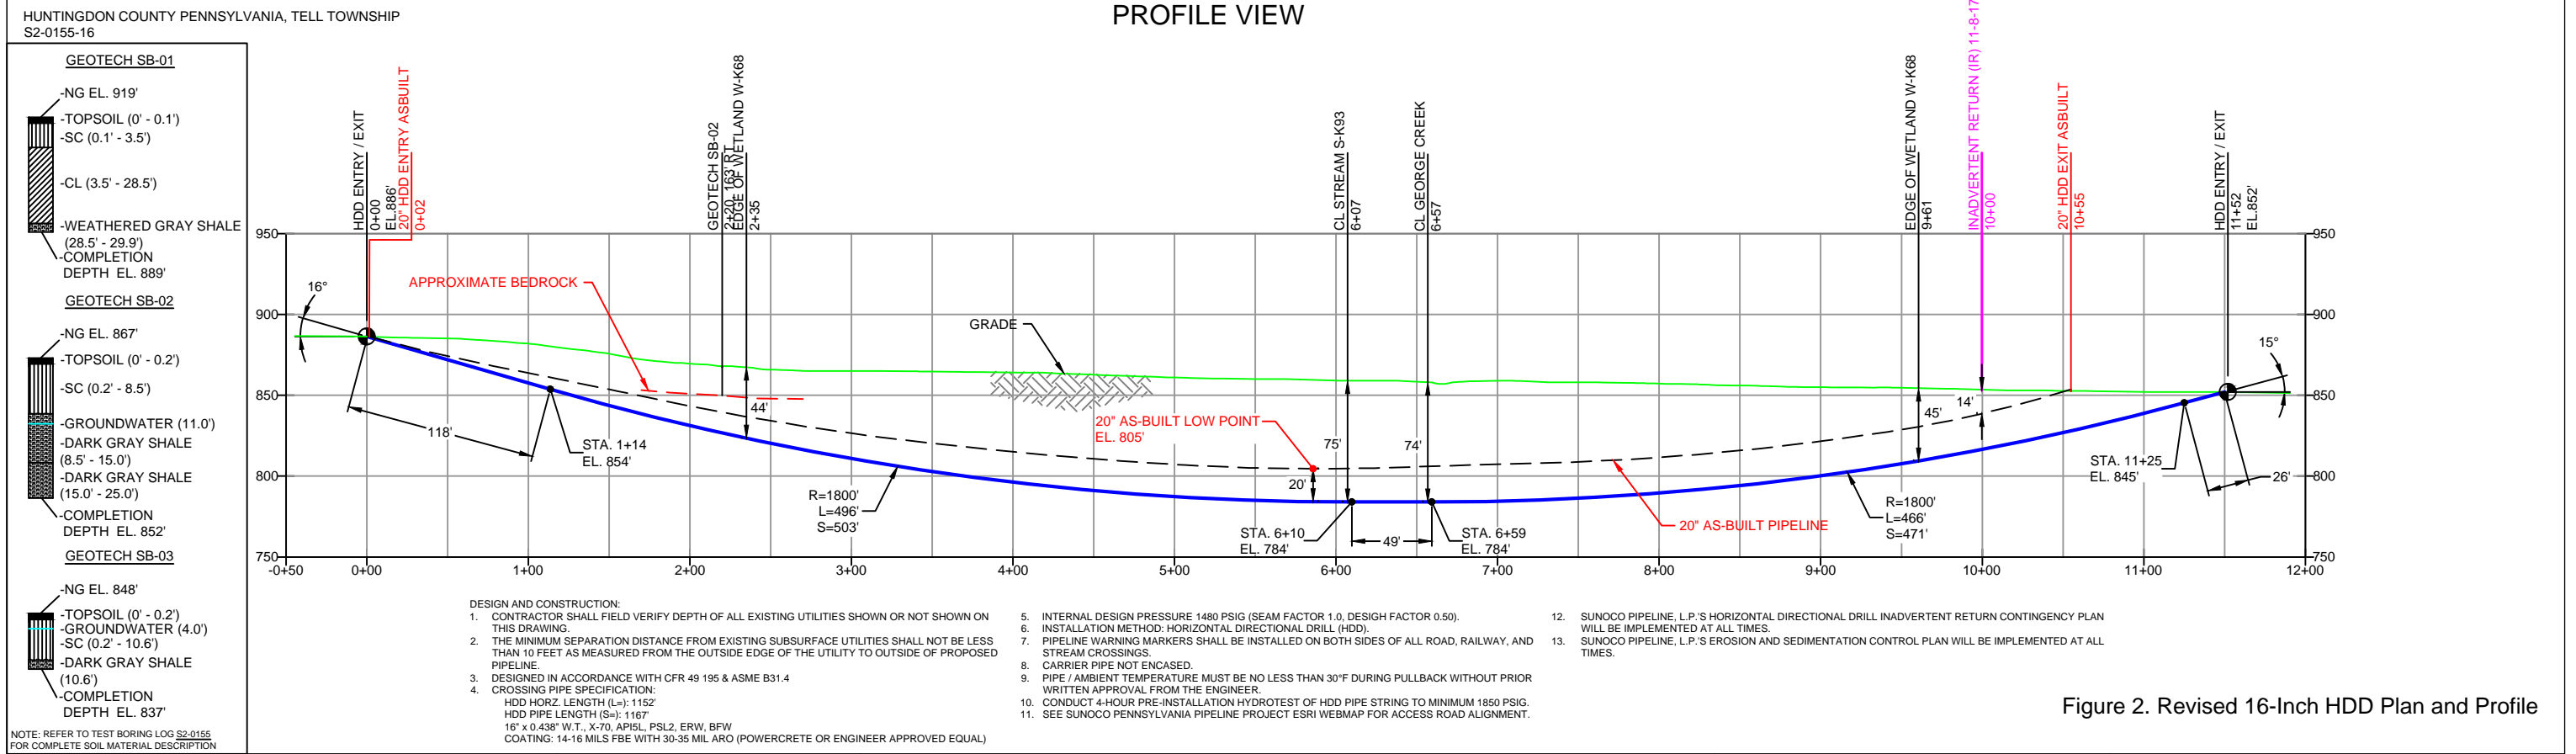
Figure 2. Revised 16-Inch HDD Plan and Profile

- DESIGNED IN ACCORDANCE WITH CFR 49 195 & ASME B31.4
 - CROSSING PIPE SPECIFICATION:
HDD HORZ. LENGTH (L): 850'
HDD PIPE LENGTH (S): 854'
16" x 0.438" W.T., X-70, API5L, PSL2, ERW, BFW
COATING: 14-16 MILS FBE WITH 30-35 MIL ARO (POWERCRETE R95)

The originally designed 16-inch HDD profile was relatively shallow at the eastern and western entry/exit points compared to the land surface, wetlands (K-68PEM, K-68PSS-1, and K-68PFO-1), and surface streambeds (S-K93 and S-K 91) and passed through both soil overburden and fractured bedrock. Based on the hydro-structural characteristics of the underlying geology described in this report and geologic information obtained and utilized during installation of the 20-inch HDD, HDD S2-0155 is susceptible to the IR of drilling fluids during HDD operations. As a result, the proposed 16-inch HDD profile was redesigned to a depth greater than the as-built 20-inch HDD bore path to allow for a deeper crossing beneath the identified streams and wetlands. The revised profile is approximately 75 feet (S-K93) and 74 feet (S-K91) below the streams and 44-45 feet below the wetlands (K-68PEM, K-68PSS-1, and K-68PFO-1) (this will be approximately 25 feet deeper than the 20-inch pipeline). The inclination of the entry and exit angles has been increased to allow the pipe to be installed through protective soils, residual soils, and bedrock, and in closer proximity to the entry and exit points than the original, shorter and
