**HORIZONTAL DIRECTIONAL DRILL ANALYSIS  
HIGHWAY 15 CROSSING  
PADEP SECTION 105 PERMIT NO.: E21-449  
PA-CU-0176.0019-RD-16  
(SPLP HDD No. S2-0247-16)**

This reevaluation of the horizontal directional drill (HDD) installation of a 16-inch diameter pipeline that traverses Highway 15 in Upper Allen Township, Cumberland County, Pennsylvania, is in accordance with the Stipulated Order issued under Environmental Hearing Board Docket No. 2017-009-L for HDDs listed on Exhibit 3 of the Stipulated Order. This HDD is number 10 on the list of HDDs included on Exhibit 3 of the Order.

The 16-inch pipeline HDD is referred to herein as HDD S2-0247-16.

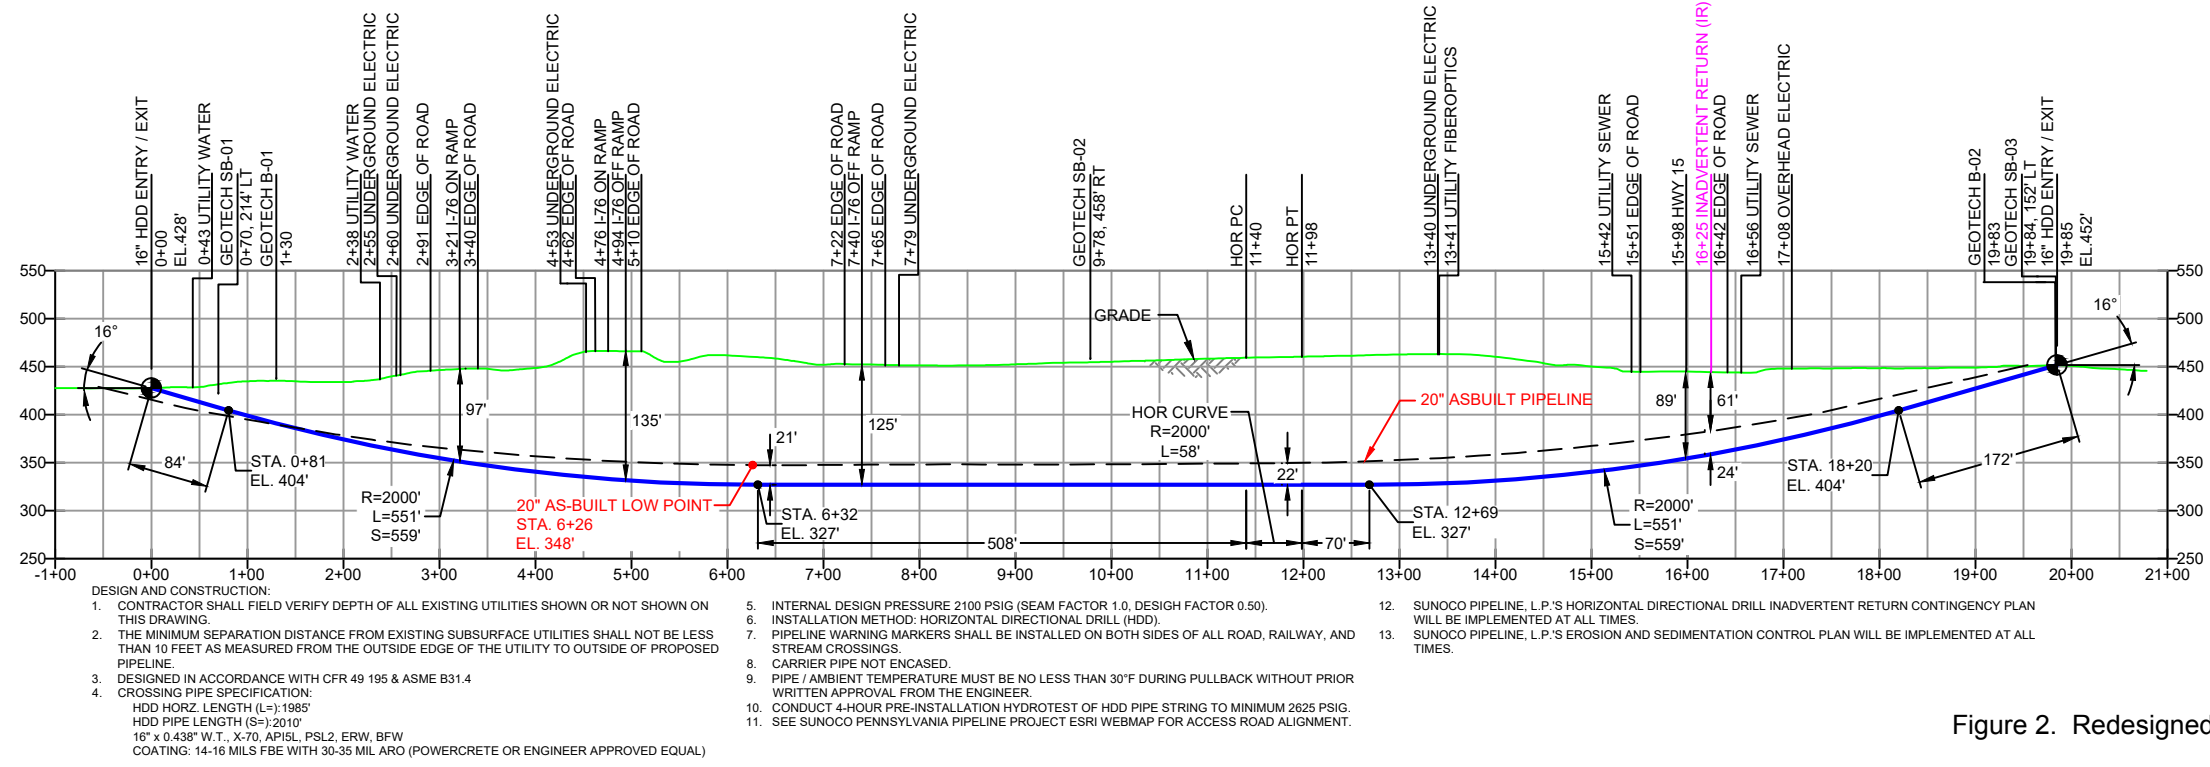
Figure 2. Redesigned 16-Inch HDD Plan and Profile

PROFILE VIEW

The originally proposed 16-inch HDD profile was relatively shallow at the western entry and eastern exit points and passed through both the unconsolidated overburden and fractured bedrock for an extended period. Based on the hydro-structural characteristics of the underlying geology described in this report and the previous occurrence of an IR during installation of the 20-inch pipe, the Highway 15 HDD site is susceptible to an IR of drilling fluids during HDD operations. As a result, the 16-inch HDD profile was redesigned to allow for deeper crossings beneath Highway 15 and the location of the June 27, 2017 IR. The revised 16-inch HDD profile is approximately 89 and 85 feet beneath Highway 15 and the IR location (approximately 24 feet deeper than the as-built 20-inch pipe), respectively. The inclination of the eastern and western entry angle was increased to allow the pipe to be installed through protective soils, residual soils, and bedrock, and in closer proximity to the entry point than the original profile. From a geologic perspective, the deeper profile, in conjunction with the proposed proactive engineering controls and drilling best management practices (BMPs), will be used to reduce the risk of an IR and/or a loss of drilling fluid. Drilling BMPs are described in the Horizontal Directional Drill Analysis component of the overall re-evaluation package.

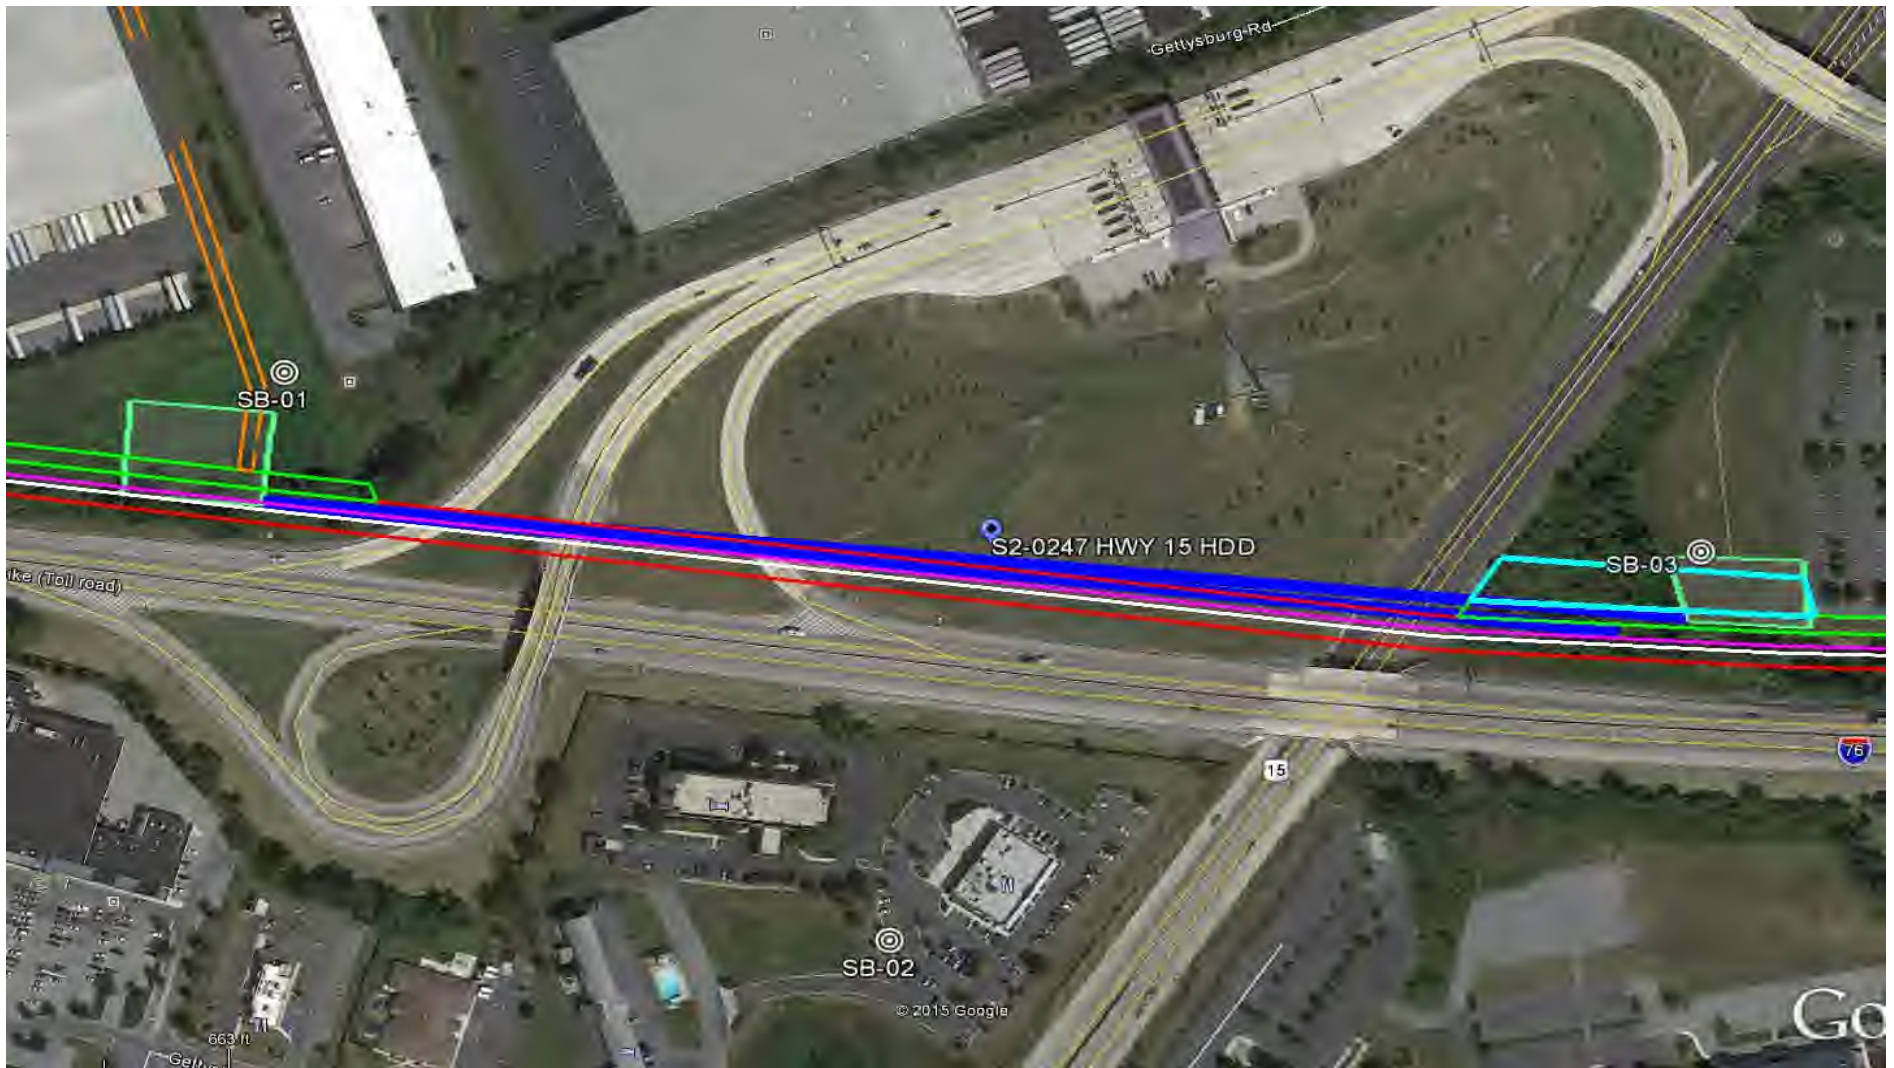
SCALE: 1"=200'	DWG. NO: PA-CU-0176.0019-RD-16
----------------	--------------------------------

As shown on Figure 2, the redesigned HDD profile for the 16-inch pipeline increases the entry-exit angles to allow for a profile depth that is 42 ft deeper than the permitted design. The redesign of the HDD will not prevent all IRs. IRs are common on entry and exit of the drilling tool and other measures are required to minimize IR potential. In particular, upon the start of this HDD, SPLP will employ the following HDD best management practices:

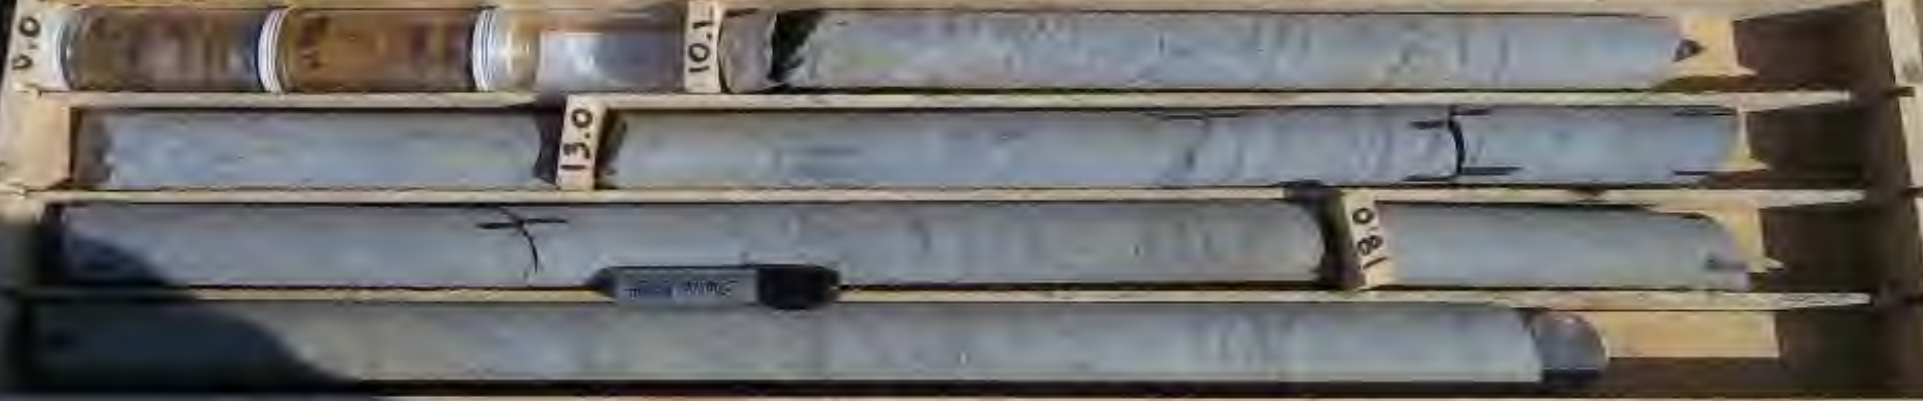
DATE STARTED: 9/5/17  
 DATE COMPLETED: 9/6/17  
 COMPLETION DEPTH: 110.0 ft  
 BENCHMARK: N/A  
 ELEVATION: N/A  
 LATITUDE: n/a°  
 LONGITUDE: n/a°  
 STATION: N/A    OFFSET: N/A  
 REMARKS:

DRILL COMPANY: AWK Drilling  
 DRILLER: J. Growden, Jr    LOGGED BY: D. Calvert  
 DRILL RIG: CME 55 Track Mount  
 DRILLING METHOD: Casing/Rock Coring  
 SAMPLING METHOD: 2-in SSNQ2-in Core  
 HAMMER TYPE: Automatic  
 EFFICIENCY: N/A  
 REVIEWED BY: F. Hoffman
