**Re: Responses to DEP Comments for Hydrogeological HDD Re-Evaluation Report
U.S. Rt. 15 16" Horizontal Directional Drill Location (S2-0247-16)
Permit No. E21-449
Upper Allen Township, Dauphin County**

**HIGHWAY 15 CROSSING
PADEP SECTION 105 PERMIT NO. E21-449
PA-CU-0176.0019-RD-16
(SPLP HDD No. S2-0247-16)**

**ATTACHMENT 2
HORIZONTAL DIRECTIONAL DRILL PLAN AND PROFILES**

**ATTACHMENT 1
GEOLOGY AND HYDROGEOLOGICAL EVALUATION REPORT**

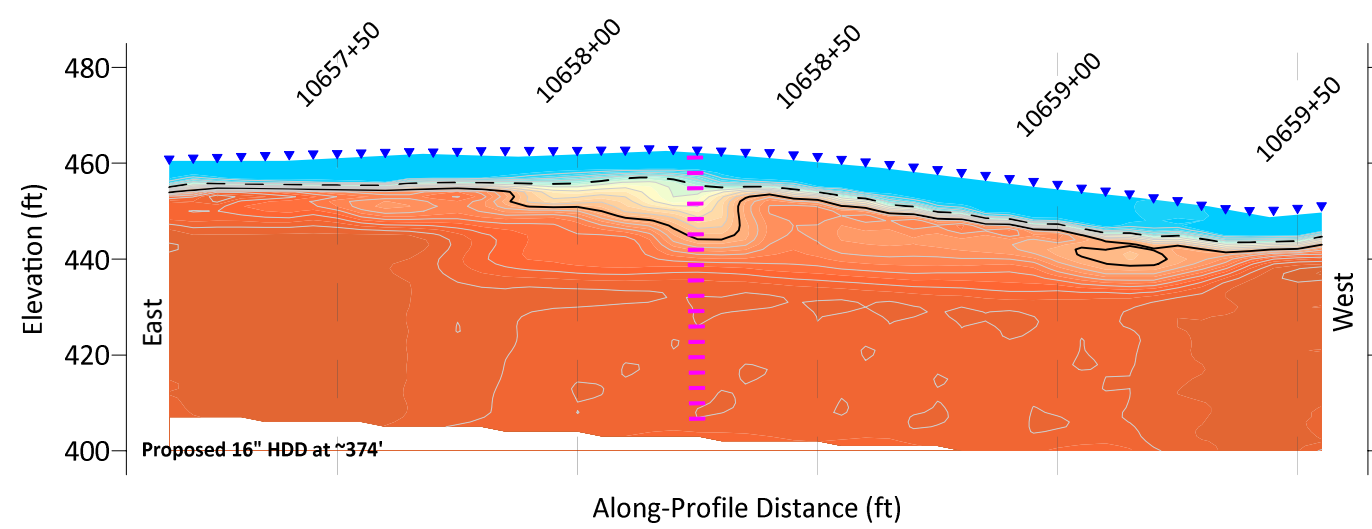
Figure 4: Seismic Refraction Survey Results

Weighted Average
P-Wave Velocity

$$\frac{V_1 = 1,299 \text{ fps}}{V_2 = 17,172 \text{ fps}}$$

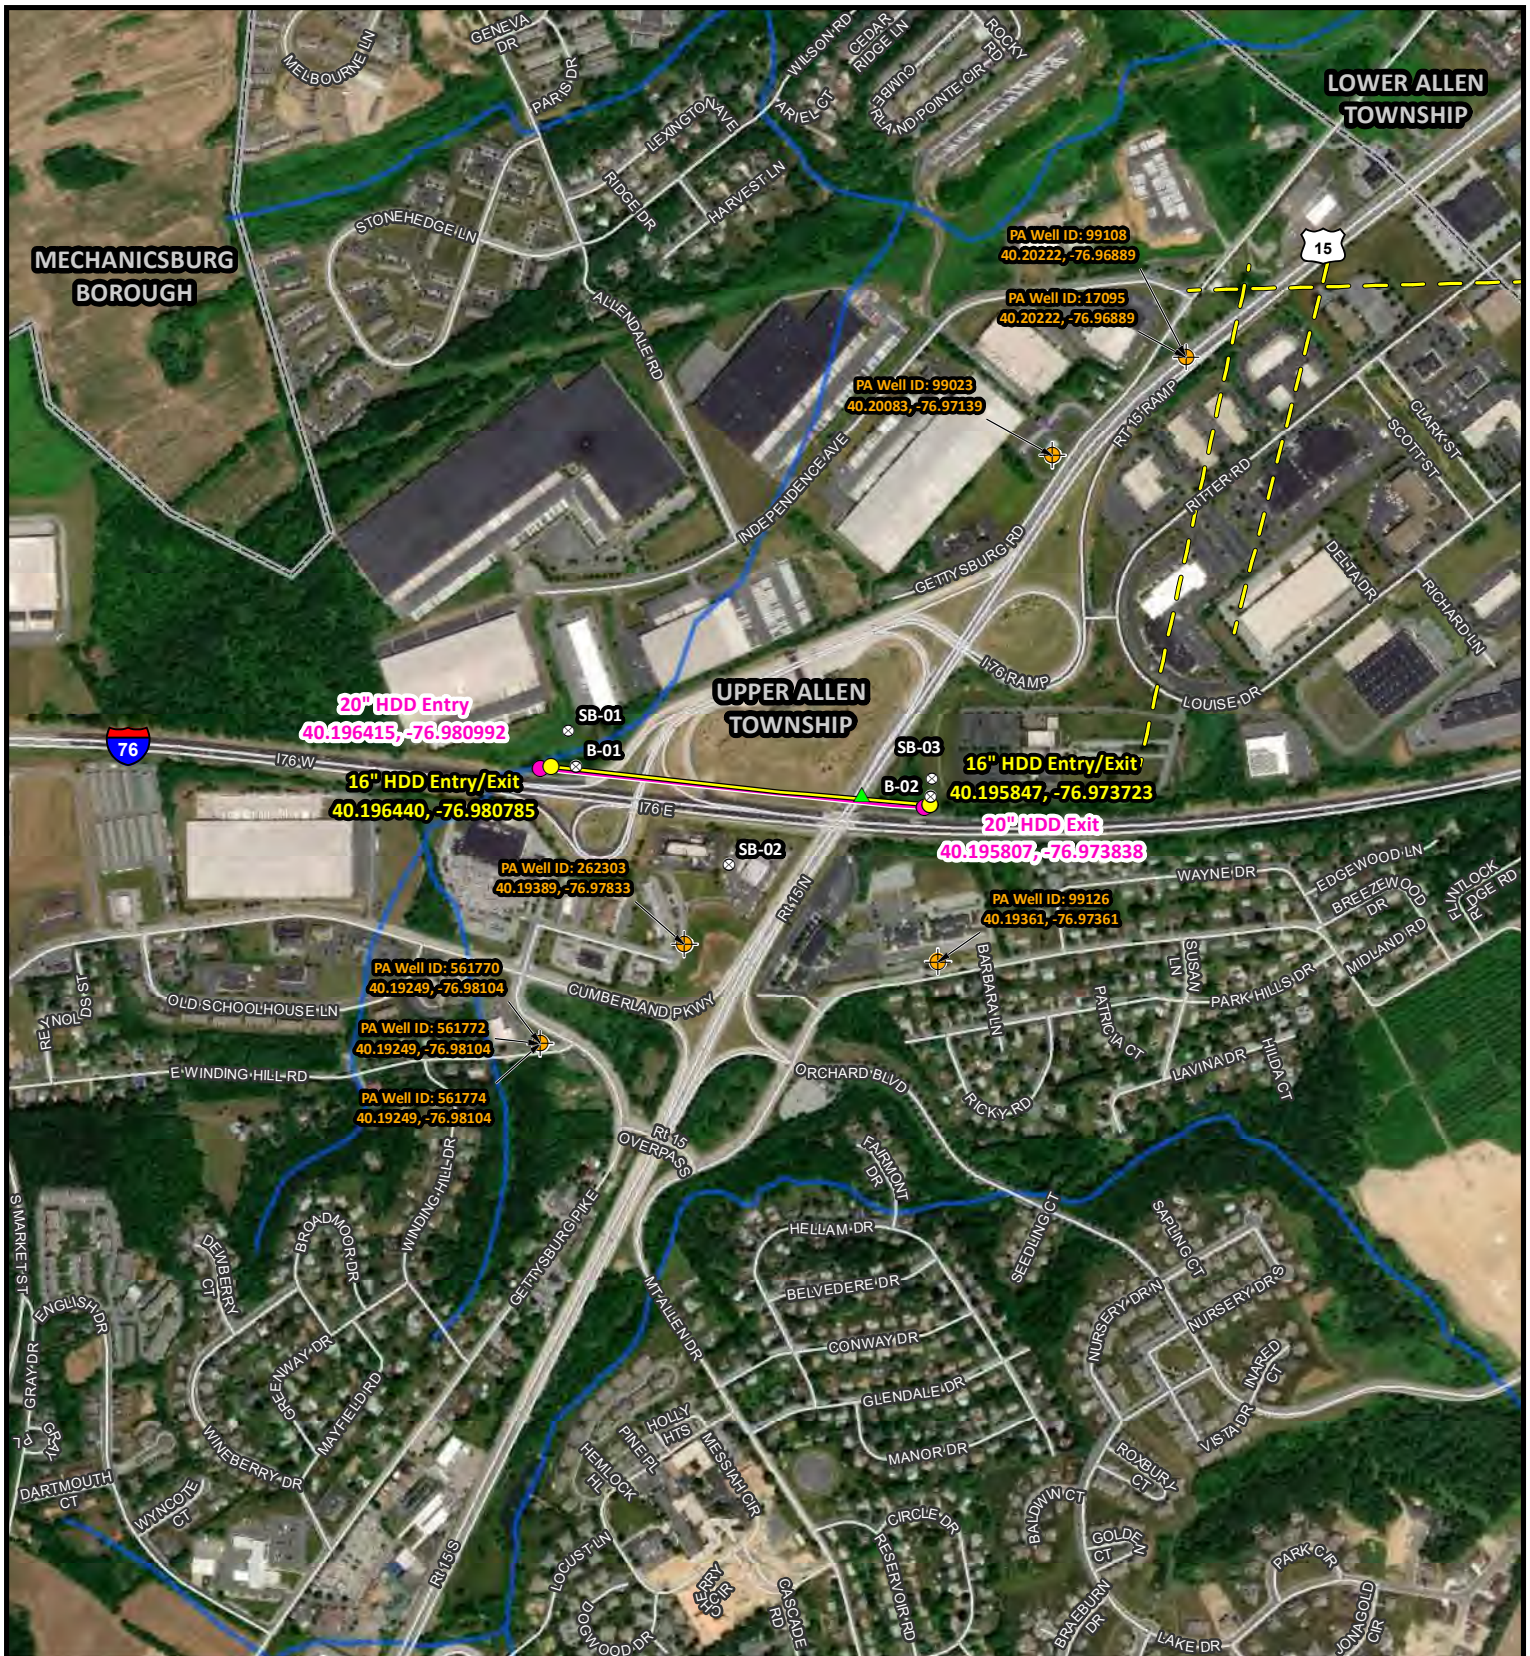
Sunoco Pipeline, L.P.
Highway 15 HDD Location
Figure 2 - Geologic Map
 Upper Allen Township, Dauphin County, PA
 Project No. 096302011

Inadvertent Return		20" HDD Profile
	Residential Well		Inferred Fracture Trace
	Soil Boring		NHD Stream
	16" HDD Entry/Exit		Road
	20" HDD Entry/Exit		Municipal Boundary
	16" HDD Profile

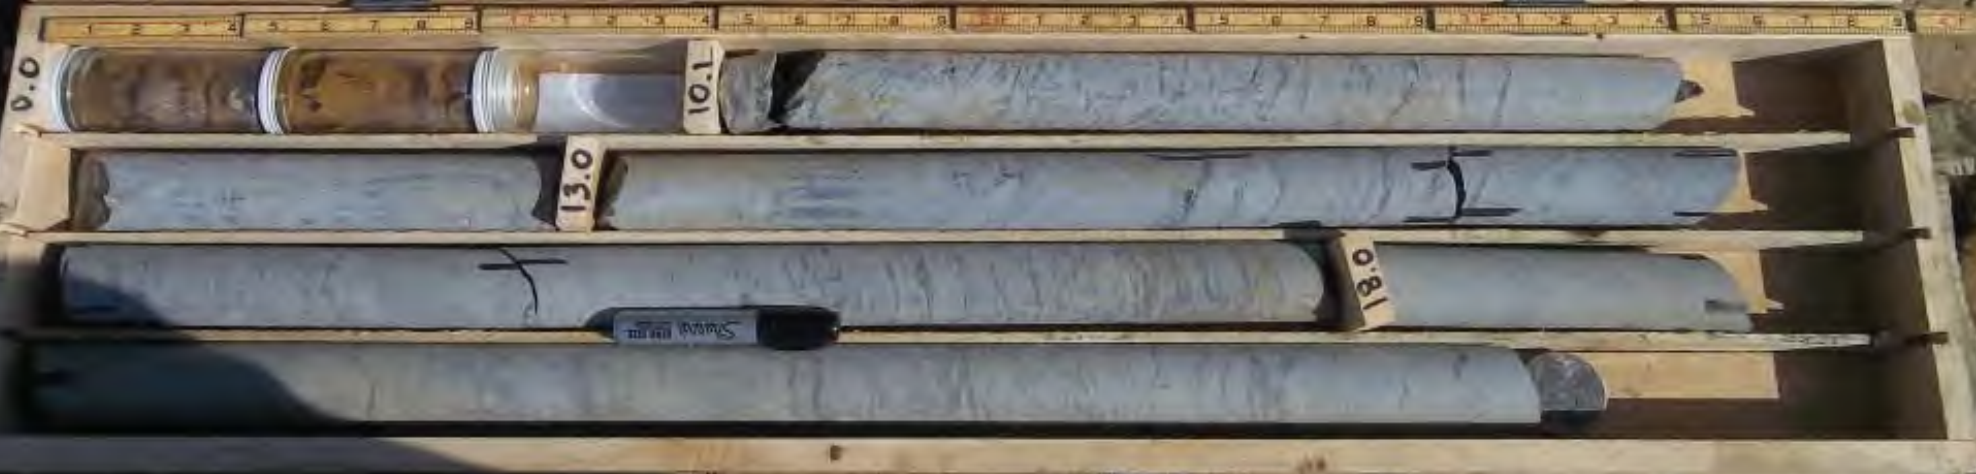
PSI #: 09911465 9/7/17
Bar B-1 Depth 230 to 330
Spread PPP4-HW 15

Run	Depth	Rec	RGD
1	10.8-13.0	2.8	2.8
2	13.0-18.0	5.0	5.0
3	18.0-23.0	2.0 5.0	4.9

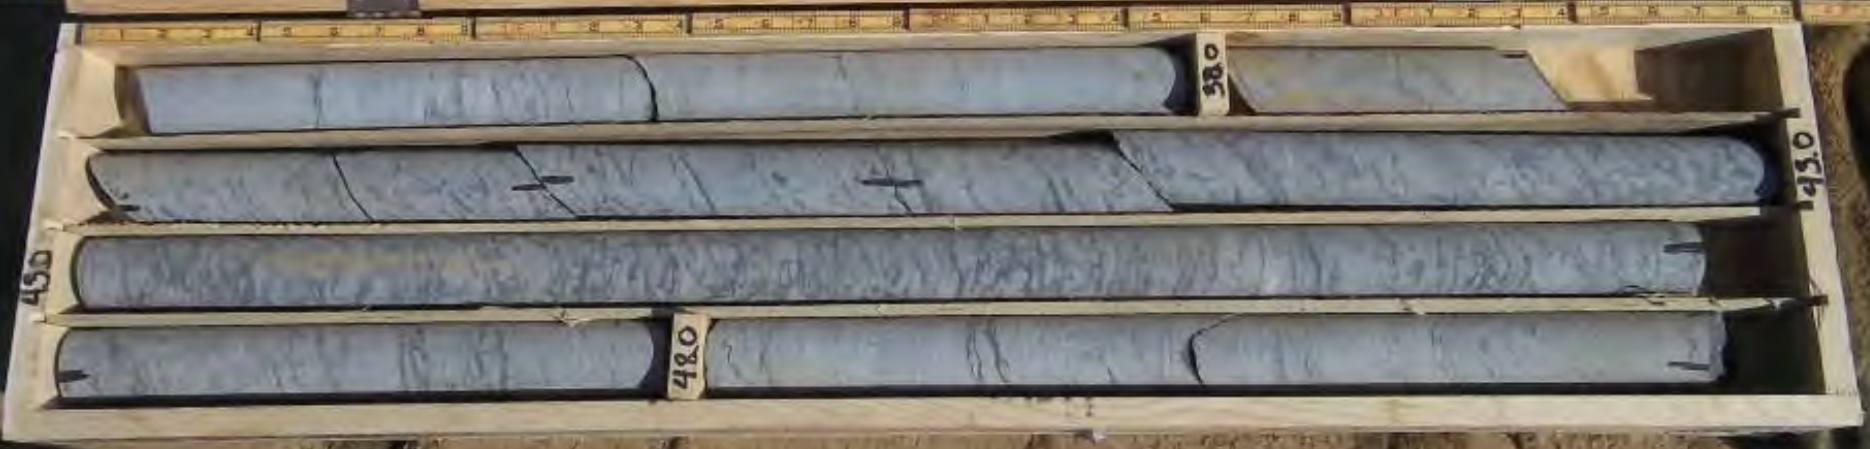
PSI #: 04911465 9/7/17
 Bor B1 Depth 380 to 530
 Spread PPP4-HWY 15

Run	Depth	Rec.	RQD
7	380-430	5.0	5.0
8	430-480	5.0	5.0
9	480-530	5.0	5.0

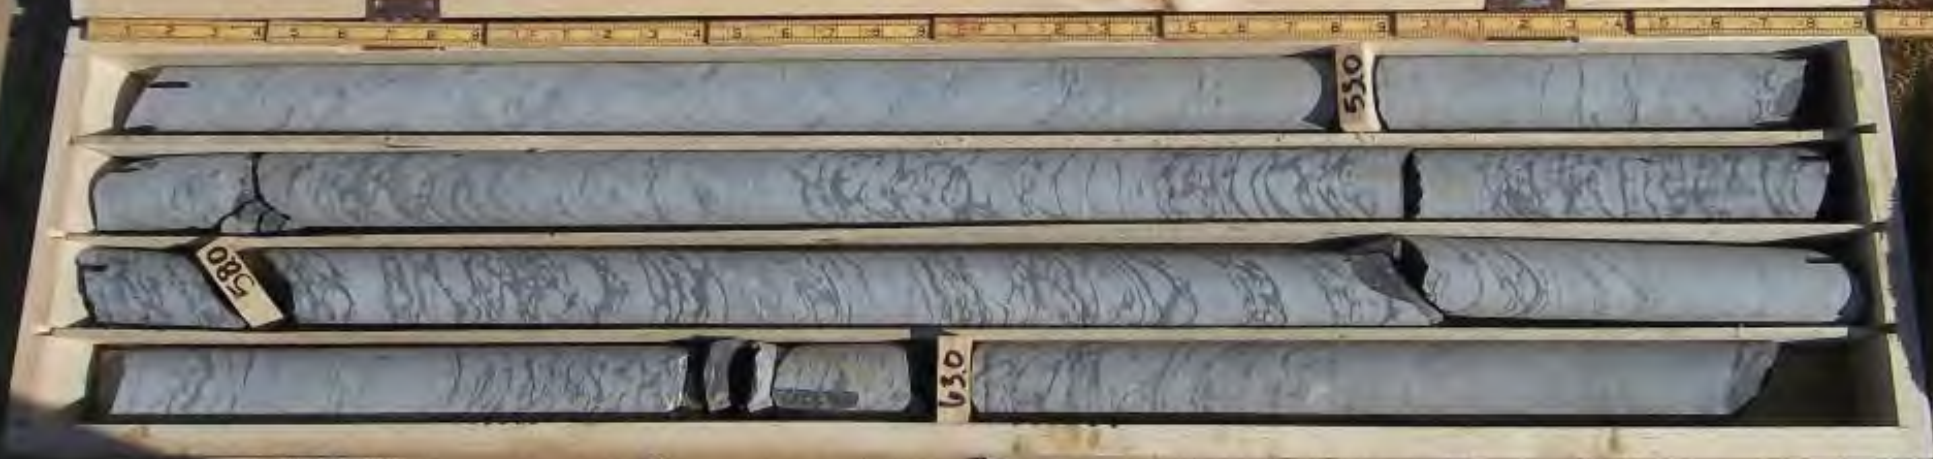
PSI #: 04911465 9/7/17
 Bor B-1 Depth 53.0 to 68.0
 Spread PPP4 - HWY 15

Run	Depth	Rec	RGD
10	53.0-580	5.0	5.0
11	580-630	5.0	4.5
12	630-680	5.0	5.0

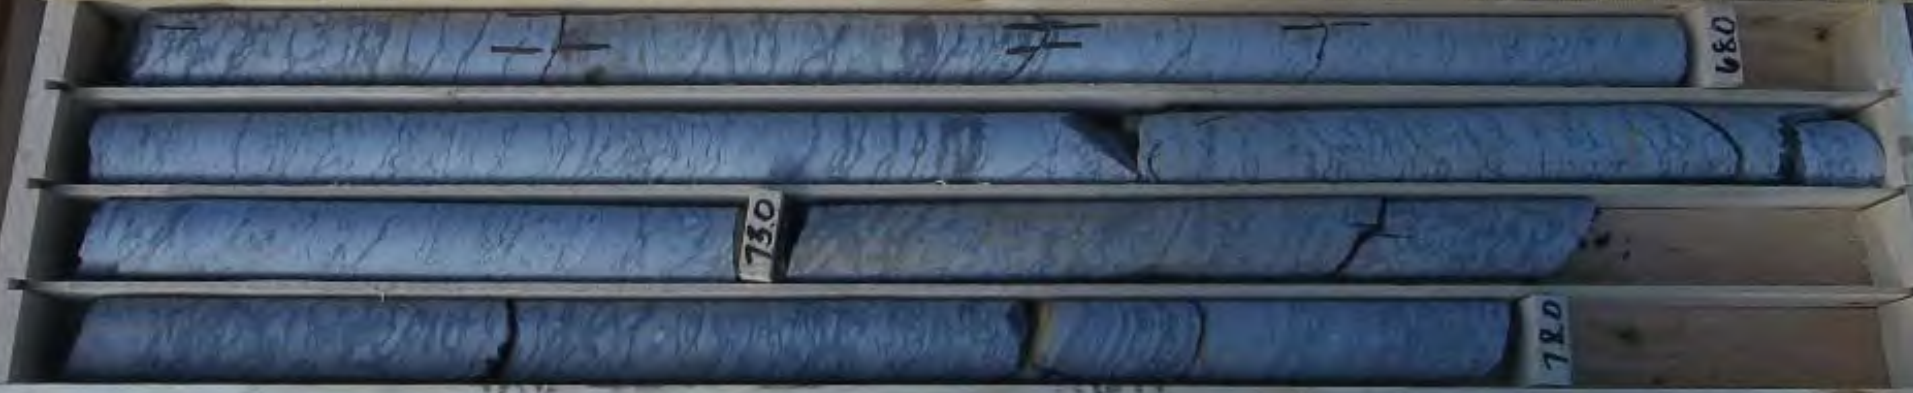
PSI # 04911465 9/17/17
 Bor B-1 Depth 680 to 780
 Spread PPP4-HWY 15

Run	Depth	Rec	RQD
13	680-730	5.0	4.4
14	730-780	5.0	4.1

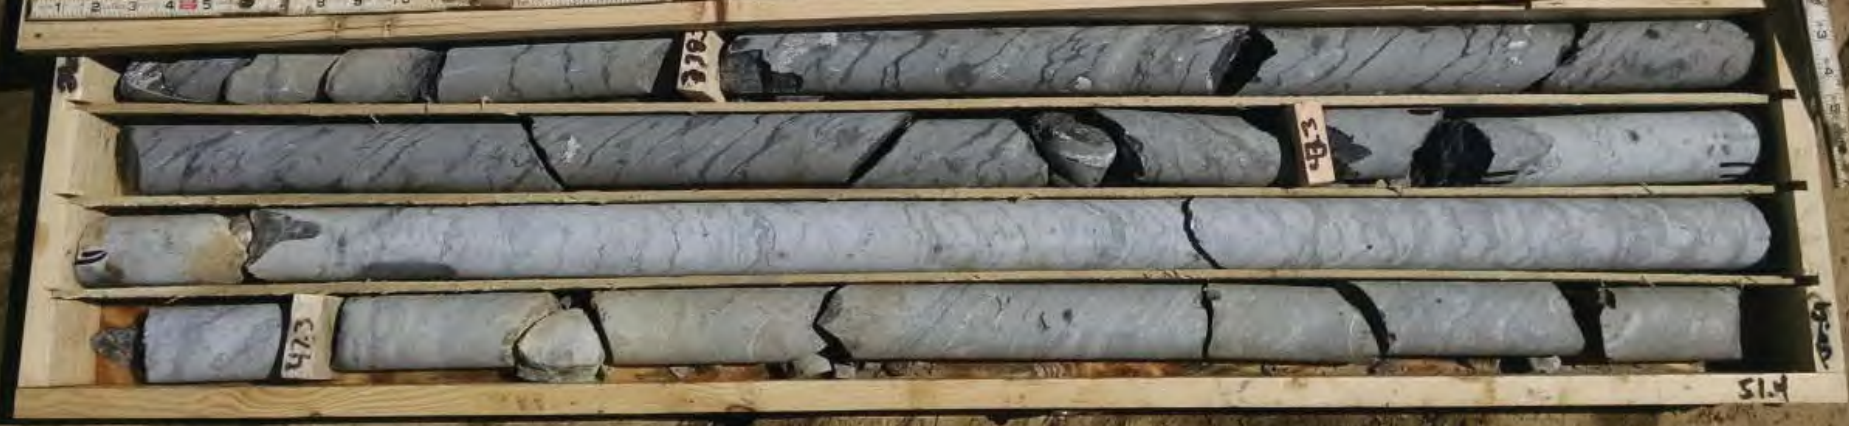
PSI# 04911465 - PPP4 - AWK - Hwy 15 - Lumberland Co
 TT Dist: PA - CO - 076 0019 - PD
 Dps 008 207 0824-1

RUN	DEPTH	REC	RECD
7	37.3 - 43.3	60"	58"
8	43.3 - 48.3	60	60
9	48.3 - 53.3	59"	50"

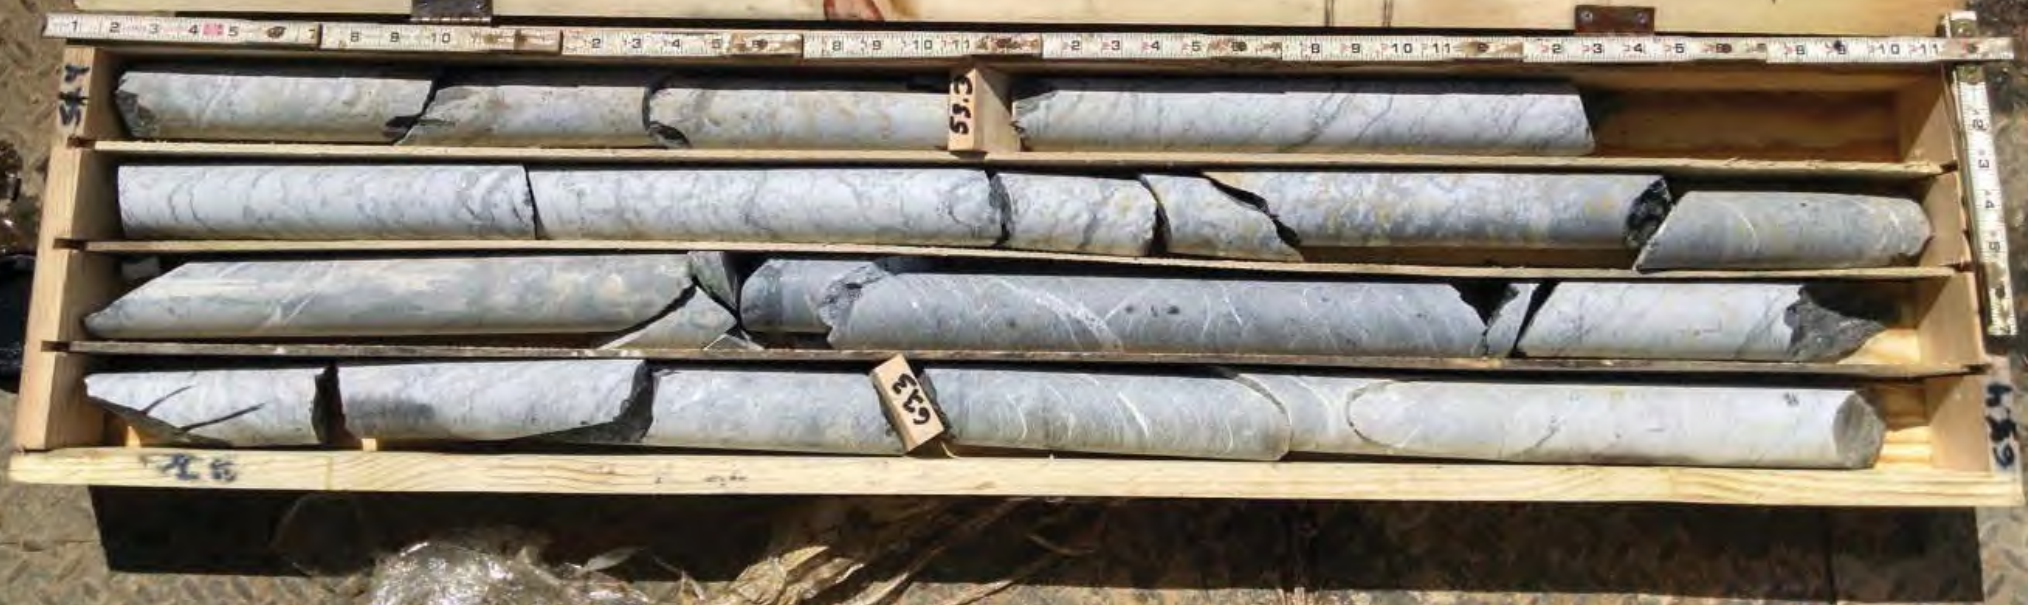
(C) CUMBERLAND DEPTH 524.514 FT. TO 654 FT.

RUN	DEPTH	REC	ROD
10	53.3 -58.3	60	53
11	57.3 -63.3	60	54
12	63.3 -68.3	60	58

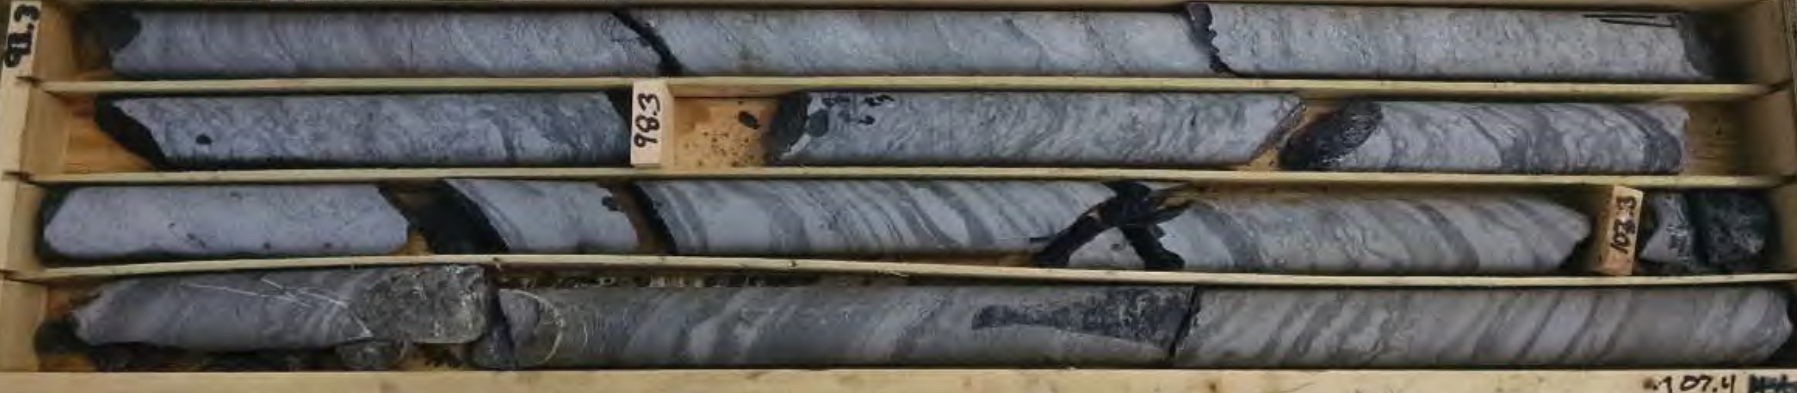
Run	DEPTH	R/L (in)	R/O (in)
18	98.3 -98.3	60	60
19	98.3 -103.3	60	56.5
20	103.3- 108.3	60	57
