**HORIZONTAL DIRECTIONAL DRILL ANALYSIS
LITTLE CONESTOGA ROAD CROSSING
PADEP SECTION 105 PERMIT NO.: E15-862
PA-CH-0100.0000-RD
(SPLP HDD# S3-0290)**

The 20-inch pipe HDD is referred to herein as HDD S3-0290.

ROOT CAUSE ANALYSIS FOR THE 20-INCH PIPE INSTALLATION IR

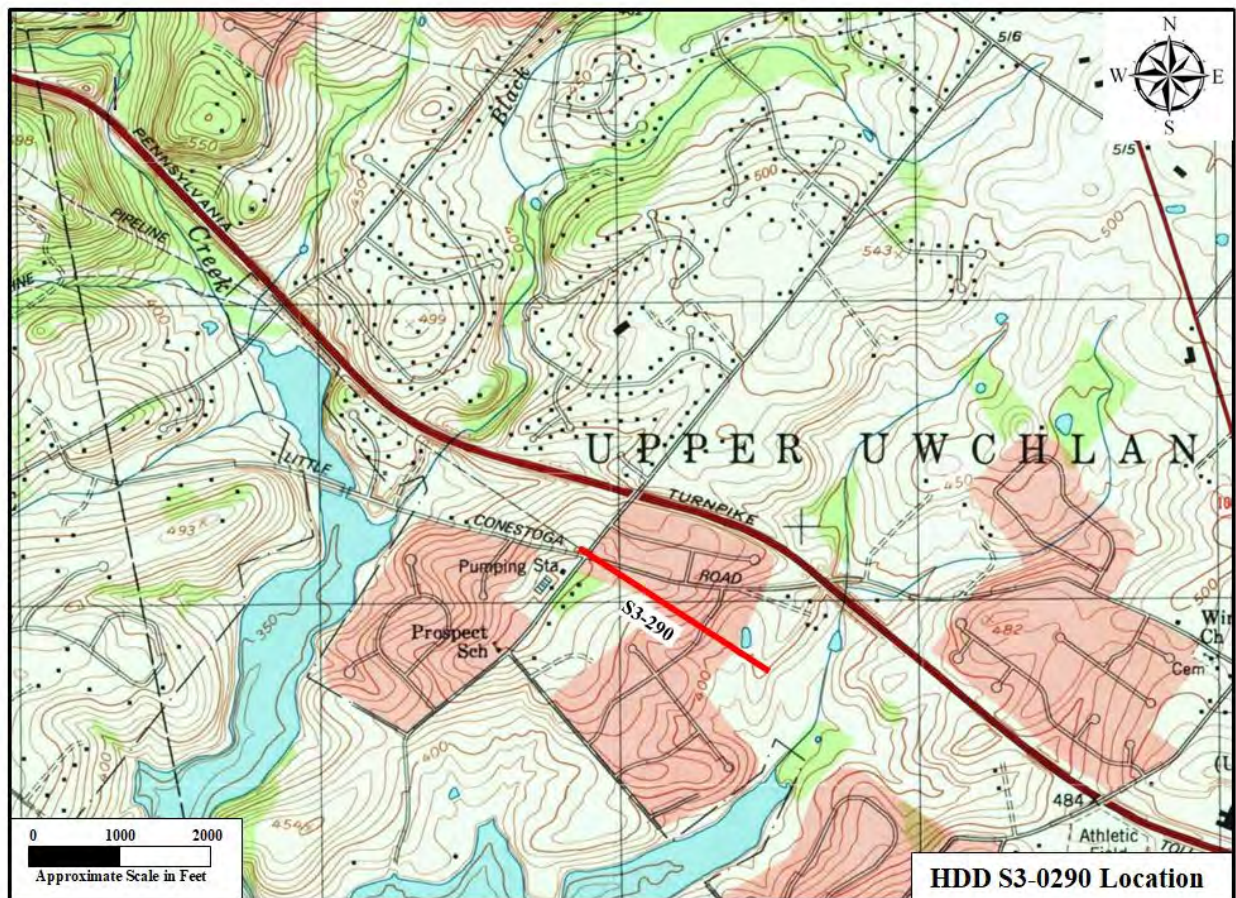
Figure 1. Site Location Map (modified from USGS, revised 1999)

Figure 1 shows the location of the alignment for the 20-inch line at HDD S3-0290-16, with topographic information for the surrounding area.

The 20-inch HDD will run from the undeveloped lot located on the west-northwest side of Milford Road to the southeast crossing the intersection of Milford Road and Little Conestoga Road, then cross under several residential properties, until exiting in cultivated fields to the southeast of Highview Road.

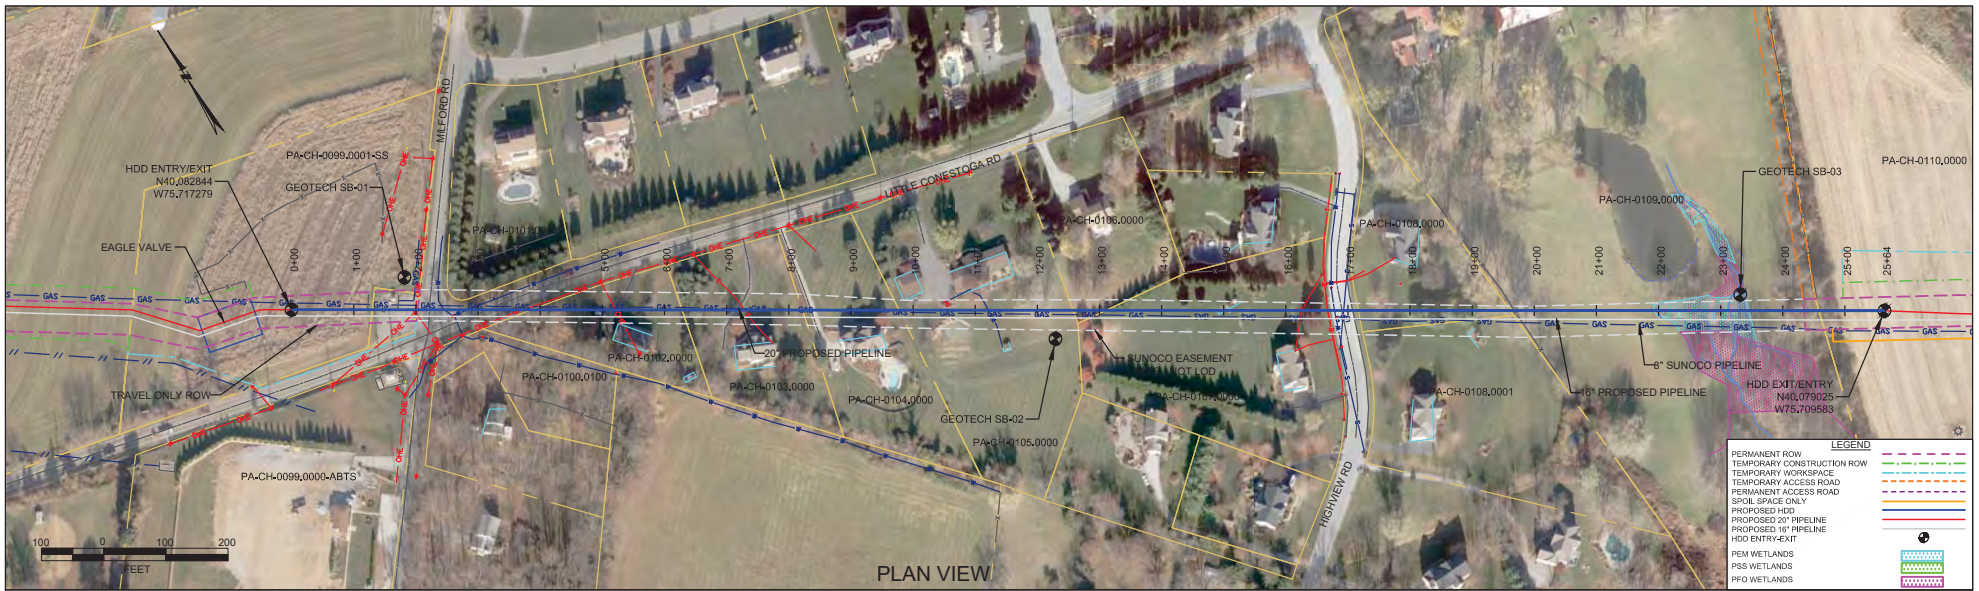
Proposed HDD S3-0290 Plan and Profile (rev. 3/14/19), showing IRs and geology

- GEOTECH SB-01**
- NG EL. 499'
 - TOPSOIL (0' - 0.3')
 - SM (0.3' - 30.0')
 - COMPLETION DEPTH EL. 469'
- GEOTECH SB-02**
- NG EL. 460'
 - TOPSOIL (0' - 0.7')
 - SM (0.7' - 7.0')
 - GNEISS (7.0' - 12.0')
 - COMPLETION DEPTH EL. 448'
- GEOTECH SB-03**
- NG EL. 390'
 - TOPSOIL (0' - 1.0')
 - CL (1.0' - 6.5')
 - SM (6.5' - 30.0')
 - GROUNDWATER (16.0')
 - COMPLETION DEPTH EL. 360'
- NOTE: REFER TO TEST BORING LOG S3-0202 FOR COMPLETE SOIL MATERIAL DESCRIPTION.

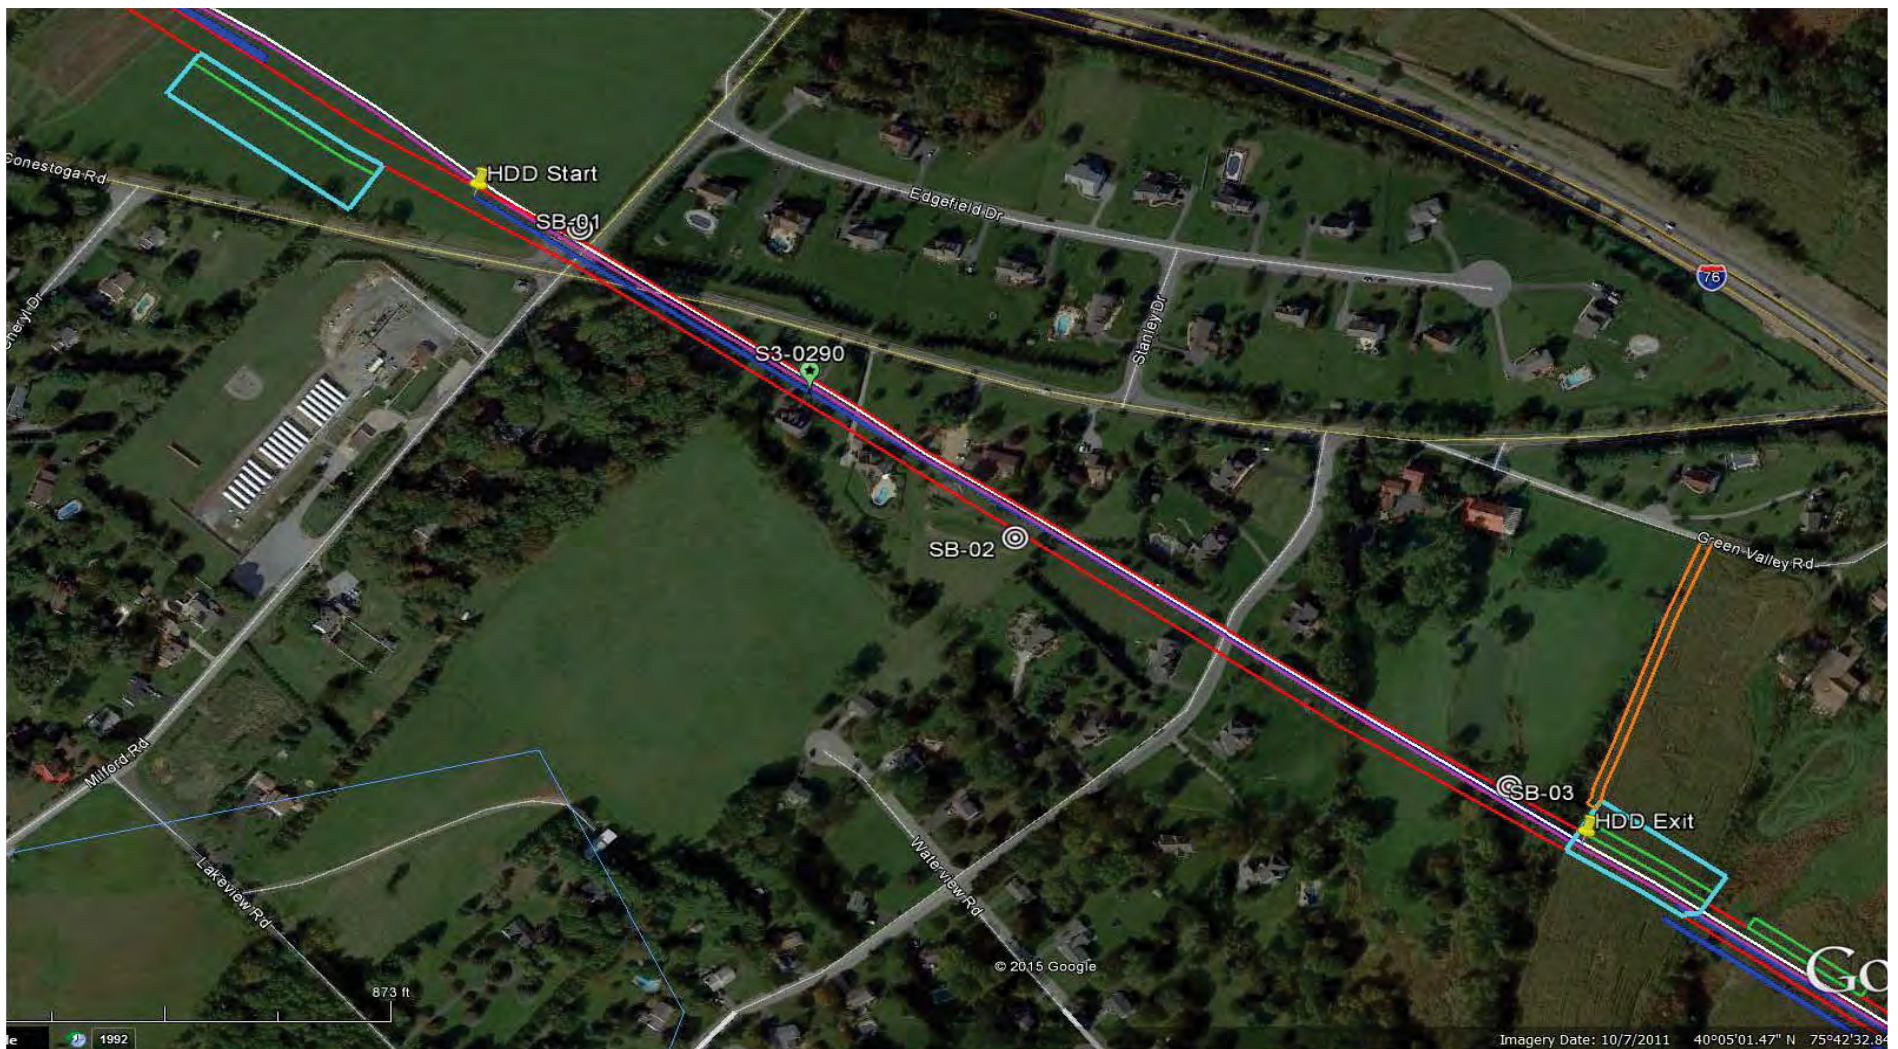
⊙ Geotechnical Soil Boring (SB) Locations

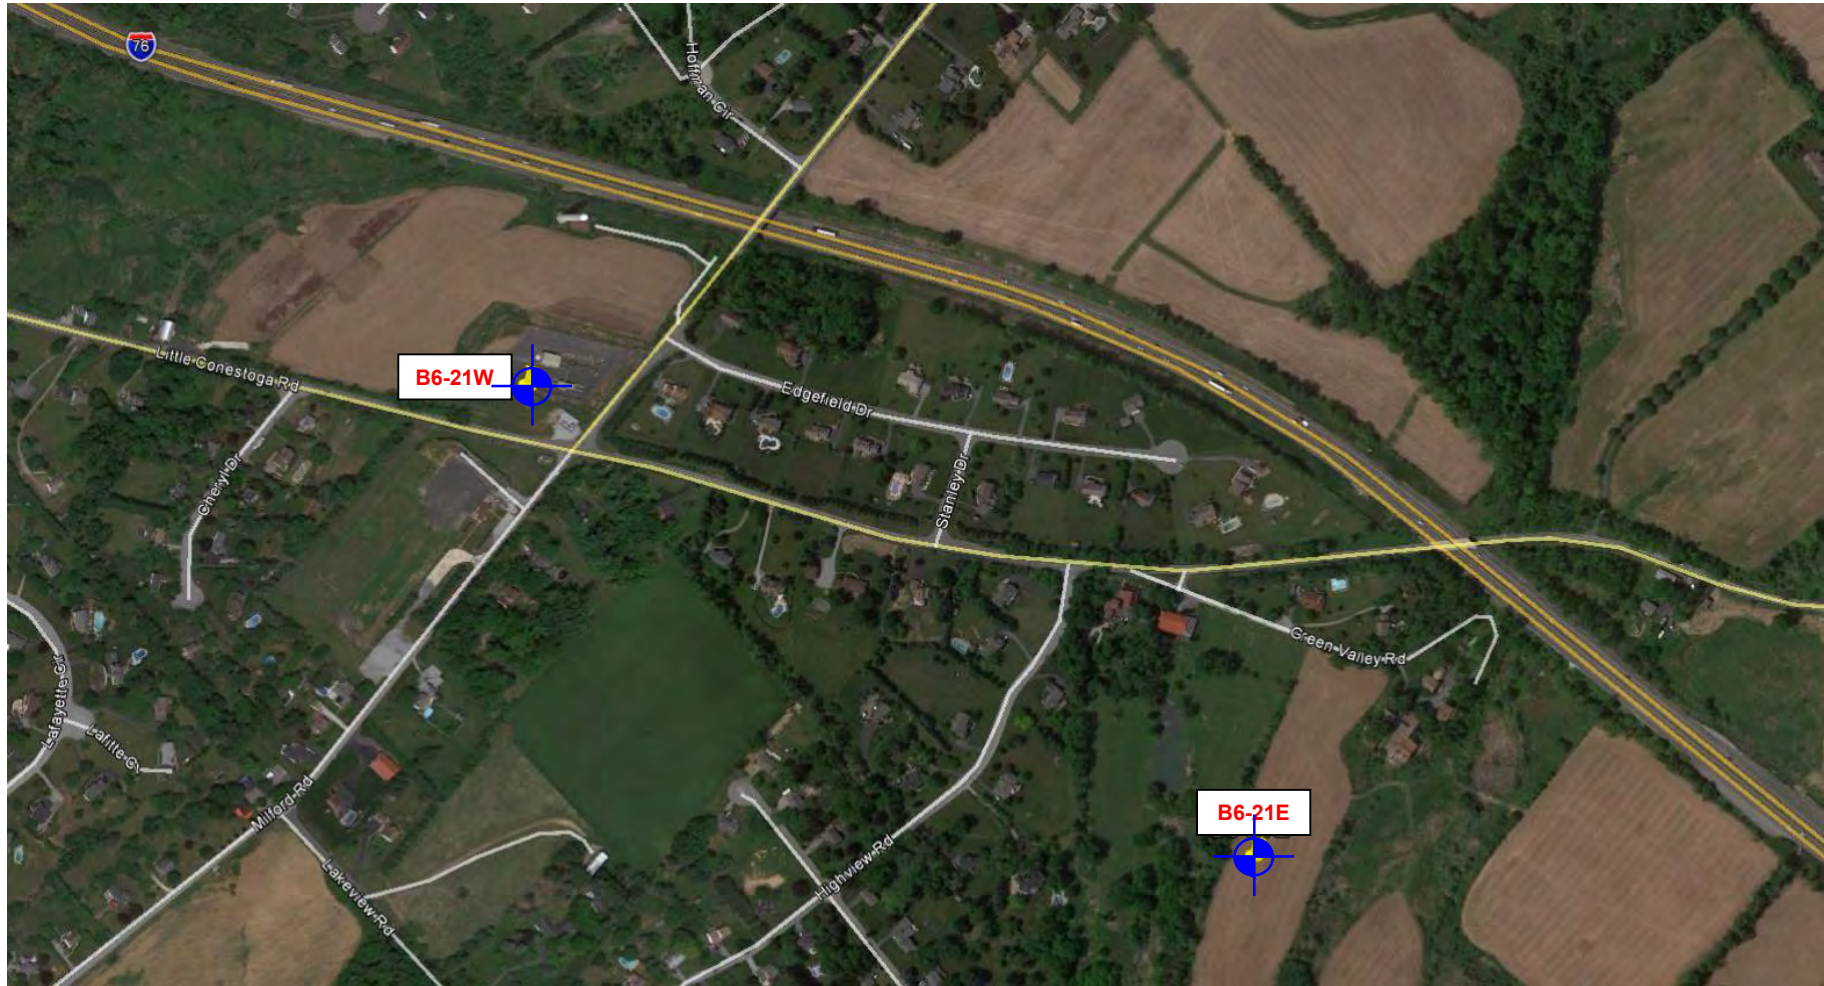
TEST BORING LOCATION PLAN

**APPROXIMATE
BORING
LOCATION**

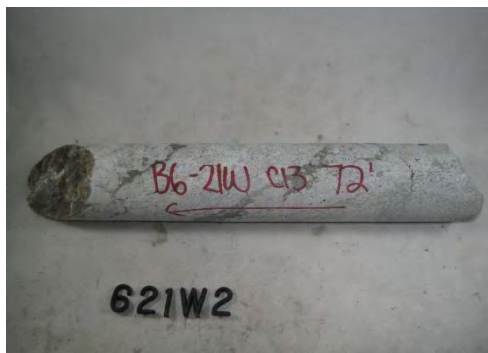
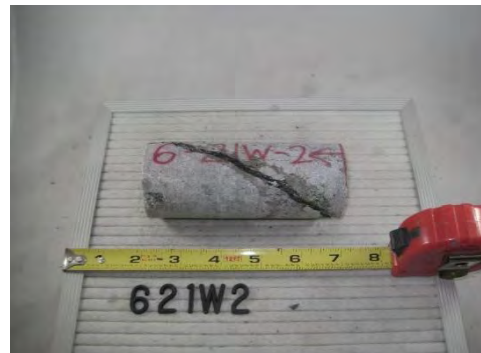
Maximum Axial Load at Failure: 19,940 lb
 Compressive Strength: 6,476 psi
 Compressive Strength: 44.65 Mpa
 Unit Weight 173 pcf

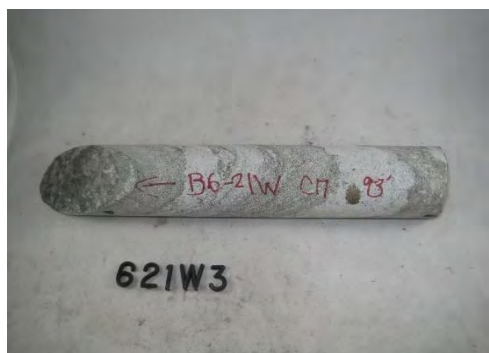
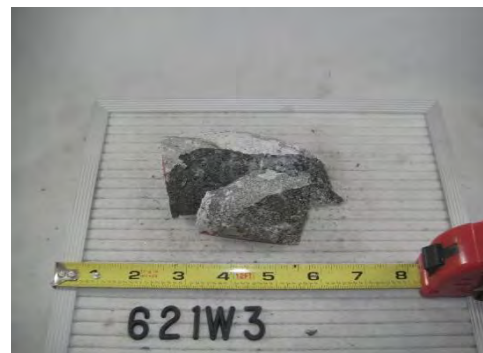
Maximum Axial Load at Failure: 37,800 lb
 Compressive Strength: 12,276 psi
 Compressive Strength: 84.64 Mpa
 Unit Weight 175 pcf

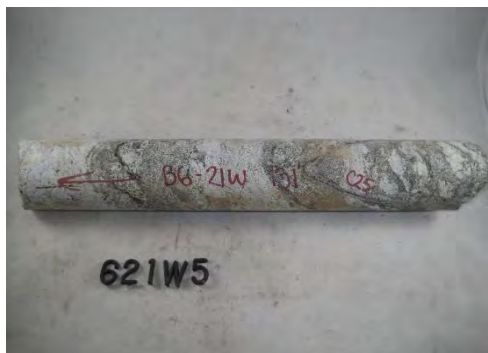
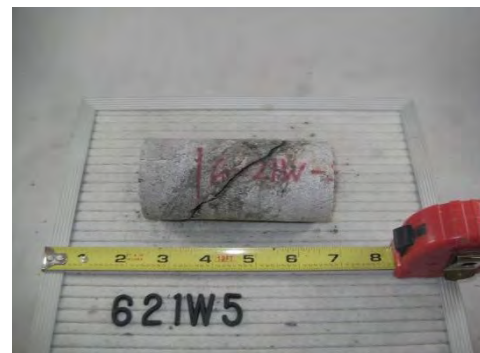
Maximum Axial Load at Failure: 6,450 lb
 Compressive Strength: 2,074 psi
 Compressive Strength: 14.30 Mpa
 Unit Weight 166 pcf

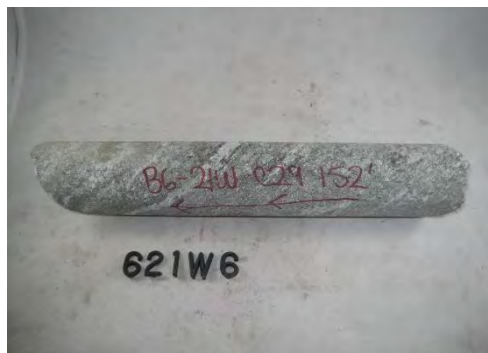
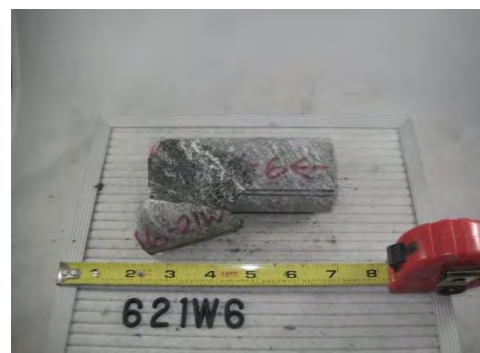
Maximum Axial Load at Failure: 25,510 lb
 Compressive Strength: 8,285 psi
 Compressive Strength: 57.12 Mpa
 Unit Weight 182 pcf

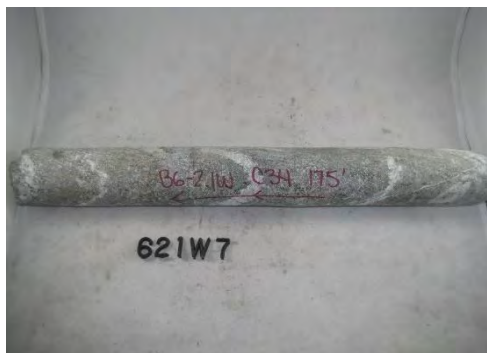
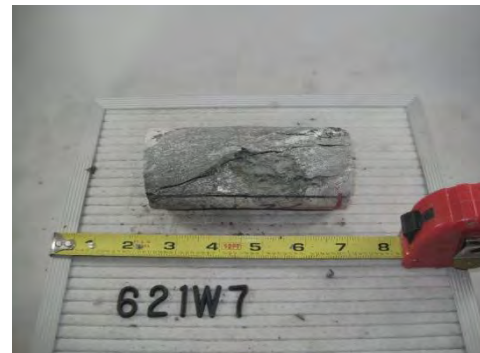
Maximum Axial Load at Failure: 22,720 lb
 Compressive Strength: 7,608 psi
 Compressive Strength: 52.45 Mpa
 Unit Weight 179 pcf

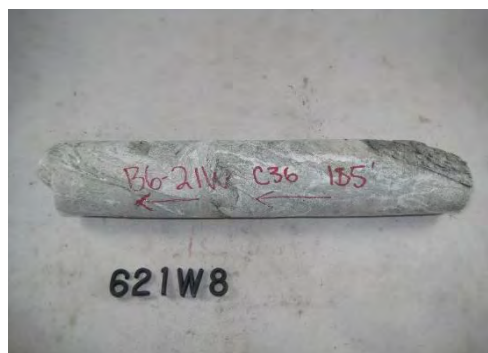
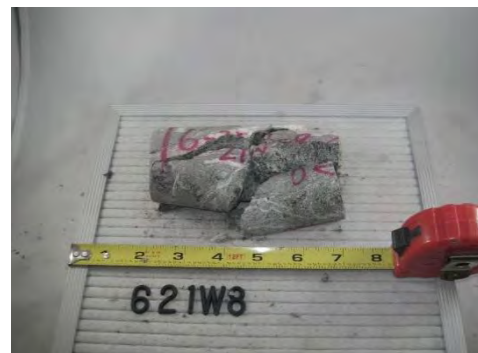
Maximum Axial Load at Failure: 2,060 lb
 Compressive Strength: 669 psi
 Compressive Strength: 4.61 Mpa
 Unit Weight 157 pcf

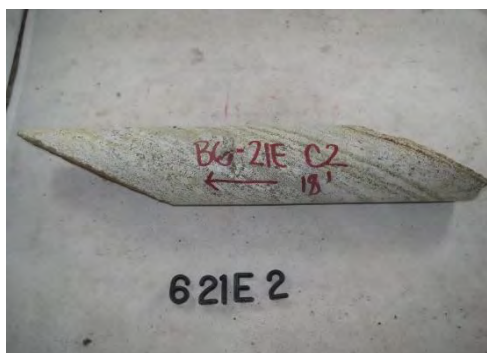
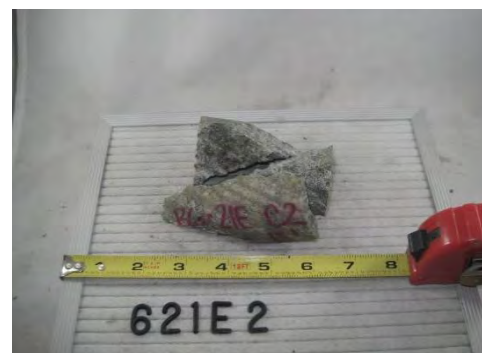
Comments : Due to lack of available specimens, the length to diameter ratio of the tested specimen is not conformant with ASTM D7012. The results obtained during testing may differ from those obtained from the test specimens that meet the requirements.

Photographs are mislabeled as 6-21E-2

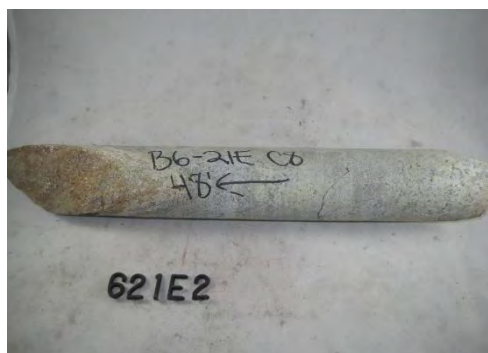
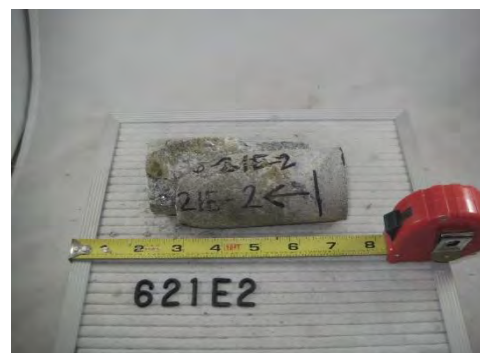
Maximum Axial Load at Failure: 27,070 lb
 Compressive Strength: 8,617 psi
 Compressive Strength: 59.41 Mpa
 Unit Weight 164 pcf

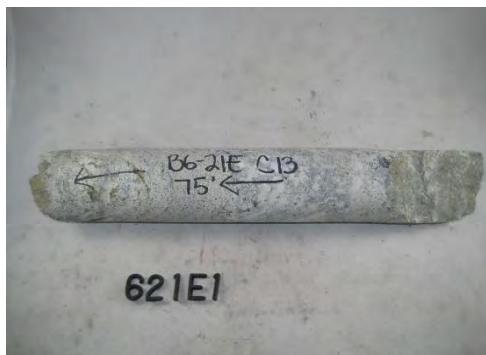
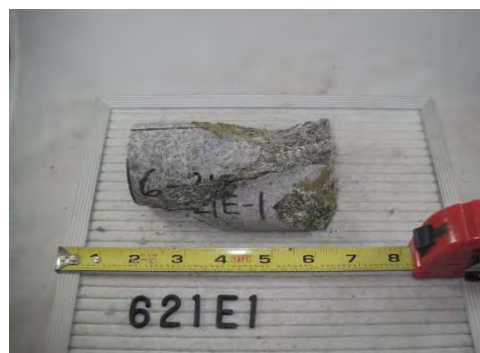
Comments : Due to lack of available specimens, the length to diameter ratio of the tested specimen is not conformant with ASTM D7012. The results obtained during testing may differ from those obtained from the test specimens that meet the requirements.

Photographs are mislabeled as 6-21E-1

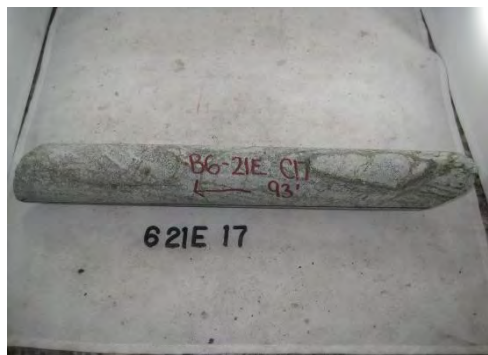
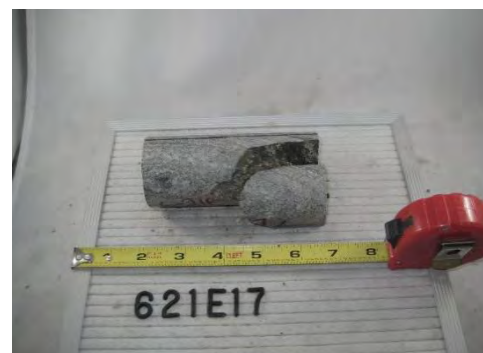
Maximum Axial Load at Failure: 18,610 lb
 Compressive Strength: 5,865 psi
 Compressive Strength: 40.44 Mpa
 Unit Weight 168 pcf
