**HORIZONTAL DIRECTIONAL DRILL ANALYSIS
MIDDLE CREEK & T307 CROSSING
PADEP SECTION 105 PERMIT NO.: E38-194
PA-LE-0117.0000-WX-16
(SPLP HDD No. S3-0110)**

This reevaluation of the horizontal directional drill (HDD) installation of a 16-inch diameter pipeline that traverses Middle Creek and Township Road 307 (Creek & T307) in Heidelberg Township, Lebanon County, Pennsylvania is in accordance with the Stipulated Order issued under Environmental Hearing Board Docket No. 2017-009-L for HDDs listed on Exhibit 3 of the Stipulated Order. This HDD is number 13 on the list of HDDs included on Exhibit 3 of the Order requiring a reevaluation.

The 16-inch pipe HDD is referred to herein as HDD S3-0110.

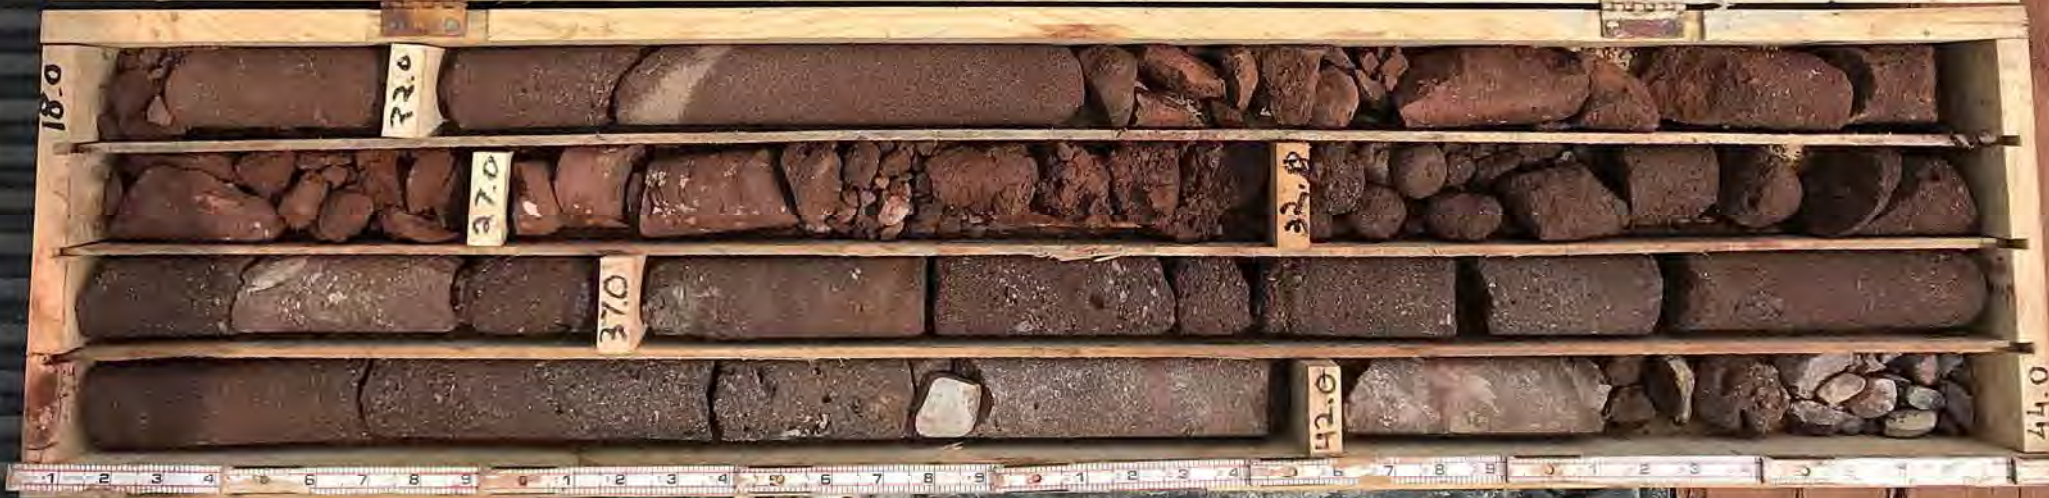
Run	Depth	rec.	R&D
1	18.0-22.0	0.65	0.40
2	22.0-27.0	3.8	0.85
3	27.0-32.0	1.6	0
4	32.0-37.0	2.45	0.35
5	37.0-42.0	5.0	4.3

Run	depth	rec.	R&D
6	42.0-47.0	2.2	1.3

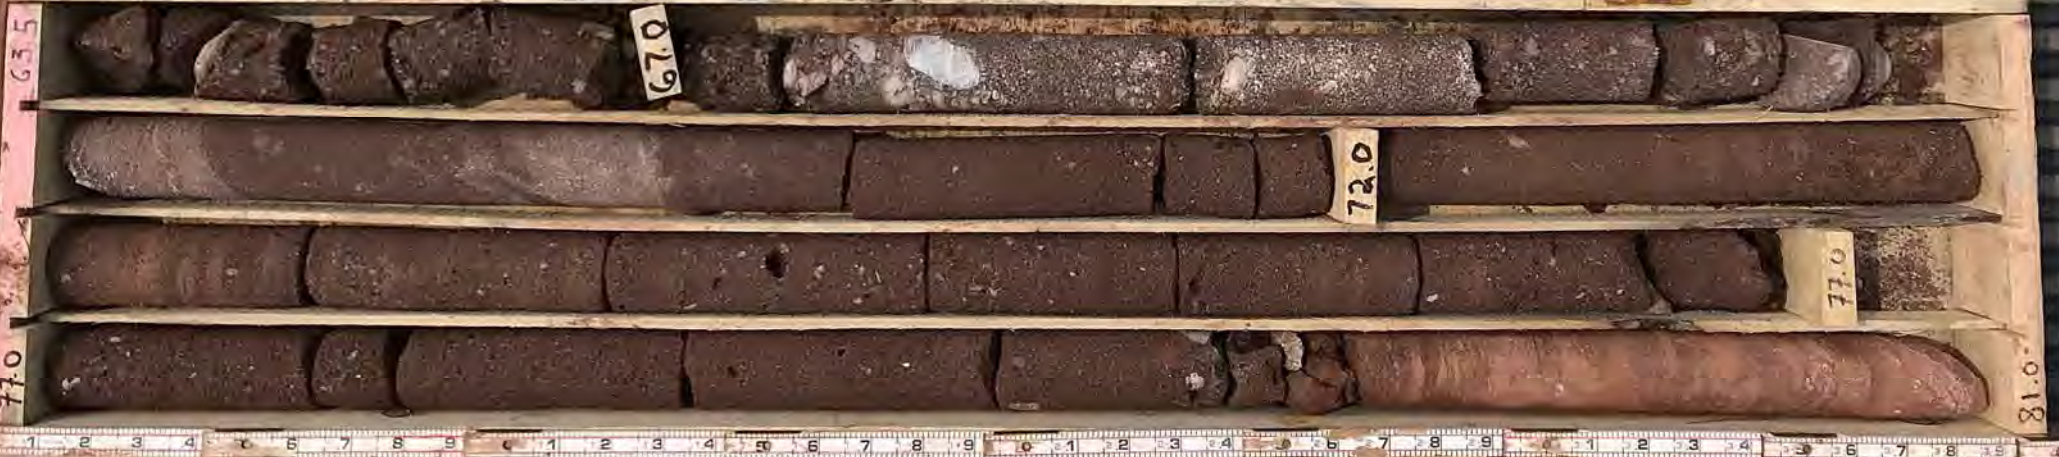
HDD Boring (B-1)
DPS # 20170830-3
PSI # 0491 1459
09/12/17
Depth: 63.5ft - 81.0ft.
Box: 3 of
Creek Rd 8 T307

Run	Depth	Rec (in)	Rqd (in)
11	67.0-72.0	60"	41"
12	72.0-77.0	55"	49"
13	77.0-82.0	57"	43"

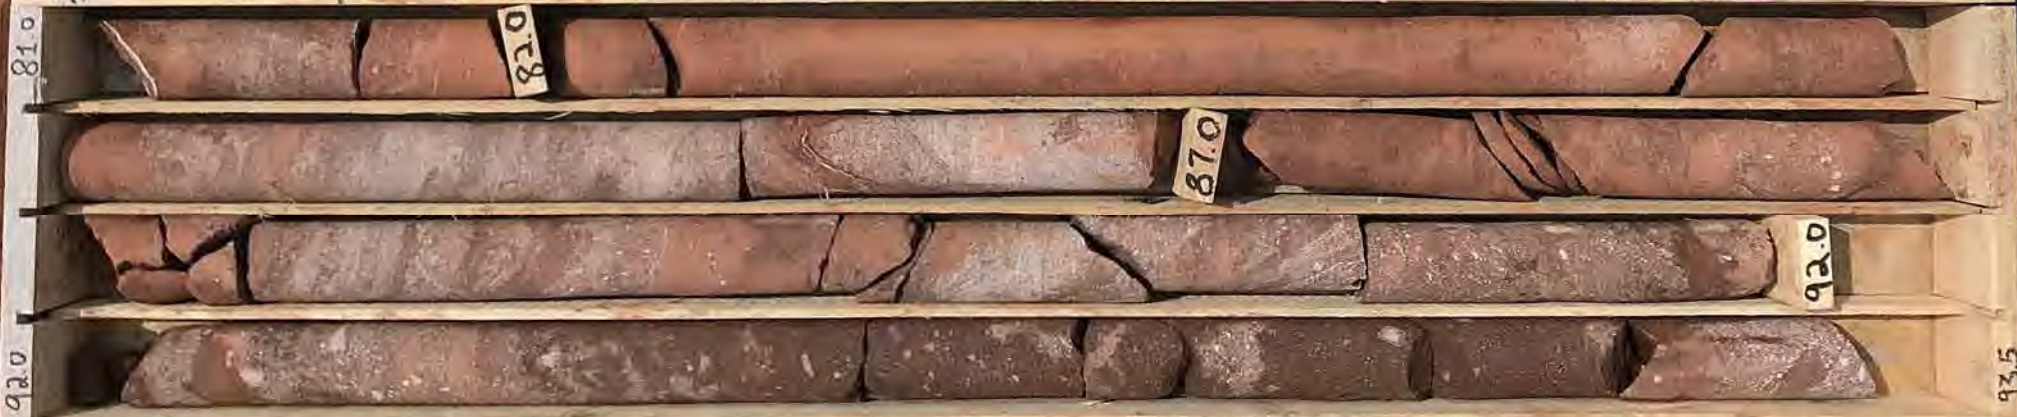
HDD Boring (B-1)
DPS # 20170830-3
PFI # 04911459
09/12/17
Depth: 81.0-93.5
Box: 40f
Creek # 2 T307

Run	Depth	Recon	Recon
14	82.0-87.0	60"	50.5"
15	87.0-92.0	60"	39.0"
16	92.0-97.0	60"	48.0"

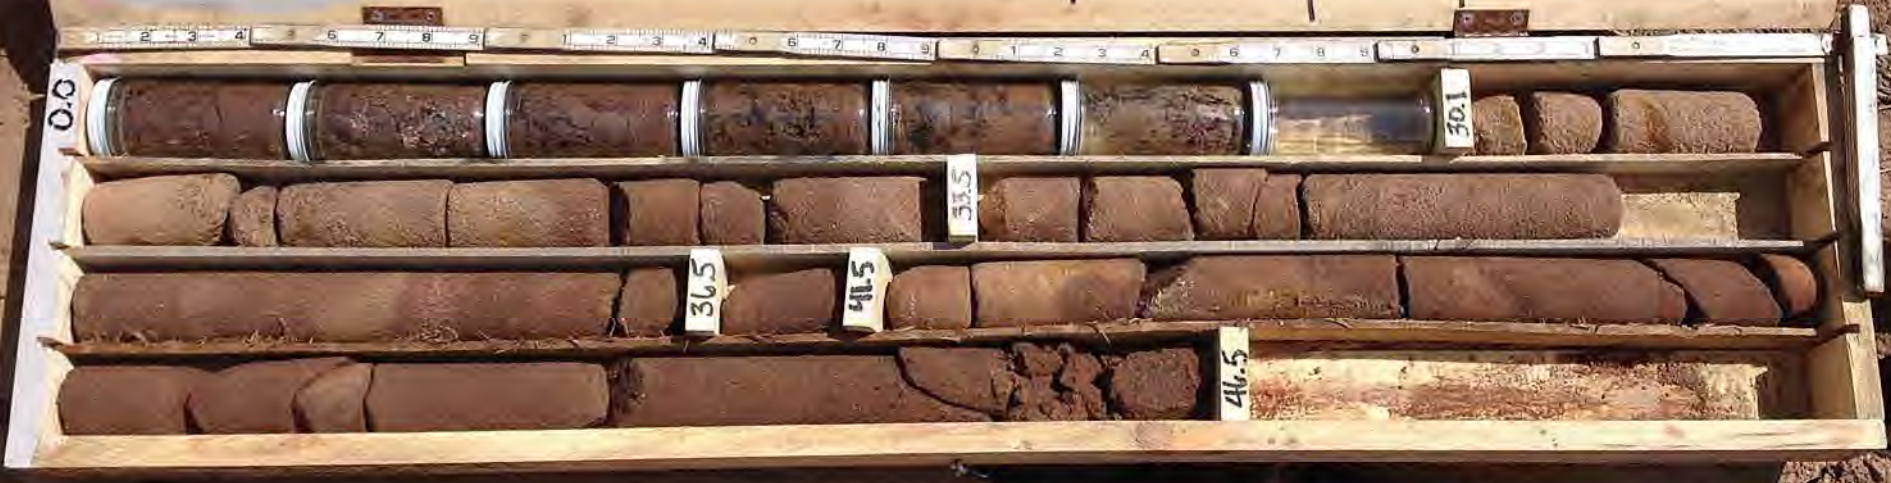
HT
02

Run	Depth	Rec	RQD
1	30.1-33.5	2.4	0.0
2	33.5-36.5	2.8	1.8
3	36.5-41.5	0.3	0.0
4	41.5-46.5	4.5	2.3

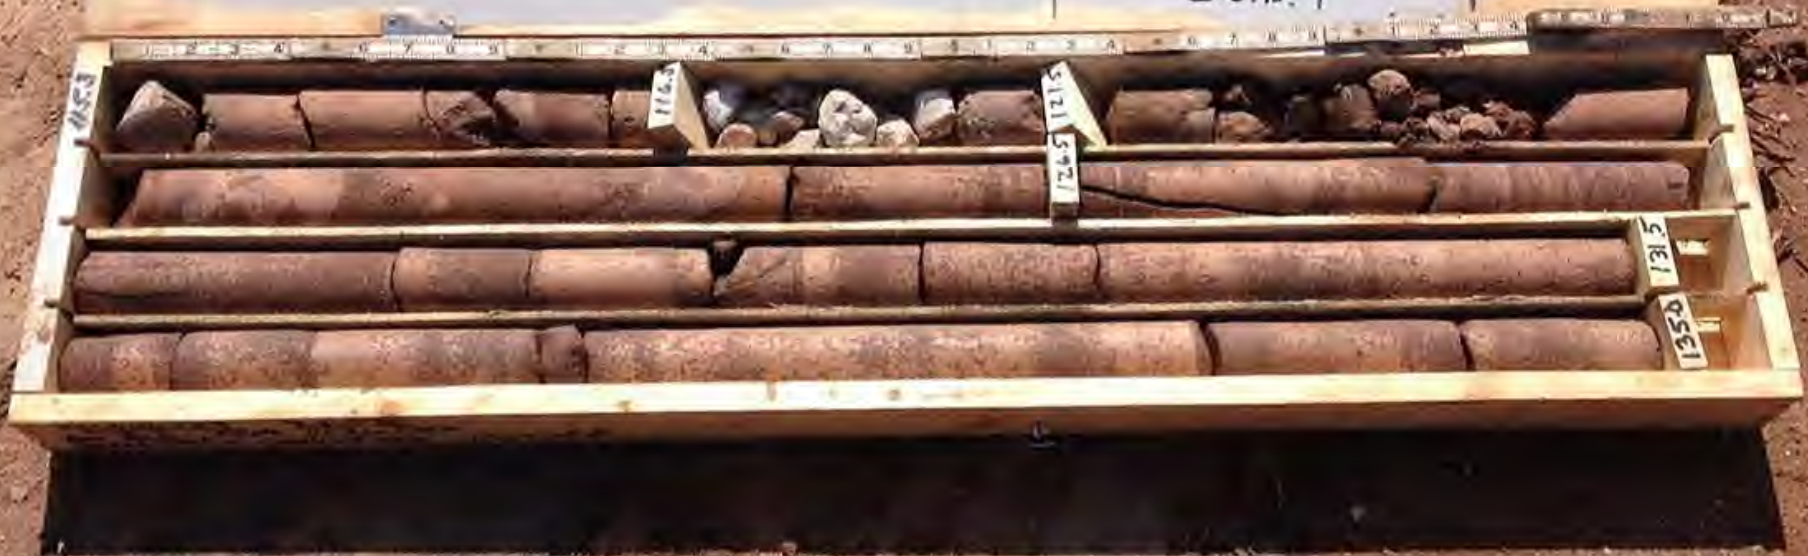
Run	Depth	RC	RQD
18	111.5 - 116.5	5.0	1.7
19	116.5 - 221.5	0.8	0.0
20	121.5 - 126.5	3.4	2.1
21	126.5 - 131.5	5.0	4.5
22	131.5 - 135.0	3.5	3.0

E.O.B.

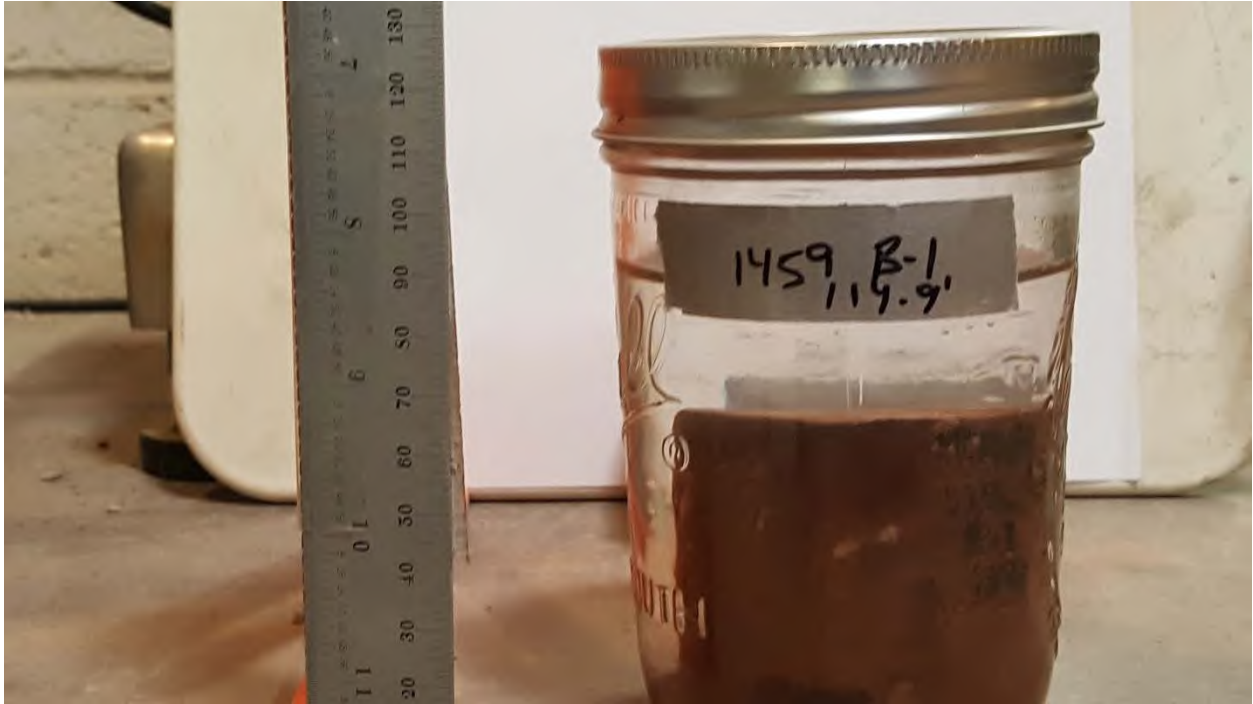
Slake Test: 04911459 B-1 114.9'

Start

2 Minutes: Slake Index 6

4 Hours: Slake Index 6

8 Hours: Slake Index 6

24 Hours: Slake Index 6

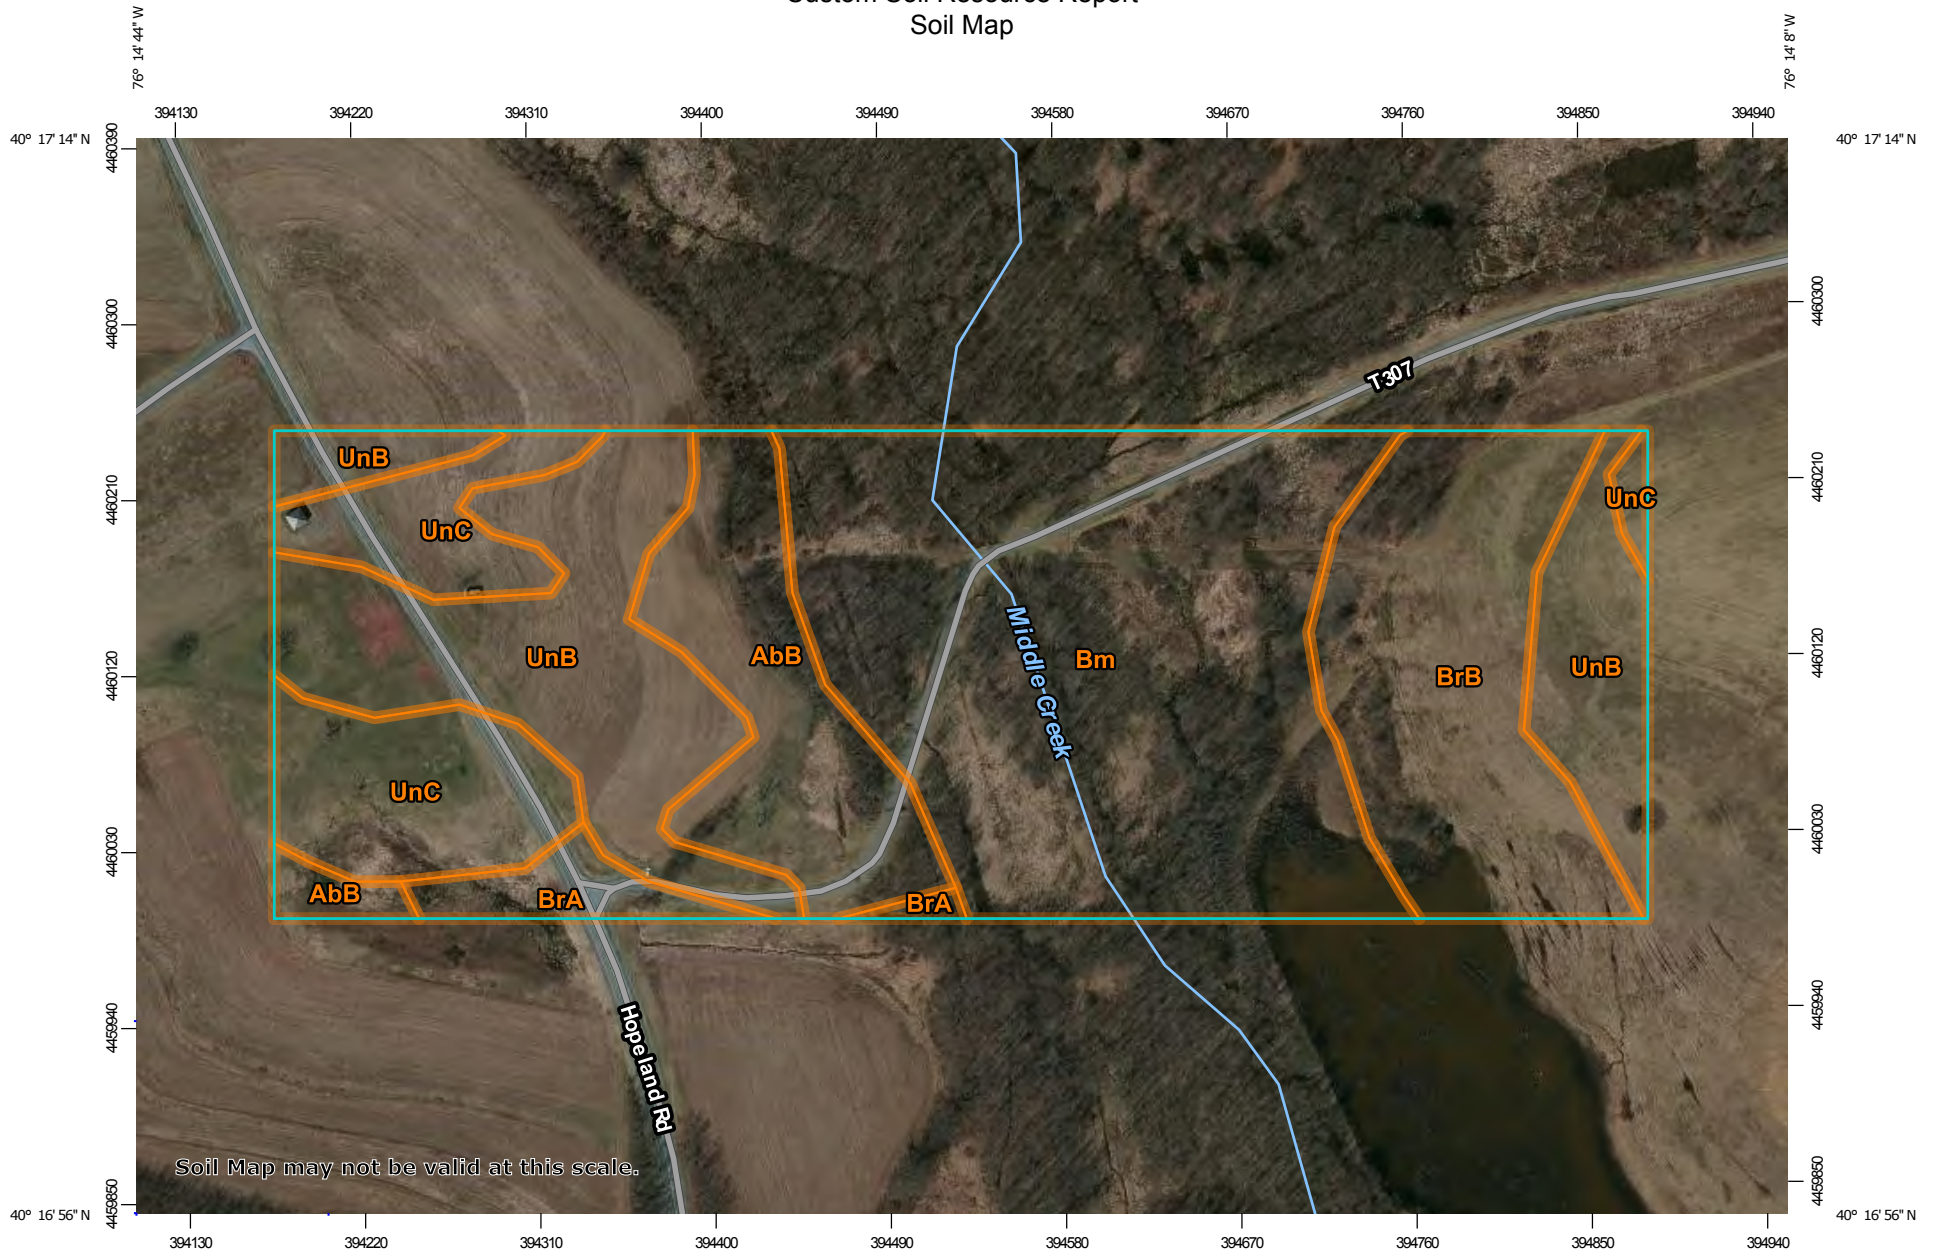
Custom Soil Resource Report Soil Map

The soil map section includes the soil map for the defined area of interest, a list of soil map units on the map and extent of each map unit, and cartographic symbols displayed on the map. Also presented are various metadata about data used to produce the map, and a description of each soil map unit.

Map Scale: 1:3,880 if printed on A landscape (11" x 8.5") sheet.
