**HORIZONTAL DIRECTIONAL DRILL ANALYSIS  
NORFOLK SOUTHERN RAILROAD CROSSING  
PADEP SECTION 105 PERMIT NO.: E65-973  
PA-WM1-0088.0000-RR  
(SPLP HDD# S1B-0250)**

This reanalysis of the horizontal directional drill (HDD) installation of a 20-inch diameter pipeline crossing under stream S199, Penn Avenue, Norfolk Southern Railroad, and Depot Street (south to north), HDD No. S1B-0250, has been completed in accordance with paragraphs 4 and 5 of the Stipulated Order (Order) issued under Environmental Hearing Board Docket No. 2017-009-L. This HDD is number 3 on the list of HDDs included on Exhibit 2 of the Order

**ORIGINAL HORIZONTAL DIRECTIONAL DRILL DESIGN SUMMARY: 20-INCH**

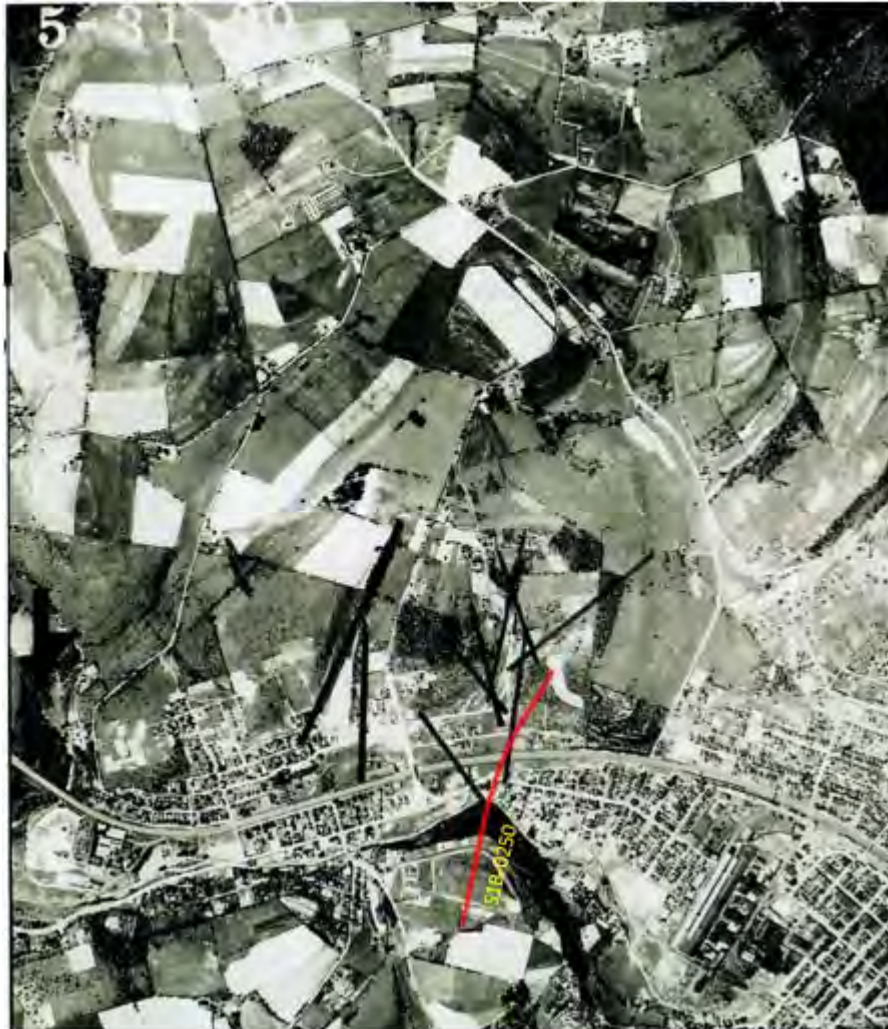
**Figure 4. Fracture Trace Map**

Figure 4 shows a fracture trace map prepared for this reevaluation. This mapping was performed using aerial stereographic pairs flown in the spring of 1939. As such, much of the land surface appears undeveloped therefore; fracture traces are more easily seen. Several fracture trace orientations are shown

on **Figure 4**. Two general sets of orientations are present in the mapped fracture traces. Most traces are oriented with trends between NNW and NNE. Two traces are oriented NW and one is oriented NE.

The proposed path of the revised boring is shown in red on **Figure 4** and two of the mapped fracture traces intersect the drill path in the middle part of the alignment.

If the revised profile is adopted for HDD S1B-0250, the results of two core borings at either entry/exit point show the drill indicate variable bedrock strength conditions will be encountered with depth. Two fracture traces cross the path of the drill as well, indicating potential for weaker rock zones. Trenching does not appear to be a viable alternative as the excavation would have to cross Brush Creek, Penn Avenue, the Norfolk Southern Railroad, and Depot street. The drilling plan for this HDD should account for this variability. North of Station 14+00 on the revised profile the proposed path for the 20-inch line is not that much deeper than the ME I 12-inch line and IRs occurred at stations 13+50 and 12+20 during installation of the 12-inch line. Due to rock conditions and drilling history for this site, an elevated level of IR inspection is warranted, especially at Brush Creek. Although the pre-construction 150-foot survey and PAGWIS search did not identify local water users, the alignment of HDD S1B-0250 is in close proximity to residential dwellings along several roadways in Jeanette; therefore, a door-to-door survey should be implemented to determine the presence or absence of any domestic water supplies that could potentially be impacted by HDD activities.

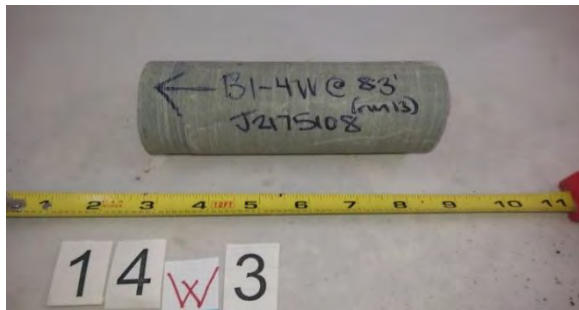
Before the Test

Lithology : Siltstone  
 Moisture Content : As received  
 Lab Temperature : 70° F  
 Loading Rate: 55 psi/s  
 Time to Failure: 0 min

Maximum Axial Load at Failure: N/A lb  
 Compressive Strength: N/A psi  
 Compressive Strength: N/A Mpa  
 Unit Weight: N/A pcf

Specimen broke during preparation

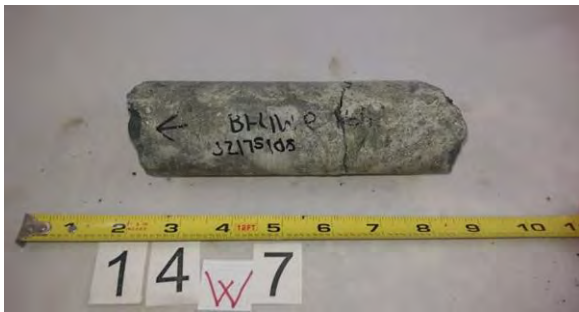
Before the Test

Lithology : Siltstone  
 Moisture Content : As received  
 Lab Temperature : 70° F  
 Loading Rate: 55 psi/s  
 Time to Failure: 0 min

Maximum Axial Load at Failure: N/A lb  
 Compressive Strength: N/A psi  
 Compressive Strength: N/A Mpa  
 Unit Weight: N/A pcf

Specimen broke during preparation

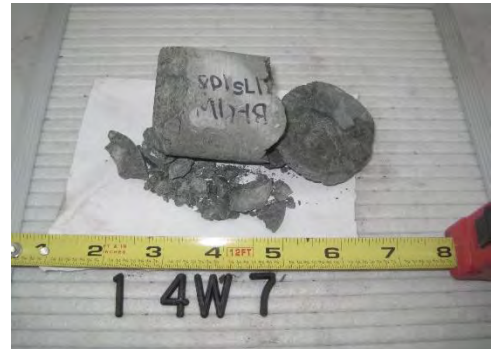
After the Test

Lithology : Mudstone  
 Moisture Content : As received  
 Lab Temperature : 70° F  
 Loading Rate: 55 psi/s  
 Time to Failure: 0 min

Maximum Axial Load at Failure: N/A lb  
 Compressive Strength: N/A psi  
 Compressive Strength: N/A Mpa  
 Unit Weight N/A pcf

Specimen broke during preparation. Target depth range is too fractured to assign second test.

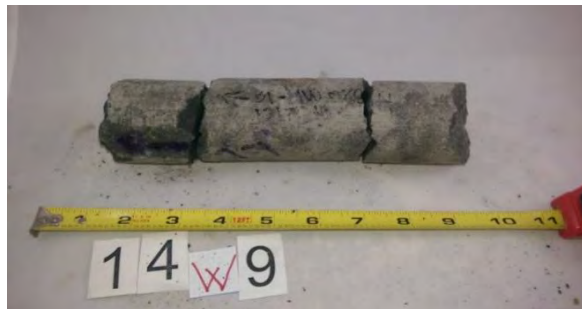
Before the Test

Lithology : Siltstone  
 Moisture Content : As received  
 Lab Temperature : 70° F  
 Loading Rate: 55 psi/s  
 Time to Failure: 0 min

Maximum Axial Load at Failure: N/A lb  
 Compressive Strength: N/A psi  
 Compressive Strength: N/A Mpa  
 Unit Weight: N/A pcf

Specimen broke during preparation

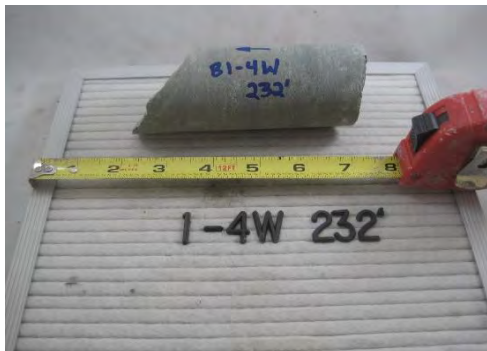
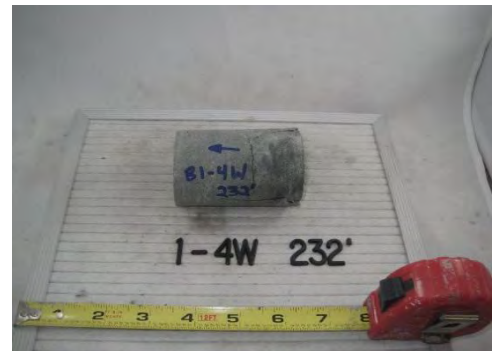
Lithology : Siltstone  
 Moisture Content : As received  
 Lab Temperature : 70° F  
 Loading Rate: 55 psi/s  
 Time to Failure: 10 min

Maximum Axial Load at Failure: 34,210 lb  
 Compressive Strength: 10,999 psi  
 Compressive Strength: 75.84 Mpa  
 Unit Weight 167 pcf

Comments : Due to lack of available specimens, the length to diameter ratio of the tested specimen is not conformant with ASTM D7012. The results obtained during testing may differ from those obtained from the test specimens that meet the requirements.

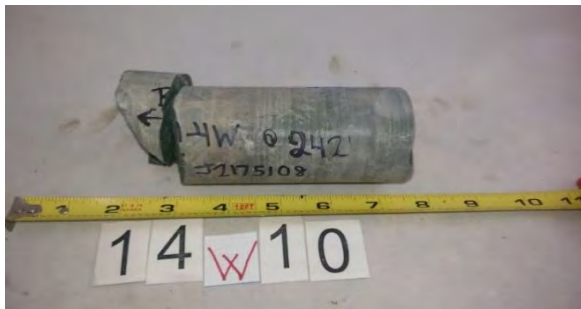
Before the Test

Lithology : Siltstone  
 Moisture Content : As received  
 Lab Temperature : 70° F  
 Loading Rate: 55 psi/s  
 Time to Failure: 0 min

Maximum Axial Load at Failure: N/A lb  
 Compressive Strength: N/A psi  
 Compressive Strength: N/A Mpa  
 Unit Weight: N/A pcf

Specimen broke during preparation

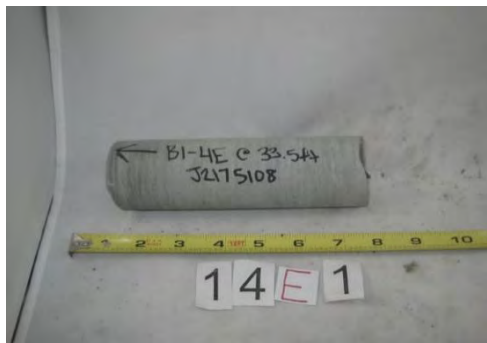
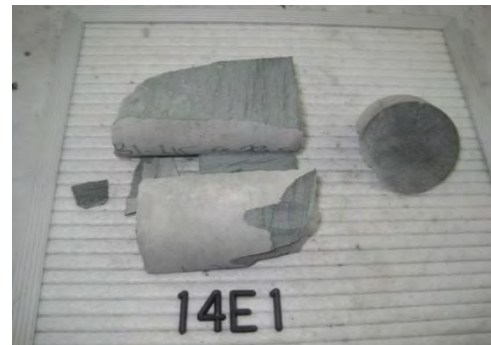
Lithology : Mudstone  
 Moisture Content : As received  
 Lab Temperature : 70° F  
 Loading Rate: 55 psi/s  
 Time to Failure: 11 min

Maximum Axial Load at Failure: 35,890 lb  
 Compressive Strength: 11,656 psi  
 Compressive Strength: 80.37 Mpa  
 Unit Weight 159 pcf

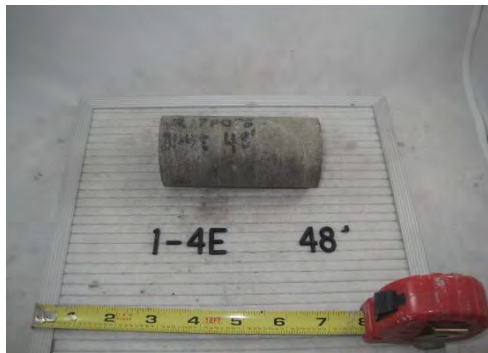
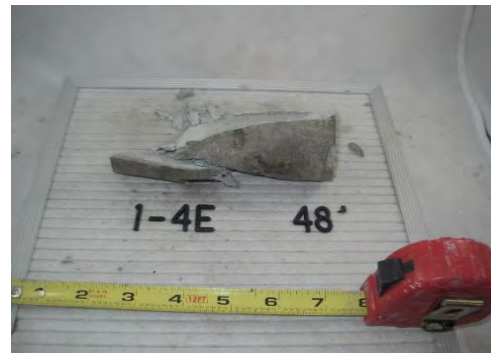
Lithology : Sandstone  
 Moisture Content : As received  
 Lab Temperature : 70° F  
 Loading Rate: 55 psi/s  
 Time to Failure: 9 min

Maximum Axial Load at Failure: 29,860 lb  
 Compressive Strength: 9,796 psi  
 Compressive Strength: 67.54 Mpa  
 Unit Weight 159 pcf

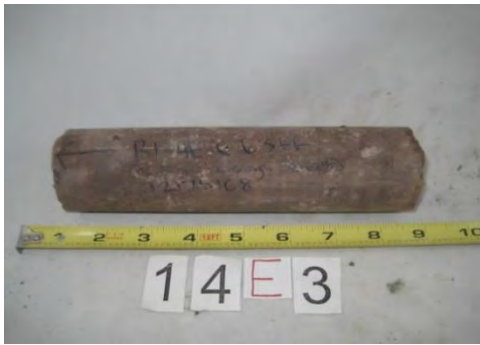
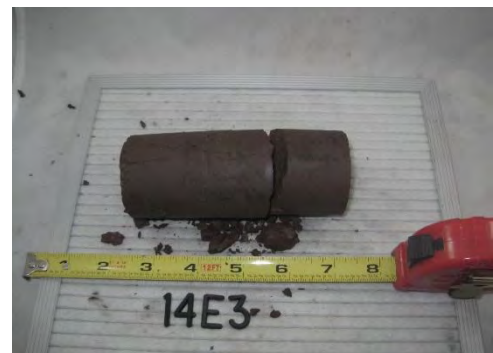
Lithology : Mudstone  
 Moisture Content : As received  
 Lab Temperature : 70° F  
 Loading Rate: 55 psi/s  
 Time to Failure: 2 min

Maximum Axial Load at Failure: 7,910 lb  
 Compressive Strength: 2,569 psi  
 Compressive Strength: 17.71 Mpa  
 Unit Weight 163 pcf

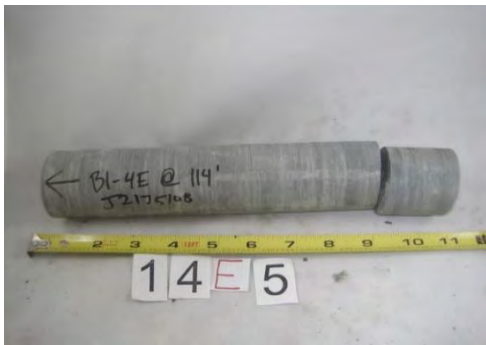
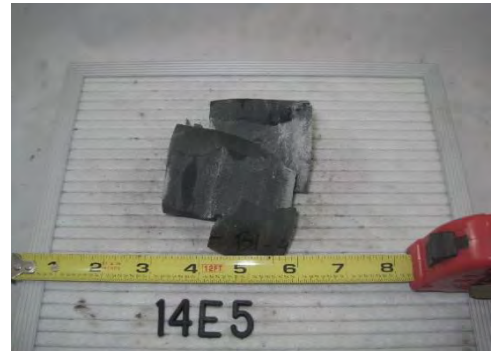
Comments : Due to lack of available specimens, the length to diameter ratio of the tested specimen is not conformant with ASTM D7012. The results obtained during testing may differ from those obtained from the test specimens that meet the requirements.

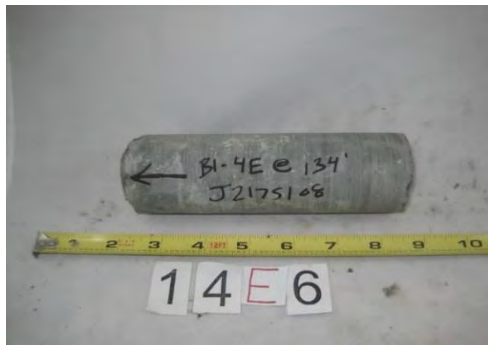
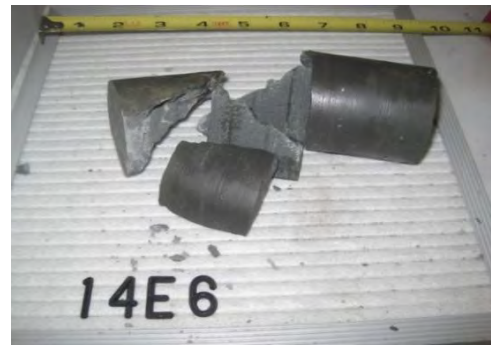
Maximum Axial Load at Failure: 21,720 lb  
 Compressive Strength: 7,054 psi  
 Compressive Strength: 48.64 Mpa  
 Unit Weight 169 pcf

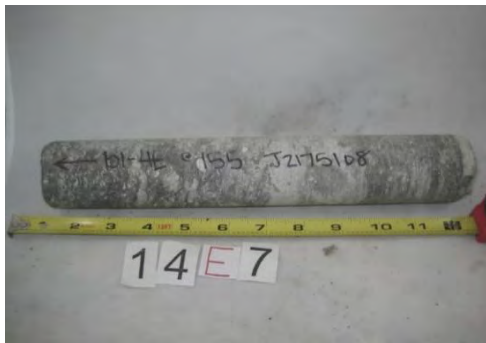
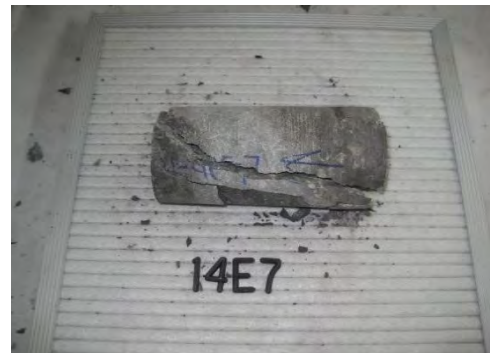
Maximum Axial Load at Failure: 19,610 lb  
 Compressive Strength: 6,369 psi  
 Compressive Strength: 43.91 Mpa  
 Unit Weight 166 pcf

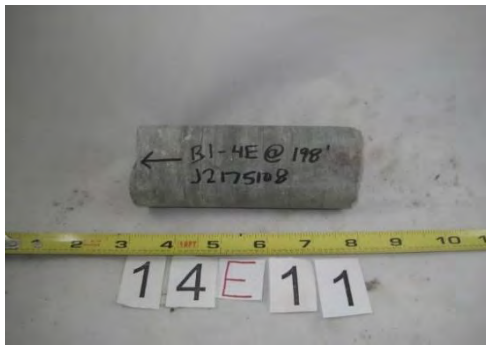
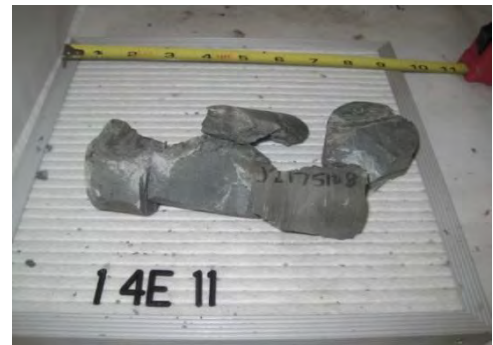
Maximum Axial Load at Failure: 14,800 lb  
 Compressive Strength: 4,807 psi  
 Compressive Strength: 33.14 Mpa  
 Unit Weight 169 pcf
