**HORIZONTAL DIRECTIONAL DRILL ANALYSIS
OLD MILL ROAD CROSSING
PADEP SECTION 105 PERMIT NO.: E34-136
PA-JU-0004.0000-WX-16
(SPLP HDD No. S2-0156-16)**

**OLD MILL ROAD CROSSING
PADEP SECTION 105 PERMIT NO.: E34-136
PA-JU-0004.0000-WX-16
(SPLP HDD No. S2-0156-16)**

This reevaluation of the horizontal directional drill (HDD) installation of a 16-inch diameter pipeline that traverses under Old Mill Road/Berry Ridge Road, Tuscarora Creek (Stream K-74) and associated emergent and forested wetlands (WK-59, WK-60) in Juniata County, Lack Township, Pennsylvania has been completed in accordance with Condition No. 3 of the Stipulated Order issued under Environmental Hearing Board Docket No. 2017-009-L. Condition No. 3 stipulates, for HDDs initiated after the temporary injunction issued by the Pennsylvania Department of Environmental Protection (PADEP) Environmental Hearing Board on July 25, 2017, a reanalysis must be performed on HDDs for which an inadvertent return (IR) occurs during the installation of one pipe (20-inch or 16-inch diameter) where a second pipe will thereafter be installed in the same right-of-way (ROW).

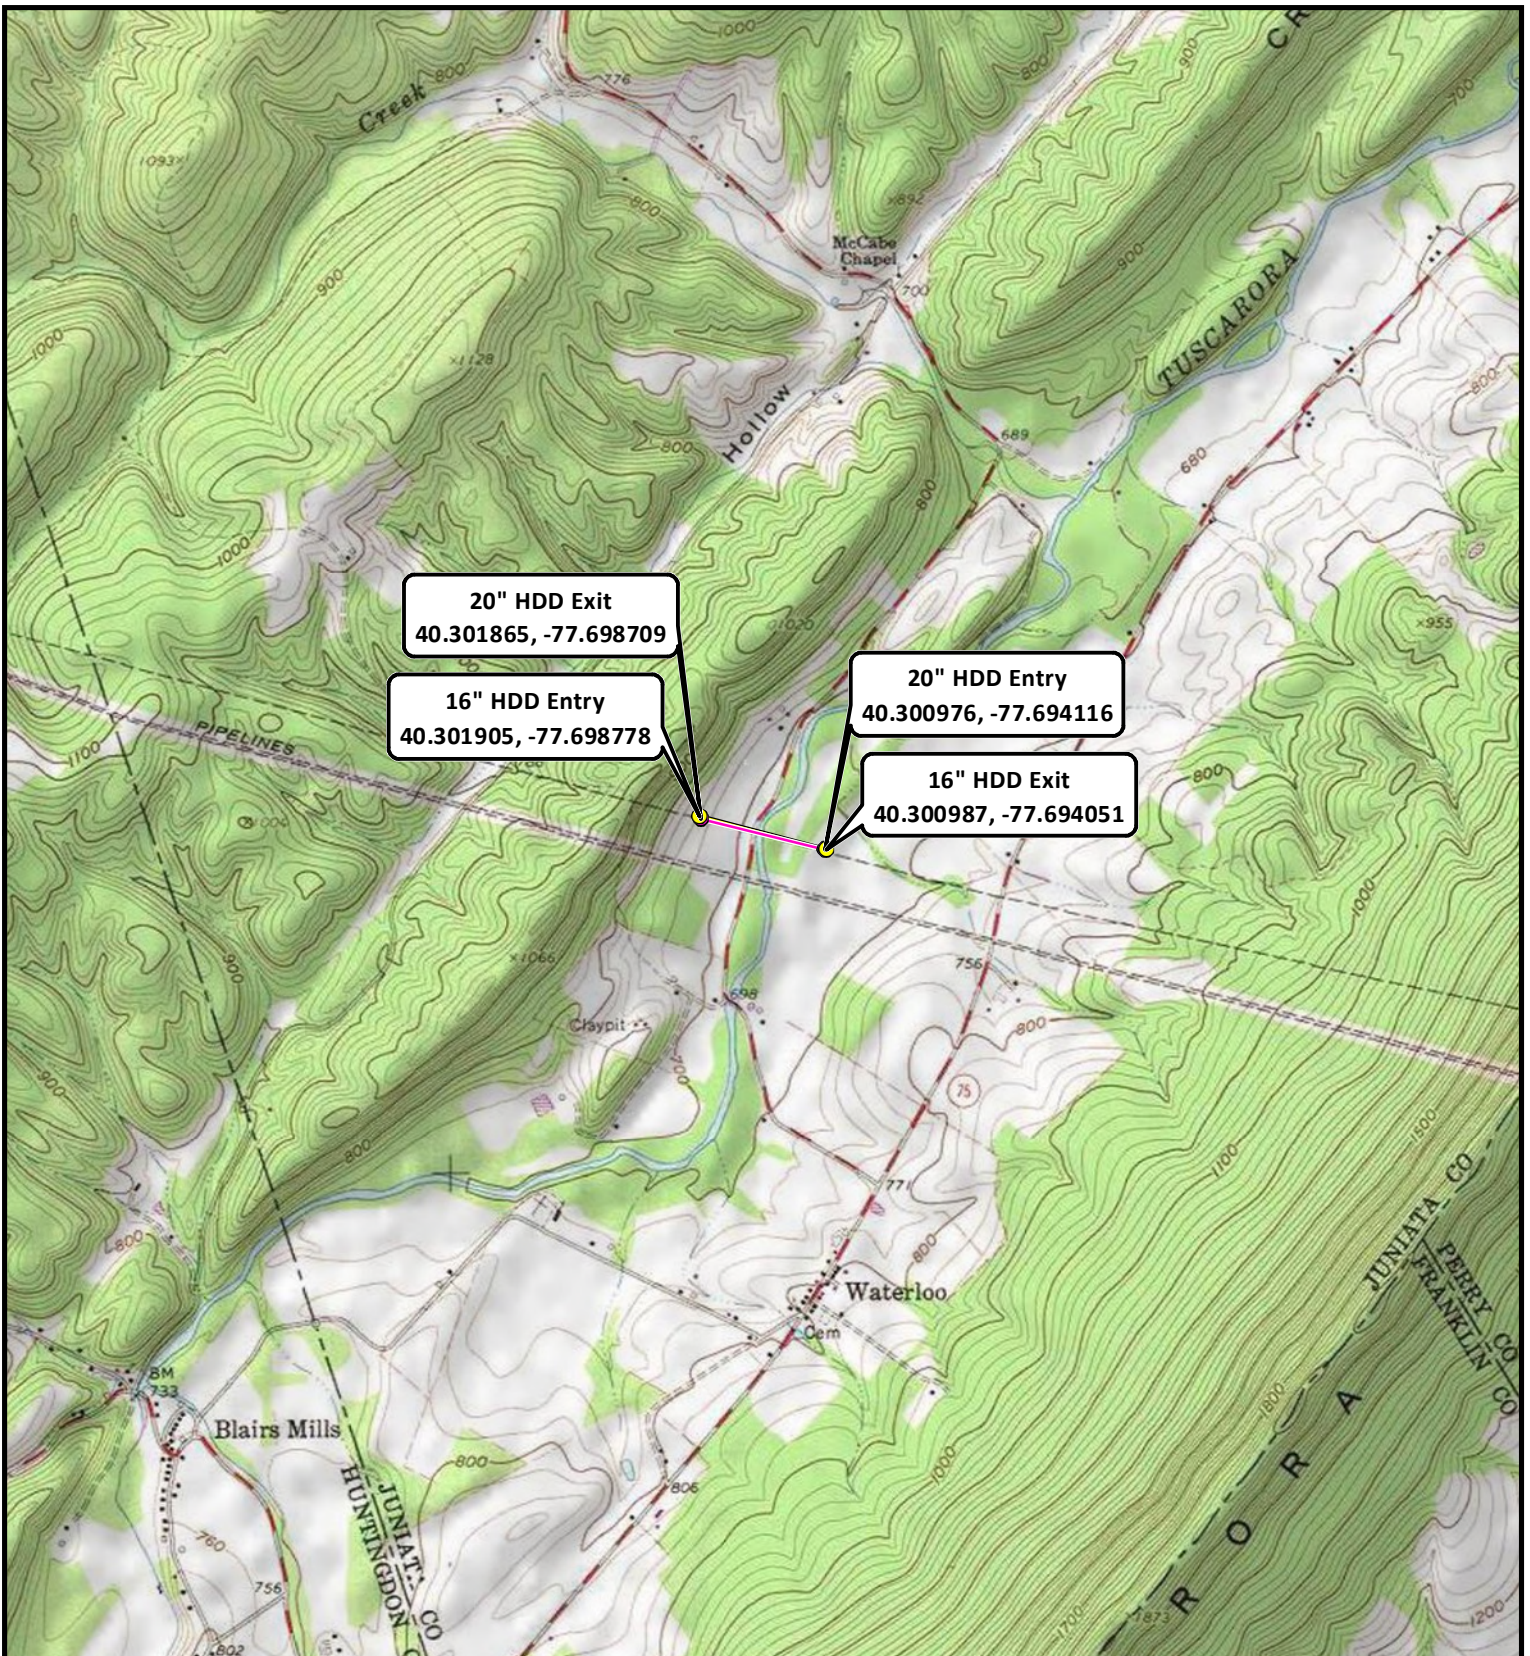
Figure 1 - Topographic Basemap
 Lack Township, Juniata County, PA
 Project No. 096302011

- 16" HDD Entry/Exit
- 20" HDD Entry/Exit
- 16" HDD Profile
- 20" HDD Profile

Sunoco Pipeline, L.P.
Old Mill Road / S.R. 3025 HDD Location

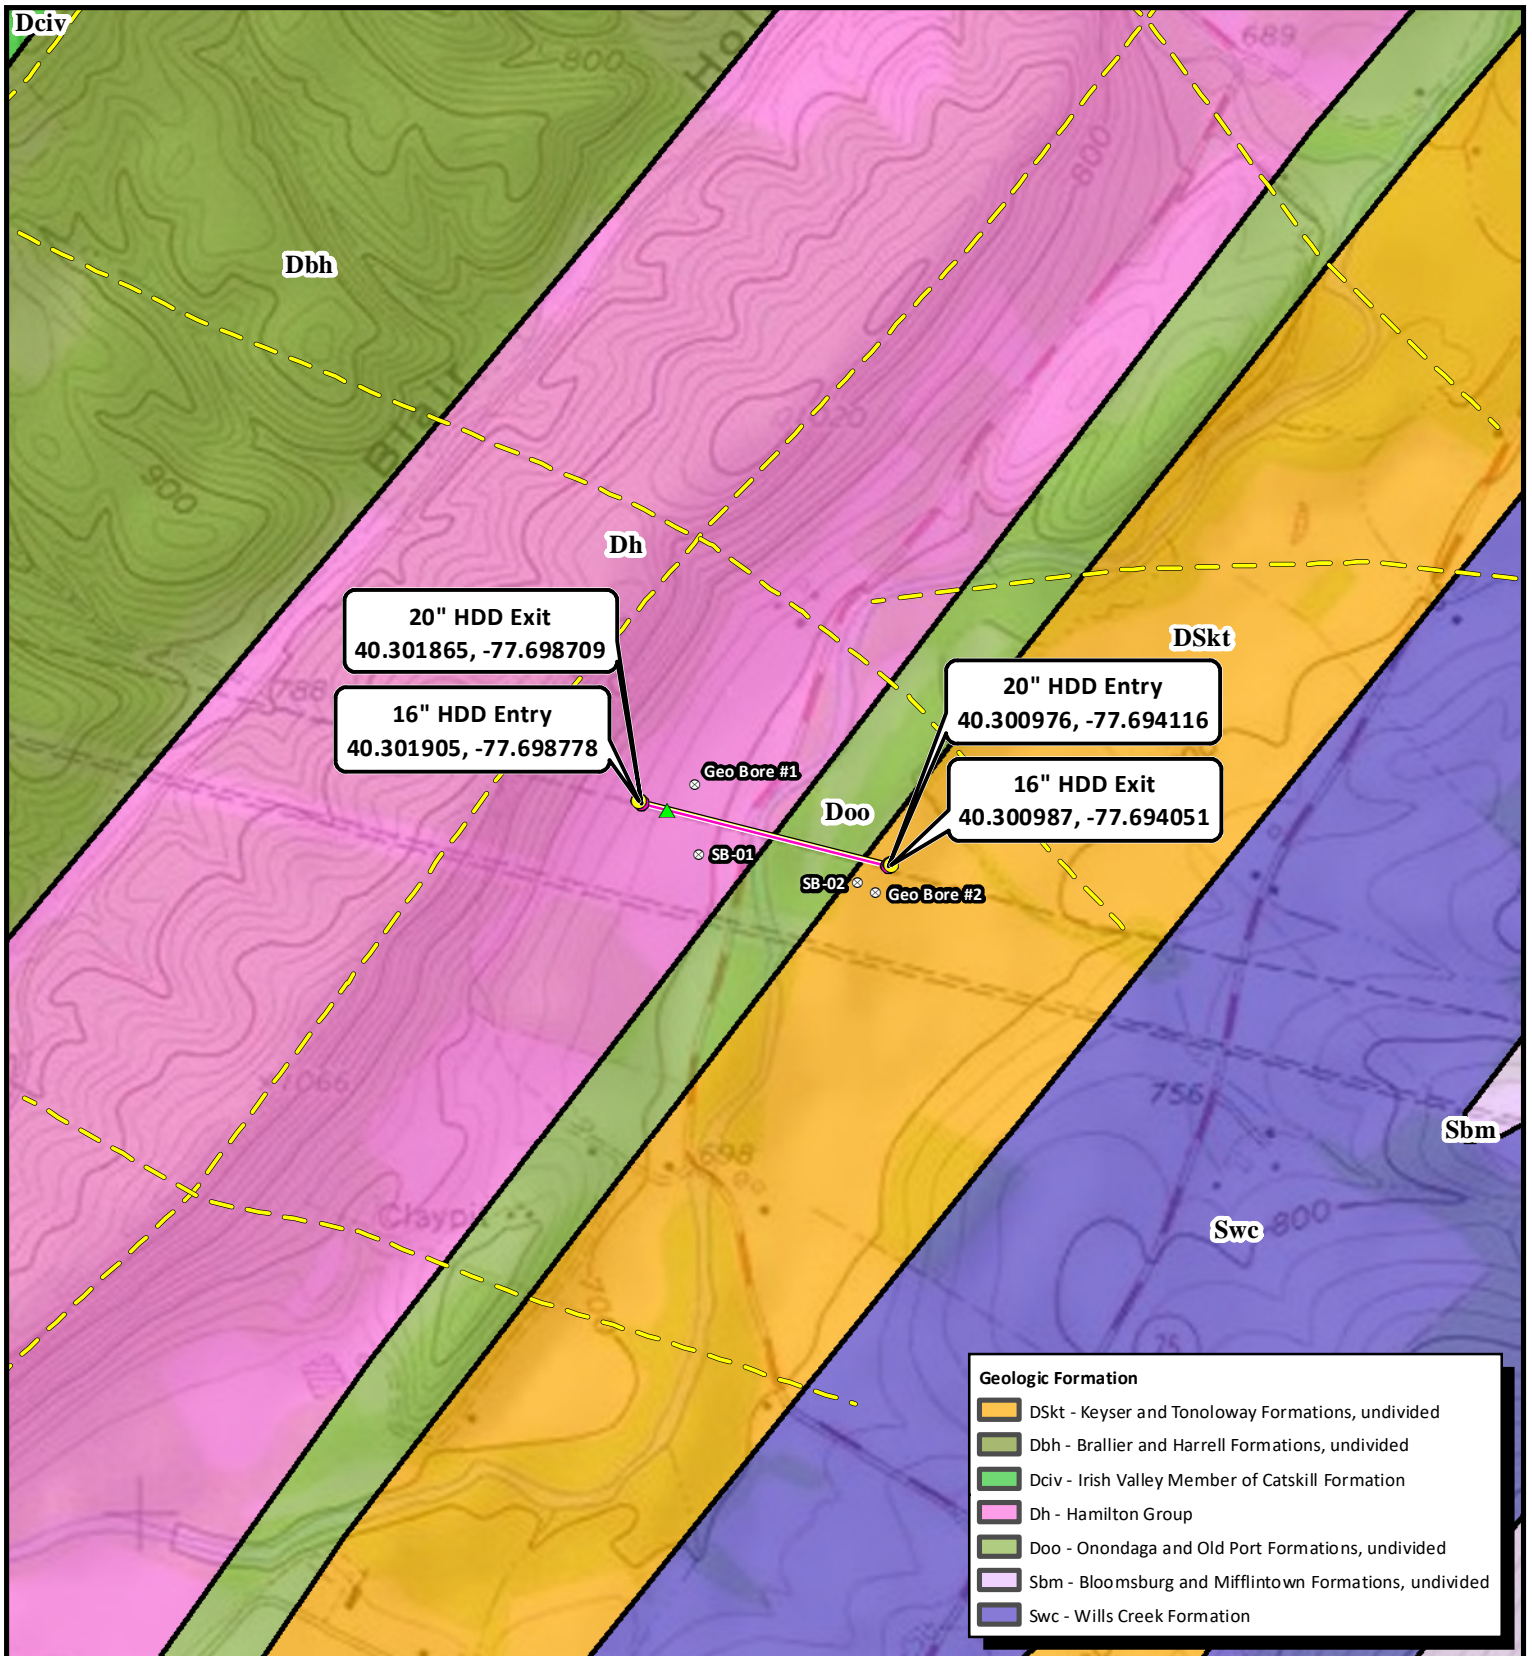
Figures 2 and 3 show the results of the fracture trace analysis overlain on the geologic map and aerial base map, respectively. Six fracture traces were identified in close proximity to the proposed Old Mill HDD that are likely related to the primary geologic structure of the area. Due to the nature of the ridges and folded geology near the site, the most prominent fracture trace trends approximately northeast-southwest (NE-SW) and perpendicular to the HDD alignment. Additional fracture traces were identified in an approximately northwest-southeast (NW-SE) orientation crossing the prominent fracture trace and generally parallel to the HDD alignment. Fracture lineaments are presumed to be stress-related joint sets. General surface drainage patterns near the site are characterized by linear stream reaches trending NE-SW that reflect the local geologic structure.

▲ Inadvertent Return	— 16" HDD Profile
⊙ Soil Boring	— 20" HDD Profile
● 16" HDD Entry/Exit	- - - Inferred Fracture Trace
● 20" HDD Entry/Exit

Fracture traces underlying, or in close proximity to, the Old Mill Road HDD were evaluated using historical aerial photographs from the years 1993 through 2016 (Google Earth, 2017), the Blairs Mills, PA USGS 7.5 Minute Quadrangle Topographic Map and the Geologic Map of the Blairs Mills Quadrangle (Berg and Dodge, 1981). The aerial photographs and maps were used to approximate locations of natural linear features or lineaments expressed on the ground surface. The linear features may be the surficial representation of deeper fractures, joints, faults or bedding planes within the subsurface which can transmit groundwater through the fractured bedrock aquifer underlying the Old Mill HDD.

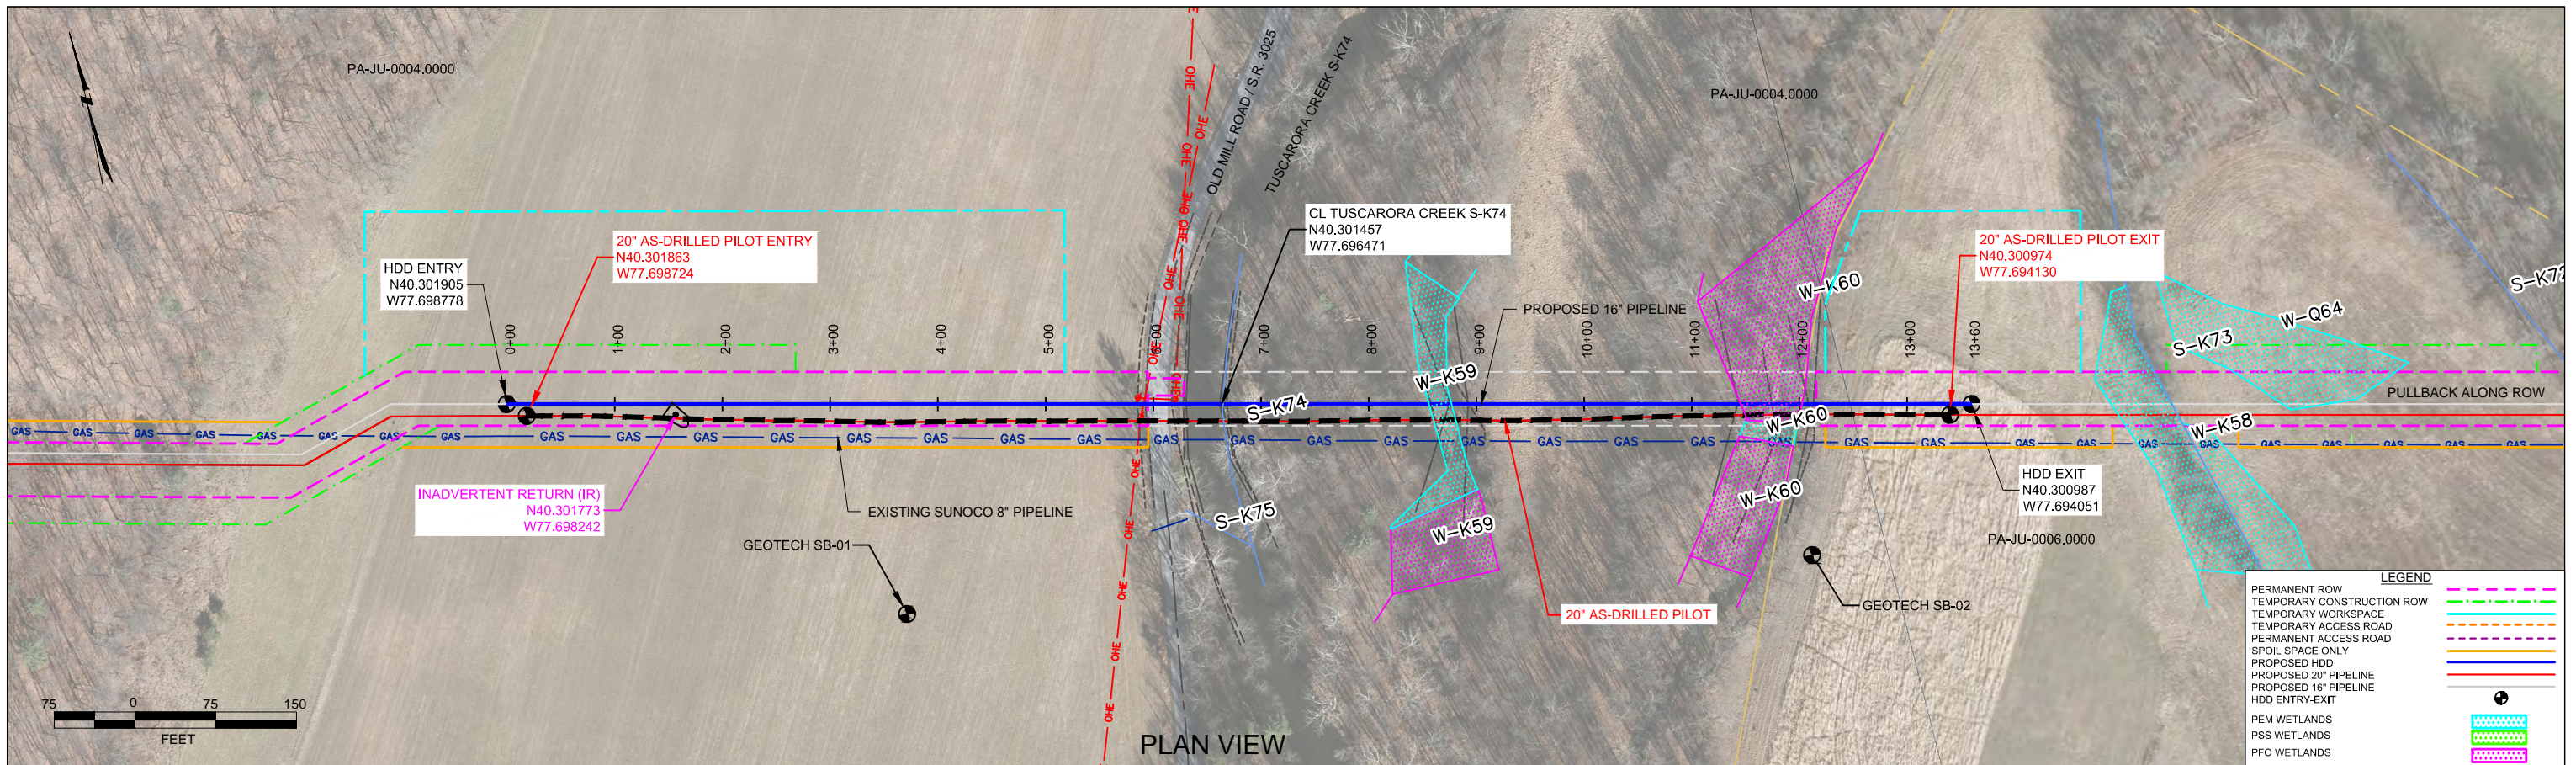
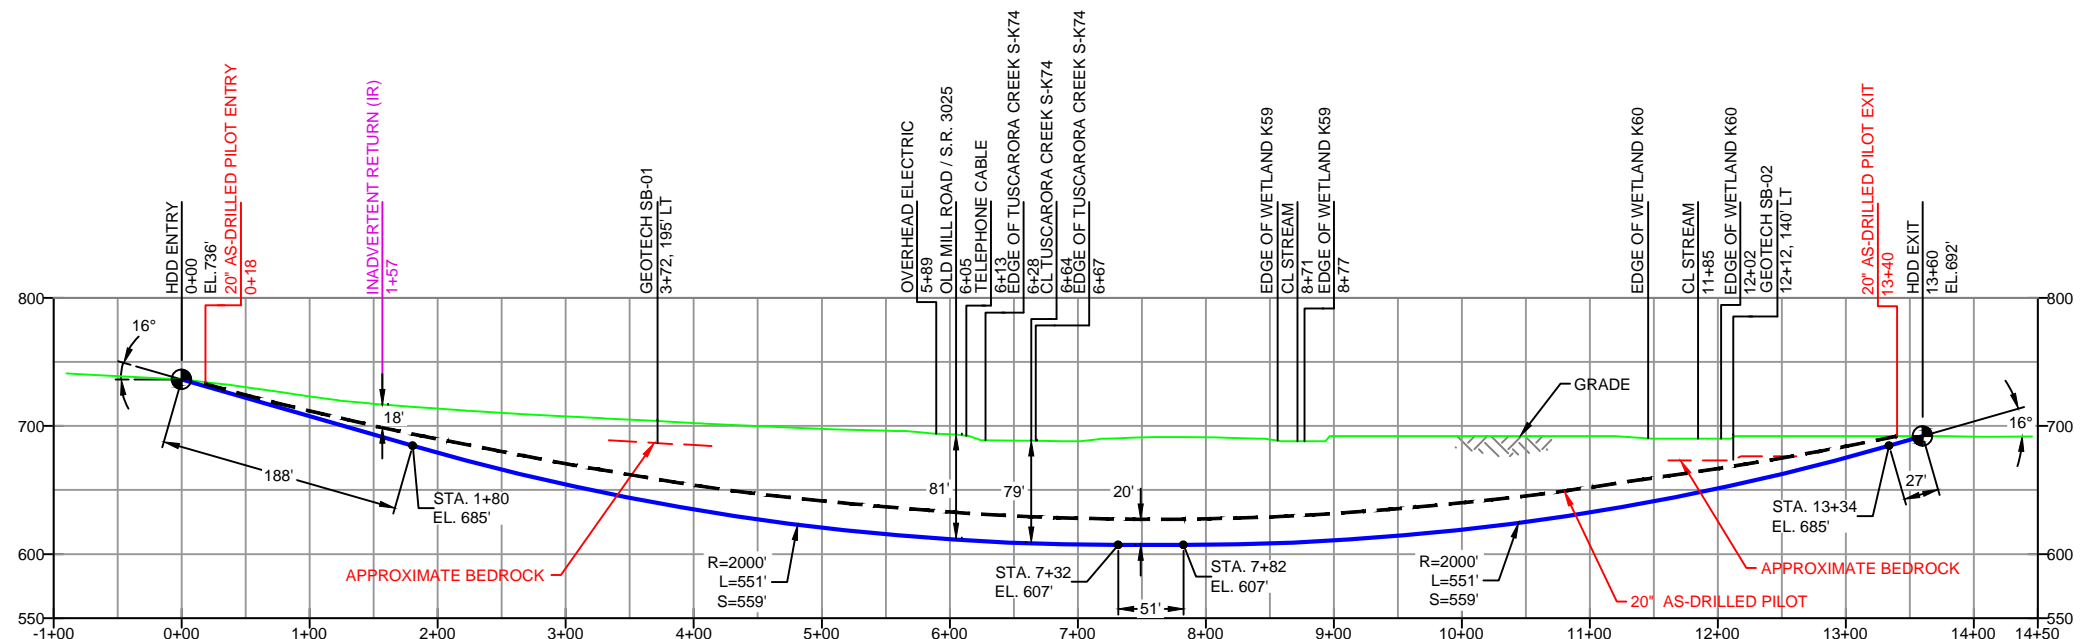
SCALE: 1"=150'
DWG. NO: PA-JU-0004.0000-WX-16

JUNIATA COUNTY PENNSYLVANIA, LACK TOWNSHIP
S2-0156-16

PROFILE VIEW

16-INCH HORIZONTAL DIRECTIONAL DRILL
OLD MILL ROAD / S.R. 3025
PENNSYLVANIA PIPELINE PROJECT

- Horizontal length: 860 foot (ft)
- Entry/Exit angle: 7-10 degrees
- Maximum Depth of cover: 44 ft
- Depth below Tuscarora Creek: 25 ft
- Pipe design radius: 1,600 ft

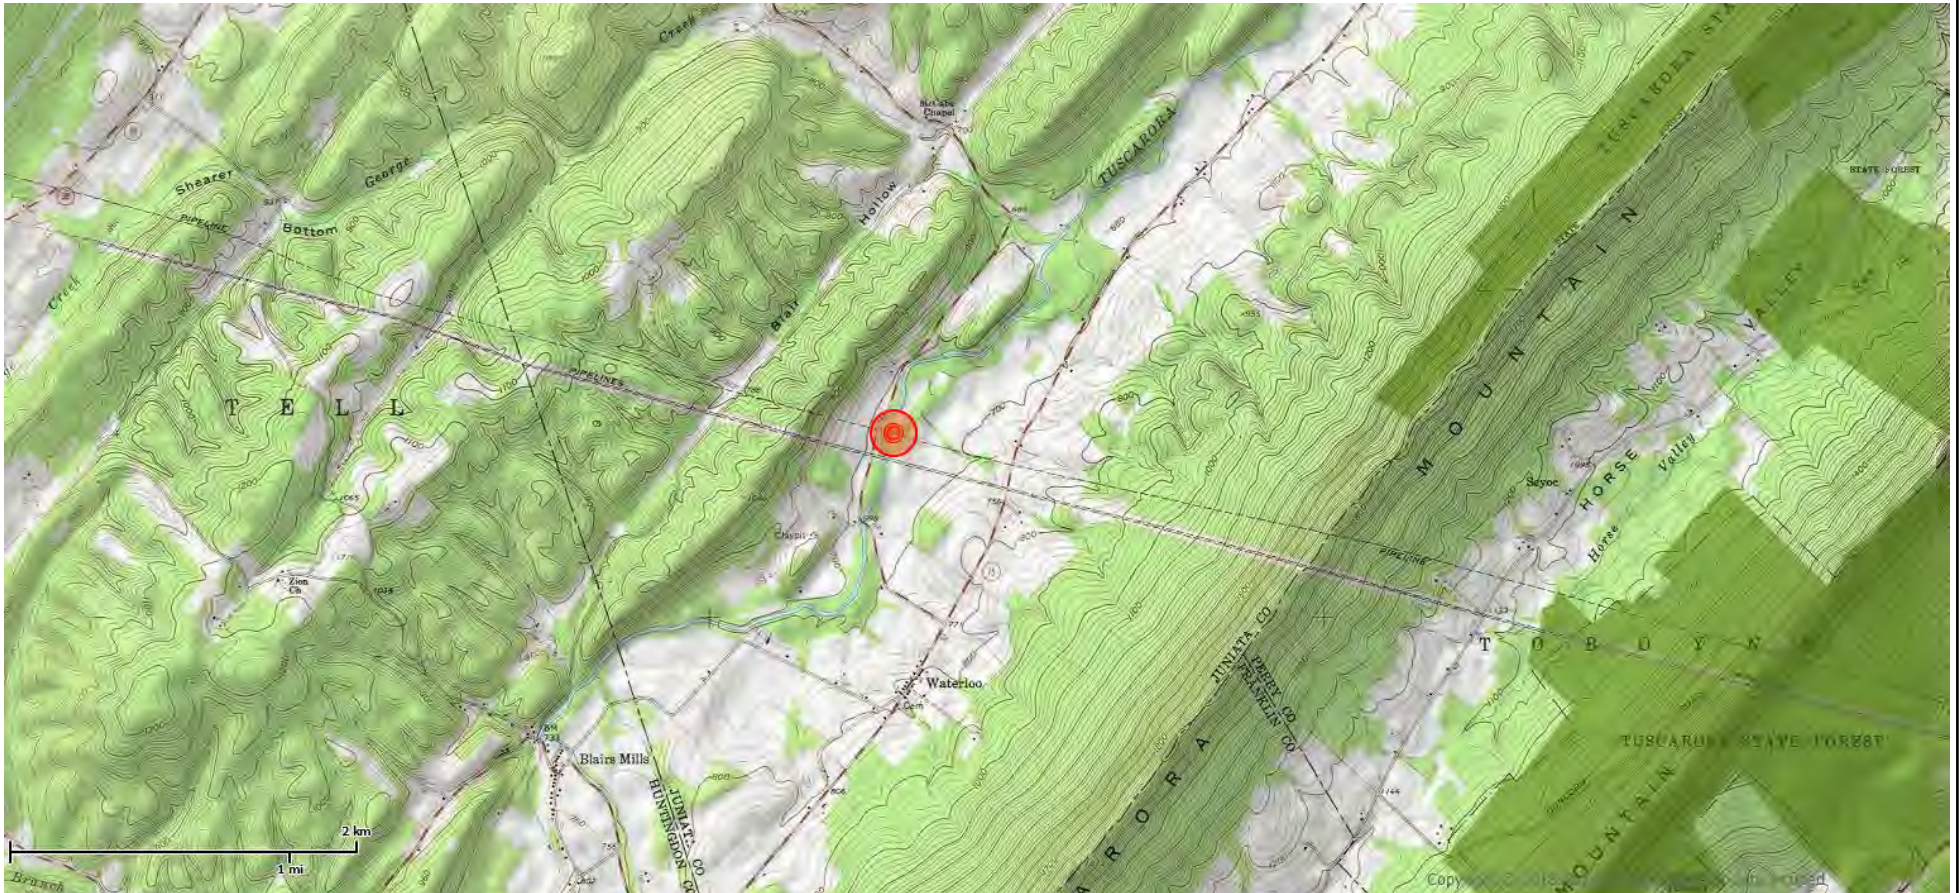
**FIGURE 2: Boring Location Plan
Berry Ridge Road - PPP3
DPS PO # 20170922-1
PSI Project # 08031076**

**GEO BORE #1
(120 FT)**

**GEO BORE #2
(120 FT)**

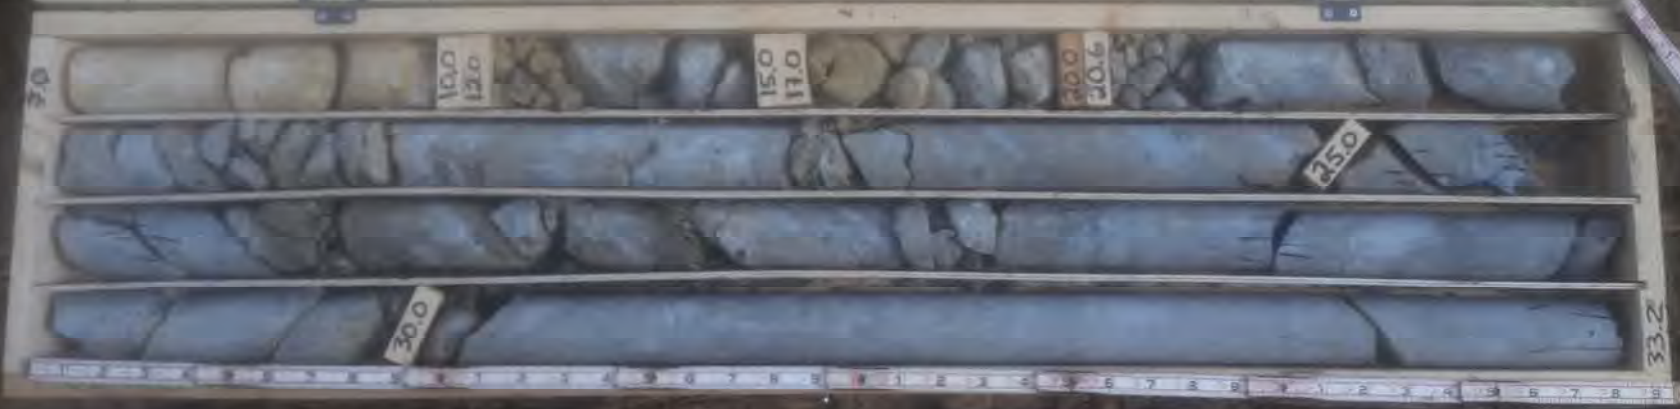
PSI # 08031076 9/28/17
 B-2 Box 1 of 7 Depth 7.0 to 33.2
 PPP#3 PA-JV-0004.0000-WX-16

Run	Depth	ReC	RSD	
R-1	7.0 - 10.0	0.7	0.4	Conds
R-2	12.0 - 15.0	0.7	0.0	Conds
R-3	17.0 - 20.0	0.6	0.0	Conds
R-4	20.6 - 25.0	4.3	1.6

- **Boring B-02:** B-02 was completed to a total depth of 120 feet bgs. From 20.6 to 120 feet bgs gray to light blue gray, very fine grained, very thin to thick bedded, weathered to slightly weathered, moderately hard to hard LIMESTONE with shallow to very steeply dipping bedding joints with calcite veins were observed. A moderately to completely weathered zone was encountered from 20.6 to 23 feet bgs. Weathered zones were observed between 35 to 40, 50 to 55, 75 to 80, 105 to 110, and 115 to 120 feet bgs, and solution activity was observed between 40 to 50, 60 to 70, 75 to 80 and 115 to 120 feet bgs. Discrete zones of solution activity were observed between 90.8 to 91.5 and 98.5 to 98.9 feet bgs. A 1-foot tool drop, indicative of a soft weathered or solutioned zone, occurred between 55 and 60 feet bgs, while a 2-foot tool drop occurred between 60 and 65 feet bgs. Rock recoveries ranged from 36 to 100%, while rock quality designations (RQDs) ranged from very poor (0%) to excellent (100%). Groundwater was observed at 2.25 feet bgs at the completion of coring operations (5.18 feet before coring).

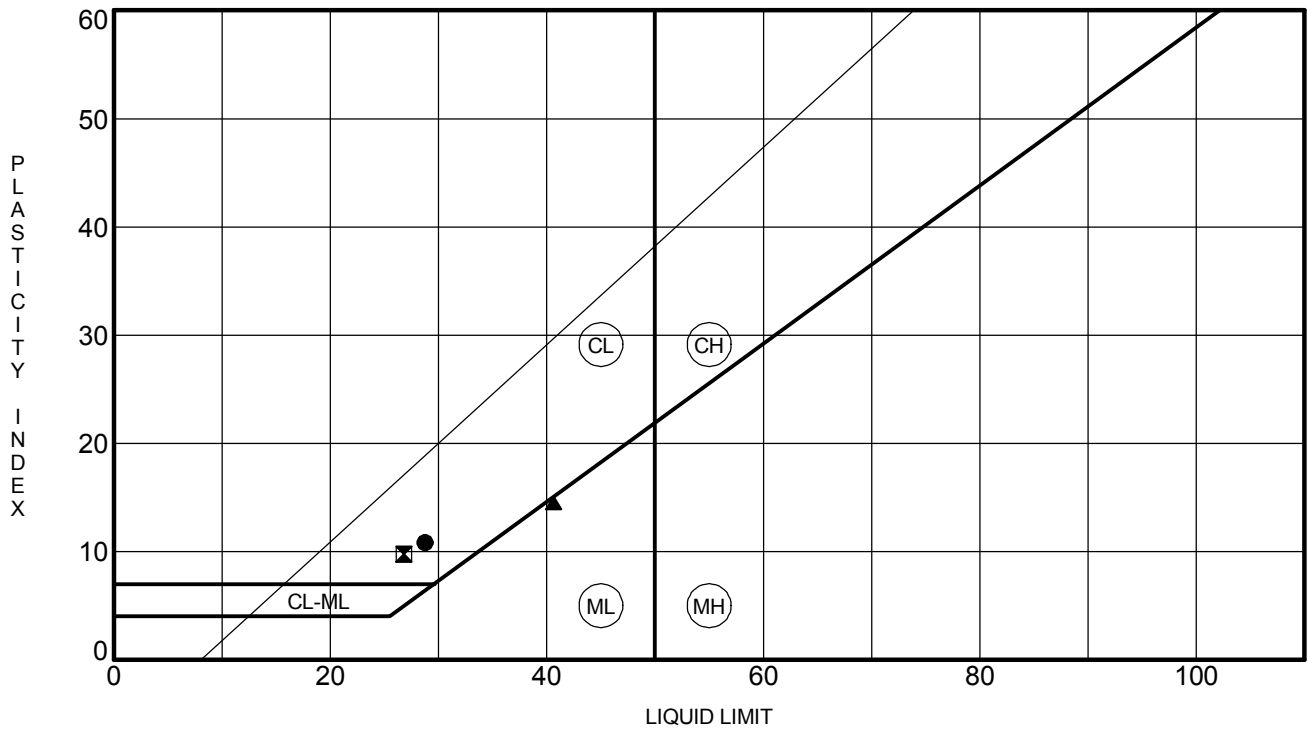
ATTERBERG LIMIT RESULTS

Boring	Depth (ft)	LL	PL	PI	Fines	Classification (*Visual)
● B-01	6.0	29	18	11	35.6	
⊠ B-01	11.0	27	17	10	86.8	
▲ B-02	16.0	41	26	15	85.7

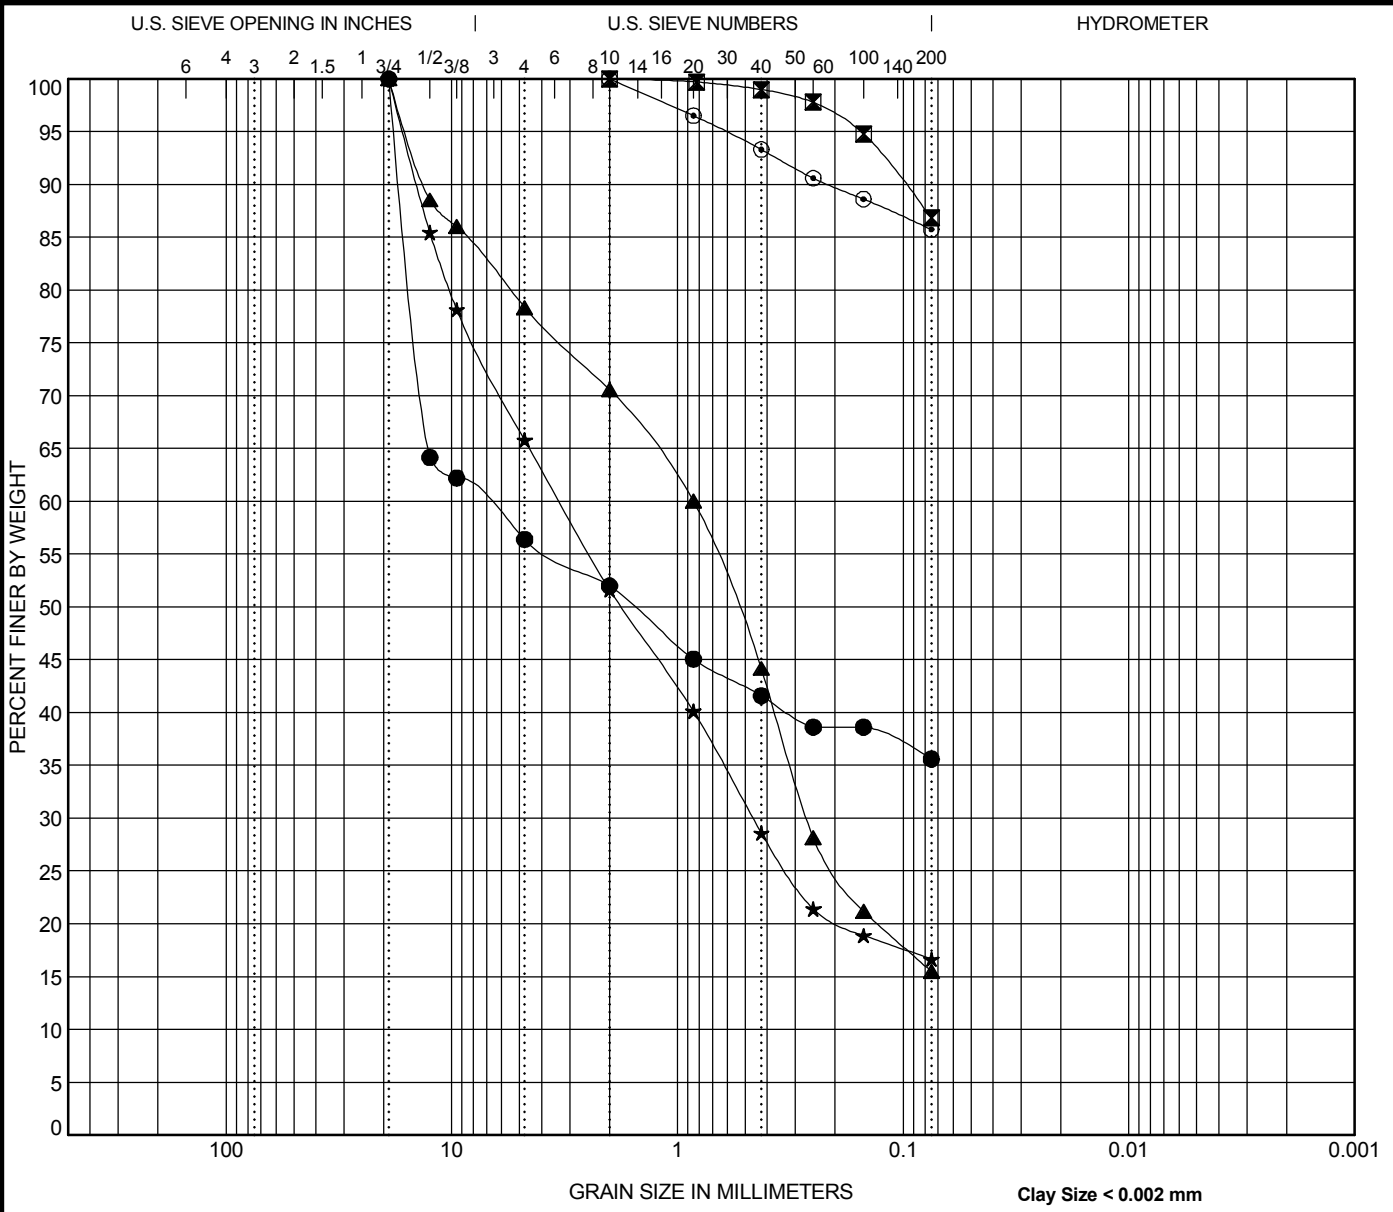
COBBLES	GRAVEL		SAND			SILT OR CLAY	
	coarse	fine	coarse	medium	fine

Specimen Identification	Classification	LL	PL	PI	Cc	Cu		
● B-01 6.0		29	18	11				
☒ B-01 11.0		27	17	10				
▲ B-02 6.0								
★ B-02 11.0								
◎ B-02 16.0		41	26	15				
Specimen Identification	D100	D60	D30	D10	%Gravel	%Sand	%Silt	%Clay
● B-01 6.0	19	7.305			43.6	20.8	35.6	
☒ B-01 11.0	2				0.0	13.2	86.8	
▲ B-02 6.0	19	0.849	0.266		21.6	62.9	15.5	
★ B-02 11.0	19	3.333	0.463		34.2	49.2	16.6	
◎ B-02 16.0	2				0.0	14.3	85.7

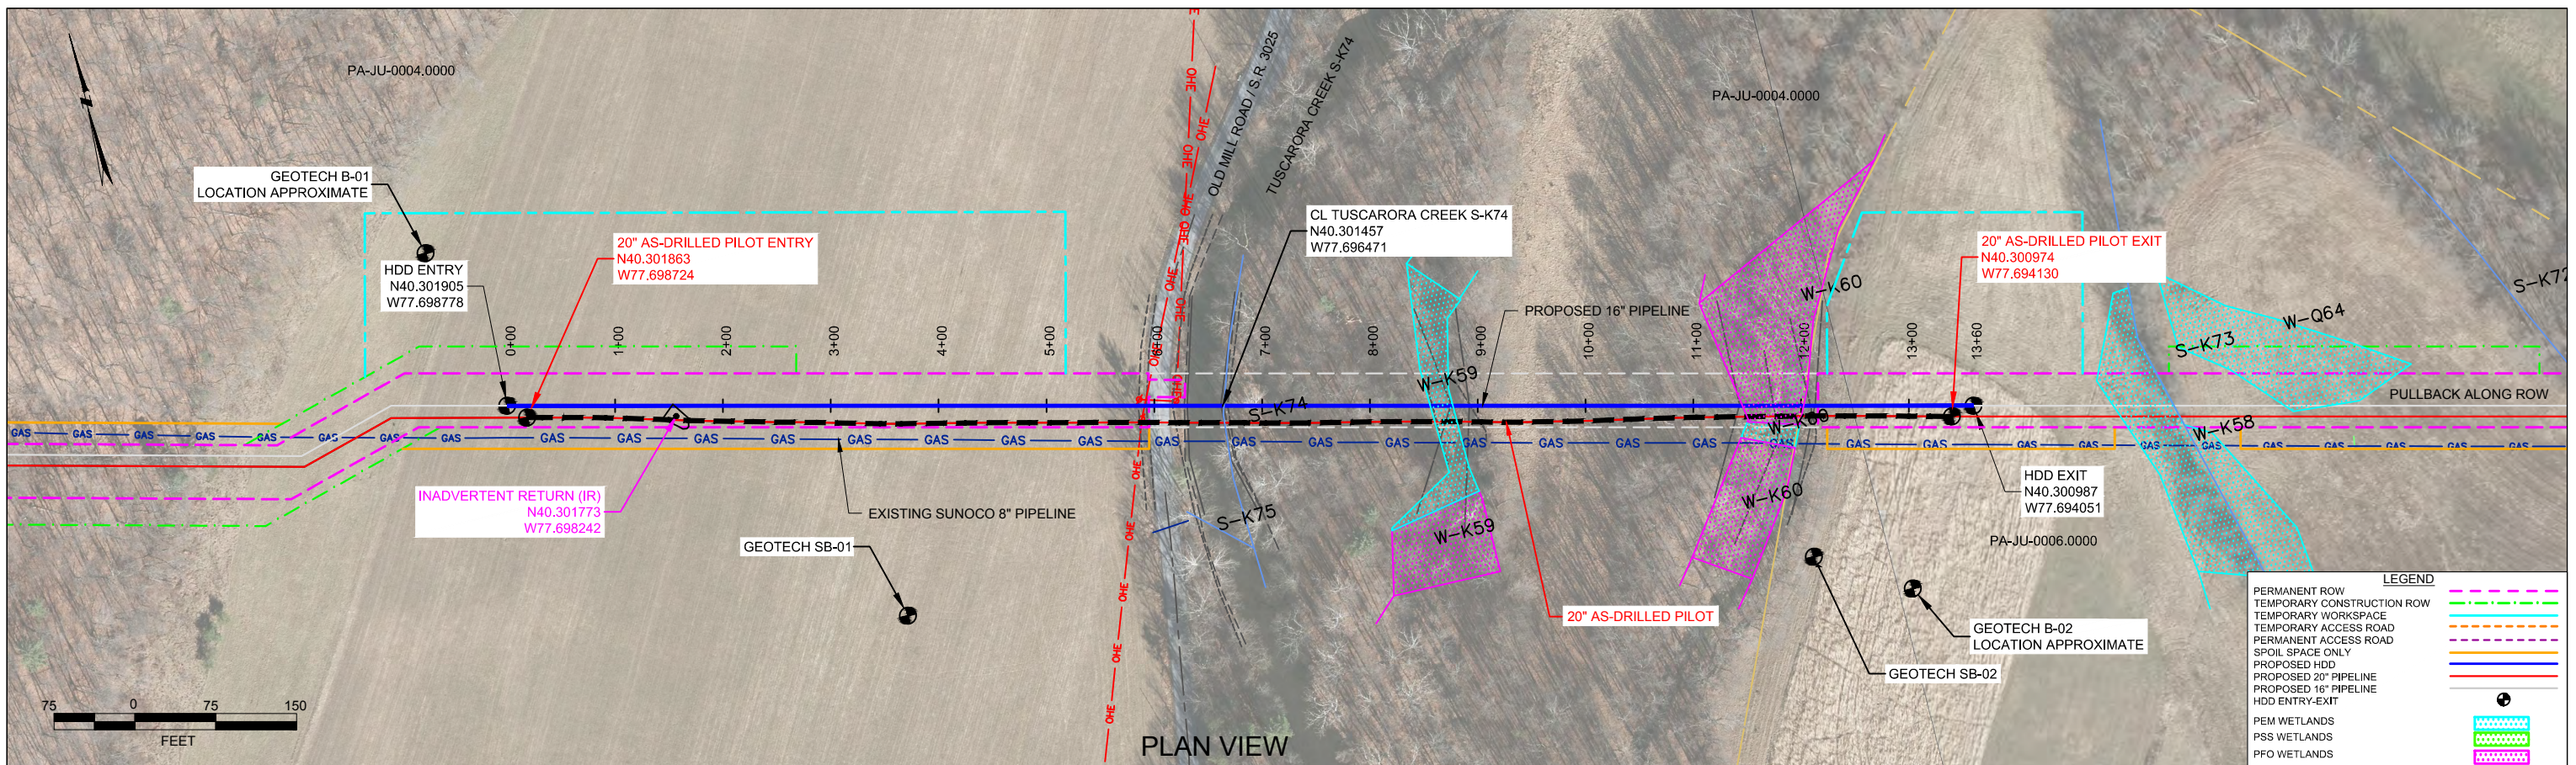
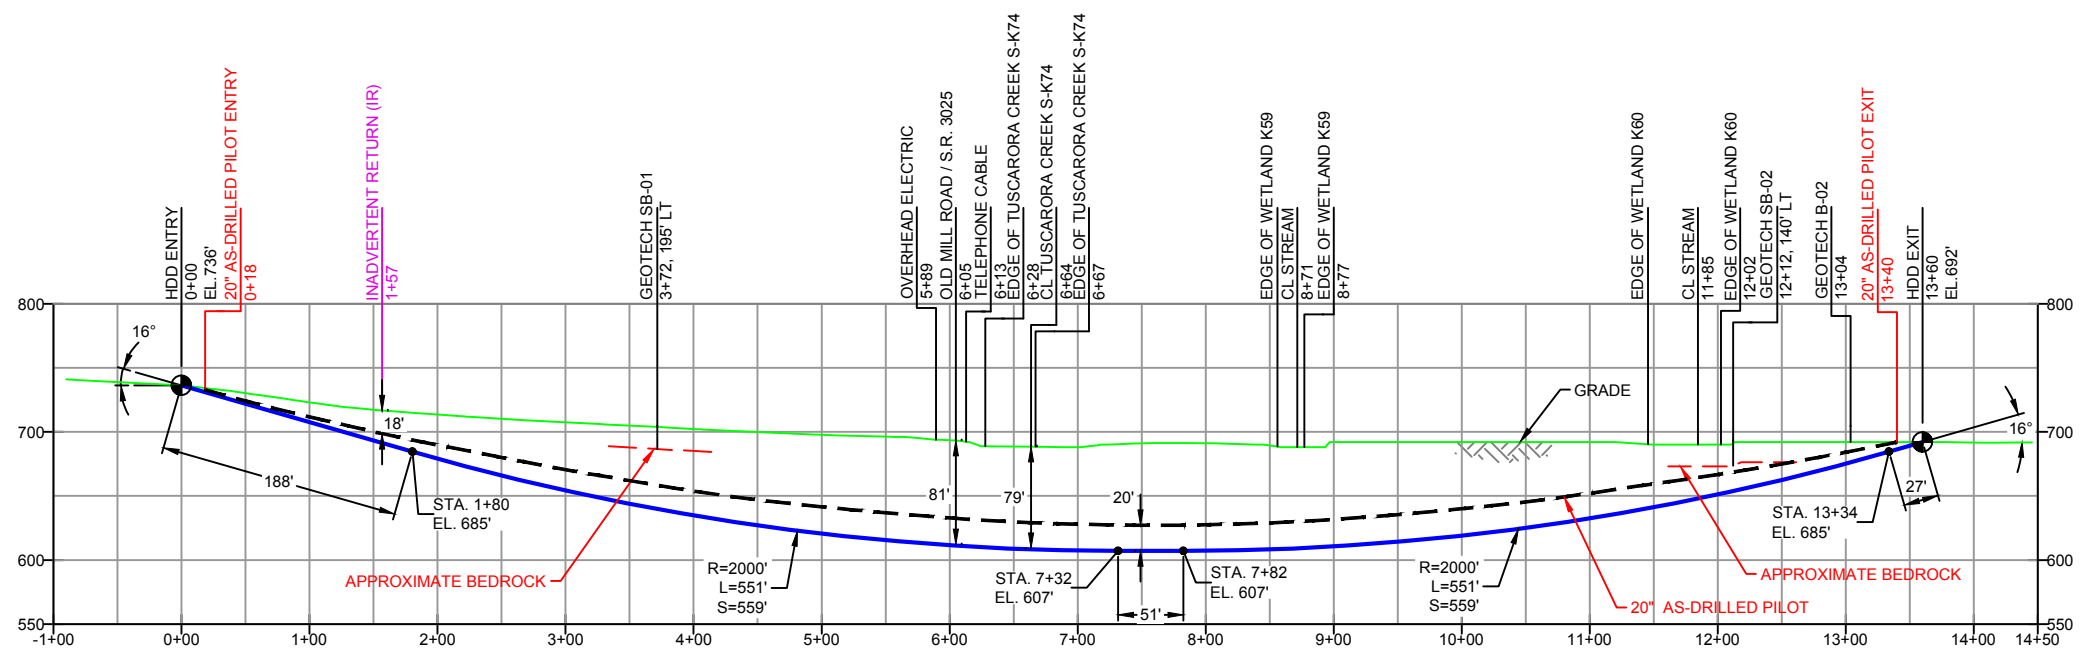
JUNIATA COUNTY PENNSYLVANIA, LACK TOWNSHIP
S2-0156-16

- DESIGNED IN ACCORDANCE WITH CFR 49 195 & ASME B31.4
 - CROSSING PIPE SPECIFICATION:
HDD HORZ. LENGTH (L)=1360'
HDD PIPE LENGTH (S)=1383'
16" x 0.438" W.T. X-70, API5L, PSL2, ERW, BFW
COATING: 14-16 MILS FBE WITH 30-35 MIL ARO (POWERCRETE R95)

The originally designed 16-inch HDD profile was relatively shallow at the eastern and western entry/exit points in comparison to the land surface and surface streambed (Tuscarora Creek, StreamK-74). The original profile also passed through soil overburden and fractured bedrock. Based on the hydro-structural characteristics of the underlying geology described in this report and geologic information obtained and utilized during installation of the 20-inch HDD, the Old Mill HDD is susceptible to an IR of drilling fluids during HDD operations. As a result, the 16-inch HDD profile was redesigned to depth greater than the as-built 20-inch HDD boring to allow for a deeper crossing beneath the stream and wetlands. The revised profile is approximately 79 feet below Tuscarora Creek (this is approximately 25 feet deeper than the 20-inch pipe). The inclination of the entry and exit angles has been increased to allow the pipe to be installed through protective soils, residual soils, and bedrock, and in closer proximity to the entry and exit points than the original, shorter and shallower profile. From a geologic perspective, the longer and deeper
