**HORIZONTAL DIRECTIONAL DRILL ANALYSIS
PARK ROAD CROSSING
PADEP SECTION 105 PERMIT NO.: E15-862
PA-CH-0111.0000-RD-20
(SPLP HDD# S3-0300-20)**

This reanalysis of the horizontal directional drill (HDD) installation of a 20-inch diameter pipeline that traverses Park Road and Wetland C43, in Upper Uwchlan Township, Chester County, Pennsylvania is in accordance with the Stipulated Order issued under Environmental Hearing Board Docket No. 2017-009-L for HDDs listed on Exhibit 3 of the Stipulated Order. This HDD is number 18 on the list of HDDs included on Exhibit 3 of the Order.

ATTACHMENT 1

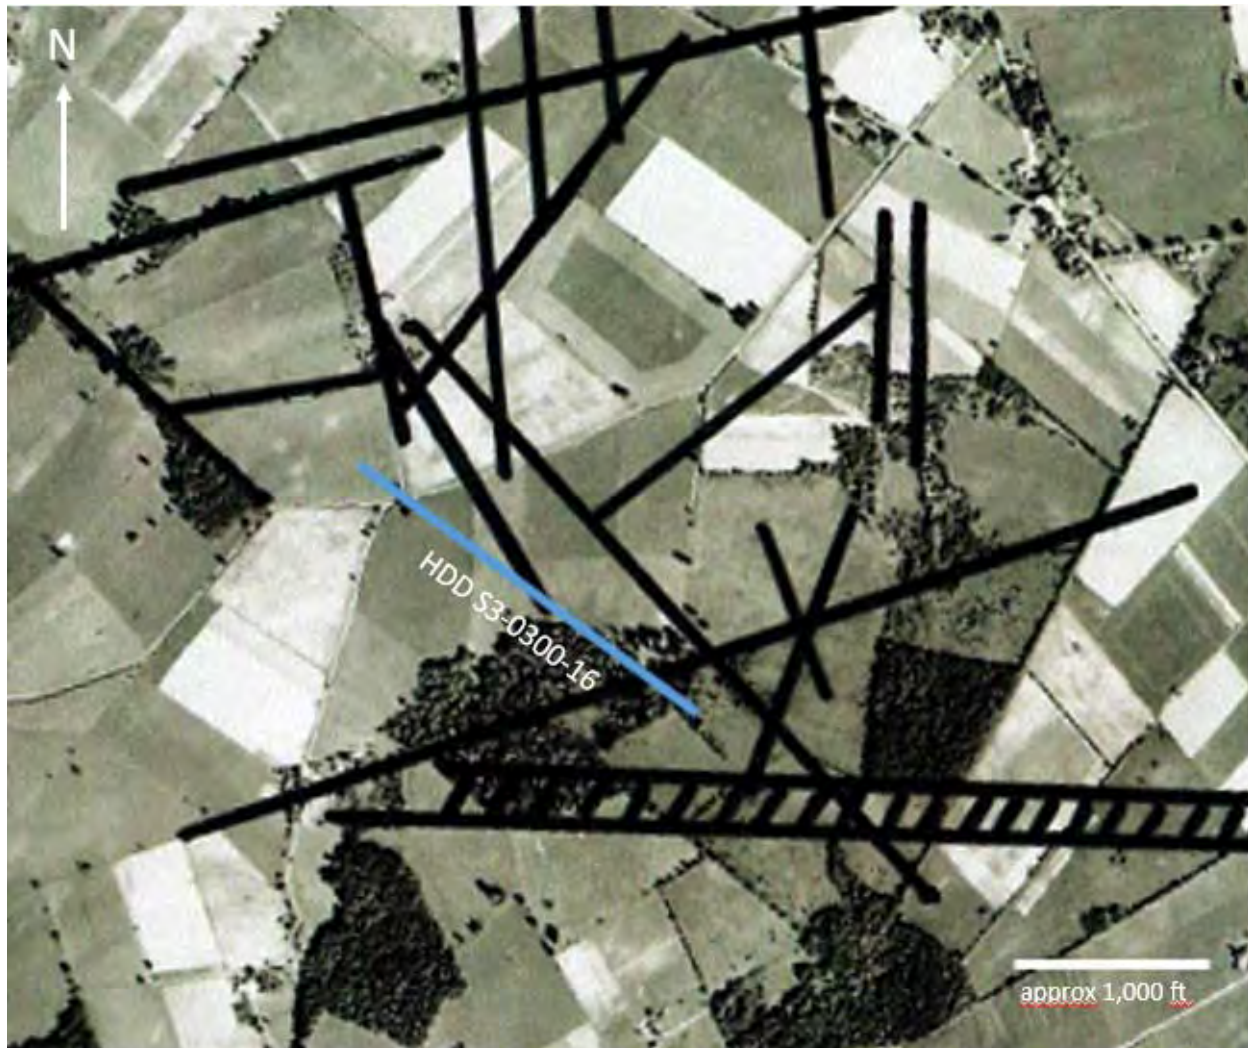
Figure 3. Fracture Trace Map.

Fracture trace analysis using high altitude aerial photography was performed for the area of interest to identify potential zones of bedrock weakness along drill paths. Fracture traces (one mile in length or less) and lineaments (greater than one mile in length) can be the surficial expression on natural landscapes of vertical to near vertical zones of bedrock fracture concentration. Fracture trace analysis is partly subjective; therefore, every mapped fracture trace does not necessarily represent a zone of bedrock fracture concentration.

Figure 3 show the fracture trace mapping conducted for this reevaluation. The mapping was performed using aerial stereographic pairs flown in the fall of 1937. As such, much of the land surface appears undeveloped and fracture traces are more easily seen. The analysis yielded evidence of local fracture traces generally trending north and east-northeast. Two of the mapped fracture traces cross the drill path, one east-northeast trending trace at approximately Station 3+40 and a north-northwest trending trace that terminates along the alignment at approximately Station 9+05 on the proposed profile (see **Attachment A**).

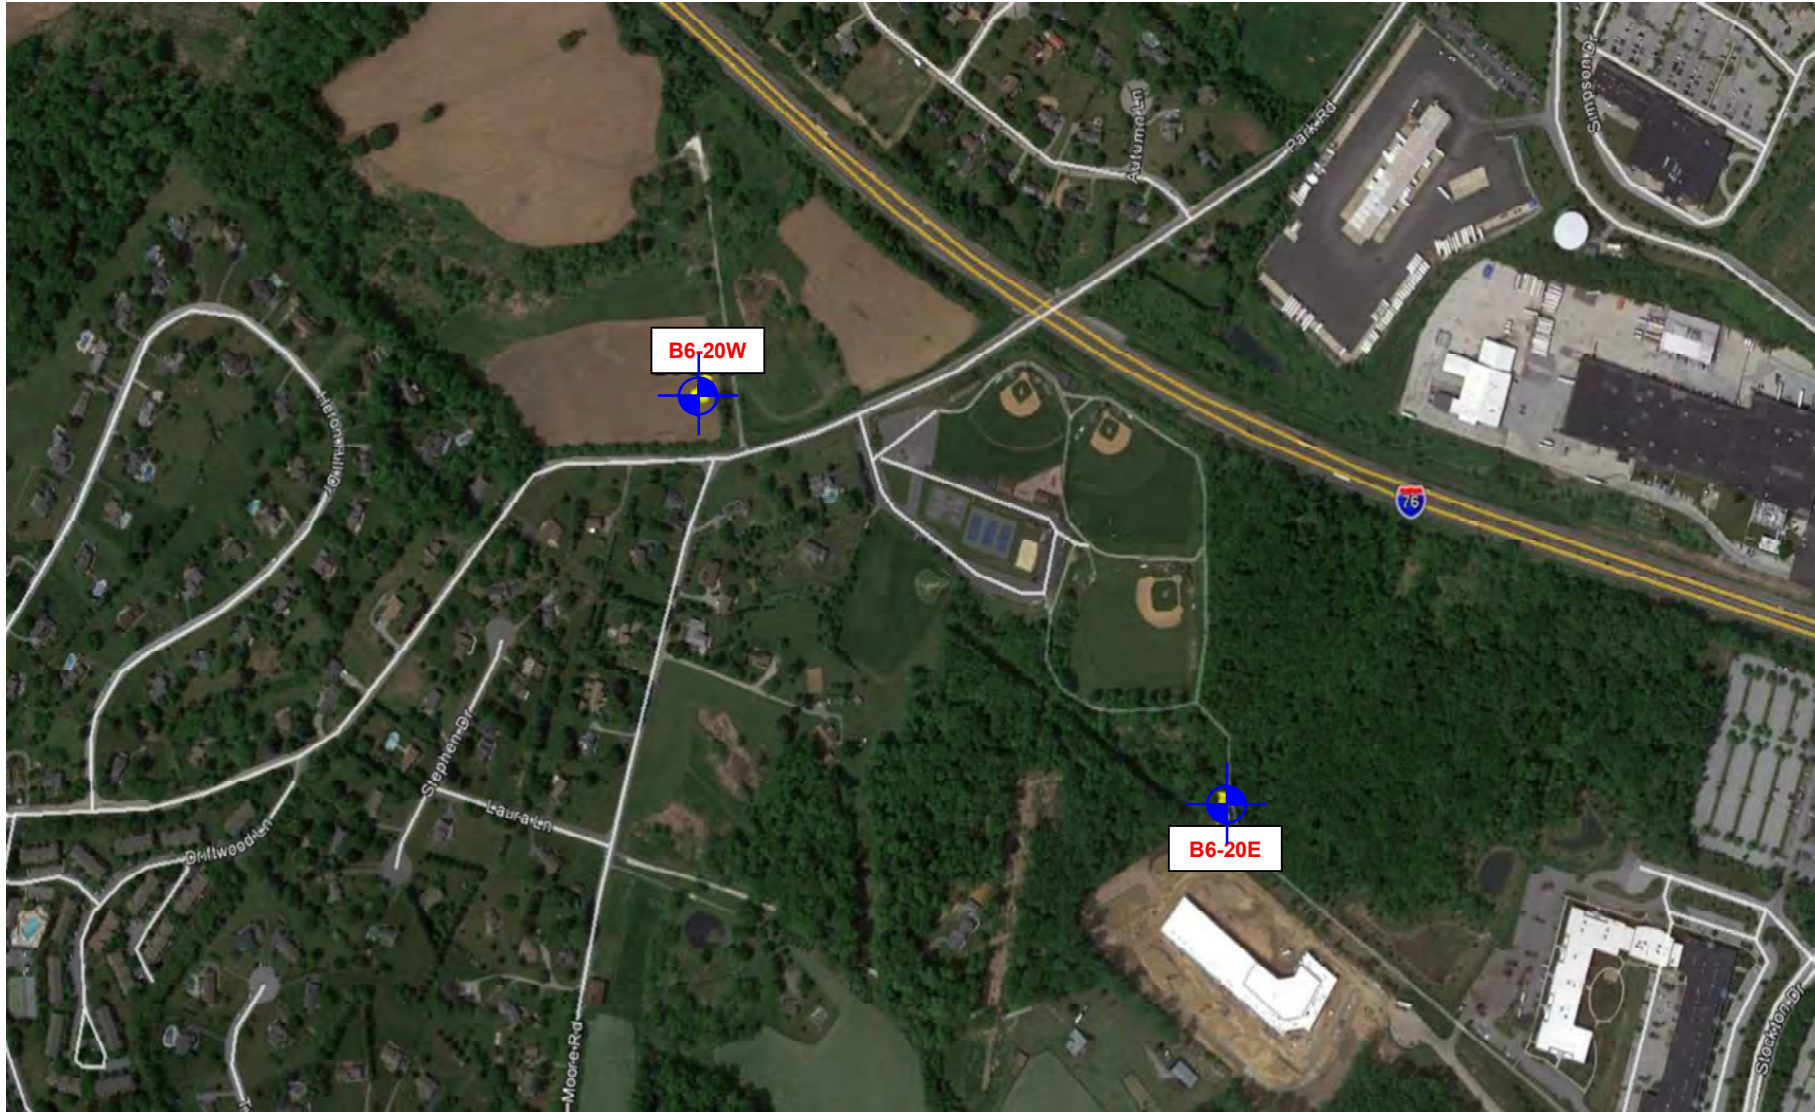
TEST BORING LOCATION PLAN

Test borings, B6-20W and B6-20E were drilled between September 25 and 28, 2017 to a depth of 136.0 feet, as shown on the attached **Test Boring Location Plan**. Bedrock typically consisted of metamorphic rock comprised of gneiss at B6-20W, and gneiss and quartzite at B6-20E. Final test boring logs documenting overburden soil and bedrock conditions as well as photographs of the rock core samples are attached.

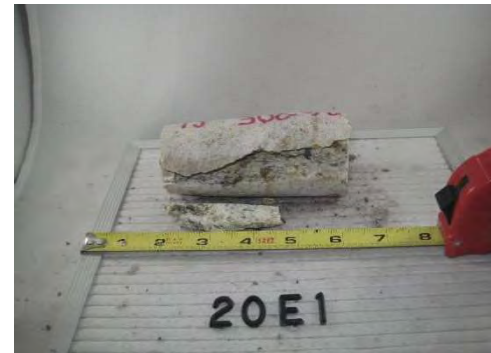
Maximum Axial Load at Failure: **26,680 lb**
Compressive Strength: **8,843 psi**
Compressive Strength: **60.97 Mpa**
Unit Weight **161 pcf**

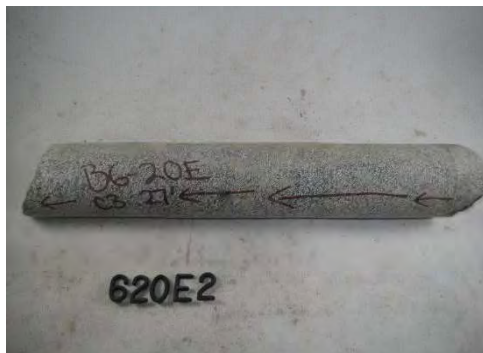
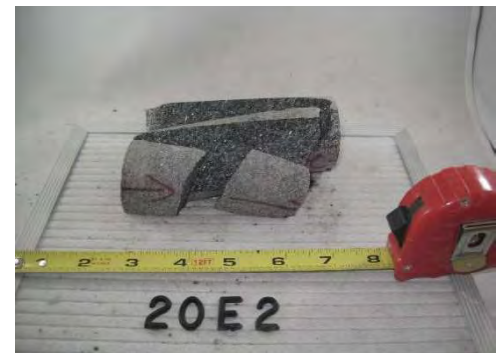
Maximum Axial Load at Failure: **43,820 lb**
Compressive Strength: **14,523 psi**
Compressive Strength: **100.14 Mpa**
Unit Weight **176 pcf**

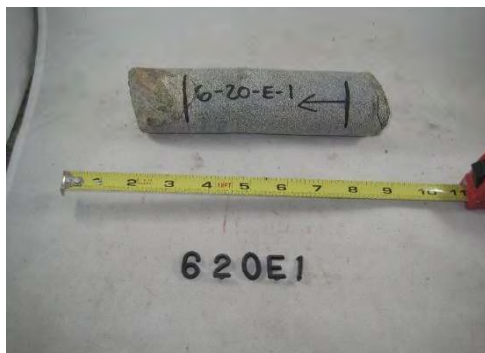
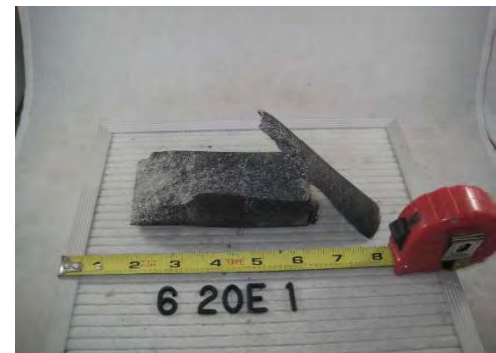
Maximum Axial Load at Failure: **52,160 lb**
Compressive Strength: **16,770 psi**
Compressive Strength: **115.63 Mpa**
Unit Weight **177 pcf**

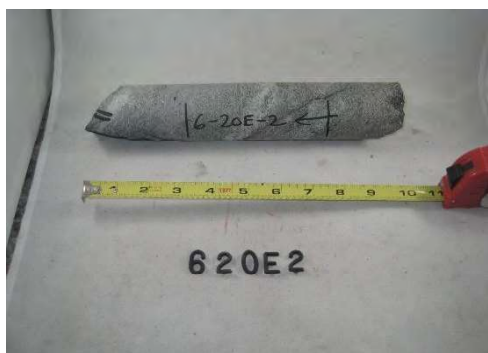
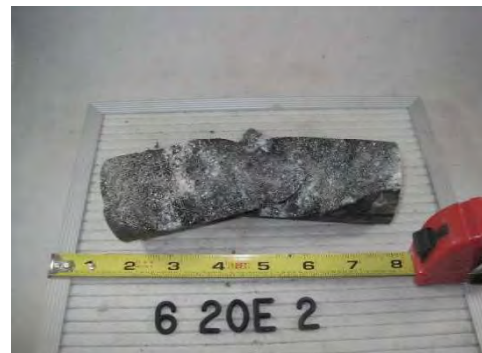
Maximum Axial Load at Failure: **26,320 lb**
Compressive Strength: **8,548 psi**
Compressive Strength: **58.94 Mpa**
Unit Weight **178 pcf**

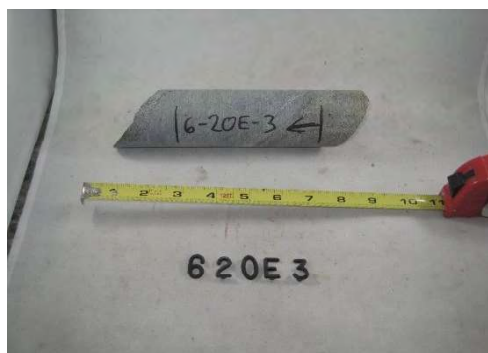
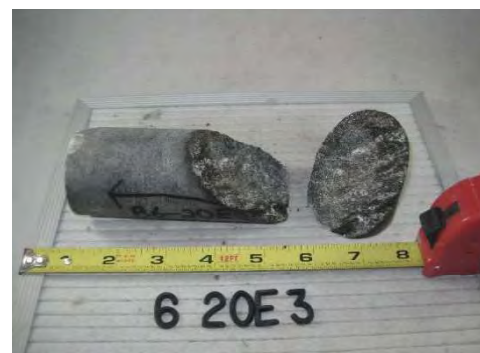
Maximum Axial Load at Failure: **15,210 lb**
Compressive Strength: **4,940 psi**
Compressive Strength: **34.06 Mpa**
Unit Weight **168 pcf**

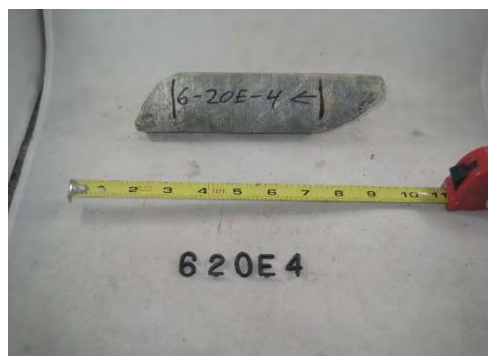
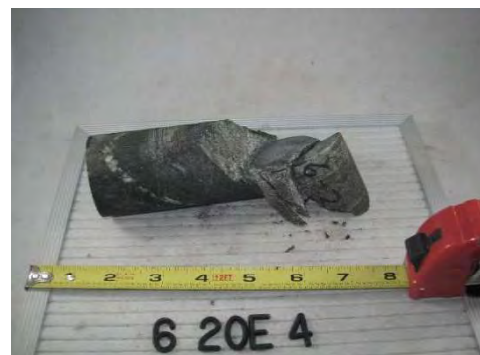
Maximum Axial Load at Failure: **35,110 lb**
Compressive Strength: **11,288 psi**
Compressive Strength: **77.83 Mpa**
Unit Weight **172 pcf**

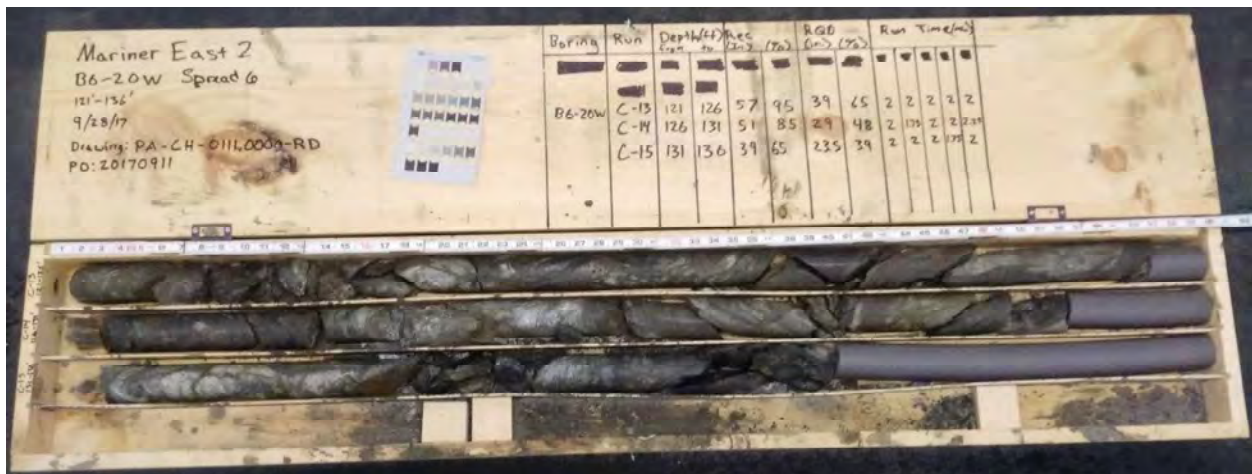
Photograph 2: B6-20W, Samples C-13 to C-15 (121 to 136 feet)

The RQD values for the core samples taken at borings B6-20 W and B6-20E are congruent with other lines of evidence that suggest that the metamorphic rock along portions of the HDD S3-0300 profile show variable amounts of weathering and rock strength. Highly weathered bedrock was observed to as much as 116 ft bgs. The maximum depth of overburden along the profile is approximately 85 ft bgs therefore the drilling plan should account for zones of weaker bedrock and associated preferred pathways of fluid migration.

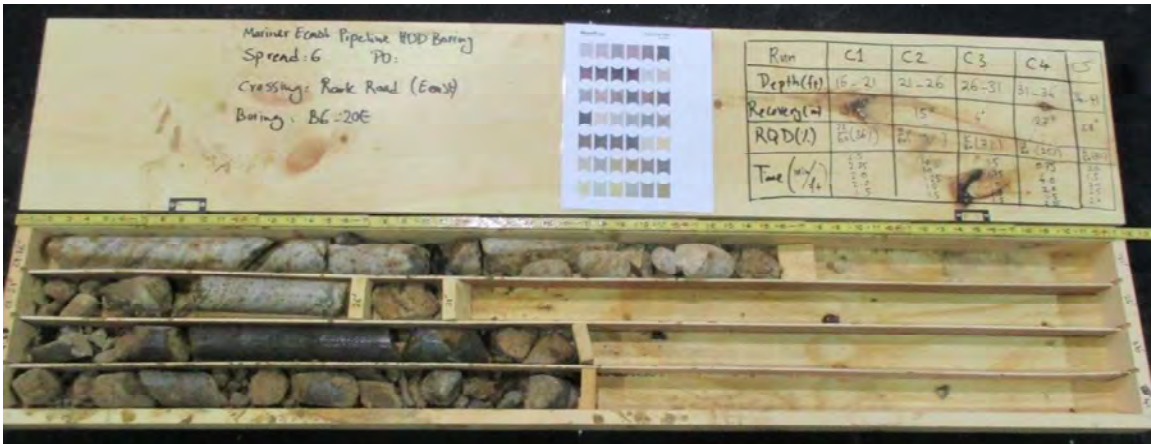
Photograph 1: B6-20E, Samples C-1 to C-5 (16 to 41 feet)

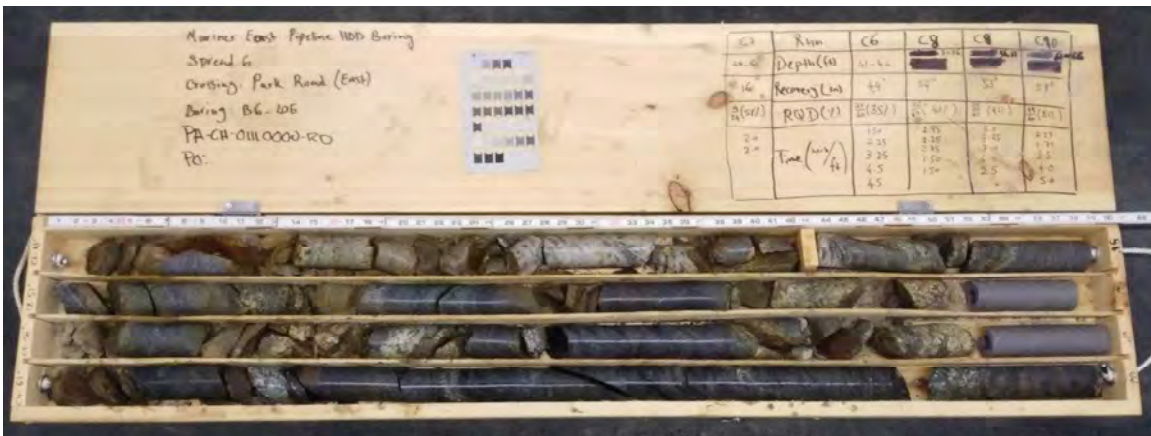
Photograph 2: B6-20E, Samples C-6 to C-10 (41 to 66 feet)

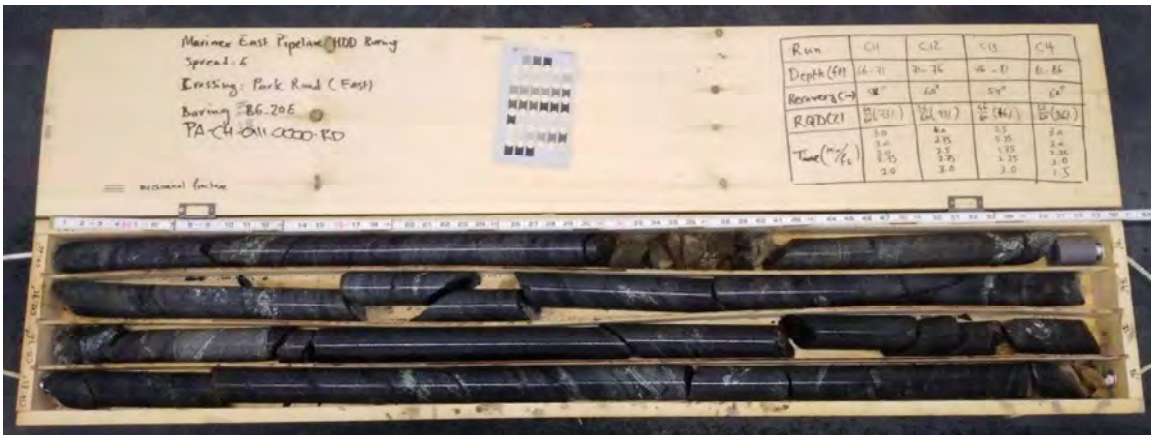
Photograph 3: B6-20E, Samples C-11 to C-14 (66 to 86 feet)

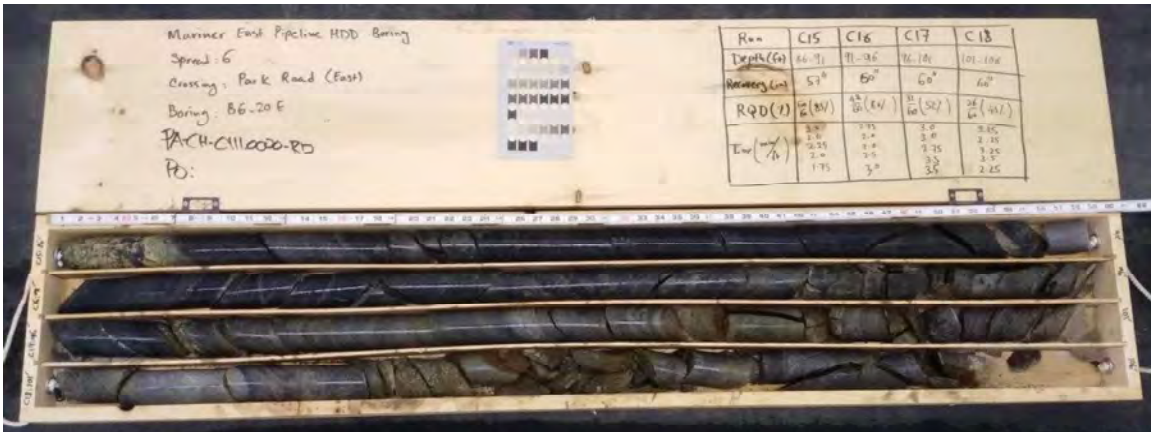
Photograph 4: B6-20E, Samples C-15 to C-18 (86 to 106 feet)

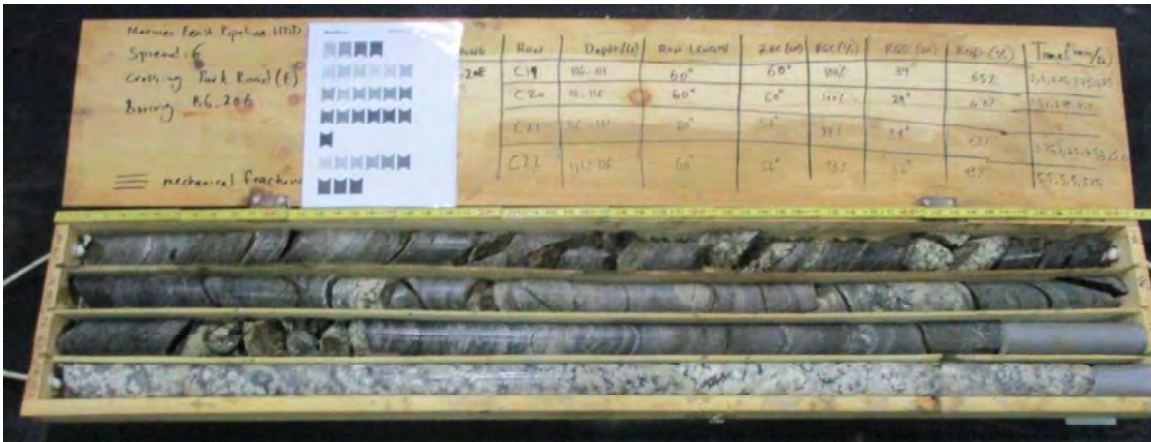
Photograph 5: B6-20E, Samples C-19 to C-22 (106 to 126 feet)

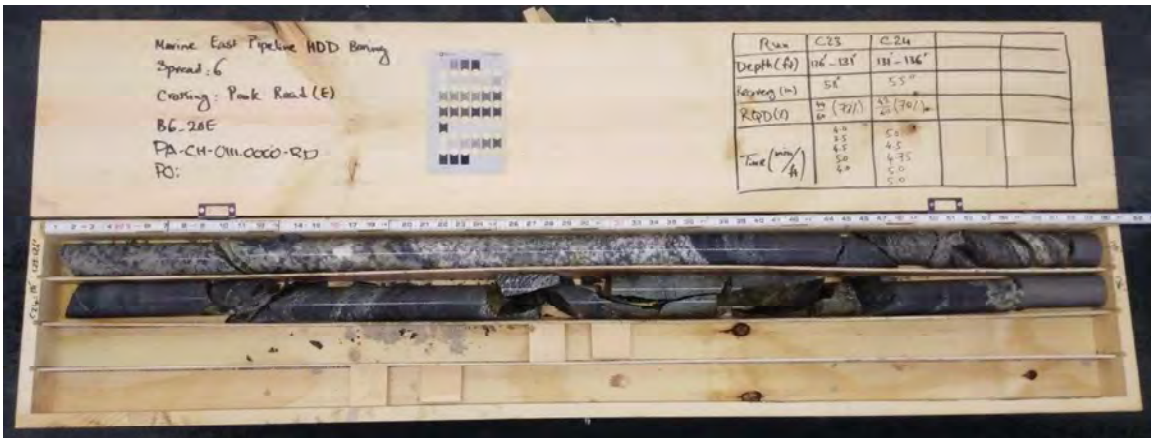
Photograph 6: B6-20E, Samples C-23 to C-24 (126 to 136 feet)
