**HORIZONTAL DIRECTIONAL DRILL ANALYSIS  
PINEY CREEK CROSSING  
PADEP SECTION 105 PERMIT NO.: E07-459  
PA-BL-0126.0000-RD AND PA-BL-0126.0000-RD-16  
(SPLP HDD No. S2-0142)**

**PINEY CREEK CROSSING**  
**PADEP SECTION 105 PERMIT NO.: E07-459**  
**PA-BL-0126.0000-RD AND PA-BL-0126.0000-RD-16**  
**(SPLP HDD No. S2-0142)**

This reanalysis of the horizontal directional drill (HDD) installation of a 20-inch and 16-inch diameter pipeline crossing under Stream S-M3, Wetland M26, Lower Piney Creek Road, Stream S-M30 (Piney Creek), and High Street (State Road 866), is in accordance with Stipulated Order issued under Environmental Hearing Board Docket No. 2017-009-L for HDDs listed on Exhibit 2 of the Stipulated Order. This HDD is number 9 on the list of HDDs included on Exhibit 2. Activities at this HDD were initiated and suspended in June of 2017, before the issuance of the Order on August 9, 2017.

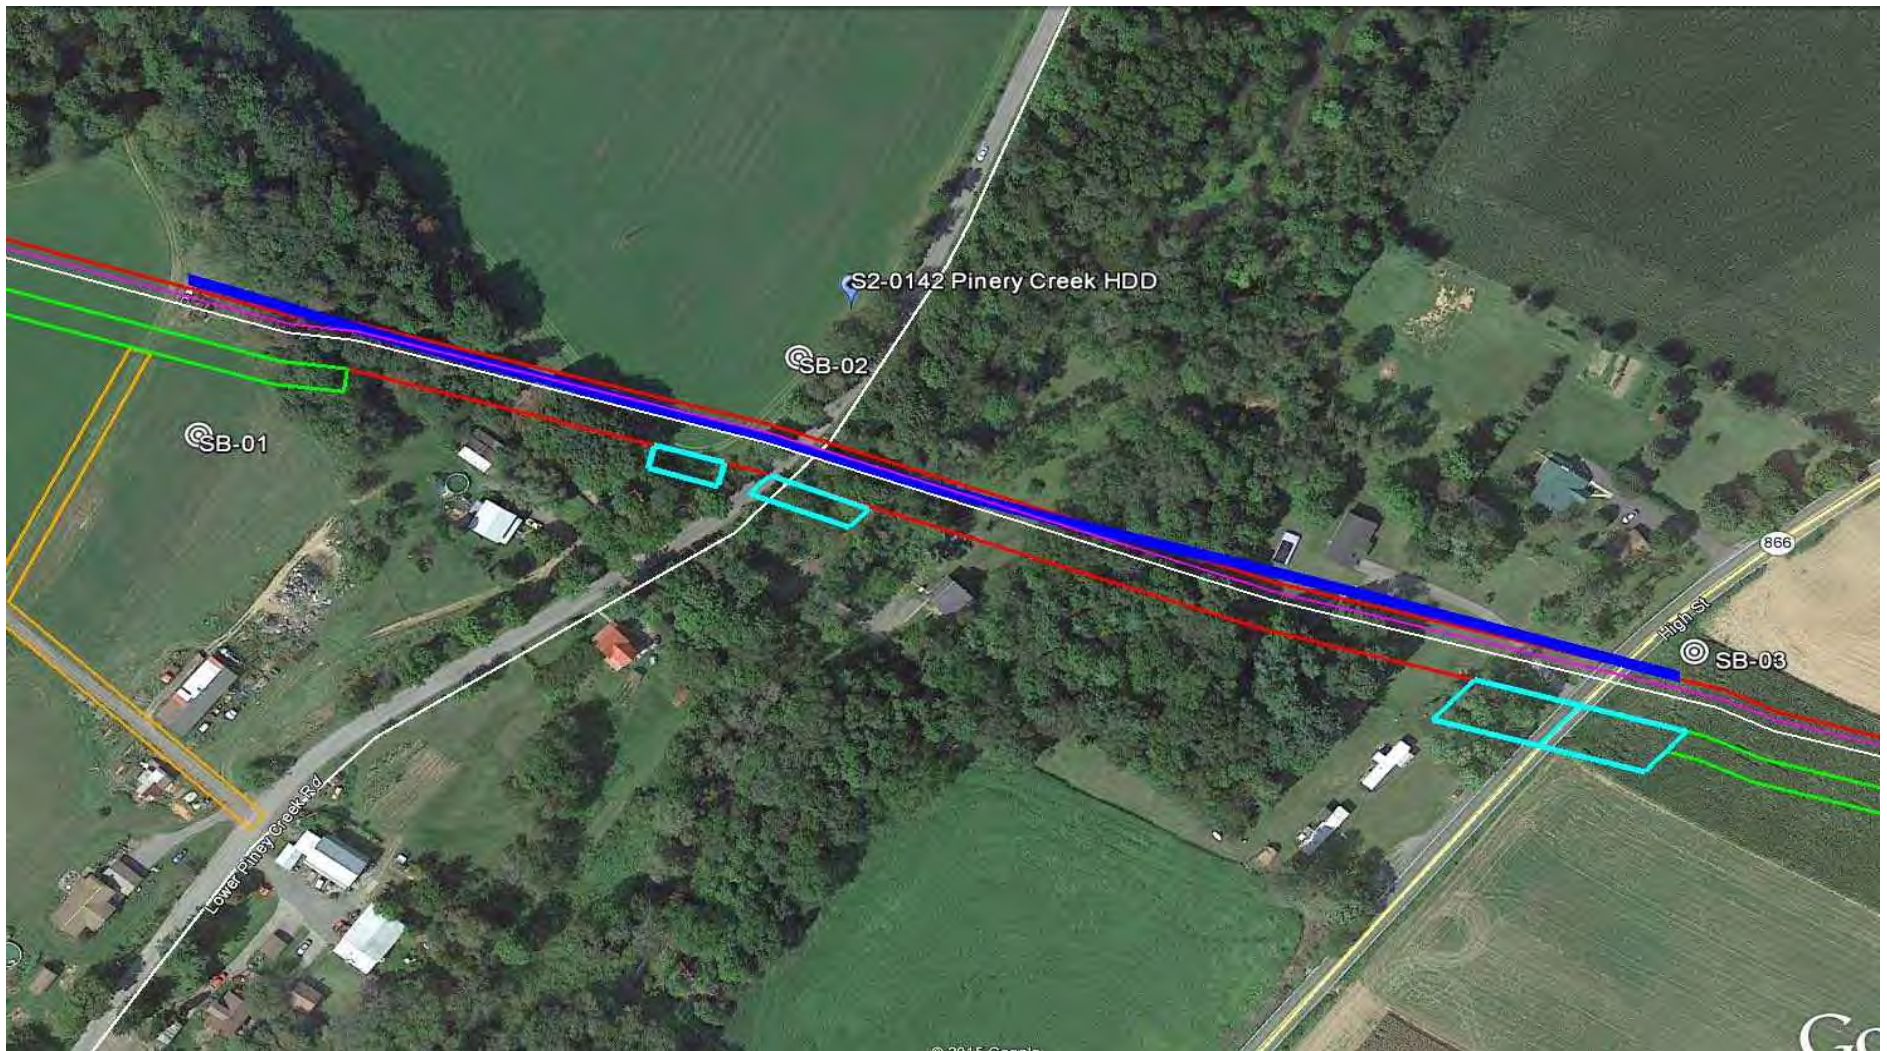
SCALE: 1"=150'  
DWG. NO. PA-BL-0126.0000-RD-16

HORIZONTAL DIRECTIONAL DRILL  
LOWER PINEY CREEK RD  
PENNSYLVANIA PIPELINE PROJECT

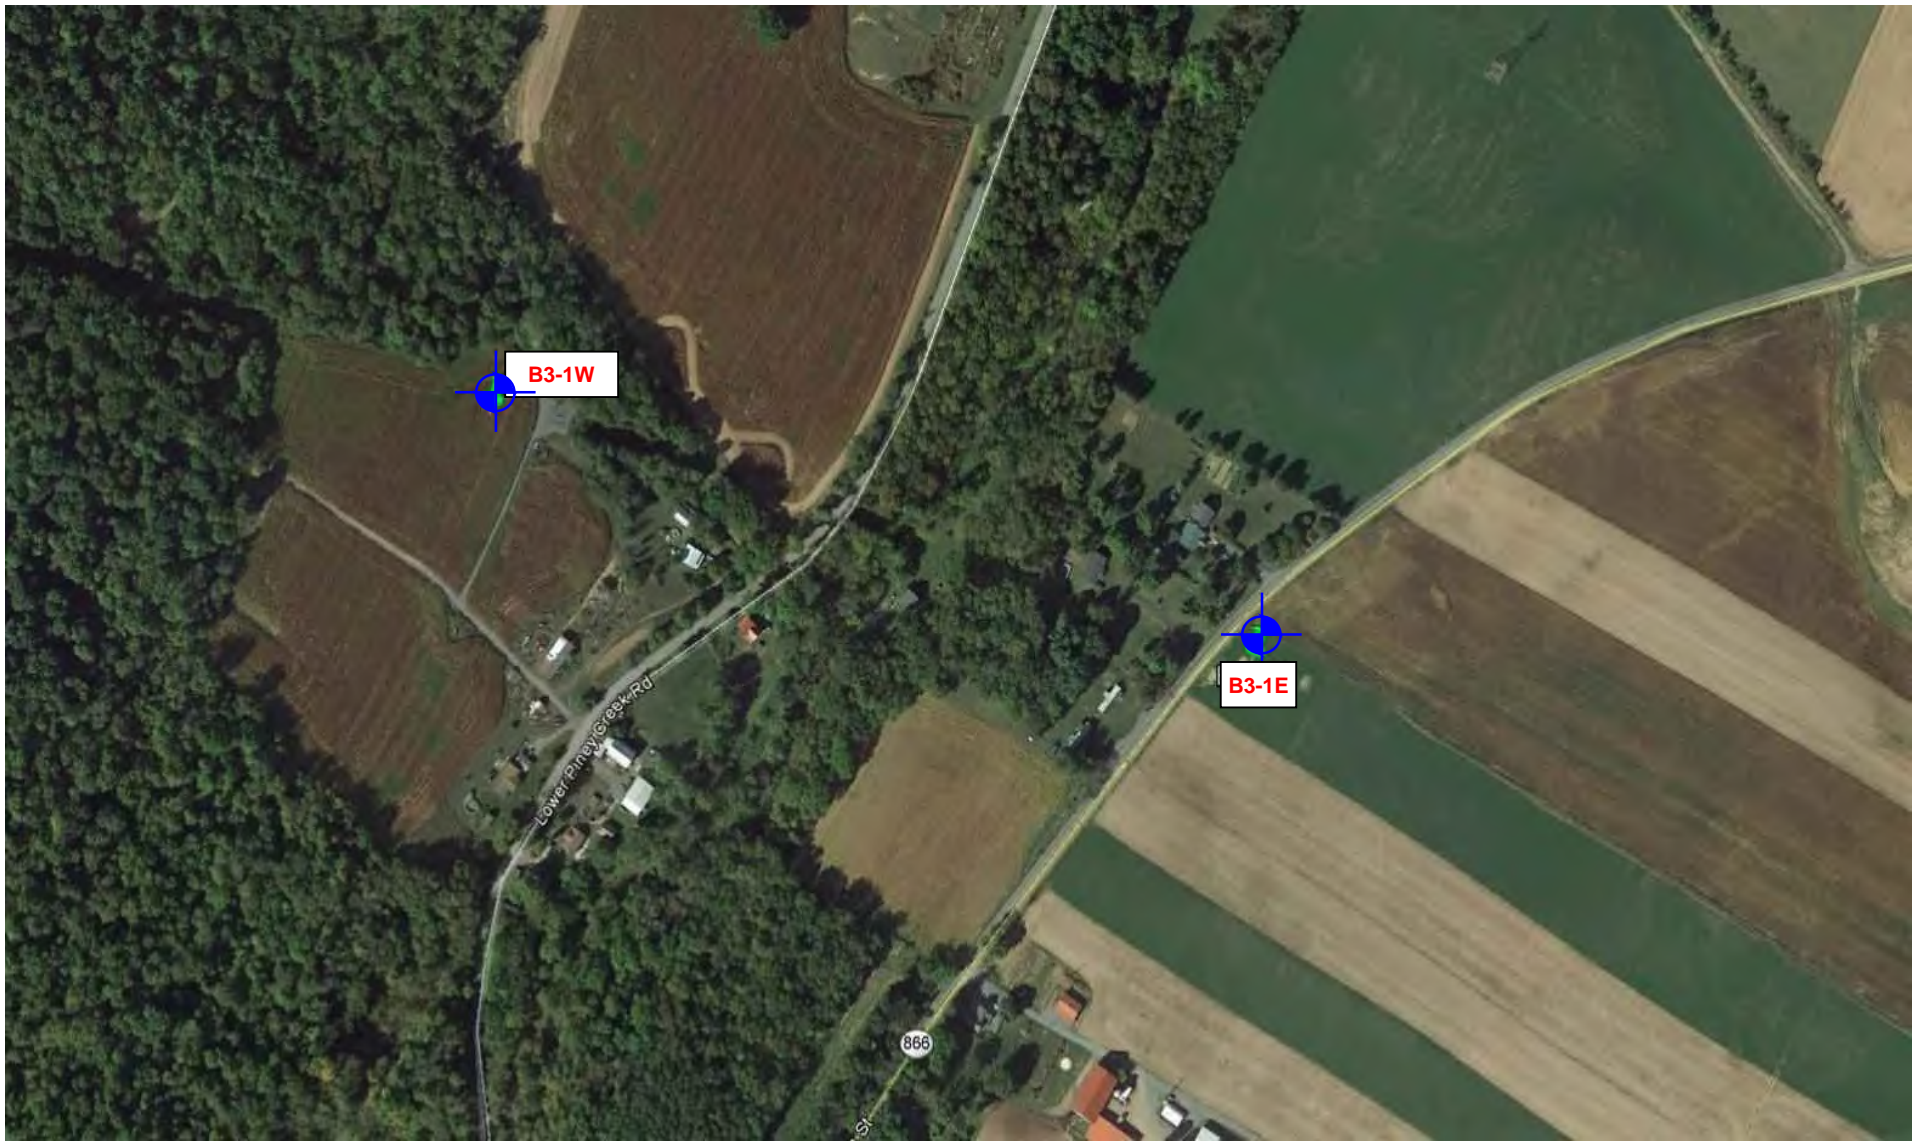
# **TEST BORING LOCATION PLAN**

**APPROXIMATE  
BORING  
LOCATION**

Test borings, B3-1W and B3-1E were drilled between August 8 and 14, 2017 to depths of 195 and 190 feet, respectively as shown on the attached **Test Boring Location Plan**. Bedrock typically consisted of shale at B3-1W and interlayered sedimentary rock comprised of shale, mudstone, dolomite, and limestone at B3-1E. Final test boring logs documenting overburden soil and bedrock conditions as well as photographs of the rock core samples are attached.

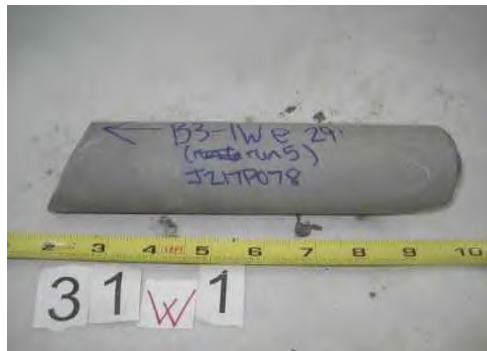
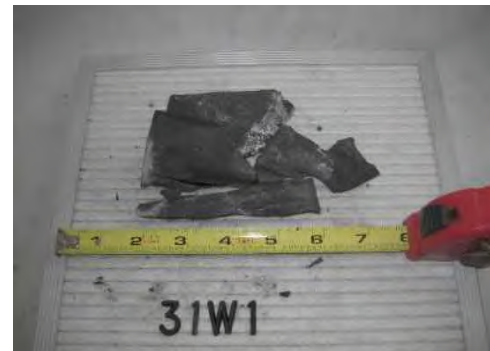
Maximum Axial Load at Failure: 53,420 lb  
 Compressive Strength: 19,450 psi  
 Compressive Strength: 134.11 Mpa  
 Unit Weight 167 pcf

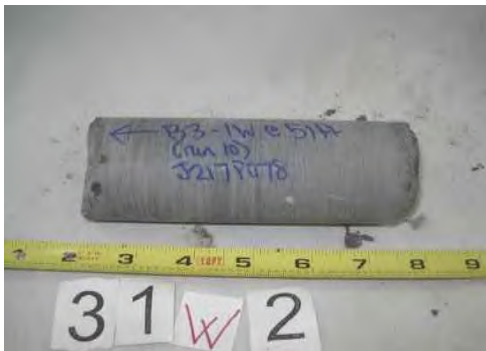
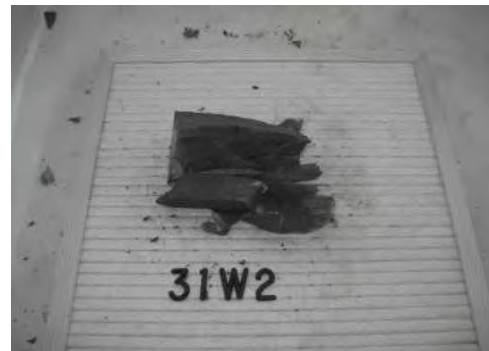
Maximum Axial Load at Failure: 45,660 lb  
 Compressive Strength: 15,770 psi  
 Compressive Strength: 108.73 Mpa  
 Unit Weight 167 pcf

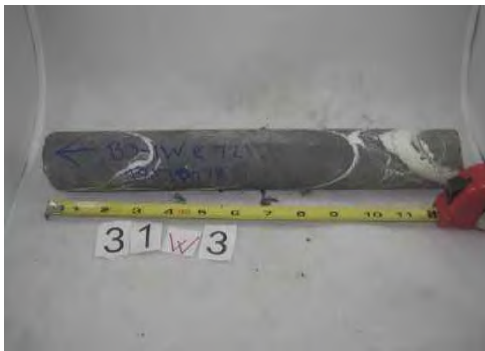
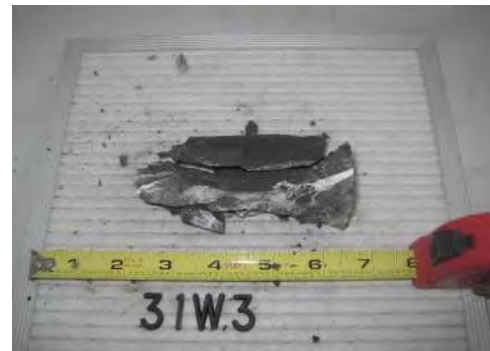
Maximum Axial Load at Failure: 72,670 lb  
 Compressive Strength: 23,601 psi  
 Compressive Strength: 162.72 Mpa  
 Unit Weight 166 pcf

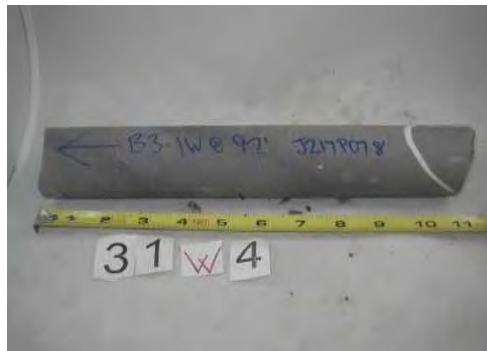
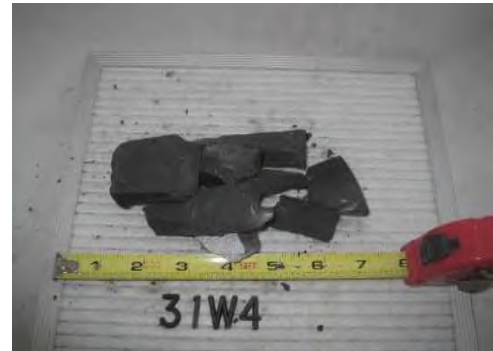
Maximum Axial Load at Failure: 65,450 lb  
 Compressive Strength: 21,473 psi  
 Compressive Strength: 148.05 Mpa  
 Unit Weight 167 pcf

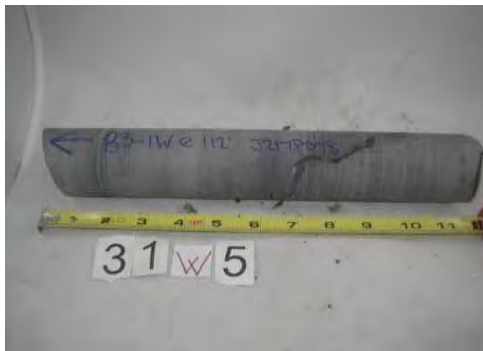
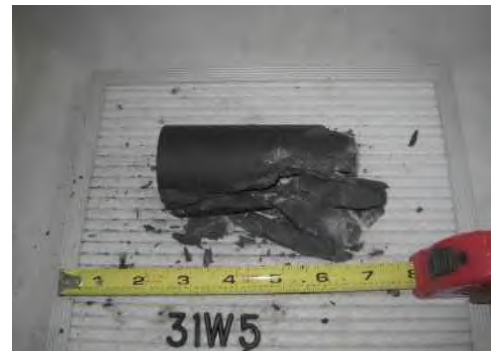
Maximum Axial Load at Failure: 61,920 lb  
 Compressive Strength: 20,110 psi  
 Compressive Strength: 138.65 Mpa  
 Unit Weight 167 pcf

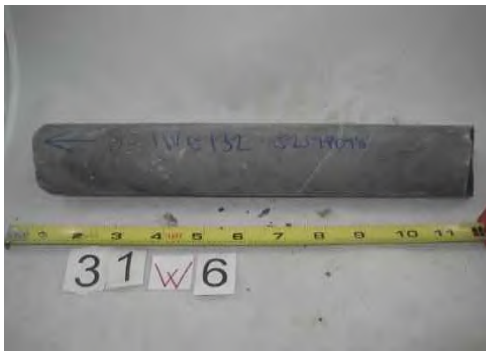
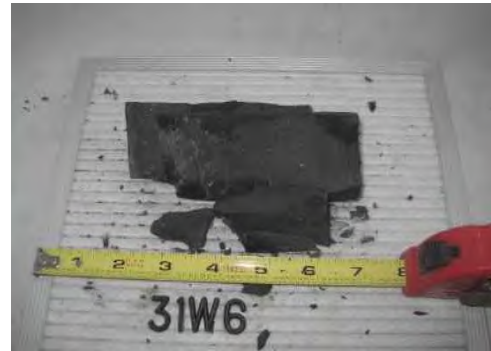
Maximum Axial Load at Failure: 24,440 lb  
 Compressive Strength: 7,937 psi  
 Compressive Strength: 54.73 Mpa  
 Unit Weight 167 pcf

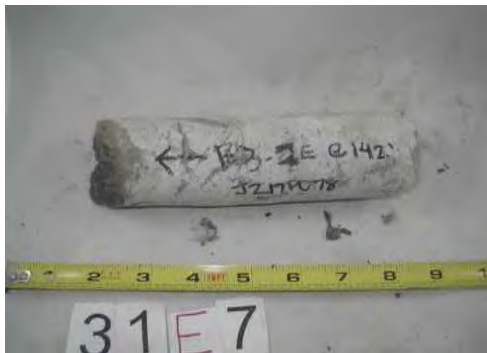
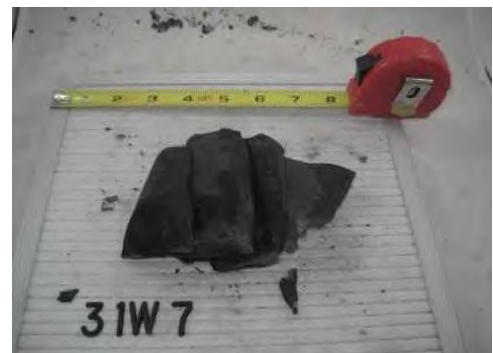
Comments : Due to lack of available specimens, the length to diameter ratio of the tested specimen is not conformant with ASTM D7012. The results obtained during testing may differ from those obtained from the test specimens that meet the requirements.

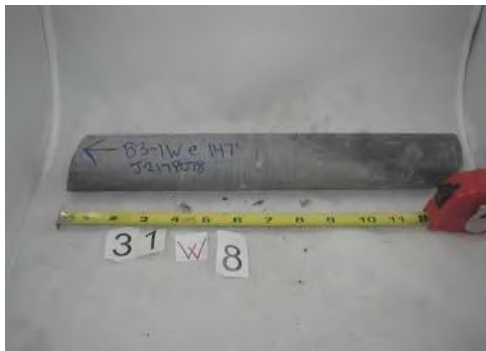
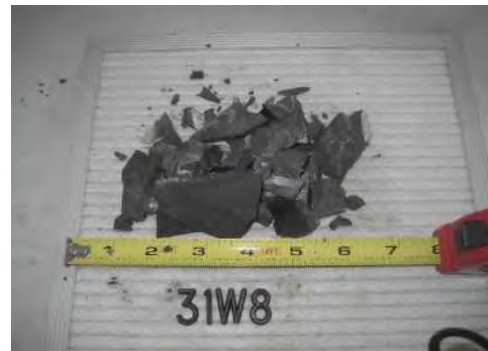
Maximum Axial Load at Failure: 77,960 lb  
 Compressive Strength: 25,319 psi  
 Compressive Strength: 174.57 Mpa  
 Unit Weight 168 pcf

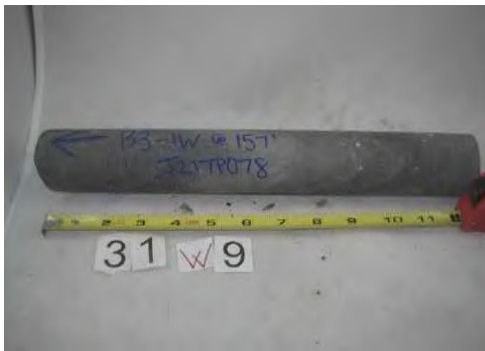
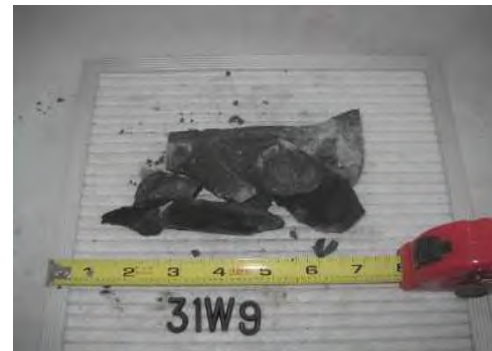
Maximum Axial Load at Failure: 78,740 lb  
 Compressive Strength: 25,573 psi  
 Compressive Strength: 176.32 Mpa  
 Unit Weight 169 pcf

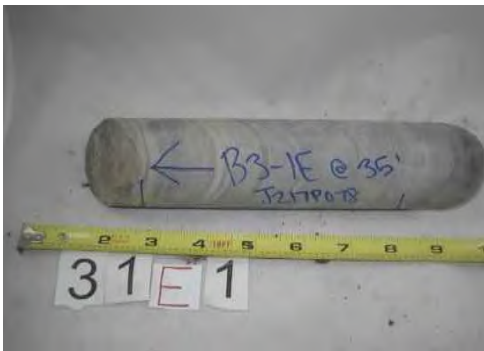
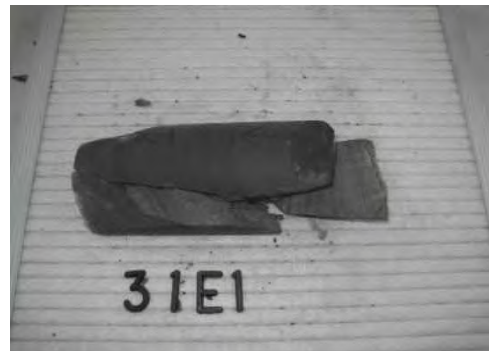
Maximum Axial Load at Failure: 38,720 lb  
 Compressive Strength: 12,575 psi  
 Compressive Strength: 86.70 Mpa  
 Unit Weight 174 pcf

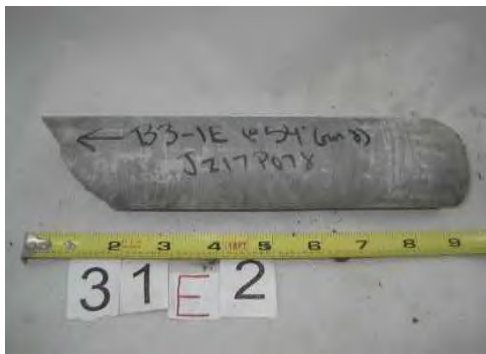
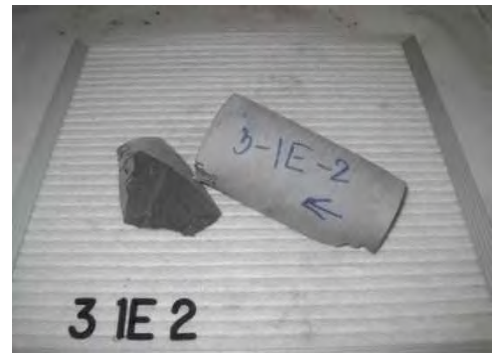
Maximum Axial Load at Failure: 19,940 lb  
 Compressive Strength: 6,542 psi  
 Compressive Strength: 45.10 Mpa  
 Unit Weight 174 pcf

Comments : Due to lack of available specimens, the length to diameter ratio of the tested specimen is not conformant with ASTM D7012. The results obtained during testing may differ from those obtained from the test specimens that meet the requirements.

Before the Test

After the Test

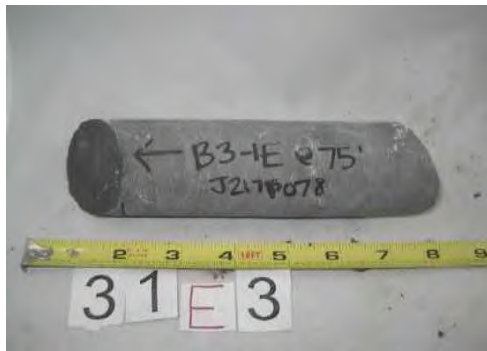
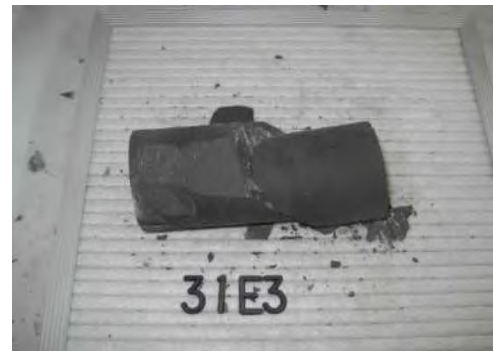
Maximum Axial Load at Failure: 20,220 lb  
 Compressive Strength: 6,771 psi  
 Compressive Strength: 46.68 Mpa  
 Unit Weight 71 pcf

Before the Test

After the Test

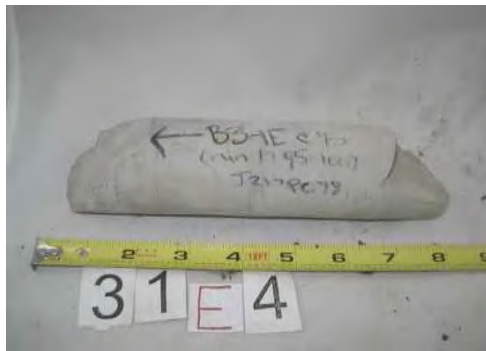
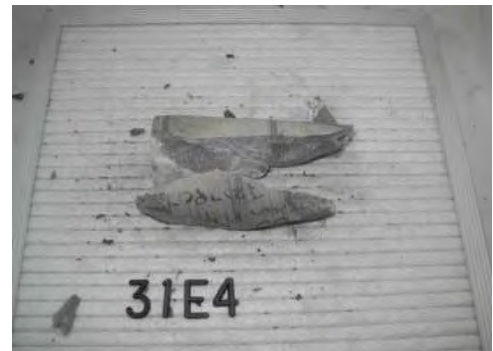
Comments : Due to lack of available specimens, the length to diameter ratio of the tested specimen is not conformant with ASTM D7012. The results obtained during testing may differ from those obtained from the test specimens that meet the requirements.

Before the Test

After the Test

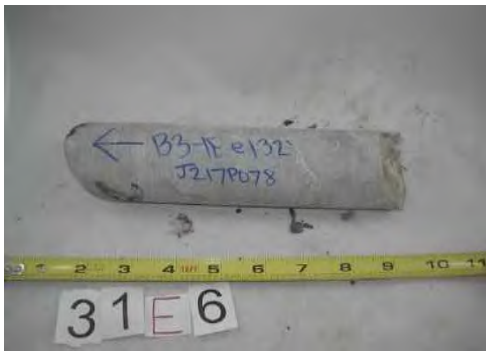
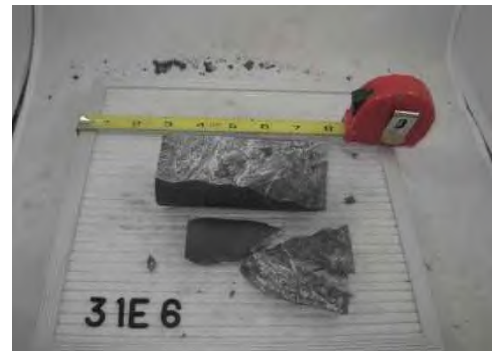
Maximum Axial Load at Failure: 2,490 lb  
 Compressive Strength: 817 psi  
 Compressive Strength: 5.63 Mpa  
 Unit Weight 176 pcf

Before the Test

After the Test

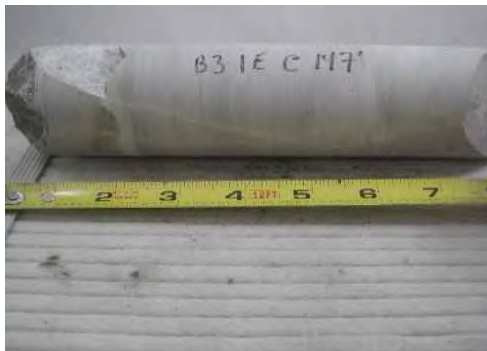
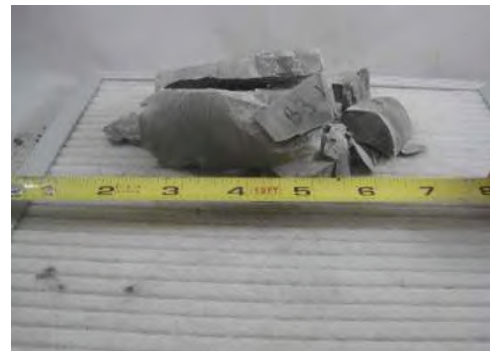
Comments : Due to lack of available specimens, the length to diameter ratio of the tested specimen is not conformant with ASTM D7012. The results obtained during testing may differ from those obtained from the test specimens that meet the requirements.

Before the Test

After the Test

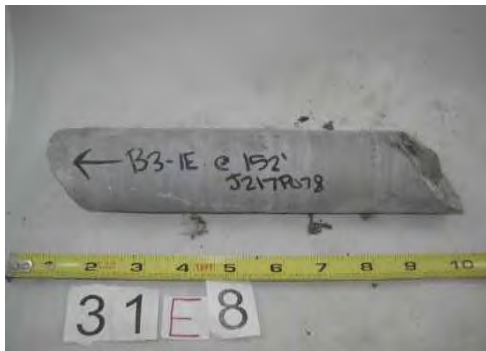
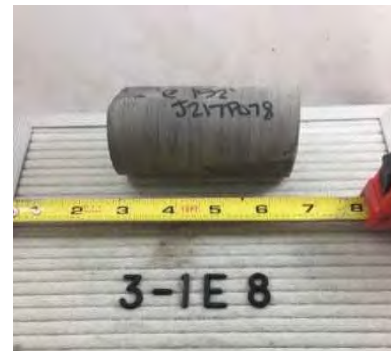
Machine reached loading capacity before specimen broke

Before the Test

After the Test

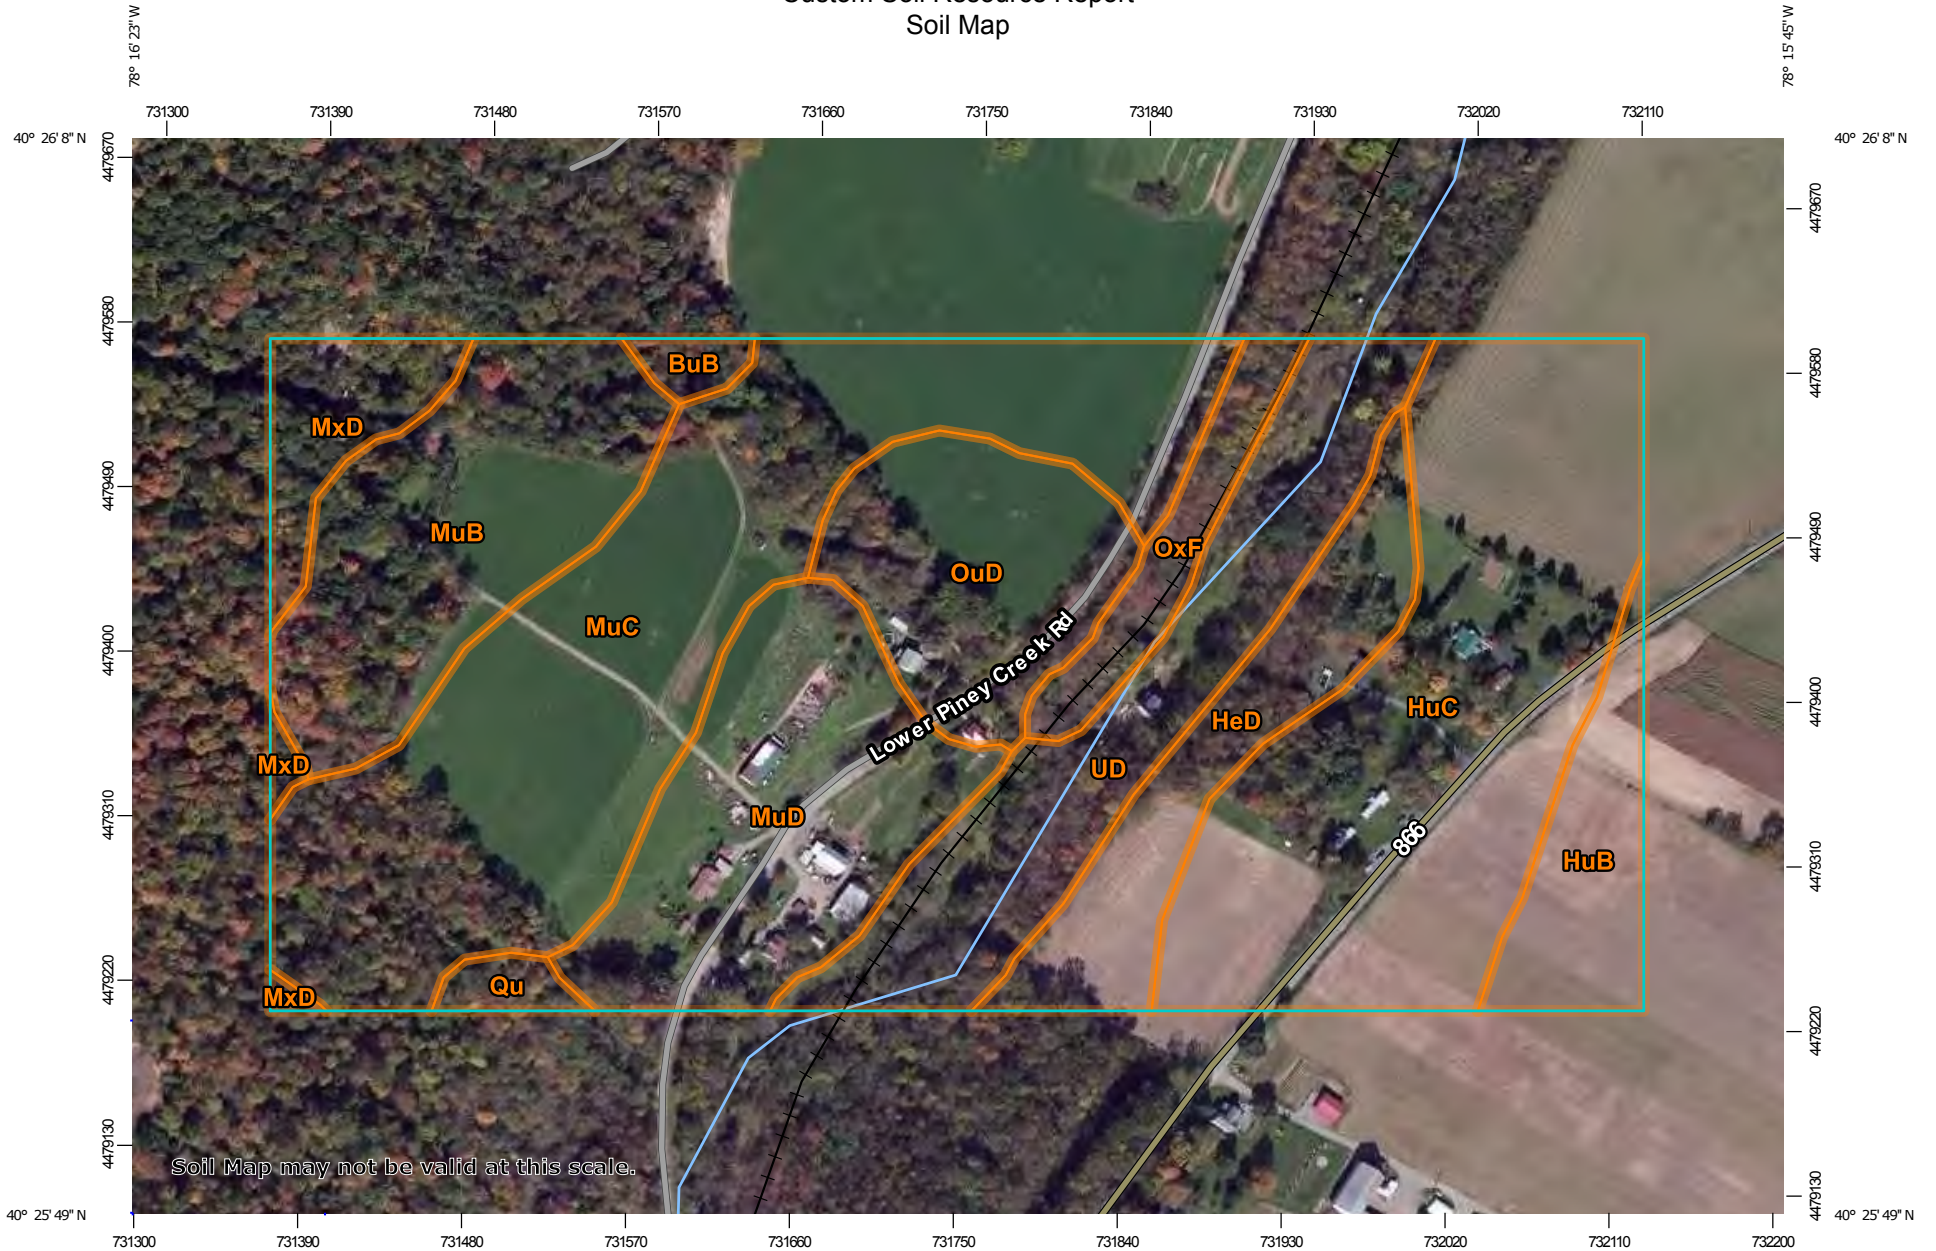
# Custom Soil Resource Report Soil Map

The soil map section includes the soil map for the defined area of interest, a list of soil map units on the map and extent of each map unit, and cartographic symbols displayed on the map. Also presented are various metadata about data used to produce the map, and a description of each soil map unit.

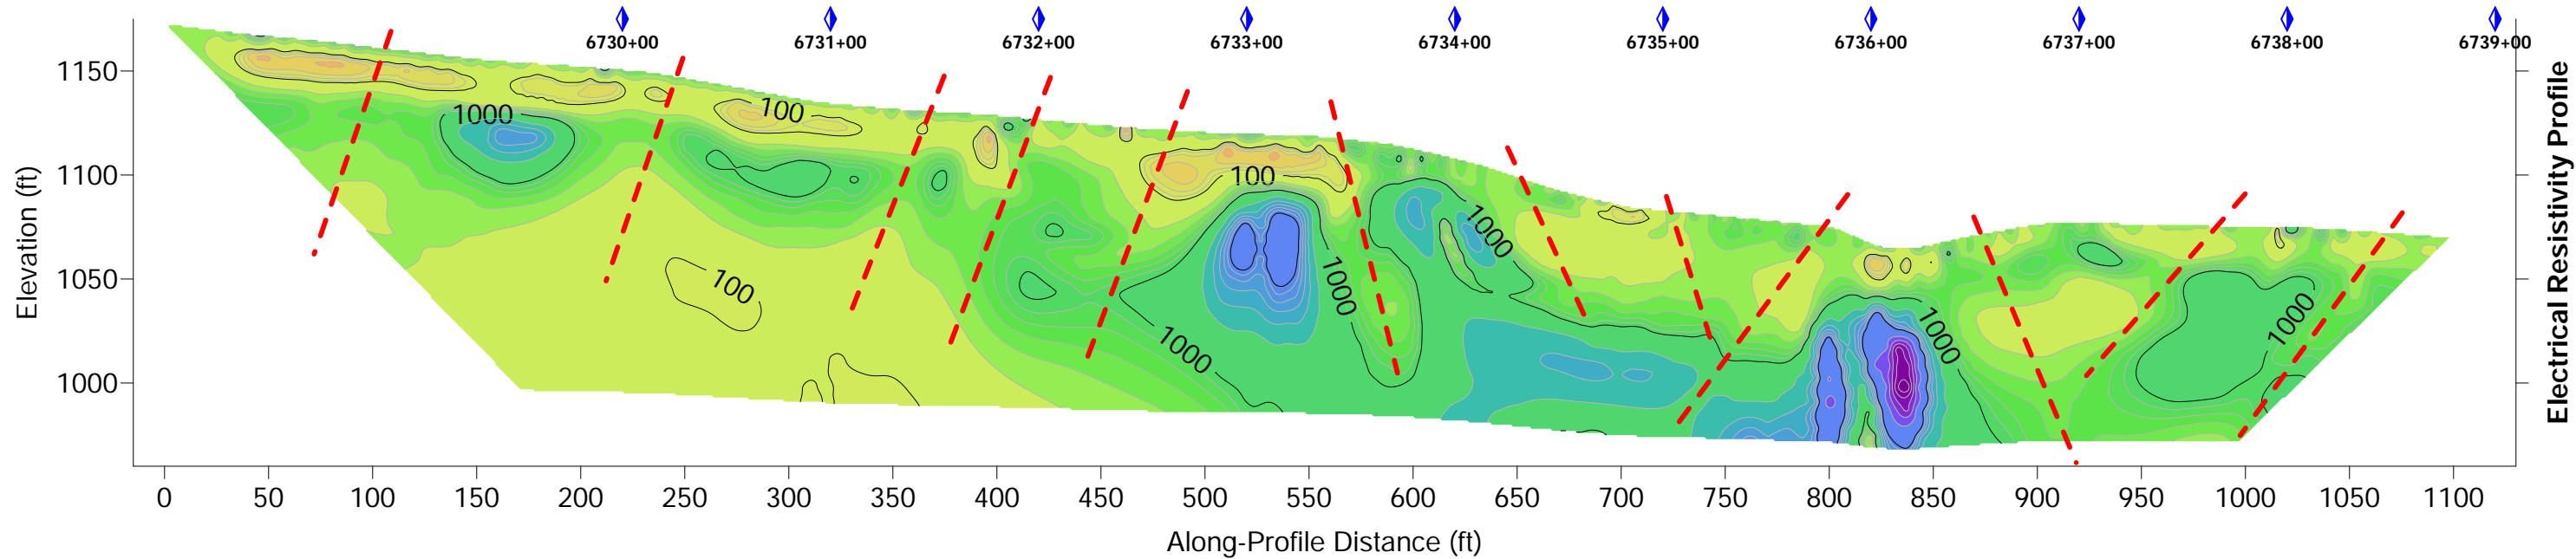
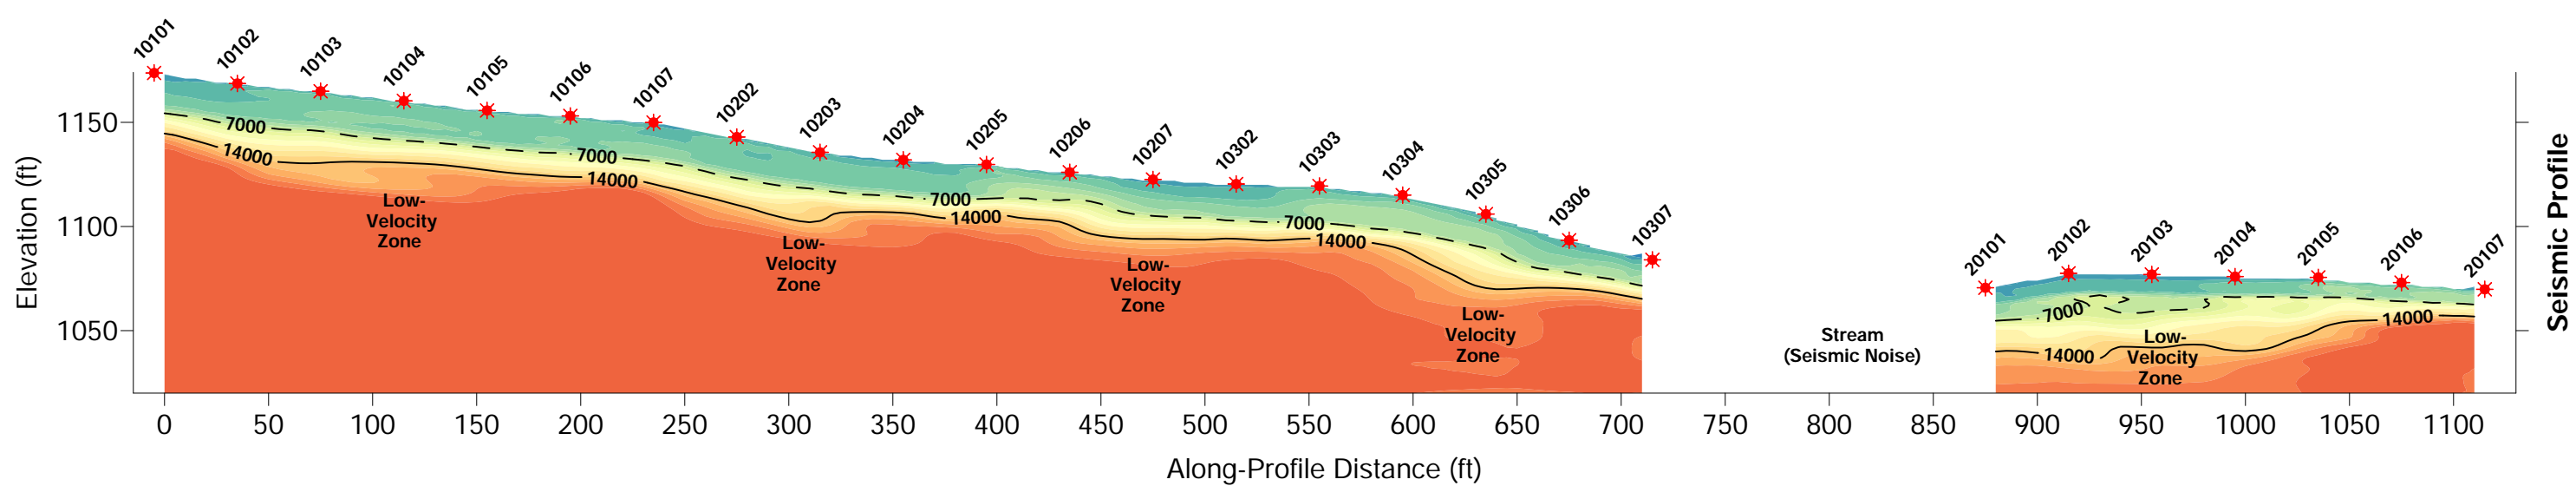
- - - Possible Fracture Zone
- \* Seismic Shot Location
- ♦ Survey Stakes (by others)

Karst geology is present at this HDD location, and a geophysical survey was performed. As is discussed in the Hydrogeology Report in Attachment 1, the results of this assessment indicated a high degree of fracturing in the near subsurface geology from immediately west of Piney Creek to within 200 of the west end of the HDD. As is presented in the Reconsideration of the Horizontal Directional Drill section below. The use of HDD best management practices such as annular pressure monitoring, the use of Loss Control Materials, and potentially grouting, will be implemented to maintain returns in both the pilot and reaming phases of the HDD as measure to reduce the risk of inadvertent returns (IRs) to the land surface or waters of the Commonwealth.

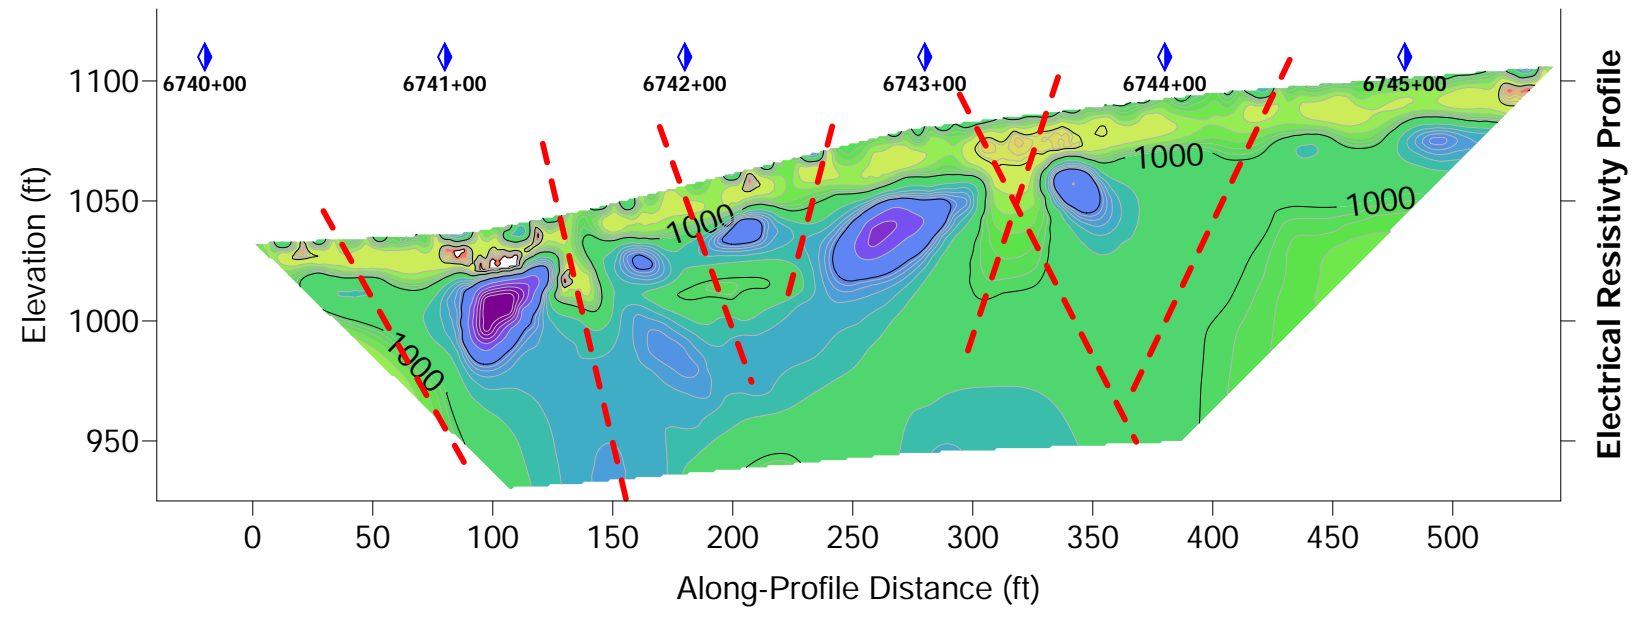
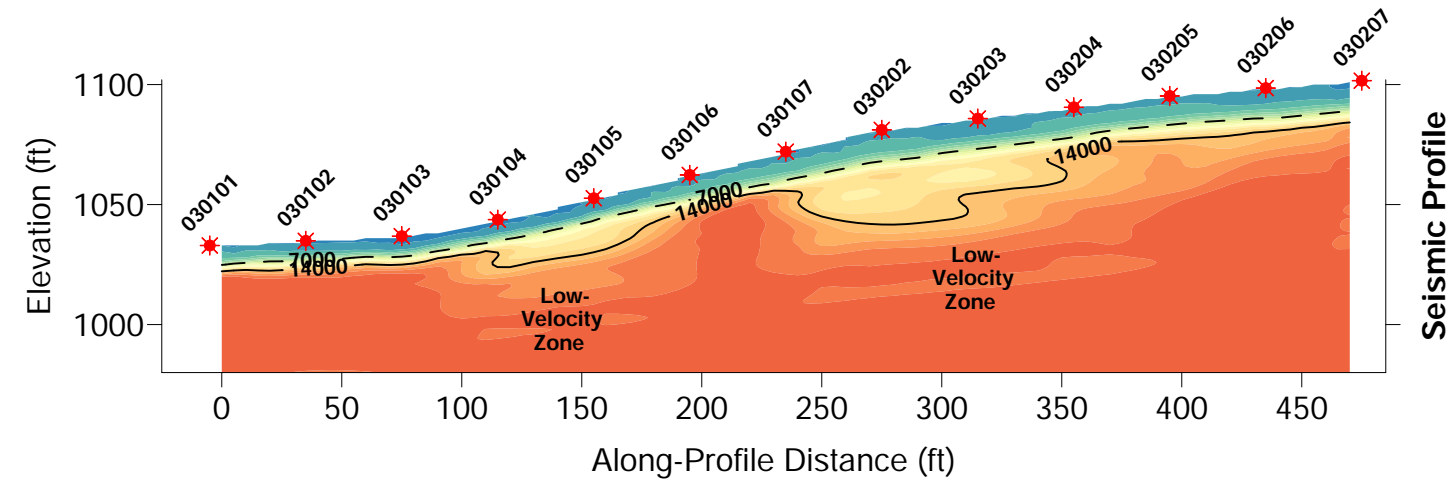
- - - - - **V1 = 1434 fps**  
 Inferred Bedrock  
 \_\_\_\_\_ **V2 = 15724 fsp**

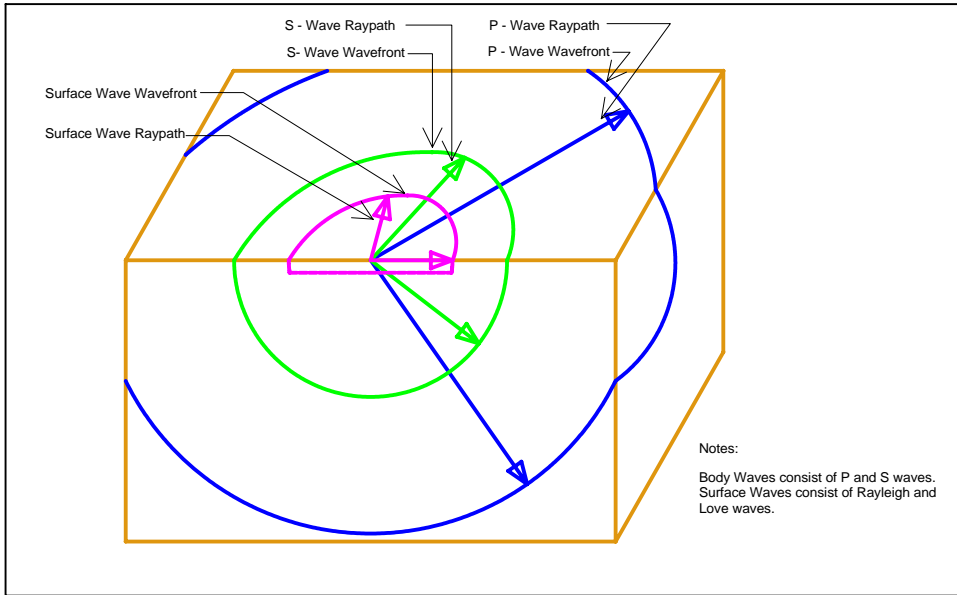
Figure SR-1

Seismic Wave Types

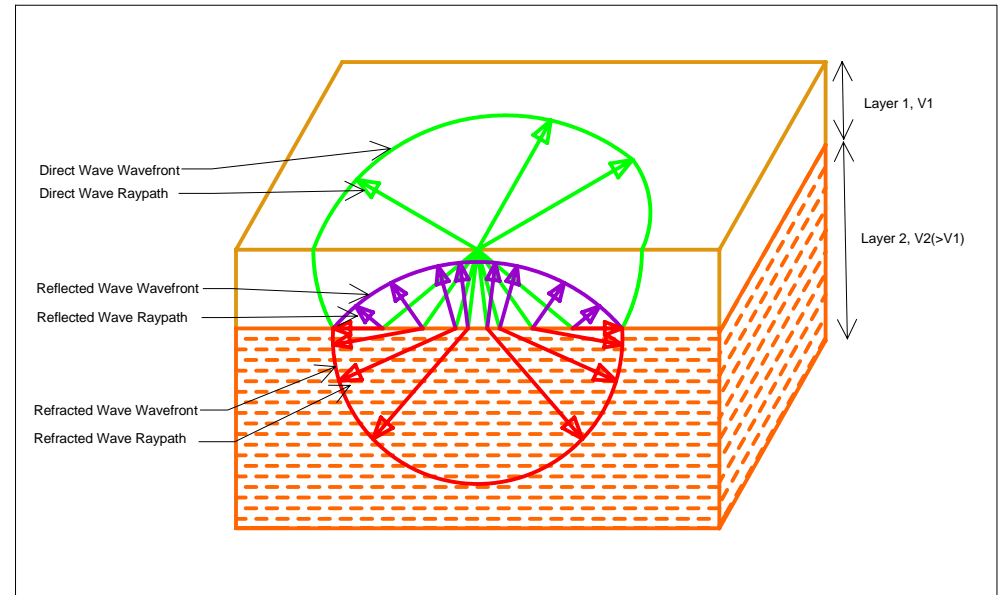
Figure SR-2

Effect of Layering on Body Wave Raypath

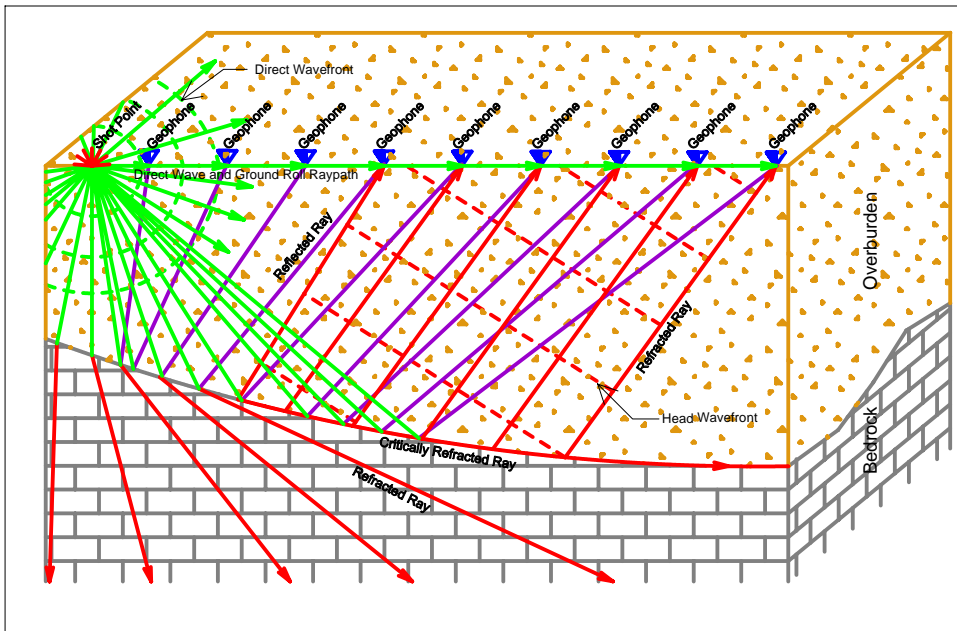
Figure SR-3

Seismic Ray Path Geometry

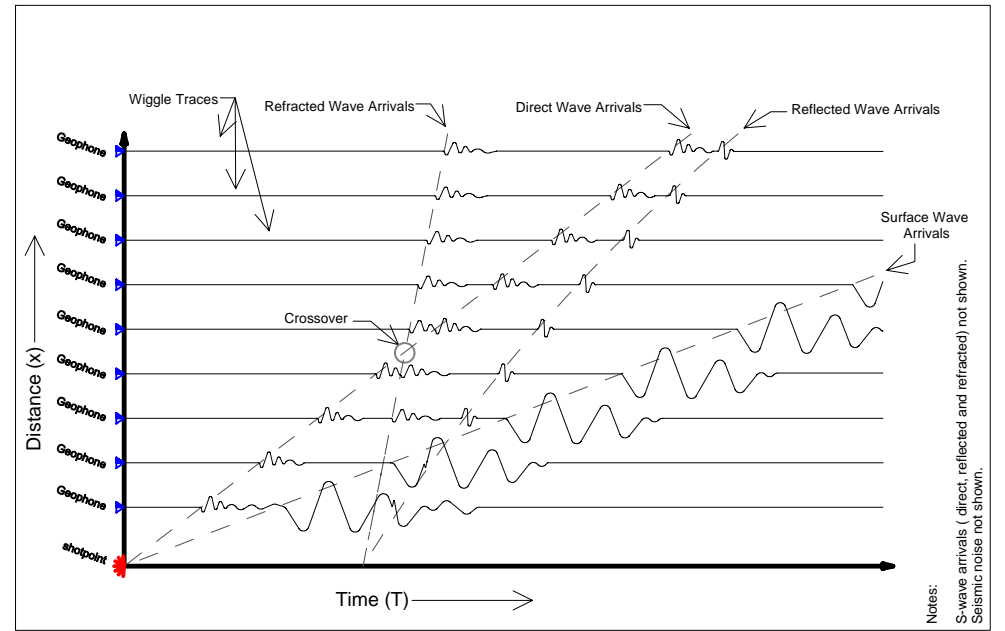
Figure SR-4

Idealized Seismic Record and T- X Graph

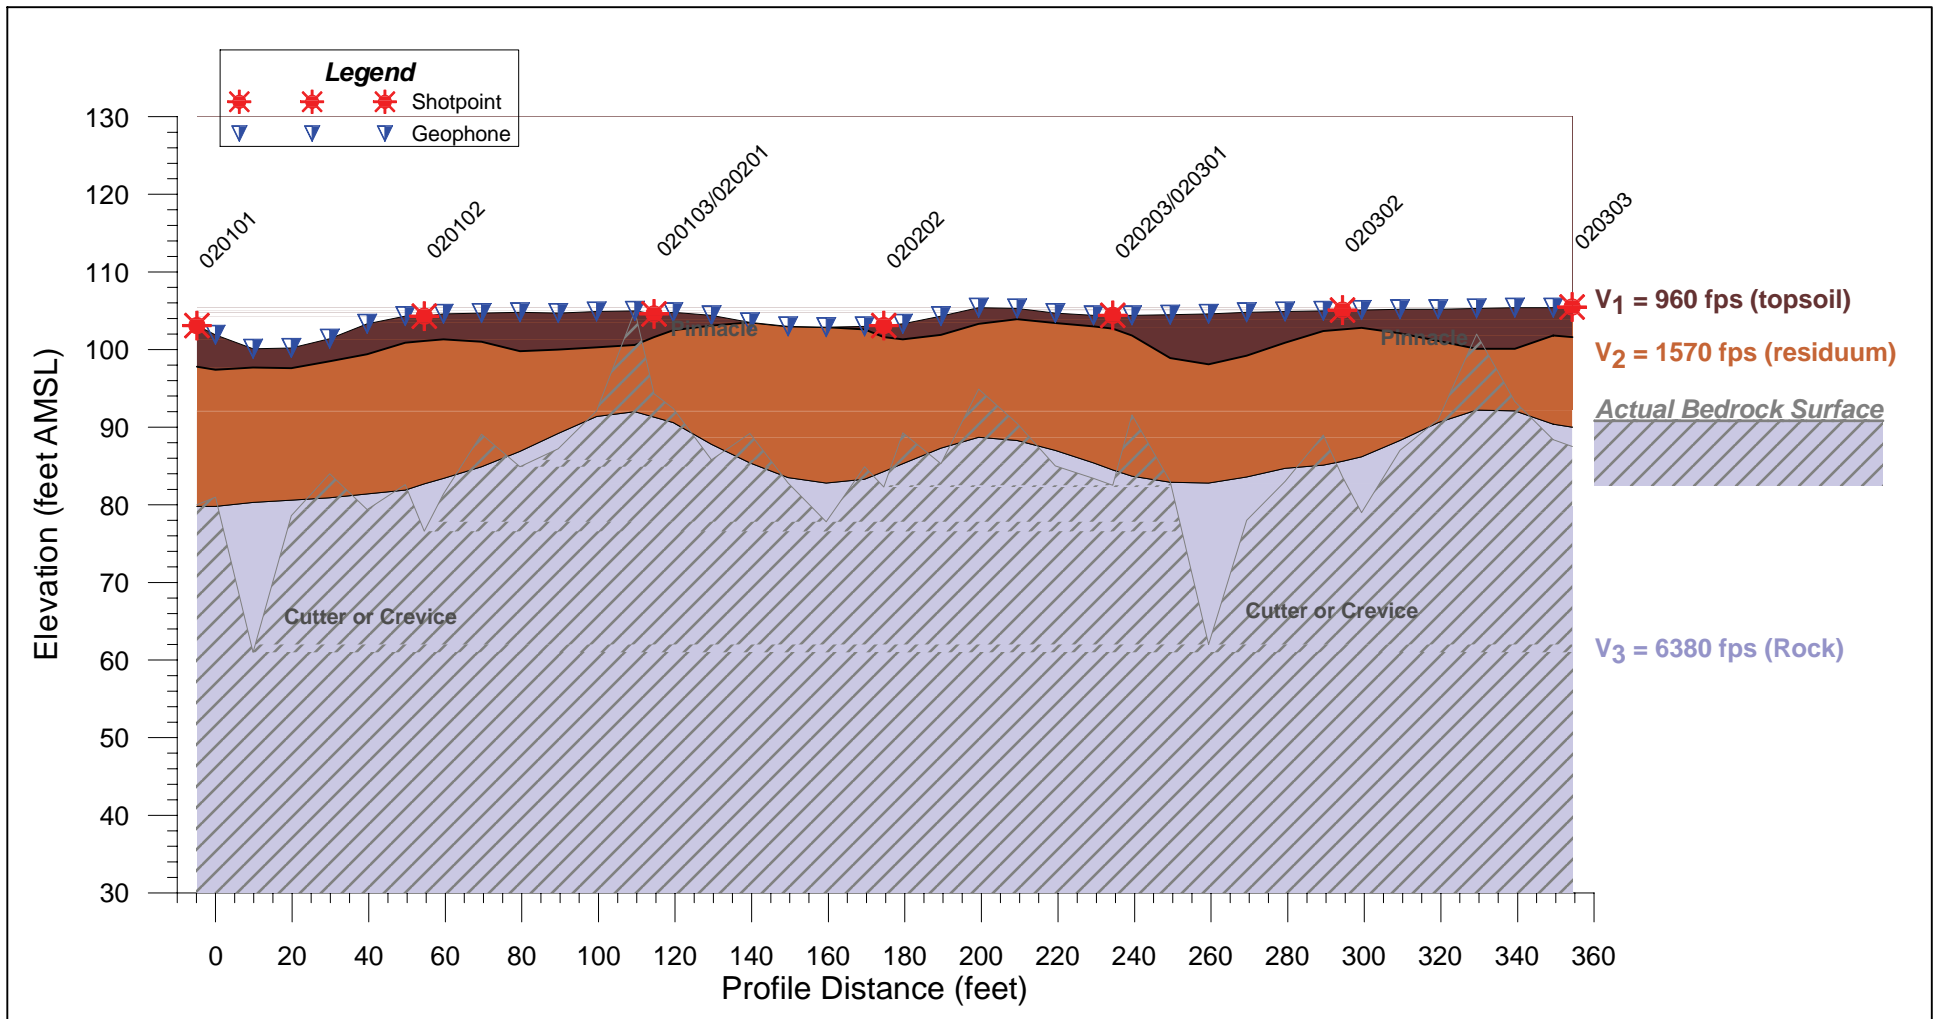
**Figure SR-5**

**Example Karst Terrane Seismic Profile**
