**HORIZONTAL DIRECTIONAL DRILL ANALYSIS  
PINEY CREEK CROSSING  
PADEP SECTION 105 PERMIT NO.: E07-459  
PA-BL-0126.0000-RD AND PA-BL-0126.0000-RD-16  
(SPLP HDD No. S2-0142)**

**PINEY CREEK CROSSING**  
**PADEP SECTION 105 PERMIT NO.: E07-459**  
**PA-BL-0126.0000-RD AND PA-BL-0126.0000-RD-16**  
**(SPLP HDD No. S2-0142)**

This reanalysis of the horizontal directional drill (HDD) installation of a 20-inch and 16-inch diameter pipeline crossing under Stream S-M3, Wetland M26, Lower Piney Creek Road, Stream S-M30 (Piney Creek), and High Street (State Road 866), is in accordance with Stipulated Order issued under Environmental Hearing Board Docket No. 2017-009-L for HDDs listed on Exhibit 2 of the Stipulated Order. This HDD is number 9 on the list of HDDs included on Exhibit 2. Activities at this HDD were initiated and suspended in June of 2017, before the issuance of the Order on August 9, 2017.

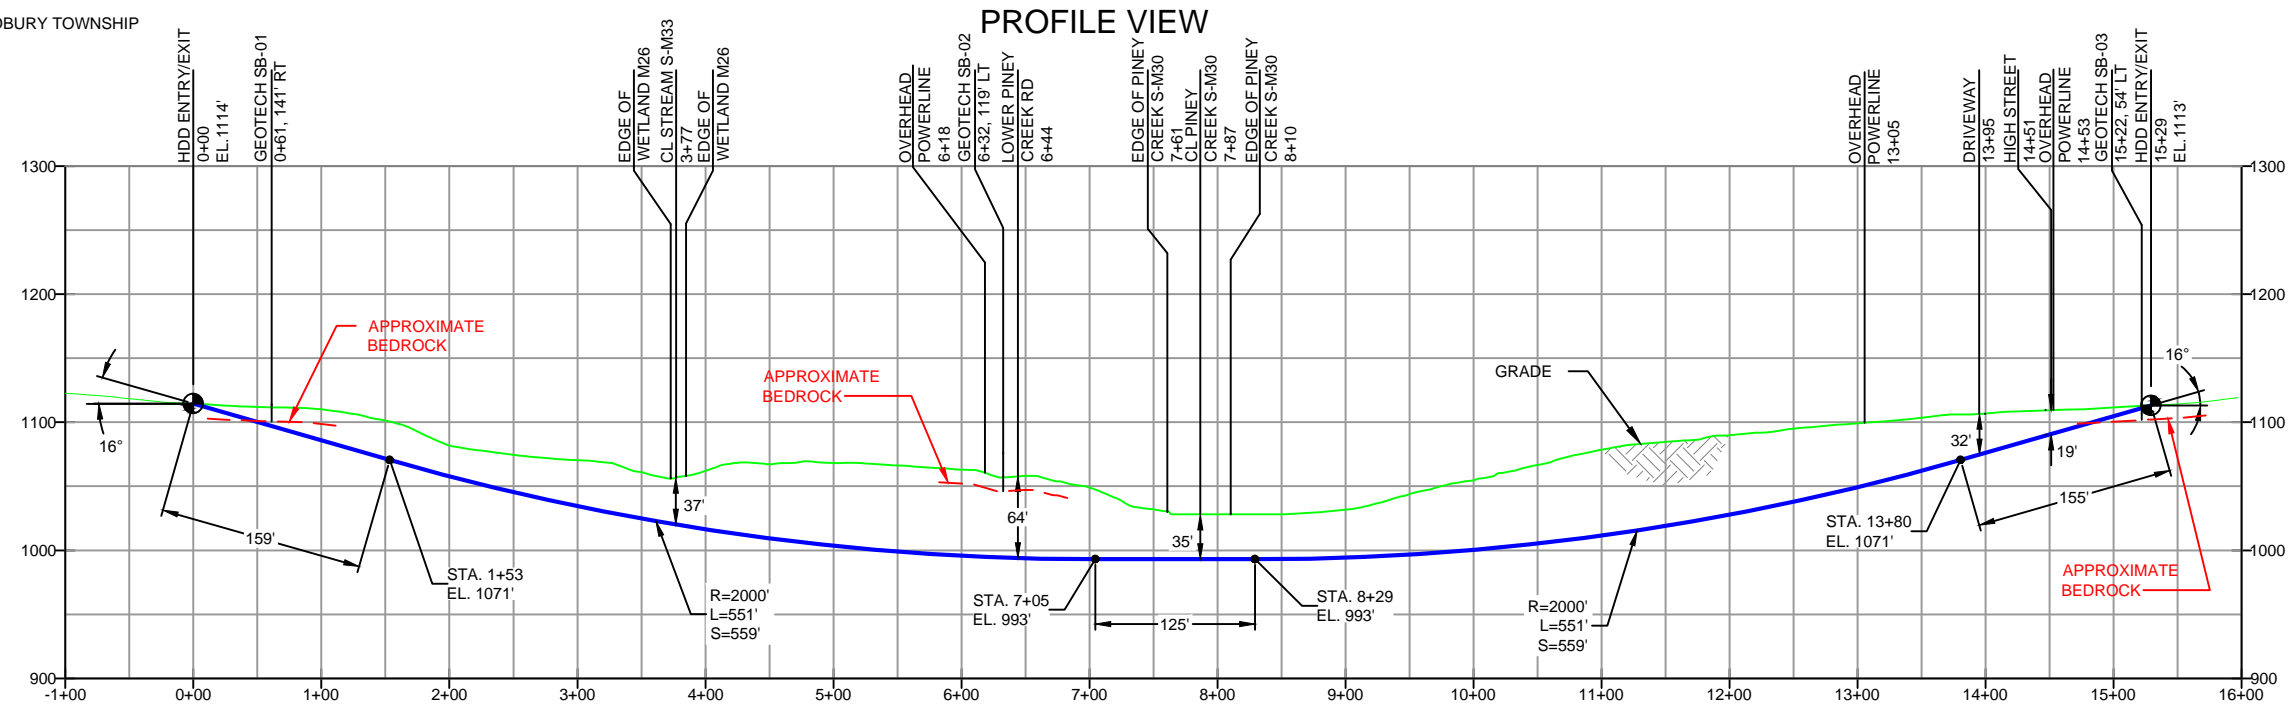
SCALE: 1"=150' DWG. NO: PA-BL-0126.000-RD

- Horizontal length: 1,529 feet (ft)
- Entry/Exit angle: 16 degrees
- Maximum Depth of cover: 70 ft
- Depth under UNT to Piney Creek (Stream S-M33): 37 ft
- Depth under Piney Creek (Stream S-M30): 35 ft
- Depth under adjacent wetlands (Wetland M26): 35 ft
- Pipe design radius: 1,556 ft

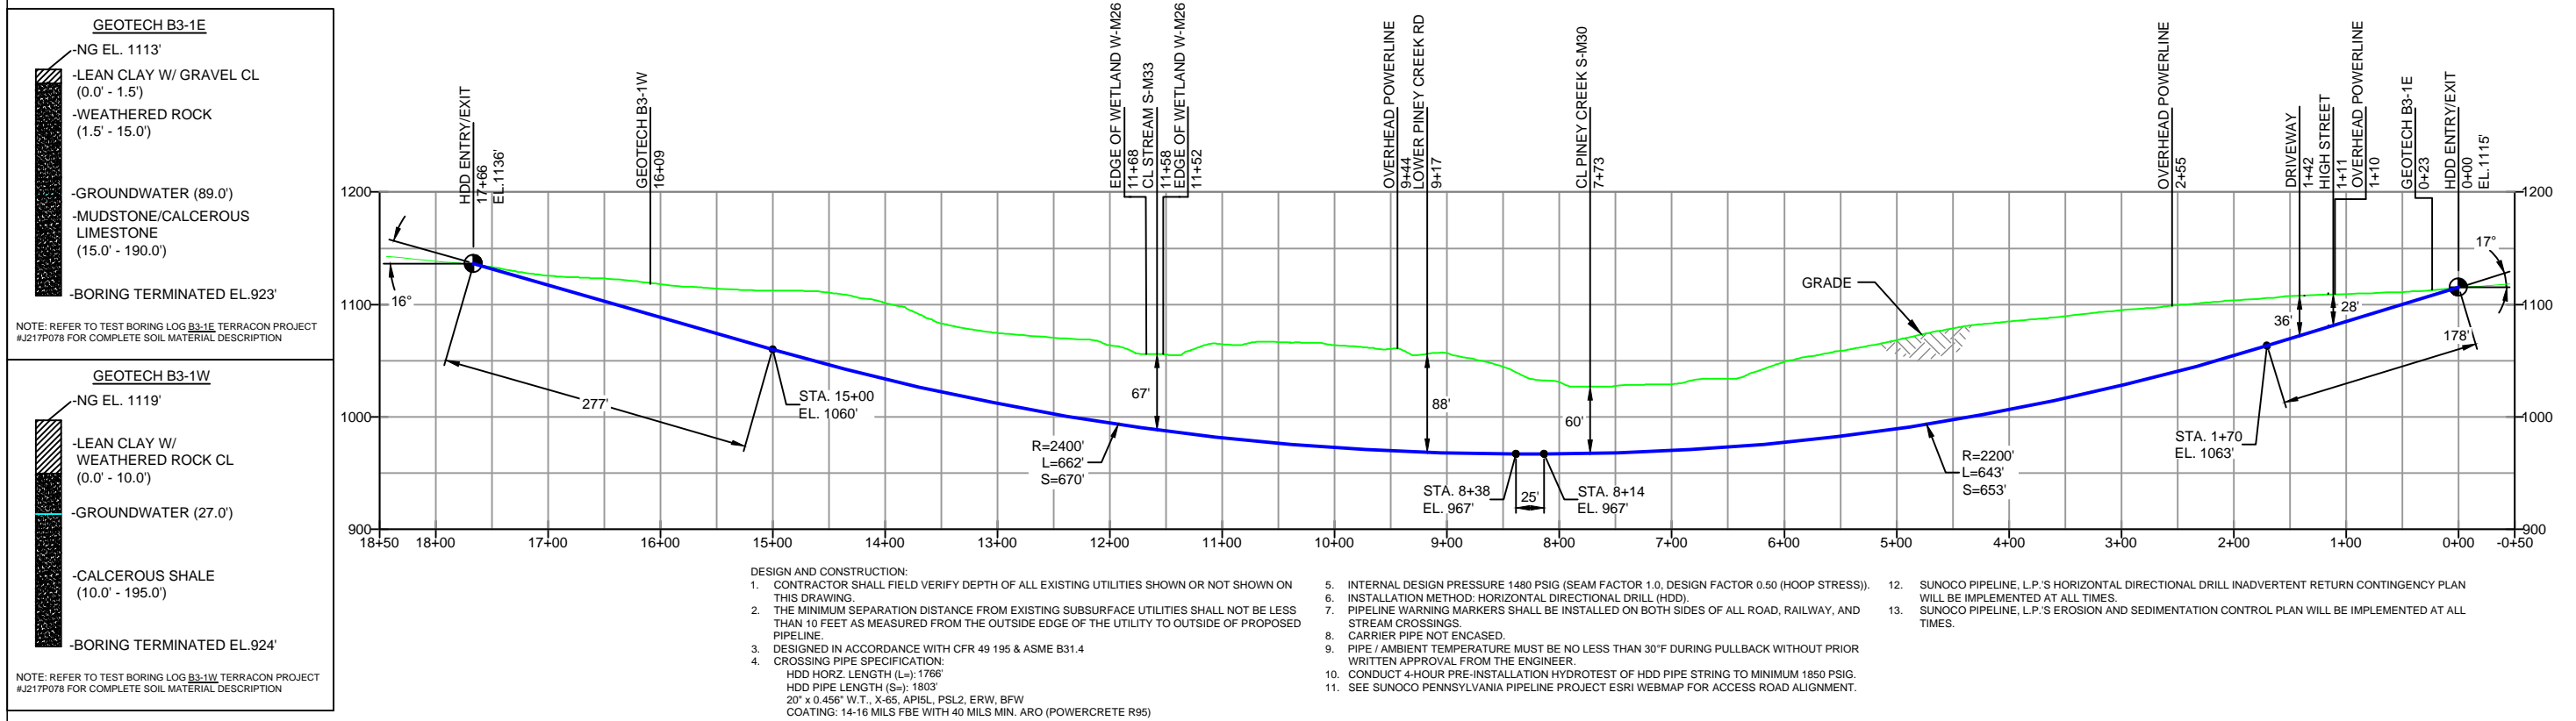
SCALE: 1"=150'      DWG. NUMBER: PA-BL-0126.0000-RD

**GEOTECH B3-1E**  
 -NG EL. 1113'  
 -LEAN CLAY W/ GRAVEL CL (0.0' - 1.5')  
 -WEATHERED ROCK (1.5' - 15.0')  
 -GROUNDWATER (89.0')  
 -MUDSTONE/CALCEROUS LIMESTONE (15.0' - 190.0')  
 -BORING TERMINATED EL.923'

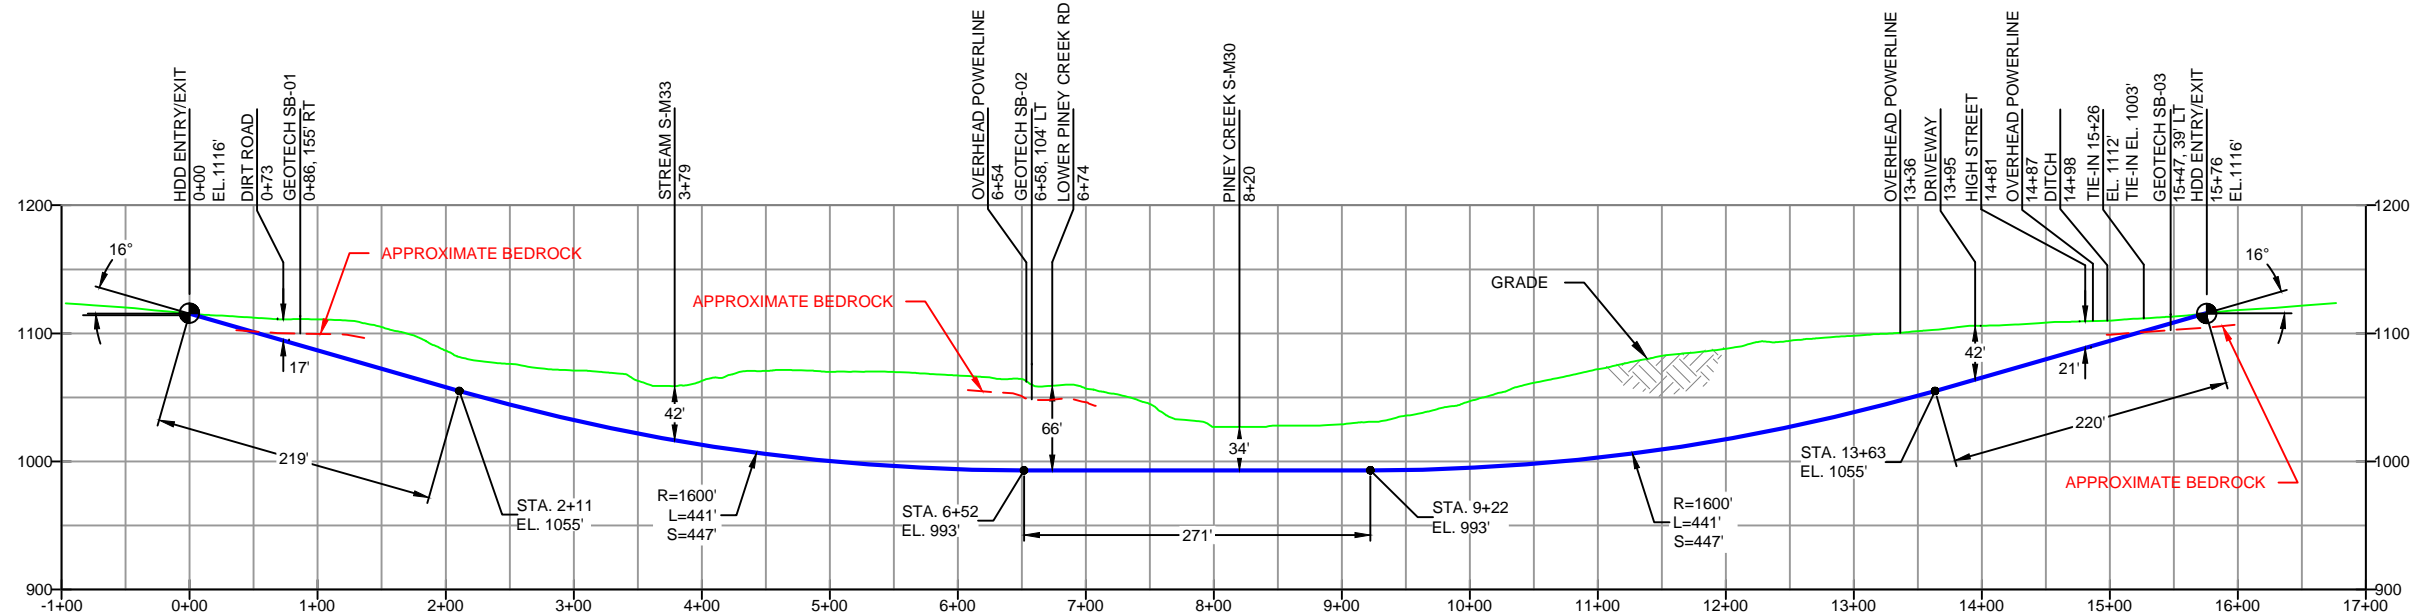
SCALE: 1"=150' DWG. NO. PA-BL-0125.0000-RD-16

- Horizontal length: 1,575 ft
- Entry/Exit angle: 16 degrees
- Maximum Depth of cover: 75 ft
- Depth under UNT to Piney Creek (Stream S-M33): 41 ft
- Depth under Piney Creek (Stream S-M30): 35 ft
- Depth under adjacent wetlands (Wetland M26): 35 ft
- Pipe design radius: 1,600 ft

- DESIGNED IN ACCORDANCE WITH CFR 49 195 & ASME B31.4
  - CROSSING PIPE SPECIFICATION:  
HDD HORZ LENGTH (L<sub>H</sub>): 1575'  
HDD PIPE LENGTH (S<sub>H</sub>): 1604'  
16" x 0.438" W.T., X-70, API5L PSL2, ERW, BFW  
COATING: 14-16 MILS FBE WITH 40 MILS MIN. ARO (POWERCRETE R95)
