**HORIZONTAL DIRECTIONAL DRILL ANALYSIS  
SCHOOL HOUSE ROAD CROSSING  
PADEP SECTION 105 PERMIT NO.: E38-194  
PA-LE-0005.0000-RD-16  
(SPLP HDD No. S3-0091-16)**

**SCHOOL HOUSE ROAD CROSSING  
PADEP SECTION 105 PERMIT NO. E38-194  
PA-LE-0005.0000-RD-16  
(SPLP HDD No. S3-0091-16)**

**ATTACHMENT 1  
GEOLOGY AND HYDROGEOLOGICAL EVALUATION REPORT**

**ATTACHMENT 2  
HORIZONTAL DIRECTIONAL DRILL PLAN AND PROFILES**

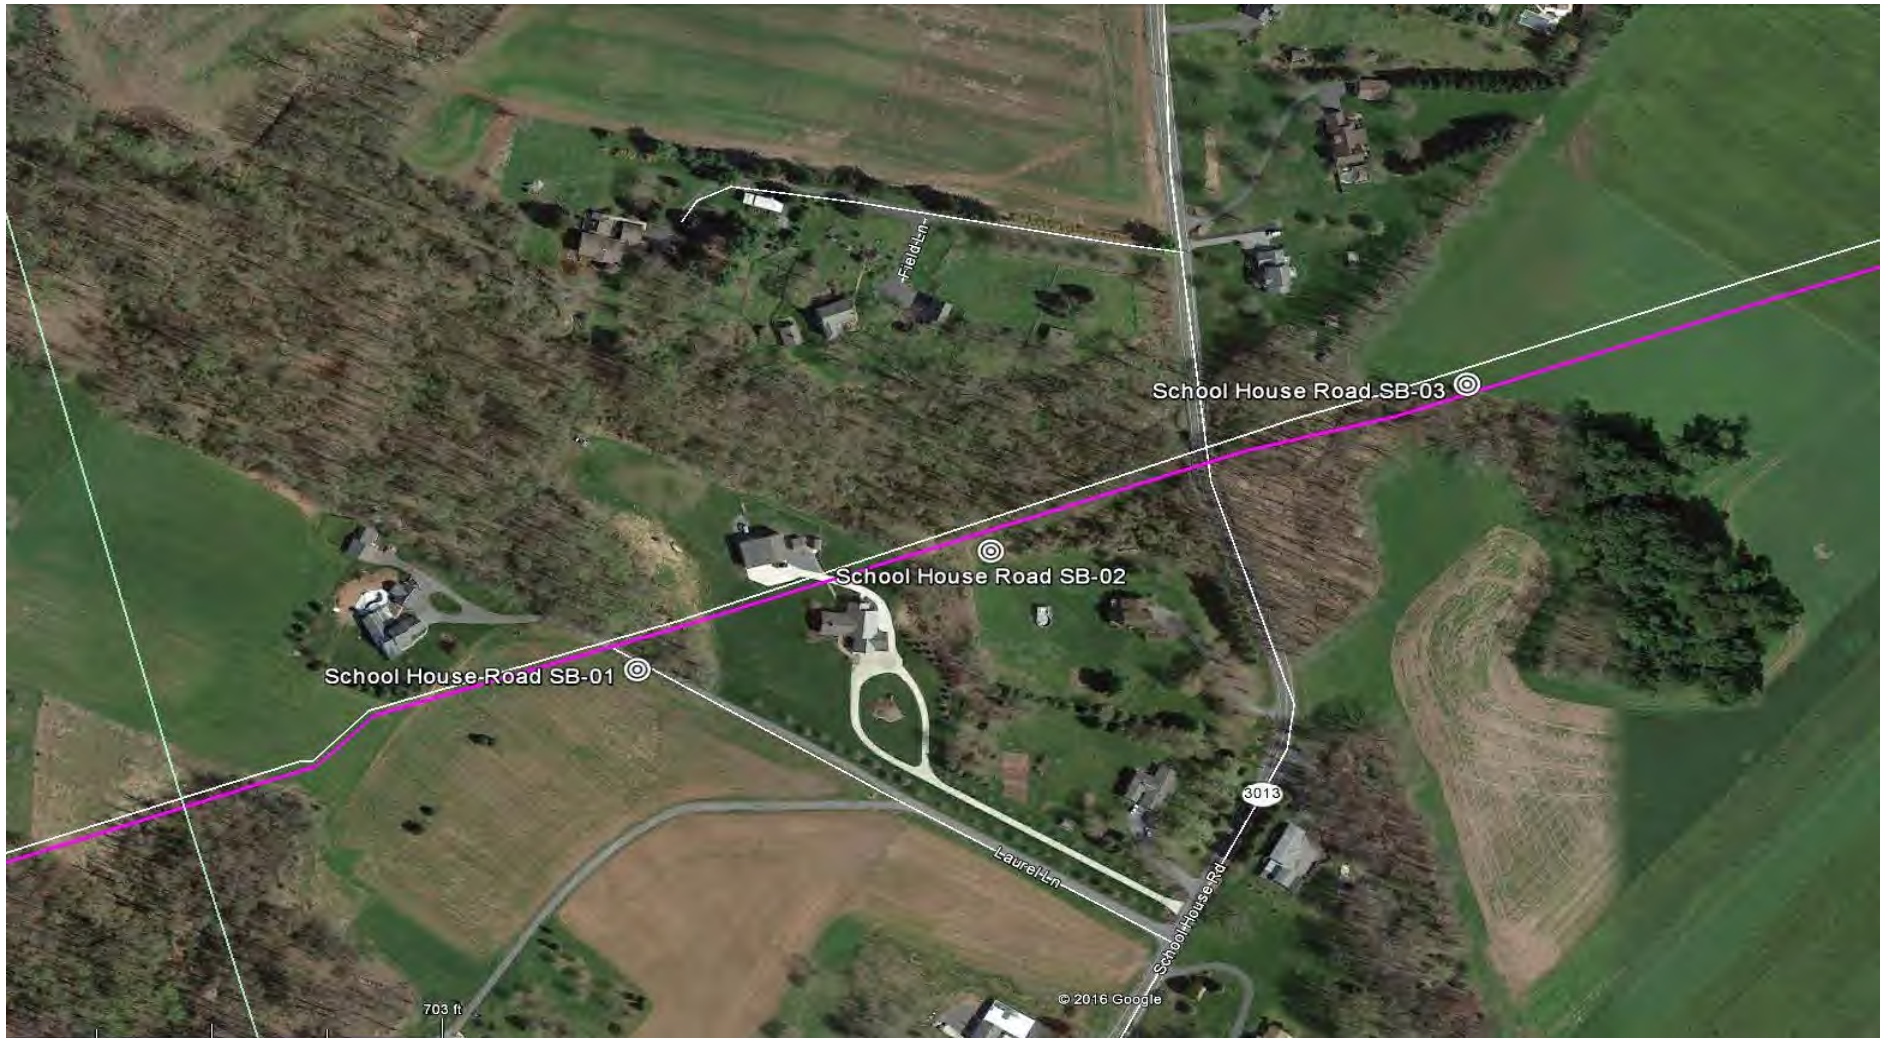
SCALE: 1"=150'    DWG. NO: PA-LE-0005.0000-RD-16

HORIZONTAL DIRECTIONAL DRILL  
SCHOOL HOUSE RD  
PENNSYLVANIA PIPELINE PROJECT

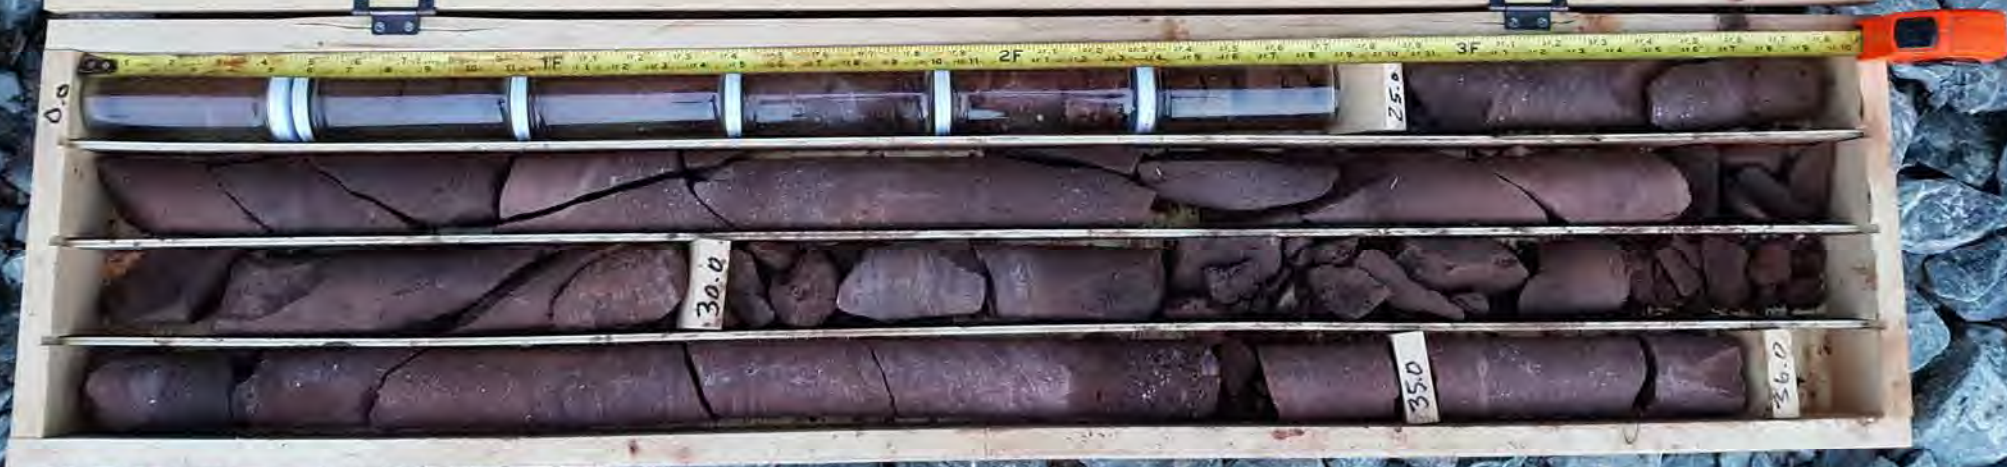
BOR No B-2 DATE 12/5/17 Box 2  
DEPTH 36.0 FT to 50.0 FT SPREAD PPP5  
HQP SCHOOLHOUSE LN PSI # 04911458  
TT# PA-LE.0005.0000-RD-16

RUN	DEPTH	REC	RQD
R-1	25.0' - 30.0	5.0	0.5
R-2	30.0' - 35.0	4.0 5.0	1.7
R-3	35.0 - 40.0	5.0	4.3

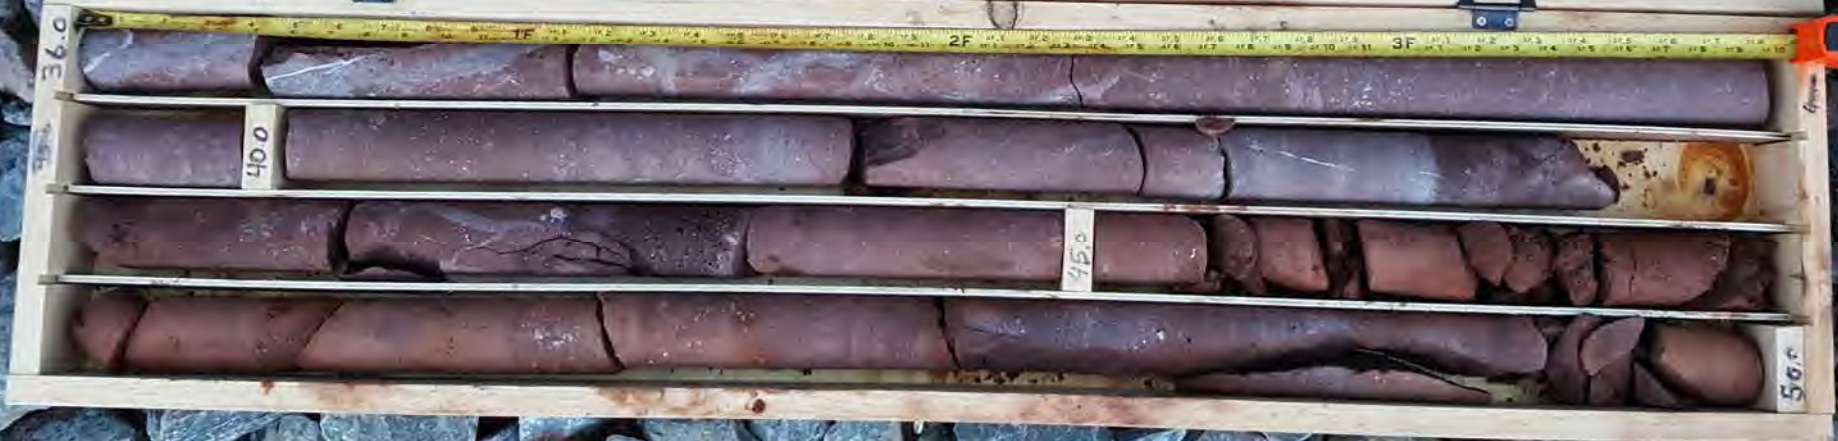
RW	DEPTH	REC	R&D
R-3	35.0 - 40.0	5.0	4.3
R-4	40.0 - 45.0	5.0	5.0
R-5	45.0 - 50.0	5.0	1.8

- **Boring SB-03:** Rock coring was not completed at this location.
  - **Boring B-2:** B-2 was completed to a total depth of 200 feet bgs.
    - From 25 to 65 feet bgs red-brown to dark gray-brown, slightly weathered, very broken to massive, hard to very hard, flat medium to thick bedded, random SANDSTONE with moderately to widely spaced fractures with tight joints was encountered. Broken layers were observed at 28.6, 49.5 and 63.9 feet bgs, while weathered/broken layers were present at 30, 30.9 to 32.3, and 63.4 feet bgs. A weathered layer was observed at 45.3 feet bgs. Siltstone and conglomeritic sandstone interbeds of varying thicknesses

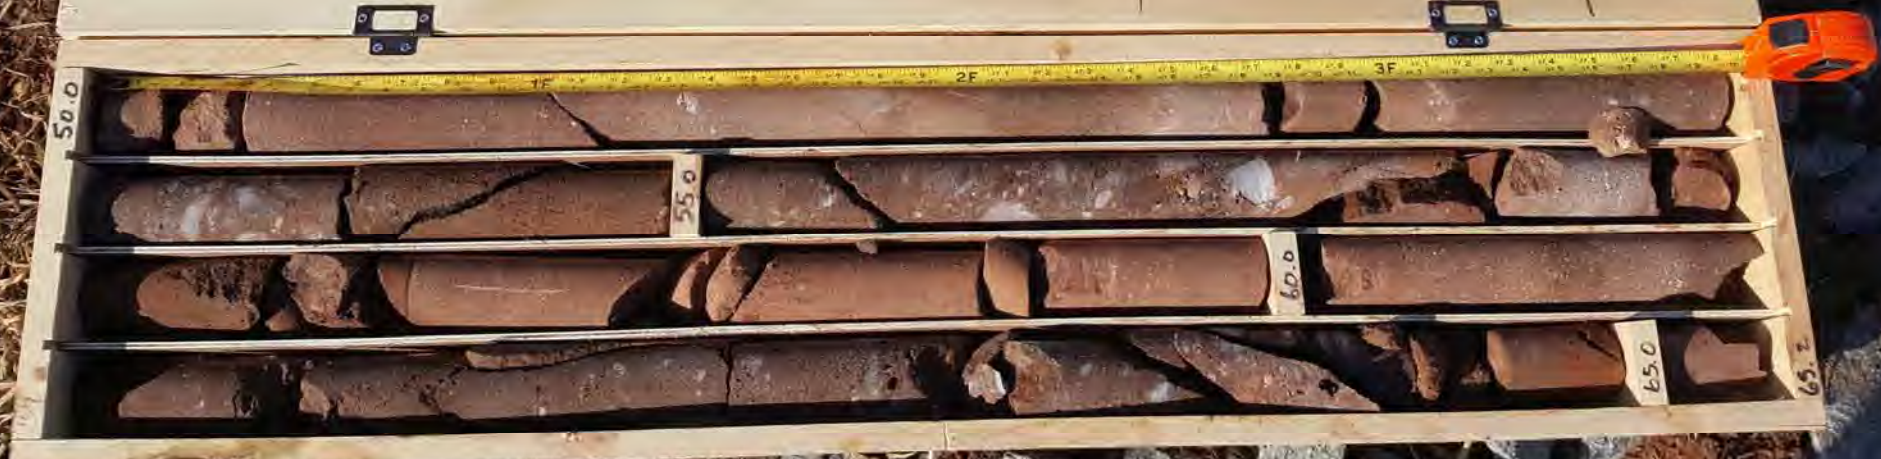
Box No B-2 Box 3 DATE 12/6/12  
DEPTH 50.0 FT + 65.2 FT SPREAD PPPS  
HDP Schoolhouse Ln PSI # 04911458  
TT# 000 QA-LE-0005-0000-RD-16

RUN	DEPTH	REL	ROD
R-6	50.0' - 55.0	5.0	3.7
R-7	55.0 - 60.0	5.0	2.4
R-8	60.0 - 65.0	4.5	1.3

were observed between 50 and 65 feet bgs. Rock recoveries ranged from 90 to 100% and RQD values ranged from very poor to excellent (10 to 100).

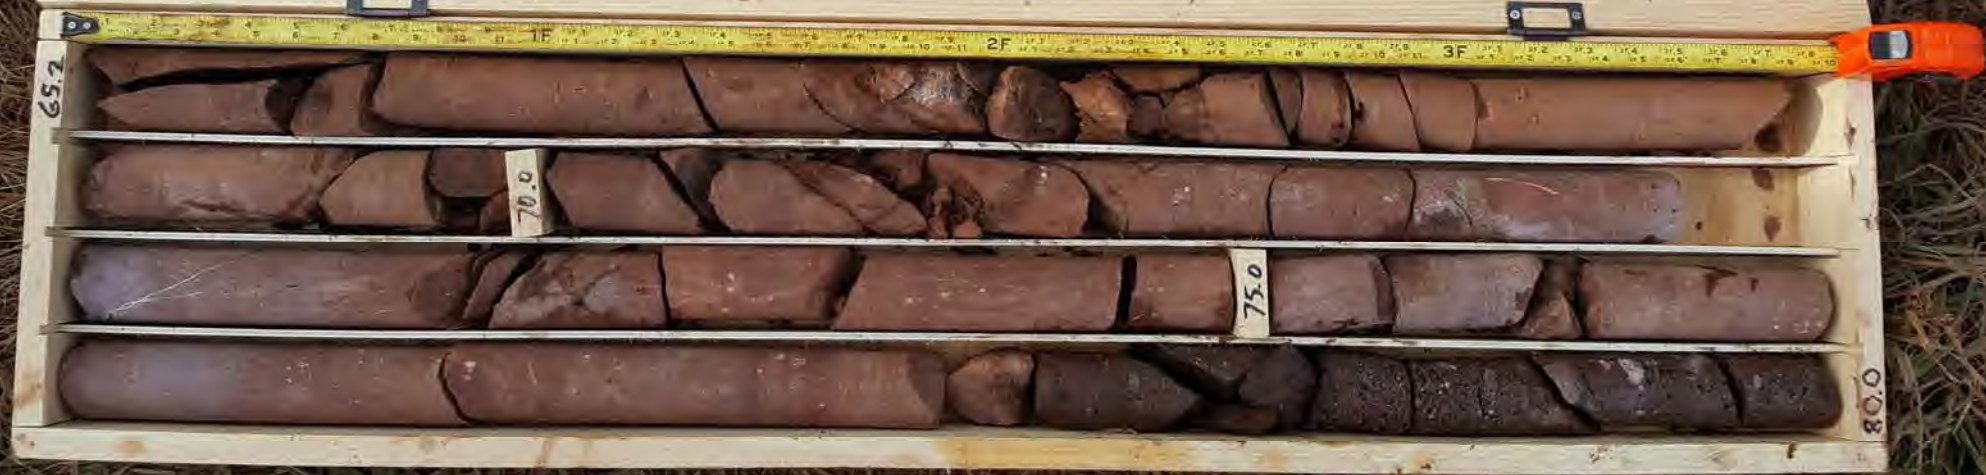
Box No B-2 Box 4 Date 12/6/17  
 DEPTH 65.2 FT to 80.0 FT SPREAD PPPS  
 HDD SCHOOLHOUSE LN PS/ # 04711458  
 TT# PA CE - 0005 - 0000 - PD-16

RUN	DEPTH	REC	ROD
R-9	65.0 - 70.0	<del>11.5</del> 5.0	1.8
R-10	70.0 - 75.0	5.0	4.0
R-11	75.0 - 80.0	5.0	3.3

- From 65 to 78.5 feet bgs red-brown to red-gray-brown, slightly weathered, very broken to massive, moderately hard to hard, laminated flat to shallow bedding, closely to moderately spaced, shallow to moderately angled fractured SILTSTONE with interbedded sandstone was encountered. Weathered layers were observed at 67.1 and 69.8 feet bgs and a highly weathered layer was observed at 70.7 feet bgs. Rock recovers were 100% and RQDs ranged from poor (37) to good (80).

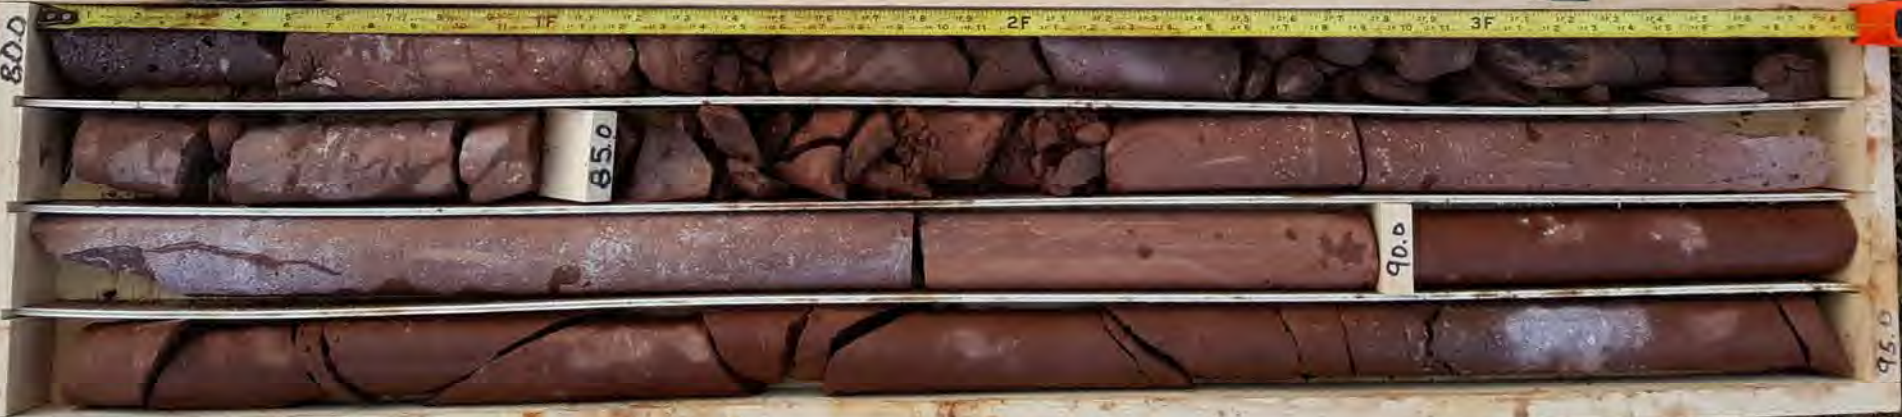
BOR No B-2 Box 5 DATE 12/6/17

DEPTH 80.0 FT TO 95.0 FT SPREAD PPP5

RUN	DEPTH	REC	ROD
R-12	80.0 - 85.0	5.0	3.0
R-13	85.0 - 90.0	5.0	4.1
R-14	90.0 - 95.0	5.0	5.0

- From 78.5 to 112.75 feet bgs red-brown to light gray, slightly weathered, very broken to massive, moderately hard to very hard, flat medium to thick bedded, SANDSTONE with random moderately to widely spaced fractures and tight joints was encountered. Broken layers were observed at 78.6 and 82.5 feet bgs, while weathered/broken layers were present at 81.3, 85, 95, and 98.9 feet bgs. A weathered/highly weathered layer was observed at 110 feet bgs. Rock recoveries ranged from 98 to 100% and RQD values ranged from fair to excellent (58 to 100).

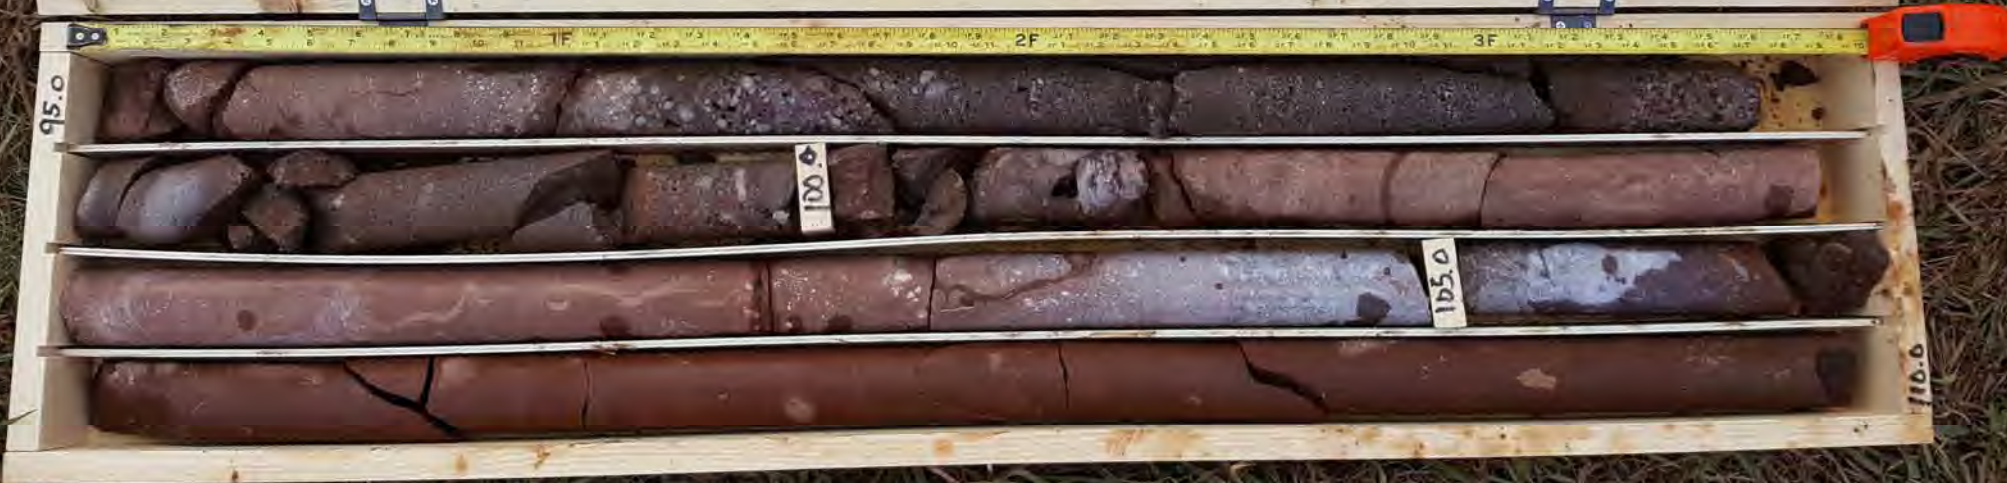
Box No B-2 Box 6 DATE 12/6/17

Run	DEPTH	REL	RWD
R-15	95.0 - 100.0	5.0	4.7
R-16	100.0 - 105.0	5.0	4.2
R-17	105.0 - 110.0	5.0	5.0

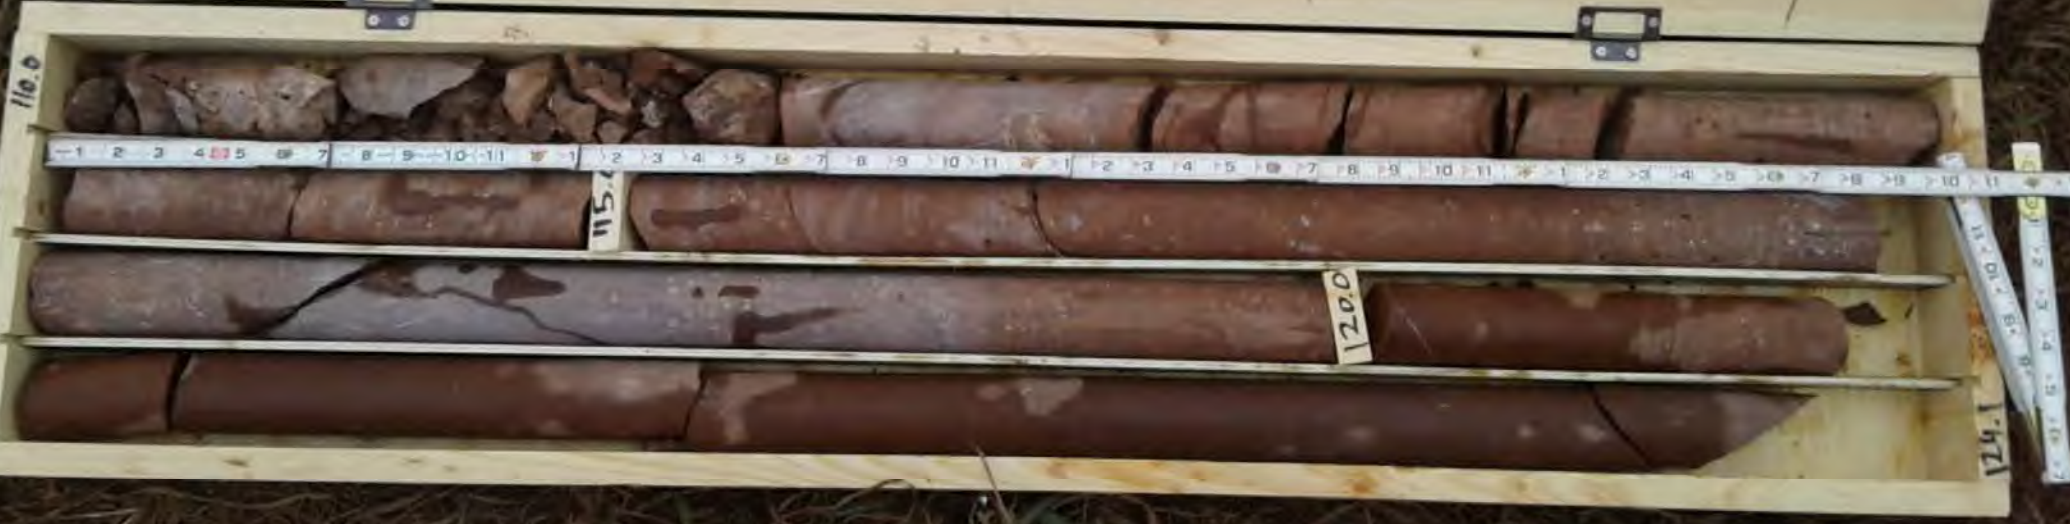
Box No B-2 Box 7 DATE 12/6/17 - 12/7/17

Run	DEPTH	REC	RQD
R-18	110.0 - 115.0	4.9	2.9
R-19	115.0 - 120.0	5.0	5.0
R-20	120.0 - 126.0	5.0	5.0

- From 112.75 to 128.75 feet bgs red-brown, slightly weathered, very broken to massive, moderately hard, laminated, flat to shallow bedding, closely to moderately spaced, shallow to moderate dip fractures SILTSTONE with interbedded sandstone was encountered. Rock recoveries ranged from 97 to 100% and RQD values were excellent (90 to 100).

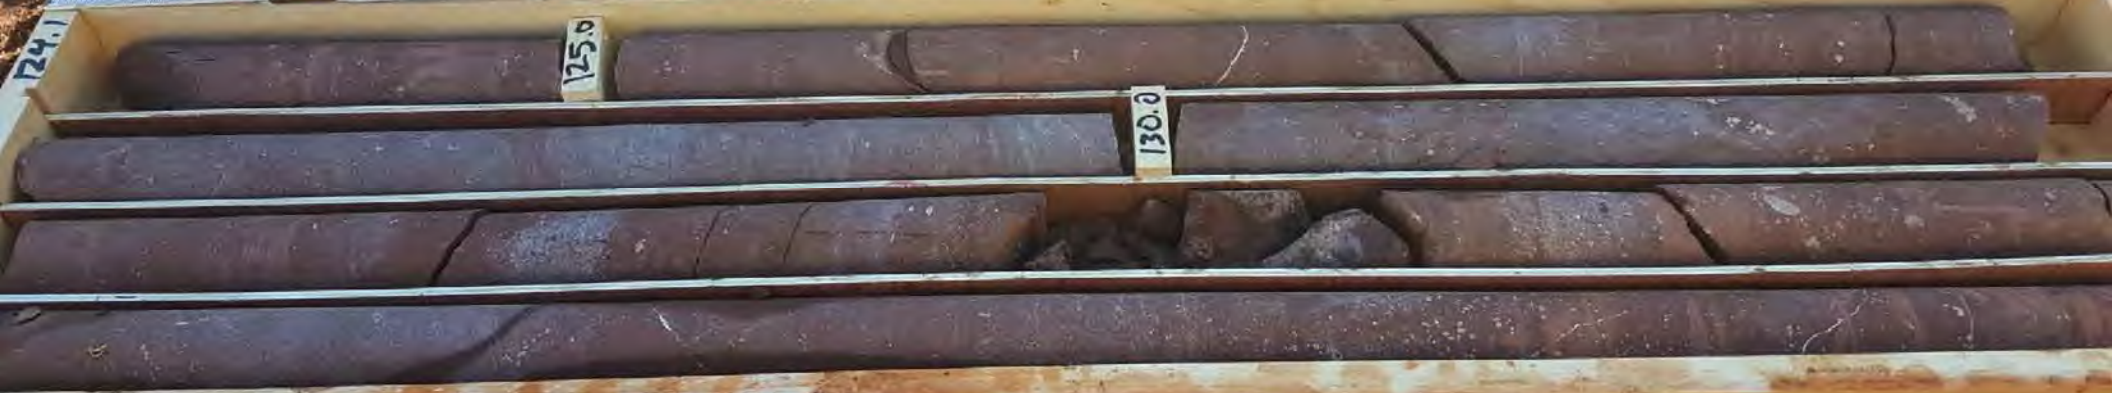
BOR NO. B-2 BOX 8 DATE 12-7-17

Depth 124.1 to 139.0 ~~SPREAD~~ SPREAD PPP-5

RUN	DEPTH	REC	RQD
R-21	125-130	4.8	4.5
R-22	130-135	5.0	4.4
R-23	135-140	4.4	4.0

- From 128.75 to 148.5 dark red-brown to gray-brown, slightly weathered, broken to massive, hard, flat medium to thick bedded, SANDSTONE with random moderately to widely spaced fractures with tight joints was encountered. A weathered/highly weathered layer was observed at 133.4 feet bgs and a soil layer was encountered at 148 feet bgs. Rock recoveries ranged from 97 to 100% and RQD values ranged from fair to excellent (72 to 100).

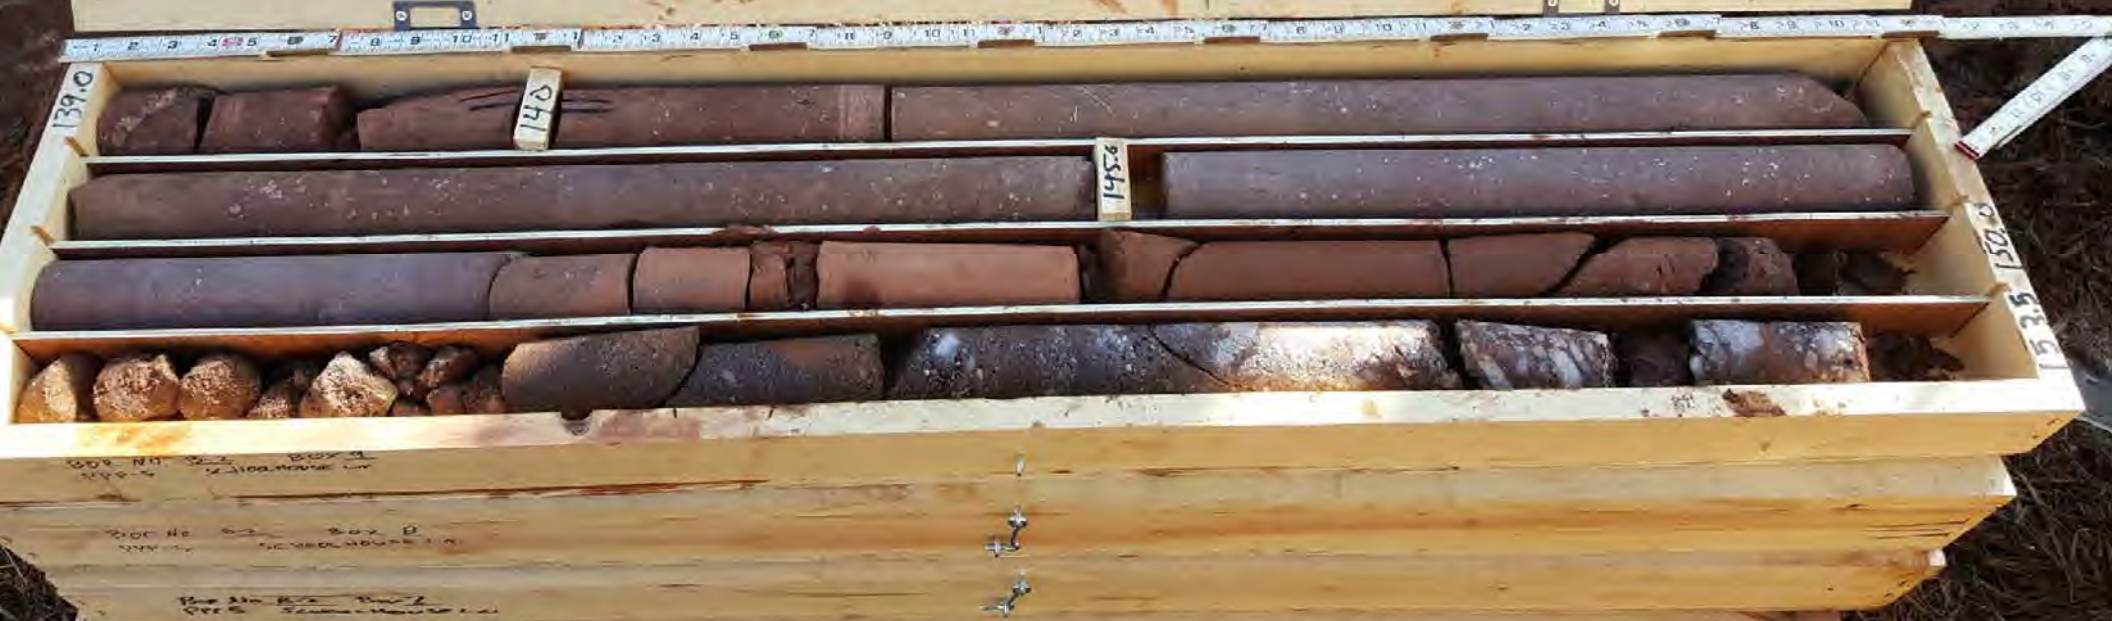
BOR NO. B-2 BOX 4 DATE 12/7/17  
 DEPTH 139.0 to 153.5 SPREAD PPP-5  
 HPD SCHOOLHOUSE LN. PSI # 4911458  
 TT# PA-LE-0005-0000-RD-16

RUN	DEPTH	REC	RQD
R-23	135.0-140.0	4.8	4.4
R-24	140.0-145.0	5.0	5.0
R-25	145.0-150.0	5.0	3.0
R-26	150.0-155.0	5.0	2.8

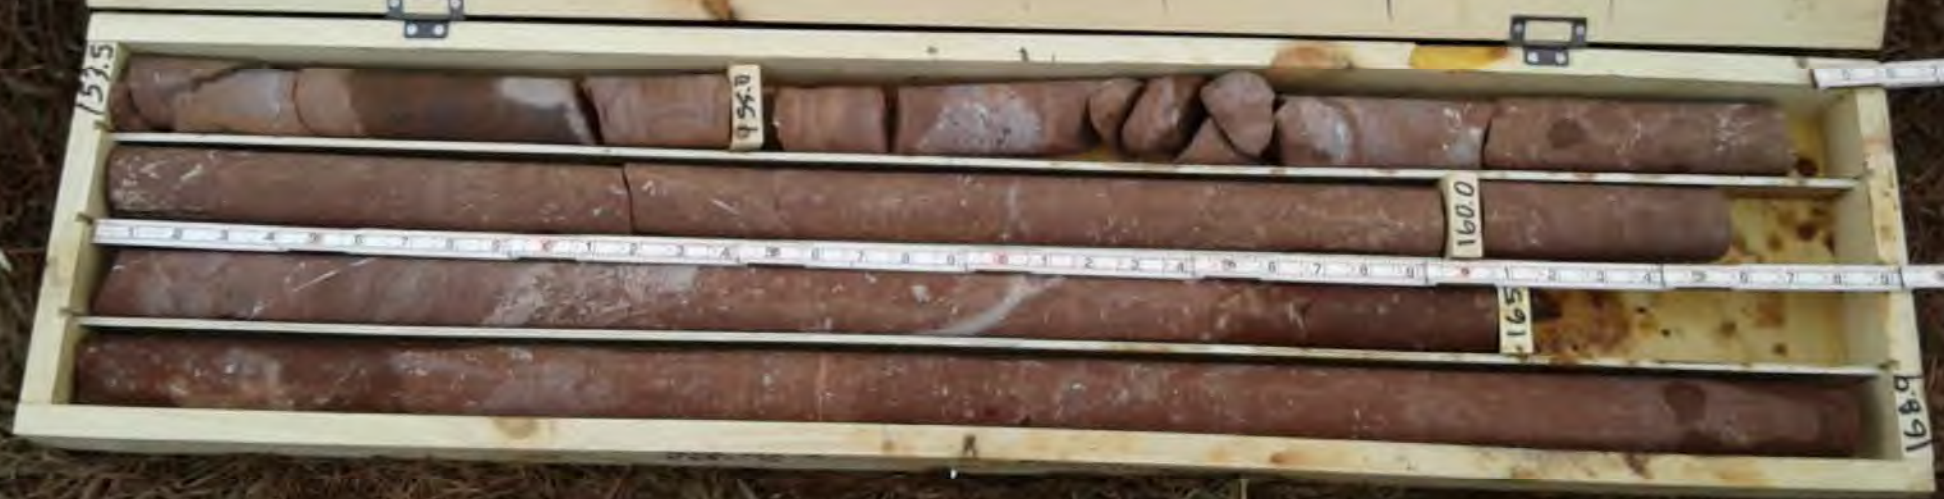
BOR NO ~~B-2~~ BOX 10 of Date 12/7/17  
 Depth 153.5 to 168.9 Spread PPP-5  
 HDD School house Ln. PSI # 4911458  
 TT# PA-LE-0005-0000-RD-16

RUN	Depth	REC	RQD
R-26	150.0-155.0	5.0	2.8
R-27	155.0-160.0	5.0	4.5
R-28	160.0-165.0	3.6	3.6
R-29	165.0-170.0	5.0	4.7

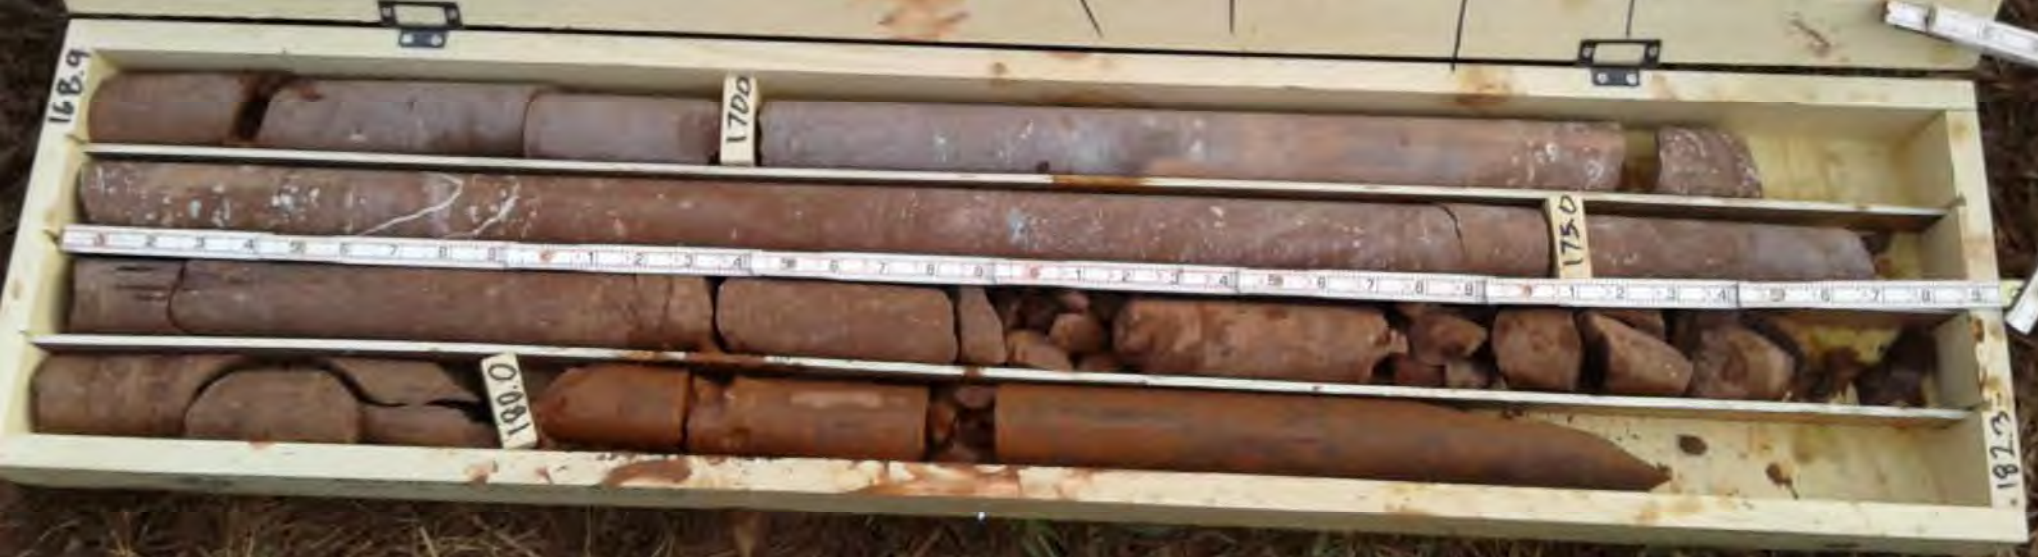
BOR NO. B-2 BOX 11 DATE 12/7/17  
DEPTH 168.9 to 182.3 SPREAD PPP-5  
HDD SCHOOLHOUSE LN. PSI # 4911458  
TT # PA-LE-0005-0000-RD-1G

RUN	DEPTH	REC	R.Q.D.
R-29	165.0-170	5.0	4.7
R-30	170.0-175.0	5.0	4.7
R-31	175.0-180.0	5.0	3.1
R-32	180.0-185.0	5.0	1.5

- From 180 to 185 feet bgs dark red-brown to light gray-brown, weathered to slightly weathered, very broken to massive, moderately hard to very hard, flat to medium bedding, moderately to highly weathered, medium hard, steep to moderate dip, closed,

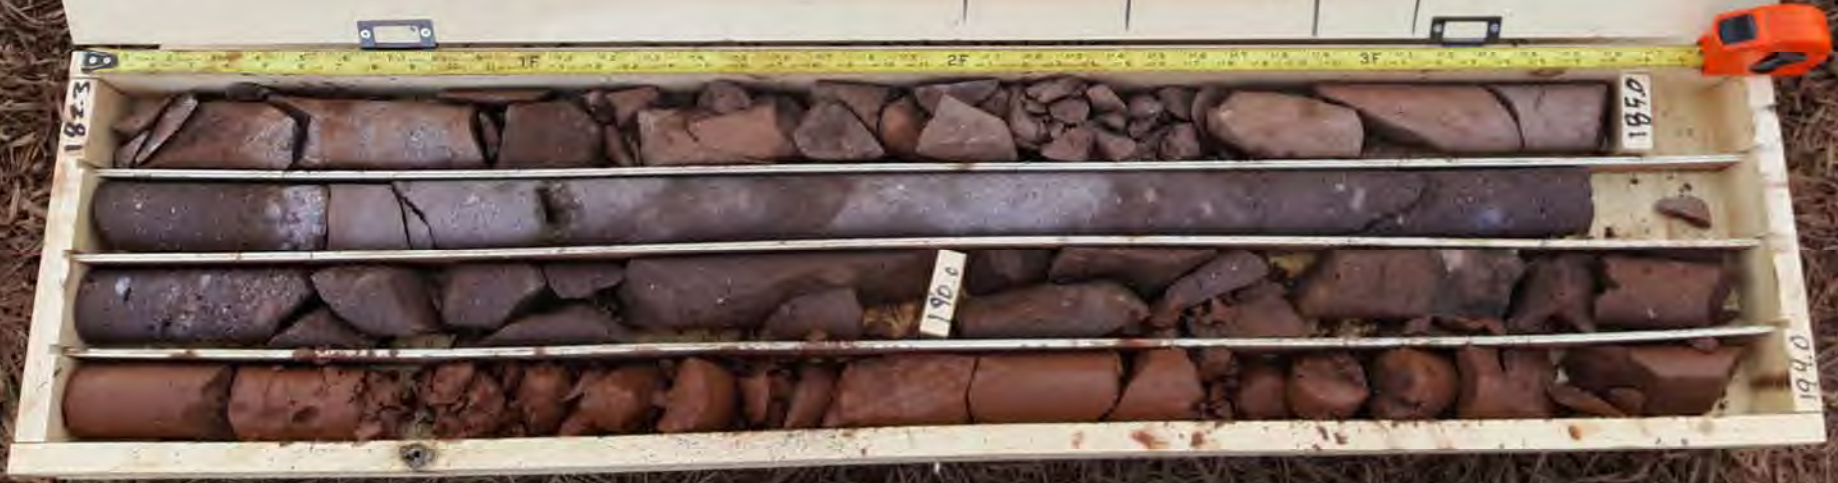
BOR NO. B-2 BOX 12 DATE 12-7-17  
DEPTH 182.3 FT + 0 194.0 FT SPREAD PPP-5  
HDD SCHOOLHOUSE LN PSI 4911458  
TT# PA-LE-0005-0000-RD-16

RUN	DEPTH	REC	RQP
R-32	180.0-185.0	5.0	1.5
R-33	185.0-190.0	5.0	4.0
R-34	190.0-195.0	5.0	0.5

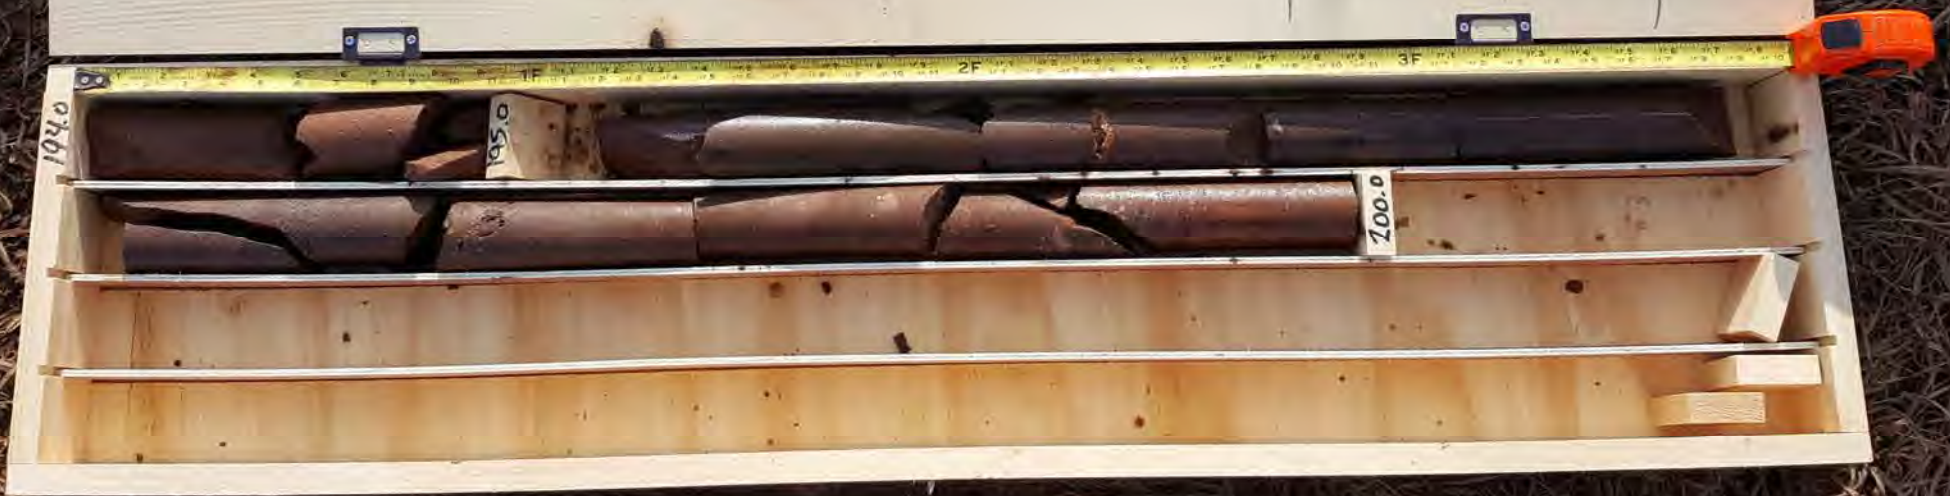
BOR No B-2 Box 13 DATE 12/8/17

DEPTH 194.0 FT to 200.0 FT SPREAD PPPS

Run	DEPTH	REC	PROD
R-34	190.0-195.0	5.0	0.5
R-35	195.0-200.0	5.0	5.0

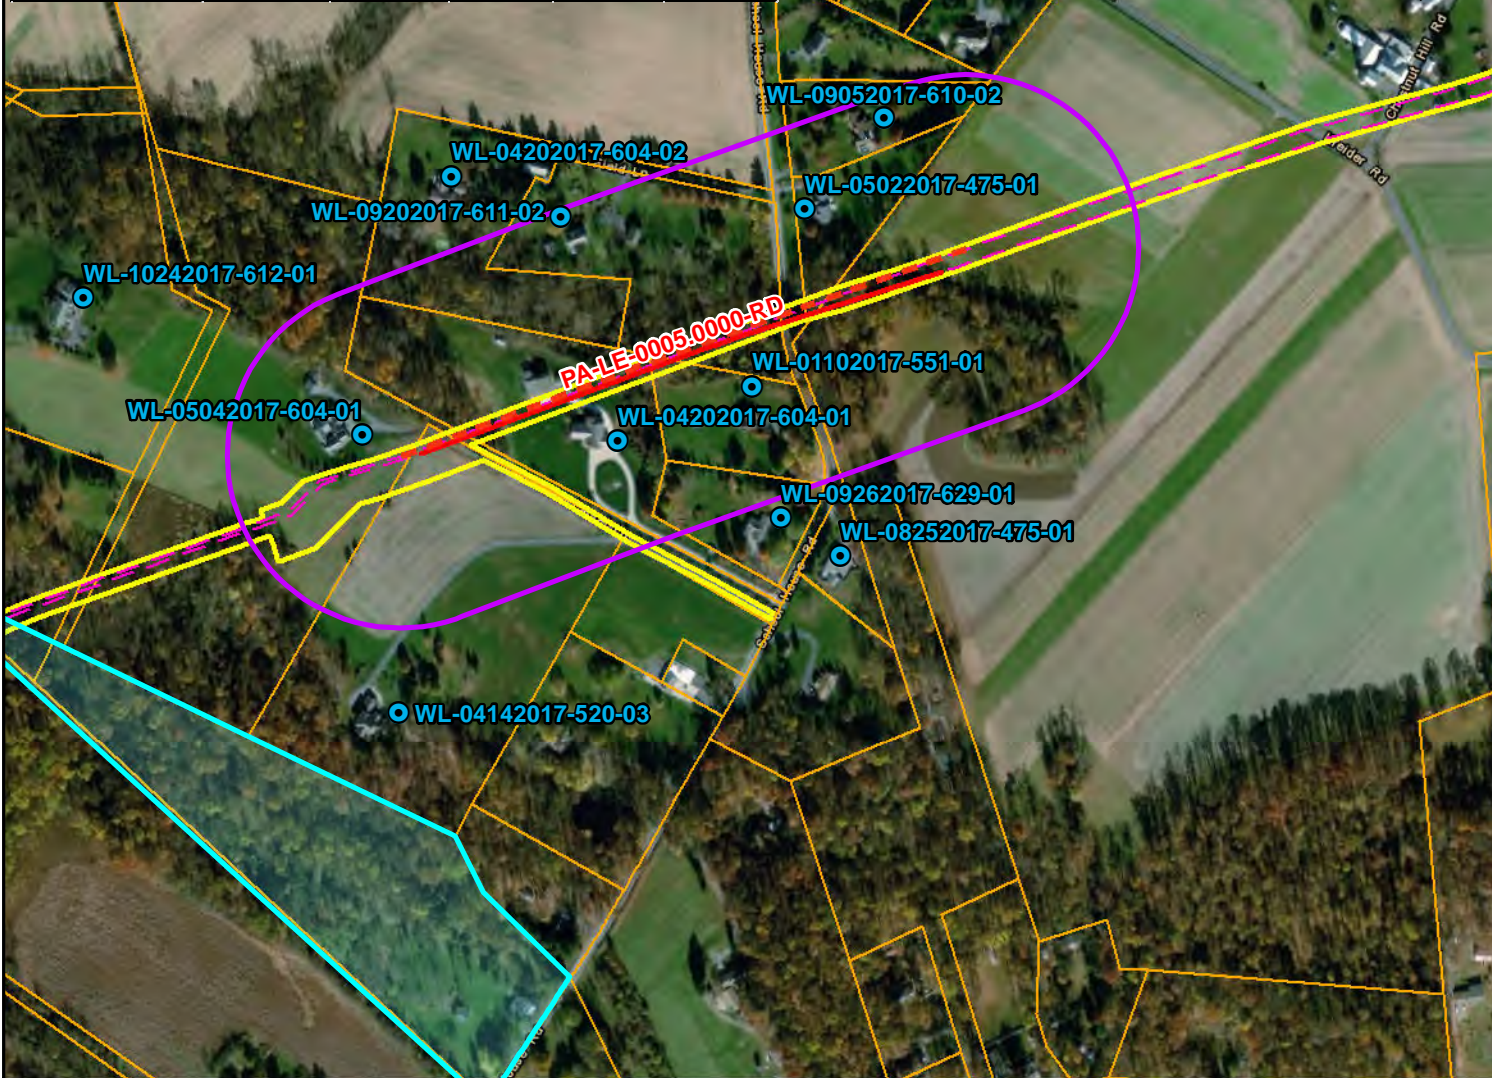
**Well Location Map**  
**HDD# PA-LE-0005.0000-RD**  
**Lebanon County, PA.**

- LOD
- Parcel
- PPP Centerline
- PPP 1 HDD
- Proposed PPP 2 HDD Redesign
- 450 foot buffer of HDD alignment
- Public Water Supply/Landowner Confirmed No Well

As a condition of the corrected Stipulated Order, other Sunoco subcontractors researched private water supplies located within a 450-foot radius of the School House Road HDD. Six water supply wells were identified within the 450-foot radius of the HDD alignment. Information regarding well depth, depth to water, or pump setting was not provided. A map of these locations is included as **Attachment 3**.
