**HORIZONTAL DIRECTIONAL DRILL ANALYSIS
SLITTING MILL ROAD CROSSING
PADEP SECTION 105 PERMIT NO.: E23-524
PA-DE-0008.0000-RD
(SPLP HDD No. S3-0560)**

**SLITTING MILL ROAD CROSSING
PADEP SECTION 105 PERMIT NO. E23-524
PA-DE-0008.0000-RD
(SPLP HDD No. S3-0560)**

ORIGINAL HORIZONTAL DIRECTIONAL DRILL DESIGN SUMMARY: 20-INCH

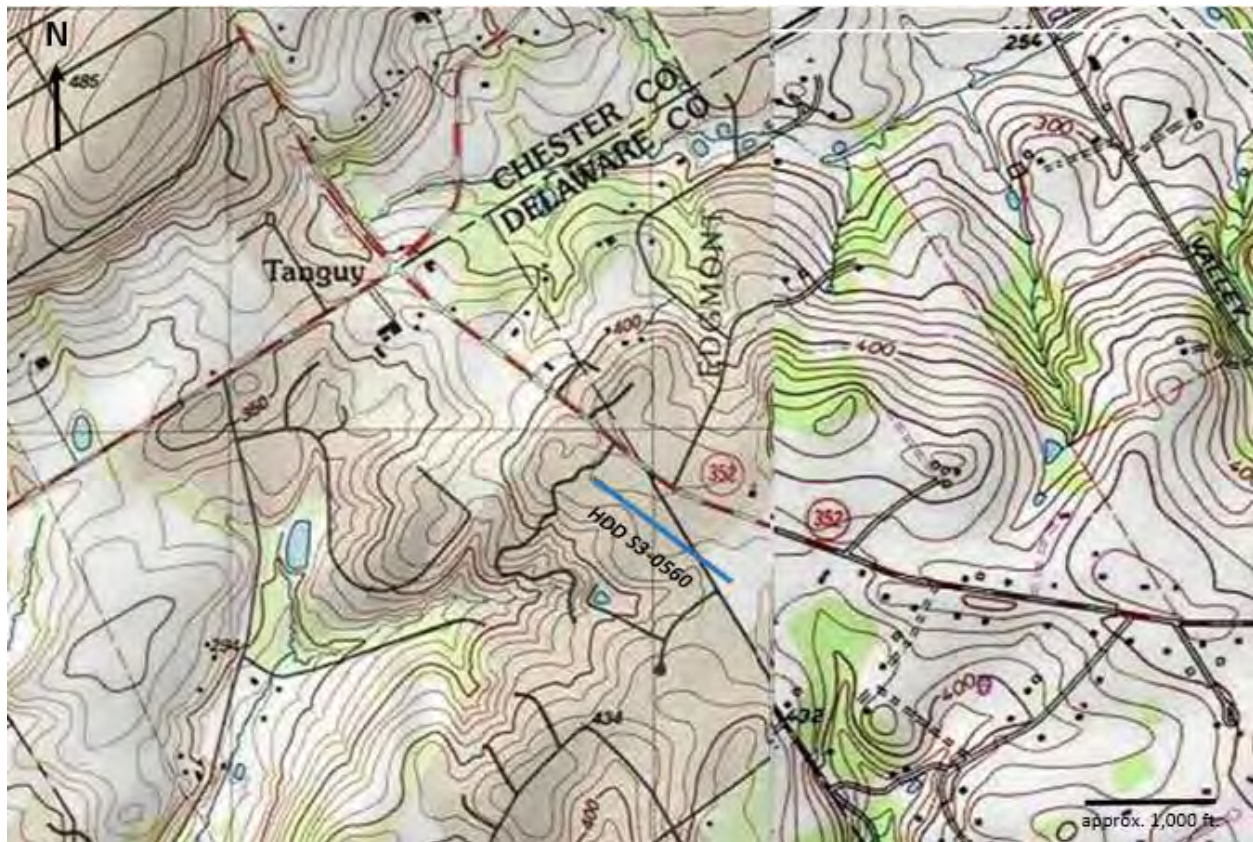
Figure 1. Site Location Map (mod. from PaGEODE).

As shown on **Figure 1**, HDD S3-0560 is located on the southwest edge of a relatively flat hilltop that trends west to east. The surrounding area is comprised of residential and light industrial property uses.

HDD S3-0560 is located within the Piedmont Upland Section of the Piedmont Physiographic Province of southeastern Pennsylvania, which consists of broad rounded to flat top hills and shallow valleys. HDD S3-0560 is located in the headwaters of Chester Creek. The nearest surface water body to HDD S3-0560 is an unnamed tributary to Chester Creek that originates approximately 2,000 feet west of the northwest entry/exit and enters Chester Creek approximately 1.1 miles southwest of the alignment. The surrounding area characterized by residential and light industrial land use (see **Figure 1**).

A map depicting the location of the HDD with topographic information for the surrounding area is presented as **Figure 1**.

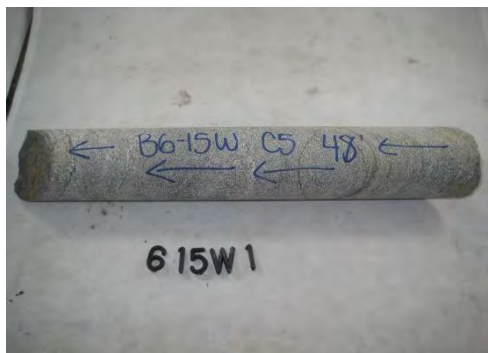
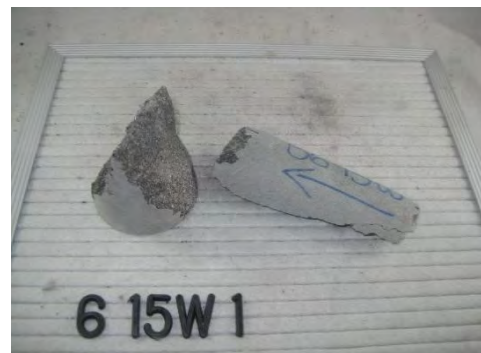
Lithology : Gneiss
 Moisture Content : As received
 Lab Temperature : 70° F
 Loading Rate: 55 psi/s
 Time to Failure: 20 min

Maximum Axial Load at Failure: 67,610 lb
 Compressive Strength: 21,958 psi
 Compressive Strength: 151.39 Mpa
 Unit Weight 183 pcf

Rock compressive strength testing was performed on samples from approximately 20-foot intervals within the bedrock strata at each boring location. As an exception to the planned 20-foot intervals, rock samples from B6-15W near 23 feet, as well as from B6-15E near 32, 40 and 50 feet, were not tested due to highly fractured or weathered conditions. Unconfined compressive strength test results are shown on the attached reports.

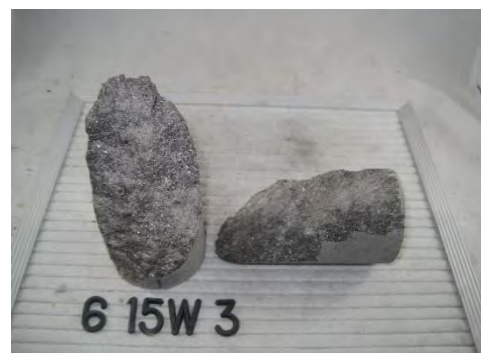
Maximum Axial Load at Failure: 29,290 lb
 Compressive Strength: 9,513 psi
 Compressive Strength: 65.59 Mpa
 Unit Weight 210 pcf

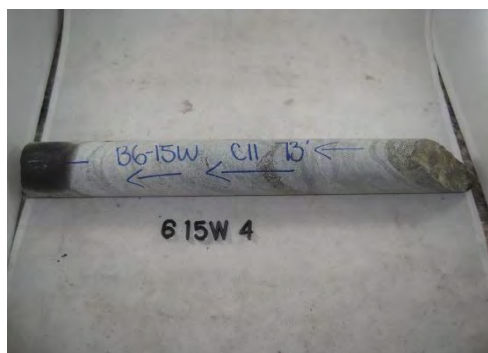
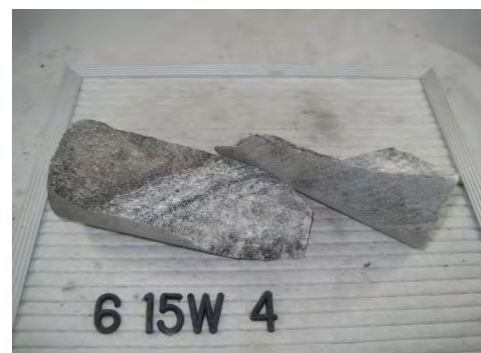
Maximum Axial Load at Failure: 33,220 lb
 Compressive Strength: 10,789 psi
 Compressive Strength: 74.39 Mpa
 Unit Weight 170 pcf

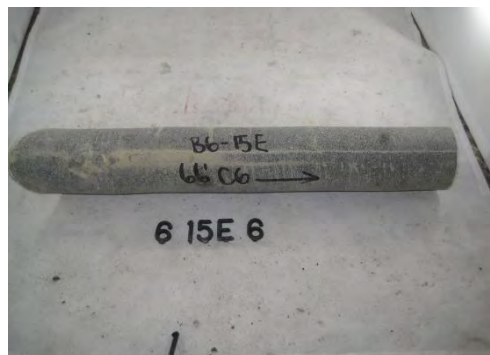
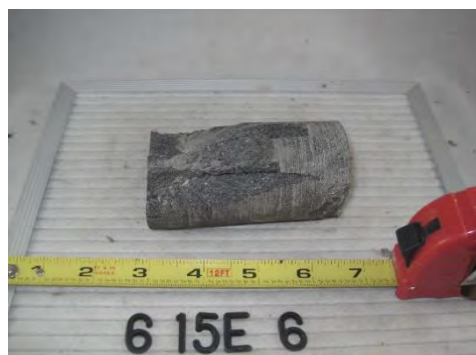
Comments : Due to lack of available specimens, the length to diameter ratio of the tested specimen is not conformant with ASTM D7012. The results obtained during testing may differ from those obtained from the test specimens that meet the requirements.

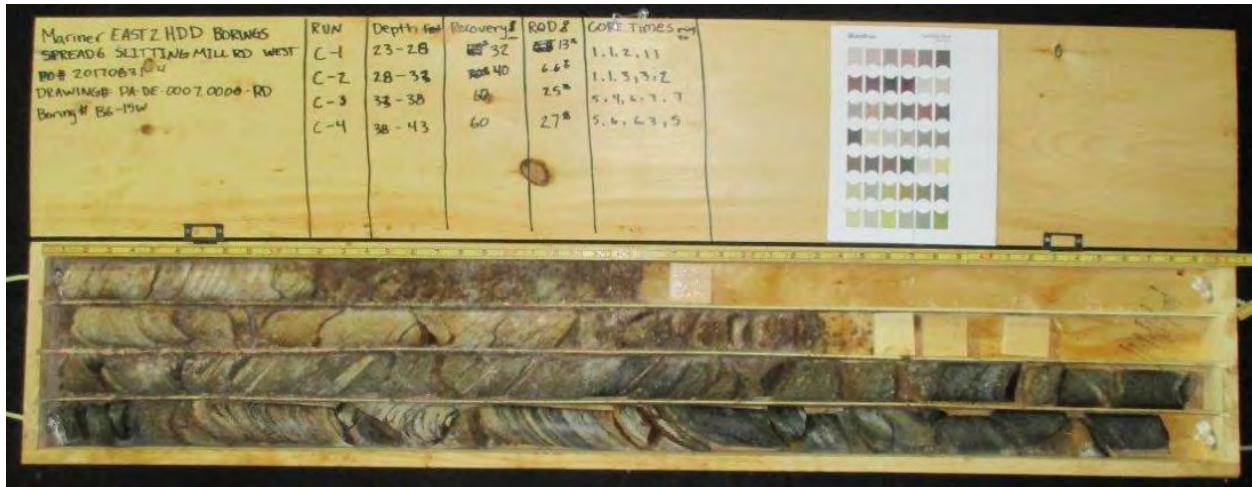
Photograph 1: B6-15W, Samples C-1 to C-4 (23 to 43 feet)

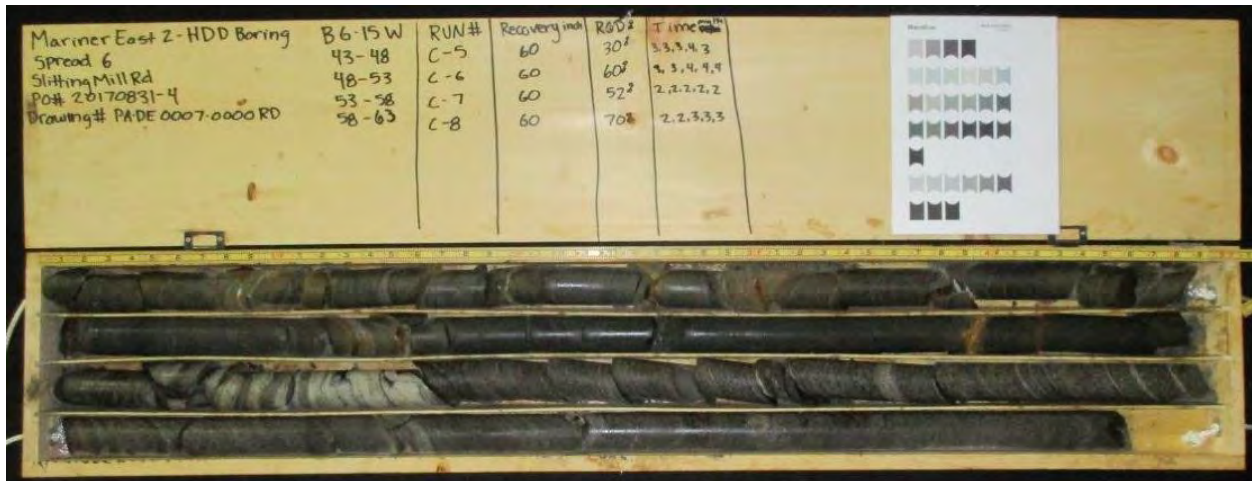
Photograph 2: B6-15W, Samples C-5 to C-8 (43 to 63 feet)

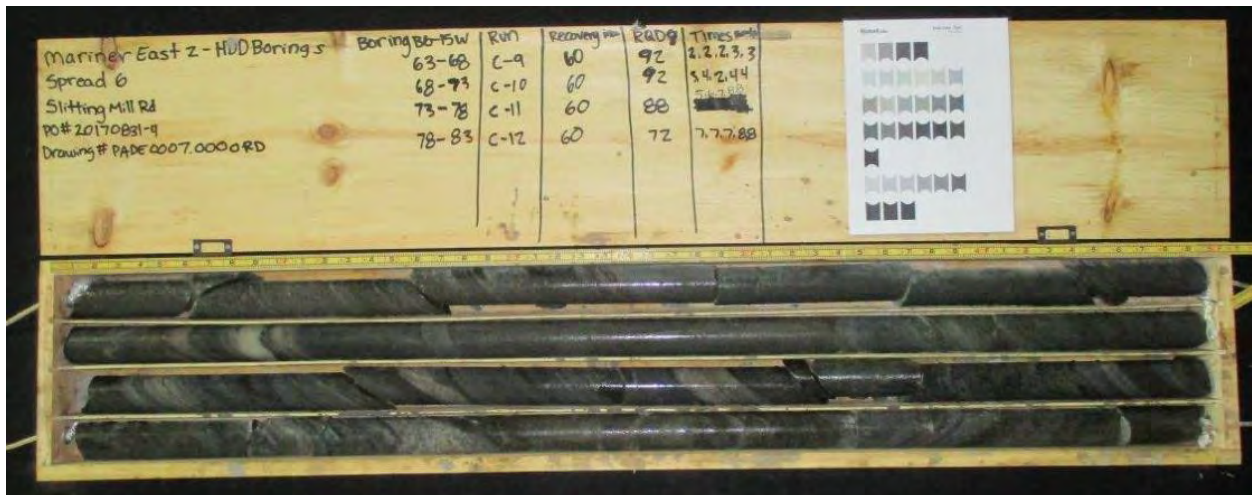
Photograph 3: B6-15W, Samples C-9 to C-12 (63 to 83 feet)

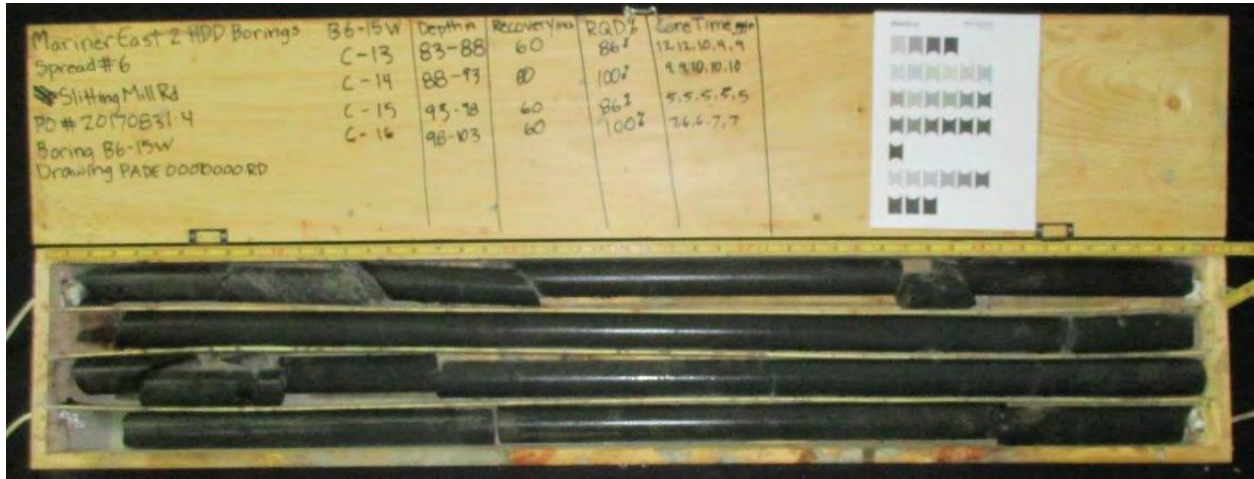
Photograph 4: B6-15W, Samples C-13 to C-16 (83 to 103 feet)

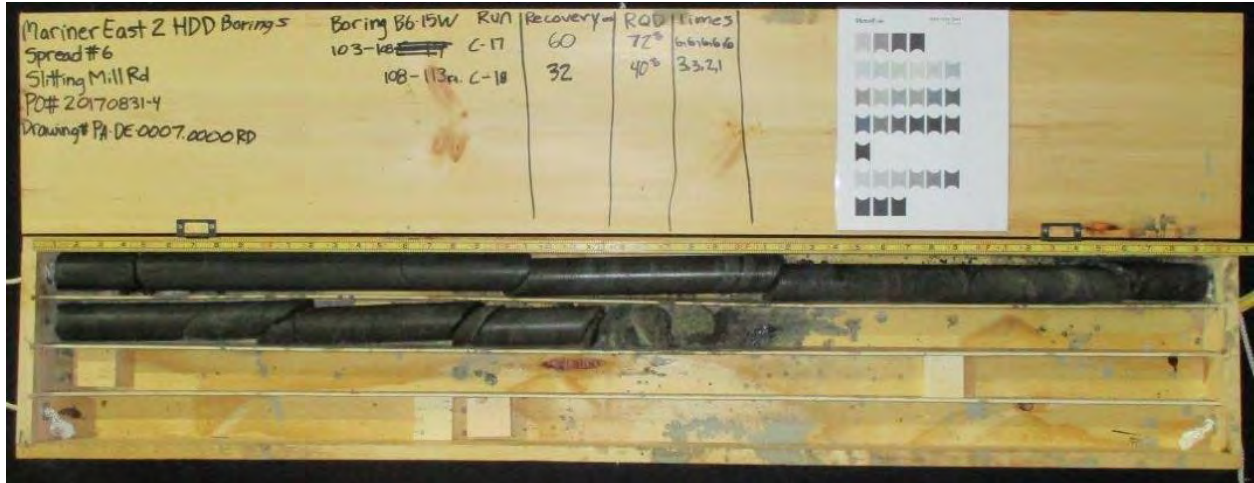
Photograph 5: B6-15W, Samples C-17 to C-18 (103 to 113 feet)

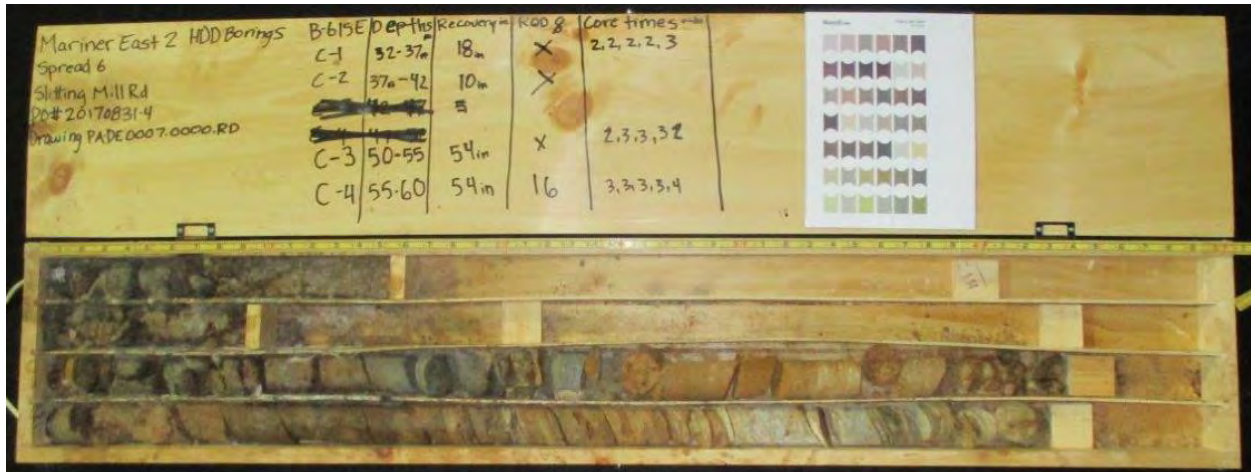
Photograph 1: B6-15E, Samples C-1 to C-4 (32 to 60 feet)

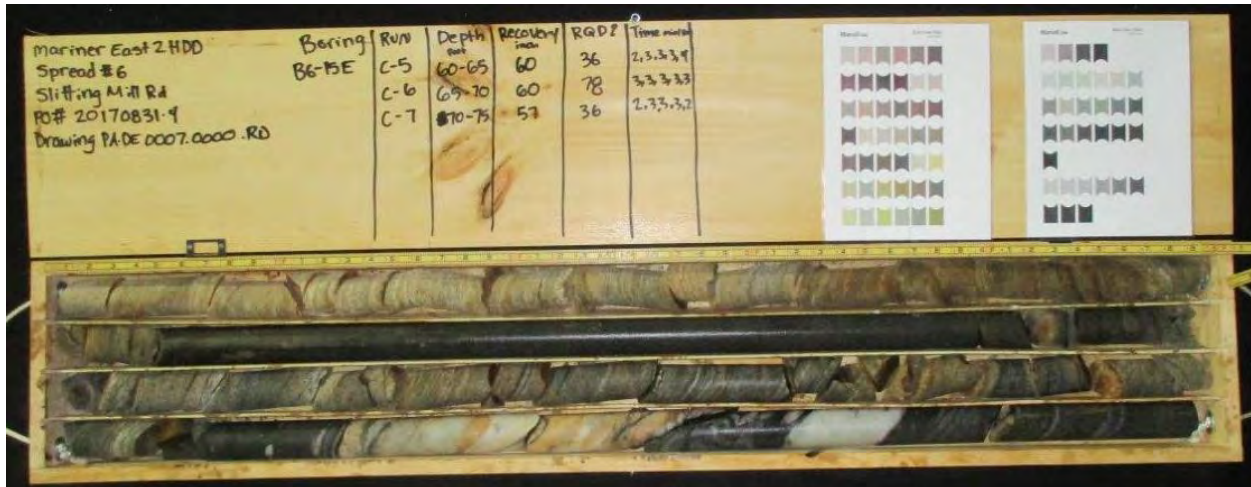
Photograph 2: B6-15E, Samples C-5 to C-8 (60 to 80 feet)

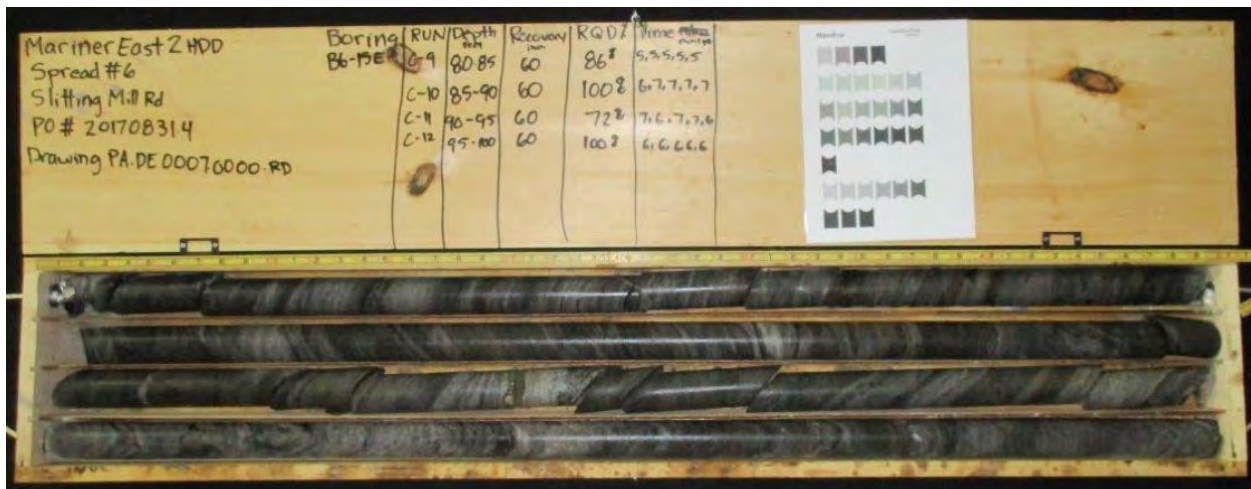
Photograph 3: B6-15E, Samples C-9 to C-12 (80 to 100 feet)

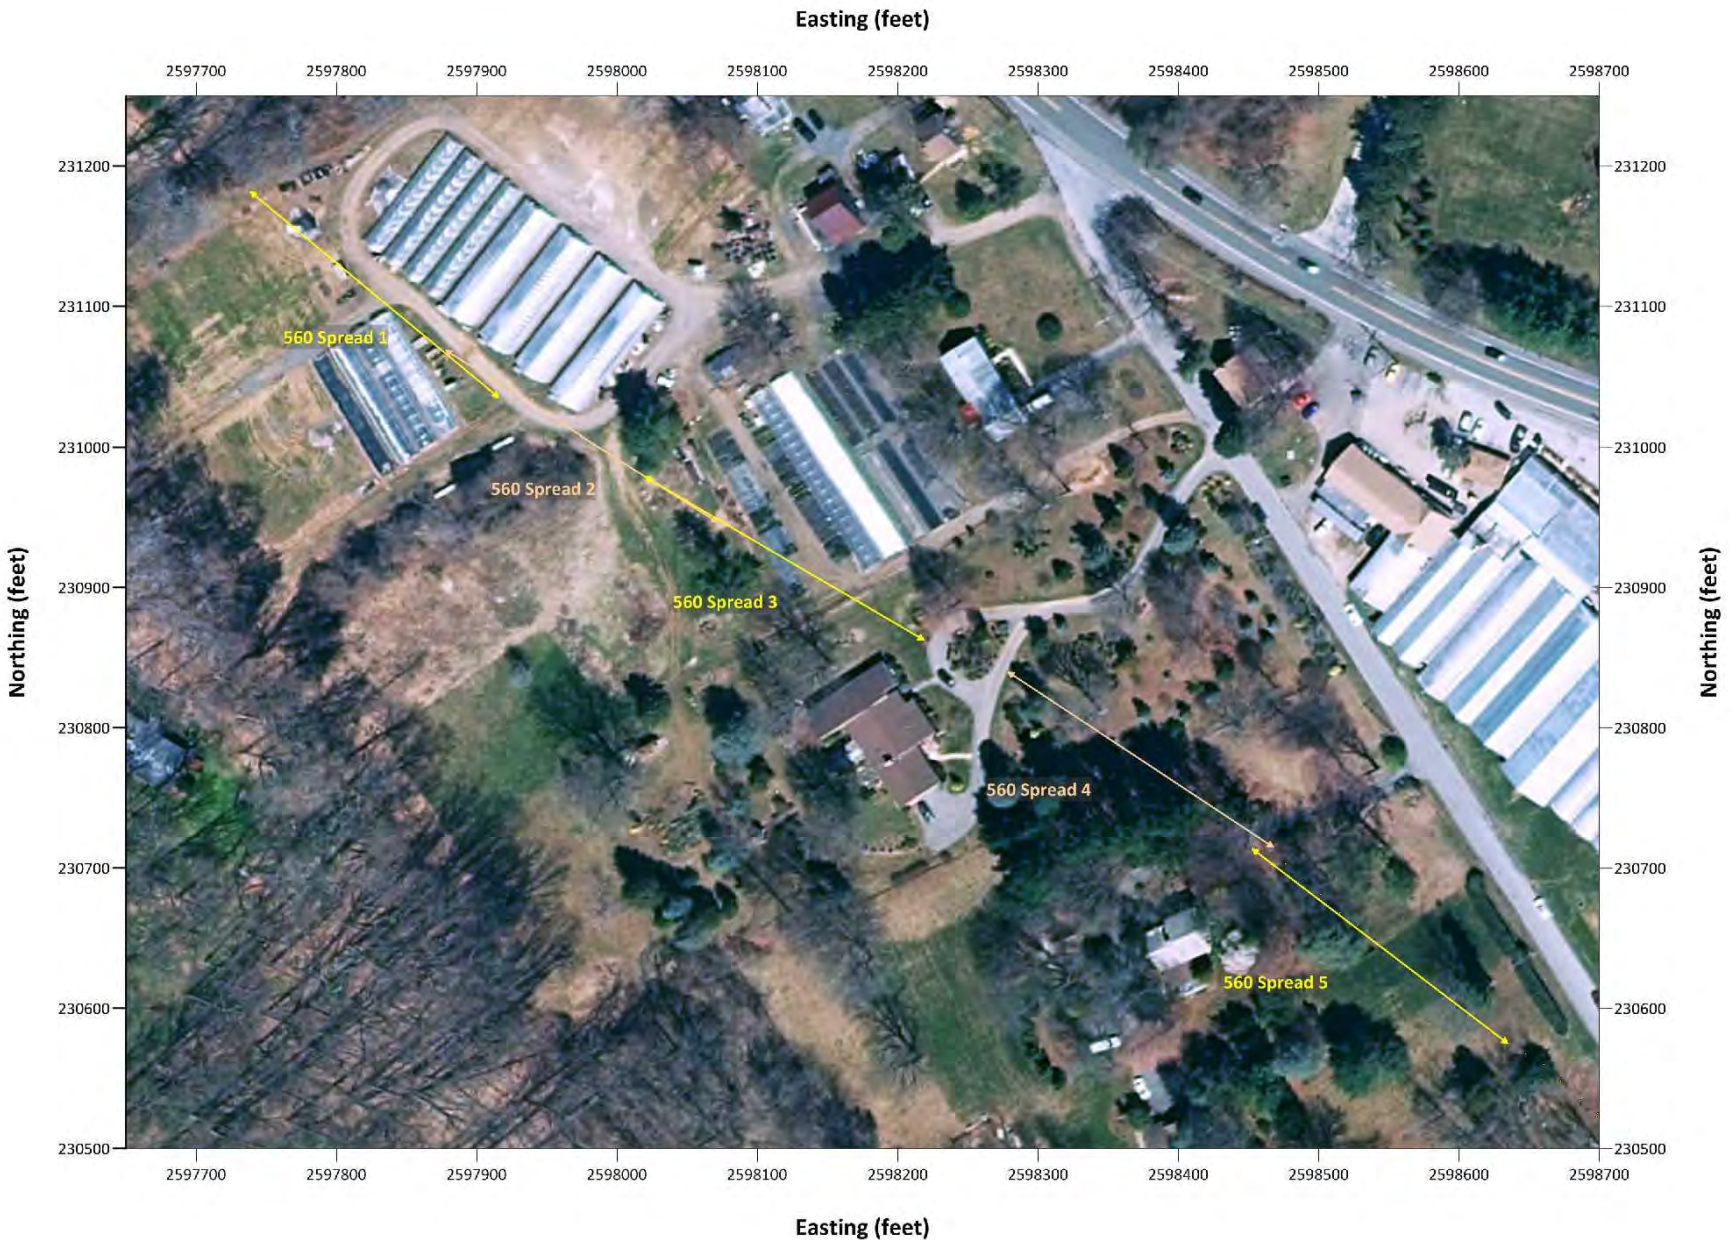
- (5) SET placed stakes at the beginning and end points (geophones 1 and 24) of each spread, and their coordinates were measured and recorded by a licensed surveyor. SET used this survey point data for placement of the spreads on Figure 1.

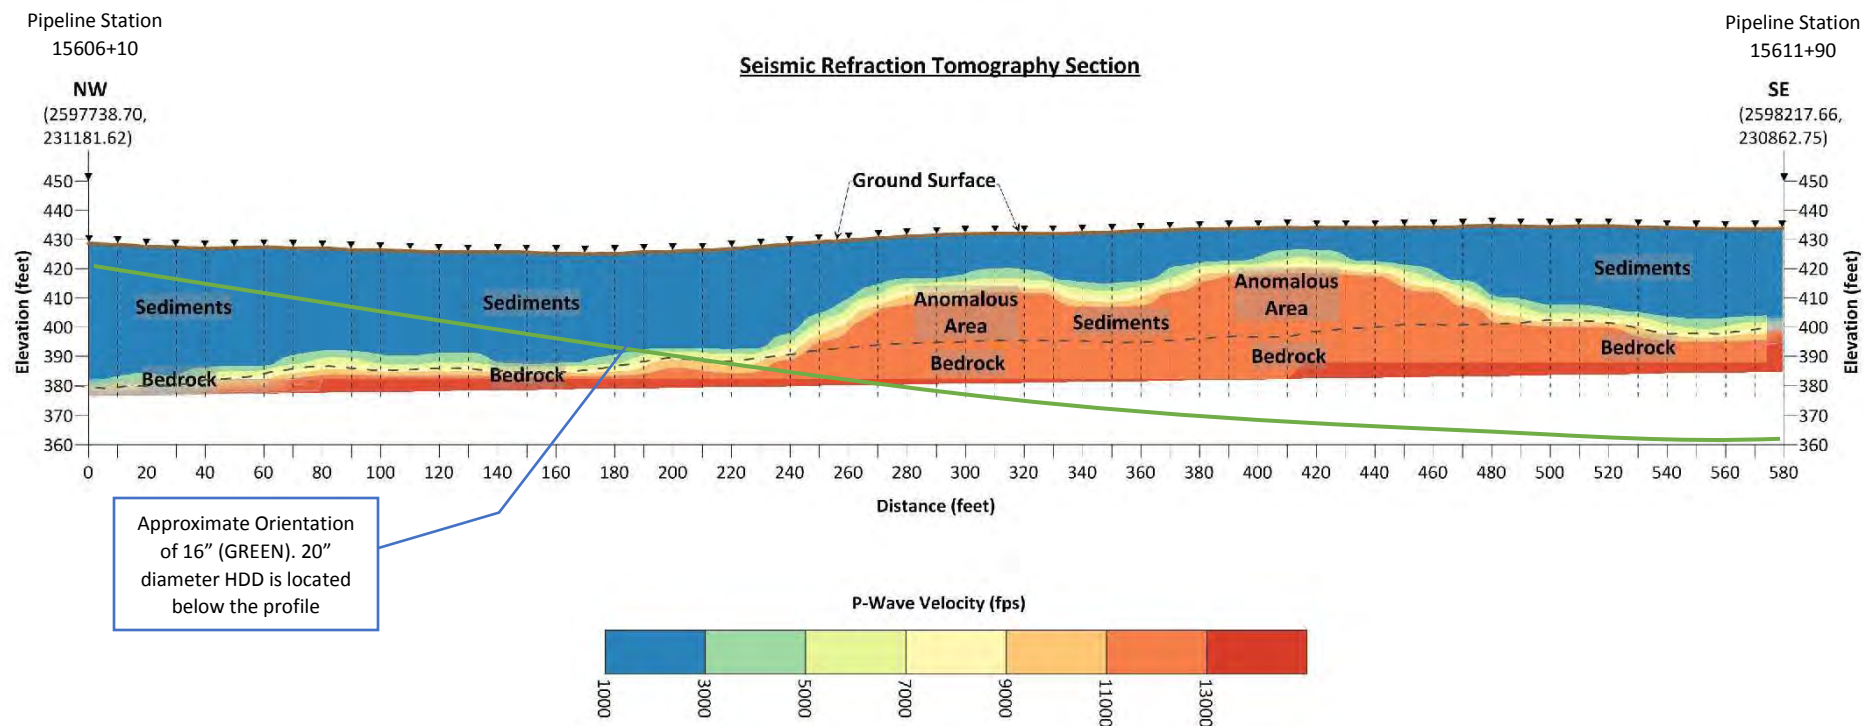
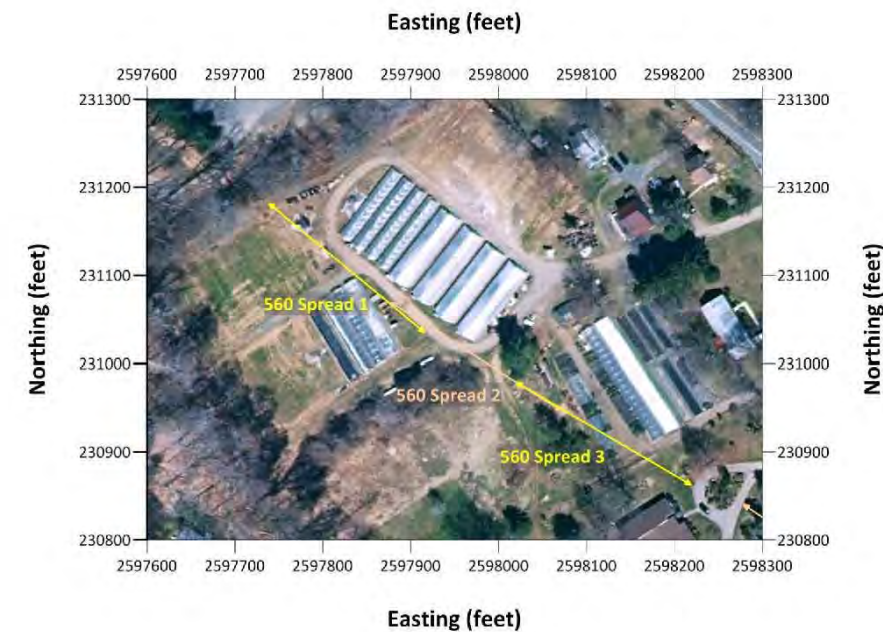
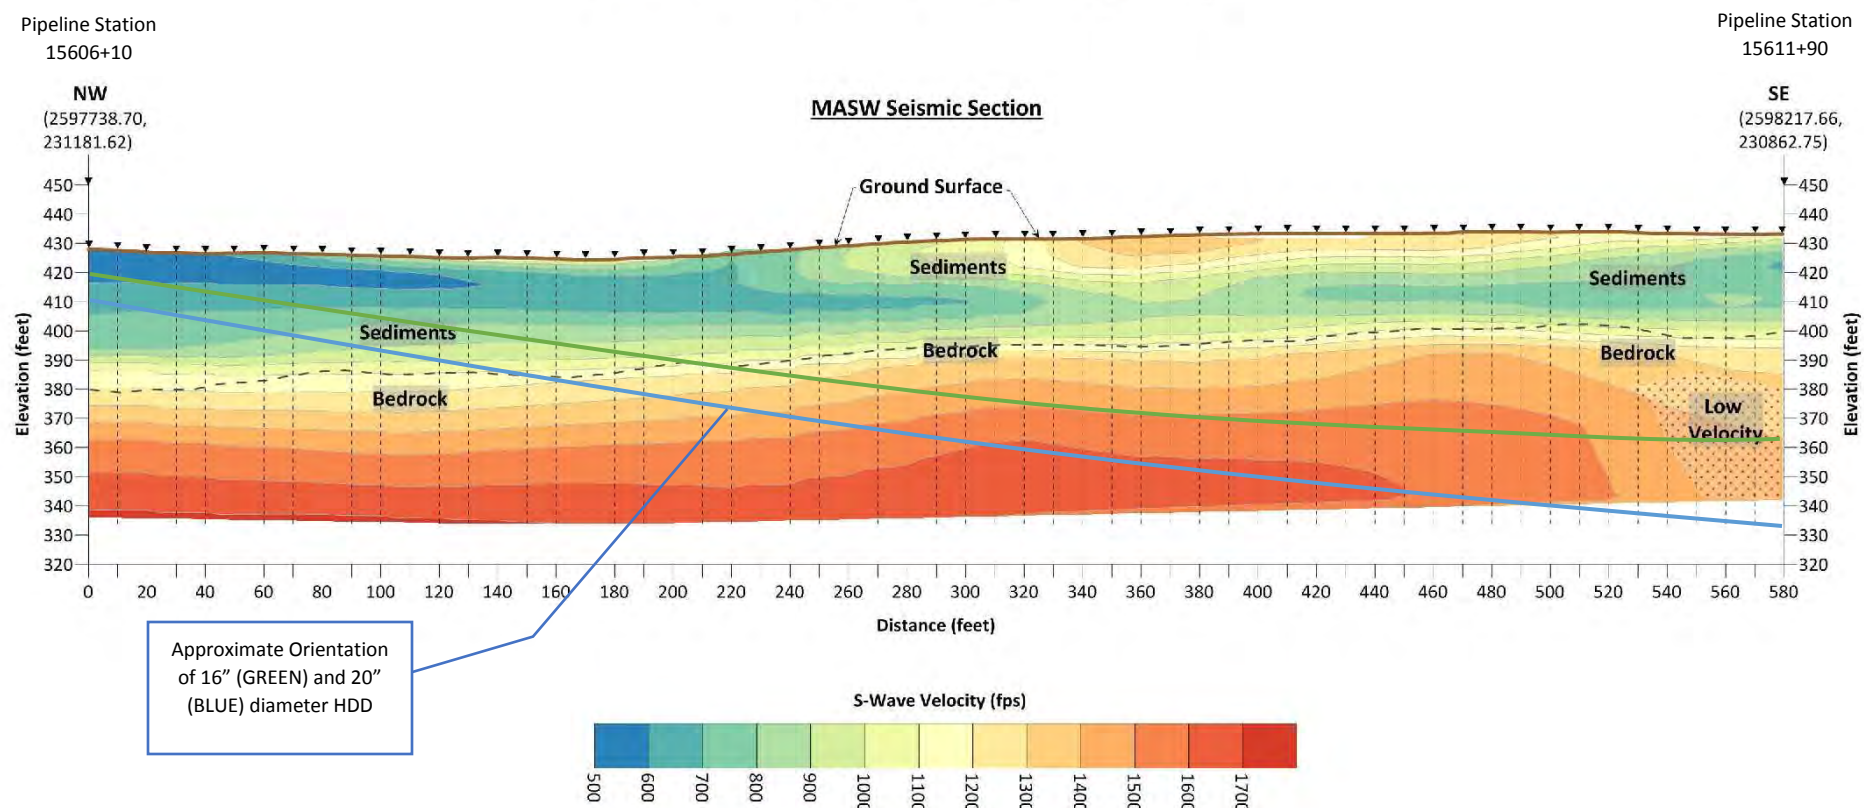
Seismic Sections
Alignment 560, Spreads 1, 2 and 3
 Sunoco Pipeline Site
 Aston, Pennsylvania

- (1) The primary objectives of the geophysical investigation were (a) to map the soil/bedrock interface, (b) to estimate bedrock competency, (c) to locate potential faults and major fractures, and (d) to locate significant weathered zones, voids, or "soft" spots at the site. This information will be valuable to the Horizontal Directional Drilling (HDD) crews in anticipating potential locations where inadvertent returns (IRs) or loss of returns (LORs) may occur. SET collected seismic refraction and seismic surface wave (multichannel analysis of surface waves, MASW) data along concurrent lines for this project.

Tetra Tech interpreted the survey data to identify “low velocity zones” and zones where the depth to bedrock was relatively deep. The overall conclusion of Tetra Tech’s report is that the geophysical survey data indicate a lack of significant fractures and faulting at HDD S3-0560. Top of relatively competent bedrock as indicated by both survey types ranged from approximately 14 to 51 ft bgs. The MASW survey

identified low velocity zones indicating potential fracture or fault zones at approximately Stations 6+50 and 12+87. In general, these two locations do not directly correlate with the two mapped fracture traces that cross the alignment. One of the mapped fracture traces passes through the southeast entry/exit on the proposed P&P, approximately 180 feet southeast from the low velocity zone located at Station 12+87. Two of the three IRs that occurred during construction of the 16-inch line were due north of the alignment at Stations 12+63 and 13+02 where the overburden was relatively shallow at 39 and 33 feet, respectively. These two IRs are in the same general location as the low velocity zone identified at Station 12+87.

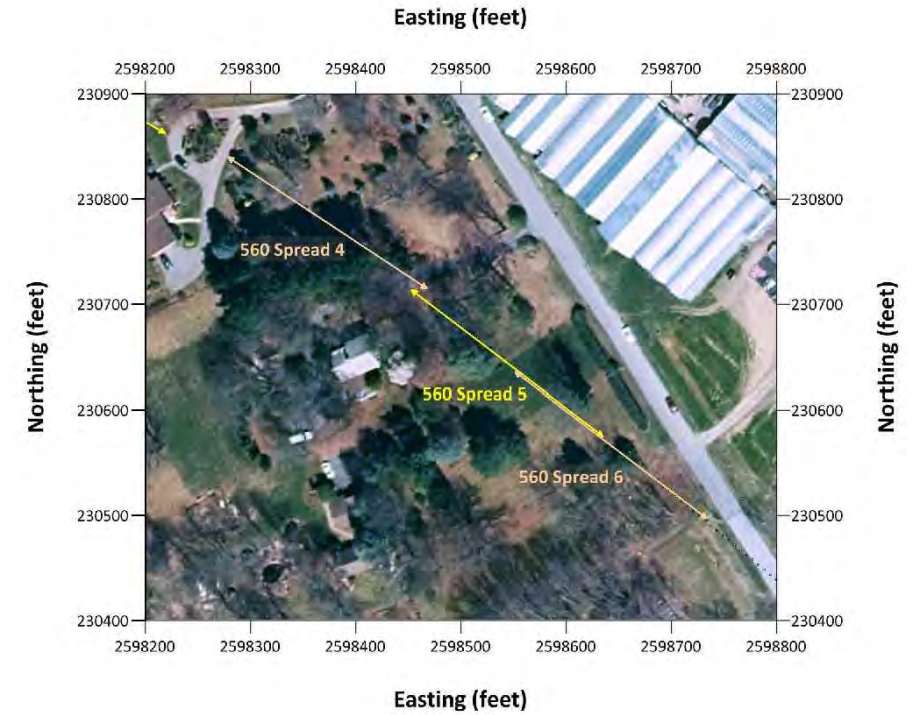
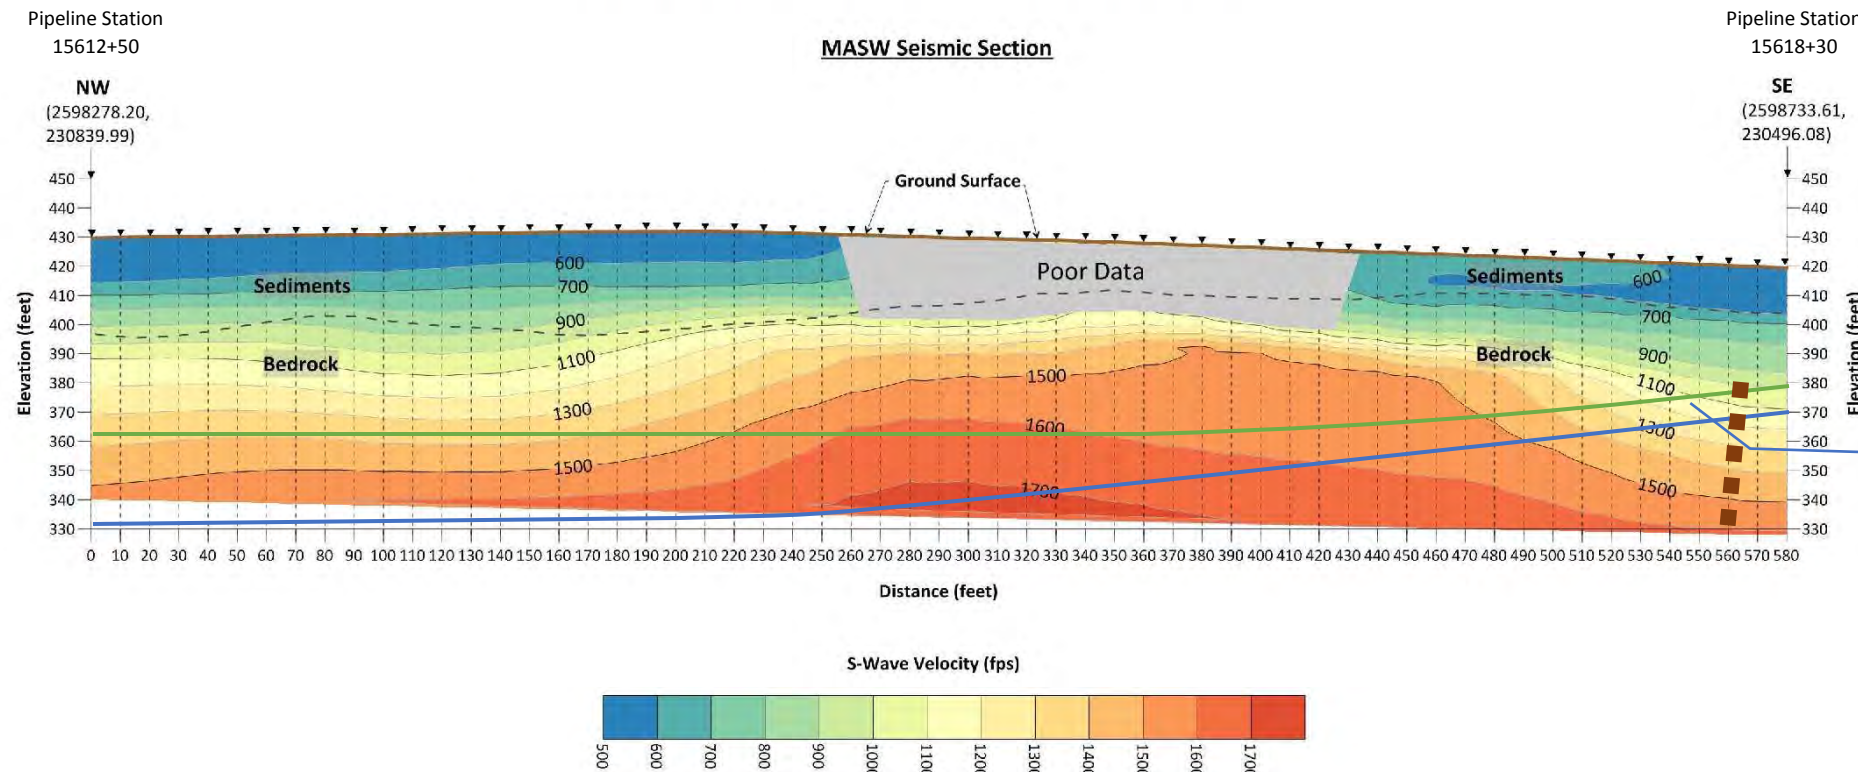
Seismic Sections
Alignment 560, Spreads 4, 5 and 6
 Sunoco Pipeline Site
 Aston, Pennsylvania

- (1) The primary objectives of the geophysical investigation were (a) to map the soil/bedrock interface, (b) to estimate bedrock competency, (c) to locate potential faults and major fractures, and (d) to locate significant weathered zones, voids, or "soft" spots at the site. This information will be valuable to the Horizontal Directional Drilling (HDD) crews in anticipating potential locations where inadvertent returns (IRs) or loss of returns (LORs) may occur. SET collected seismic refraction and seismic surface wave (multichannel analysis of surface waves, MASW) data along concurrent lines for this project.

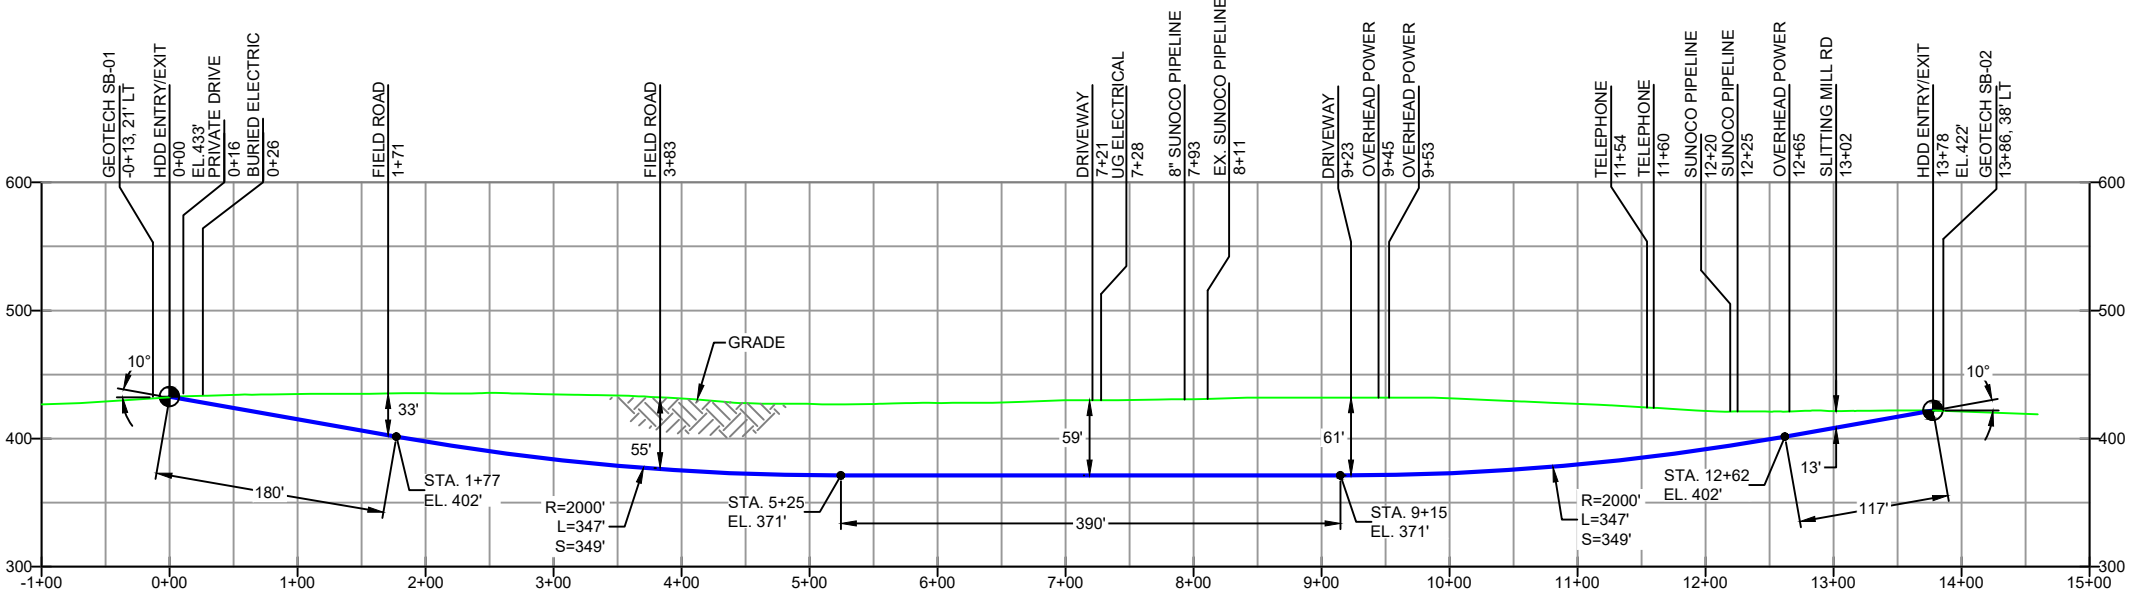
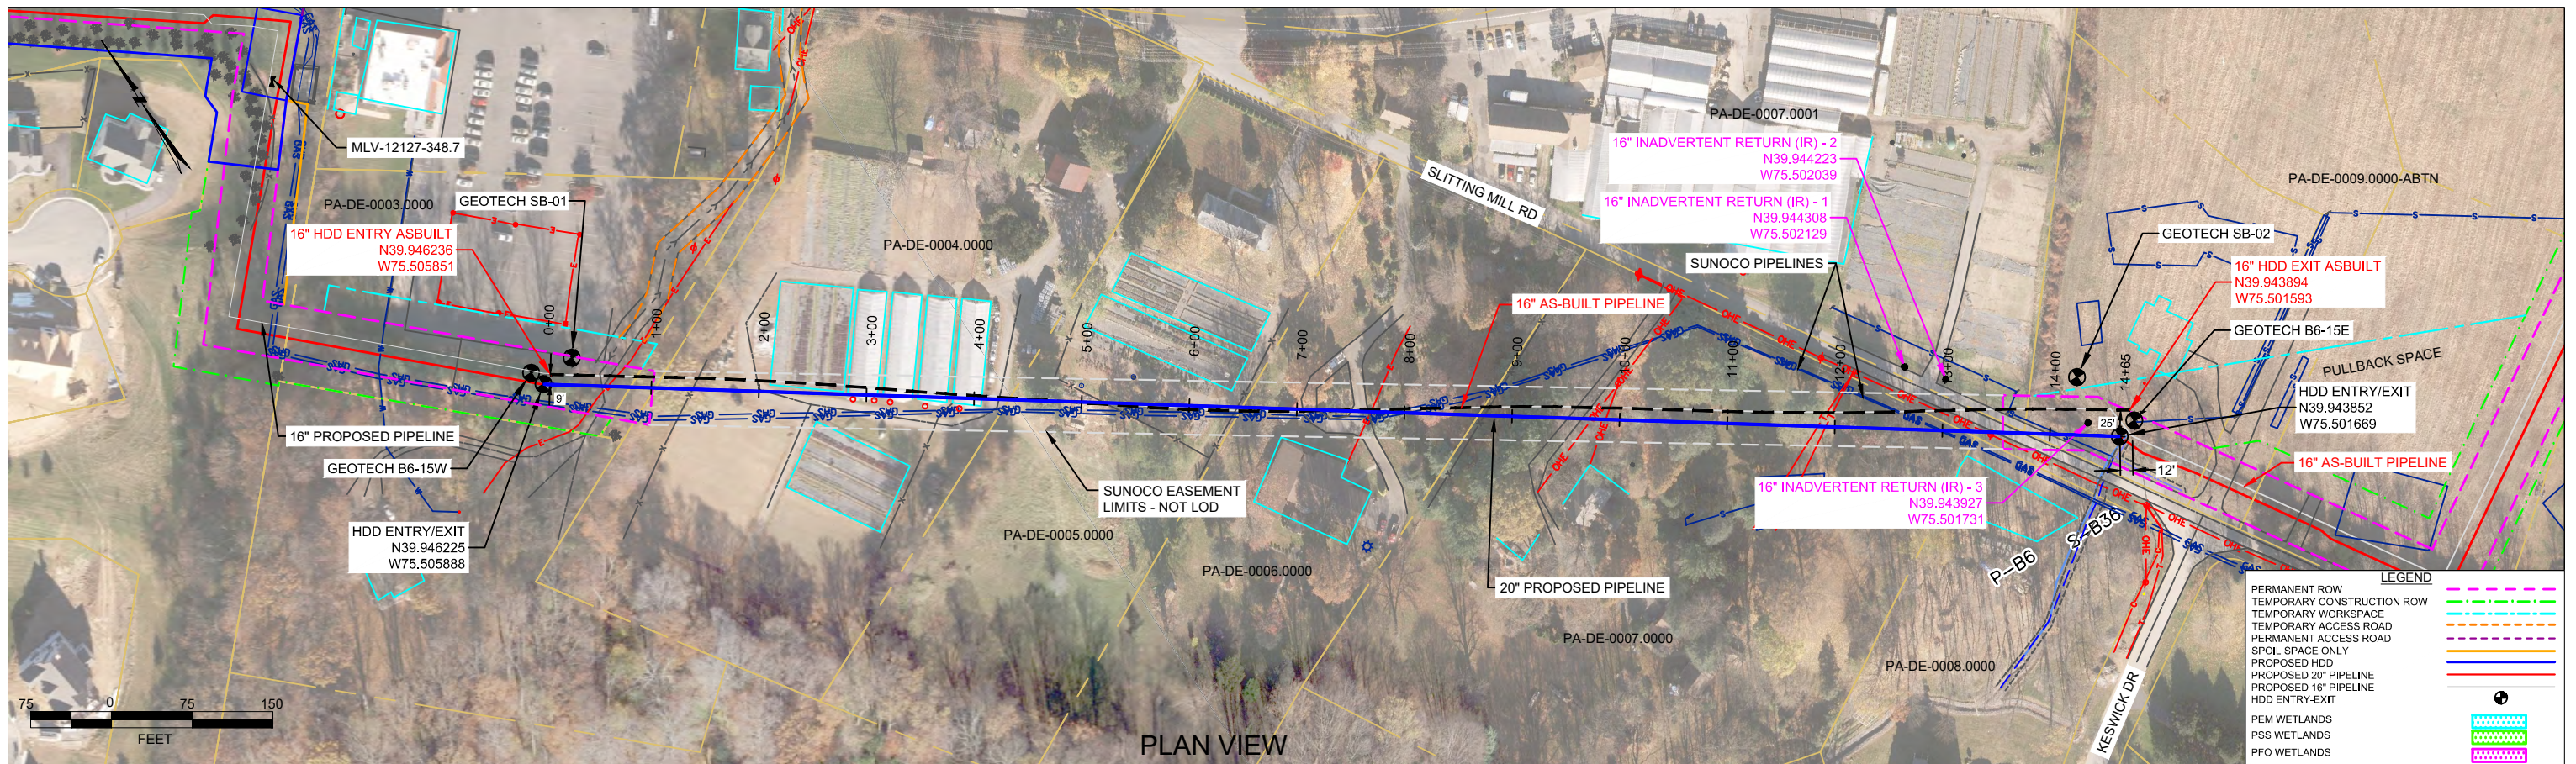
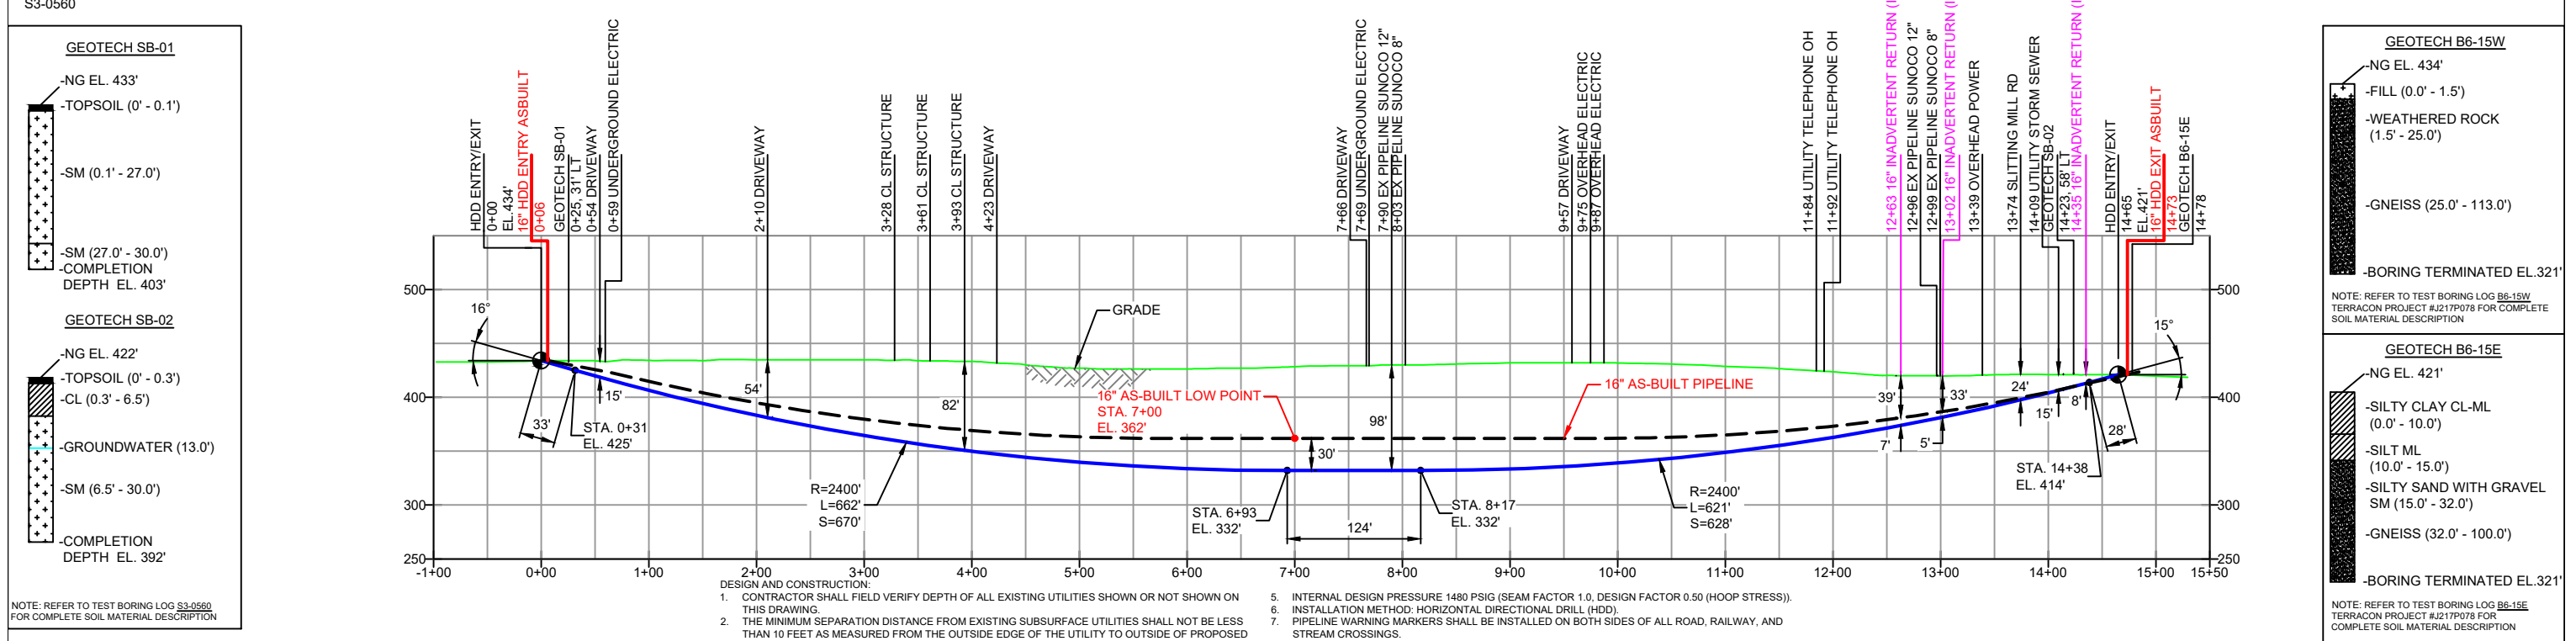
SCALE: 1"=150' DWG. NO. PA-DE-0008.0000-RD

- DESIGNED IN ACCORDANCE WITH CFR 49 195 & ASME B31.4
 - CROSSING PIPE SPECIFICATION:
HDD HORZ. LENGTH (L-): 1378'
HDD PIPE LENGTH (S-): 1385'
20" x 0.456" W.T., X-65, APISL, PSL2, ERW, BFW
COATING: 14-16 MILS FBE WITH 30-35 MIL ARO (POWERCRETE R95)

20-INCH HORIZONTAL DIRECTIONAL DRILL
SLITTING MILL RD
PENNSYLVANIA PIPELINE PROJECT

- Horizontal length: 1,378 foot (ft)
- Entry/Exit angle: 10 degrees
- Maximum Depth of cover: 61 ft
- Pipe design radius: 2,000 ft
