**Re: SPLP Response to Comments  
Hydrogeological Reevaluation Report  
Gradyville Road Crossing HDD (S3-0580)  
DEP Permit Nos. E23-524  
Edgemont Township; Delaware County, Pennsylvania**

**GRADYVILLE ROAD CROSSING  
PADEP SECTION 105 PERMIT NO.: E23-524  
PA-DE-0032.0000-RD and PA-DE-0032.0000-RD-16  
(SPLP HDD No. S3-0580 and HDD S3-0580-16)**

**ATTACHMENT 1**

**ATTACHMENT 2  
HORIZONTAL DIRECTIONAL DRILL PLAN AND PROFILES**

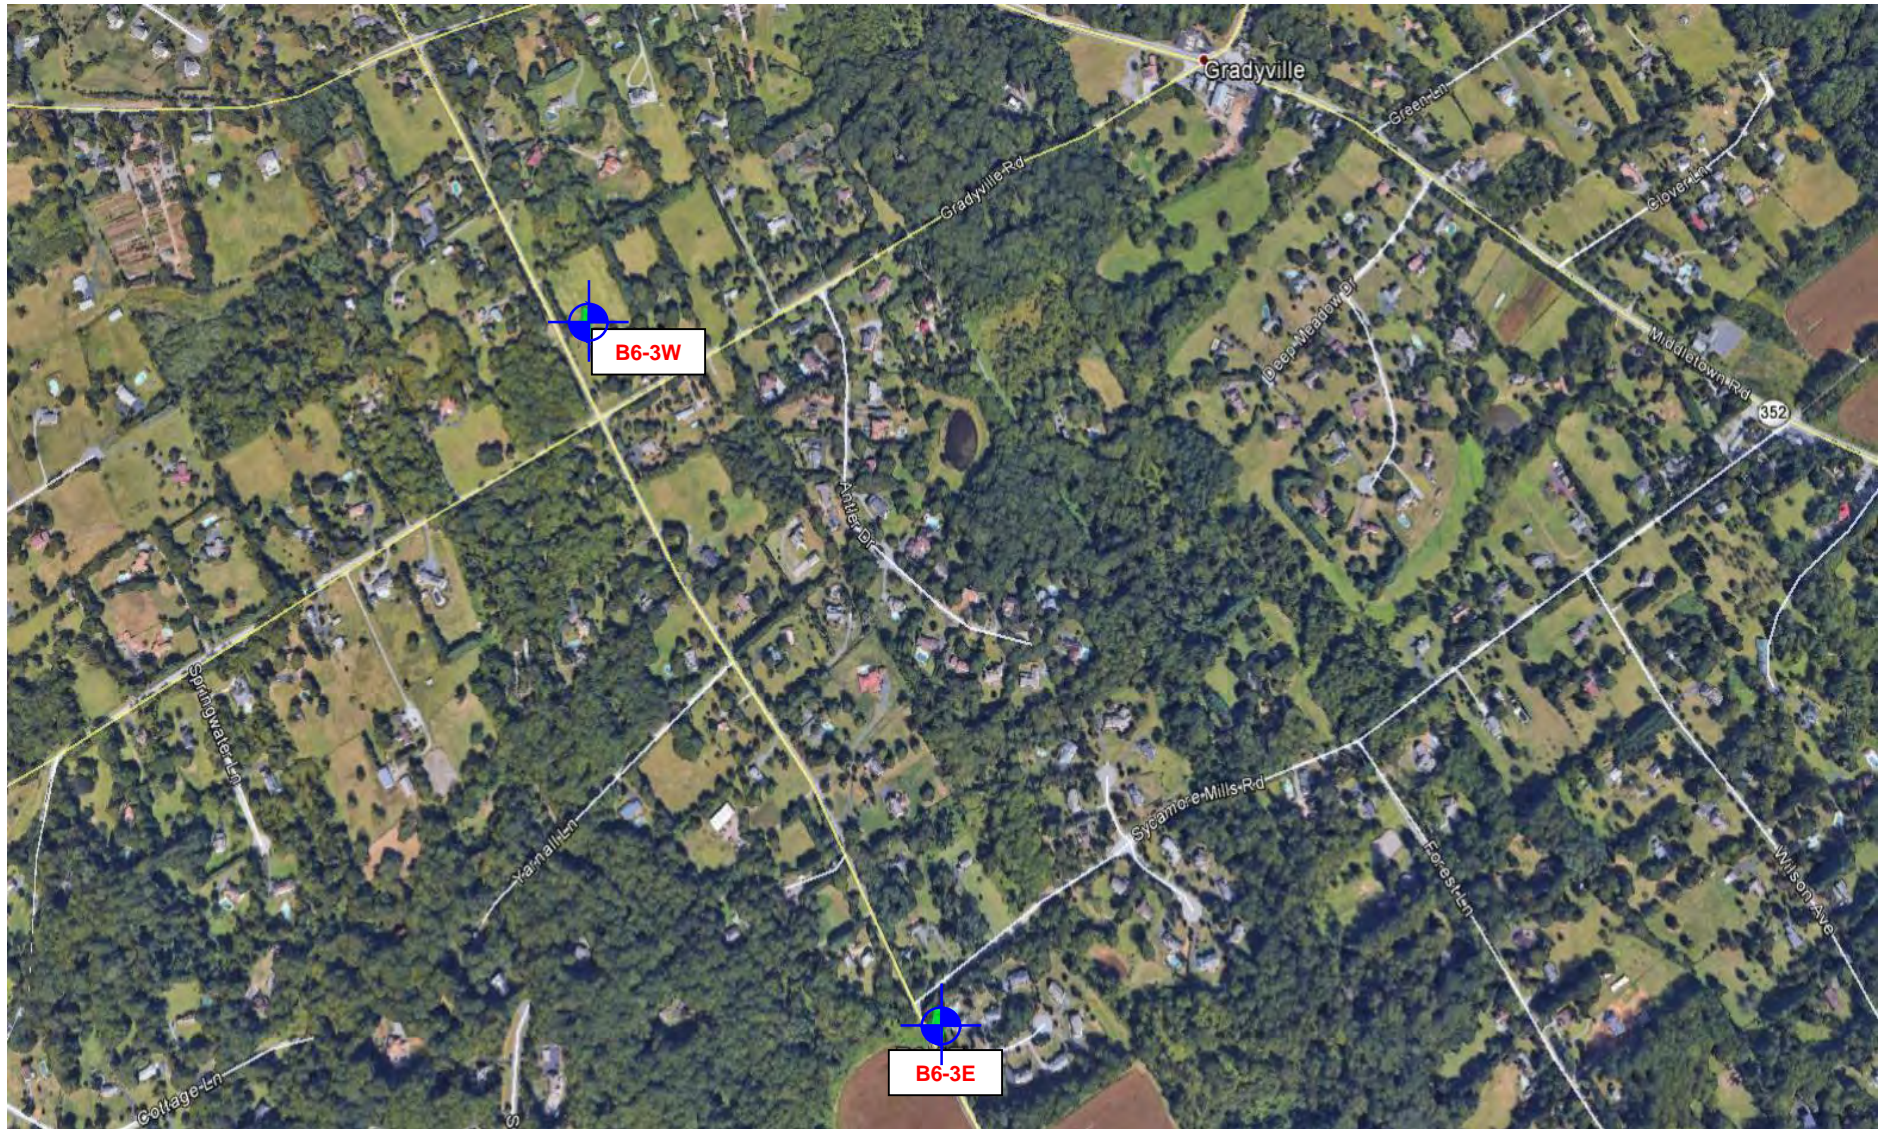
# **TEST BORING LOCATION PLAN**

**APPROXIMATE  
BORING  
LOCATION**

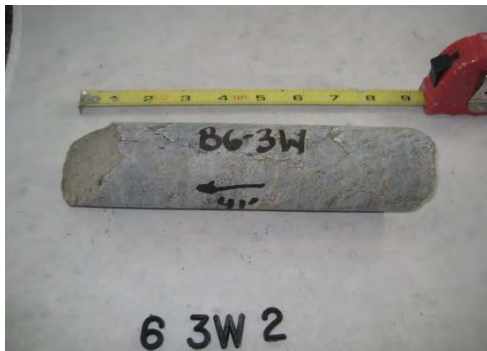
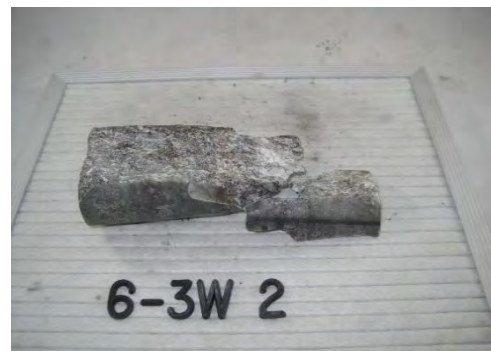
Before the Test

Maximum Axial Load at Failure: 49,850 lb  
 Compressive Strength: 16,190 psi  
 Compressive Strength: 111.63 Mpa  
 Unit Weight 174 pcf

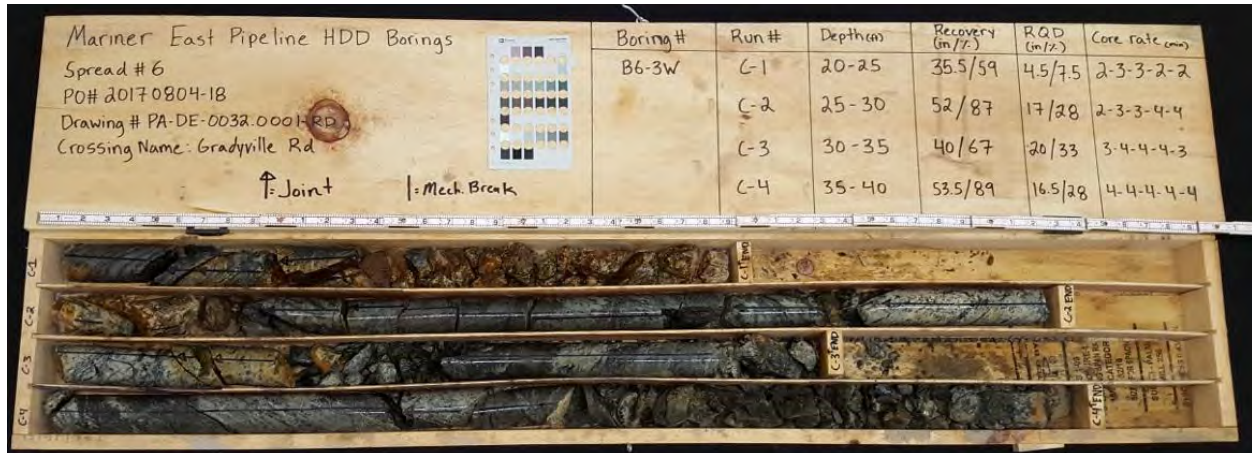
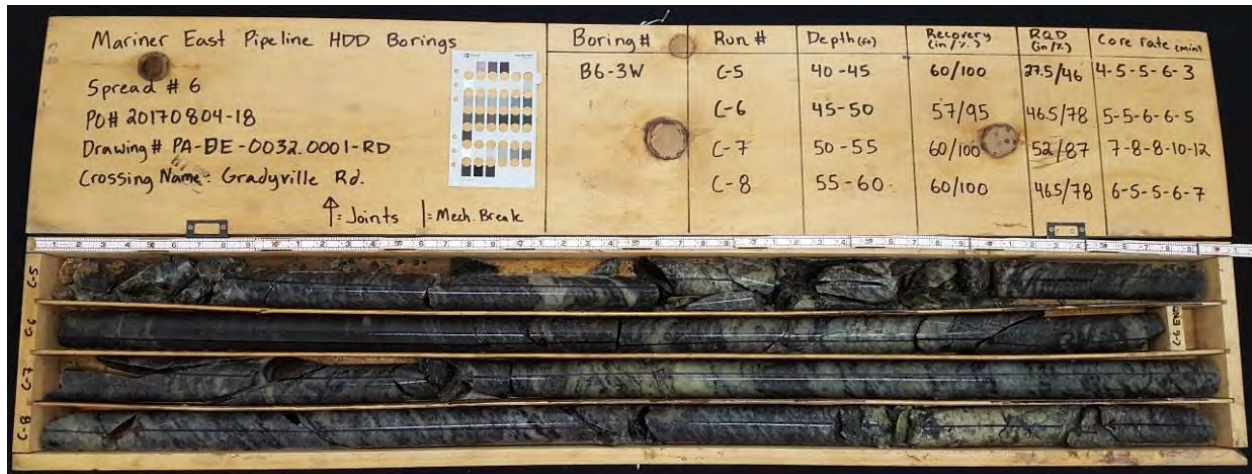
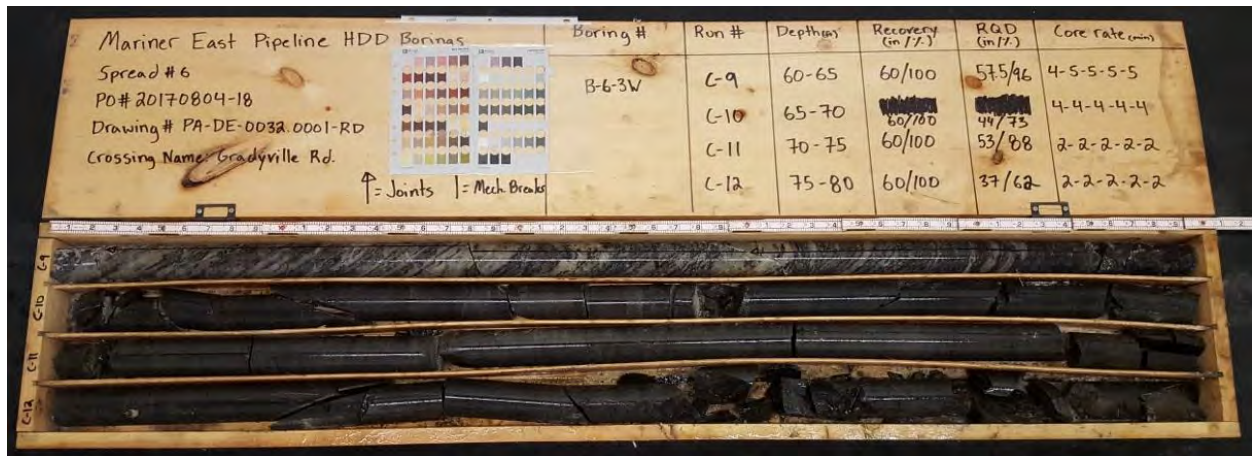
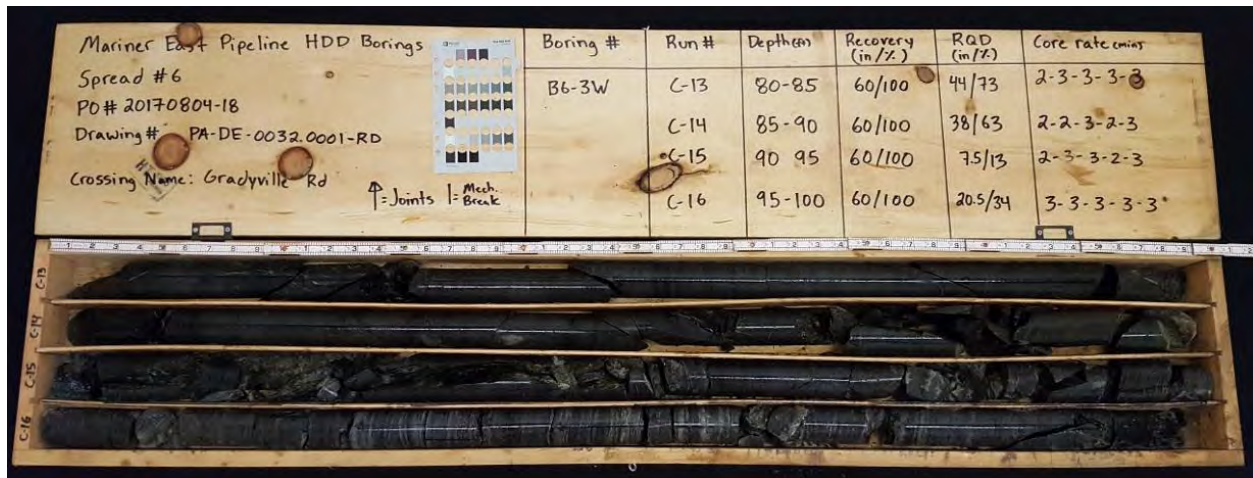
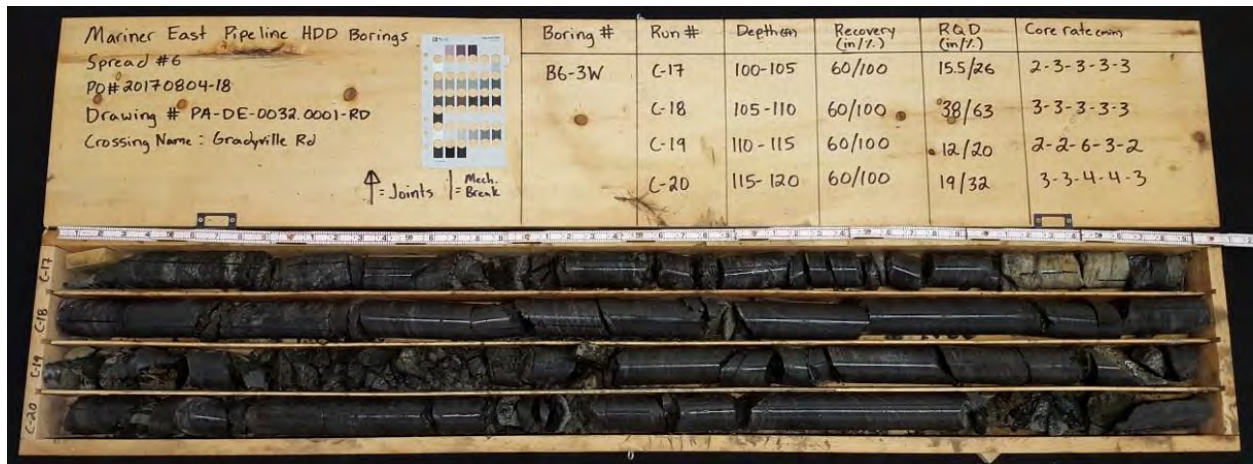
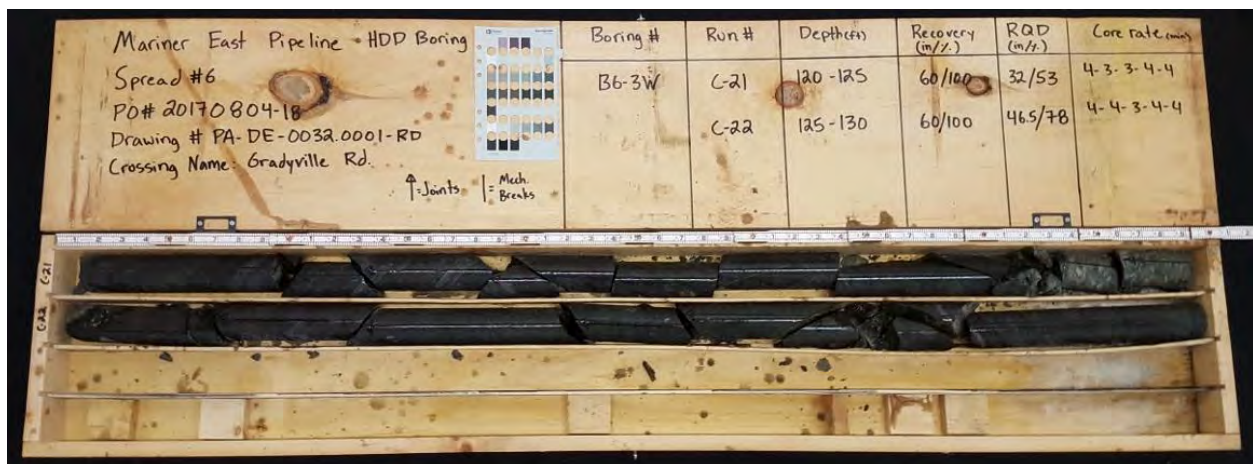
Photograph 1: B6-3W, Samples C-1 to C-4 (20 to 40 feet)

Photograph 2: B6-3W, Samples C-5 to C-8 (40 to 60 feet)

Photograph 3: B6-3W, Samples C-9 to C-12 (60 to 80 feet)

Photograph 4: B6-3W, Samples C-13 to C-16 (80 to 100 feet)

Photograph 5: B6-3W, Samples C-17 to C-20 (100 to 120 feet)

Photograph 6: B6-3W, Samples C-21 to C-22 (120 to 130 feet)

Water was used during coring of bore B6-3W, not drilling mud. The loss of water below 75 ft was most likely due to the high-angle dipping joints/fractures, which would allow for water to flow through them outside the borehole. The reduced RQD values in this depth of the bore may also reflect these steeply dipping fractures.

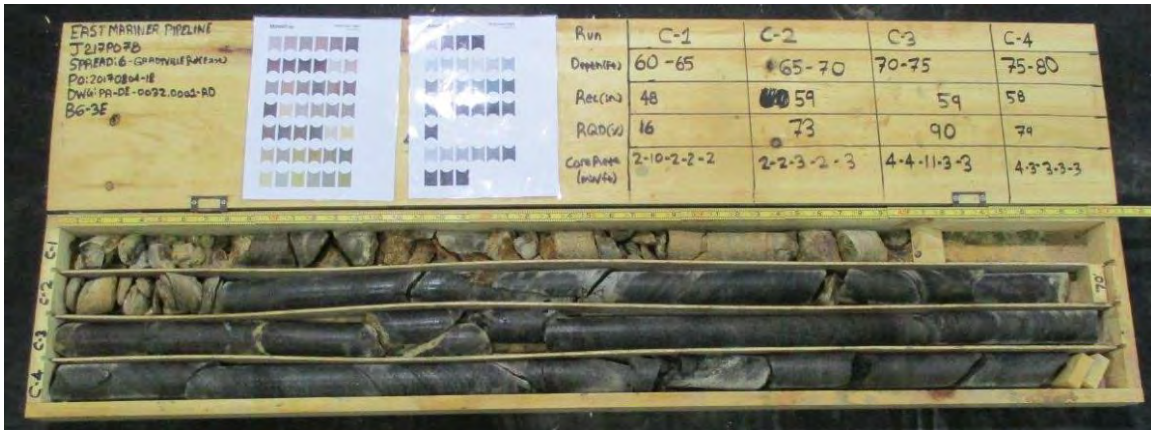
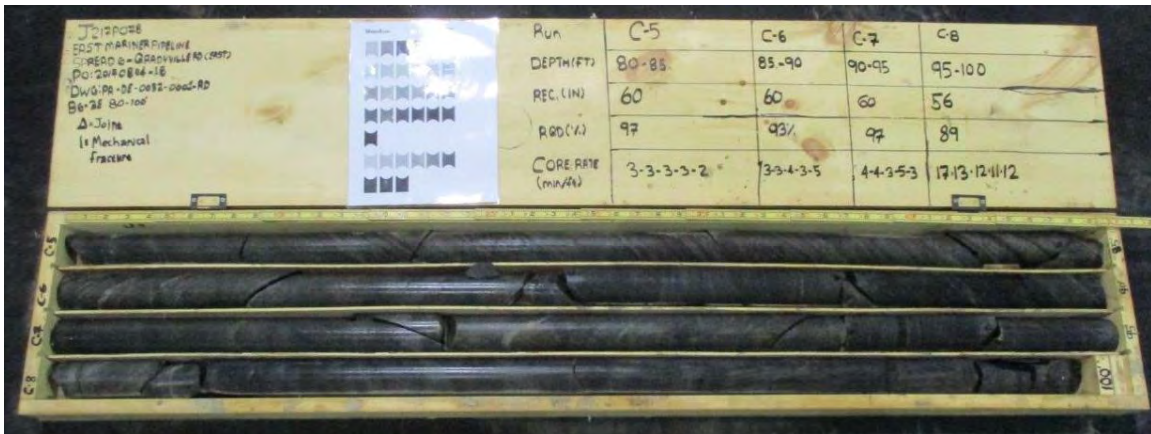
Photograph 1: B6-3E, Samples C-1 to C-4 (60 to 80 feet)

Photograph 2: B6-3E, Samples C-5 to C-8 (80 to 100 feet)

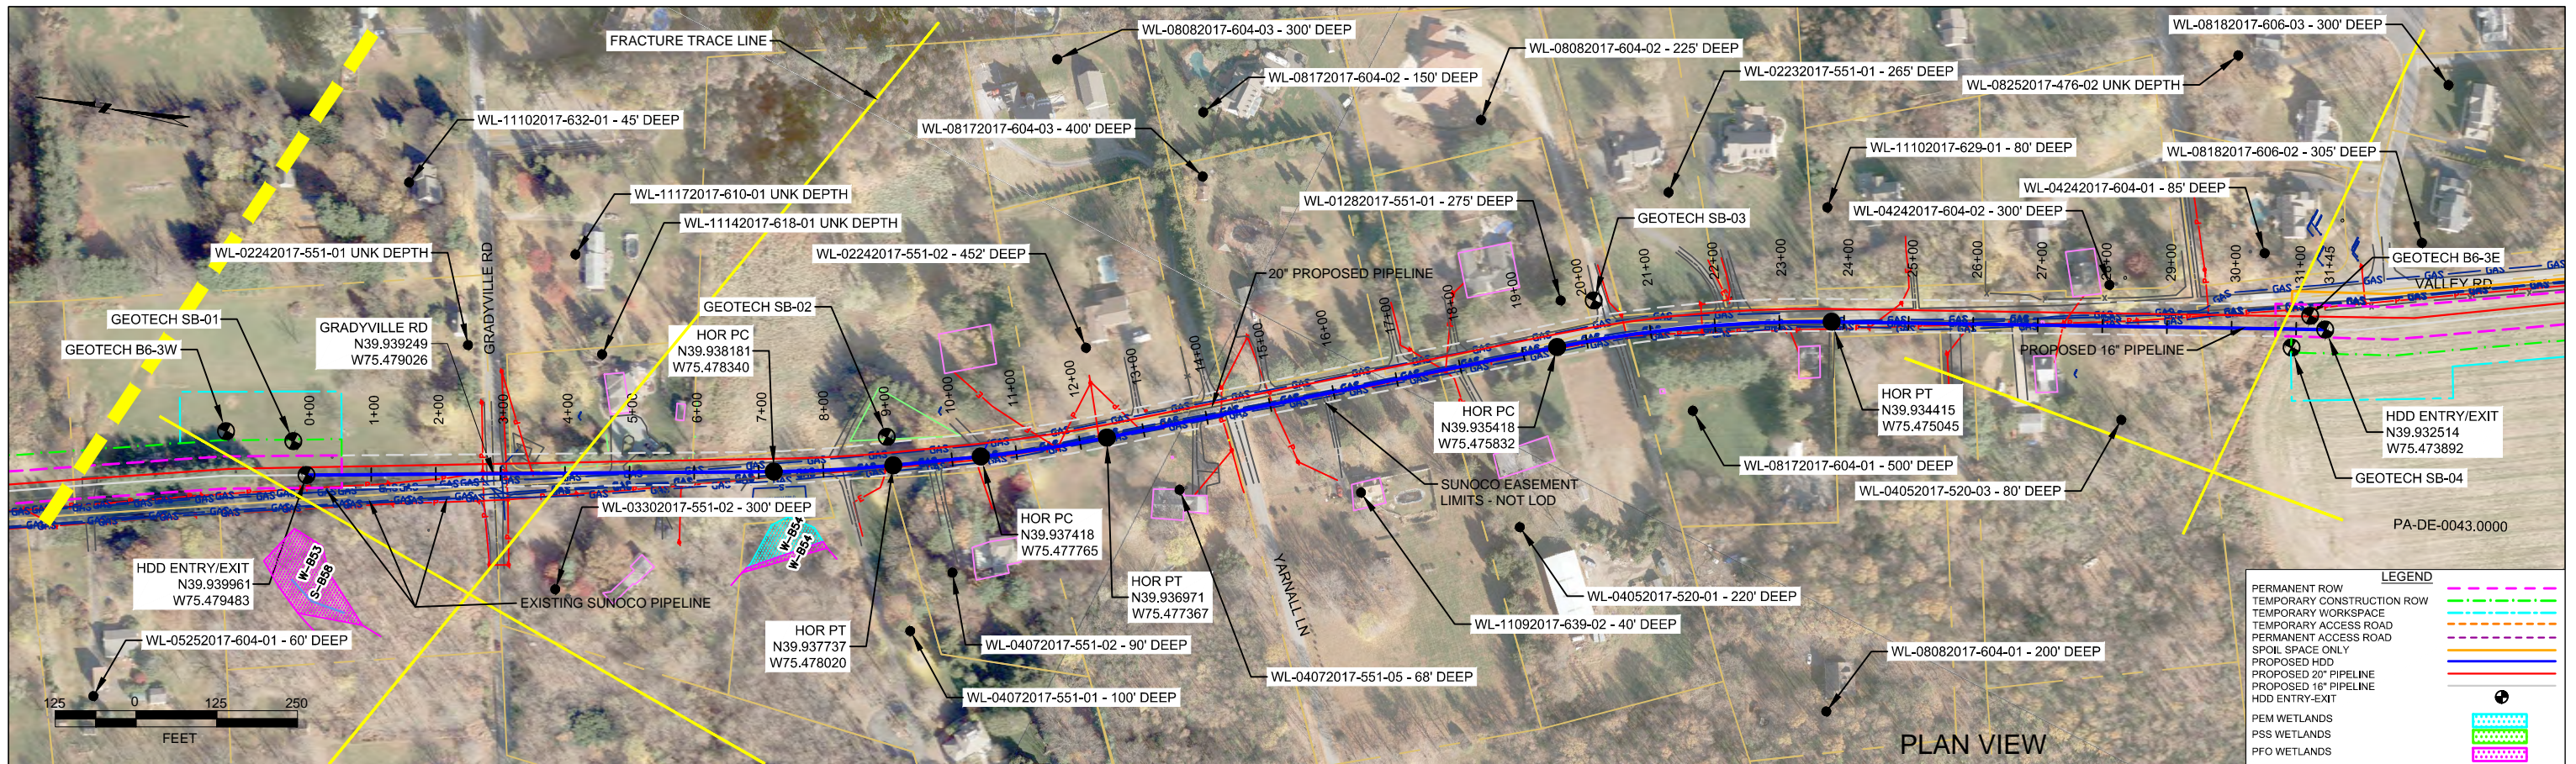
DELAWARE COUNTY PENNSYLVANIA, EDGMONT TOWNSHIP S3-0580-16

**FOR GEOLOGIC ANALYSIS ONLY**
