**Re: Reevaluation Report
 Horse Valley Road Horizontal Directional Drill Locations (S2-0157)
 Permit No. E50-258
 Toboyne Township, Perry County**

**HORSE VALLEY ROAD CROSSING
PADEP SECTION 105 PERMIT NO. E50-258
PA-PE-0002.0000-RD & PA-PE-0002.0000-RD-16
(SPLP HDD No. S2-0157)**

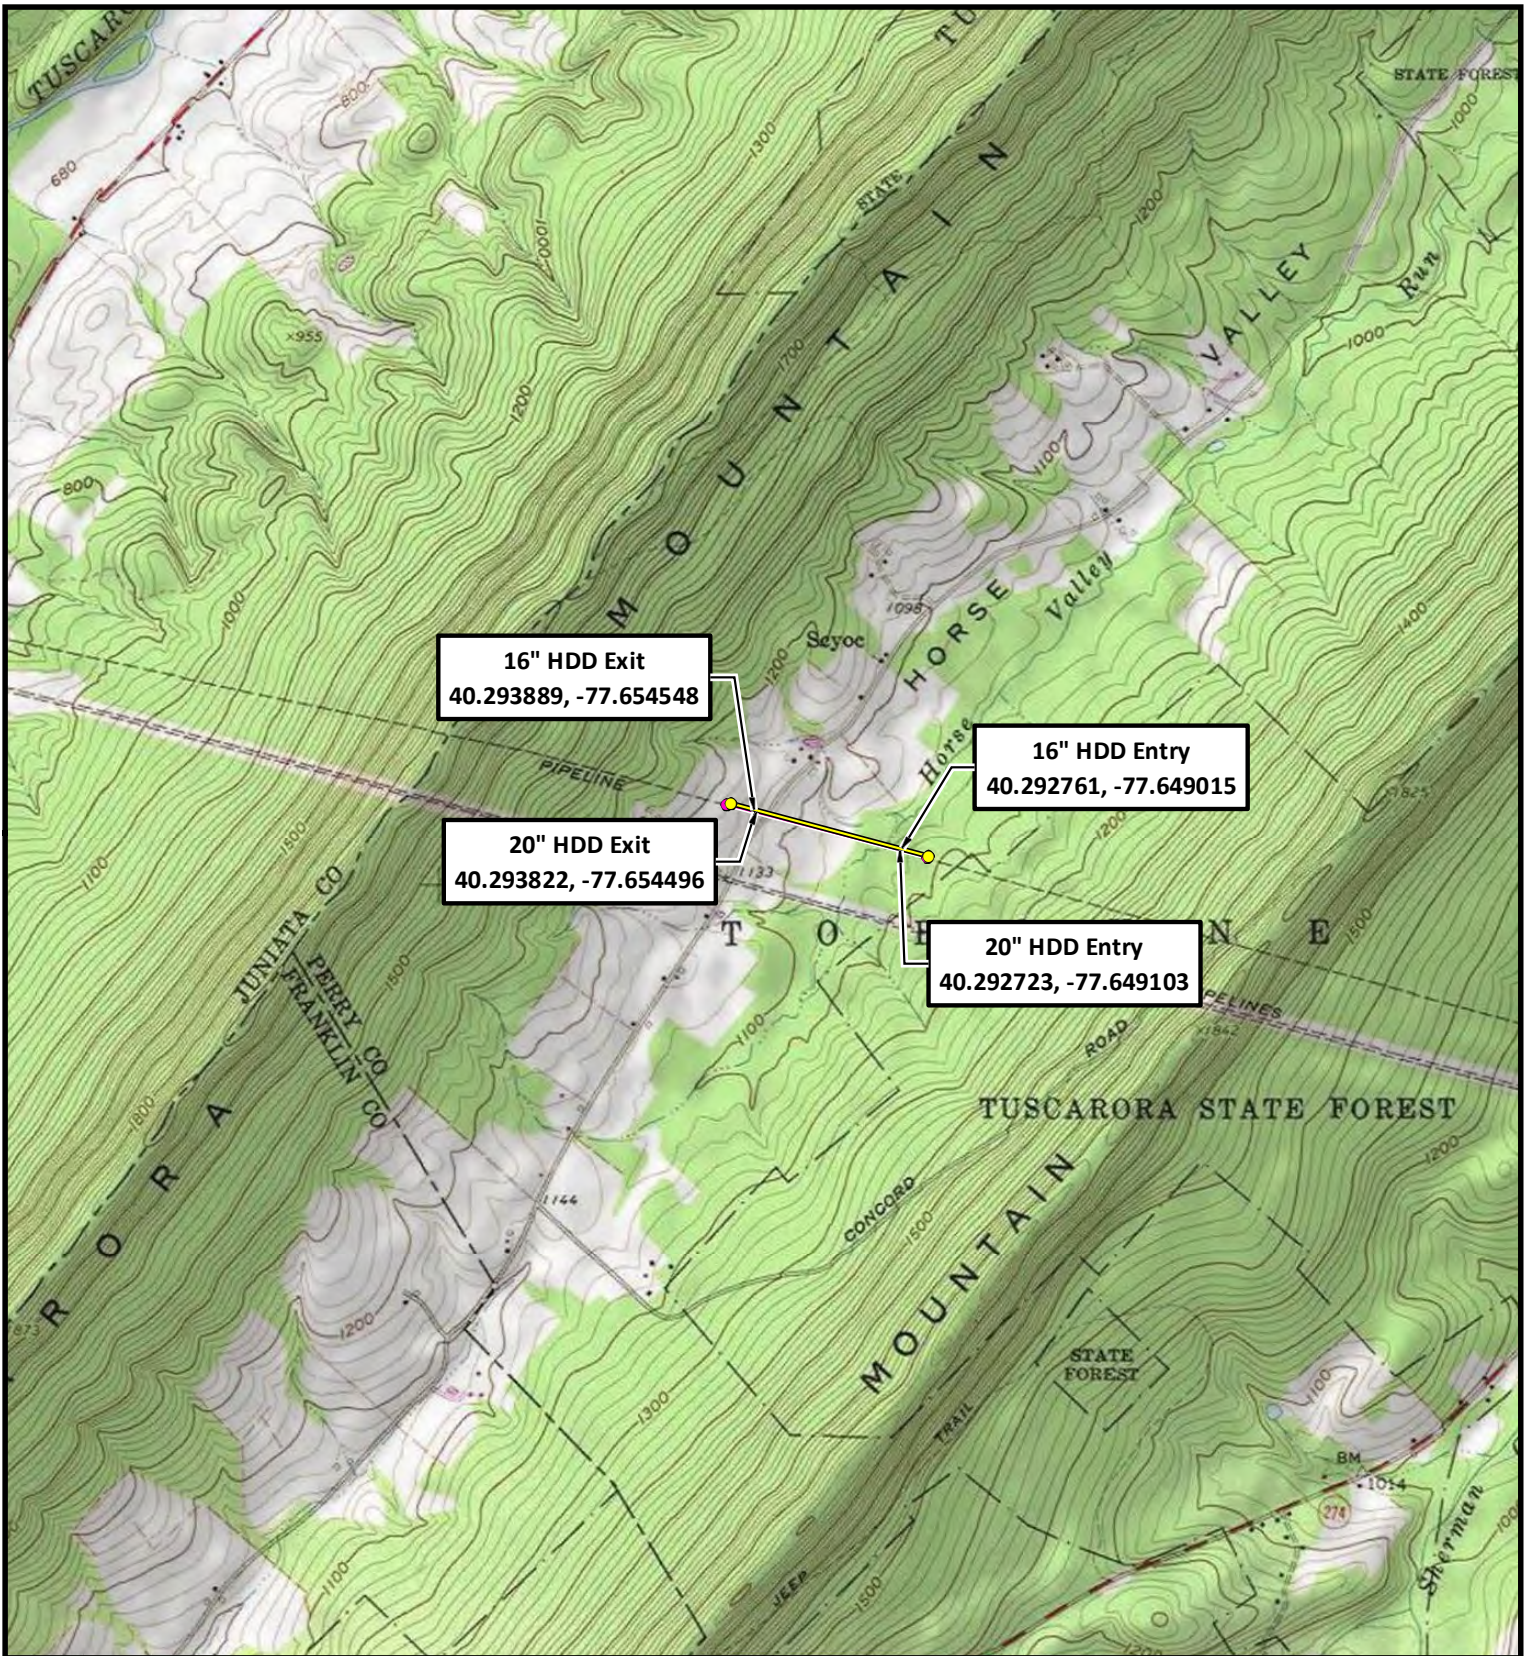
- 16" HDD Entry/Exit
- 20" HDD Entry/Exit
- 16" HDD Profile
- 20" HDD Profile

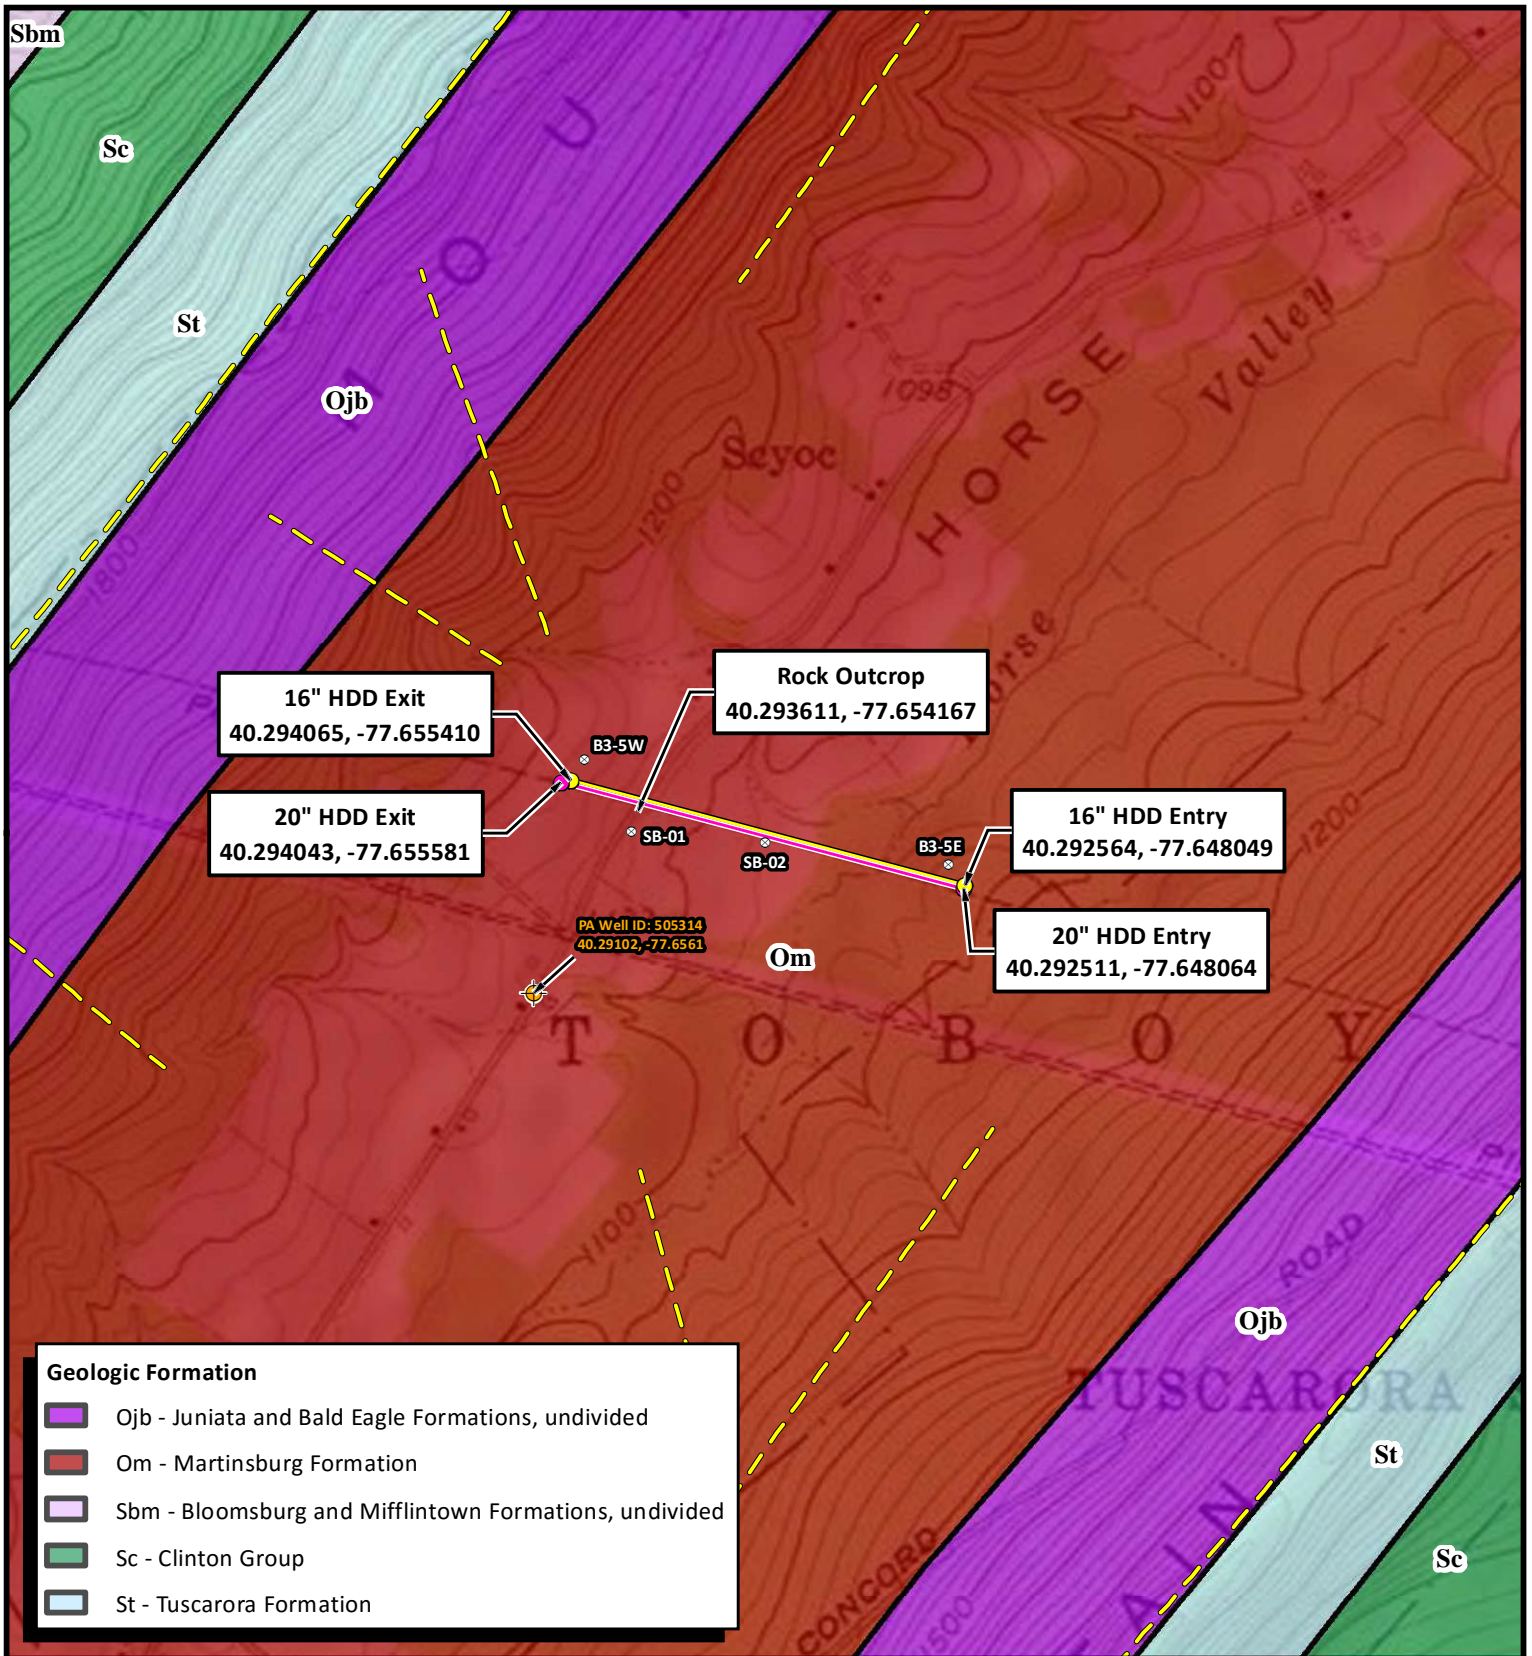
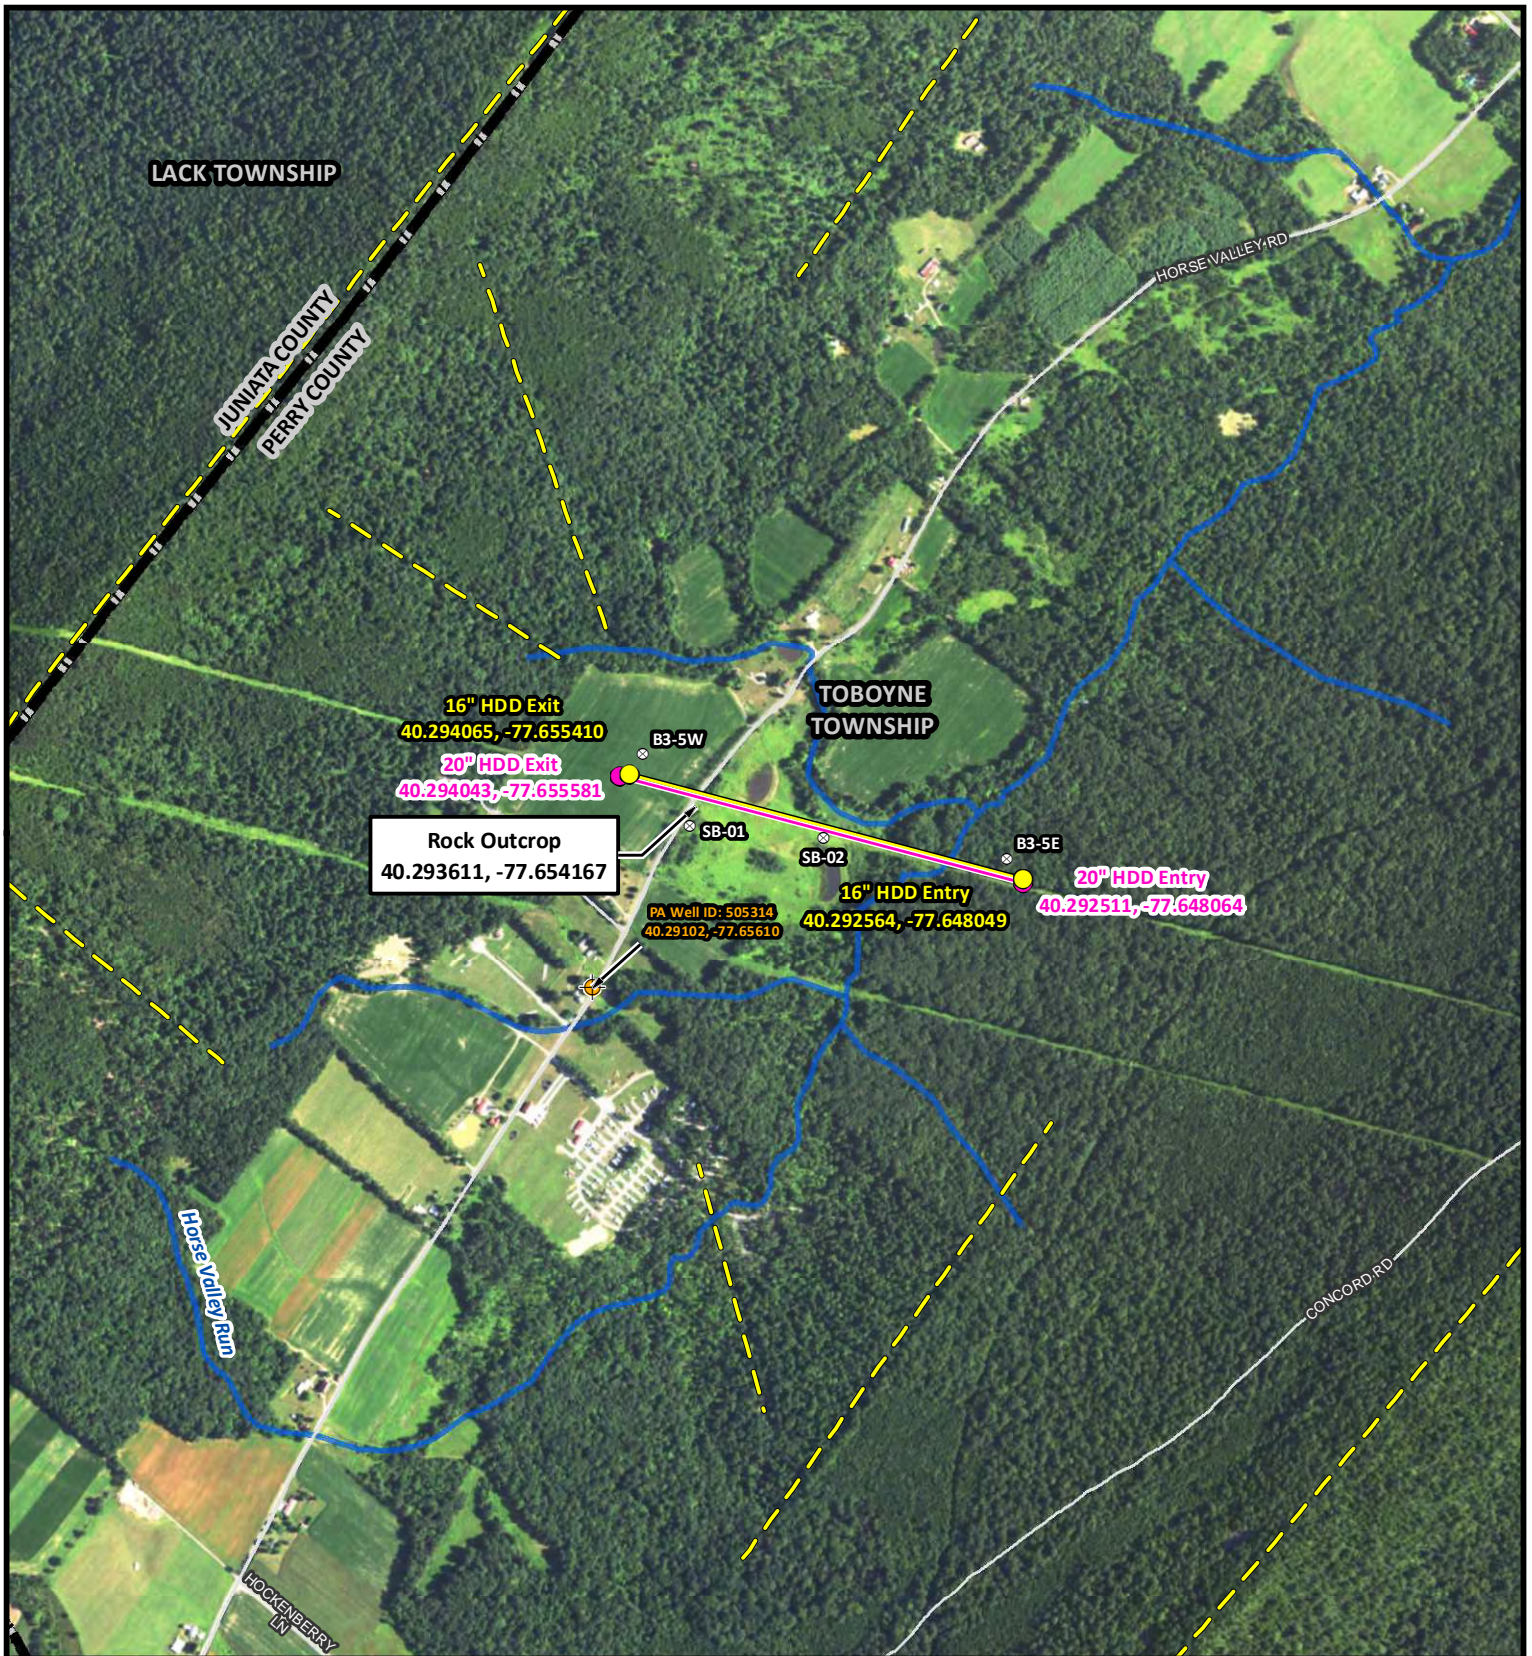
Figures 2 and 3 show the results of the fracture trace analysis overlain on the geologic map of the site and an aerial basemap. Eight fracture traces were identified within close proximity to the Horse Valley Road HDD that are likely related to the primary geologic structure. Four of the fracture traces trend approximately northeast-southwest (NE-SW), parallel to geologic strike. Four perpendicular fracture traces trend northwest-southeast (NW-SE) and may represent joint sets. Due to the nature of the ridges and folded geology near the site, the bedding-parallel fracture traces trend approximately NE-SW. Bedding-perpendicular fracture traces were identified in the approximately NW-SE fracture lineaments which are presumed to be stress-related joint sets. General surface drainage patterns near the site are characterized by linear stream reaches trending NE-SW or NW-SE that reflect the general geologic structure.

Fracture traces underlying, or in close proximity to, the site were evaluated using historical aerial photographs from the years 1995 through 2015 (Google Earth, 2017) and the Blairs Mills, Pennsylvania Geologic Quadrangle Maps from Atlas 61 (Berg and Dodge, 1981 and Royer, 1984). The photographs, publications and maps were reviewed to approximate the locations of natural linear fracture trace features or lineaments expressed on the ground surface. The linear features may be the surficial representation of deeper high angle fractures, joints, faults or bedding planes within the subsurface which can transmit groundwater through the fractured bedrock aquifer at the site.

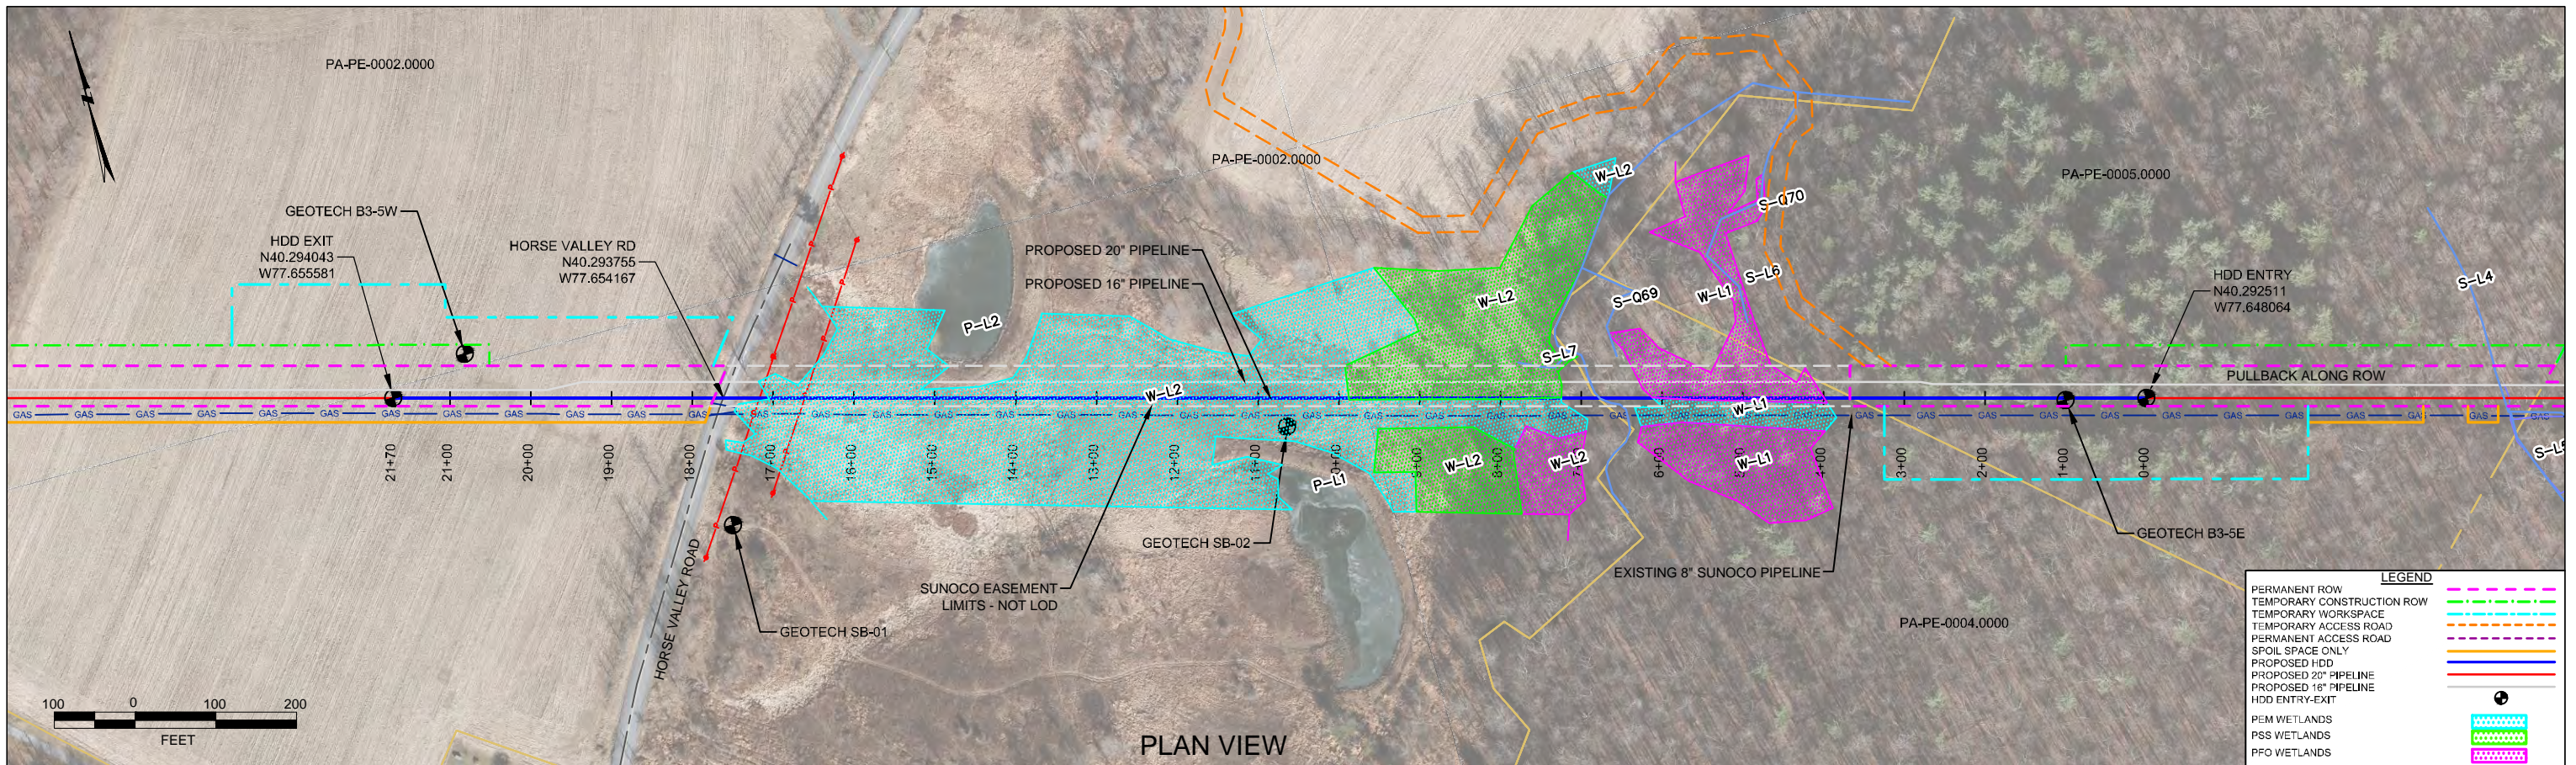
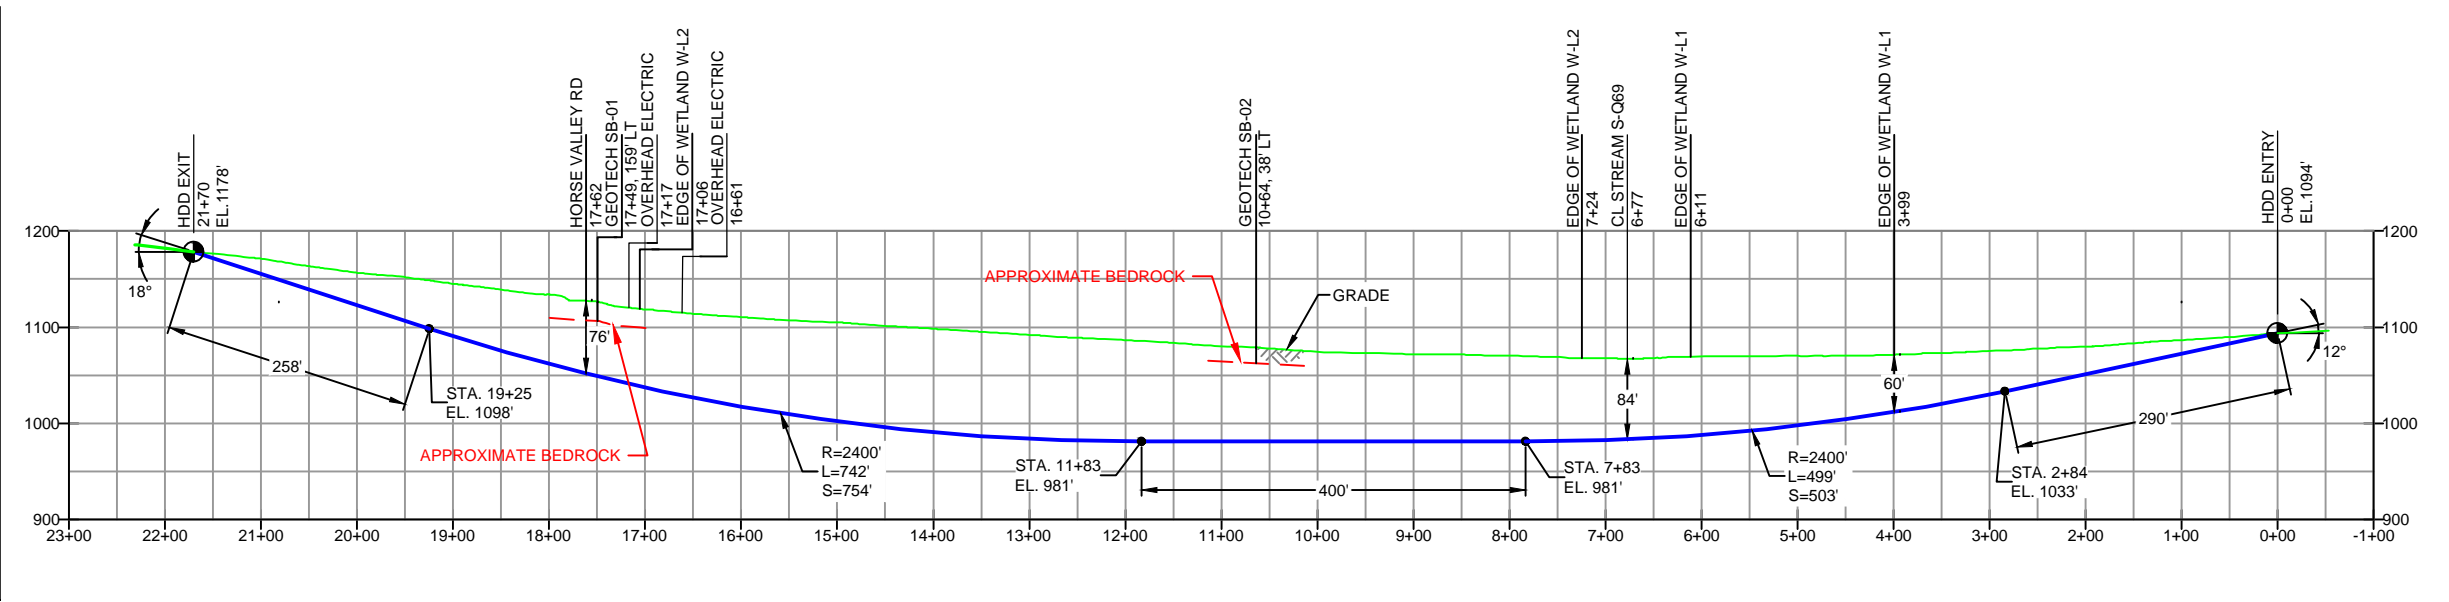
SCALE: 1"=200' DWG. NUMBER: PA-PE-0002.0000-RD

GEOTECH B3-5W

- NG EL. 1140'
- LEAN CLAY W/ GRAVEL CL (0.0' - 29.0')
- WEATHERED ROCK/SHALE (29.0' - 135.0')
- BORING TERMINATED EL. 1005'

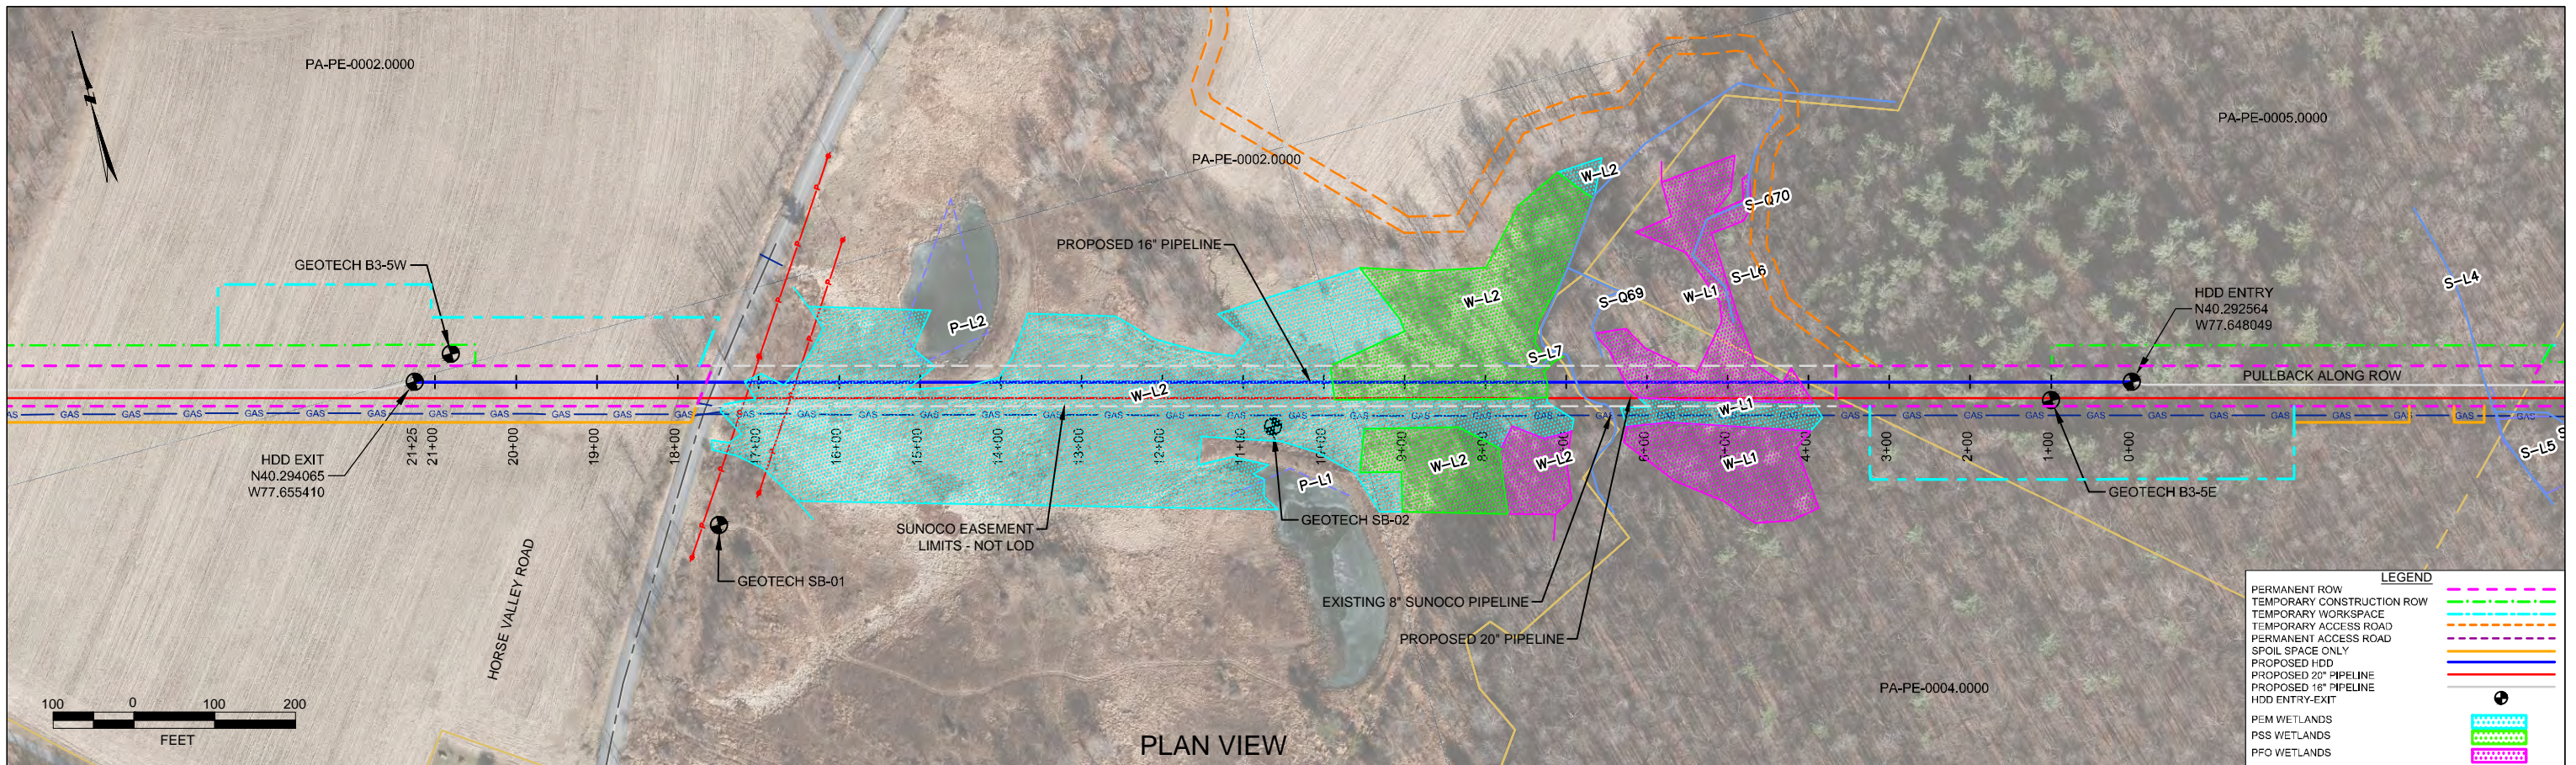
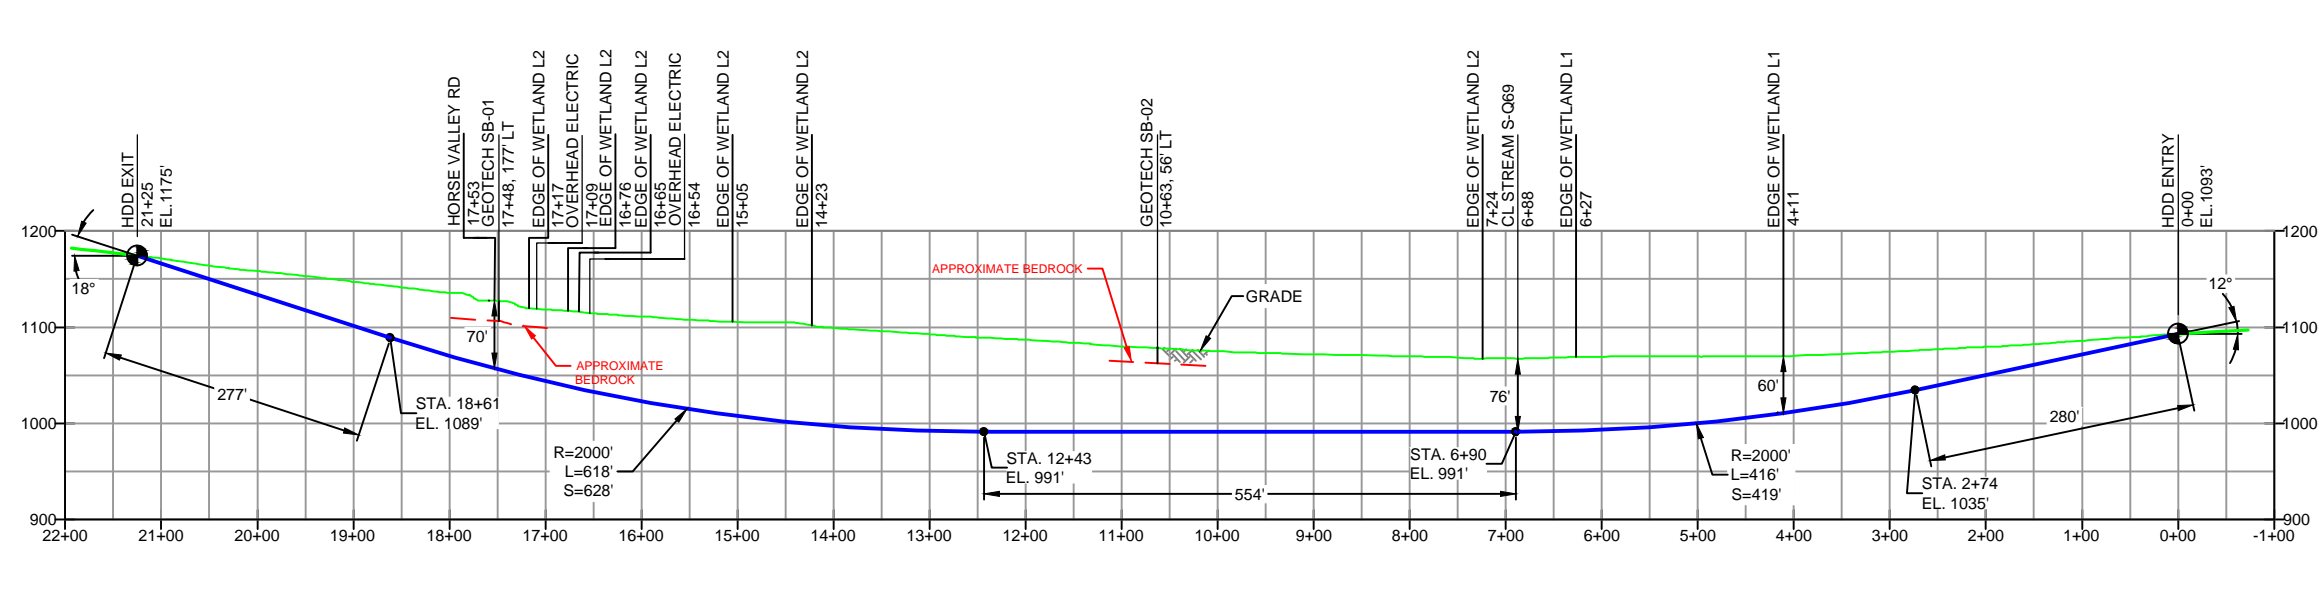
SCALE: 1"=200' DWG. NO. PA-PE-0002.0000-RD-16

- DESIGNED IN ACCORDANCE WITH CFR 49 195 & ASME B31.4
 - CROSSING PIPE SPECIFICATION:
HDD HORZ. LENGTH (L=): 2125'
HDD PIPE LENGTH (S=): 2158'
16" x 0.438" W.T., X-70, API5L PSL2, ERW, BFW
COATING: 14-16 MILS FBE WITH 30-35 MIL ARO (POWERCRETE OR ENGINEER APPROVED EQUAL)

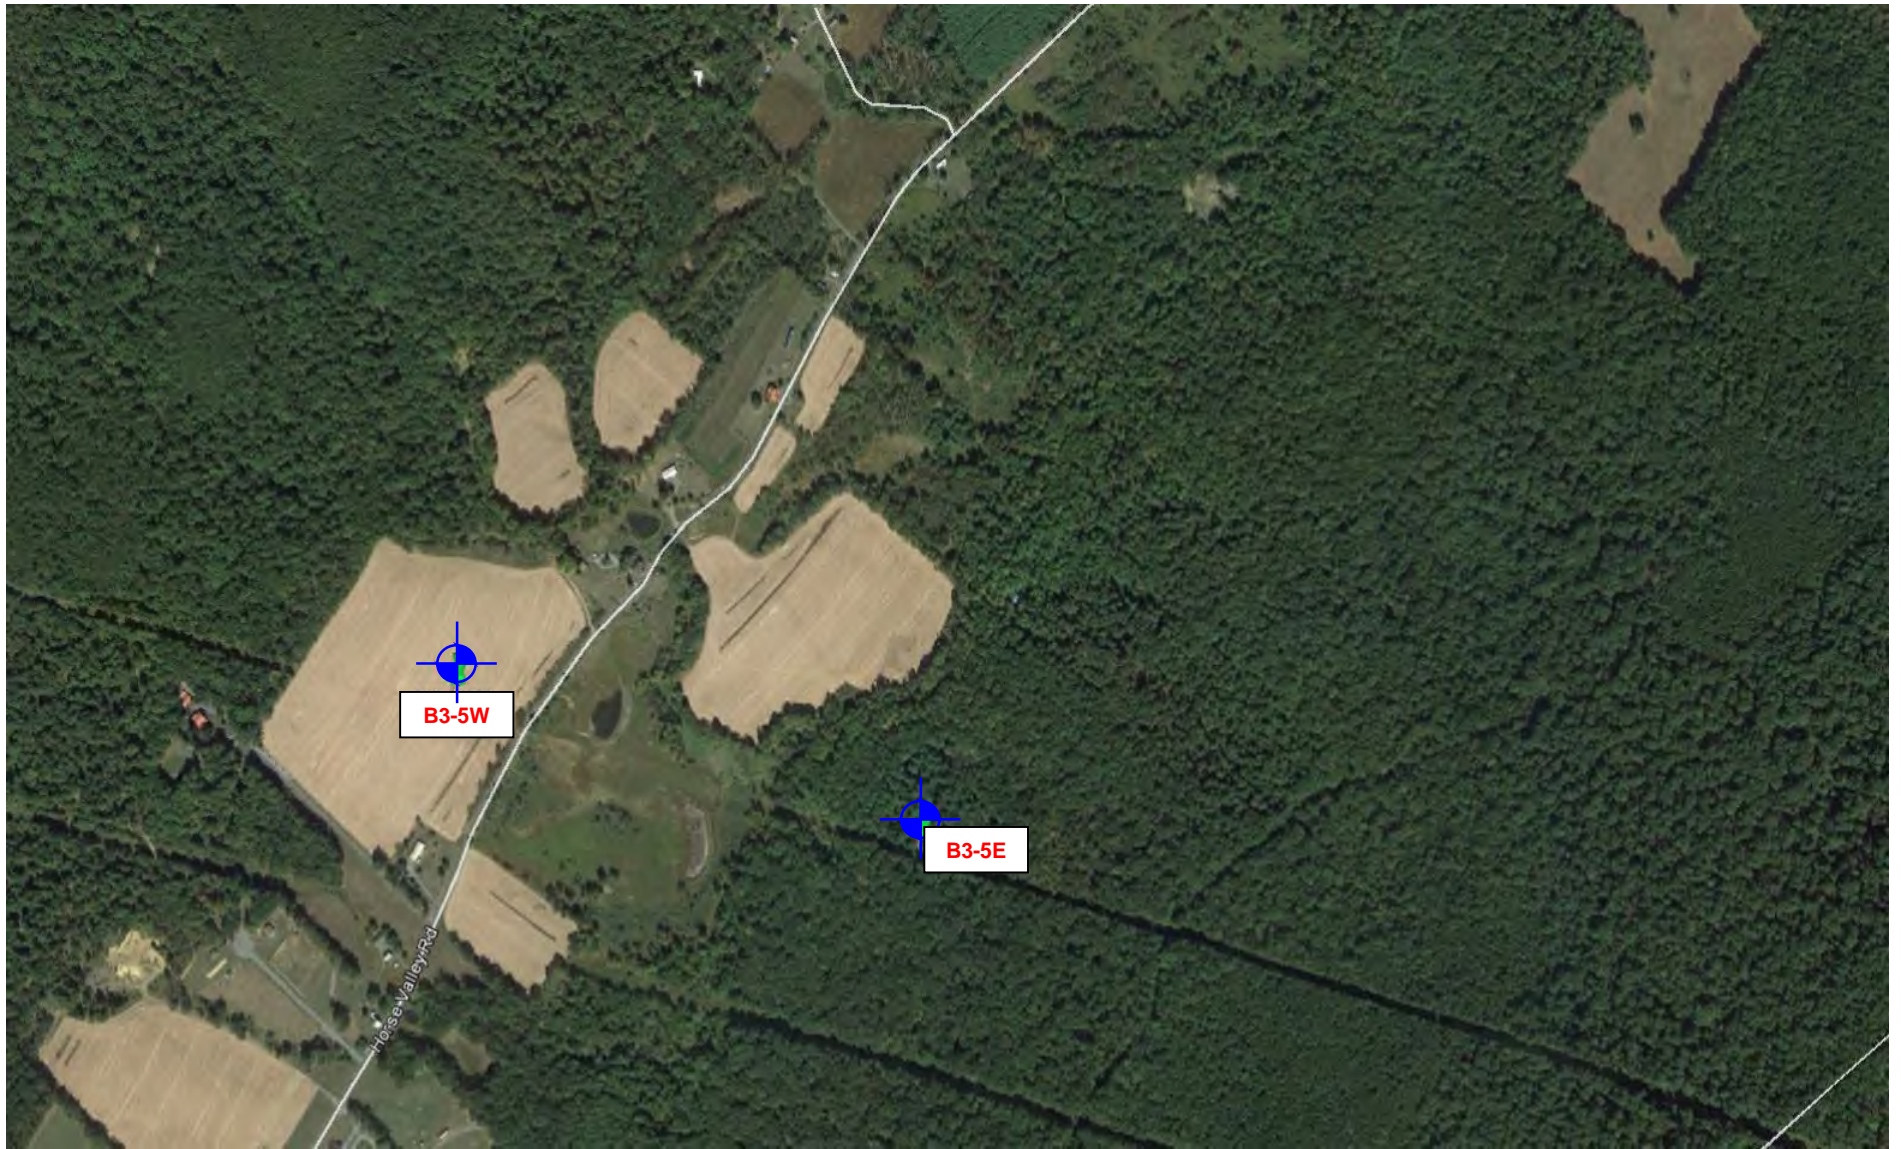
TEST BORING LOCATION PLAN

Test borings, B3-5W and B3-5E were drilled between August 22 and 26, 2017 to depths of 135 and 85 feet, respectively as shown on the attached **Test Boring Location Plan**. Test boring B3-5W was terminated before the target depth of 146 feet due to a malfunctioning core barrel retriever. Bedrock typically consisted of shale. Final test boring logs documenting overburden soil and bedrock conditions as well as photographs of the rock core samples are attached.

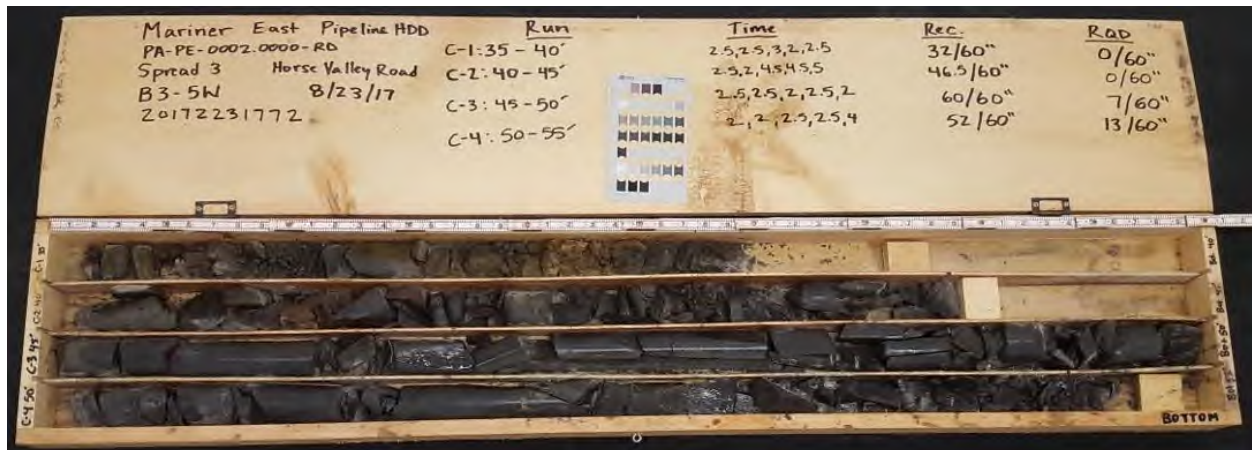
Photograph 1: B3-5W, Samples C-1 to C-4 (35 to 55 feet)

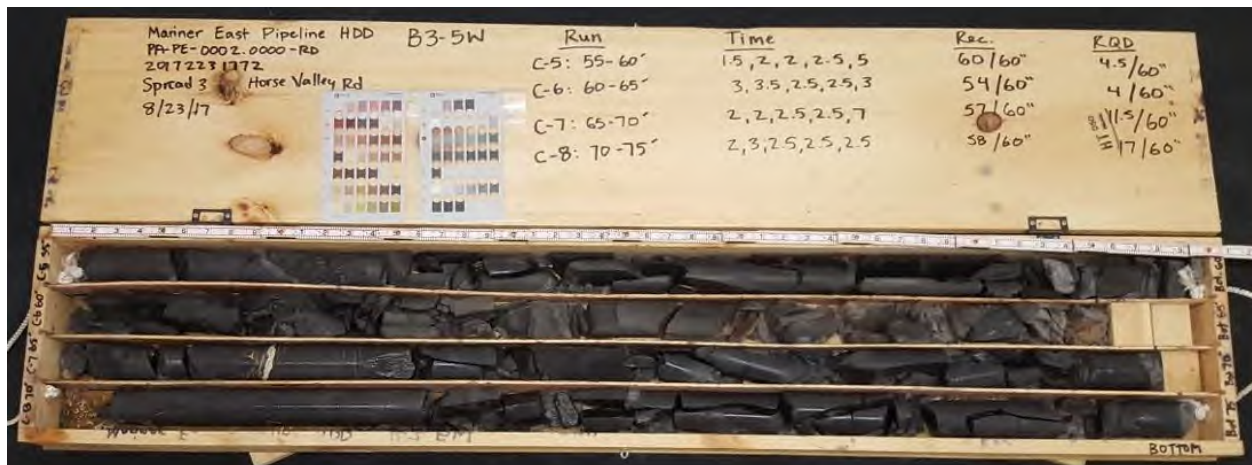
Photograph 2: B3-5W, Samples C-5 to C-8 (55 to 75 feet)

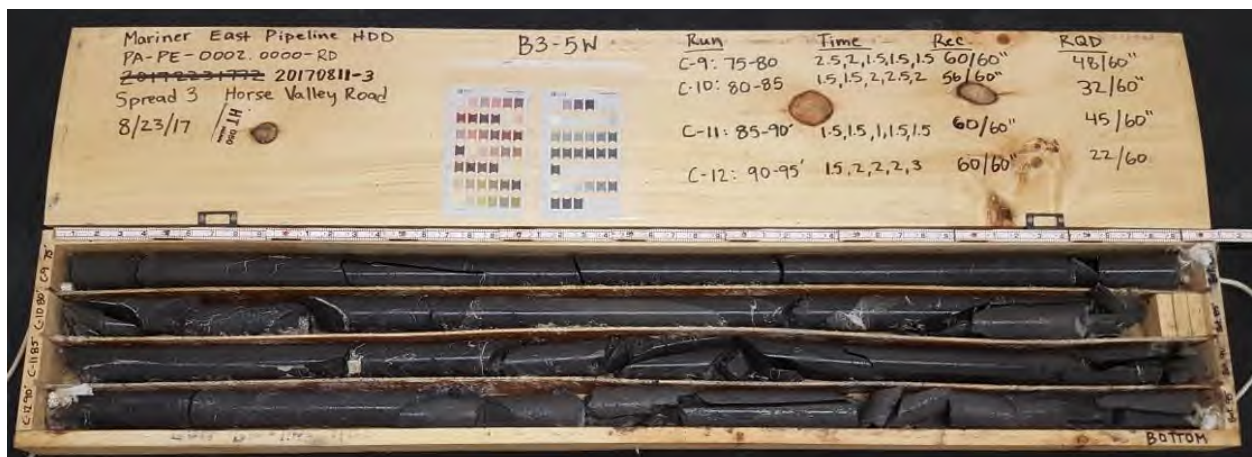
Photograph 3: B3-5W, Samples C-9 to C-12 (75 to 95 feet)

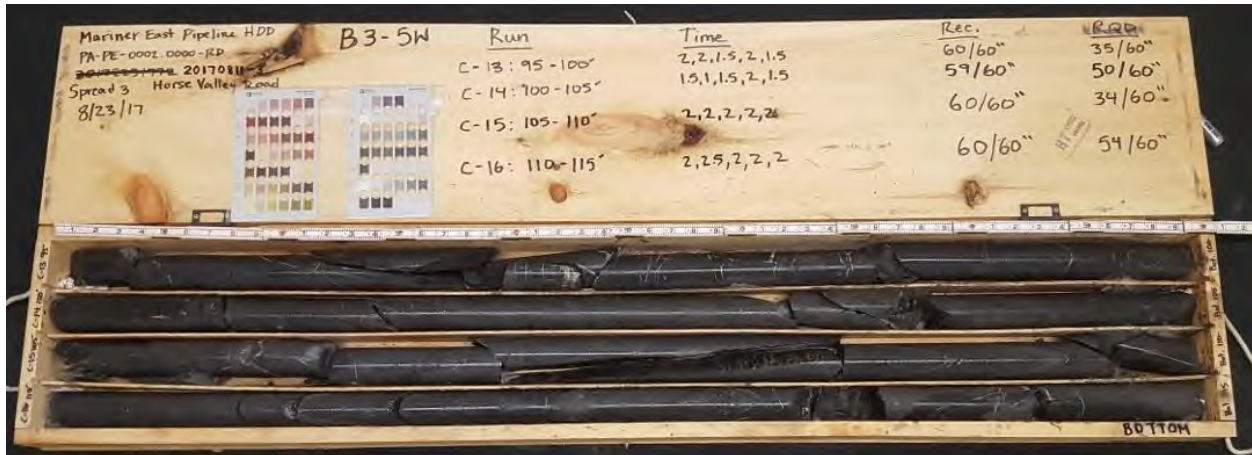
Photograph 4: B3-5W, Samples C-13 to C-16 (95 to 115 feet)

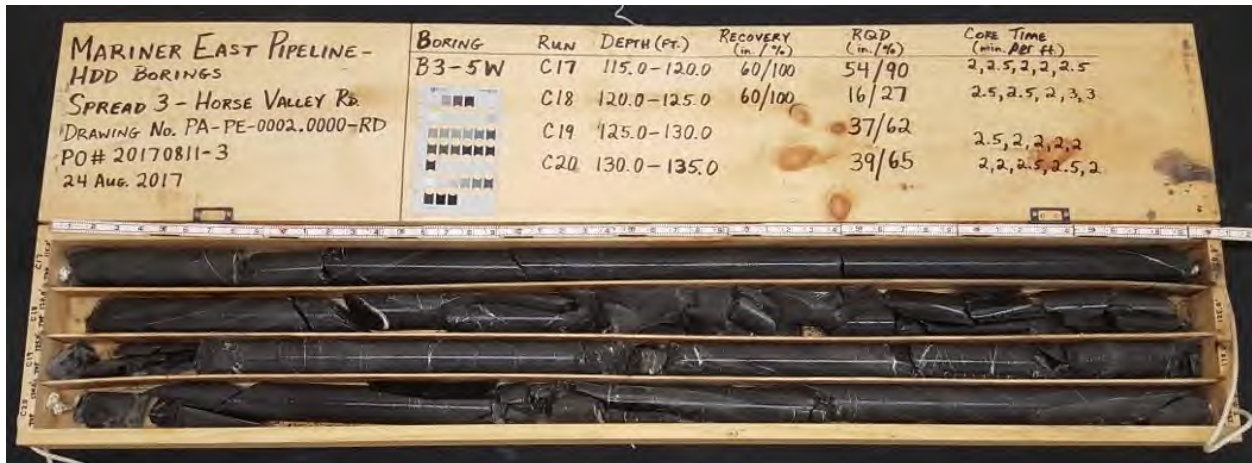
Photograph 5: B3-5W, Samples C-17 to C-20 (115 to 135 feet)

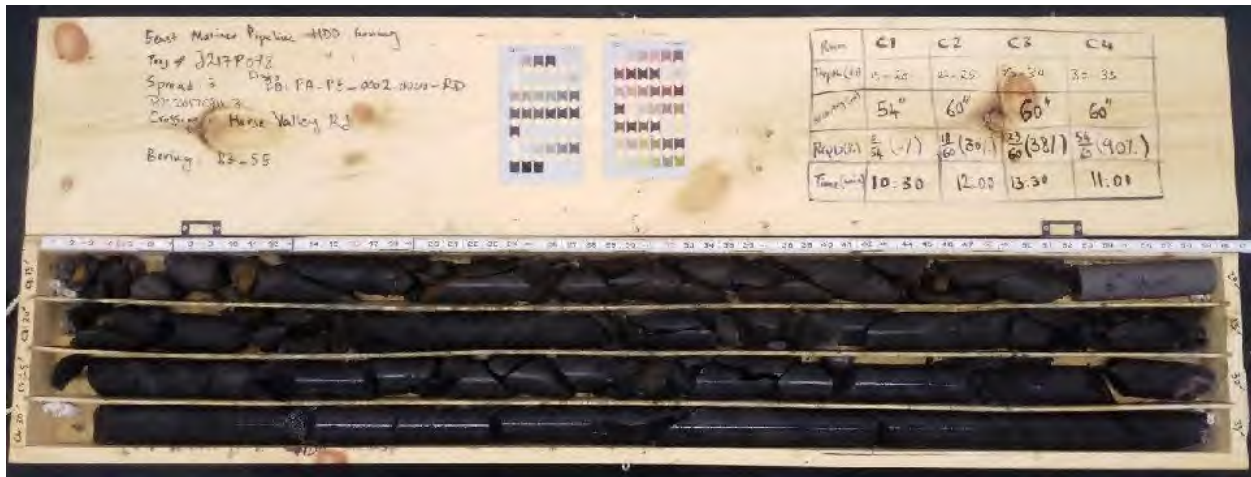
Photograph 1: B3-5E, Samples C-1 to C-4 (15 to 35 feet)

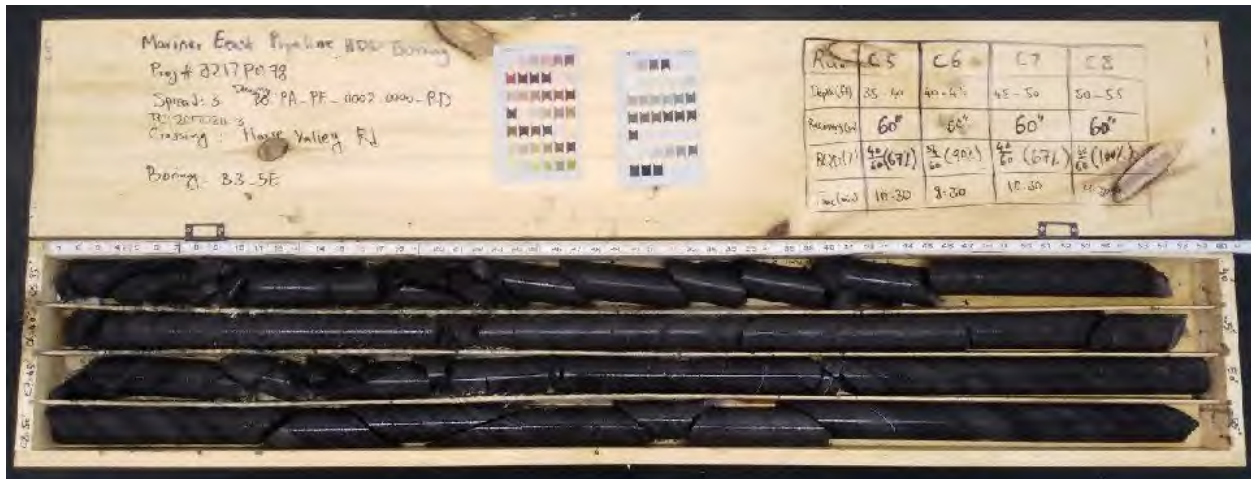
Photograph 2: B3-5E, Samples C-5 to C-8 (35 to 55 feet)

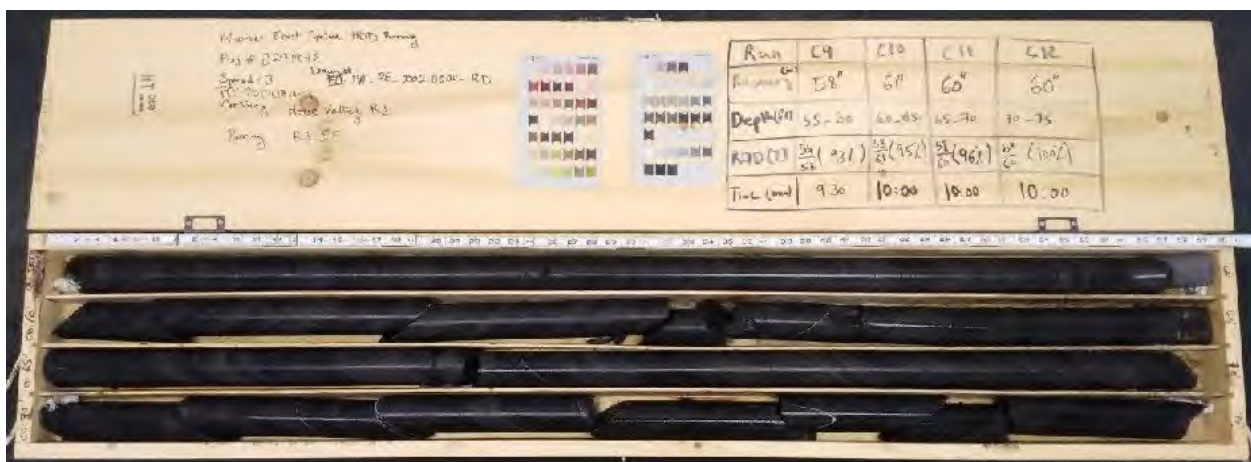
Photograph 3: B3-5E, Samples C-9 to C-12 (55 to 75 feet)

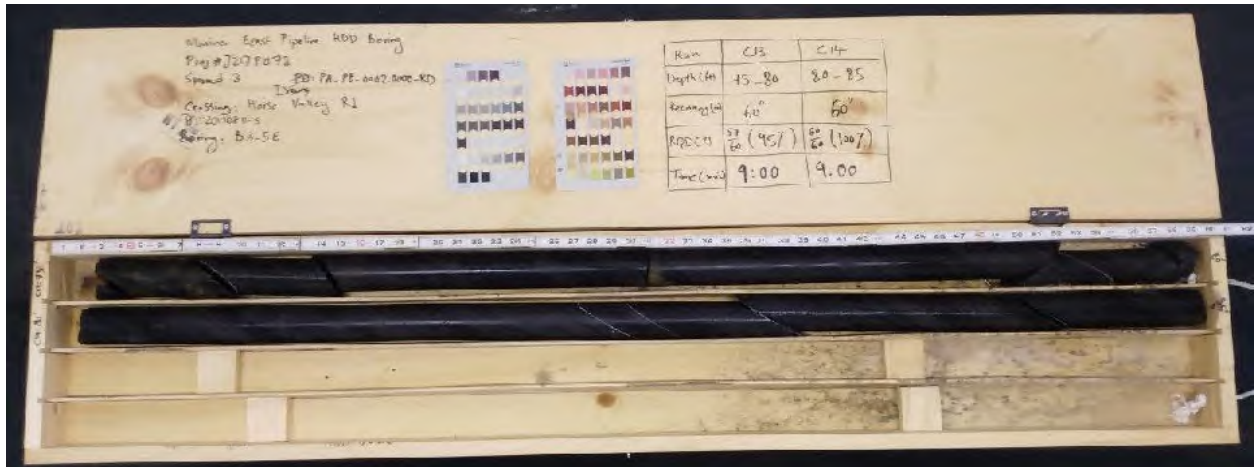
Photograph 4: B3-5E, Samples C-13 to C-14 (75 to 85 feet)
