**Re: Reevaluation Report
 Horse Valley Road Horizontal Directional Drill Locations (S2-0157)
 Permit No. E50-258
 Toboyne Township, Perry County**

**HORSE VALLEY ROAD CROSSING
PADEP SECTION 105 PERMIT NO. E50-258
PA-PE-0002.0000-RD & PA-PE-0002.0000-RD-16
(SPLP HDD No. S2-0157)**

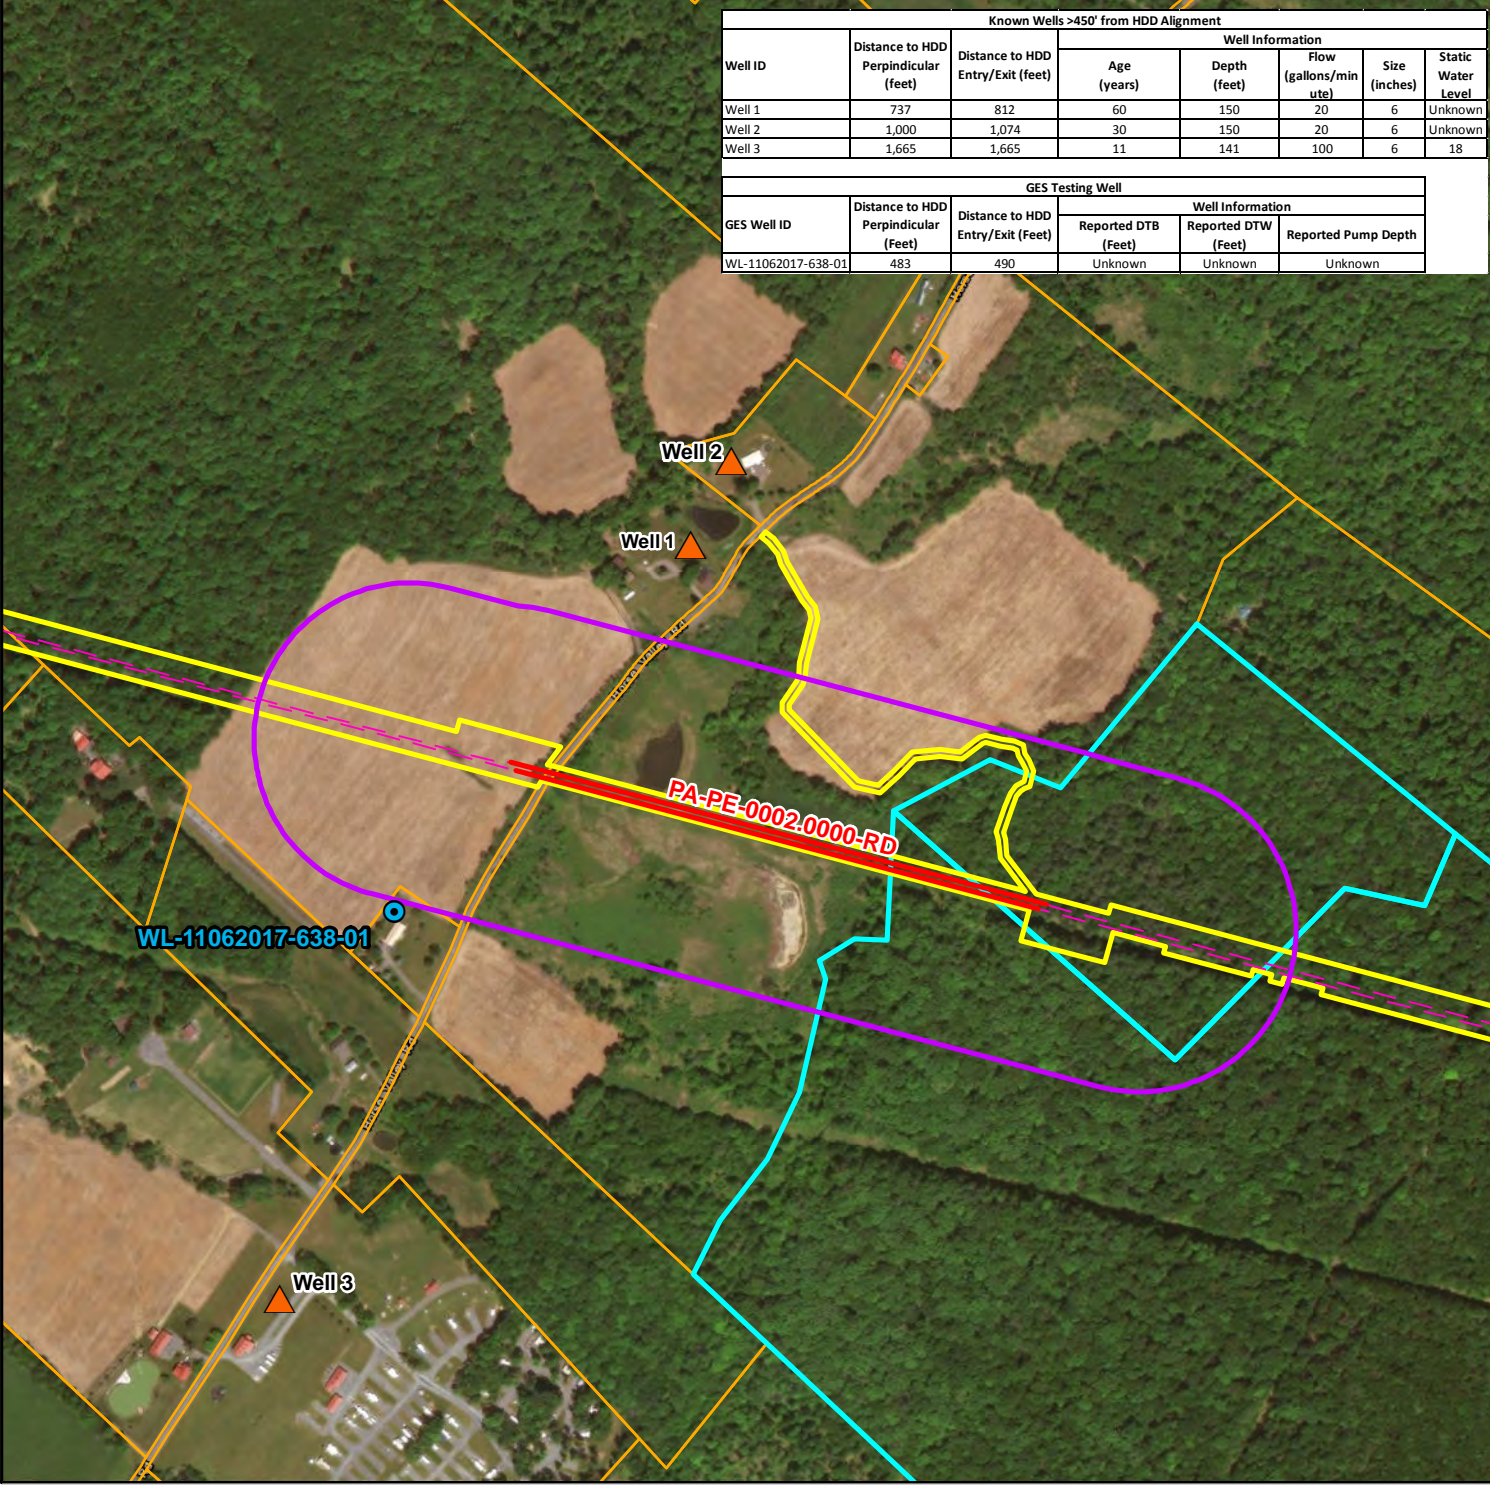
Well Location Map
HDD# PA-PE-0002.0000-RD
Perry County, PA.

As a condition of the corrected stipulated order, other Sunoco subcontractors have researched private water supplies located within 450 feet of the Horse Valley HDD. No private wells were identified within 450 feet of the Horse Valley HDD; however, one well was identified approximately 483 feet south of the HDD exit as shown on the figure in **Attachment 3**. Well construction details were not available.

On January 2, 2018, agents for SPLP investigated the two occupied properties north of the HDD location. A non-public community water well was not observed at either location. Both locations, as shown on the water supply illustration, have private wells that serve single, residential home sites. Based upon the understanding of the groundwater levels and movement through the overburden and subsurface bedrock fissures and bedding plane partings as described in the hydrogeology report, SPLP believes that neither of these wells are within a zone of concern. Both are located upgradient and west of the valley floor; therefore, the source recharge for these wells would derive from groundwater movement from higher elevations to the west, not from the direction of the HDD profile where is crossed the valley floor.

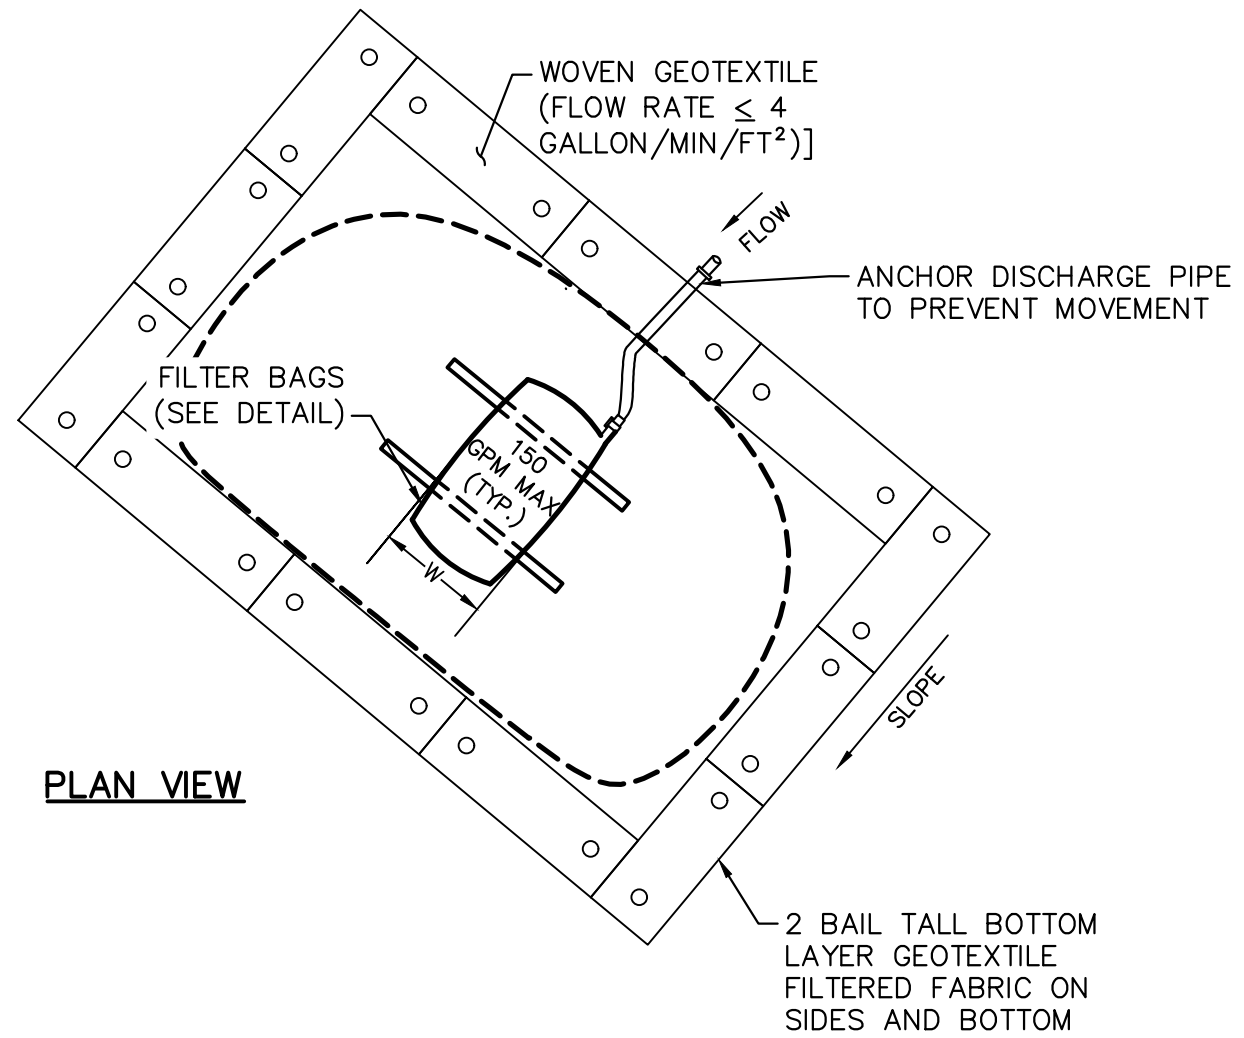
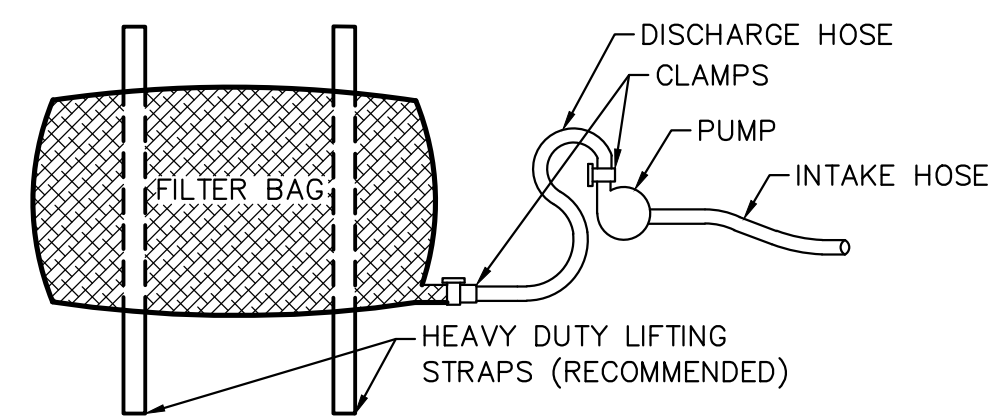
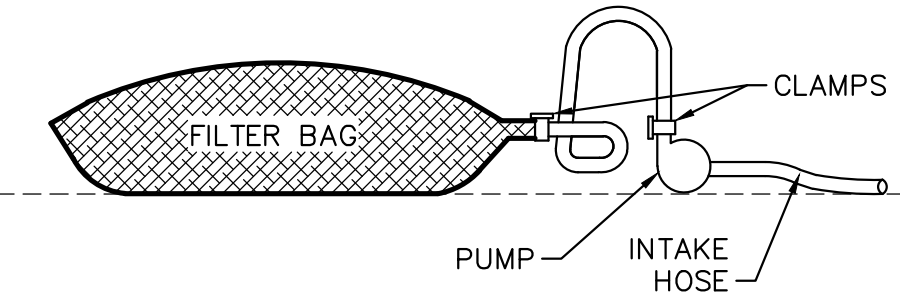
FILTER BAG DETAIL USE IN HAY BALE DISCHARGE STRUCTURE
NOT TO SCALE

NOTE:
LOW VOLUME FILTER BAGS SHALL BE MADE FROM NON-WOVEN GEOTEXTILE MATERIAL SEWN WITH HIGH STRENGTH, DOUBLE STITCHED "J" TYPE SEAMS. THEY SHALL BE CAPABLE OF TRAPPING PARTICLES LARGER THAN 150 MICRONS. HIGH VOLUME FILTER BAGS SHALL BE MADE FROM WOVEN GEOTEXTILES THAT MEET THE FOLLOWING STANDARDS:

Due to the existing saturated ground conditions, a significant volume of produced groundwater will fill all the excavations during the open cut process. These water volumes can be pumped to a discharge filtration structure; however, the current feasible filtration ability does not exceed 50 microns, therefore, cloudy water (from suspended fine clay and silt particles) would be discharged to the watershed regardless of all control methods employed for the entire duration of this crossing until completion.

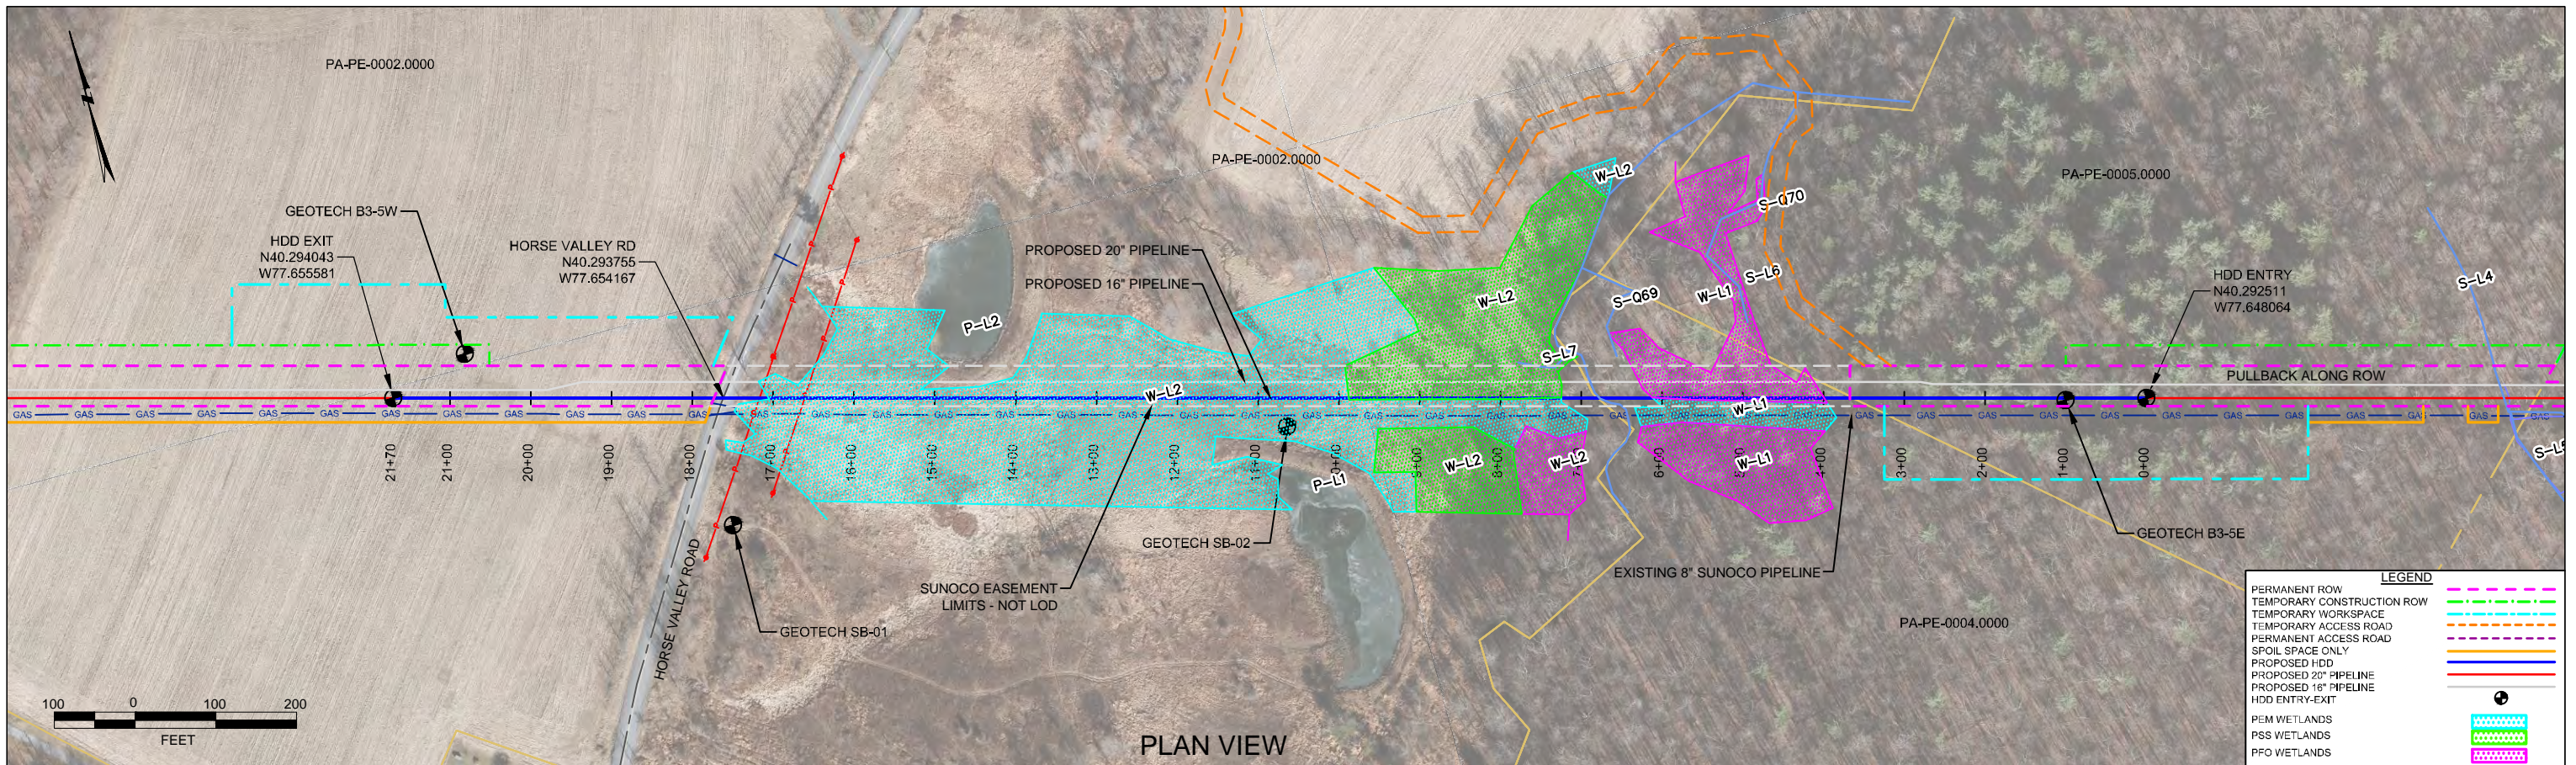
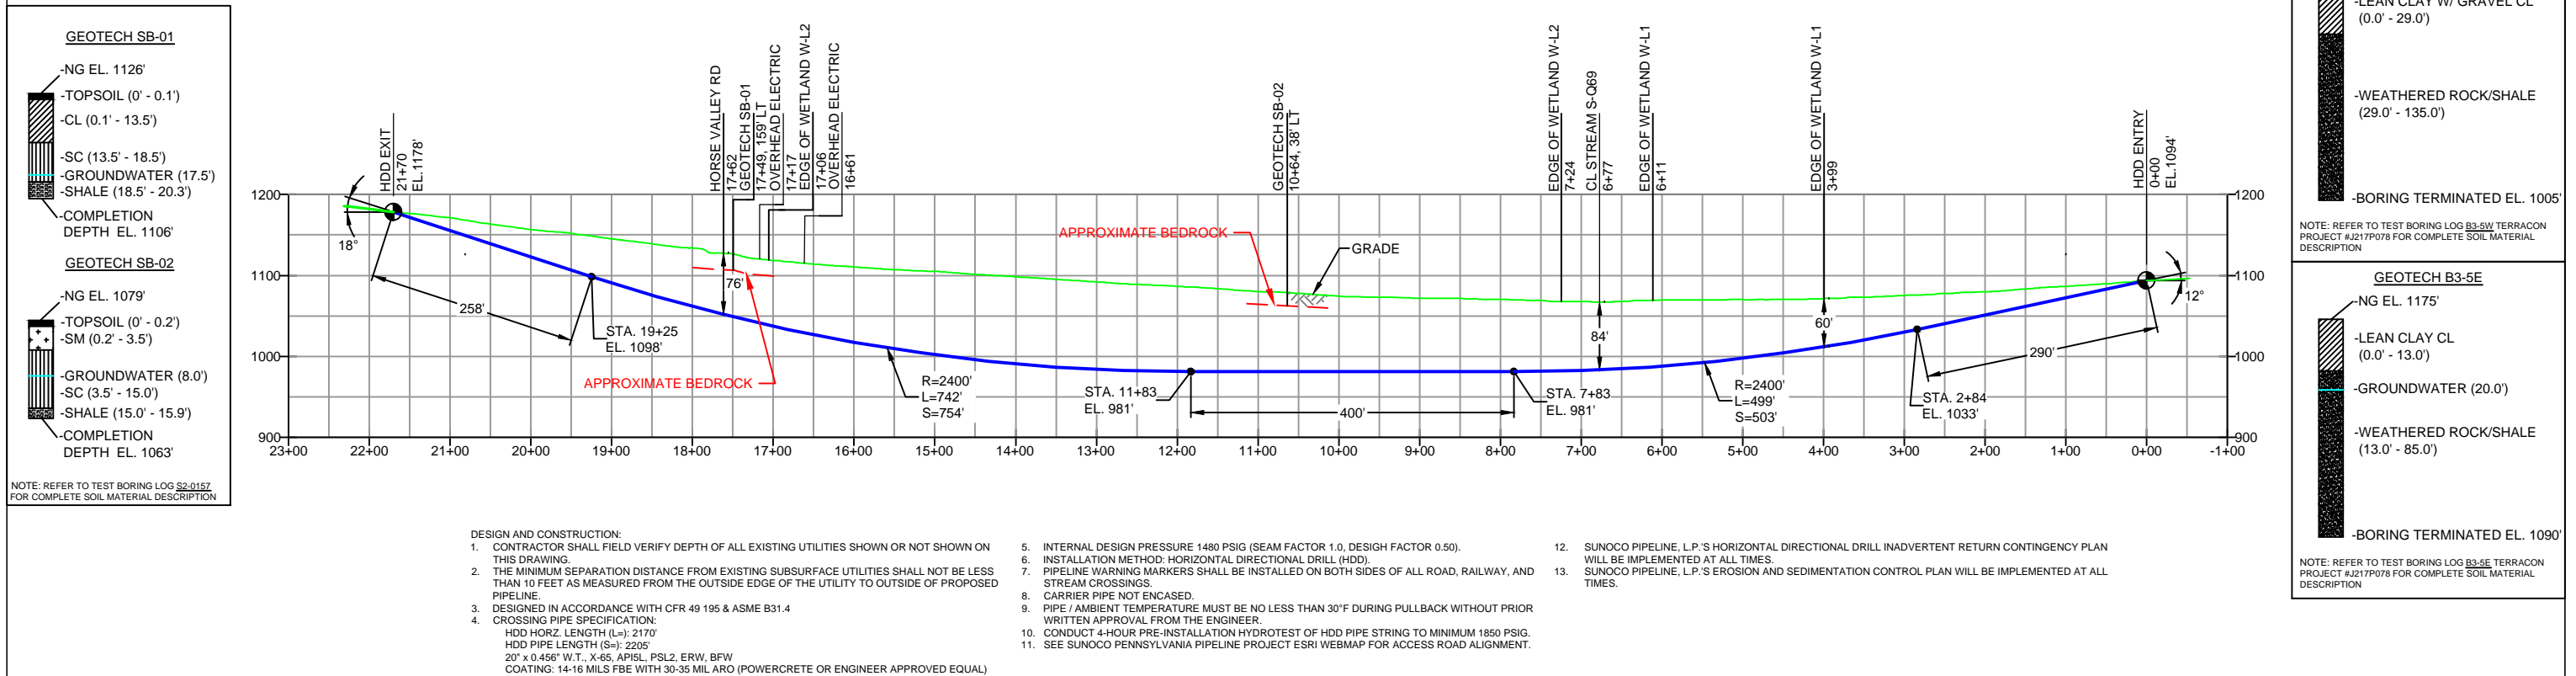
SCALE: 1"=200' DWG. NUMBER: PA-PE-0002.0000-RD

- GEOTECH SB-01**
- NG EL. 1126'
 - TOPSOIL (0' - 0.1')
 - CL (0.1' - 13.5')
 - SC (13.5' - 18.5')
 - GROUNDWATER (17.5')
 - SHALE (18.5' - 20.3')
 - COMPLETION DEPTH EL. 1106'
- GEOTECH SB-02**
- NG EL. 1079'
 - TOPSOIL (0' - 0.2')
 - SM (0.2' - 3.5')
 - GROUNDWATER (8.0')
 - SC (3.5' - 15.0')
 - SHALE (15.0' - 15.9')
 - COMPLETION DEPTH EL. 1063'
- NOTE: REFER TO TEST BORING LOG S2-0157 FOR COMPLETE SOIL MATERIAL DESCRIPTION

The originally proposed 16-inch and 20-inch HDD profiles were relatively shallow at the entry and exit points, and passed through both the unconsolidated overburden and fractured bedrock. Based on the hydro-structural characteristics of the underlying geology described in this report and the proposed HDD profiles, the Horse Valley Road HDD site is susceptible to the inadvertent return of drilling fluids during HDD operations. As a result, the HDD profile has been redesigned to allow for deeper crossings beneath the wetland complex and stream. The inclination of the entry and exit angles has been increased to allow the pipe to be installed through the protective soils, residual soils, and bedrock in closer proximity to the entry and exit points than the original, shorter and shallower profile.
