Re: Reevaluation Report
Horse Valley Road Horizontal Directional Drill Locations (S2-0157)
Permit No. E50-258
Toboyne Township, Perry County

Sunoco Pipeline, L.P.
Horse Valley Road HDD Location

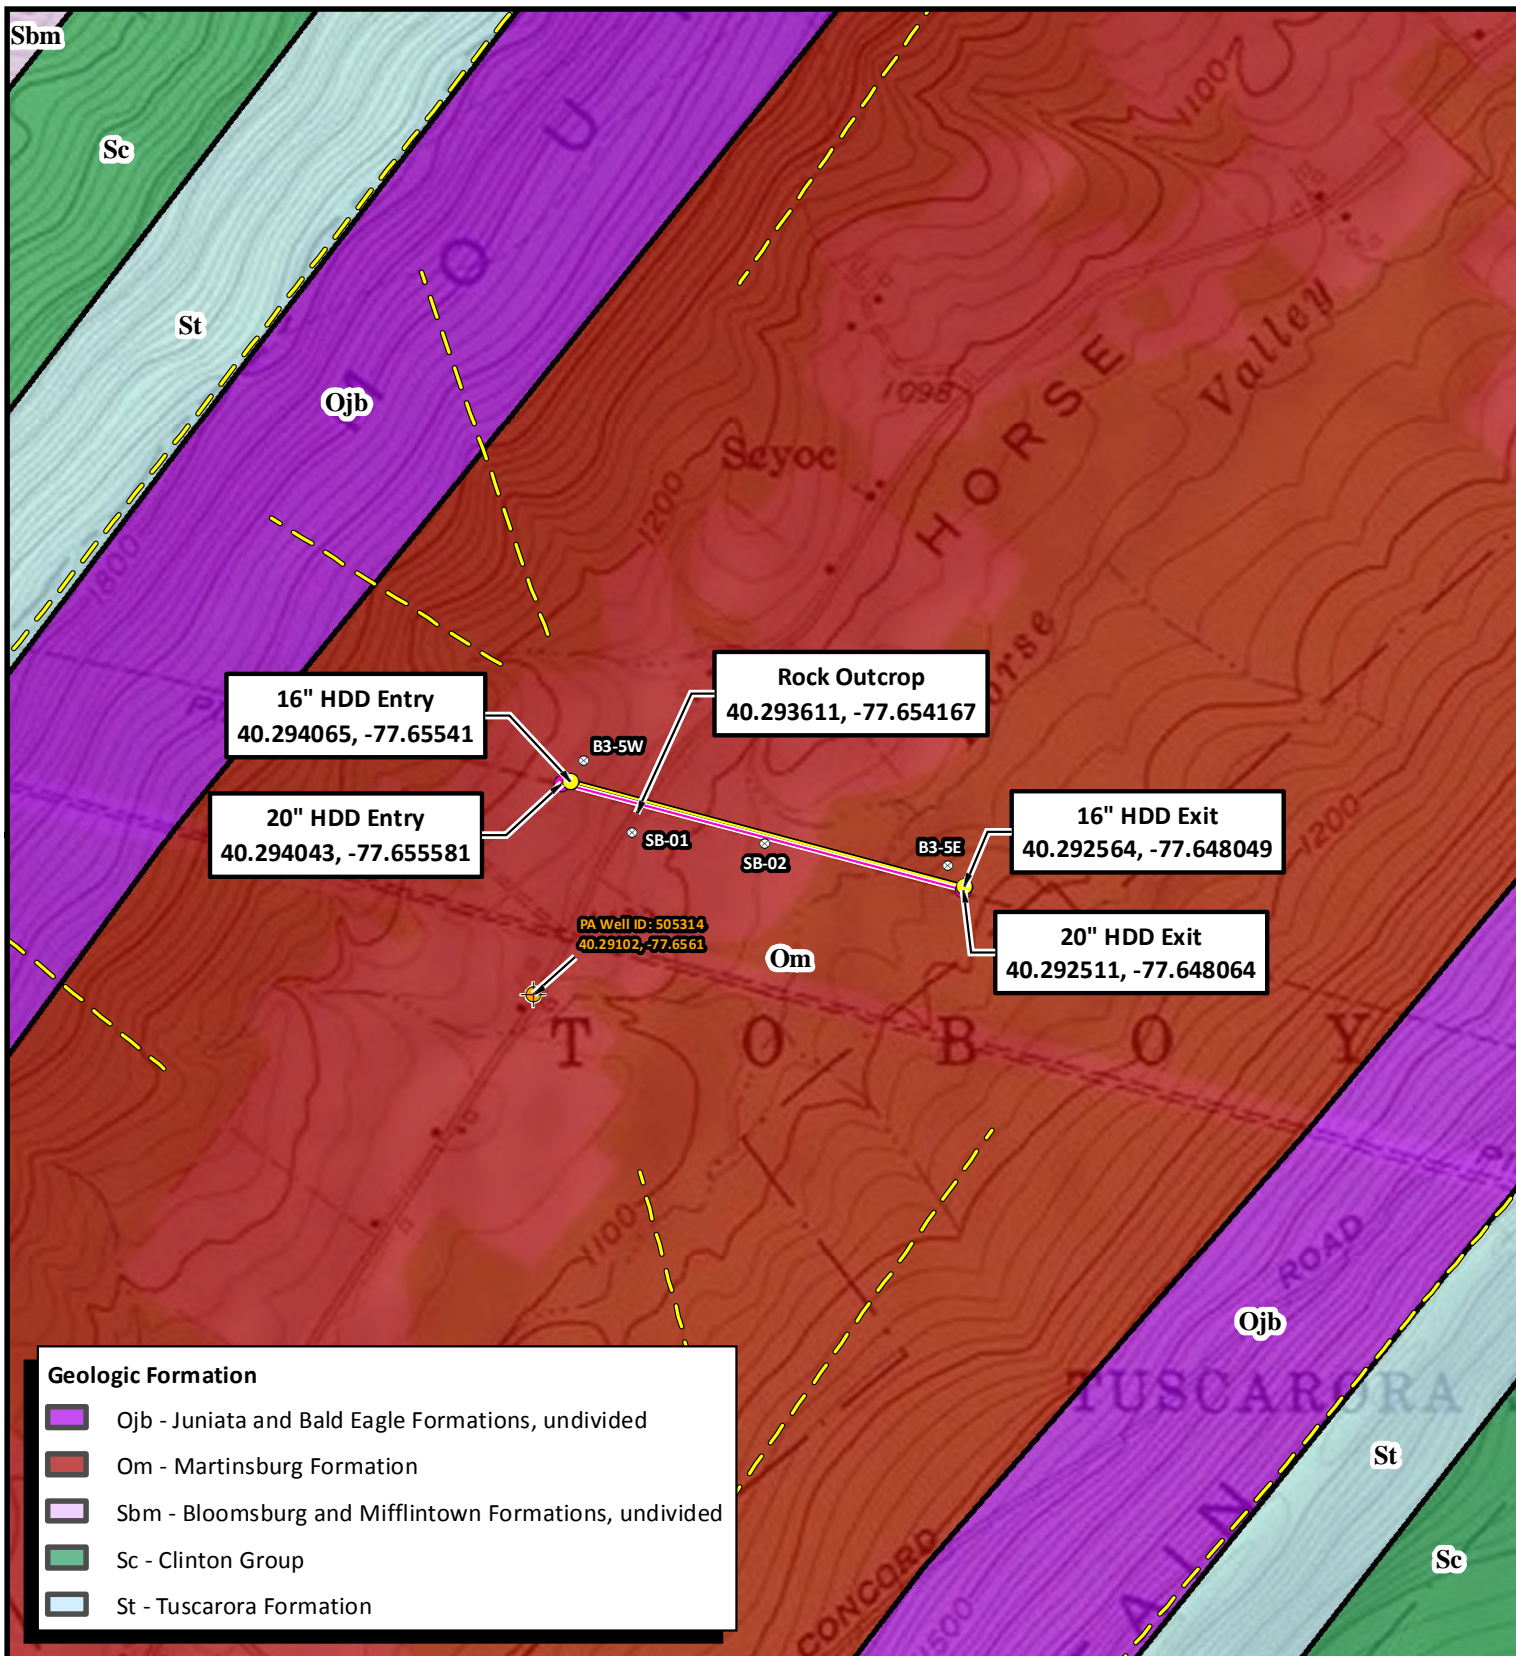
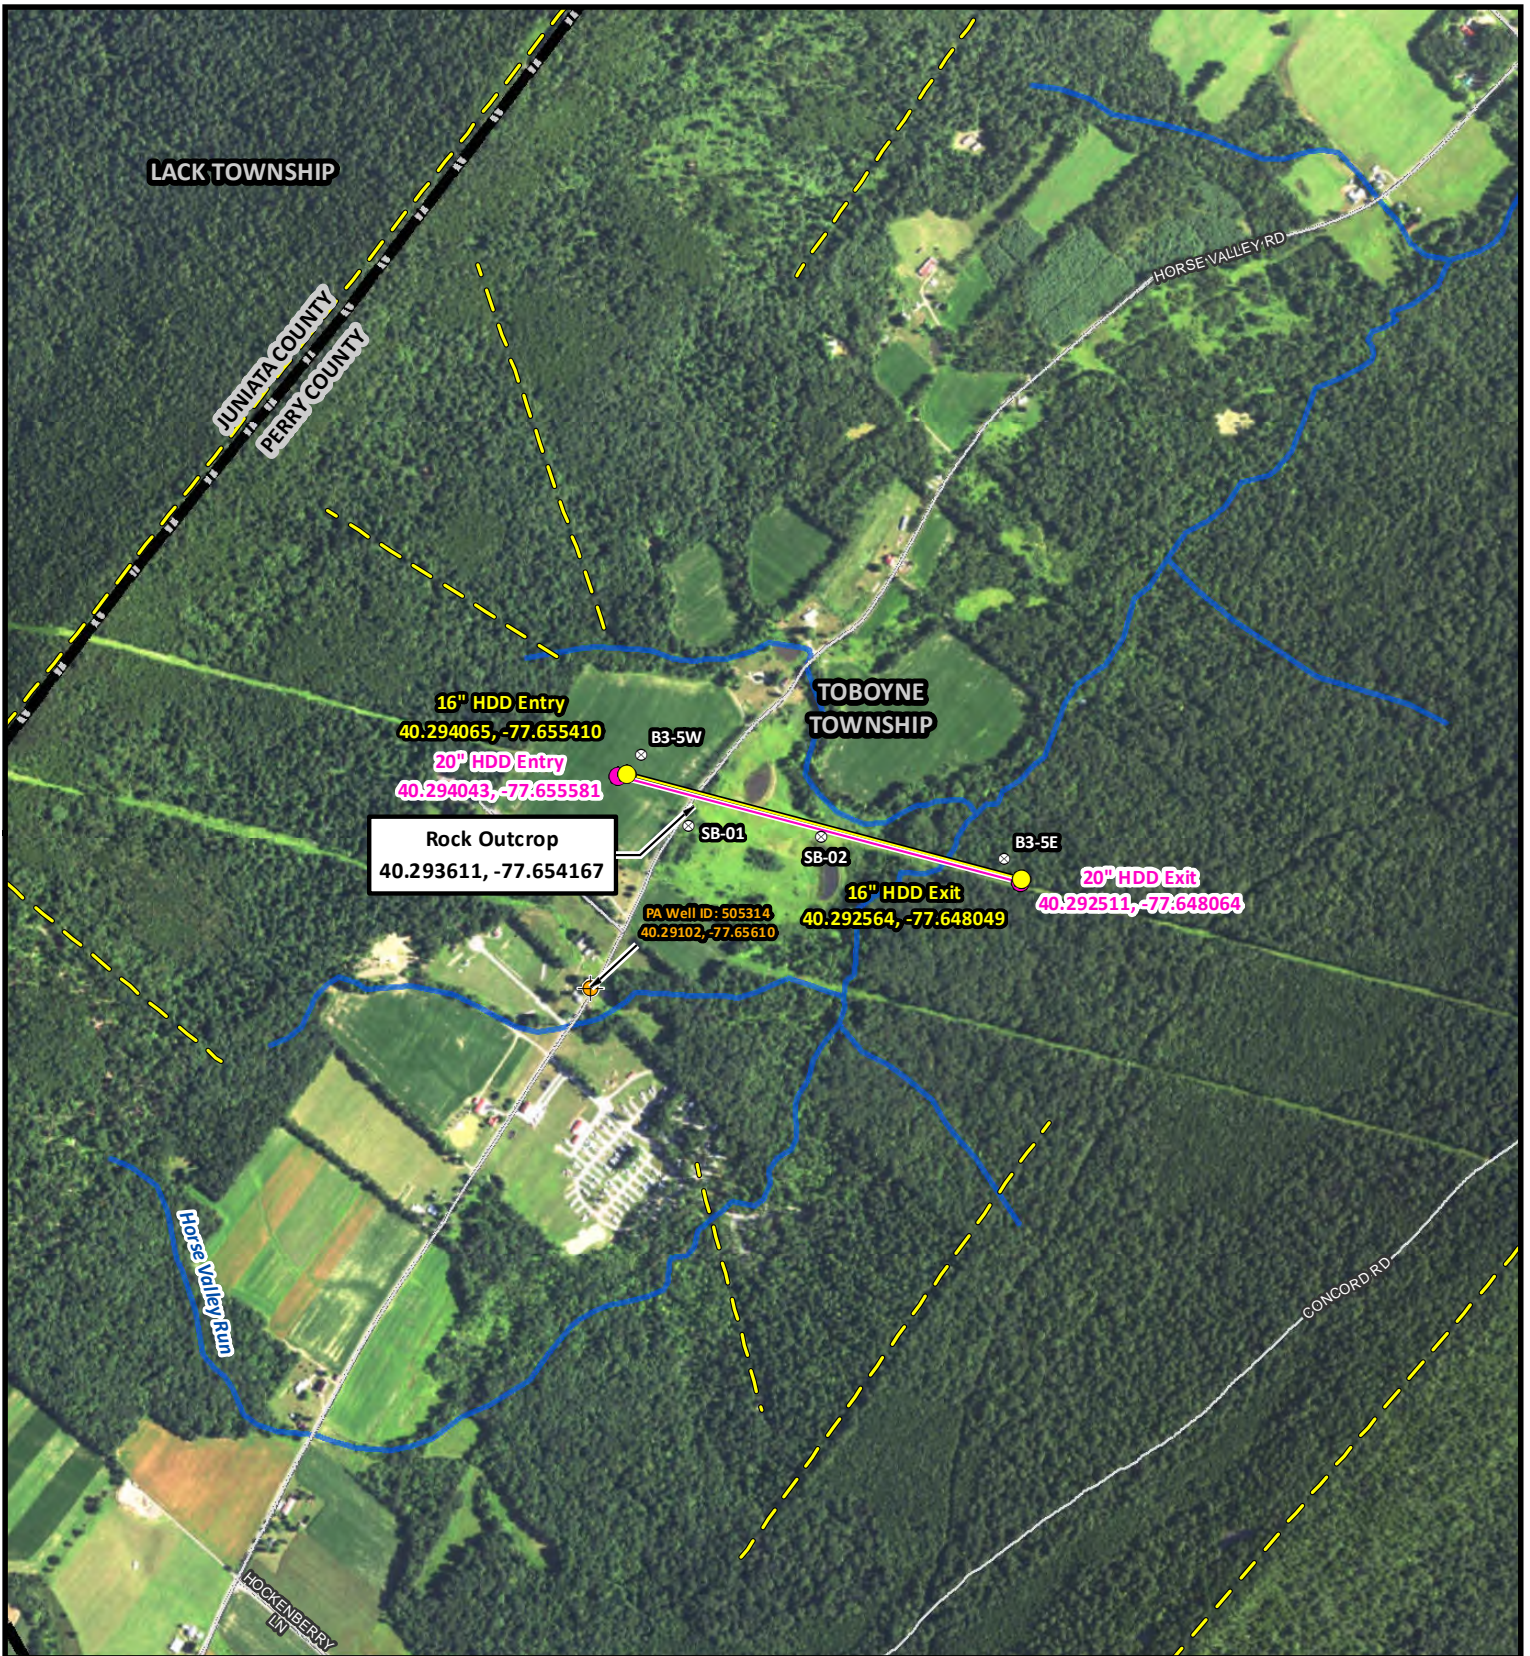
Figures 2 and 3 show the results of the fracture trace analysis overlain on the geologic map of the site and an aerial basemap. Eight fracture traces were identified within close proximity to the Horse Valley Road HDD that are likely related to the primary geologic structure. Four of the fracture traces trend approximately northeast-southwest (NE-SW), parallel to geologic strike. Four perpendicular fracture traces trend northwest-southeast (NW-SE) and may represent joint sets. Due to the nature of the ridges and folded geology near the site, the bedding-parallel fracture traces trend approximately NE-SW. Bedding-perpendicular fracture traces were identified in the approximately NW-SE fracture lineaments which are presumed to be stress-related joint sets. General surface drainage patterns near the site are characterized by linear stream reaches trending NE-SW or NW-SE that reflect the general geologic structure.

Fracture traces underlying, or in close proximity to, the site were evaluated using historical aerial photographs from the years 1995 through 2015 (Google Earth, 2017) and the Blairs Mills, Pennsylvania Geologic Quadrangle Maps from Atlas 61 (Berg and Dodge, 1981 and Royer, 1984). The photographs, publications and maps were reviewed to approximate the locations of natural linear fracture trace features or lineaments expressed on the ground surface. The linear features may be the surficial representation of deeper high angle fractures, joints, faults or bedding planes within the subsurface which can transmit groundwater through the fractured bedrock aquifer at the site.

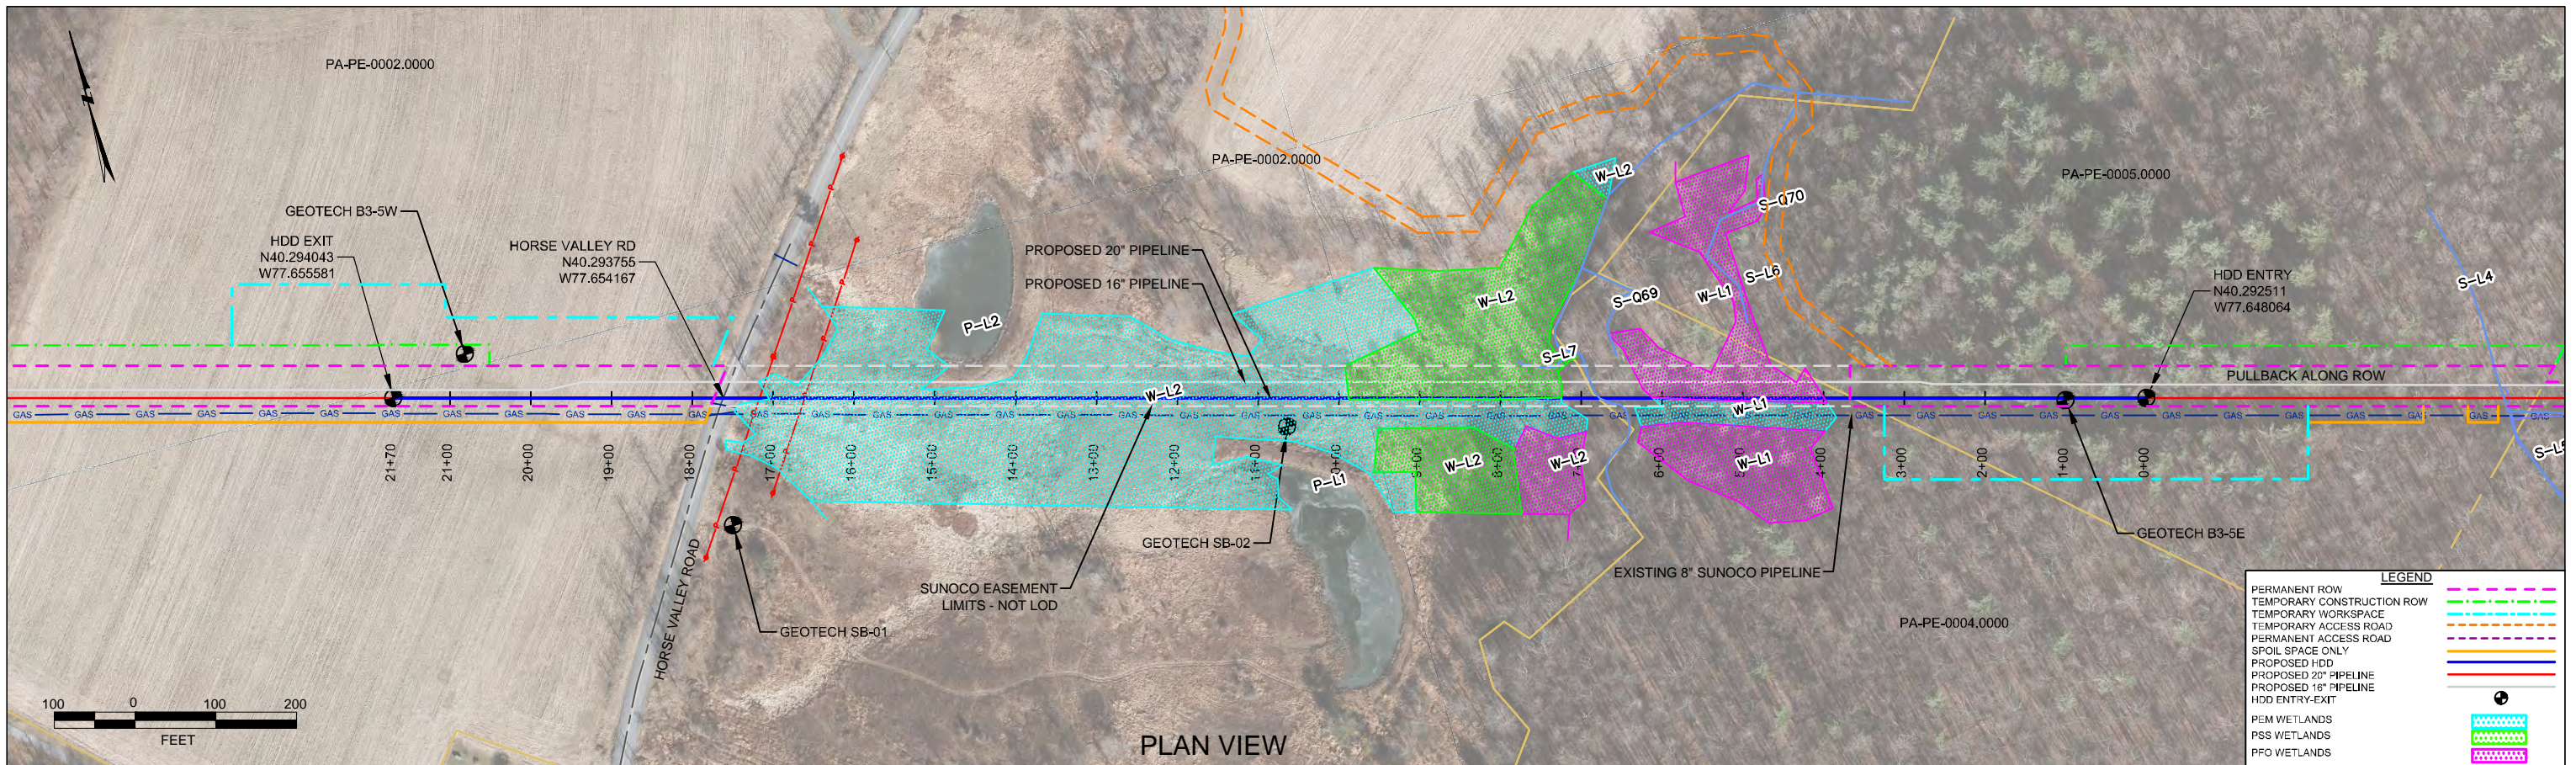
SCALE: 1"=200' DWG. NUMBER: PA-PE-0002.0000-RD

GEOTECH B3-5W

- NG EL. 1140'
- LEAN CLAY W/ GRAVEL CL (0.0' - 29.0')
- WEATHERED ROCK/SHALE (29.0' - 135.0')
- BORING TERMINATED EL. 1005'

- **Boring B3-5W:** B3-5W was completed to a depth of 135.0 feet bgs. From 29.0 feet to 45.0 feet bgs, severely weathered and fractured SHALE was encountered. From 45.0 feet to 115.0 feet bgs, slightly to severely weathered SHALE was observed. In this interval, joints are described as horizontal to vertical with close to moderately close spacing with some calcite infilling. From 115.0 feet to 135.0 feet bgs, fresh to slightly weathered SHALE with high angle to vertical bedding. Joints are described as low angle to vertical and close to moderately spaced with some calcite infilling. RQDs were very poor to excellent (0% to 90%). The highest RQDs were observed from 110.0 feet to 120.0 feet bgs. Recoveries were fair to excellent (32 inches to 60 inches) and generally increase with depth. Full recoveries (60 inches) were obtained from 85.0 feet to 135.0 feet bgs. Groundwater was not observed in this boring.

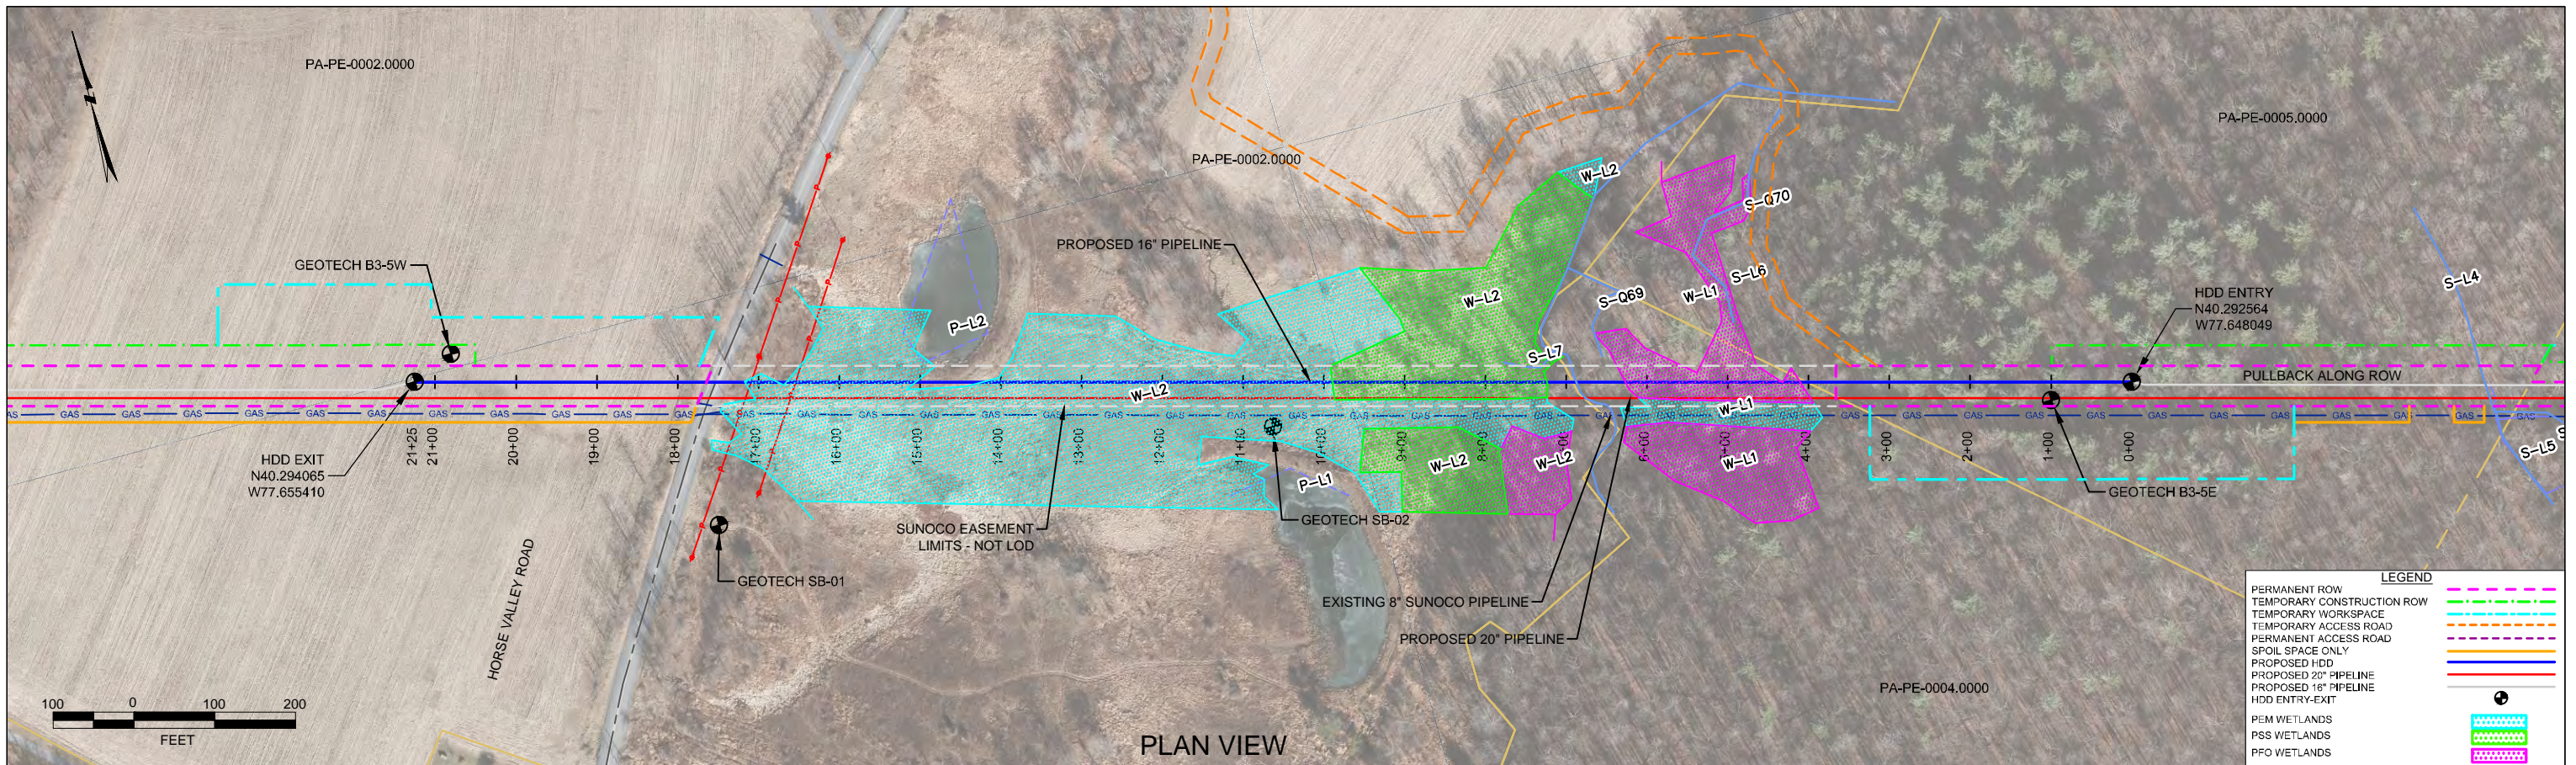
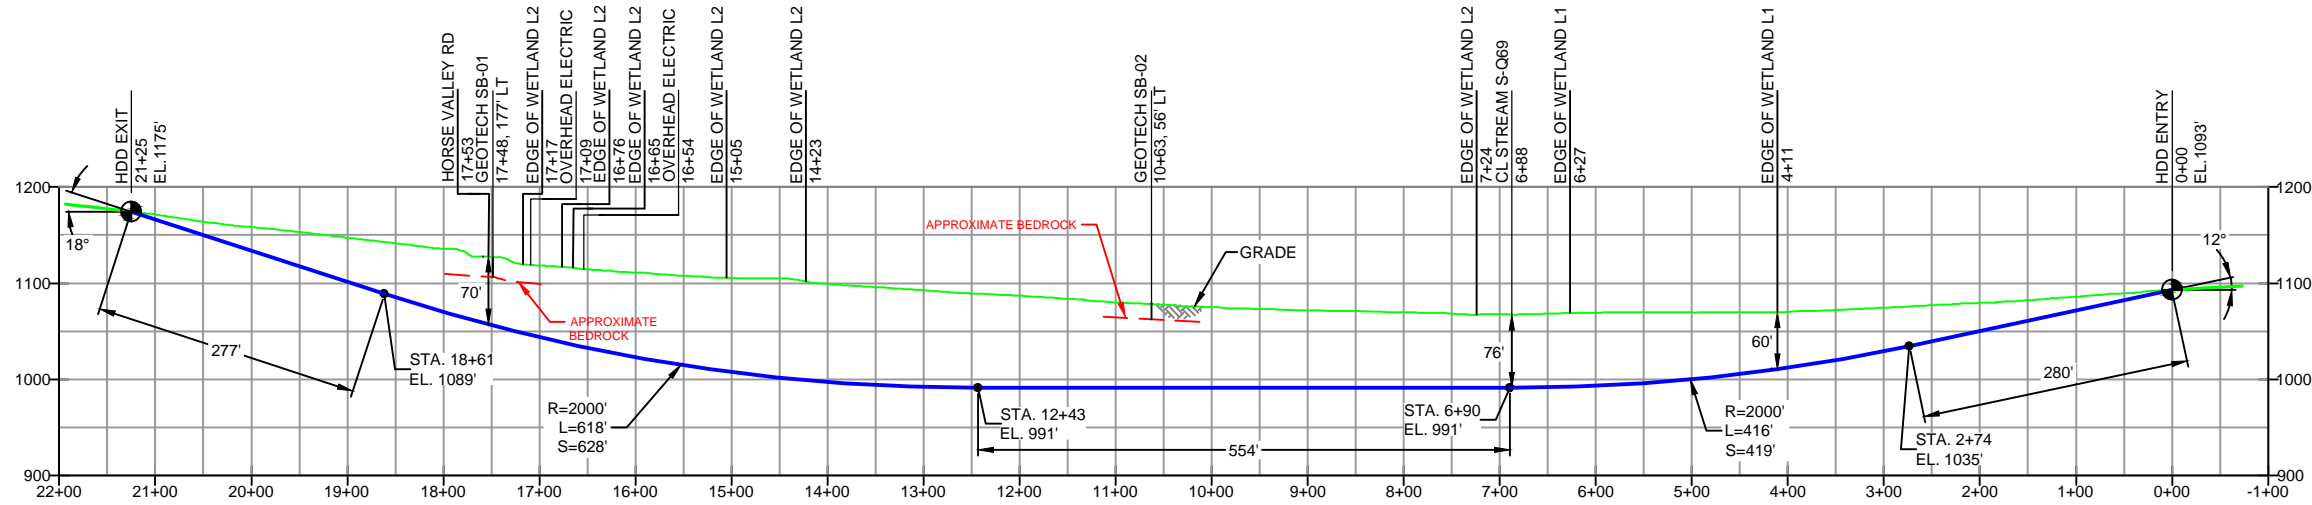
SCALE: 1"=200' DWG. NO. PA-PE-0002.0000-RD-16

- DESIGNED IN ACCORDANCE WITH CFR 49 195 & ASME B31.4
 - CROSSING PIPE SPECIFICATION:
HDD HORZ. LENGTH (L=): 2125'
HDD PIPE LENGTH (S=): 2158'
16" x 0.438" W.T., X-70, API5L PSL2, ERW, BFW
COATING: 14-16 MILS FBE WITH 30-35 MIL ARO (POWERCRETE OR ENGINEER APPROVED EQUAL)

The originally proposed 16-inch and 20-inch HDD profiles were relatively shallow at the entry and exit points, and passed through both the unconsolidated overburden and fractured bedrock. Based on the hydro-structural characteristics of the underlying geology described in this report and the proposed HDD profiles, the Horse Valley Road HDD site is susceptible to the inadvertent return of drilling fluids during HDD operations. As a result, the HDD profile has been redesigned to allow for deeper crossings beneath the wetland complex and stream. The inclination of the entry and exit angles has been increased to allow the pipe to be installed through the protective soils, residual soils, and bedrock in closer proximity to the entry and exit points than the original, shorter and shallower profile.

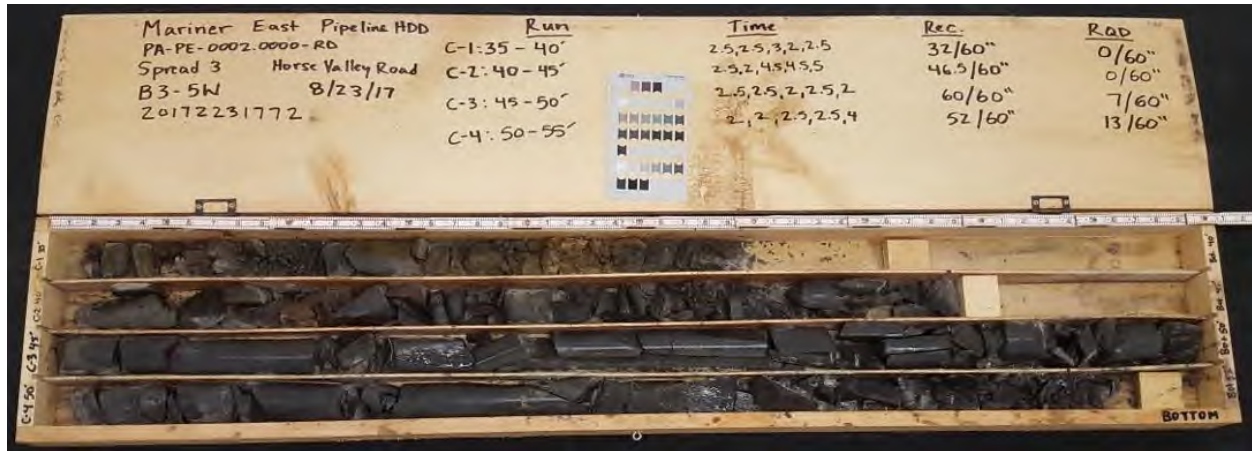
Photograph 1: B3-5W, Samples C-1 to C-4 (35 to 55 feet)

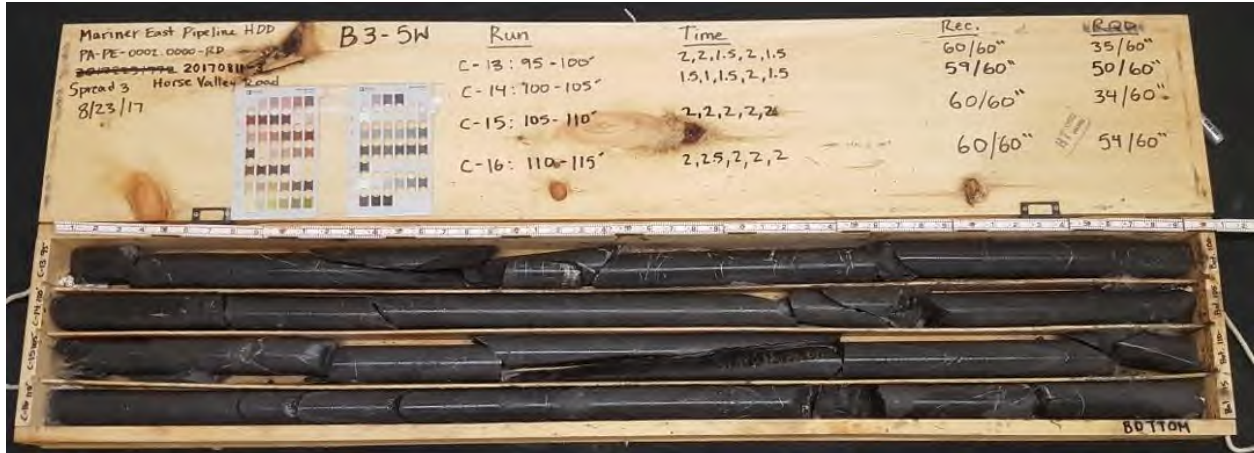
Photograph 4: B3-5W, Samples C-13 to C-16 (95 to 115 feet)

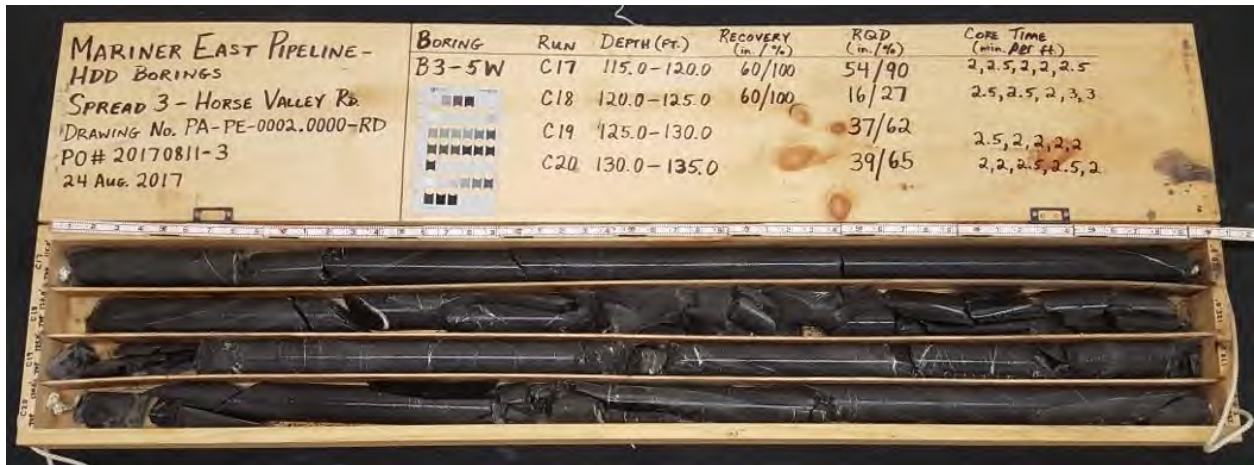
Photograph 5: B3-5W, Samples C-17 to C-20 (115 to 135 feet)

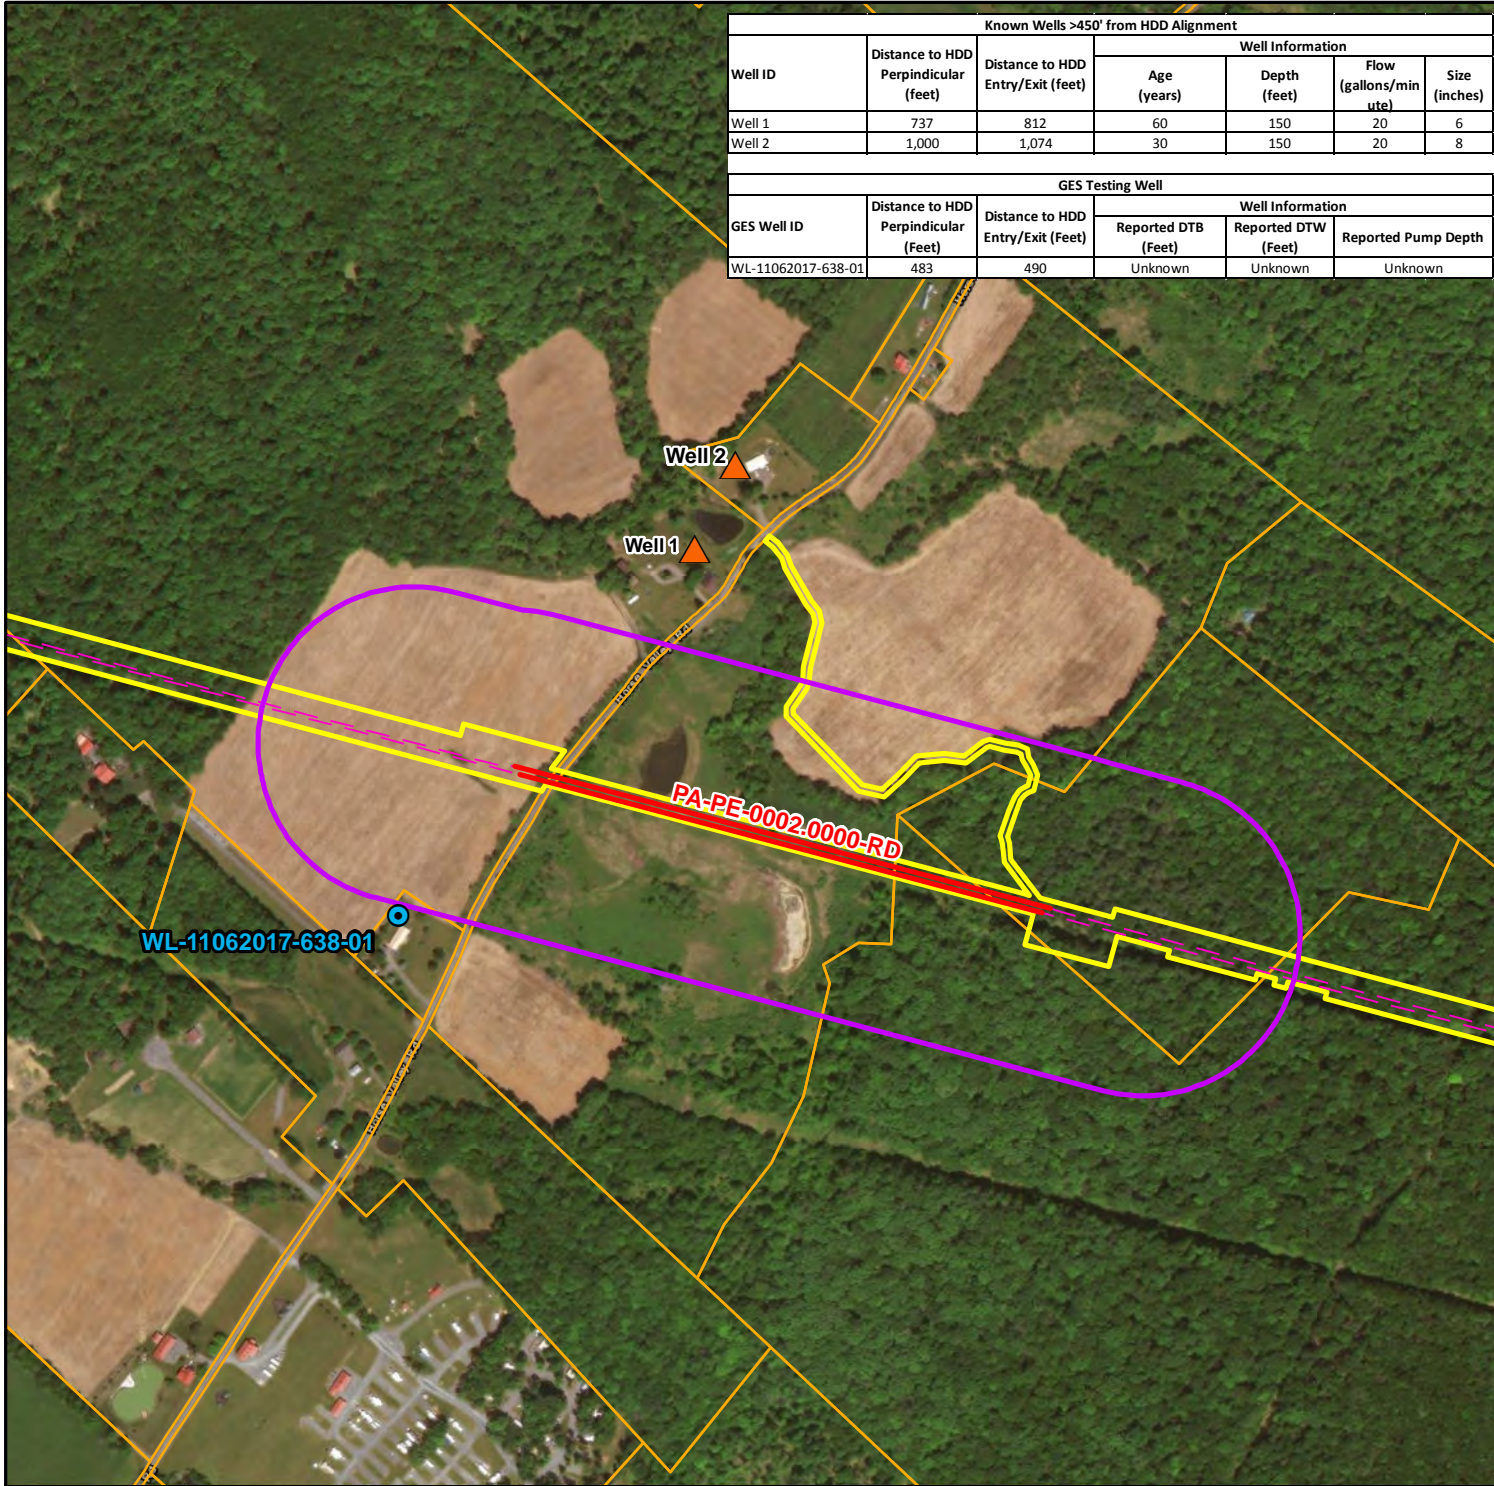
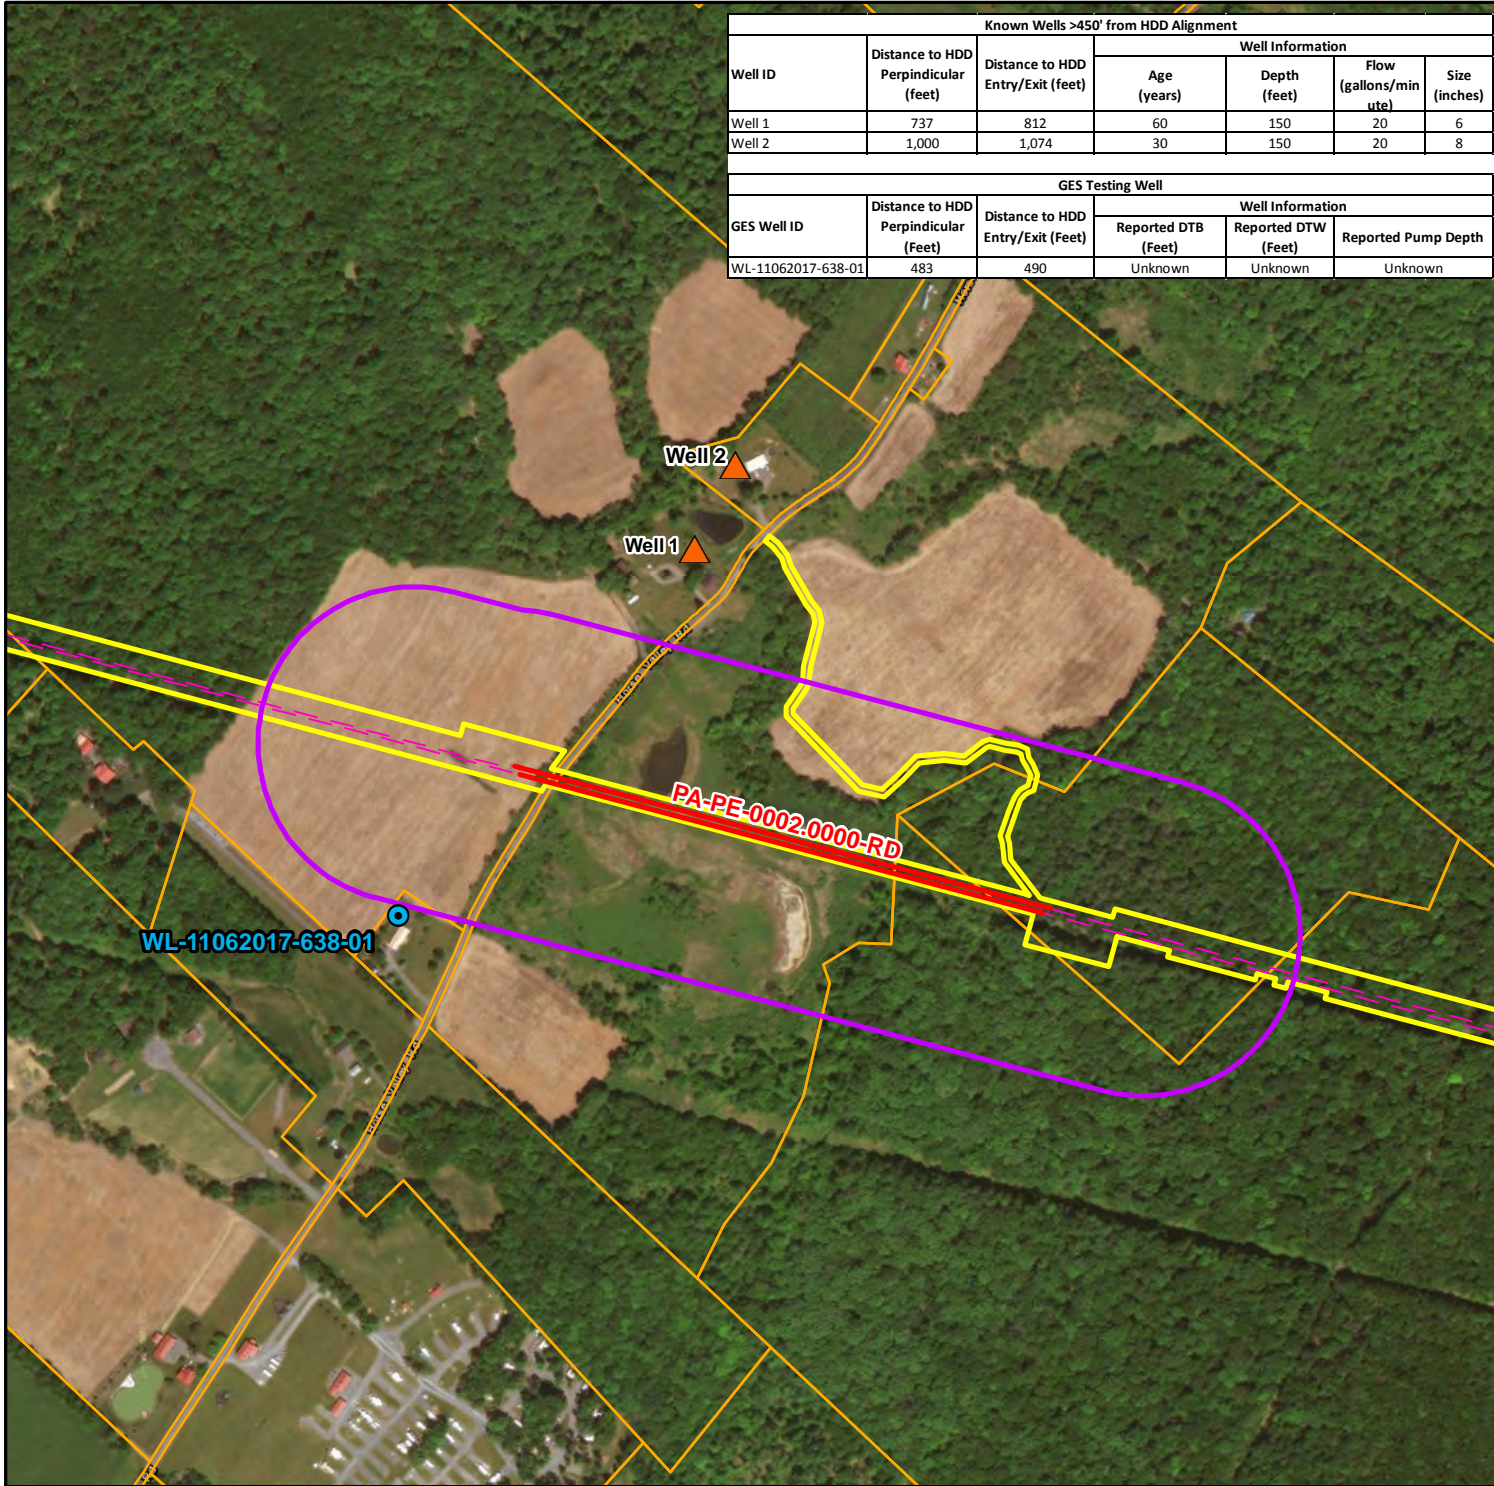
**ATTACHMENT 3
WATER SUPPLY ILLUSTRATION**

Known Wells >450' from HDD Alignment						
Well ID	Distance to HDD Perpendicular (feet)	Distance to HDD Entry/Exit (feet)	Well Information			
			Age (years)	Depth (feet)	Flow (gallons/minute)	Size (inches)
Well 1	737	812	60	150	20	6
Well 2	1,000	1,074	30	150	20	8

On January 2, 2018, agents for SPLP investigated the two occupied properties north of the HDD location. A non-public community water well was not observed at either location. Both locations, as shown on the water supply illustration, have private wells that serve single, residential home sites. Based upon the understanding of the groundwater levels and movement through the overburden and subsurface bedrock fissures and bedding plane partings as described in the hydrogeology report, SPLP believes that HDD activities could affect individual well use during active drilling for wells located within 150 linear ft. of the profile. Neither of these wells are within this zone of concern, and both are located upgradient and west of the valley floor; therefore, the source recharge for these wells would derive from groundwater movement from higher elevations to the west, not from the direction of the HDD profile where is crossed the valley floor.

As a condition of the corrected stipulated order, other Sunoco subcontractors have researched private water supplies located within 450 feet of the Horse Valley HDD. No private wells were identified within 450 feet of the Horse Valley HDD; however, one well was identified approximately 483 feet south of the HDD exit as shown on the figure in **Attachment 3**. Well construction details were not available.
