**Re: PA DEP Old Mill Rd. HDD Re-Evaluation Report –
Request for Additional Information
Old Mill Rd. 16-Inch Horizontal Directional Drill (S2-0156-16)
Permit No. E34-136
Lack Township, Juniata County**

RE: Geophysical Survey
Sunoco Pipeline, L.P. Pipeline Project
Horizontal Directional Drill S2-0156 Old Mill Road
PA-JU-0004.0000-WX
Lack Township, Juniata County, Pennsylvania
RETTEW Project No. 096302008

RETTEW Associates, Inc. completed a multi-technique geophysical survey at the S2-0156 Old Mill Road horizontal directional drill (HDD) site. The purpose of the survey was to detect and delineate subsurface fracture zones that could contribute to potential inadvertent returns (IRs) and/or a loss of circulation, and to determine the rock profile and rock rippability for possible ease-of-excavation along the HDD path. The following report, figures, and attachments describe the methods and results of the investigation.

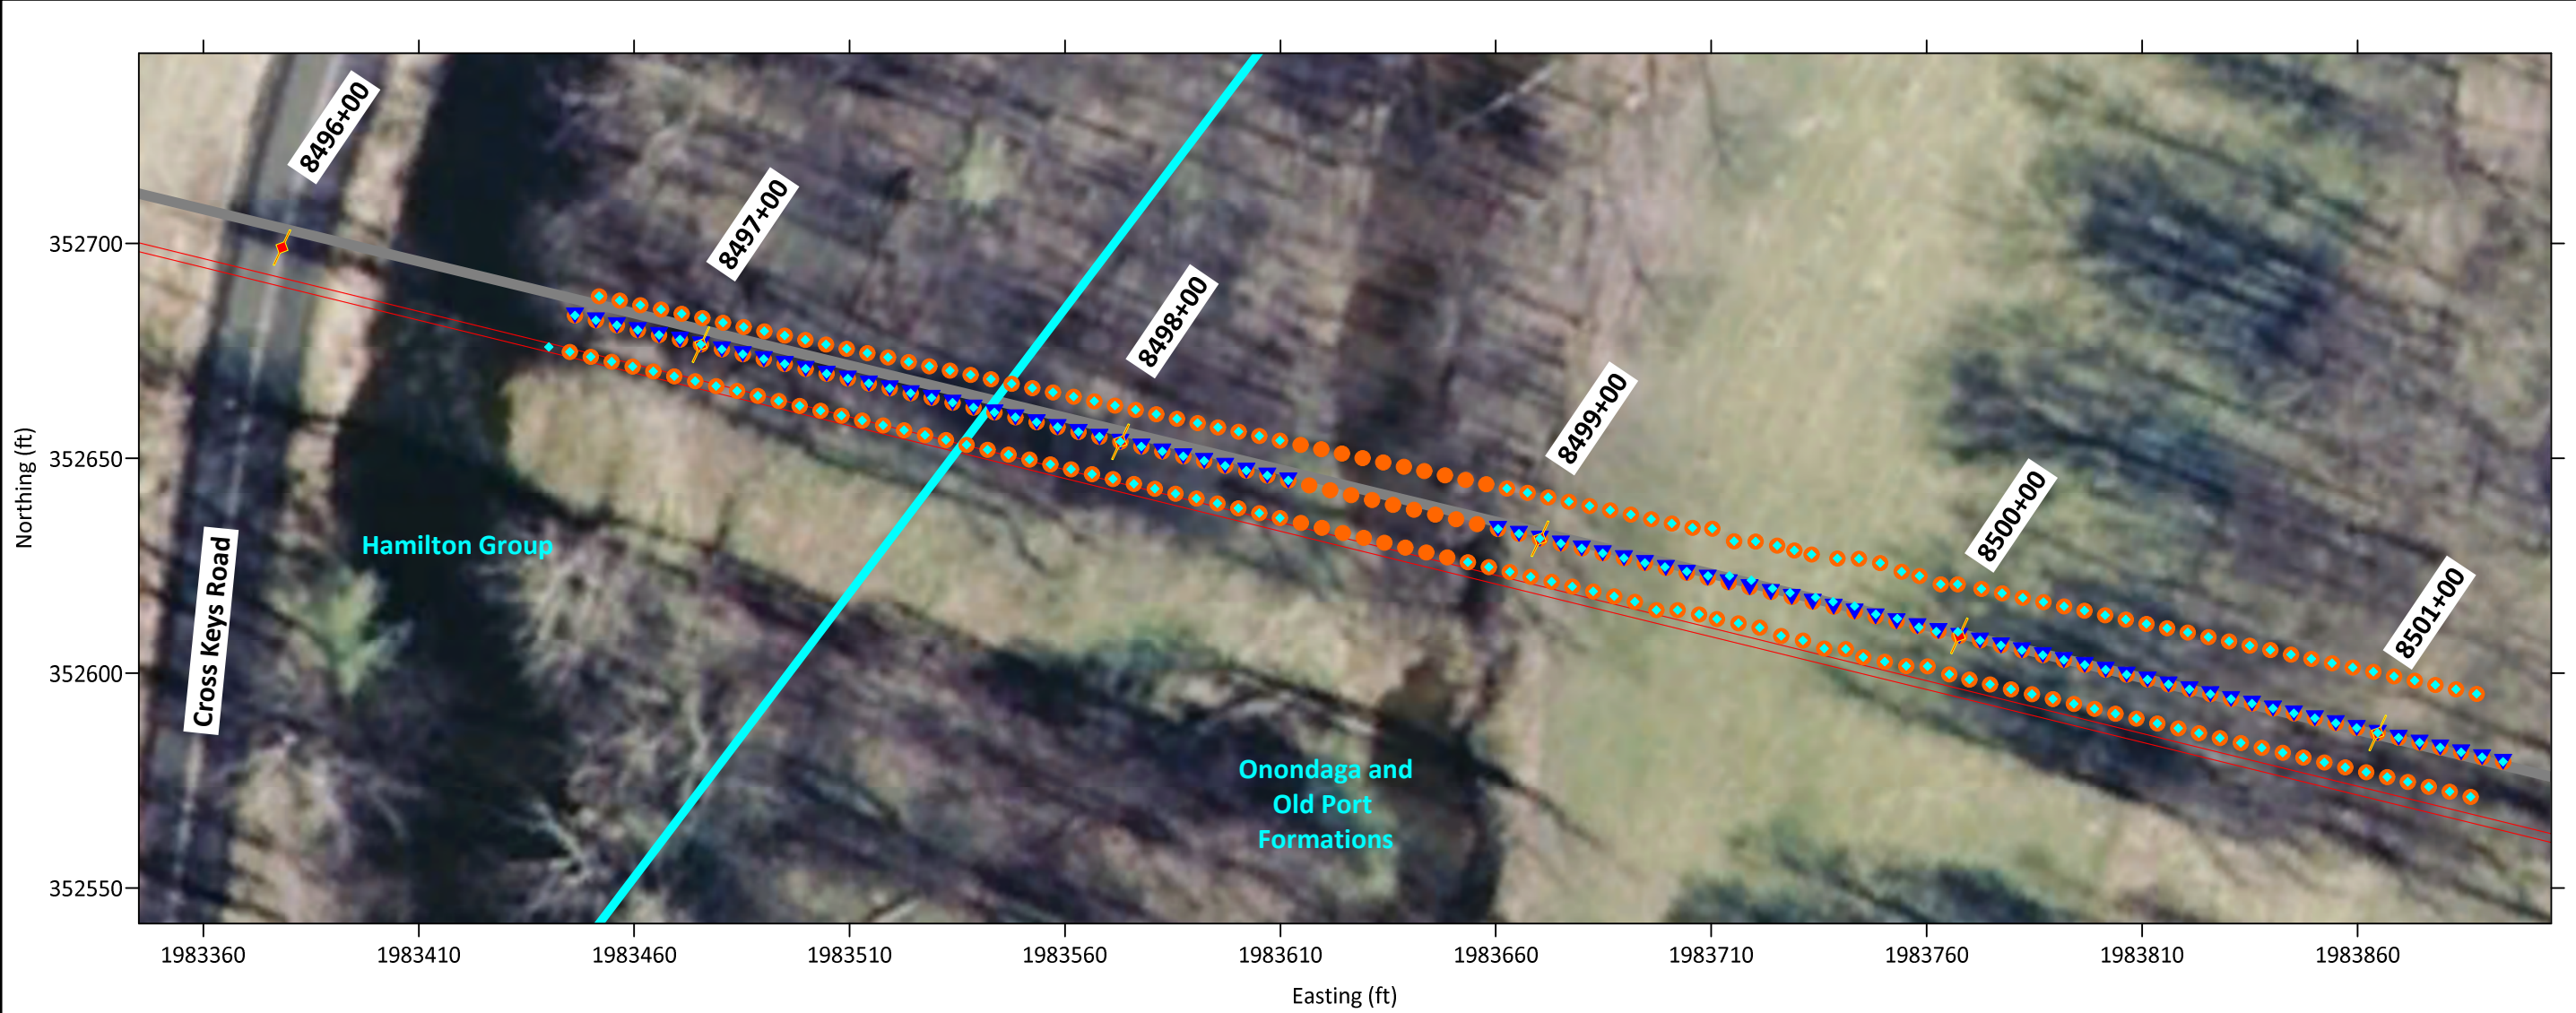
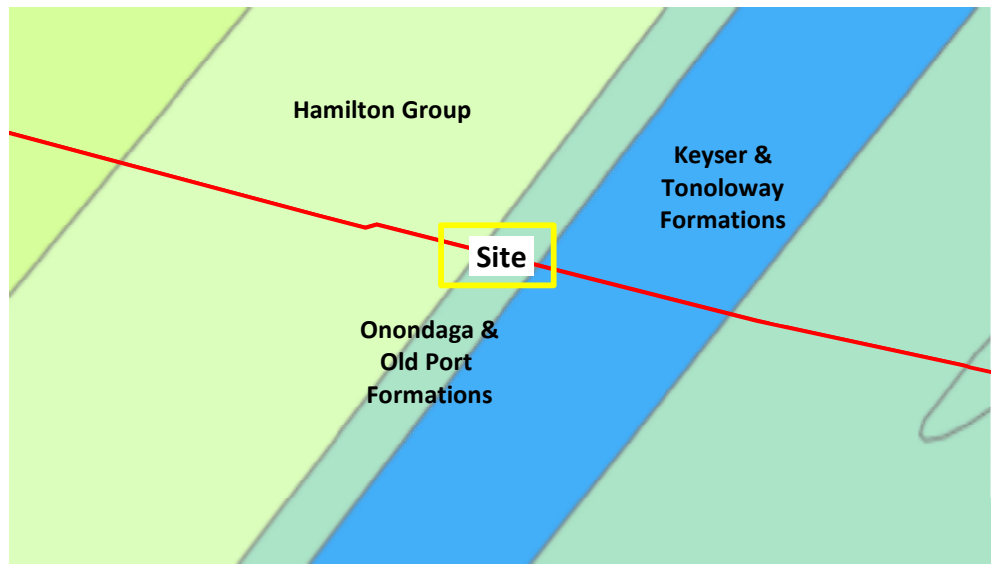
Figure 2: Data Coverage Map and Geologic Setting

accessible areas of the path between the HDD exit/entry locations (**Figure 2**). Site access was limited due to standing water as well as streams that cross the HDD profile.

The seismic survey consisted of one profile along the HDD center line, with a gap over standing water (see blue triangles, upper panel, **Figure 2**). Color-contour velocity models of the seismic profiles for the seismic refraction and MASW are presented on **Figure 4**. The vertical scale represents relative elevation in feet, and the horizontal axis represents an along-profile distance in feet. The color contours represent average seismic velocity variations; compressional or Primary (P-wave) velocities for refraction, and shear or secondary (S-wave) velocities for MASW. Increasing velocities grade from blue to yellow to orange to brown for refraction (upper cross section), and purple to grey to tan to brown for MASW (lower cross section). Please note that high- and low-velocity data along the first and last fifteen feet of any profile have higher uncertainty. Specific seismic refraction and MASW survey parameters are listed in **Appendix A**.

The resistivity survey consisted of three linear profiles centered on the HDD alignment (see orange dots, **Figure 2**). The apparent resistivity data were mathematically inverted using both EarthImager 2D by AGI to provide a cross-sectional image of each individual profile. **Figure 5** shows individual 2D profiles. The vertical scale represents relative elevation in feet, and the horizontal axis represents an along-profile distance in feet. The color contours represent average resistivity variations with increasing resistivity from purple, blue to green to yellow to orange to red. Specific ERI survey parameters are listed in **Appendix A**.

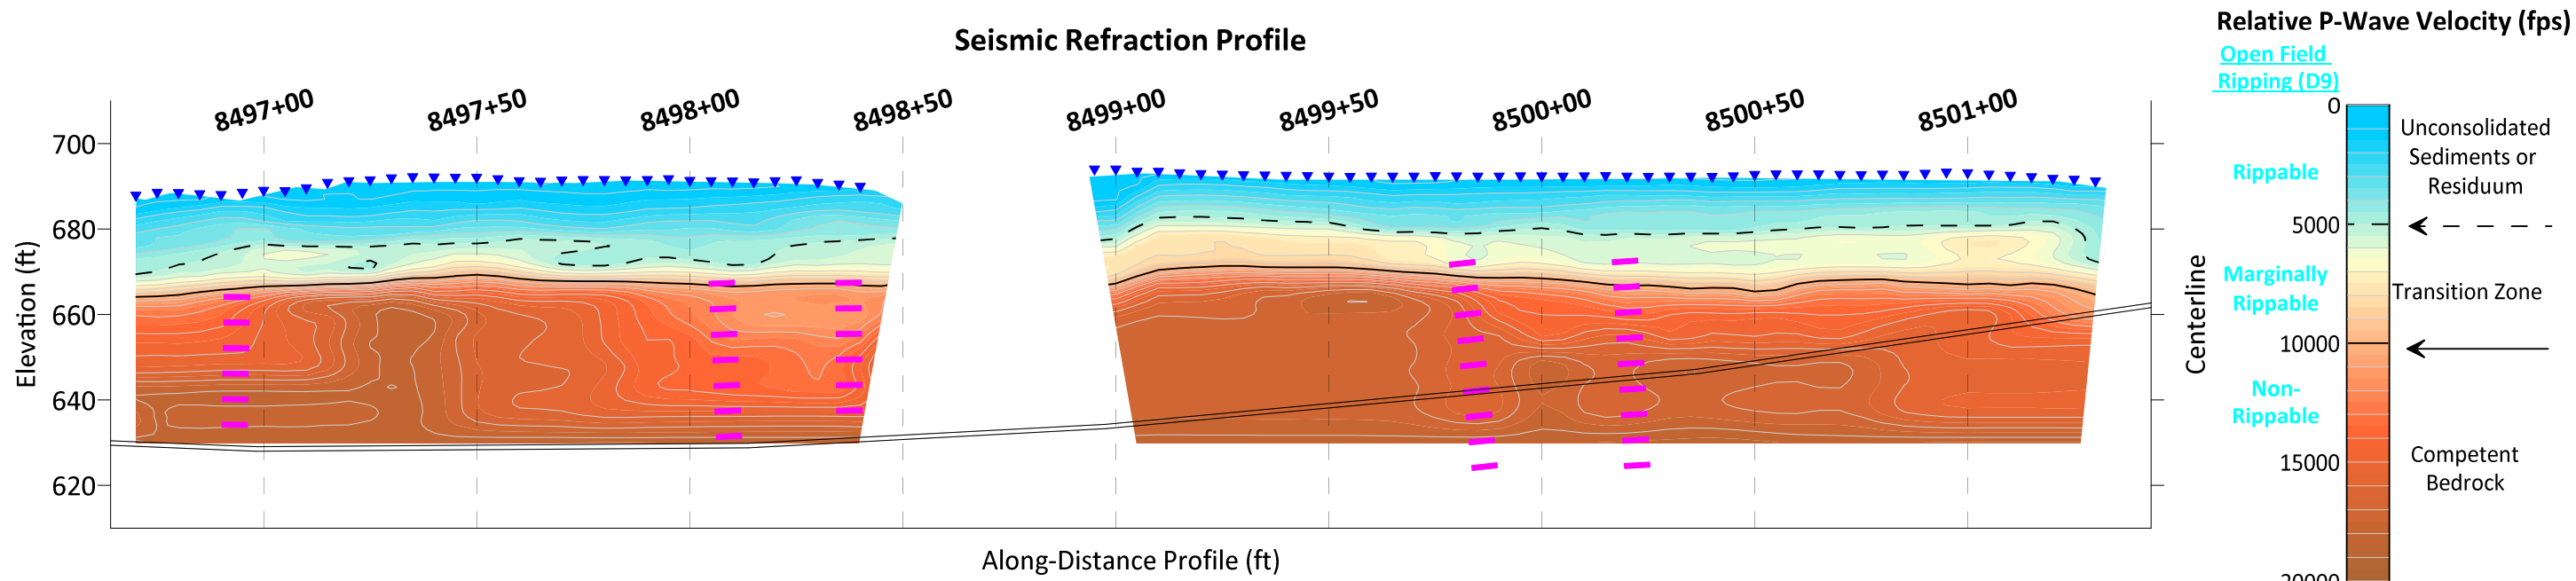
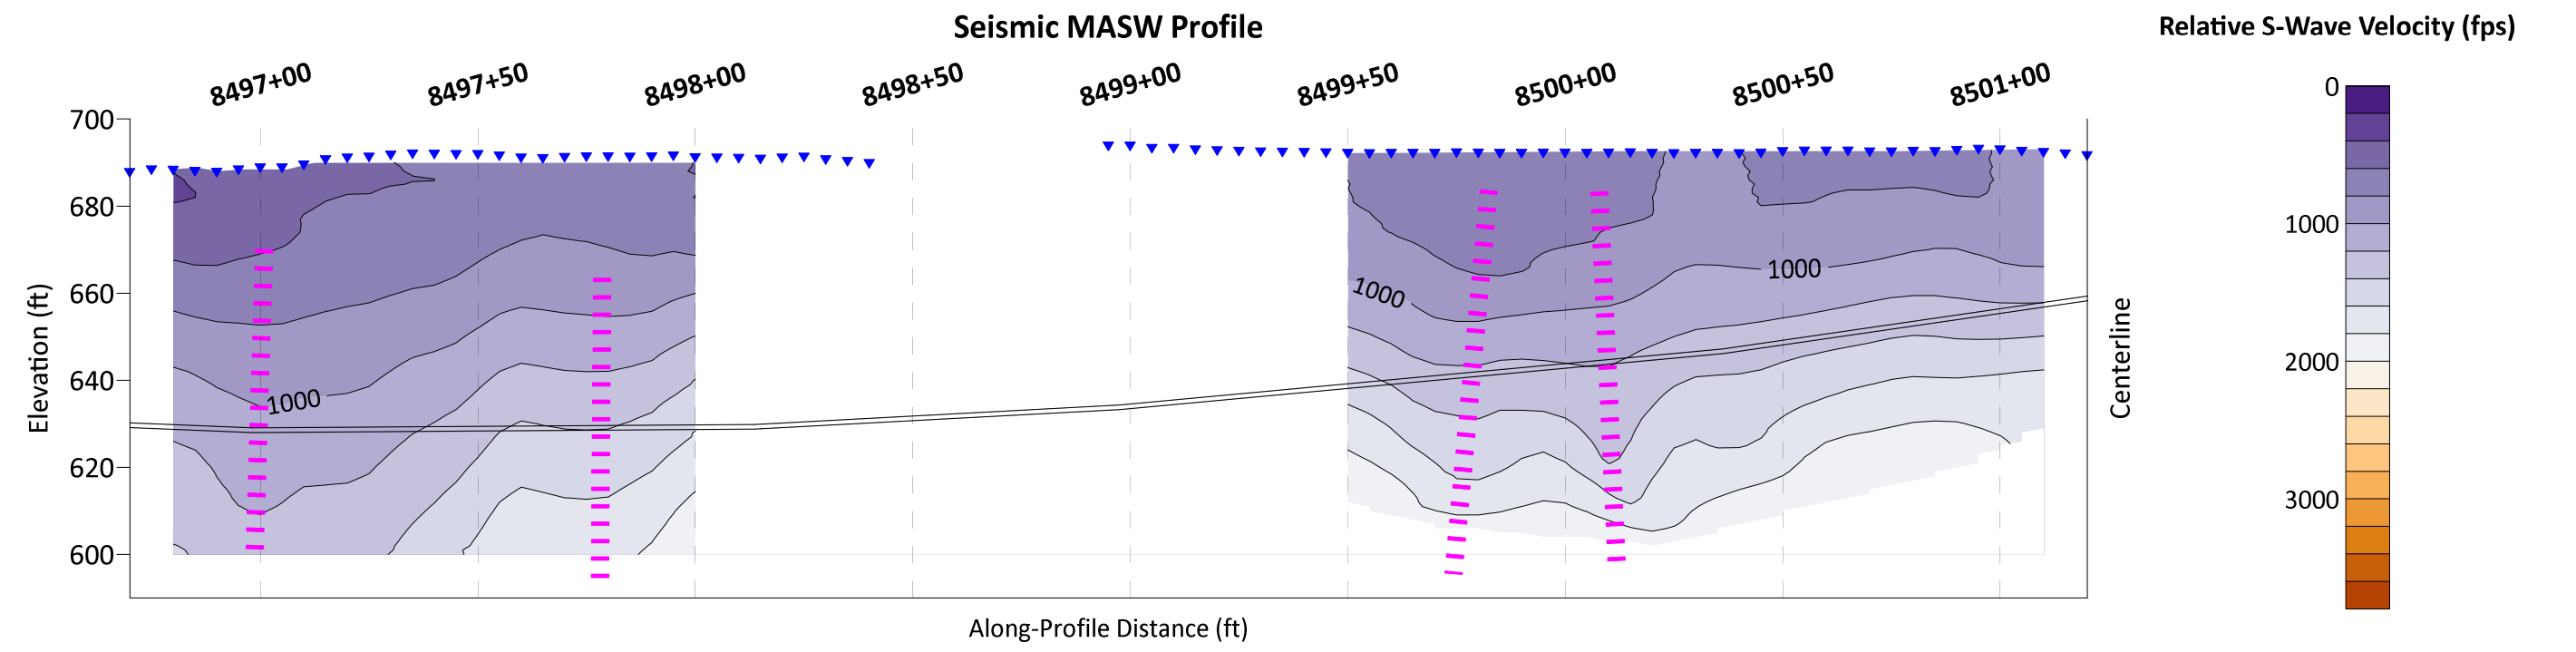
Figure 4: Seismic Survey Results

The seismic refraction data are presented as a cross-sectional profile on **Figure 4** (top panel). The data indicate a general three-layer stratigraphy consisting of a residual soil mantle, a transition (weathered) zone, and competent bedrock. The uppermost layer has average P-wave velocities generally less than 5,000 feet per second (fps) with a thickness of approximately 5-15 feet. This is consistent with a relatively compact residual clay soil mantle (shaded blue to yellow). The deepest layers have velocities over 10,000 fps (shaded orange to brown) consistent with competent bedrock (Carmichael, R. S., 1989). The zone between roughly the 5,000 and 10,000 fps contours is consistent with a saprolite (weathered bedrock), and is not really a “layer” in the stratigraphic sense. Instead, it contains material that is undergoing various degrees of weathering. This transition zone contains both competent rock, float material, and/or dipping lithologic layers that may stick-up or cut-across the smoothed contours and may impede excavation (see **Appendix B**).

The MASW seismic cross section is presented below the seismic refraction cross section (**Figure 4**, bottom panel). The MASW velocity model shows velocity changes within the bedrock layer across the profile. Velocity lows below the bedrock surface could indicate fracture features which might be potential pathways for IRs.

Seismic data from Geometrics 24-channel Geode with 4.0 Hz geophones.

Relative seismic velocity models from SeisImager (by Oyo Corporation) tomographic and ReMi inversions.

The seismic velocity models from the ray-tracing method (not shown) were compared to standard ripping charts (see **Appendix C**, Caterpillar, Inc., 1995) using the inferred/assumed layer compositions to determine the general rippability of each stratum. In general, the surficial layer down to about the top of

inferred epikarst (wavy dashed contour) should be readily to marginally rippable with a D9 multi- or single-shank ripper doing open field ripping, based on a weighted average velocity of about less than 5,000 fps. Below the 5,000-fps contour, ripping will get more difficult with depth, with the transition zone expected to become non-rippable below the 10,000-fps contour (based on the average ray-trace velocity of over 12,000 fps and Caterpillar charts). The 5,000-fps contour represents the top of the epikarst/weathered rock and not the actual surface which is often non-resolvable in karst terranes. For trenching (as opposed to open field ripping), material below approximately the 3500-fps contour color (greenish blue) may become non-rippable (for a CAT-330 tracked excavator or equivalent). The selection of the contour cut-off for trenching is based on correlations between the ray-tracing models (not shown), material properties, and various excavation strategies investigated by Kirsten (1982). The Limitations section contains additional important information regarding rippability estimation by seismic and other means.

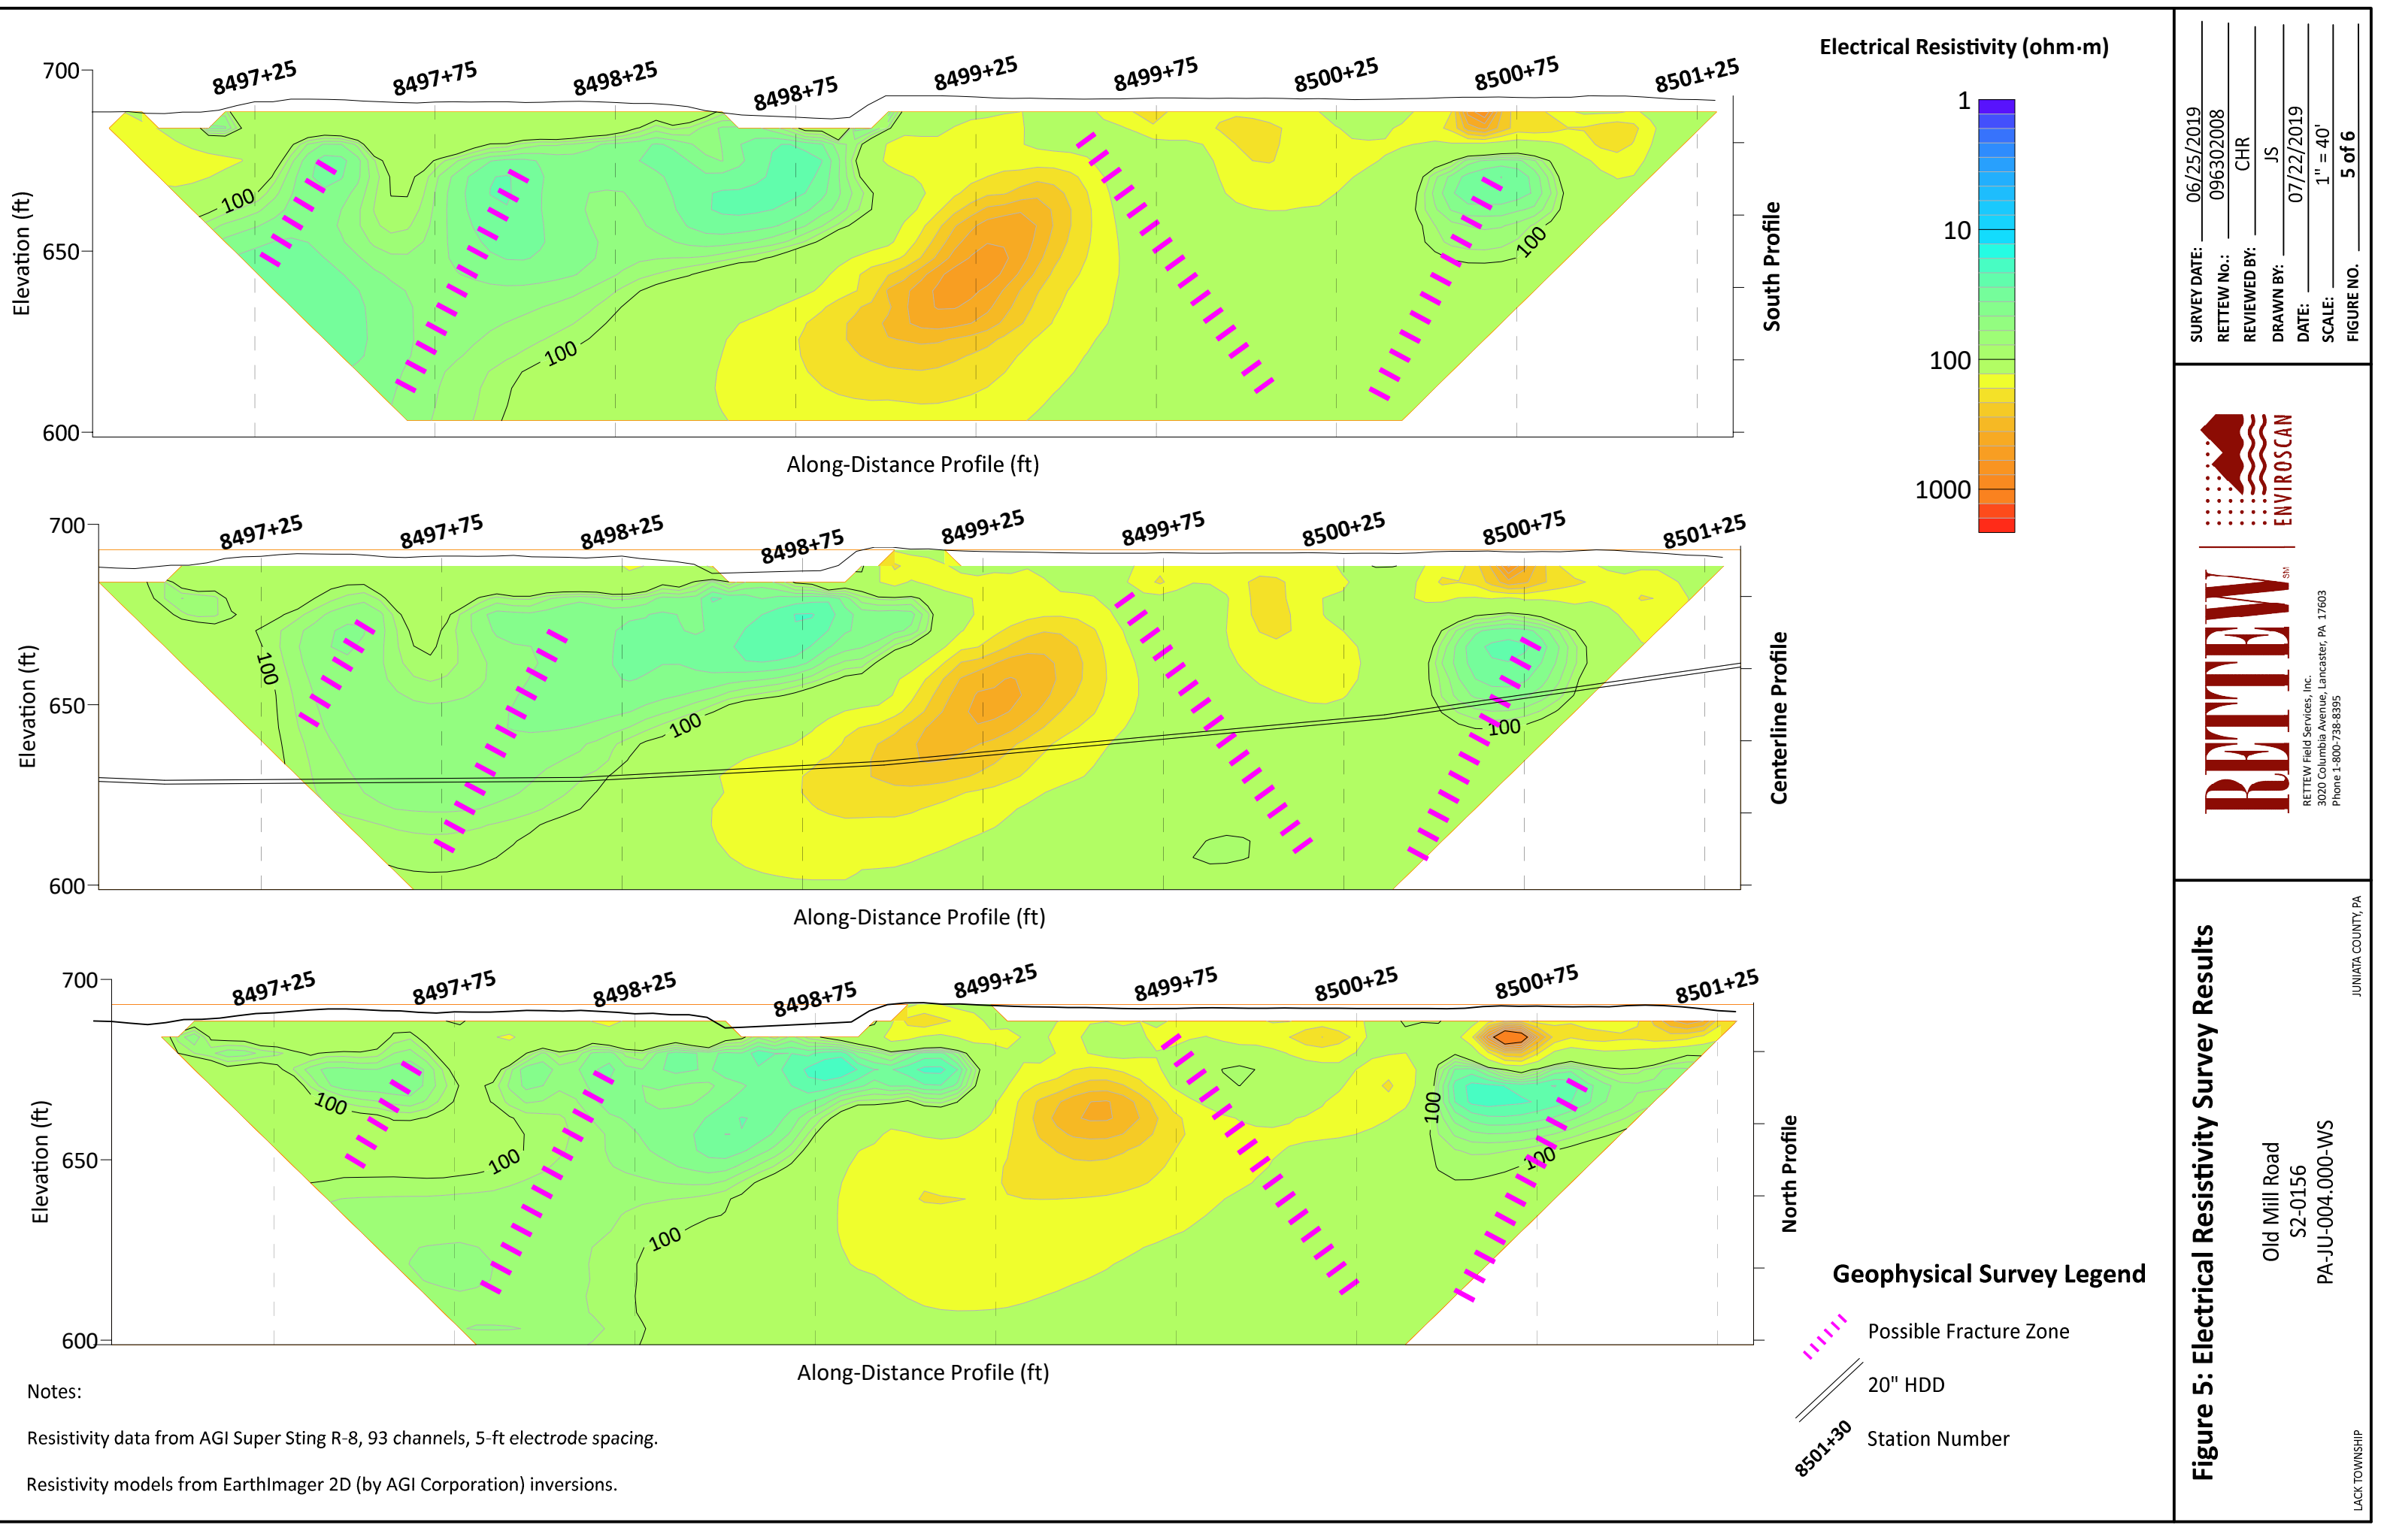
Figure 5: Electrical Resistivity Survey Results
 Old Mill Road
 S2-0156
 PA-JU-004.000-WS
 JUNIATA COUNTY, PA
 LACK TOWNSHIP

The electrical resistivity results are shown in **Figure 5**. The electrical profiles show a general two-layer model with a conductive upper layer over a more resistive lower layer, indicative of moist, conductive unconsolidated material over more resistive low-porosity bedrock. The upper layer is relatively discontinuous, with some irregularities that could represent near-surface disturbances given the site development history and drainage pattern. The deep conductive anomalies below the inferred top-of-rock may represent fractures or mud-filled voids within bedrock.

Notes:
 Resistivity data from AGI Super Sting R-8, 93 channels, 5-ft electrode spacing.
 Resistivity models from EarthImager 2D (by AGI Corporation) inversions.

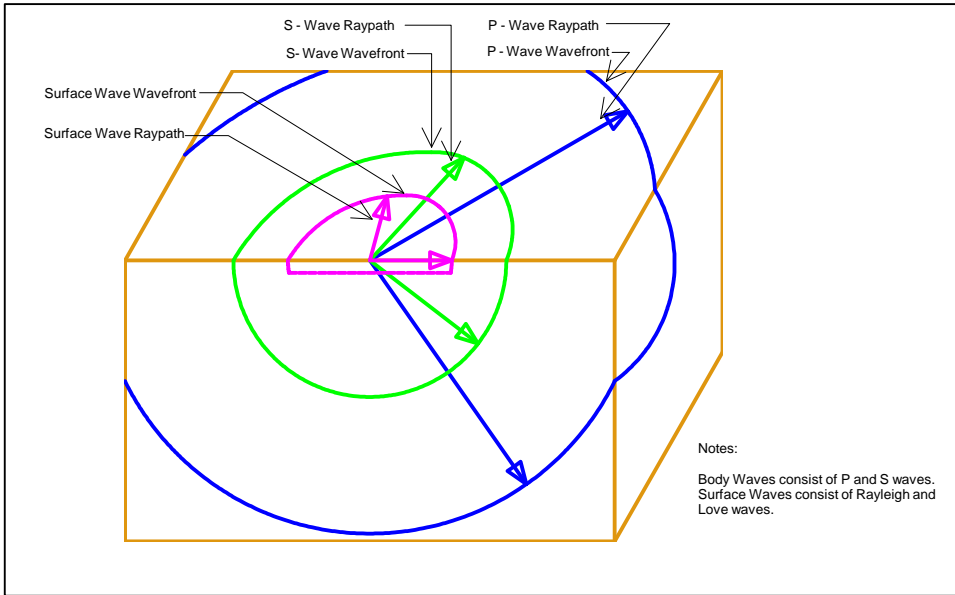
Figure SR-1

Seismic Wave Types

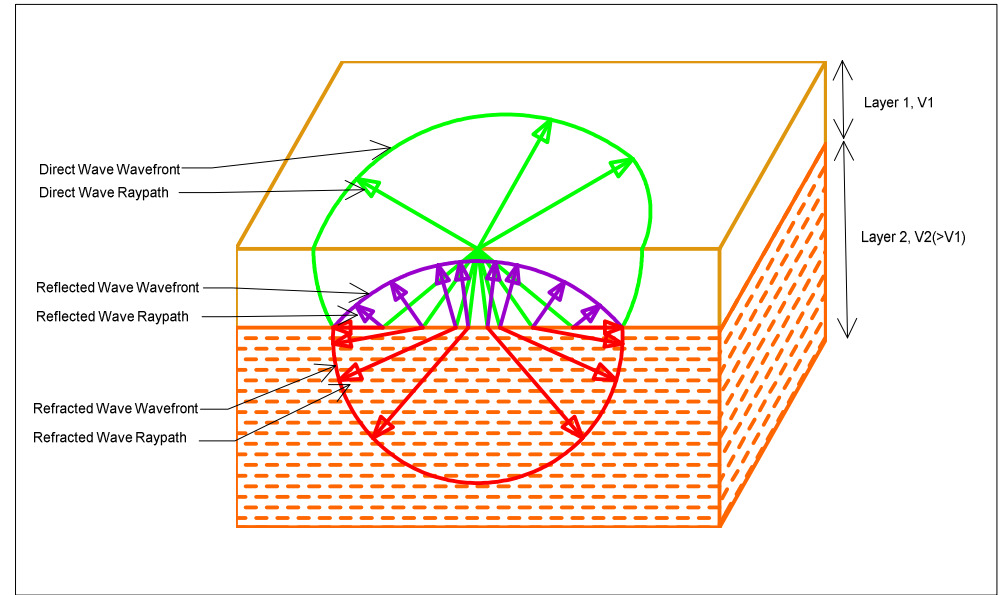
In a layered earth, the hemispherical P shock wave defined by the radially distributed P ray paths are deflected according to the laws of optics (Snell's Law) at interfaces between materials with differing seismic velocities (i.e. densities or elastic properties). Figure SR-2 depicts the deflection of ray paths due to an increase in P velocity at a bedding plane. The type of deflection that a ray path will undergo is dependent upon the angle at which it strikes the interface, and falls into one of four categories:

Some direct rays (green in **Figures SR-2** and **SR-3**) travel parallel to the ground surface at the seismic velocity of the upper layer, do not strike the underlying interface, and consequently are not deflected.

Reflected rays (purple in **Figures SR-2** and **SR-3**) arise where direct rays strike the interface, and a portion of the energy is reflected symmetrically back towards the surface.

The portion of the energy of the incident direct wave that is not reflected upward is refracted or bent as it crosses the interface – making refracted waves in the lower layer (red in **Figures SR-2** and **SR-3**).

Effect of Layering
on Body Wave Raypath

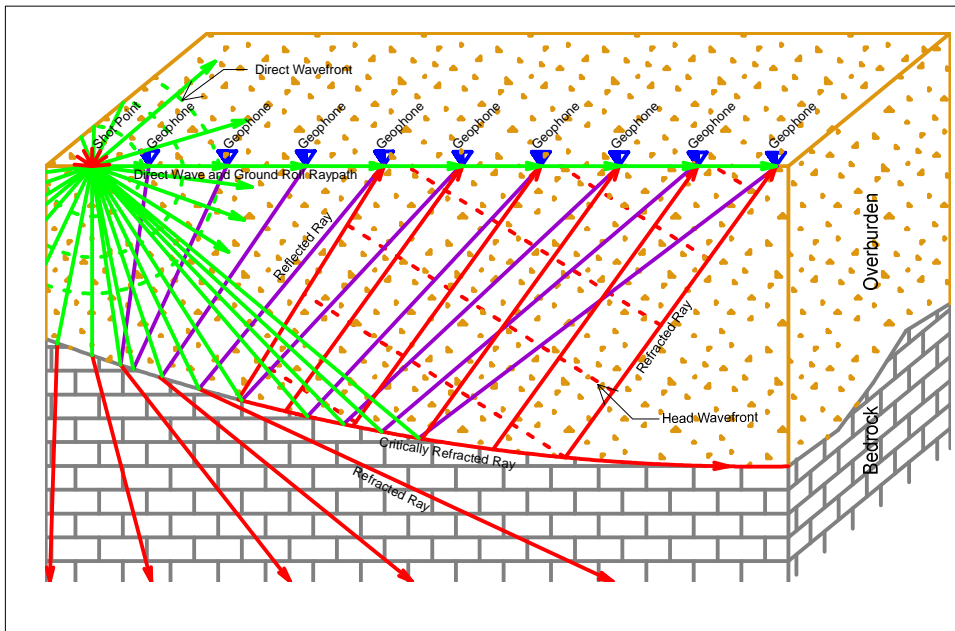
Figure SR-3

At a precise angle called the critical angle, the incident ray is refracted directly along the interface, and travels at the higher seismic velocity of the lower layer (see Critically Refracted Wave in **Figure SR-3**). As this critically refracted or head wave races along beneath the interface, it generates a secondary elastic disturbance that travels back to the surface along ray paths that define a wave front analogous to the bow wake of a ship. These returning rays again travel at the slower velocity of the upper layer.

Seismic Ray Path Geometry

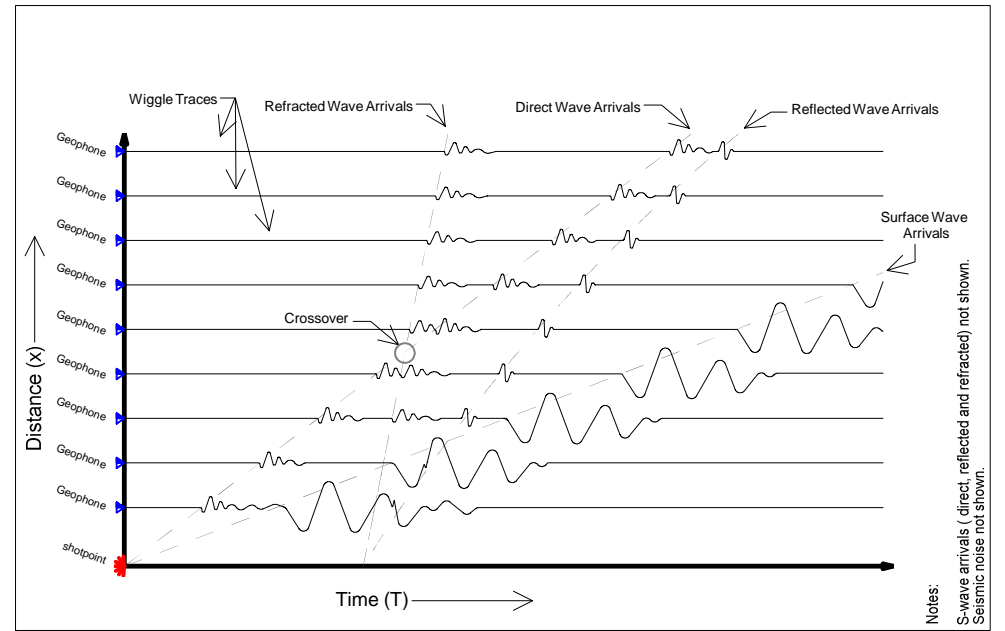
Figure SR-4

As depicted in the time-distance (T-X) curve in **Figure SR-4**, the layered earth structure can be determined by analyzing the seismographic wiggle traces. At distances close to the seismic source, the first wiggle or ground motion (the first arrival after the shot) is due to passage of the direct wave travelling at the velocity of the upper layer. Reflected waves arrive later since they have by definition traveled a greater distance at the same velocity (additional later wiggles are caused by passage of the more slowly travelling S and surface waves). Beyond a distance dictated by the critical angle, the first arrival of seismic energy represents the head wave of the critically refracted ray. These refracted rays also by definition travel a greater distance than the direct wave. However, along part of their path, they have traveled at the higher velocity of the underlying more consolidated layer. At greater distances from the shot point, where the path length in the higher velocity layer becomes significant, the head wave arrivals actually race past the direct wave and become the first arrival (see labeled crossover in **Figure SR-4**). By extension, it can be shown that if a third layer with even greater velocity lies at greater depth, the head wave from this layer will become the first arrival at a sufficient distance from the shot point.

Idealized
Seismic Record
and T- X Graph

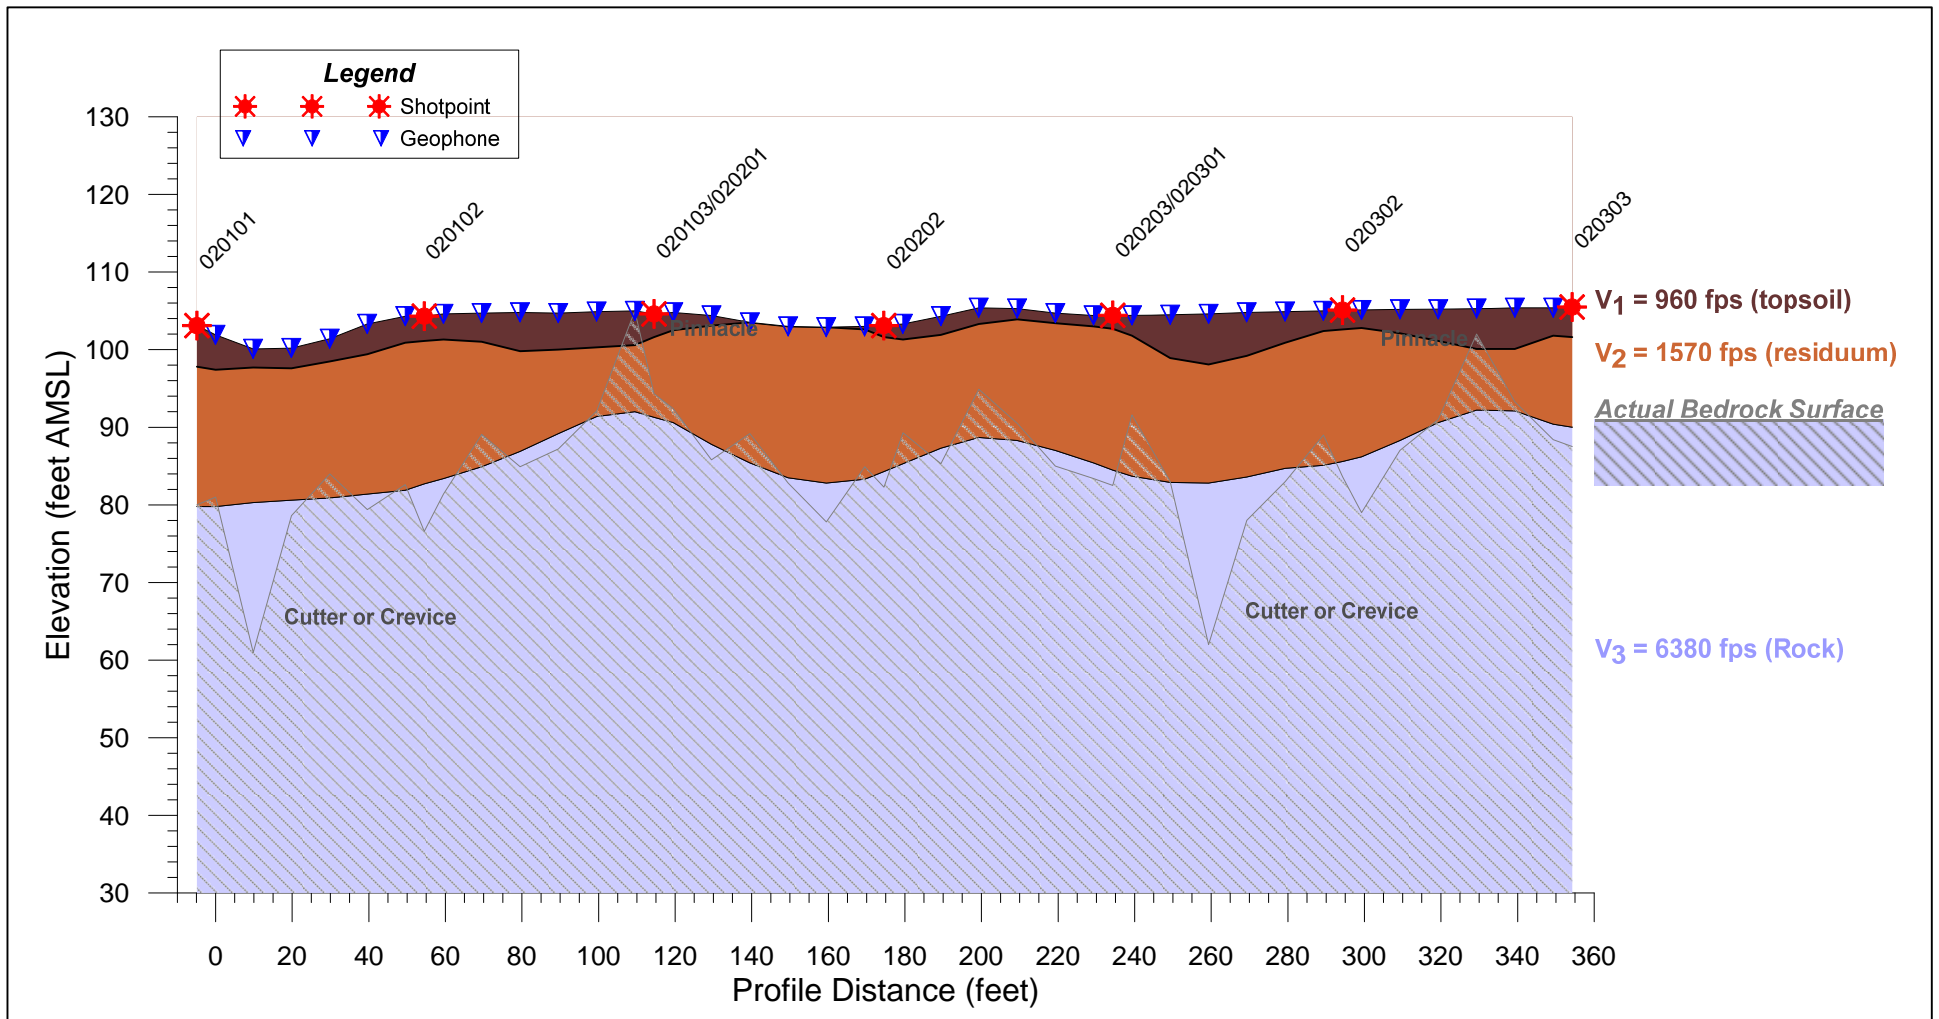
Figure SR-5

Sharp or dramatic interface relief such as limestone pinnacles cannot always be resolved even with very tight geophone spacing. Therefore, refraction profiles of expectedly irregular interfaces should be assumed to represent somewhat smoothed versions of actual relief (see e.g. Figure **SR-5**).

Example Karst Terrane Seismic Profile

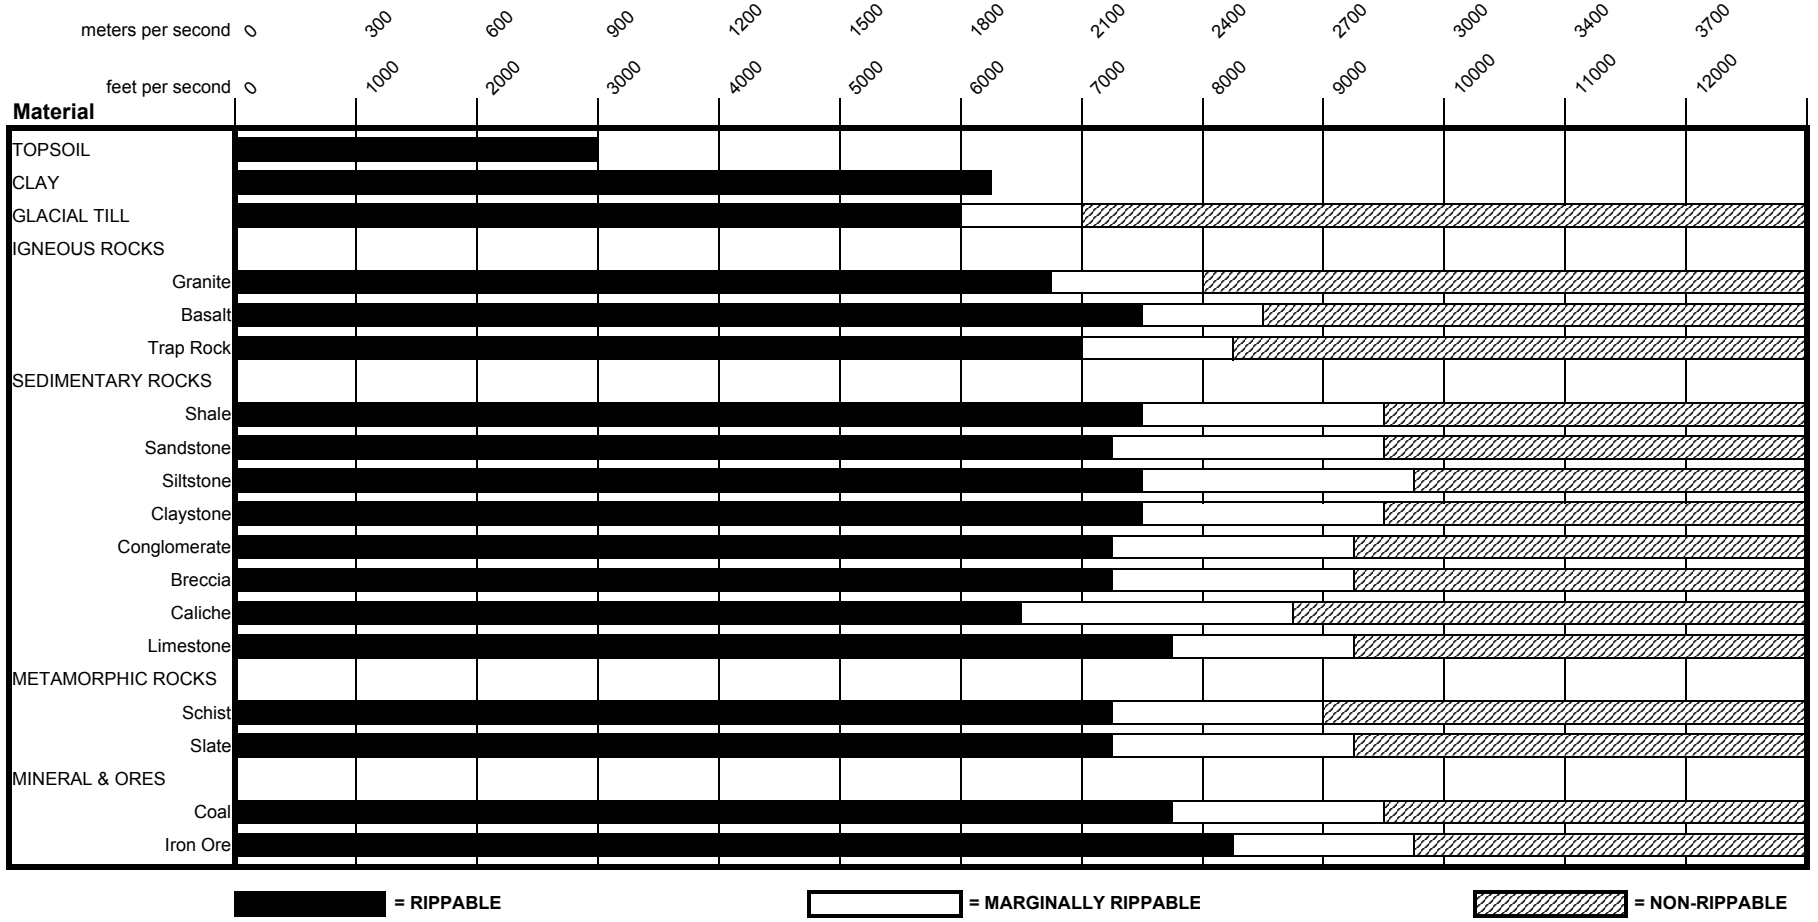
Ripping Chart *
D9R
 Multi or Single Shank No. 9 Ripper
 Estimated by Seismic P-Wave Velocities

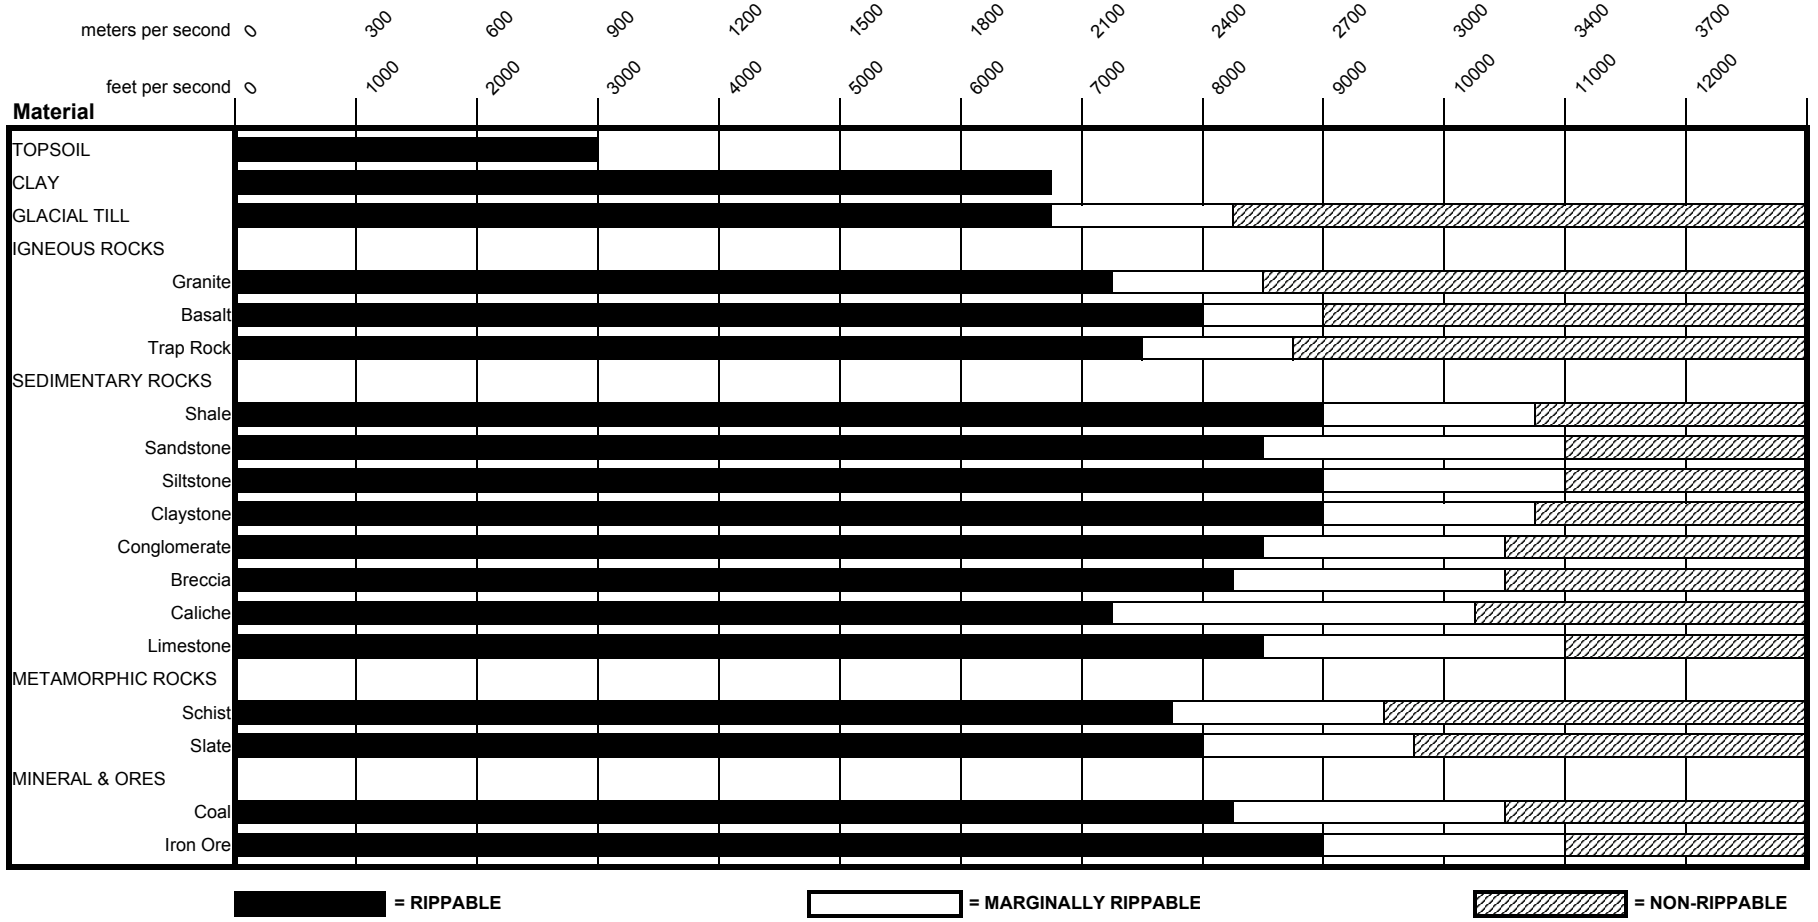
Ripping Chart *
D10N
 Multi or Single Shank No. 10 Ripper
 Estimated by Seismic P-Wave Velocities

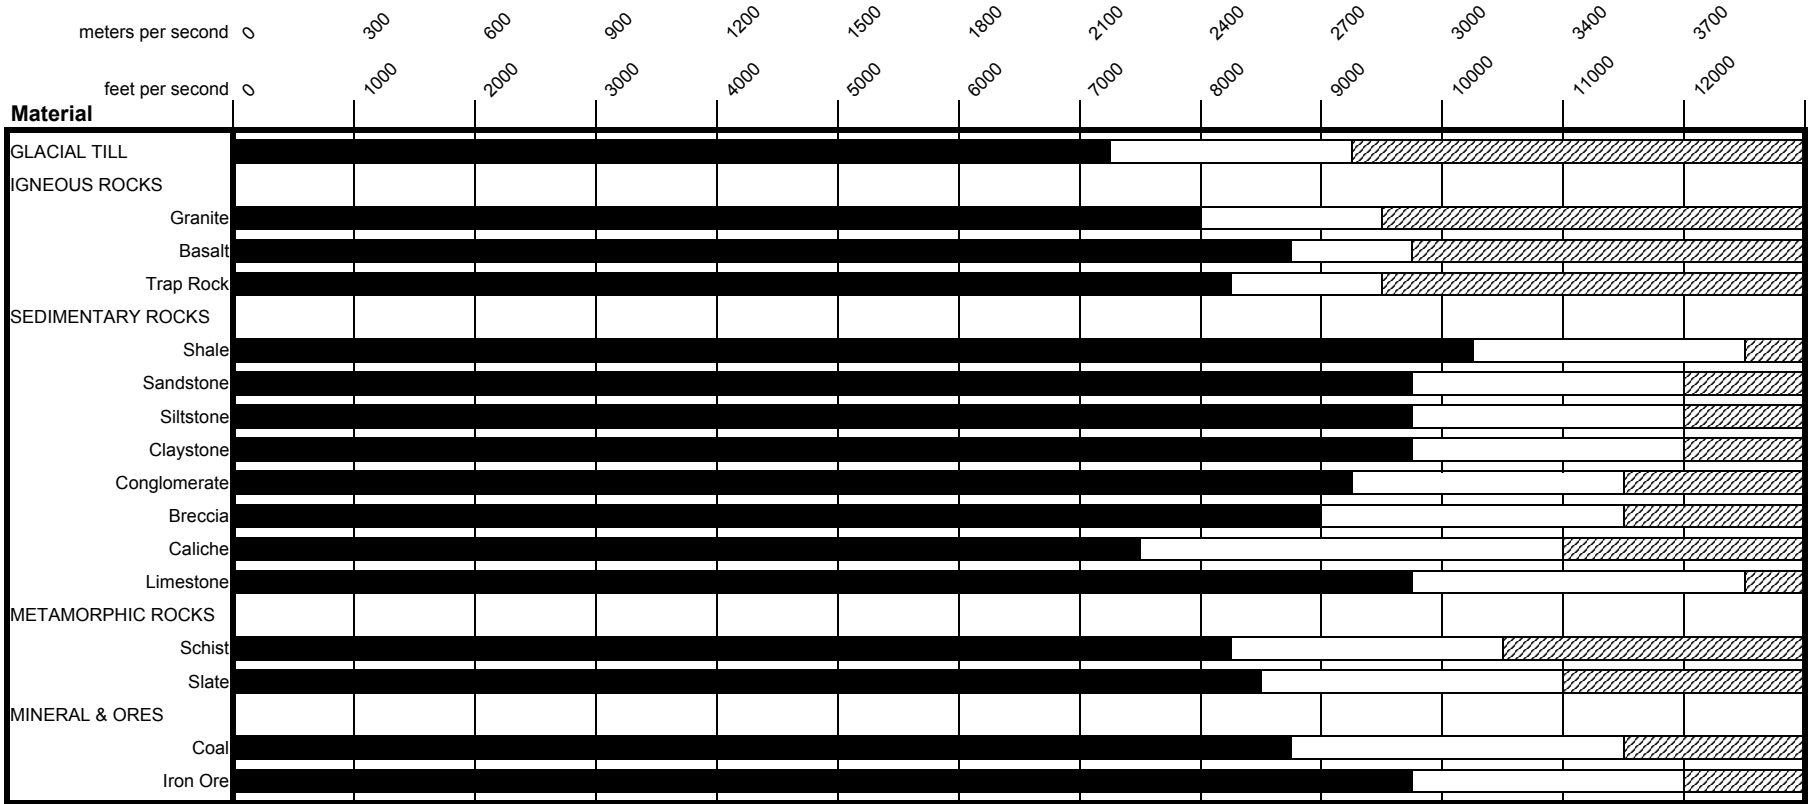
Ripping Chart *
D11N
Multi or Single Shank No. 11 Ripper
Estimated by Seismic P-Wave Velocities
