**Re: DEP Request for Additional Information
Blacklog Creek Crossing 16" Horizontal Directional Drill Location (S2-0154-16)
Permit No. E31-234
Shirley Township, Huntingdon County**

Figure 1 - Topographic Basemap
 Shirley Township, Huntingdon County, PA
 Project No. 096302011

HORIZONTAL DIRECTIONAL DRILL
SR 2017
PENNSYLVANIA PIPELINE PROJECT

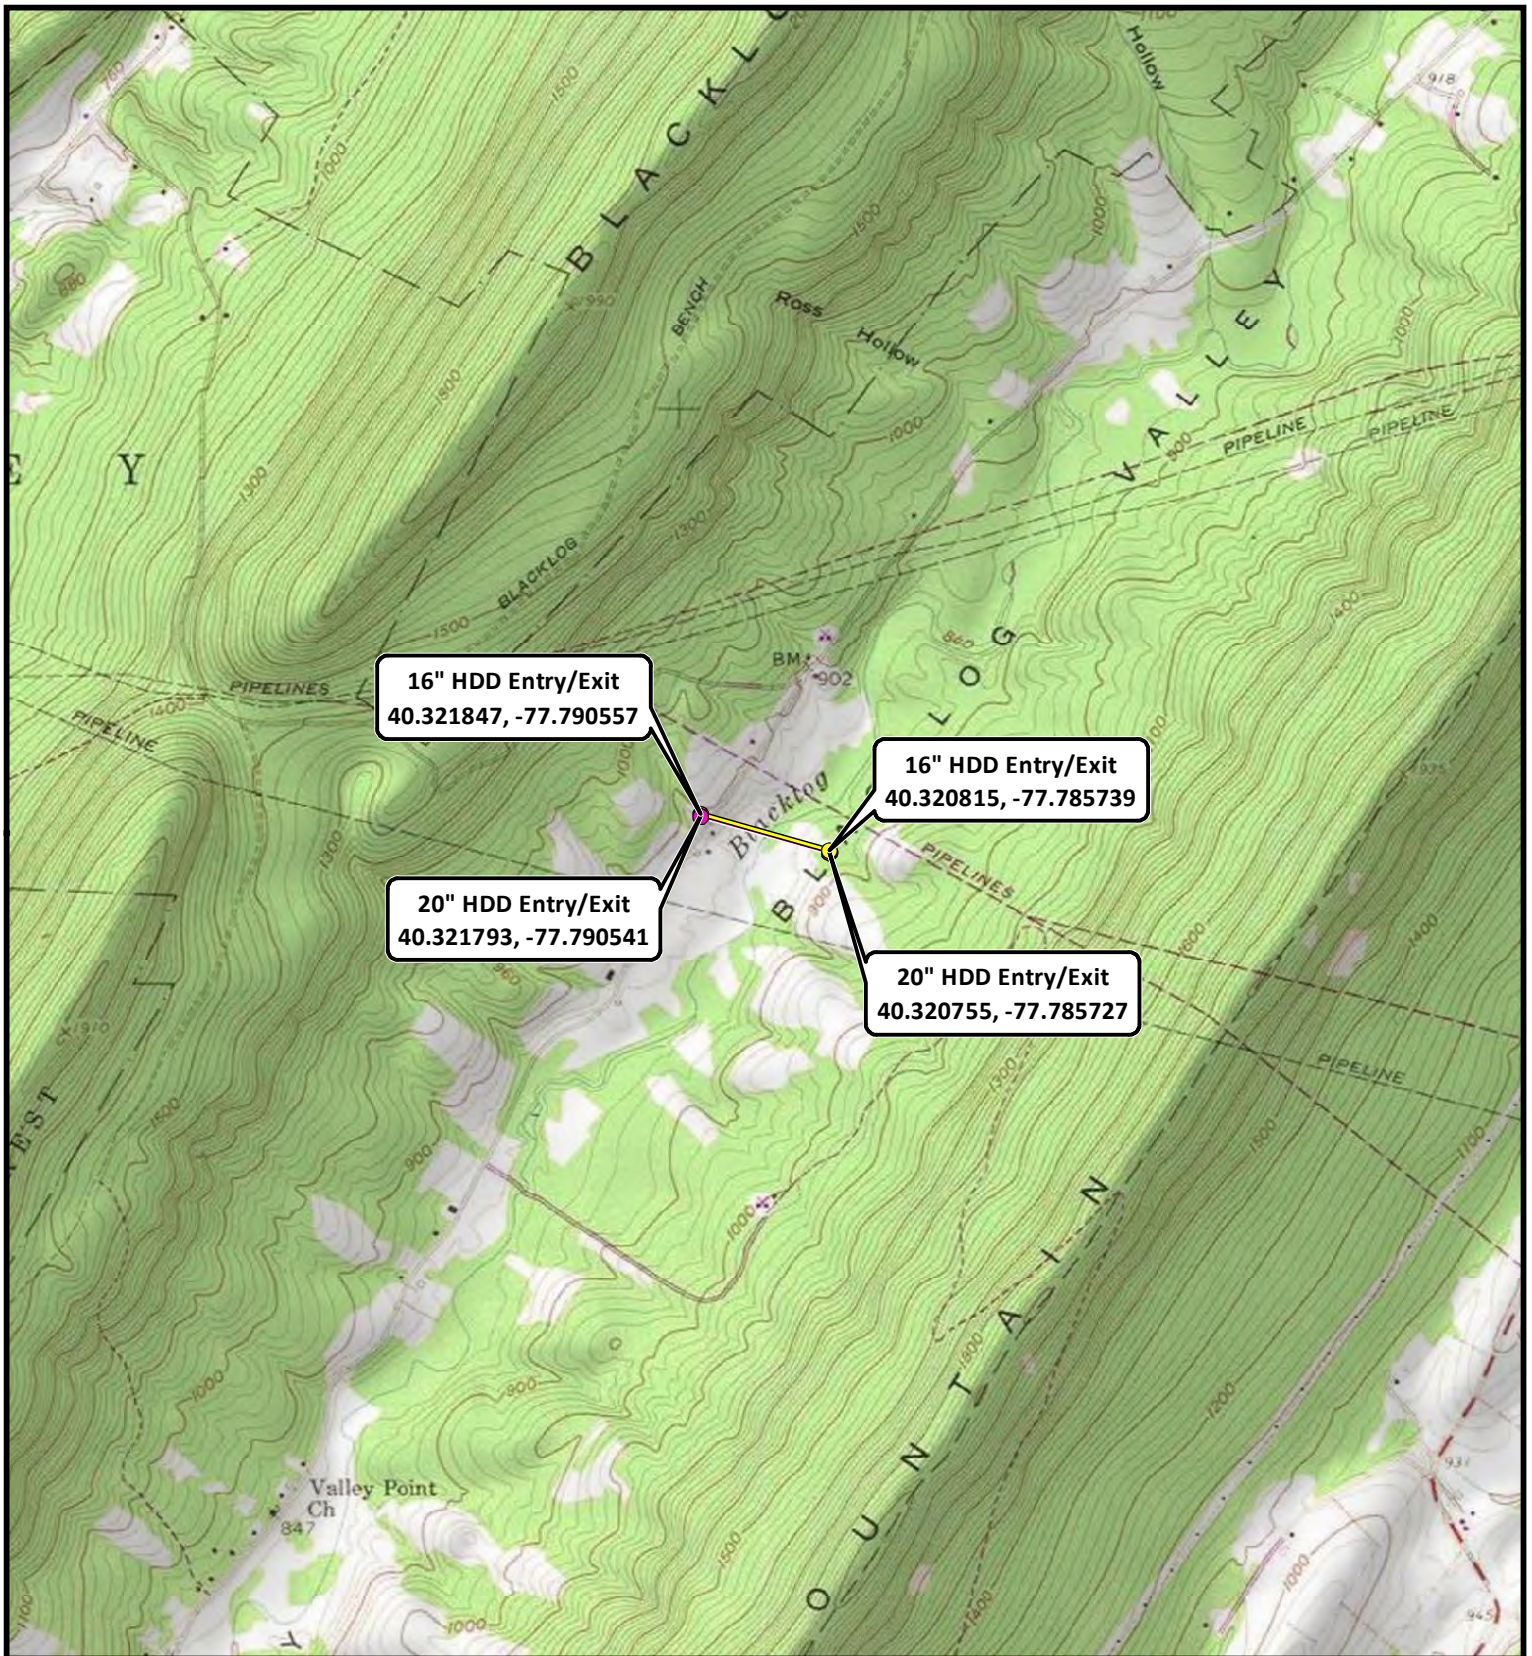
- 16" HDD Entry/Exit
- 20" HDD Entry/Exit
- 16" HDD Profile
- 20" HDD Profile

SPLP utilized all information obtained during the drilling of the 20-inch HDD in our internal assessment and evaluation of the 16-inch HDD profile as revised. The IR information represented graphically on Figure 1 in Attachment 2 presents the plan and cross section views of the March 23, 2018 IR event. This figure presents the reality of events that occurred during the HDD operations in relation to the depth of profile and allowed for correlation to monitoring data collected during active drilling.

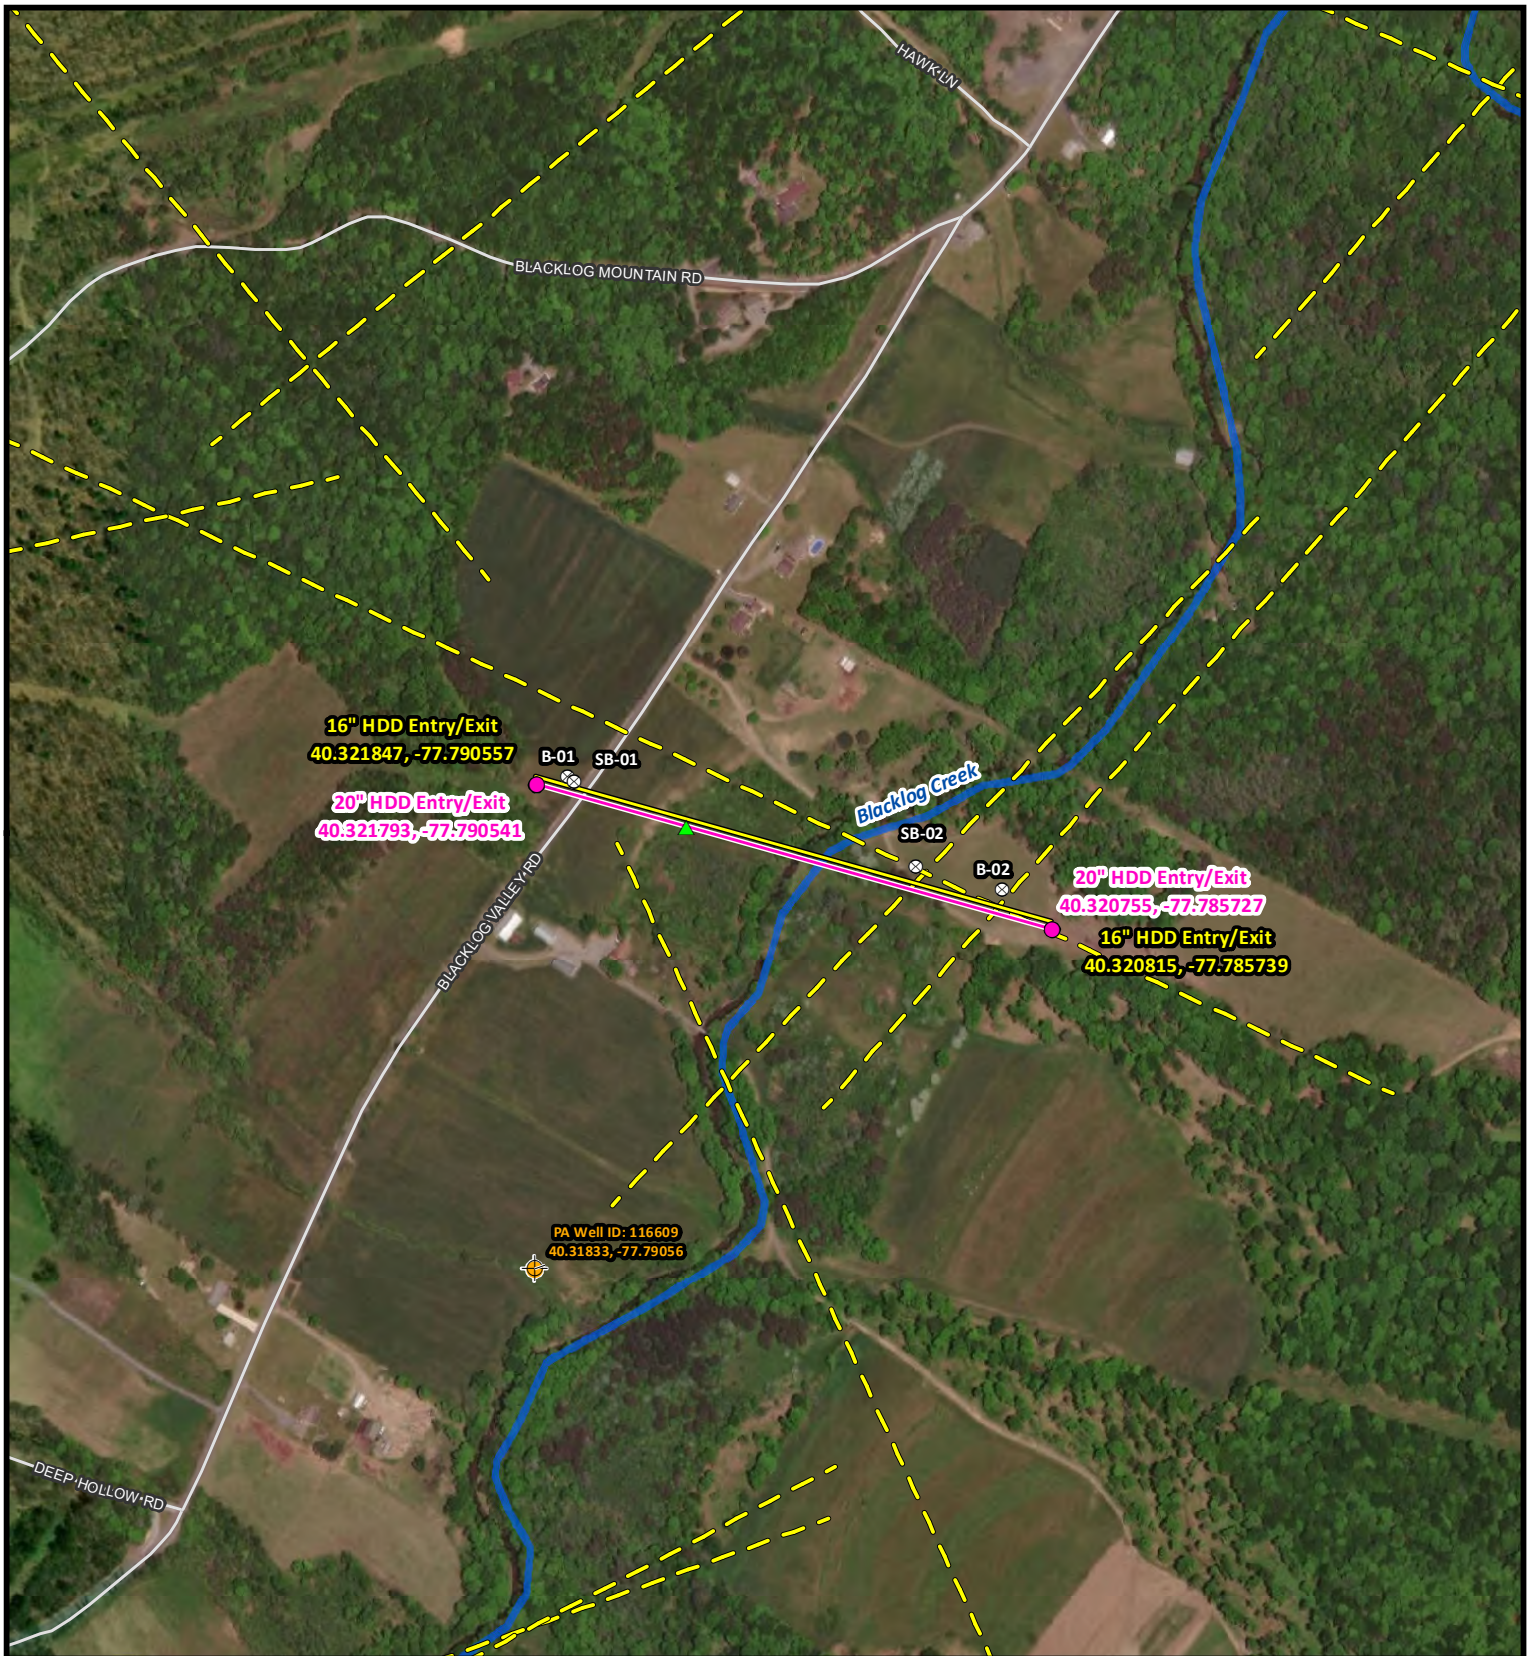
Figures 2 and **3** show the results of the fracture trace analysis overlain on the geologic map and aerial base map, respectively. Twelve fracture traces were identified in close proximity to the proposed SR 2017/Blacklog Creek HDD that are likely related to the primary geologic structure of the area. Due to the nature of the ridges and folded geology near the site, several of the fracture traces trend approximately northeast-southwest (NE-SW) and perpendicular to the HDD alignment. Additional fracture traces were identified in an approximately west-east (W-E) orientation crossing the prominent fracture traces and generally parallel to the HDD alignment. The W-E fracture lineaments are presumed to be stress-related joint sets. General surface drainage patterns near the site are characterized by linear stream reaches oriented NE-SW or W-E that also reflect the local geologic structure. Blacklog Creek flows generally NE-SW.

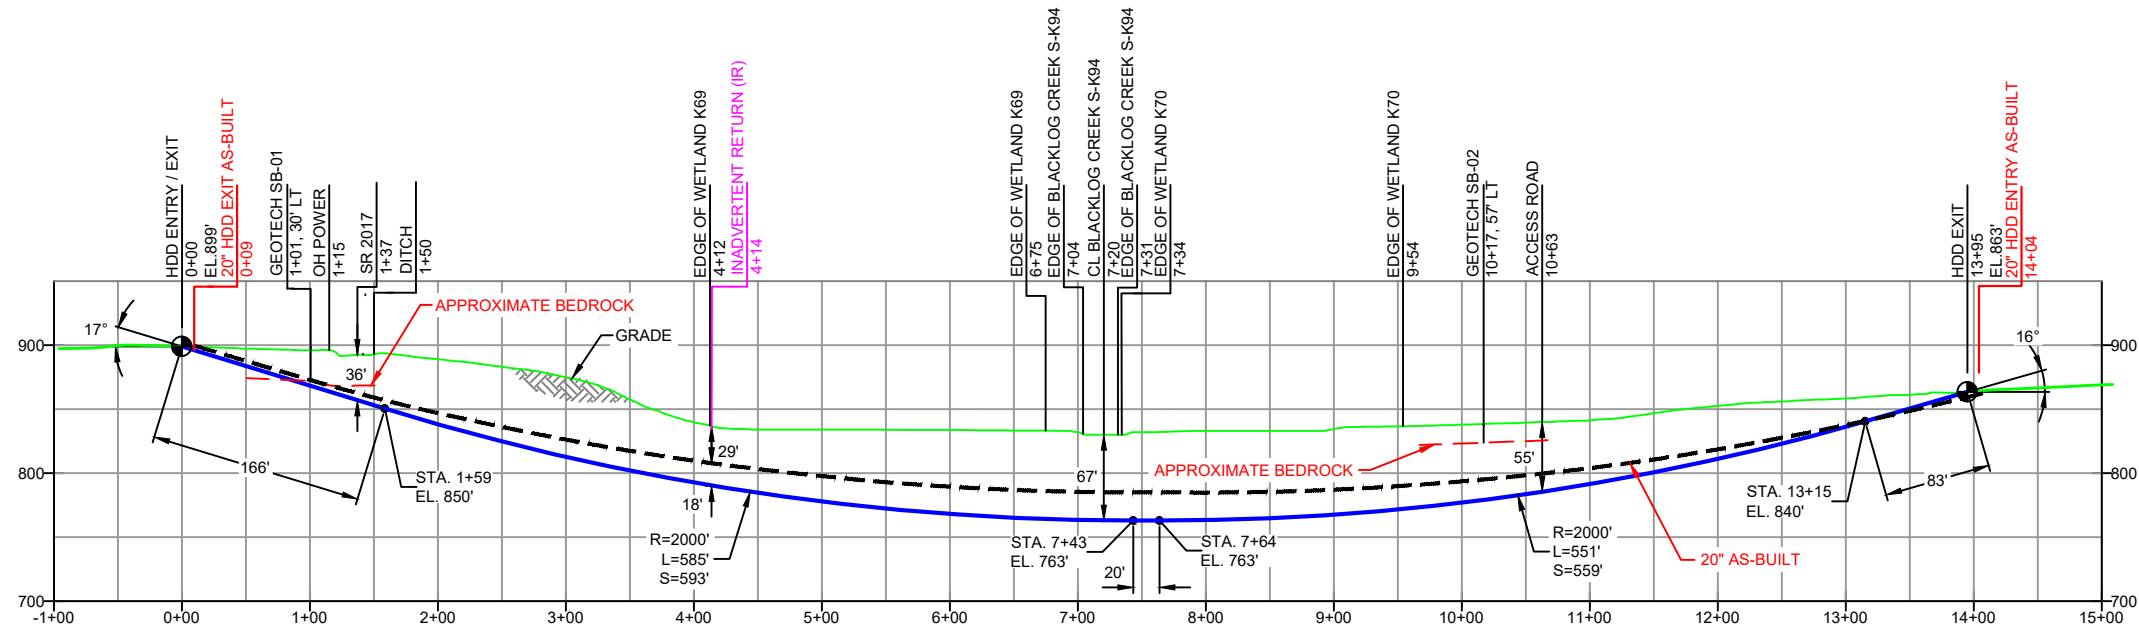
SCALE: 1"=150'
DWG. NO. PA-HU-0106.0000-RD-16

PLAN VIEW

PROFILE VIEW

- DESIGNED IN ACCORDANCE WITH CFR 49 195 & ASME B31.4
 - CROSSING PIPE SPECIFICATION:
HDD HORZ. LENGTH (L=): 1395'
HDD PIPE LENGTH (S=): 1421'
16" x 0.438" W.T., X-70, API6L, PSL2, ERW, BFW
COATING: 14-16 MILS FBE WITH 30-35 MIL ARO (POWERCRETE OR ENGINEER APPROVED EQUAL)

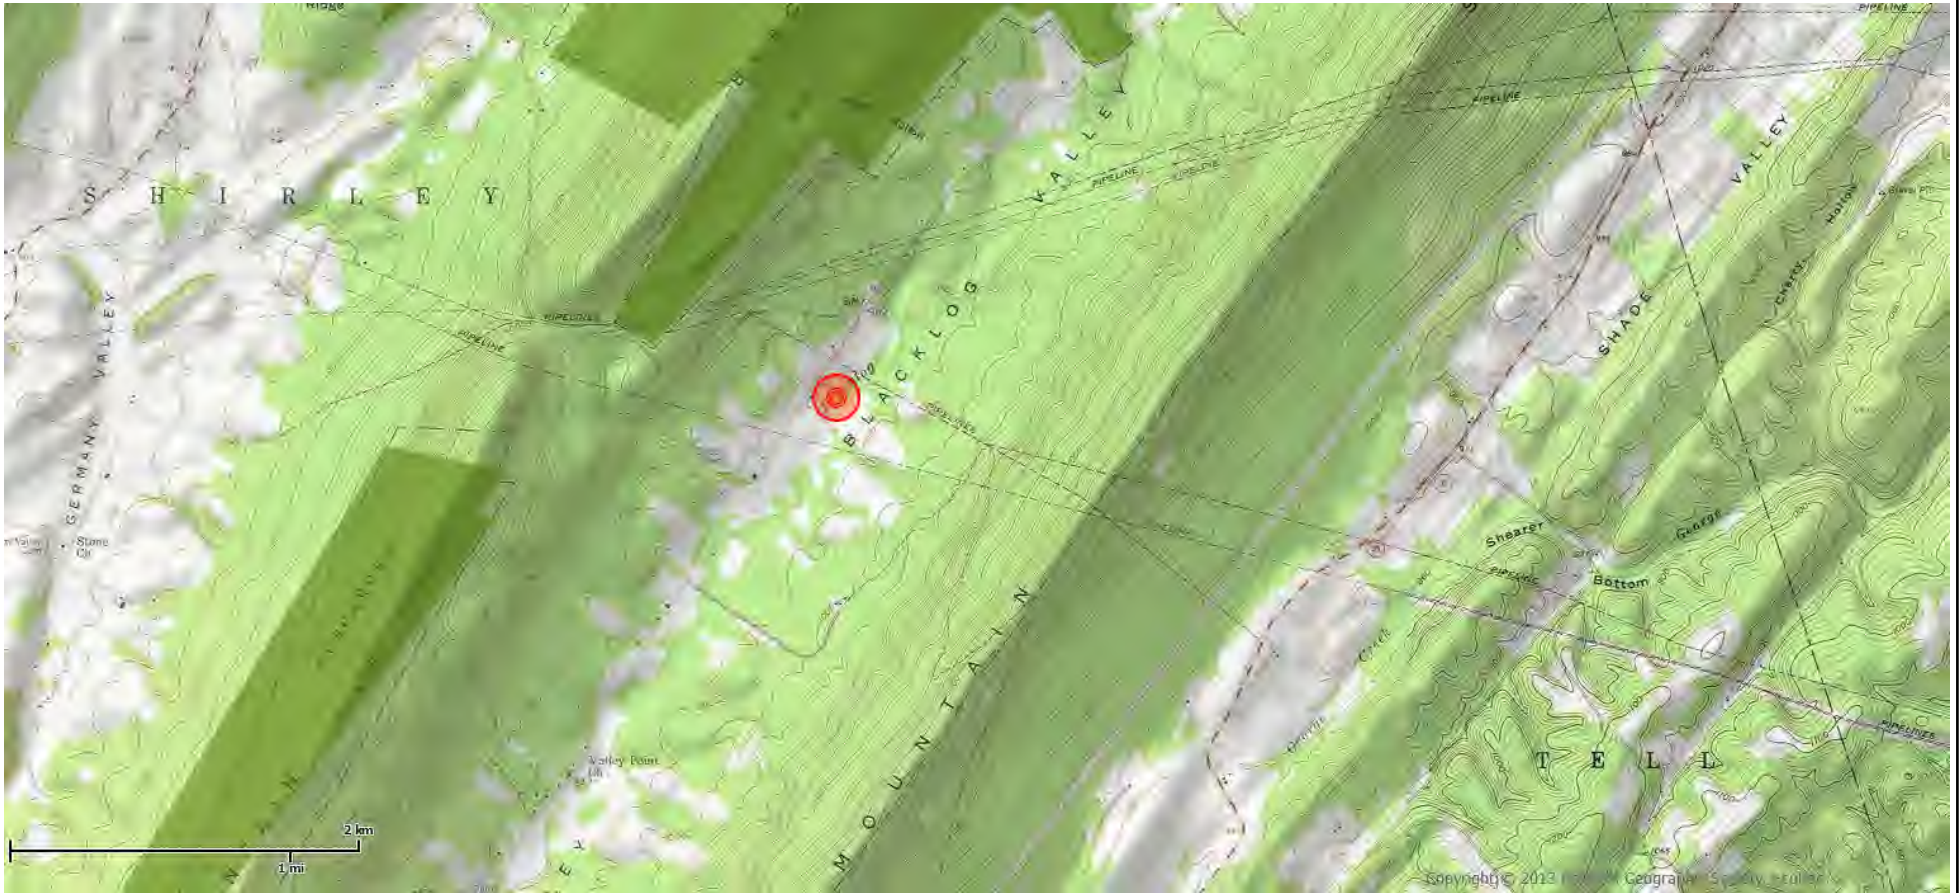
**FIGURE 2: Boring Location Plan
SR 2017 - PPP3
DPS PO #20170921
PSI Project # 08031074**

**GEO BORE #1
(150 FT)**

**GEO BORE #2
(150 FT)**

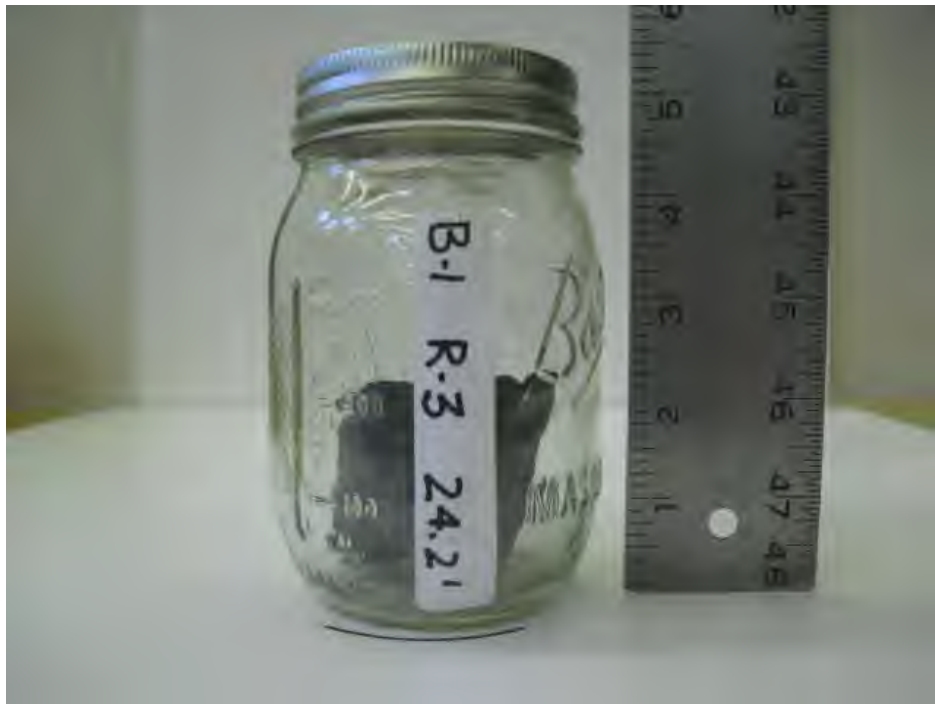
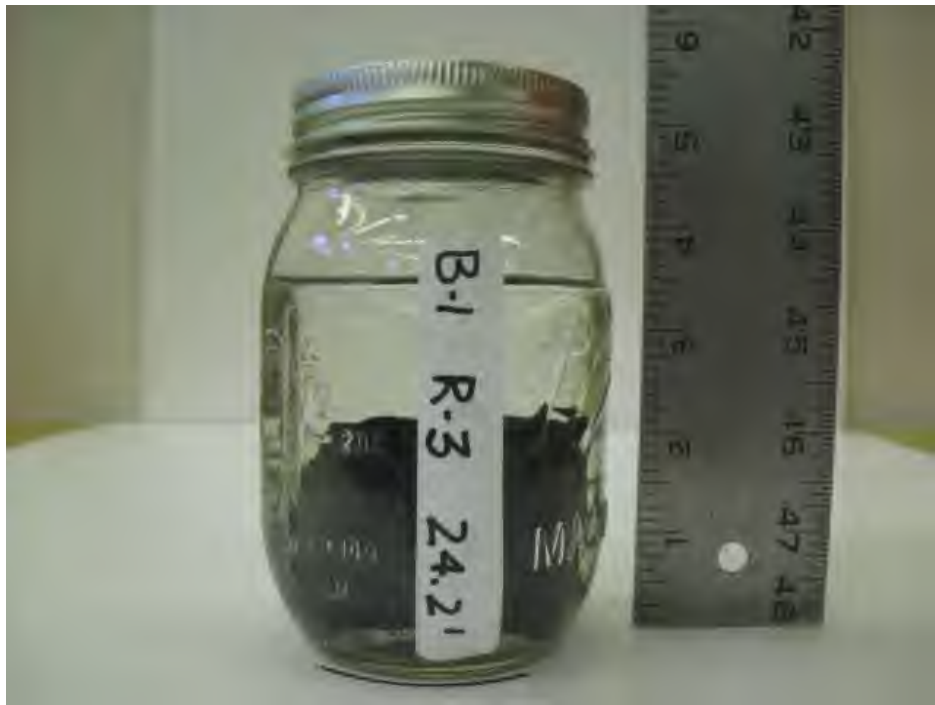
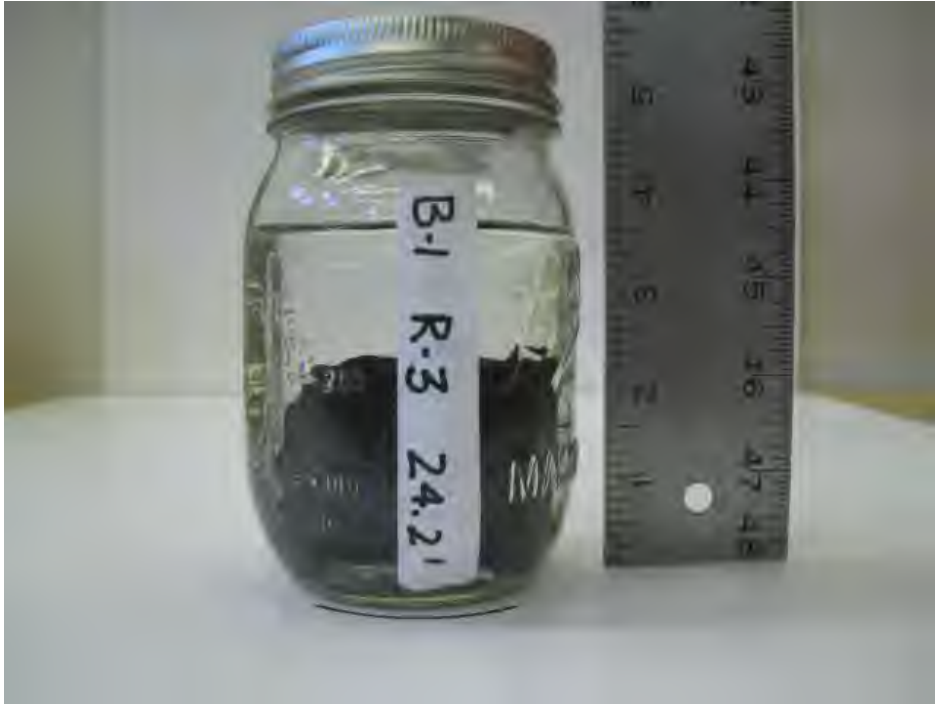
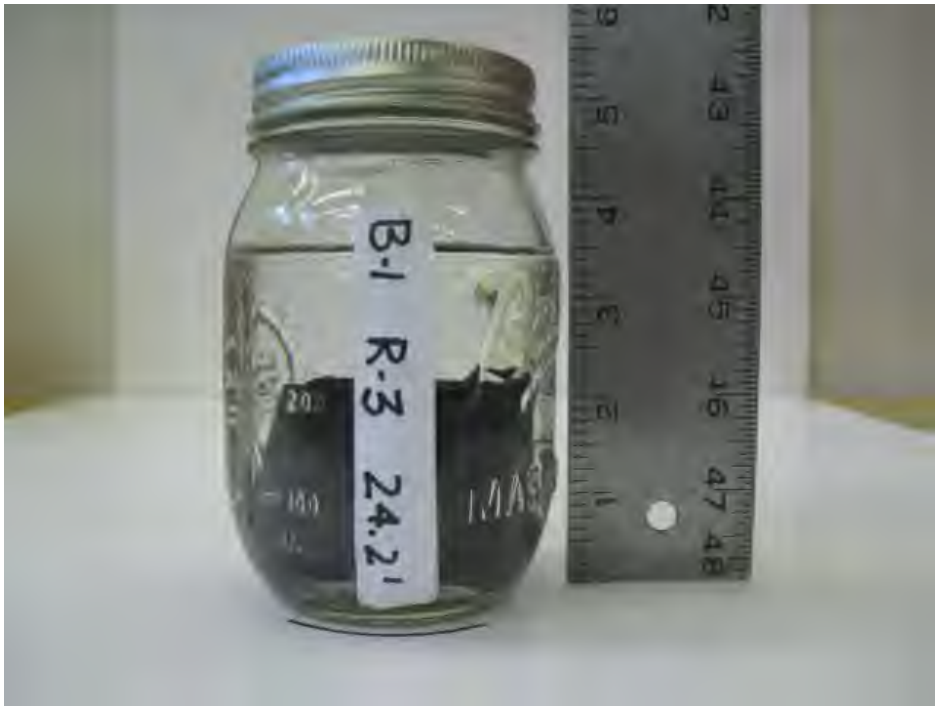
08031074 B-1 R-3 24.2'

Start

2 Minute: Slake Index 6

4 Hour: Slake Index 6

8 Hour: Slake Index 6

Jar Slake Index, Ij	General behavior during test
1	Degrades rapidly into a pile of flakes or mud
2	Breaks readily and/or forms many chips
3	Breaks slowly and/or forms few chips
4	Breaks rapidly and/or develops several fractures
5	Breaks slowly and/or develops few fractures
6	Very little or no change

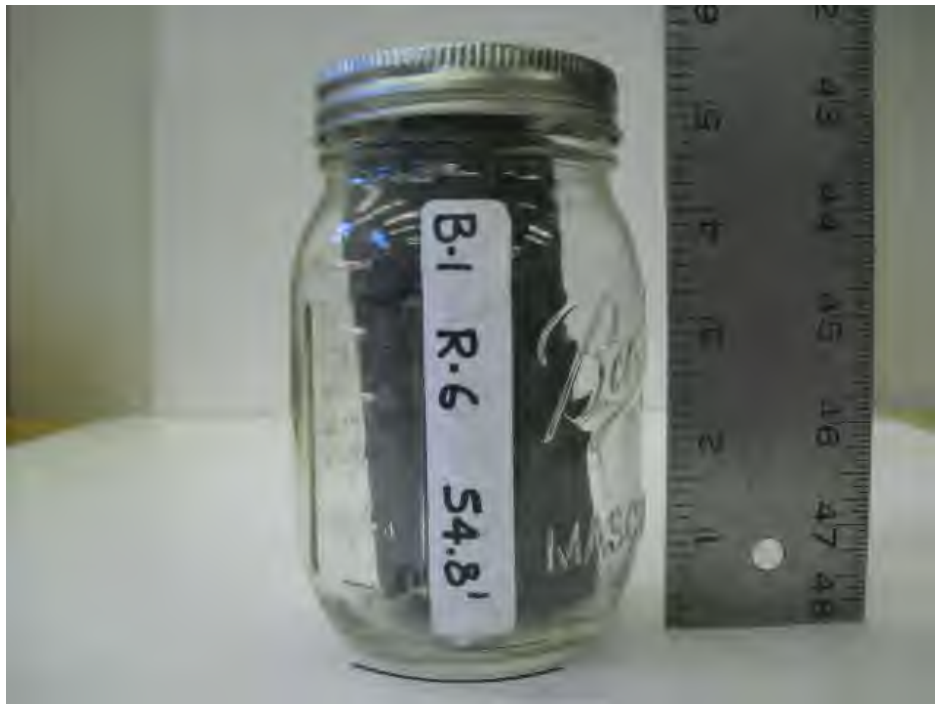
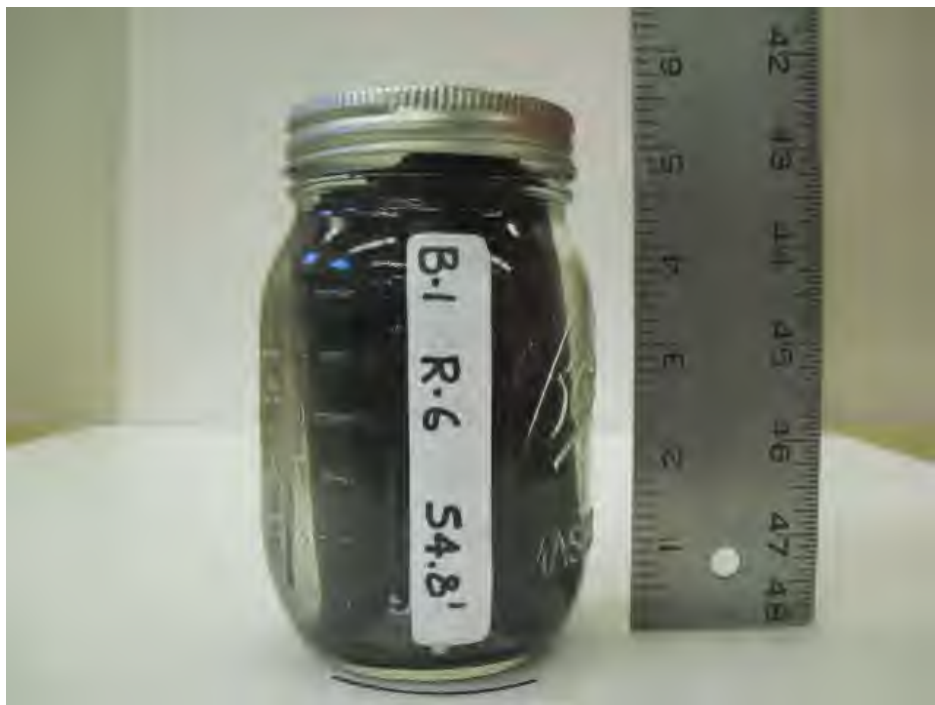
08031074 B-1 R-6 54.8'

Start

2 Minute: Slake Index 6

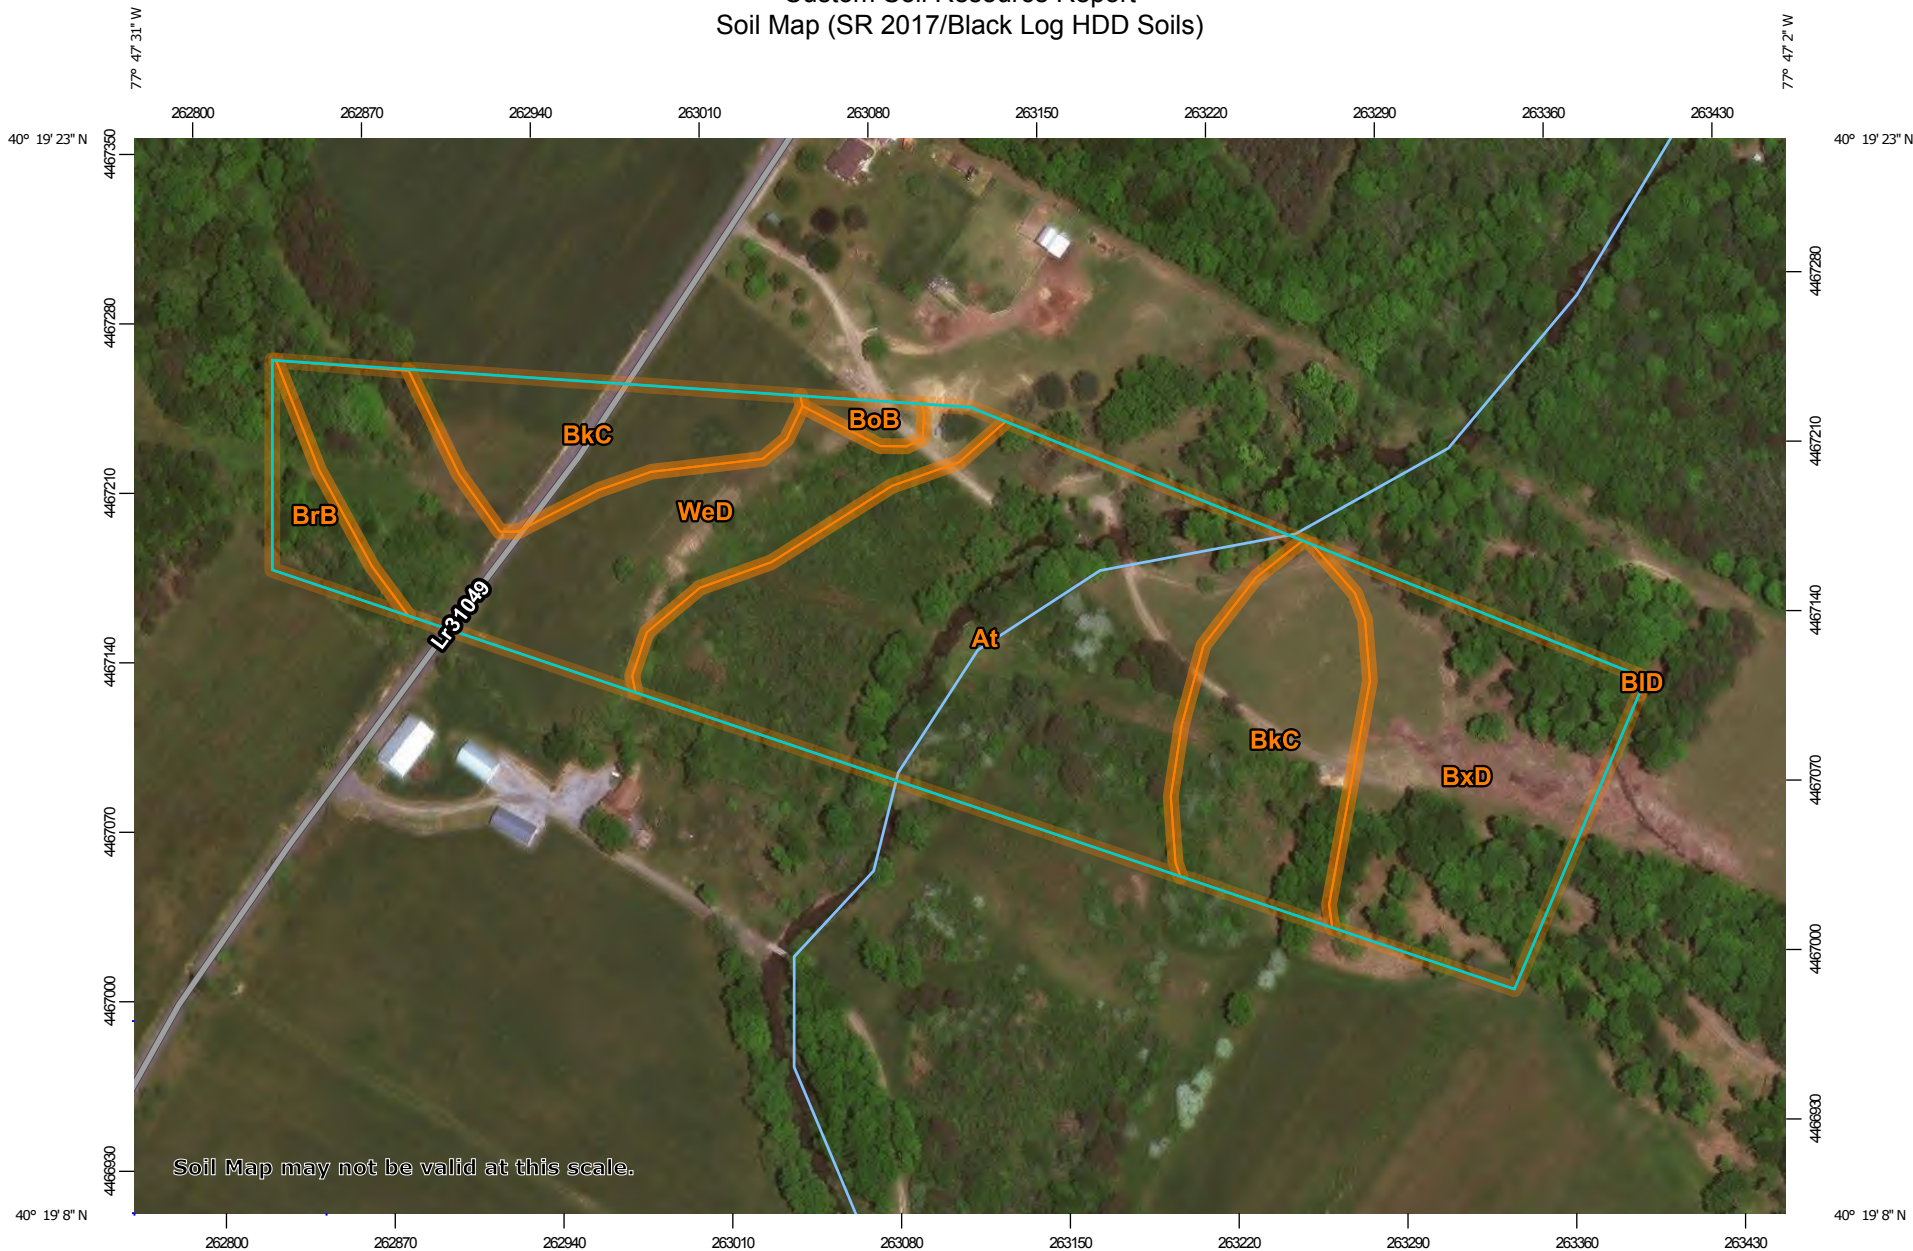
Custom Soil Resource Report Soil Map (SR 2017/Black Log HDD Soils)

The soil map section includes the soil map for the defined area of interest, a list of soil map units on the map and extent of each map unit, and cartographic symbols displayed on the map. Also presented are various metadata about data used to produce the map, and a description of each soil map unit.
