**Re: DEP HDD Re-Evaluation Report – Request for Additional Information
Old U.S. 220 16" Horizontal Directional Drill (S2-0109-16)
Permit No. E07-459
Blair Township, Blair County**

Sunoco Pipeline, L.P.
Old Route 220 HDD Location

HORIZONTAL DIRECTIONAL DRILL
OLD US 220 HWY
PENNSYLVANIA PIPELINE PROJECT

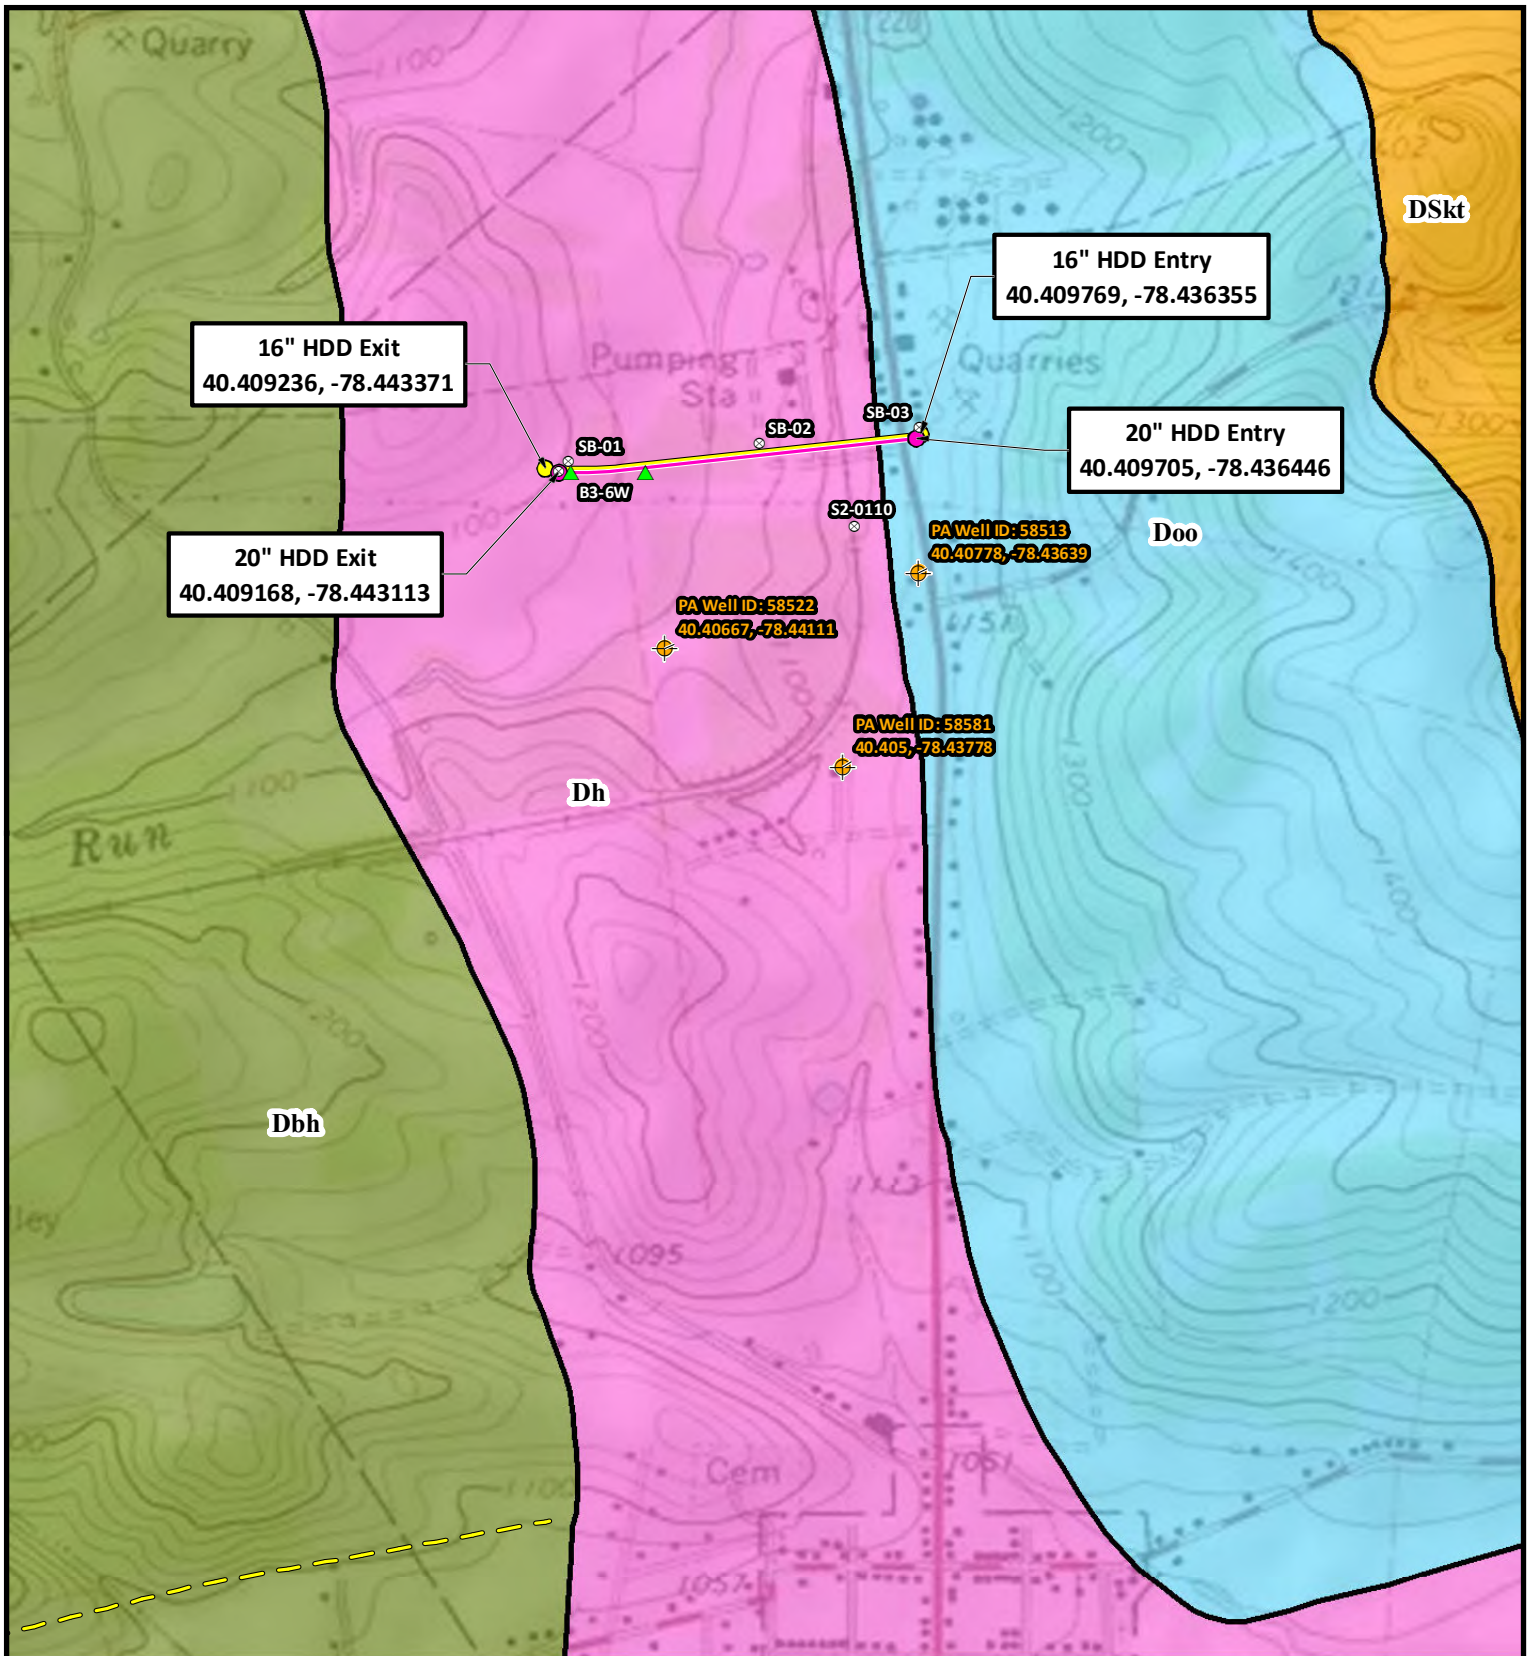
Inadvertent Return	Inferred Fracture Trace
Residential Well	Geologic Formation
Soil Boring	DSkt - Keyser and Tonoloway Formations, undivided
16" HDD Entry/Exit	Dbh - Brallier and Harrell Formations, undivided
20" HDD Entry/Exit	Dh - Hamilton Group
16" HDD Profile	Doo - Onondaga and Old Port Formations, undivided
20" HDD Profile

Figures 2 and 3 show the results of the fracture trace analysis overlain on the geologic map of the site and an aerial base map. One fracture trace was identified within close proximity to the Palmer Lane HDD that is likely related to the primary geologic structure. The fracture trace trends approximately northeast-southwest (NE-SW), parallel to geologic strike.

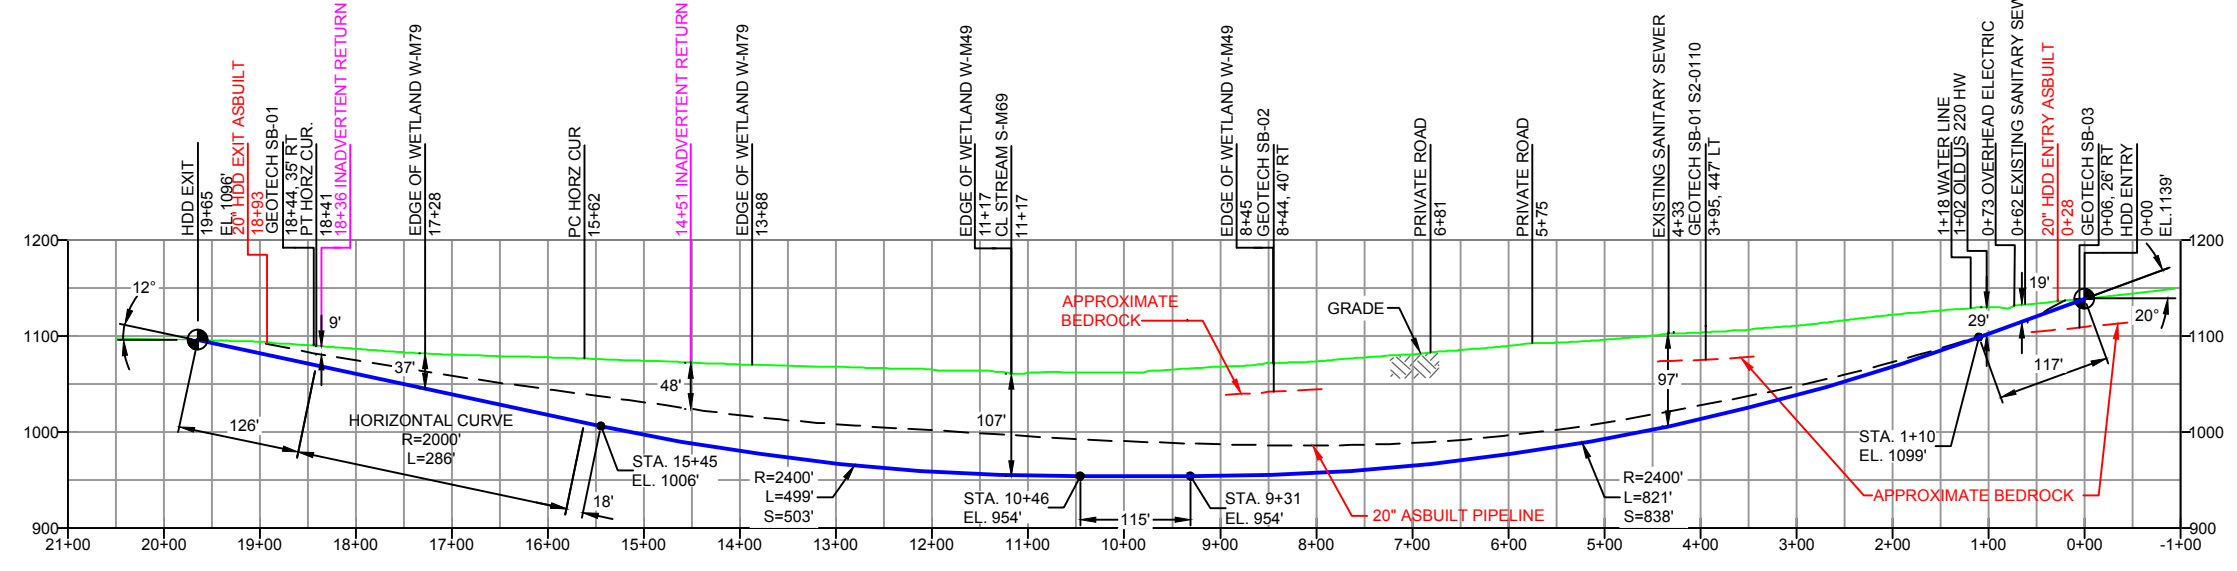
SCALE: 1"=200'
DWG. NO. PA-BL-0001.0031-RD-16

PROFILE VIEW

- DESIGNED IN ACCORDANCE WITH CFR 49 195 & ASME B31.4
 - CROSSING PIPE SPECIFICATION:
HDD HORZ. LENGTH (L)=1965'
HDD PIPE LENGTH (S)=2003'
16" x 0.438" W.T. X-70, API5L, PSL2, ERW, BFW
COATING: 14-16 MILS FBE WITH 40 MILS MIN. ARO (POWERCONCRETE R95)

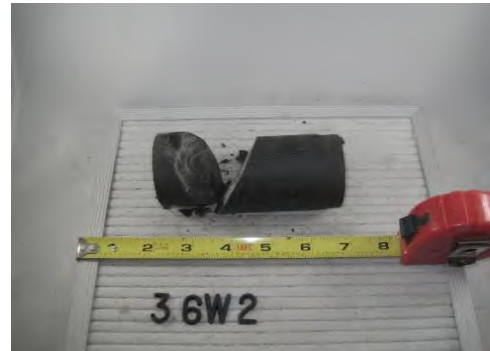
Maximum Axial Load at Failure: 12,450 lb
 Compressive Strength: 4,126 psi
 Compressive Strength: 28.45 Mpa
 Unit Weight 168 pcf

Before the Test

After the Test

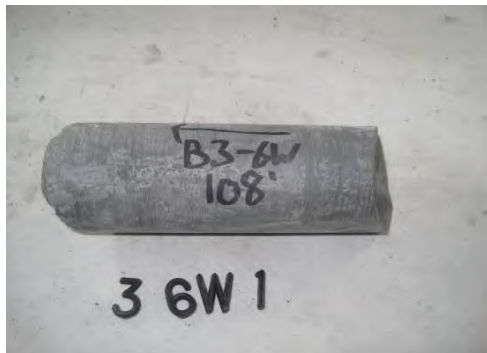
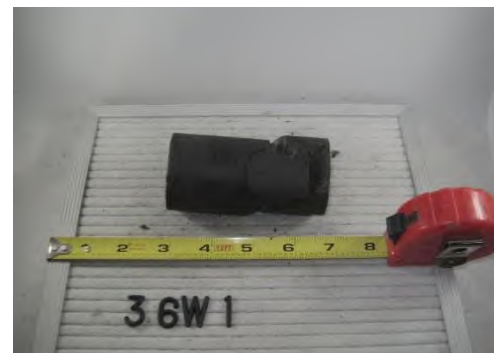
Maximum Axial Load at Failure: 10,810 lb
 Compressive Strength: 3,583 psi
 Compressive Strength: 24.70 Mpa
 Unit Weight 167 pcf

Before the Test

After the Test

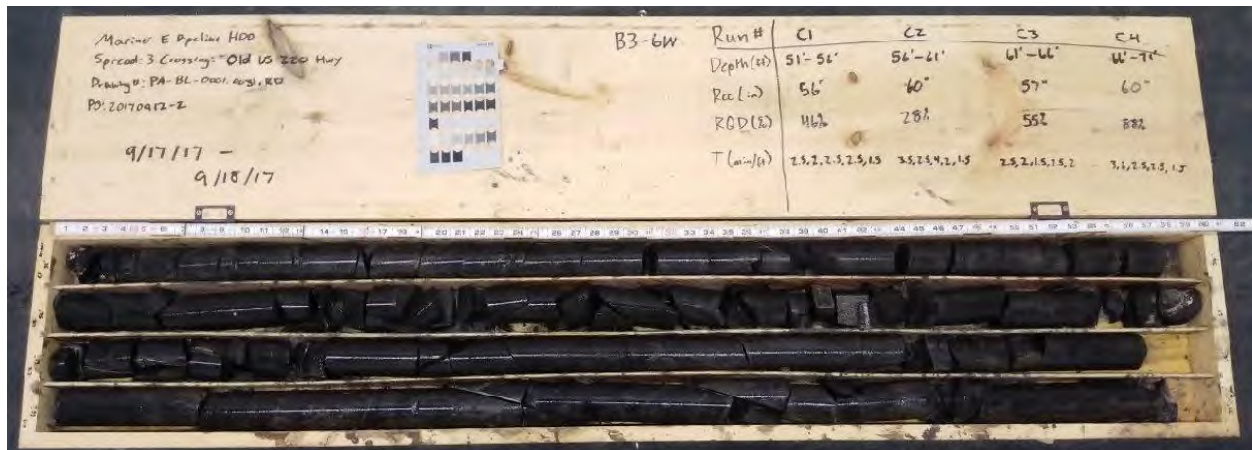
Photograph 1: B3-6W, Samples C-1 to C-4 (51 to 71 feet)

- **Boring B3-6W:** B3-6W was completed to a total depth of 171 feet. From 51 feet to 81 feet moderately hard to hard, moderately to slightly weathered SHALE with occasional calcite veins was encountered. The primary joint sets were low angle to moderately dipping, very closely to closely spaced and tight to moderately open. From 81 to 86 feet moderately hard to hard slightly to highly weathered SHALE was observed. Because of the severity of fracturing, it was not possible to fully identify details pertaining to the joints present in this interval. From 86 to 131 feet moderately hard to hard, fresh to slightly weathered SHALE was observed. The primary joint sets were low angle to moderate dipping, very closely to closely

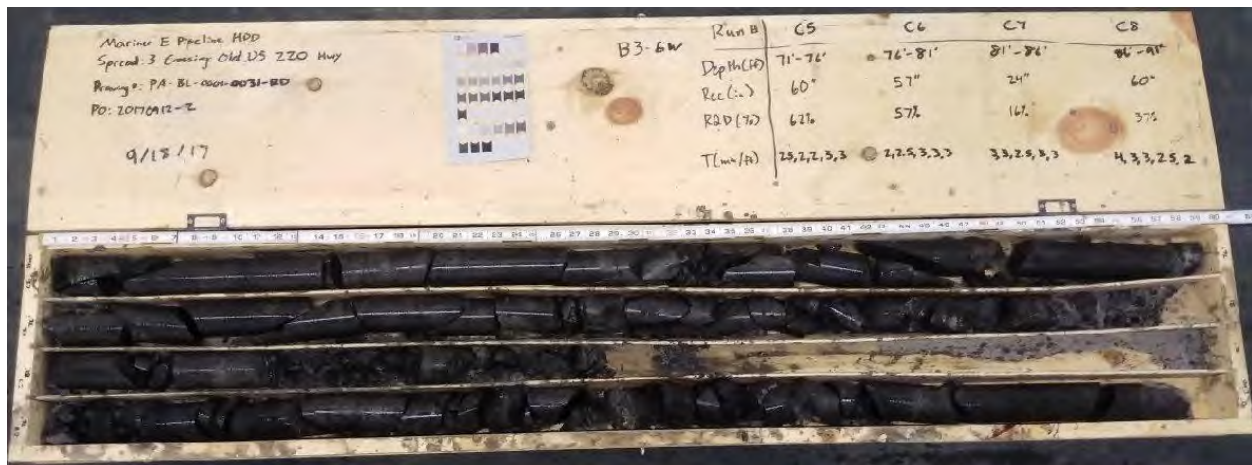
Photograph 2: B3-6W, Samples C-5 to C-8 (71 to 91 feet)

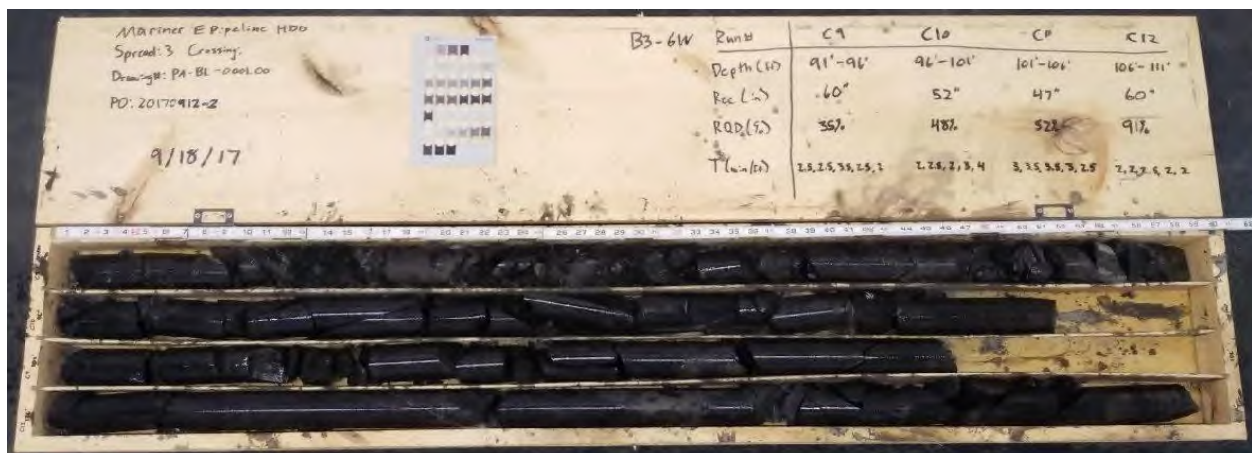
Photograph 3: B3-6W, Samples C-9 to C-12 (91 to 111 feet)

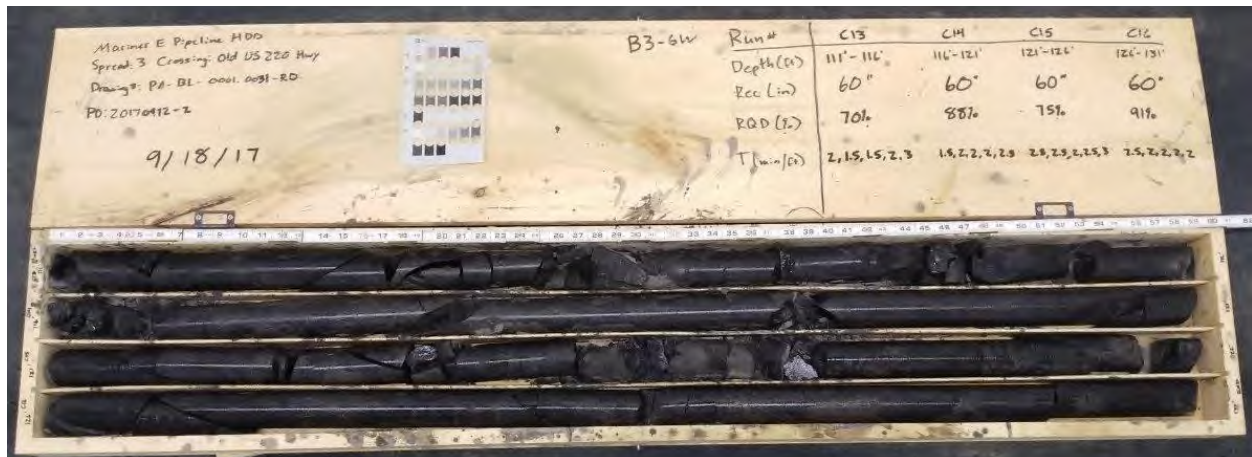
Photograph 4: B3-6W, Samples C-13 to C-16 (111 to 131 feet)

spaced and slightly to moderately open. A highly weathered zone was observed between 123.3 to 124.1 feet with a less fractured interval observed between 126 and 131 feet. From 131 to 86 feet moderately hard to hard, fresh to slightly weathered SHALE with occasional calcite veins was encountered. The primary joint set were low angle to moderate dipping, very closely to closely spaced and slightly open to open. RQDs in the SHALE ranged from very poor to excellent (16% to 100%). The lowest RQD was encountered in the severely fractured zone observed between 81 and 86 feet. The highest RQDs were encountered between 141 and 146 feet and 151 and 156 feet.

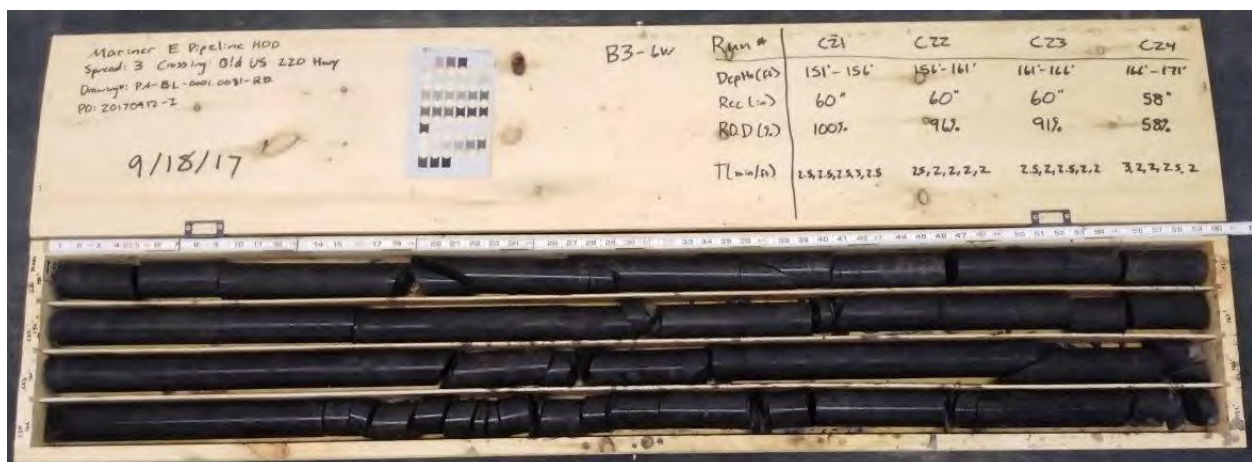
Photograph 6: B3-6W, C-21 to C-24 (151 to 171 feet)

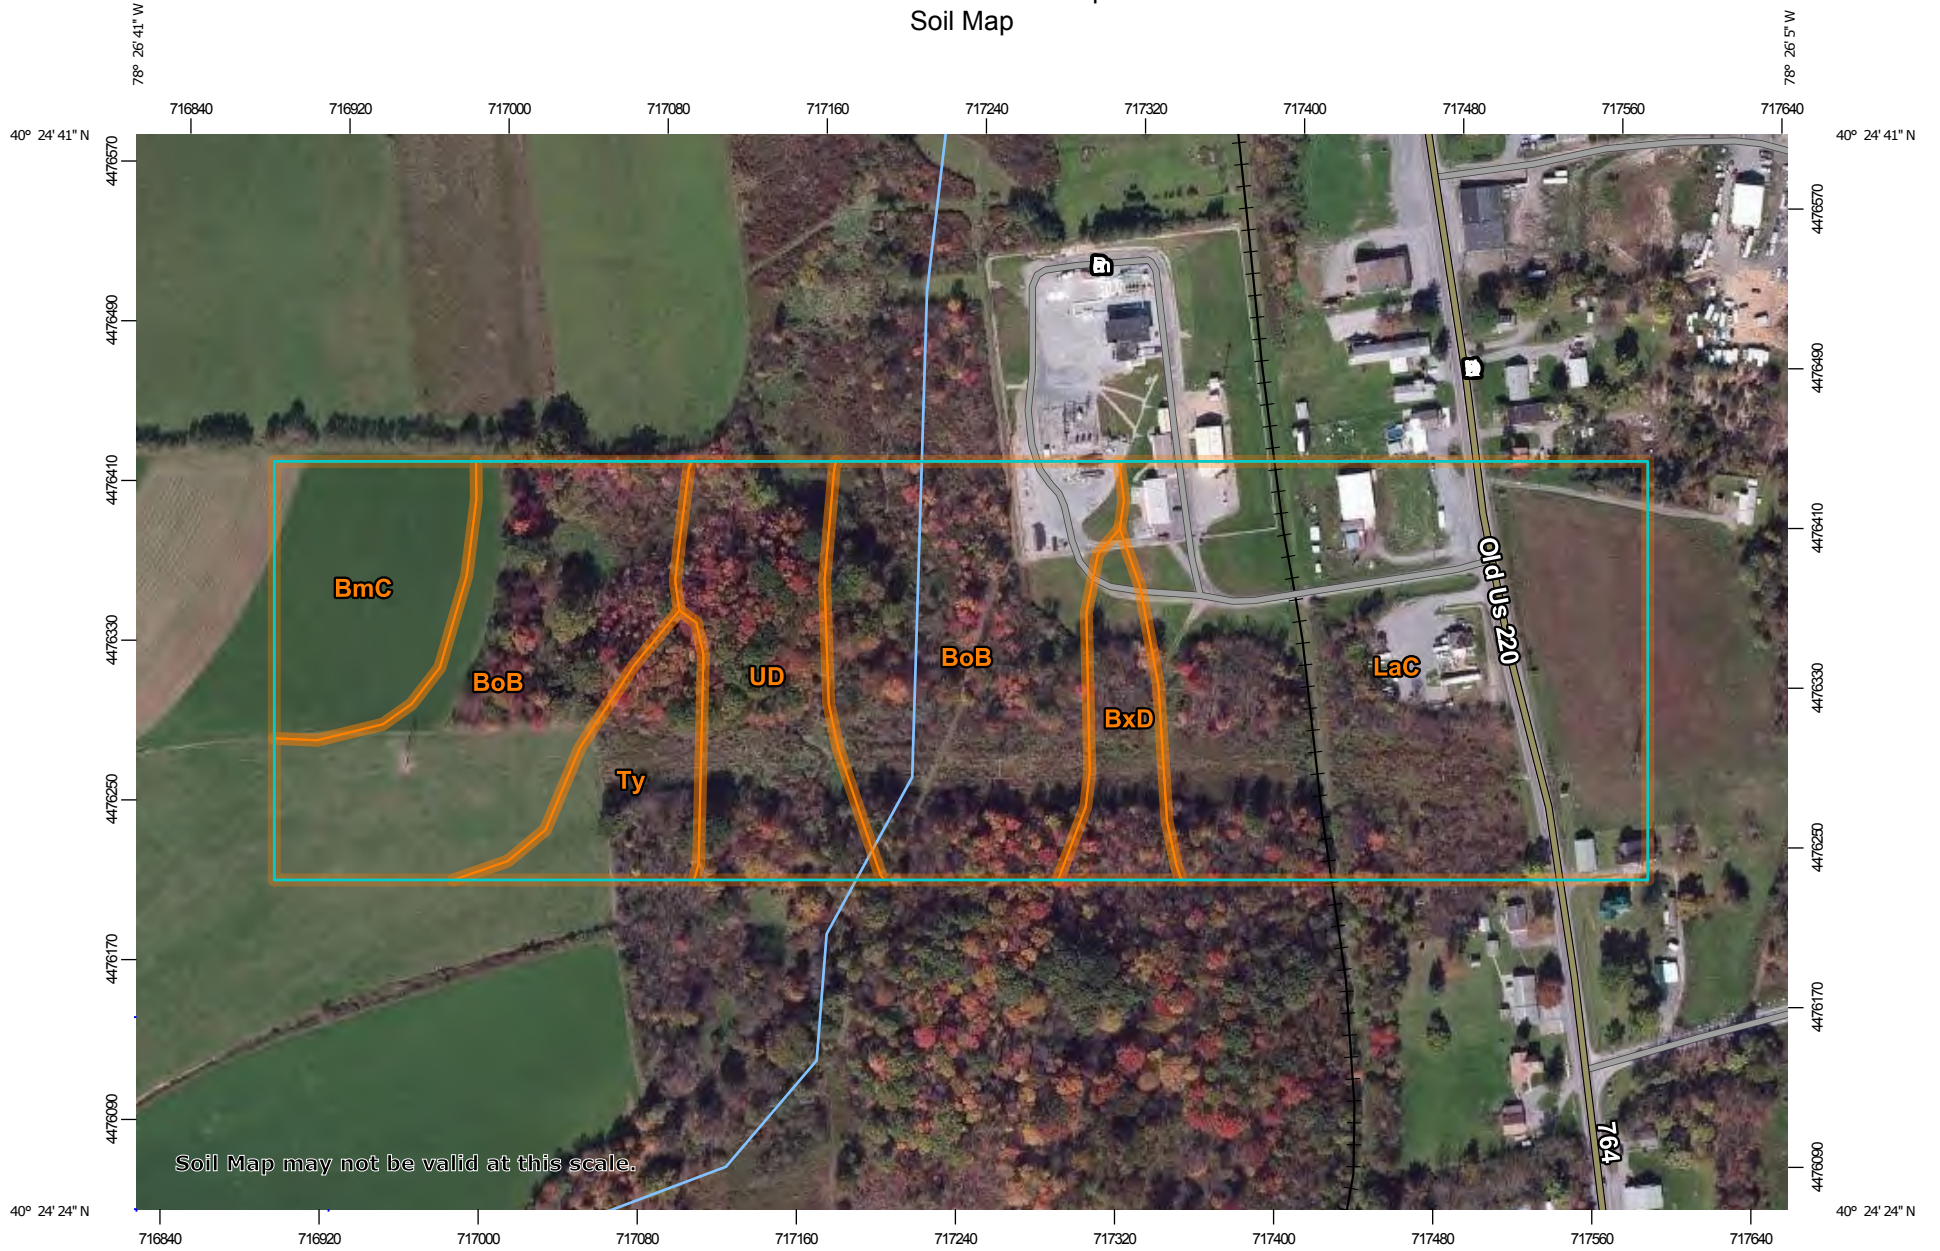
Custom Soil Resource Report Soil Map

The soil map section includes the soil map for the defined area of interest, a list of soil map units on the map and extent of each map unit, and cartographic symbols displayed on the map. Also presented are various metadata about data used to produce the map, and a description of each soil map unit.
