**HORIZONTAL DIRECTIONAL DRILL ANALYSIS
HIGHWAY 222 CROSSING
PADEP SECTION 105 PERMIT NO.: E06-701
PA-BR-0071.0000-RD-16
(SPLP HDD No. S3-0200-16)**

This reanalysis of the horizontal directional drill (HDD) installation of a 16-inch diameter pipeline that traverses Highway 222 in Cumru Township, Berks County, Pennsylvania, is in accordance with the Stipulated Order issued under Environmental Hearing Board Docket No. 2017-009-L for HDDs listed on Exhibit 3 of the Stipulated Order. This HDD is number 16 on the list of HDDs included on Exhibit 3 of the Order.

**ATTACHMENT 1
GEOLOGY AND HYDROGEOLOGICAL EVALUATION REPORT**

**ATTACHMENT 2
HORIZONTAL DIRECTIONAL DRILL PLAN AND PROFILES**

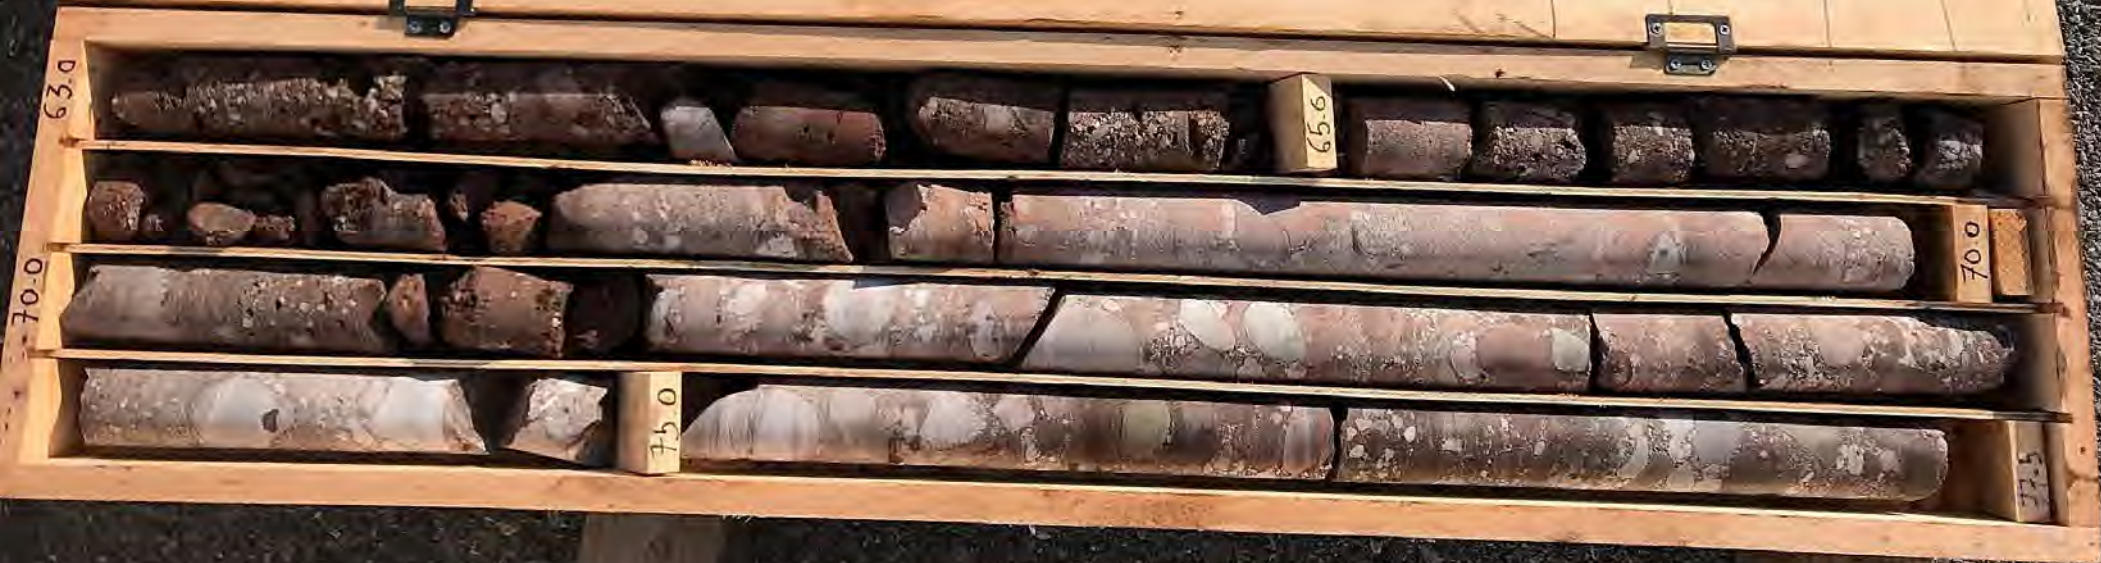
691-1-11
201-70830-2
HDD Boring (AB#1)
09/05/17
Depth: 77.5 ft - 17.5 ft
Box: 5 of 9
HWY 222 (West side)

Run	Depth	Loc	ROD
15	800-850	52'	47'
16	850-900	60'	43'
17	900-925	60'	47'

- **Boring SB-03:** Rock coring was not completed at this location.
 - **Boring B-01:** B-01 was completed to a total depth of 145 feet bgs. The top of bedrock was encountered at approximately 10.25 feet bgs. From 10.25 to 15 feet bgs, highly weathered to completely weathered SANDSTONE was observed. TCR was 12%, while RQDs were very poor (0%). From 15 to 25 feet bgs, light red-gray-brown to dark gray-brown, fine to very coarse grained, weathered to highly weathered, very broken to massive, moderately hard to hard CONGLOMERATE was observed with trace pits and vugs. TCR ranged from 92% to 100% and RQDs were very poor to poor (20 to 26). From 25 to 42 feet bgs light gray to dark brown, fine to very coarse grained, slightly weathered to highly weathered, slightly to very broken to massive, hard to very hard CONGLOMERATE was observed with trace pits and vugs. TCR ranged from 57% to 88% and RQDs were very poor to poor (8 to 38). From 42 to 43.8 feet bgs, red-brown, fine grained, weathered to slightly weathered, very broken to slightly broken, moderately hard SANDSTONE was observed. TCR was 100% and RQDs were poor (42). From 43.8 to 84.5 feet bgs, light gray-white to dark brown, fine to very coarse grained, slightly to highly weathered, very broken to massive, moderately hard to very hard CONGLOMERATE was observed with trace pits and vugs. TCR ranged from 83% to 100% and RQDs were poor to good (38 to 88). From 84.5 to 86 feet bgs, gray-brown to dark gray-brown, fine to very coarse grained, slightly weathered, slightly broken to massive, moderately hard conglomeritic SANDSTONE was observed. From 86 to 90.5 feet bgs, light gray-brown to dark gray-brown, fine to very coarse grained, weathered to slightly weathered, very broken to massive, hard to very hard CONGLOMERATE was observed. TCR was 100% and RQDs were fair (72). From 90.5 to 96 feet bgs, light gray-brown, fine to medium grained, slightly weathered, slightly broken to massive, hard to very hard SANDSTONE was observed. TCR was 100% and RQDs were good (78). From 96 to 98 feet bgs, gray-brown to dark gray-brown, fine to very coarse grained, slightly weathered, very broken to massive, hard conglomeritic SANDSTONE was observed. From 98 to 145 feet bgs, light gray-brown to dark brown, fine to very coarse grained, weathered to slightly weathered, very broken to massive, hard to very hard CONGLOMERATE was observed with trace pits and vugs. TCR ranged from 92 to 100% and RQDs ranged from fair (68) to excellent (98). Groundwater was observed at 20 feet bgs after the completion of coring operations.

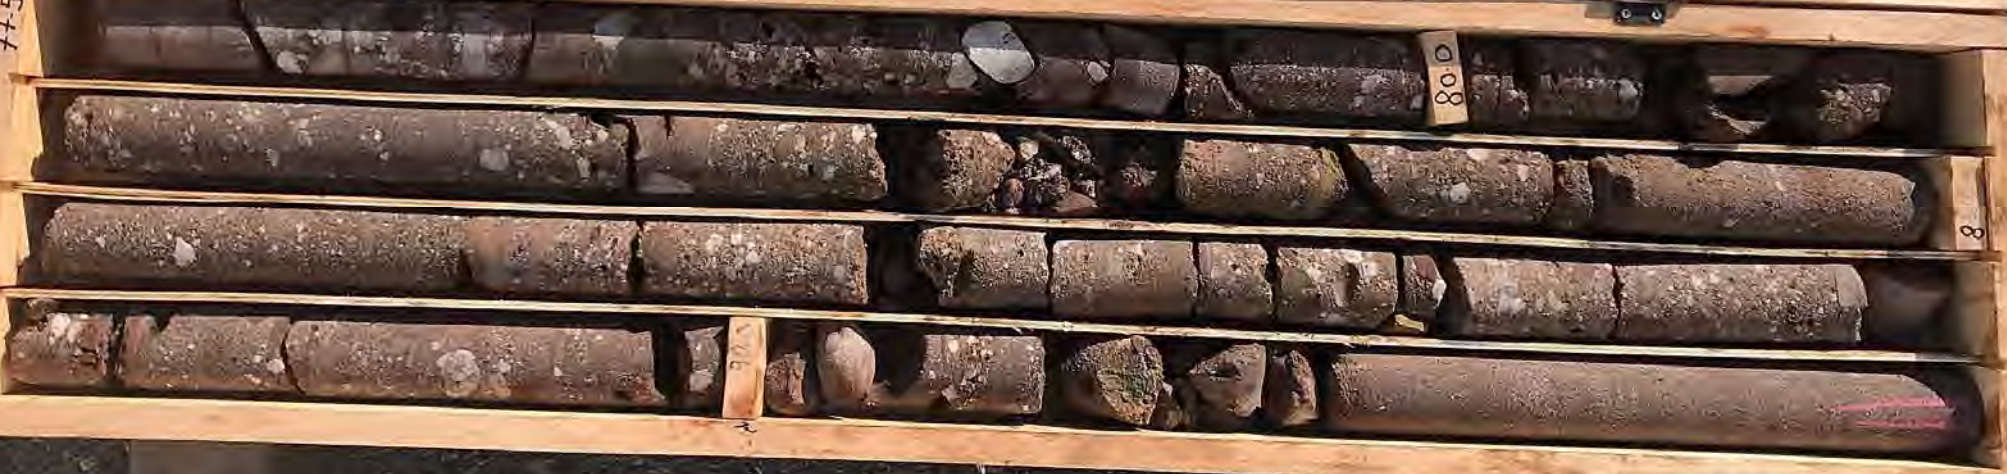
0491 1461
DPS # 20170830-2
HDD Boring 681
9/5/17
Depth: 925 ft - 1076 ft
Box 6 of 9
Hwy 222 (west side)

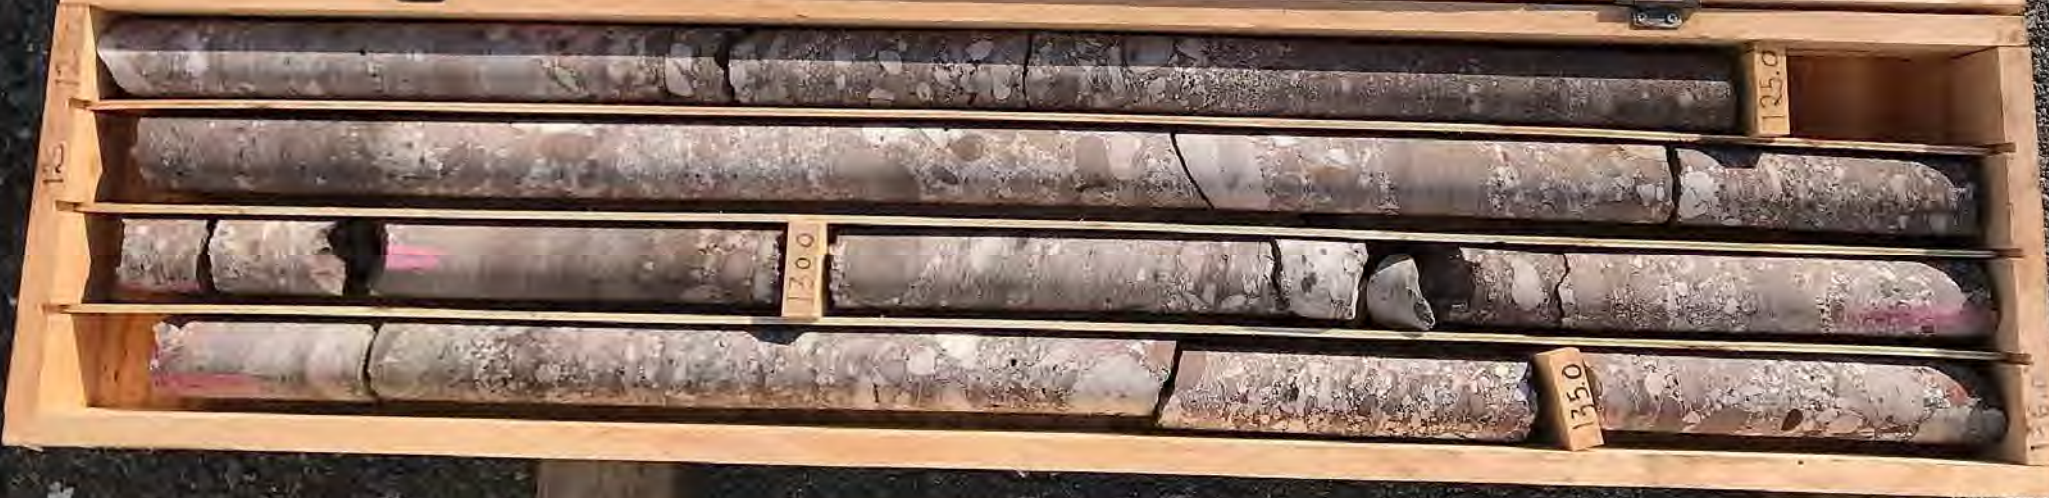
W8# 20170830-2
0491 1461
HDD Boring (6841)
09/06/17
Depth 136.0 - 145.0 ft
Box 7 of 9
HWY 222 (West side)

Run	Depth	Box	Qty
27	140-145	501	581

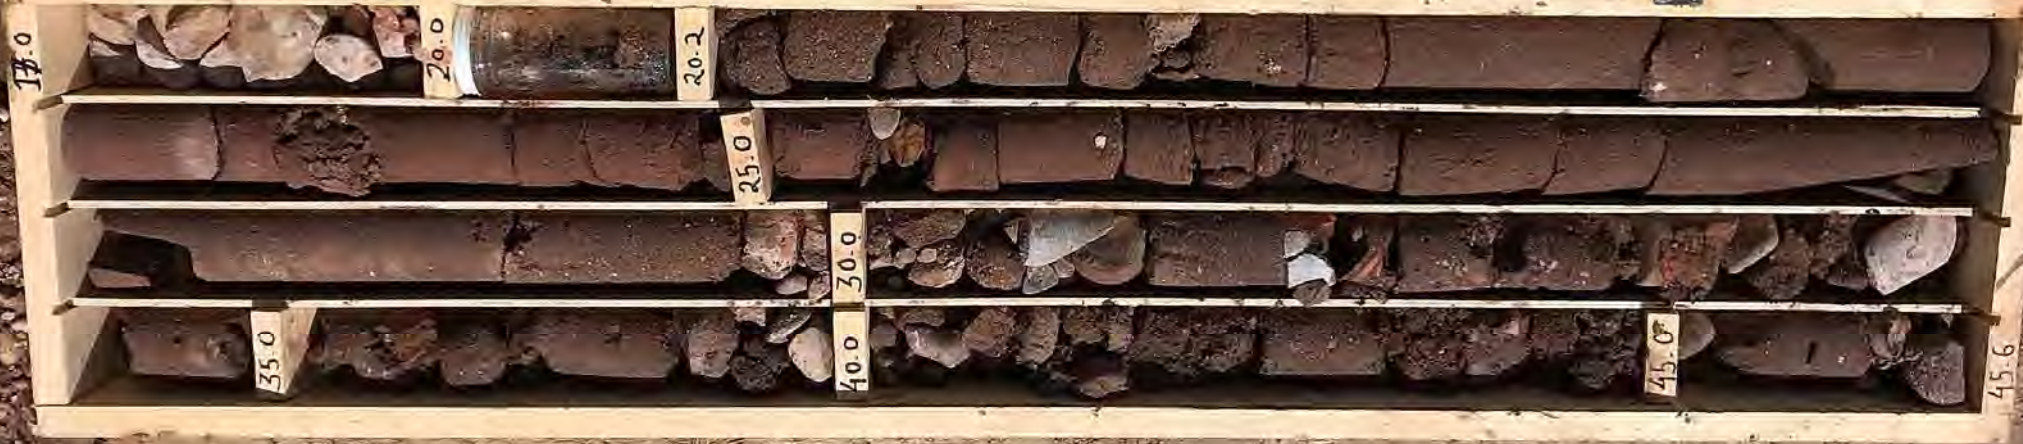
DPS # 20170830-2
 0491 1461
 HDD Boring (GB#2)
 09/07/17
 Depth: 45.6 ft - 87.5 ft
 Box: 2 of
 HWY 222 (East side)

Log	Depth (ft)	Rec (in)	Rqdc (in)
8	50.0-55.0	17"	0"
9	55.0-60.0	22"	9"
10	60.0-65.0	18"	4"
11	65.0-70.0	11"	0"
12	70.0-75.0	10"	0"
13	75.0-80.0	21"	0"
14	80.0-85.0	35"	110"

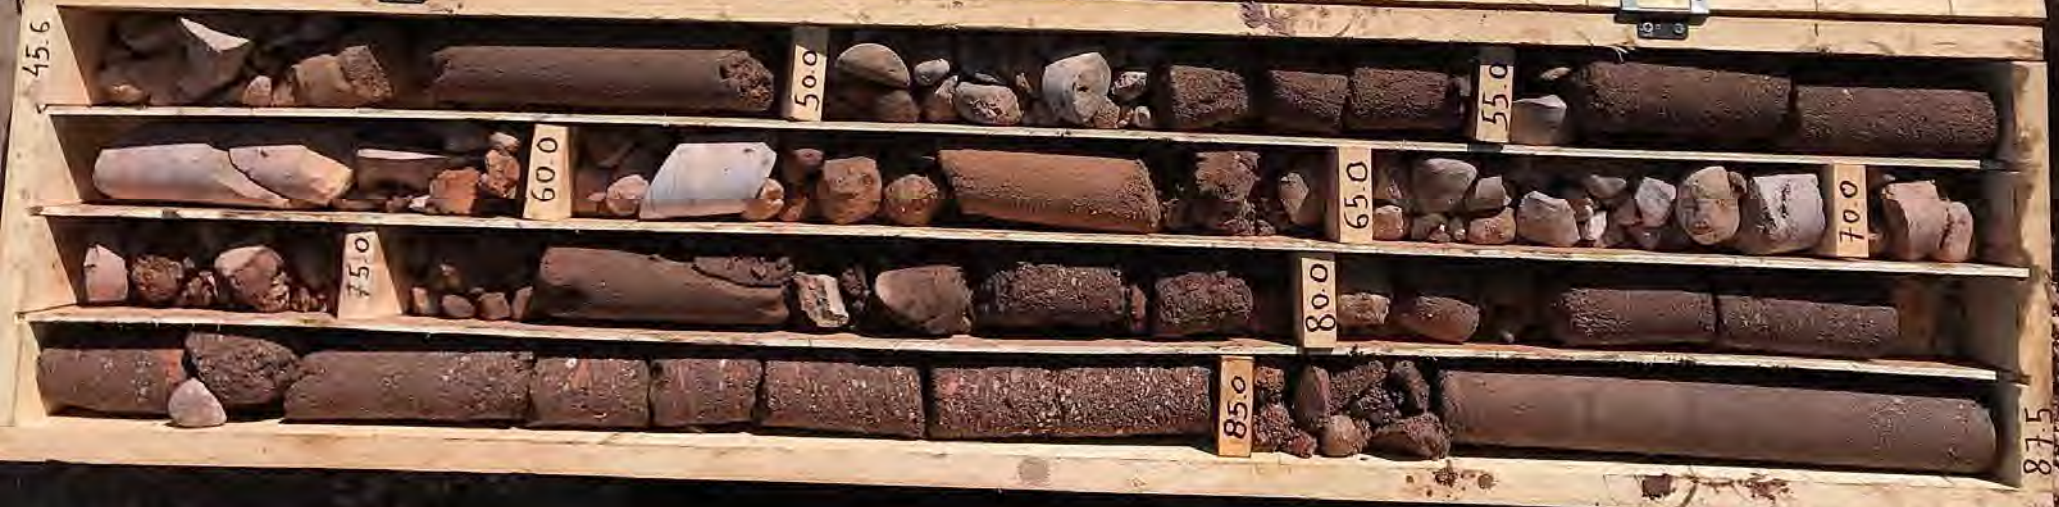
DPS# 20170830-2
 0491 1461
 HDD Boring (GB#2)
 09/07/17
~~HDD Boring~~
 Depth: 87.5ft - 105.5ft
 Box: 3 of
 HWY 222 (East side)

Run	Depth (ft)	Rec (in)	RQD (%)
15	85.0-90.0	52"	35"
16	90.0-95.0	58"	31"
17	95.0-100.0	33"	9"
18	100.0-105.0	50"	29"

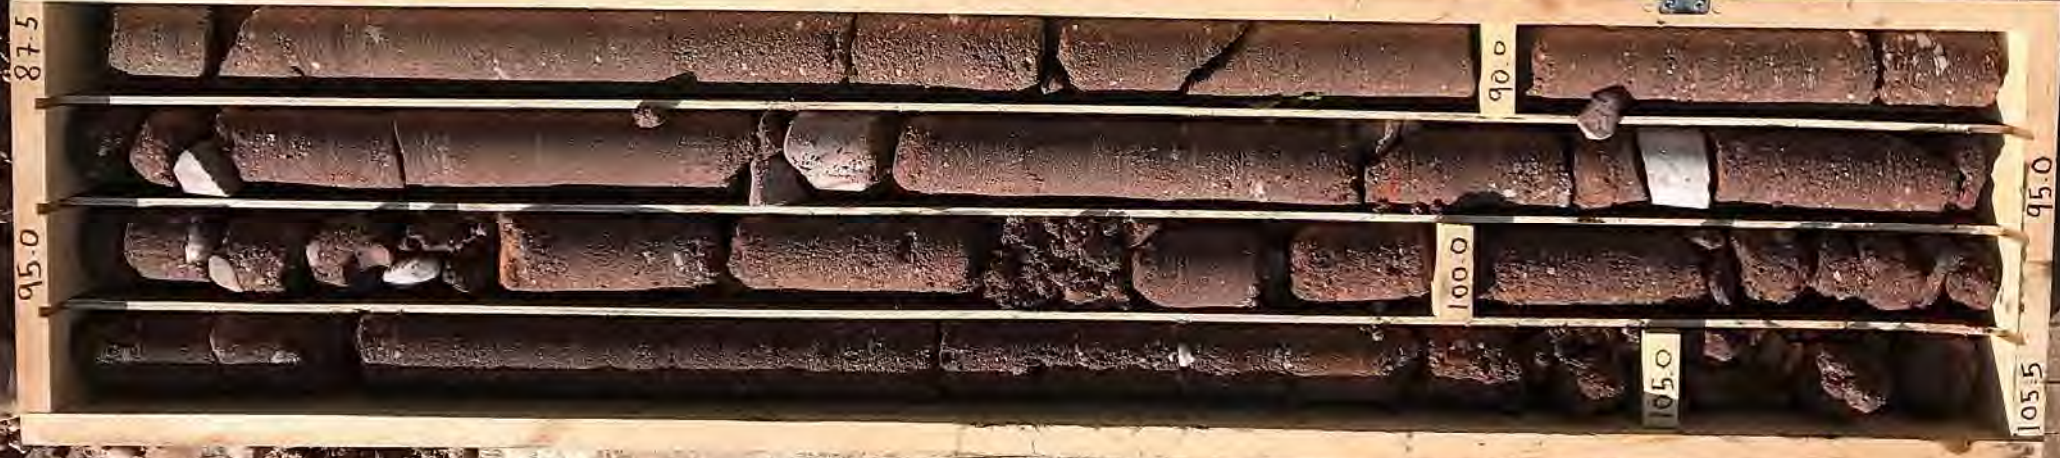
DPS # 20170830-2
04911461
MDD Boring (GB#2)
09/07/17
Depth: 105.5ft - 127.0ft
Box: 4 of
Hwy 222 (East side)

Run	Depth (ft)	Rc (in)	RQD (in)
19	105.0-110.0	22"	0"
20	110.0-115.0	37"	9"
21	115.0-120.0	60"	28"
22	120.0-125.0	36"	5"
23	125.0-130.0	60"	26"

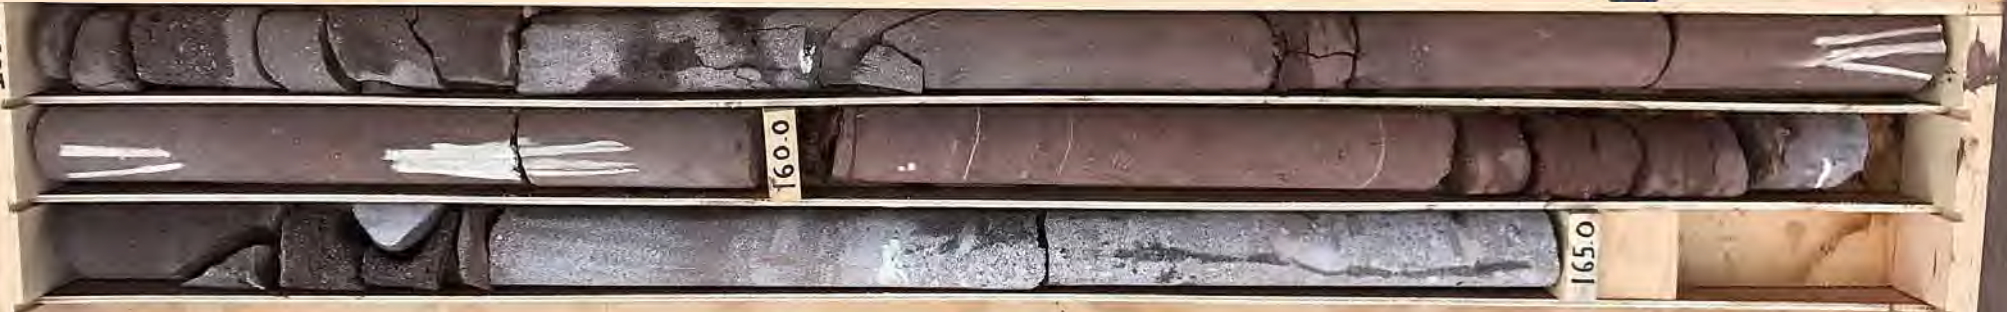
Run	Depth(ft)	Rec(in)	ROD(in)
29	155.0-160.0	60"	44"
30	160.0-165.0	60"	38"

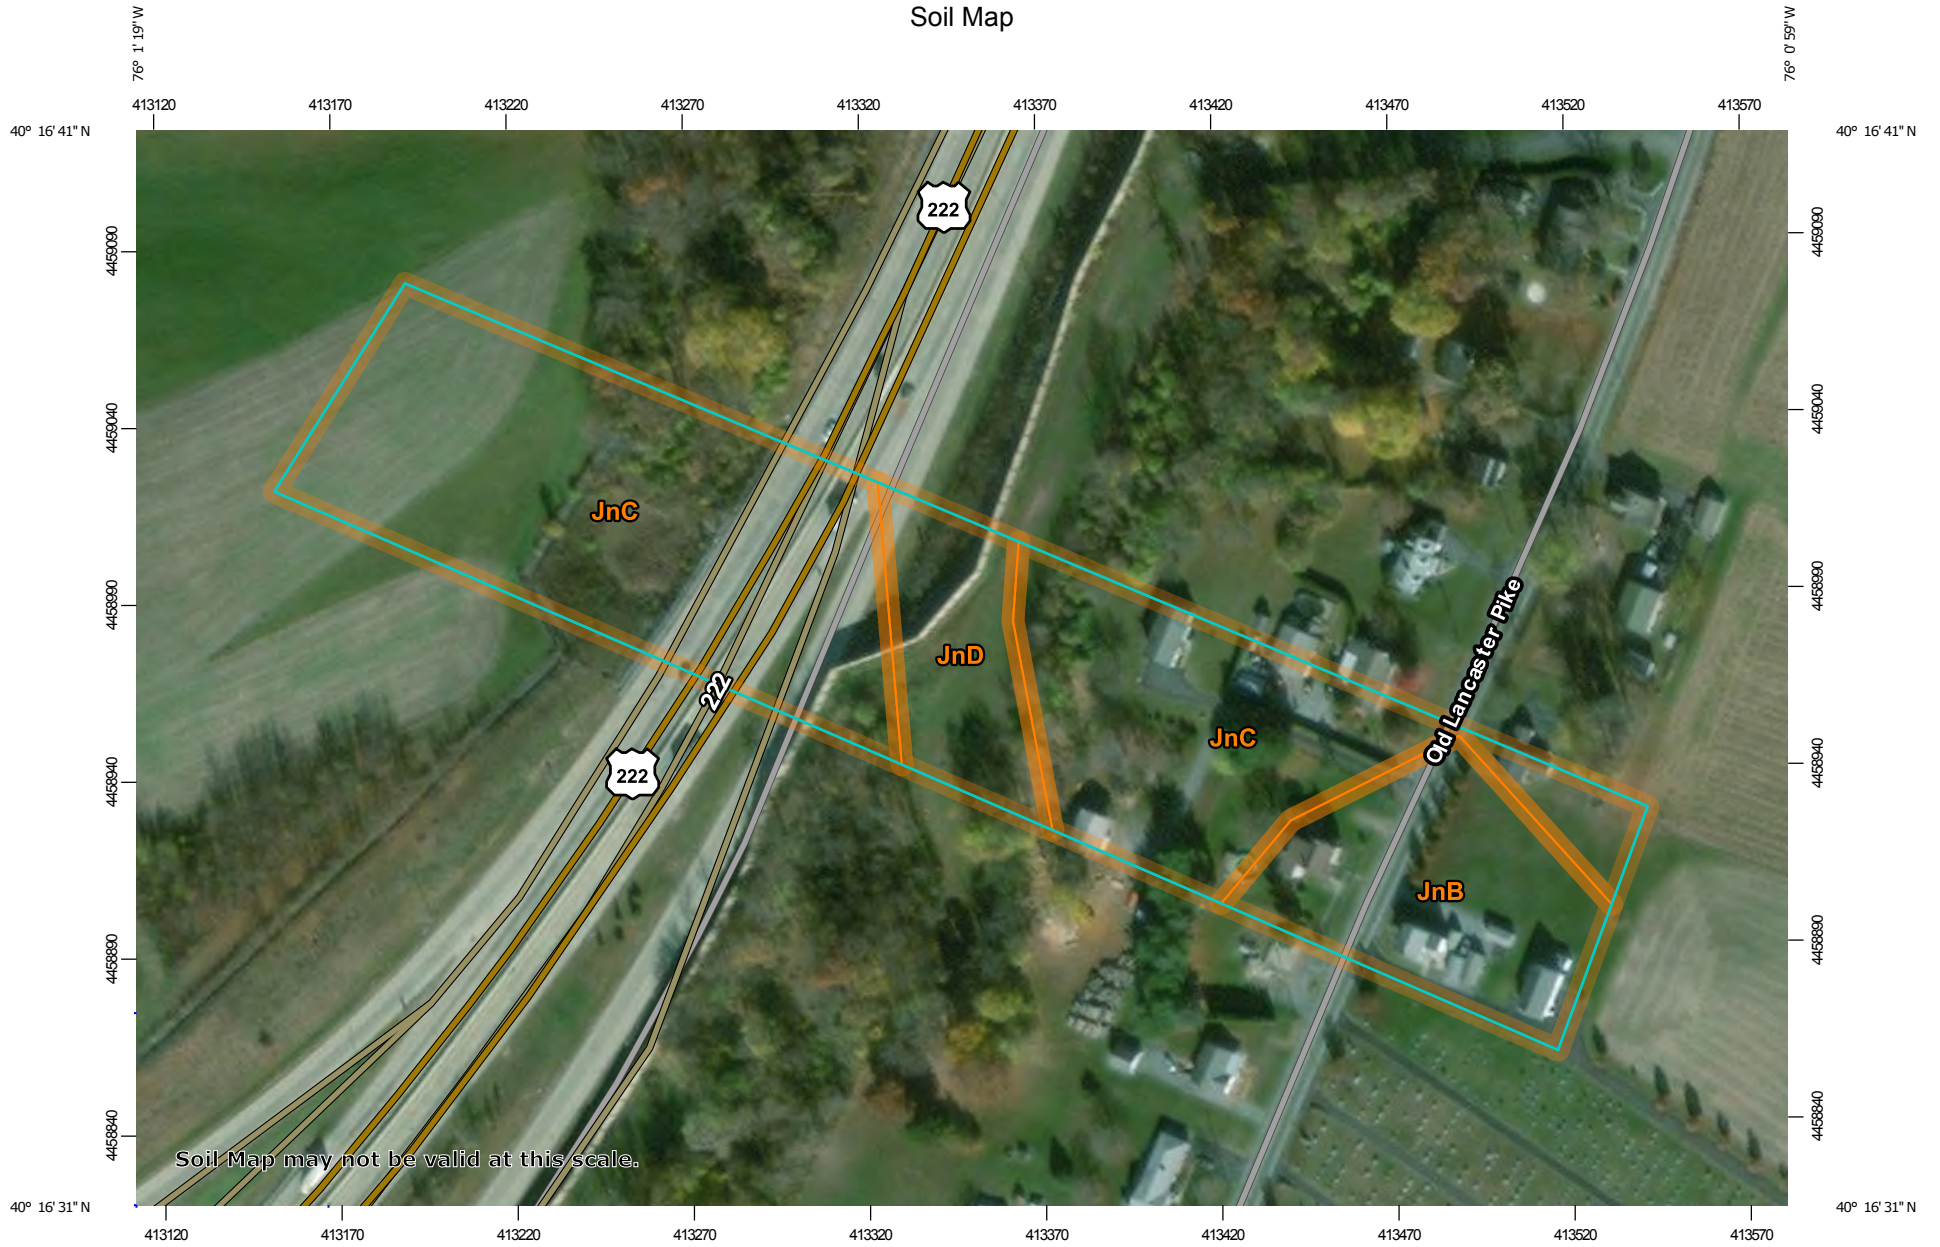
Custom Soil Resource Report Soil Map

The soil map section includes the soil map for the defined area of interest, a list of soil map units on the map and extent of each map unit, and cartographic symbols displayed on the map. Also presented are various metadata about data used to produce the map, and a description of each soil map unit.

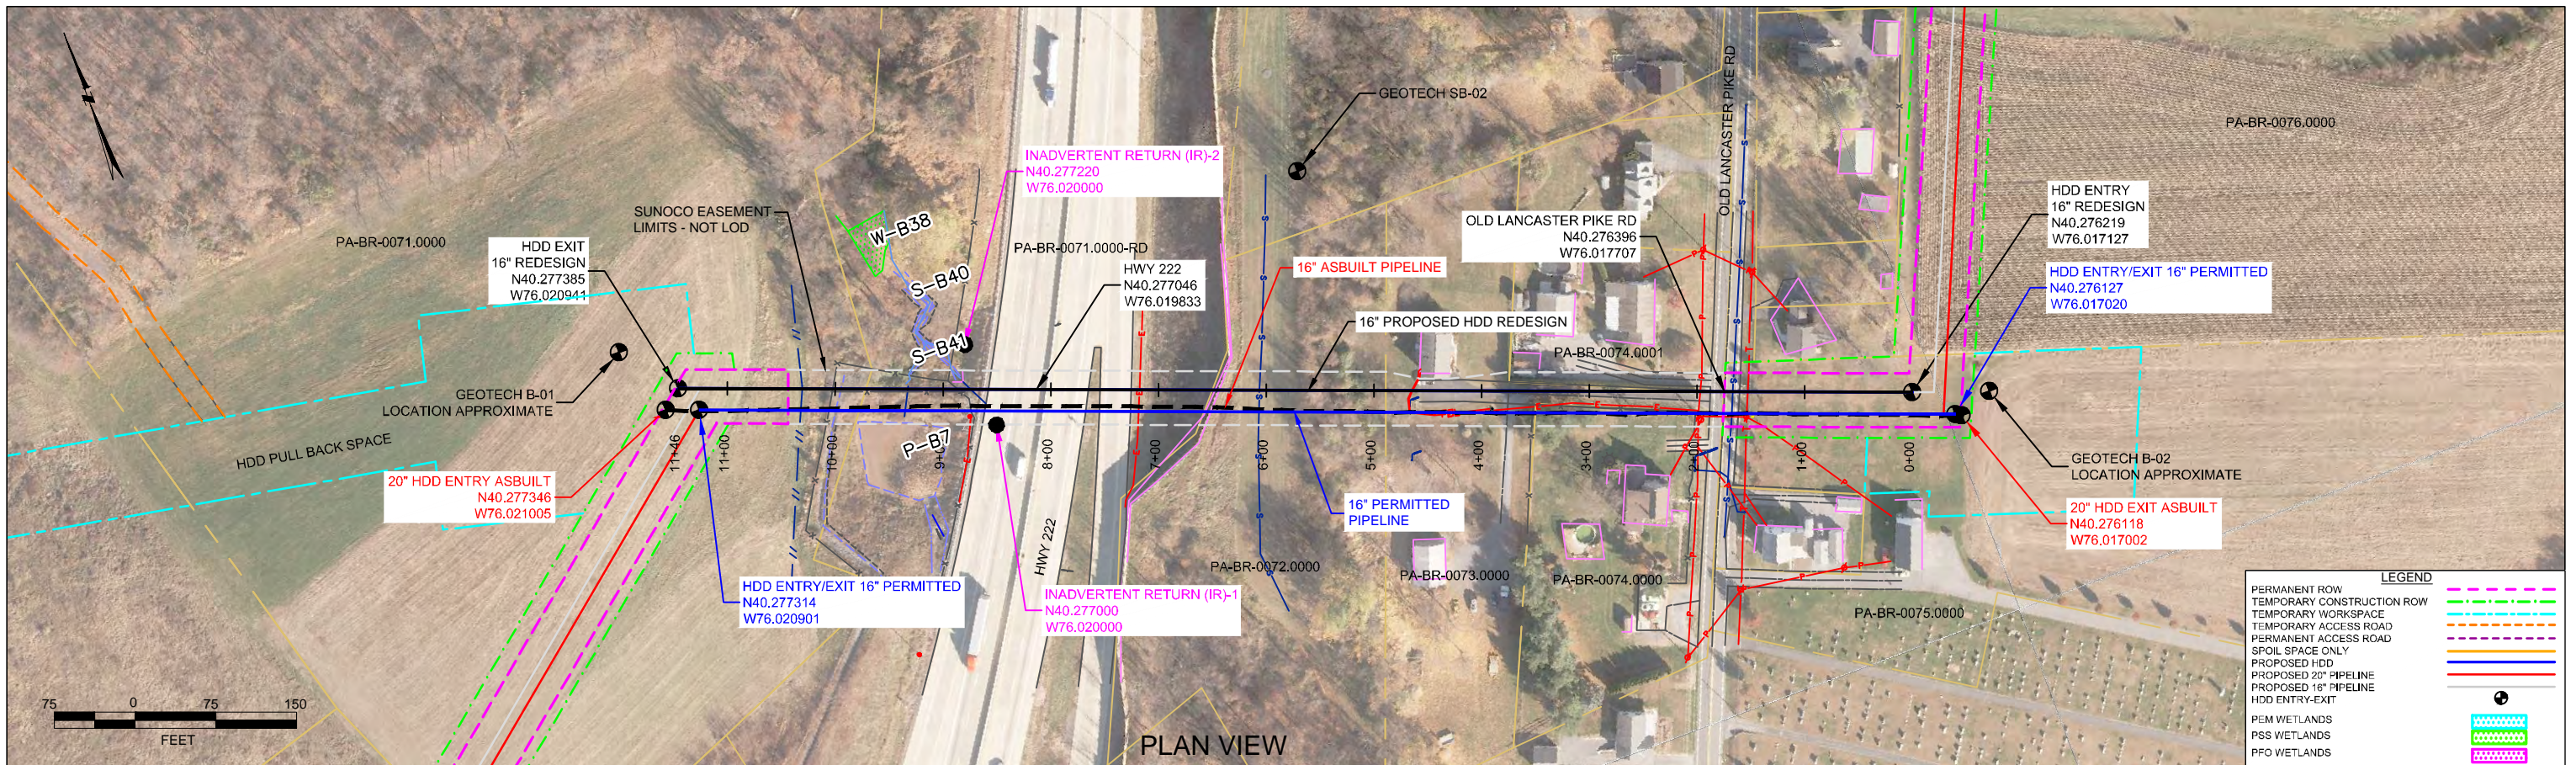
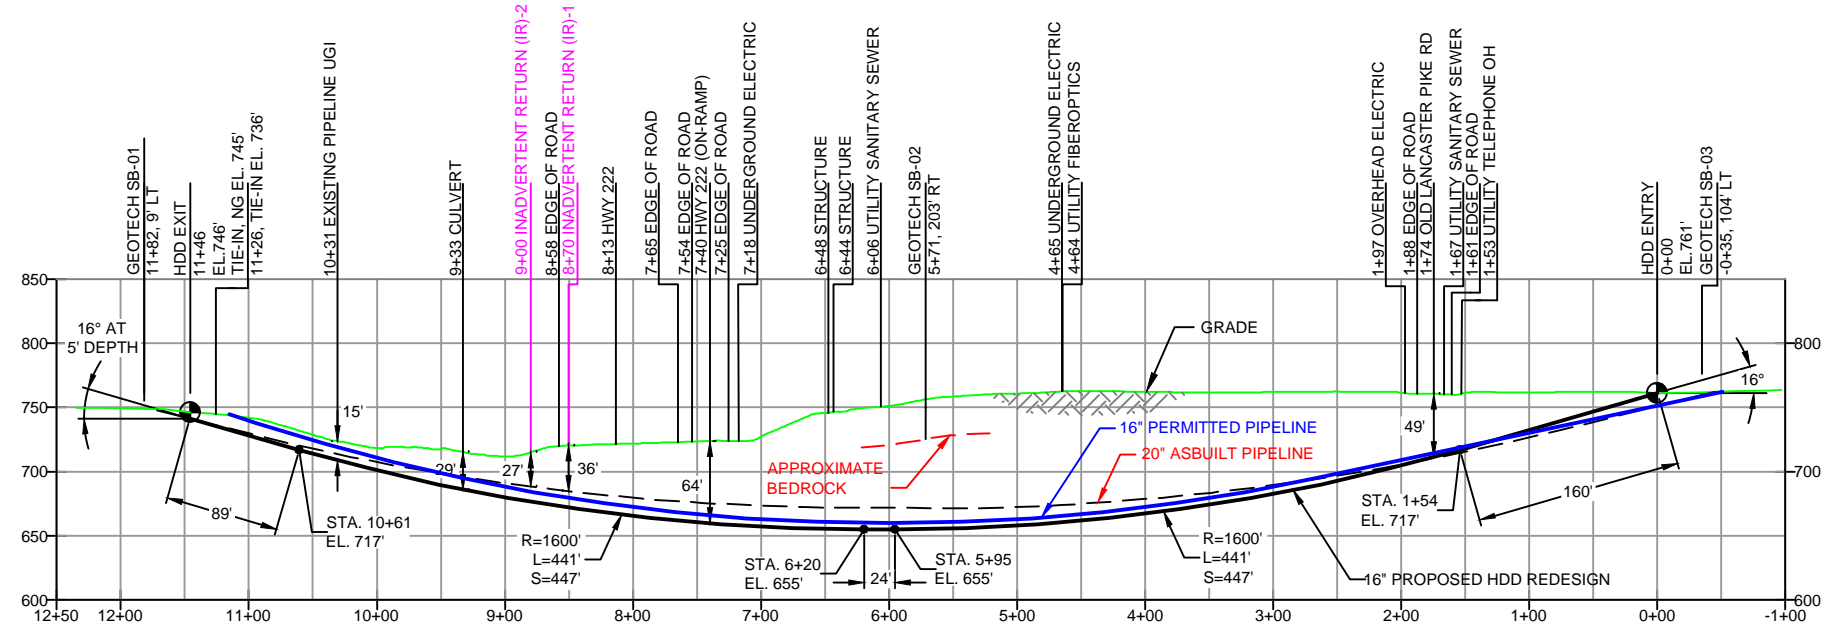
Figure 1. Permitted 16-Inch HDD Plan and Profile with 20-Inch IR Data

- DESIGNED IN ACCORDANCE WITH CFR 49 195 & ASME B31.4
 - CROSSING PIPE SPECIFICATION:
HDD HORZ. LENGTH (L): 1146'
HDD PIPE LENGTH (S): 1167'
16" x 0.438" W.T., X-70, API5L, PSL2, ERW, BFW
COATING: 14-16 MILS FBE WITH 40 MILS MIN. ARO (POWERCRETE R95)
