TRIP REPORT

Subject: Summary of Soil Infiltration Tests
Raystown Lake West
Sunoco Pipeline/Valve Stations
Penn Township, Huntingdon County, Pennsylvania

This trip report provides results of soil infiltration tests that were completed as part of the Segment 2 Pipeline Project for Sunoco, in Penn Township, Huntingdon County, Pennsylvania.

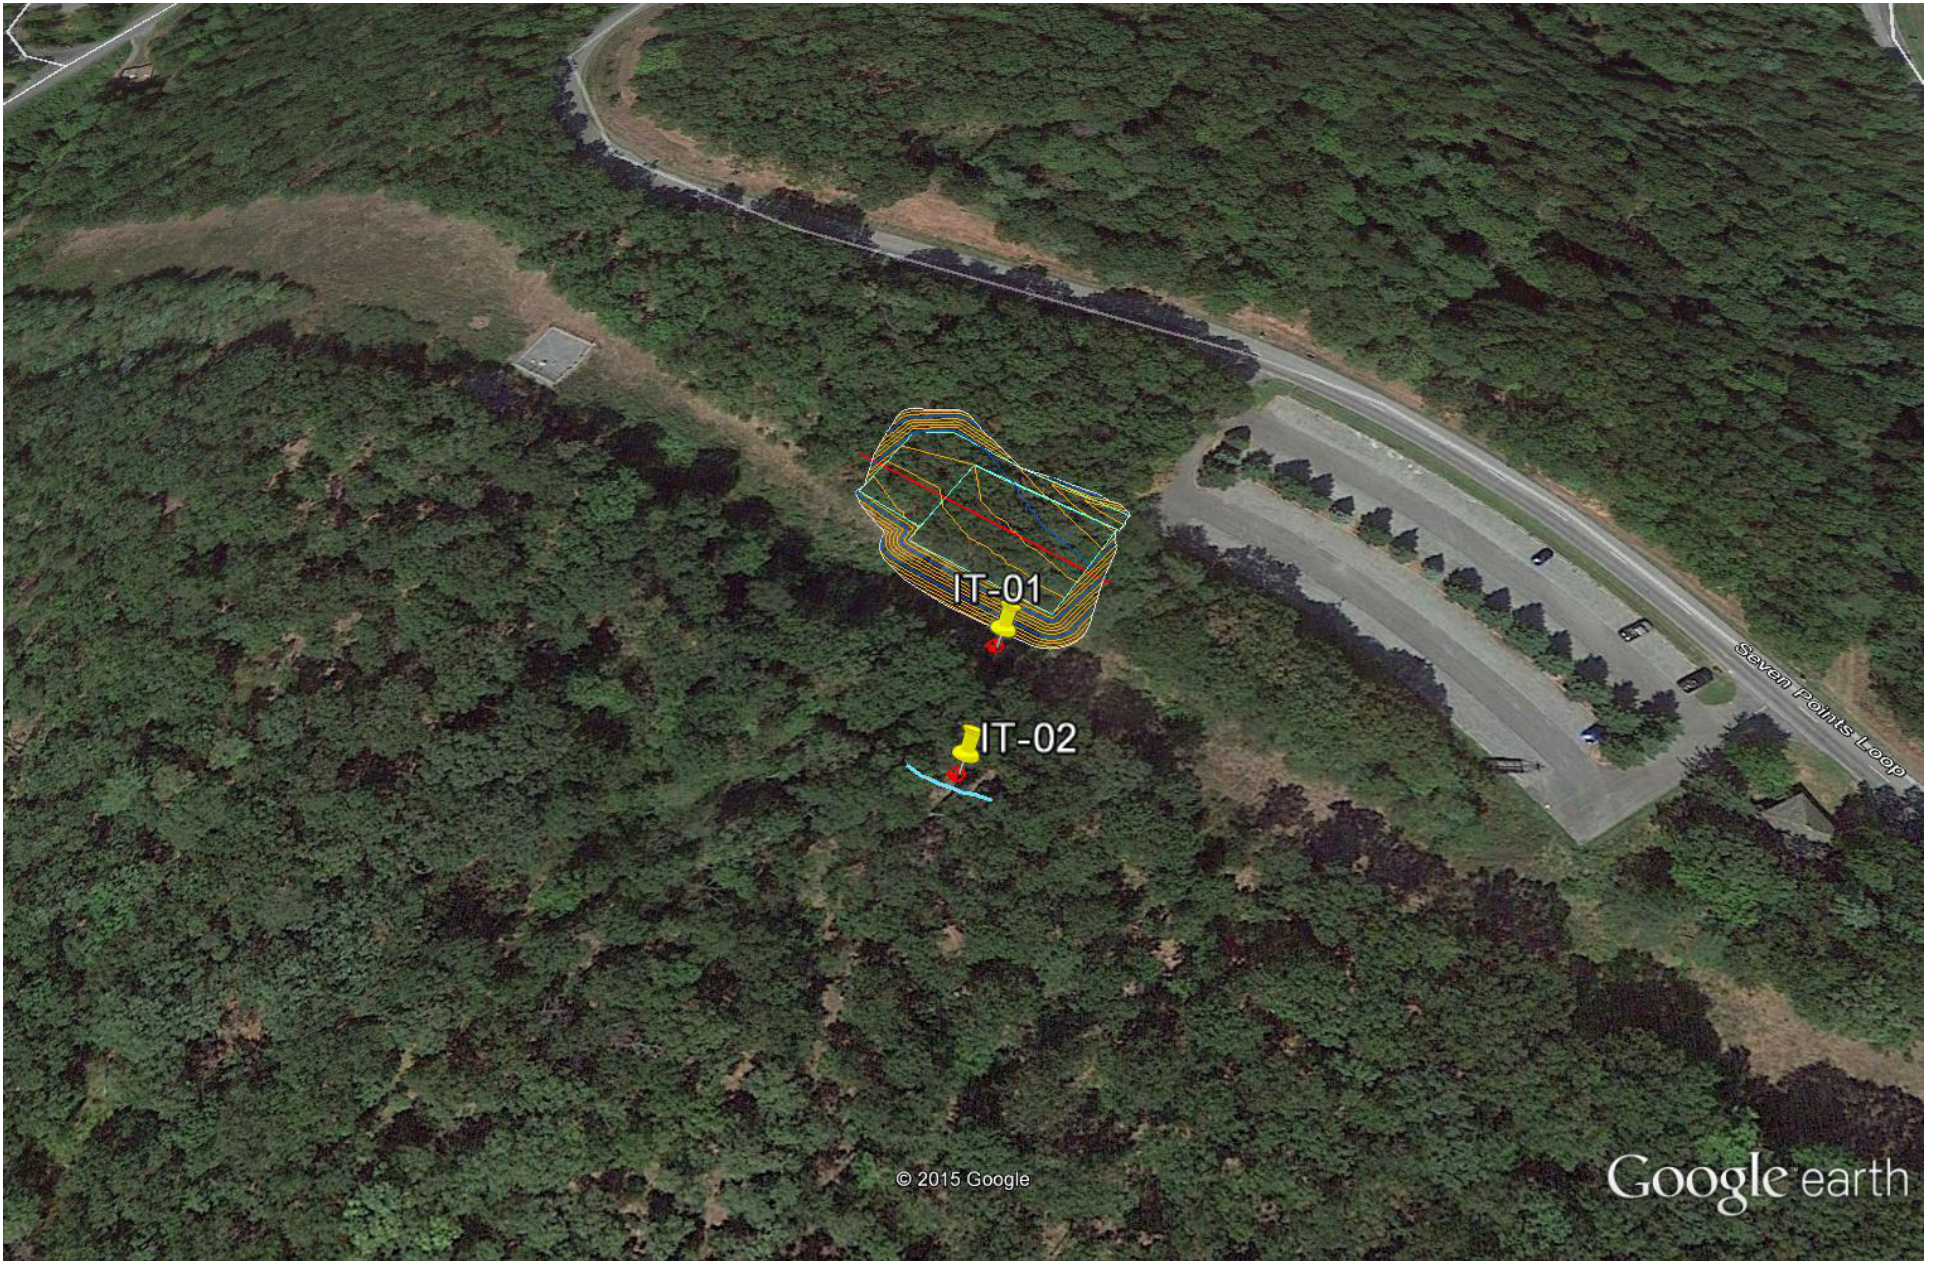
SITE FIGURE

This report presents the field data and results of double ring soil infiltration tests conducted to support the design of stormwater management systems at several locations in Penn Township, Huntingdon County, Pennsylvania. Two shallow tests (IT-1 and IT-2) were performed at the property. Test locations are listed by coordinates (latitude and longitude) in Table 1 and shown on the attached figures.

The infiltration tests were conducted by Mark Mengel and Matt Simcik of Tetra Tech, Inc., on September 21, 2015. The test locations were positioned in the field using a handheld, WAAS-enabled GPS unit and reference to google earth map. Table 1 provides the coordinates recorded in the field. IT-1 and IT-2 were located approximately in a field adjacent to a forest of moderate sized deciduous and pine trees. Photographs of testing locations are attached to this report.

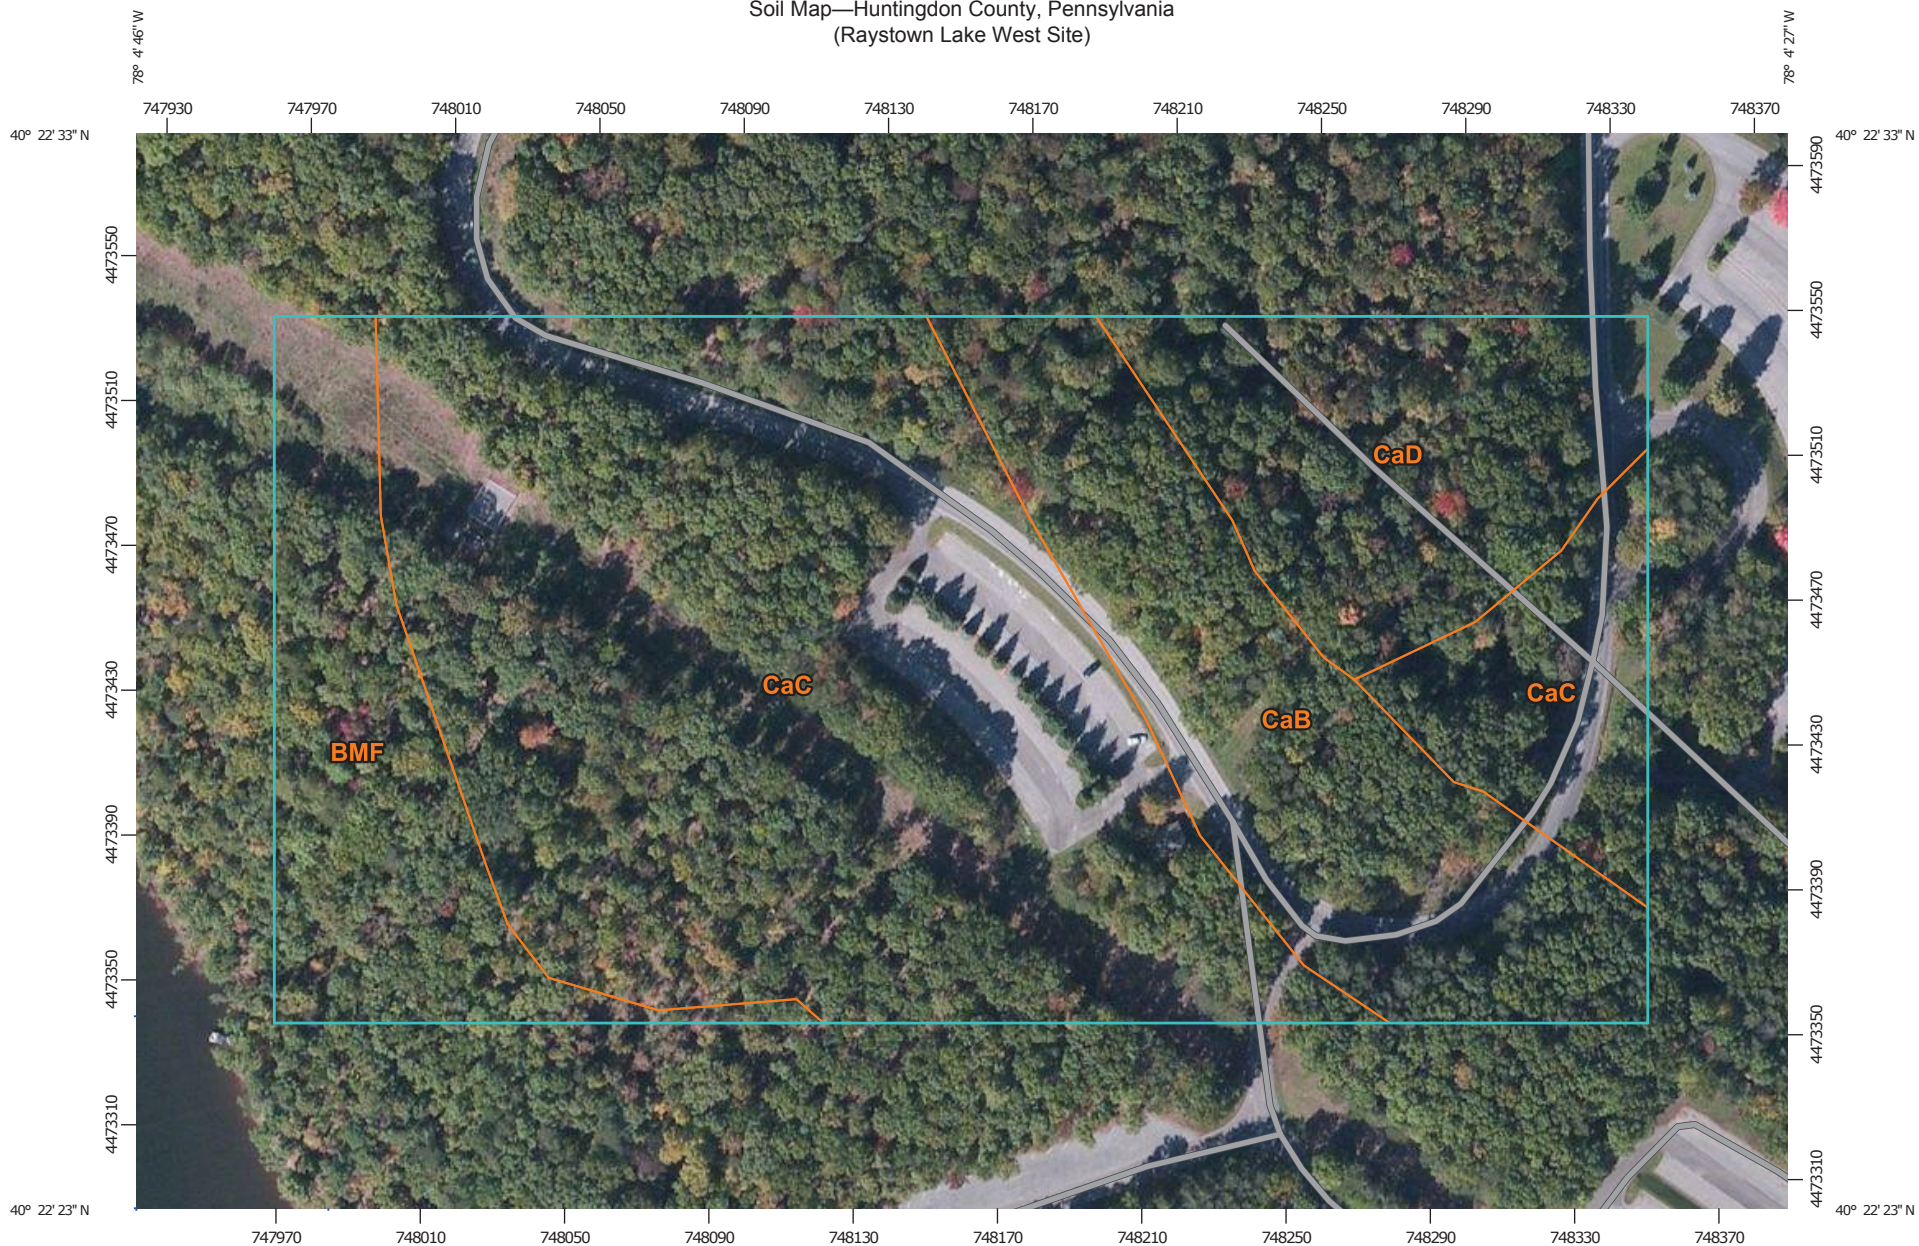
Soil Map—Huntingdon County, Pennsylvania
(Raystown Lake West Site)

According to United States Department of Agriculture Natural Resources Conservation Service Web Soil Survey¹ data, the soil types for the test locations are mapped as follows:

- IT-1 and IT-2 – Calvin shaly silt loam (CaC soil symbol) with 8 to 15 percent slopes

Huntingdon County, Pennsylvania (PA061)			
Map Unit Symbol	Map Unit Name	Acres in AOI	Percent of AOI
BMF	Berks-Weikert association, steep	2.3	12.3%
CaB	Calvin shaly silt loam, 3 to 8 percent slopes	3.4	18.4%
CaC	Calvin shaly silt loam, 8 to 15 percent slopes	10.3	55.9%
CaD	Calvin shaly silt loam, 15 to 25 percent slopes	2.5	13.3%
Totals for Area of Interest		18.4	100.0%

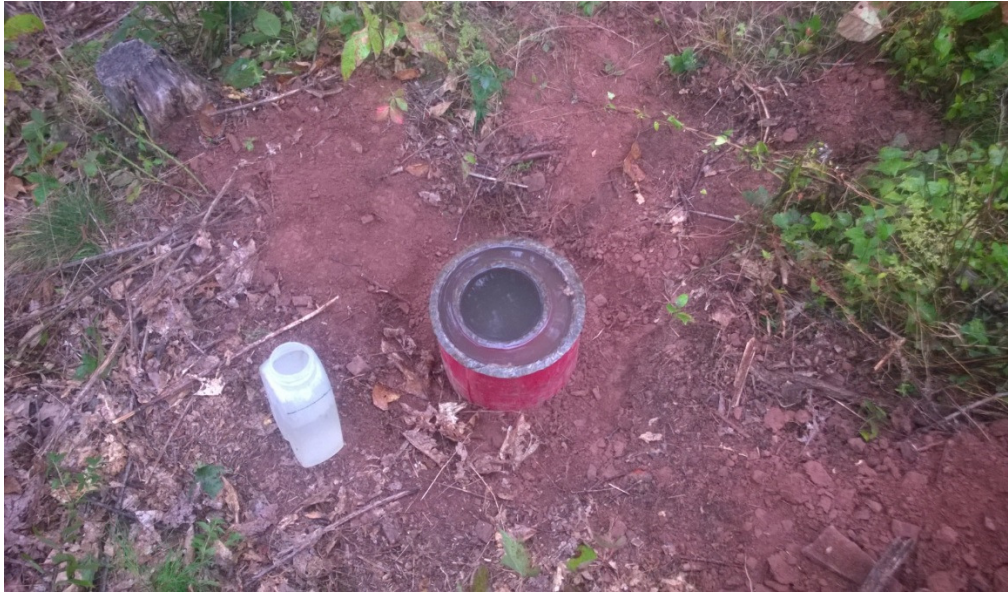
Both tests exhibited a slow rate of infiltration requiring a 30-minute test cycle.

Description: Test at Raystown Lake West IT-2, approximately 6 inches deep.
