## TRIP REPORT

**Subject:** Summary of Soil Infiltration Tests  
Schaeffer Road  
Sunoco Pipeline/Valve Stations  
South Lebanon Township, Lebanon County, Pennsylvania

This trip report provides results of soil infiltration tests that were completed as part of the Segment 3 Pipeline Project for Sunoco, in South Lebanon Township, Lebanon County, Pennsylvania.

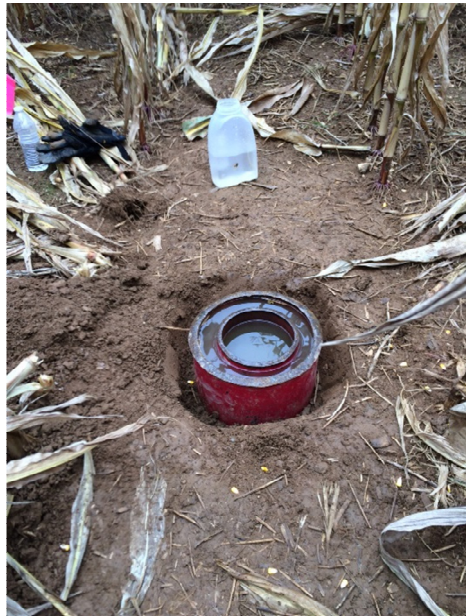
**Description:** Test at Schaeffer Rd. IT-4, approximately 6 inches deep.

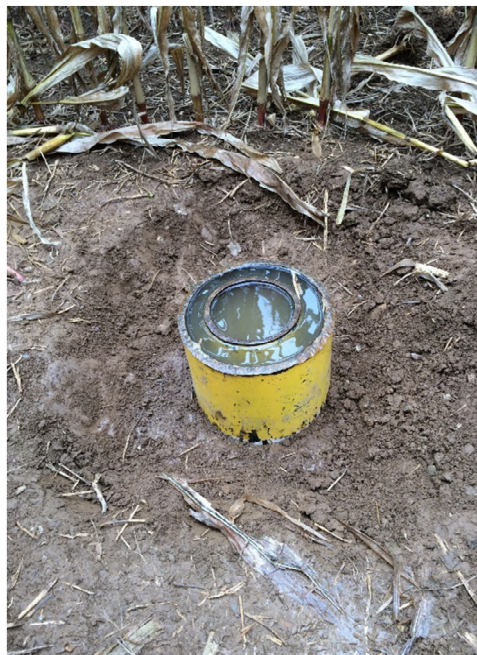
**Description:** Test at Schaeffer Rd. IT-5, approximately 6 inches deep.

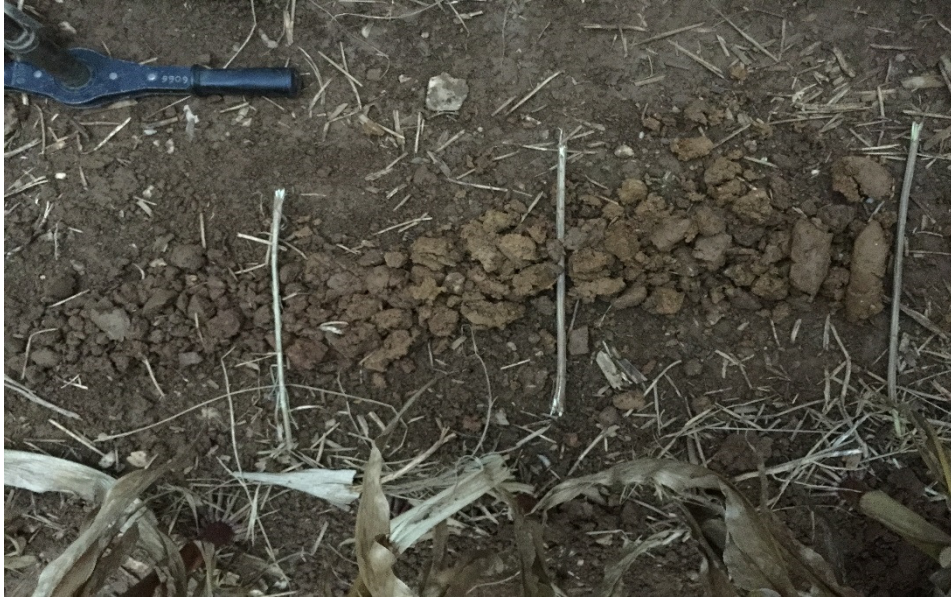
**Description:** Soil from Schaeffer Rd. IT-4/5, approximately 3 feet deep (top at left, foot marks denoted by sticks).

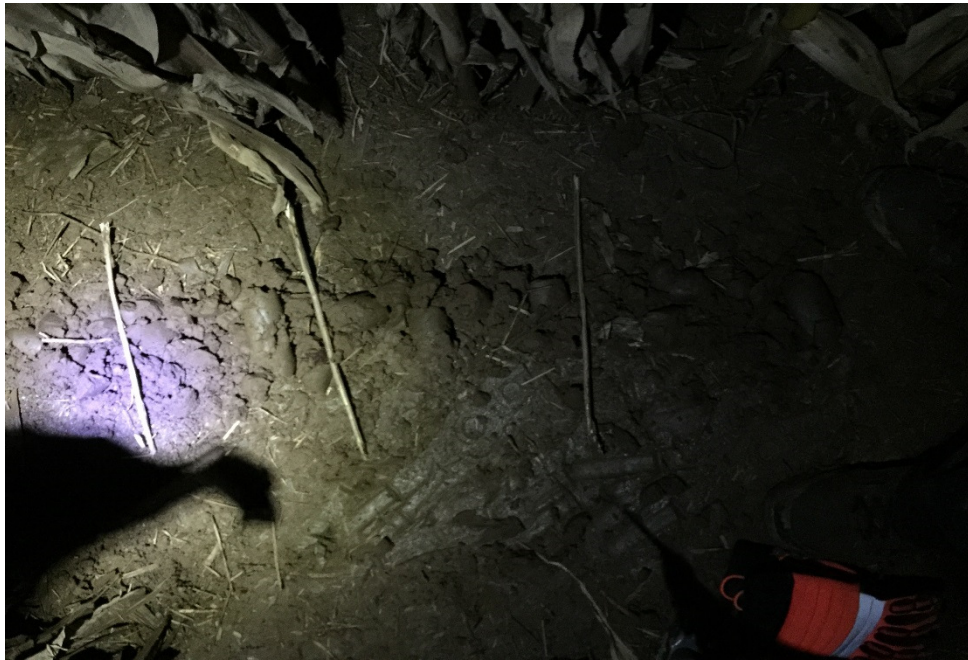
**Description:** Soil from Schaeffer Rd. IT-1/2/3, approximately 3 feet deep (top at left, foot marks denoted by sticks).
