TRIP REPORT SEVEN POINTS LOOP EFRD SITE – INFILTRATION TESTING

This Trip Report presents the field data and results of double-ring soil infiltration tests conducted to support the design of a stormwater management system at the Seven Points Loop EFRD site located in Penn Township, Huntingdon County, Pennsylvania, as part of the Pennsylvania Pipeline Project (PPP) for Sunoco Pipeline, LP. One deep and two shallow tests (IT-A and IT-B) were performed at the site. The test locations are listed by coordinates (latitude and longitude) in Table 1 and shown on the attached figure. A deep infiltration test was proposed for the IT-A location but was not conducted due access issues.

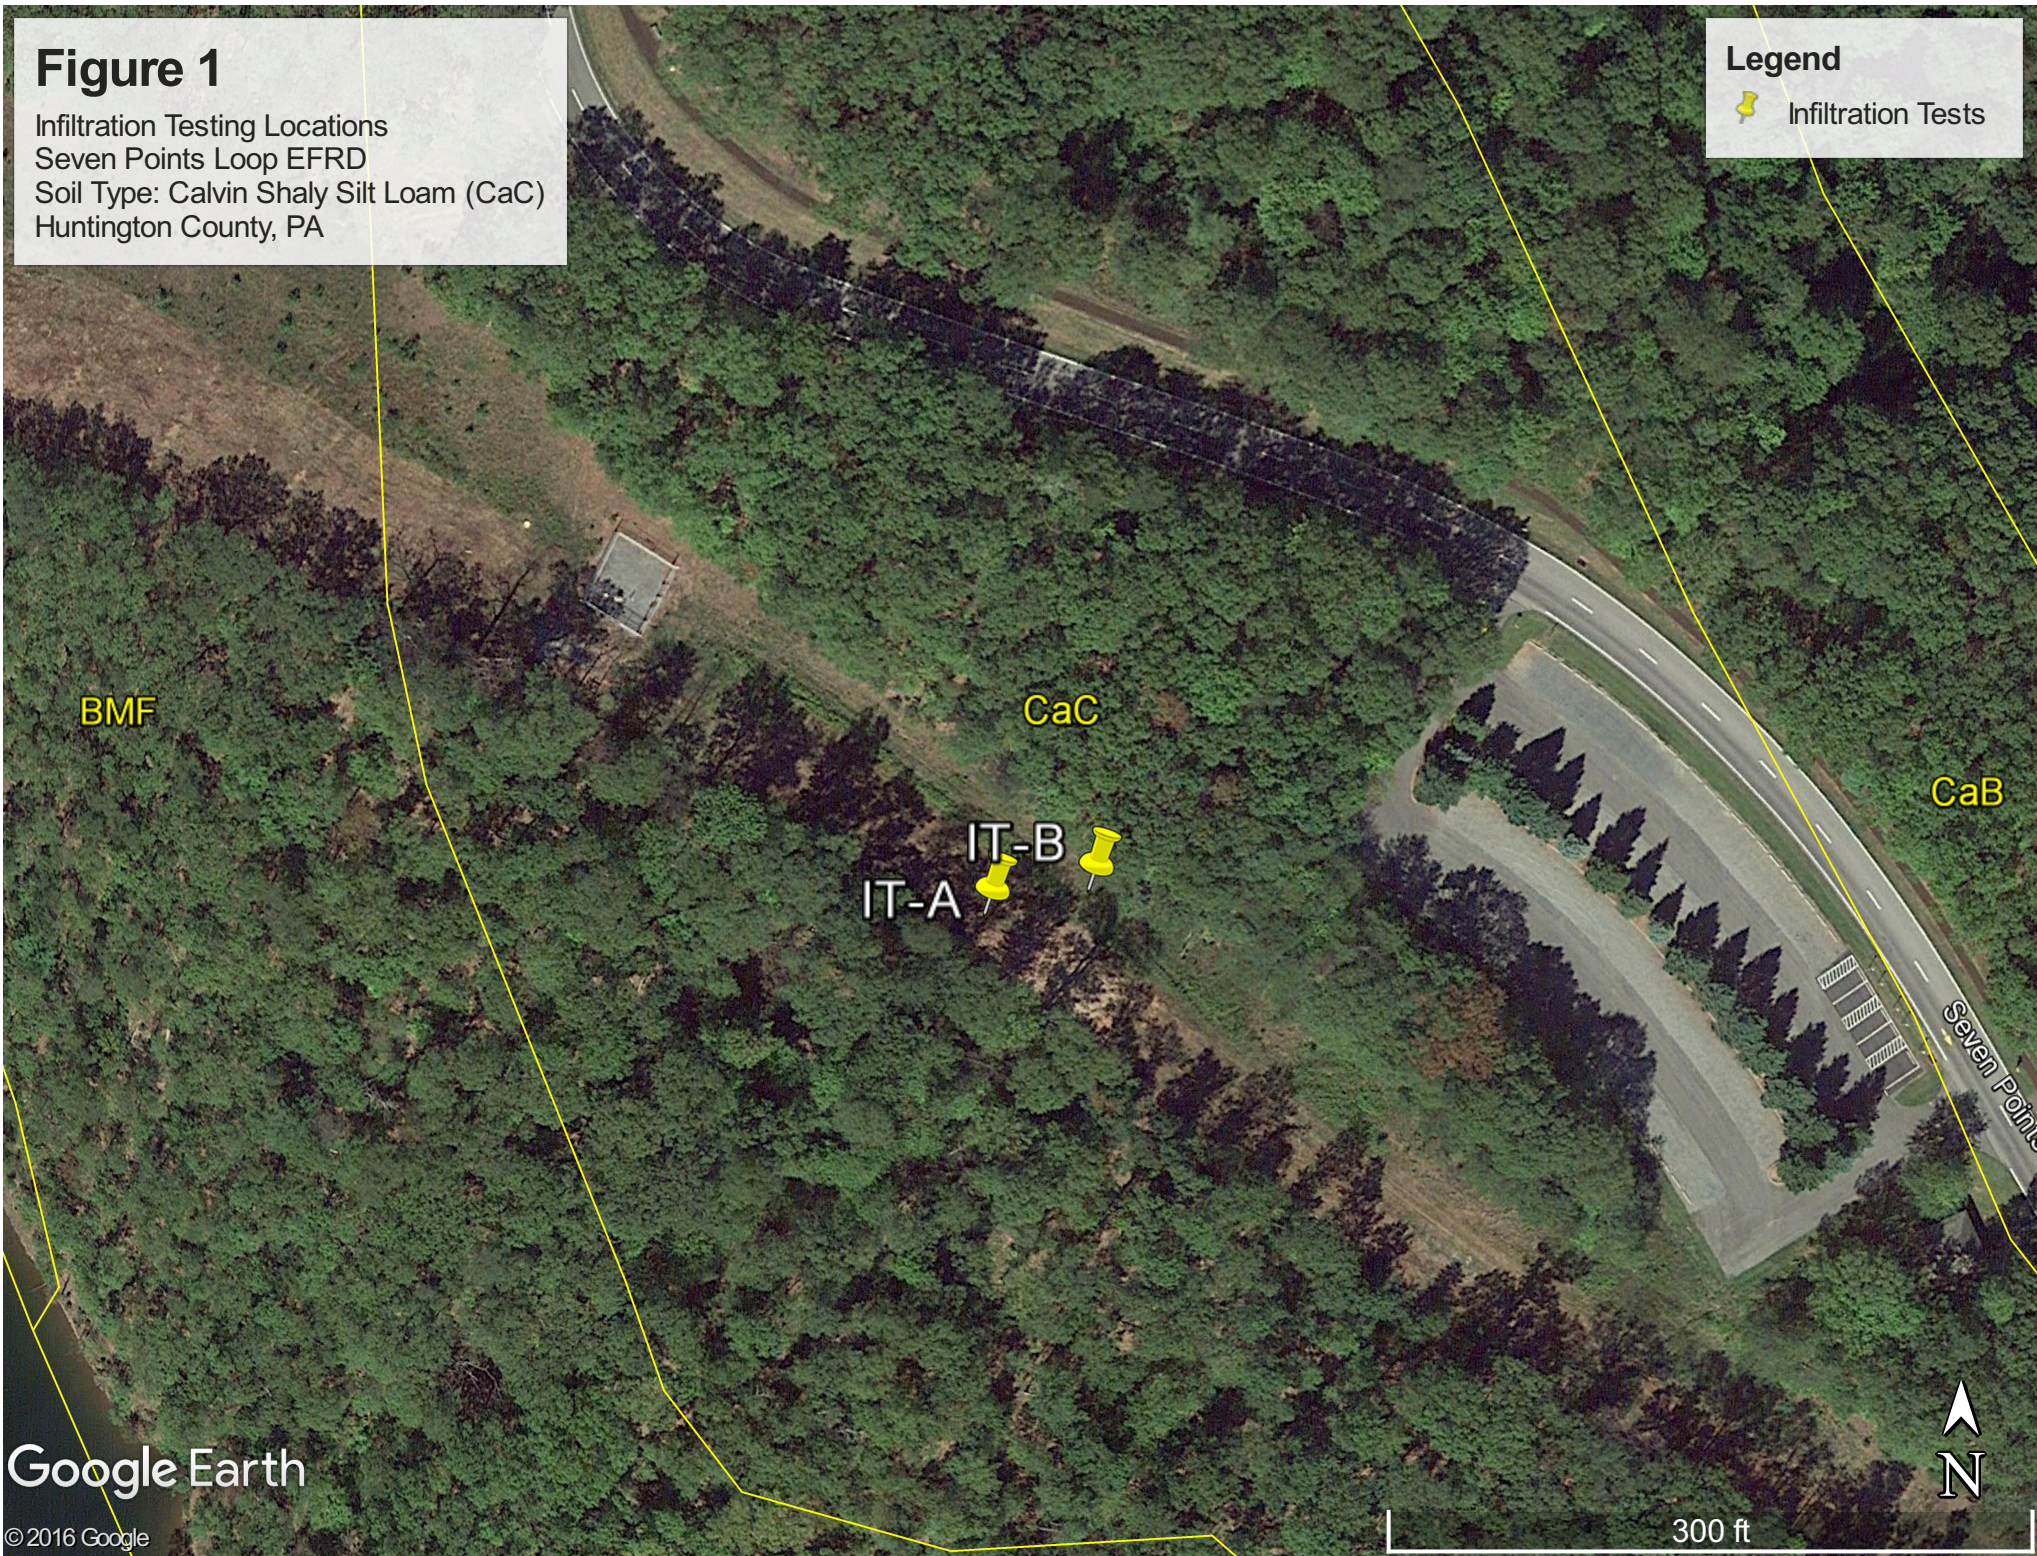
Figure 1

Infiltration Testing Locations
Seven Points Loop EFRD
Soil Type: Calvin Shaly Silt Loam (CaC)
Huntington County, PA

The infiltration tests were conducted by Keith Simpson and Jake Marlow of Tetra Tech, Inc., on September 28, 2016 and October 04, 2016. The test locations were positioned in the field using a handheld, WAAS-enabled GPS unit. Table 1 provides the coordinates of the test locations. Both testing areas were located adjacent to an existing utility corridor.
