TRIP REPORT HARES VALLEY ROAD SITE – INFILTRATION TESTING

1.0 PURPOSE

This Trip Report presents the field data and results of a double-ring soil infiltration test conducted to support the design of a stormwater management system at the Hares Valley Road site located in Union Township, Huntington County, Pennsylvania, as part of the Pennsylvania Pipeline Project (PPP) for Sunoco Pipeline, LP. One shallow test (IT-A) was performed at the site. The test location is listed by coordinates (latitude and longitude) in Table 1 and shown on the attached figure.

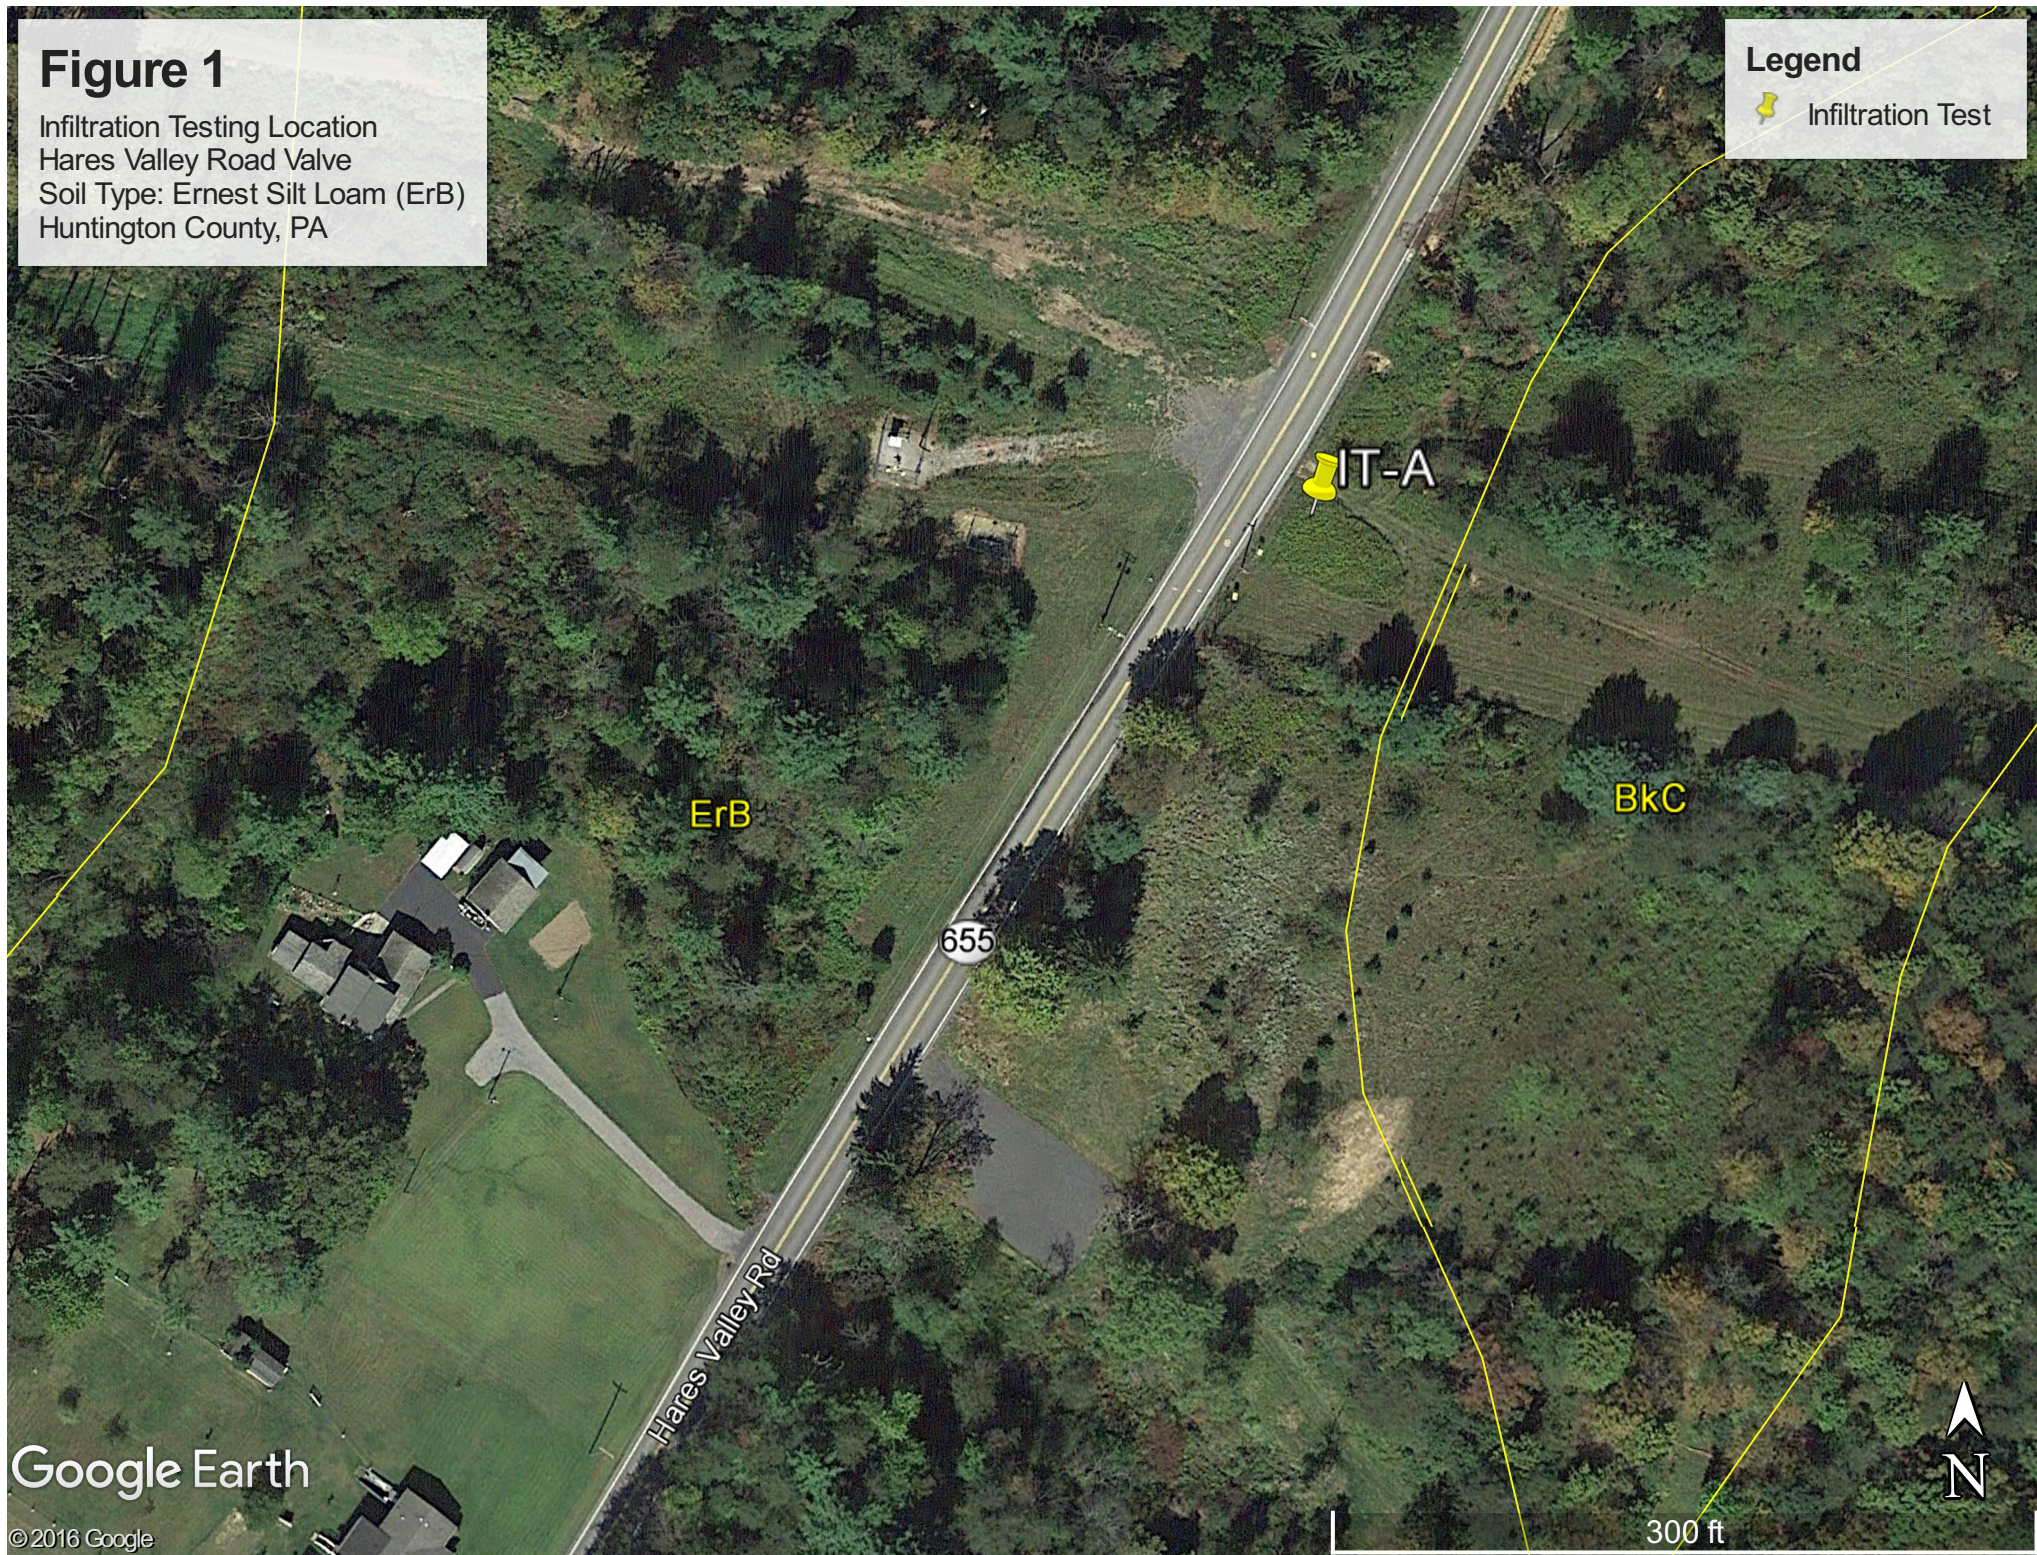
Figure 1

Infiltration Testing Location
Hares Valley Road Valve
Soil Type: Ernest Silt Loam (ErB)
Huntington County, PA

Infiltration Test

The infiltration test was conducted by Mark Mengel and Kevin Schwab of Tetra Tech, Inc., on October 3, 2016. The test location was positioned in the field using a handheld, WAAS-enabled GPS unit. Table 1 provides the coordinates of the test location. The test was located in a brushy area along mildly sloped terrain on the east side of Hares Valley Road.
