TRIP REPORT BLAINSPORT VALVE SITE – INFILTRATION TESTING

1.0 PURPOSE

This Trip Report presents the field data and results of double-ring soil infiltration tests conducted to support the design of a stormwater management system at the Blainsport site located in West Cocalico Township, Lancaster County, Pennsylvania, as part of the Pennsylvania Pipeline Project (PPP) for Sunoco Pipeline, LP. Three deep tests (IT-A through IT-C) were performed at the site. The test locations are listed by coordinates (latitude and longitude) in Table 1 and shown on the attached figure.

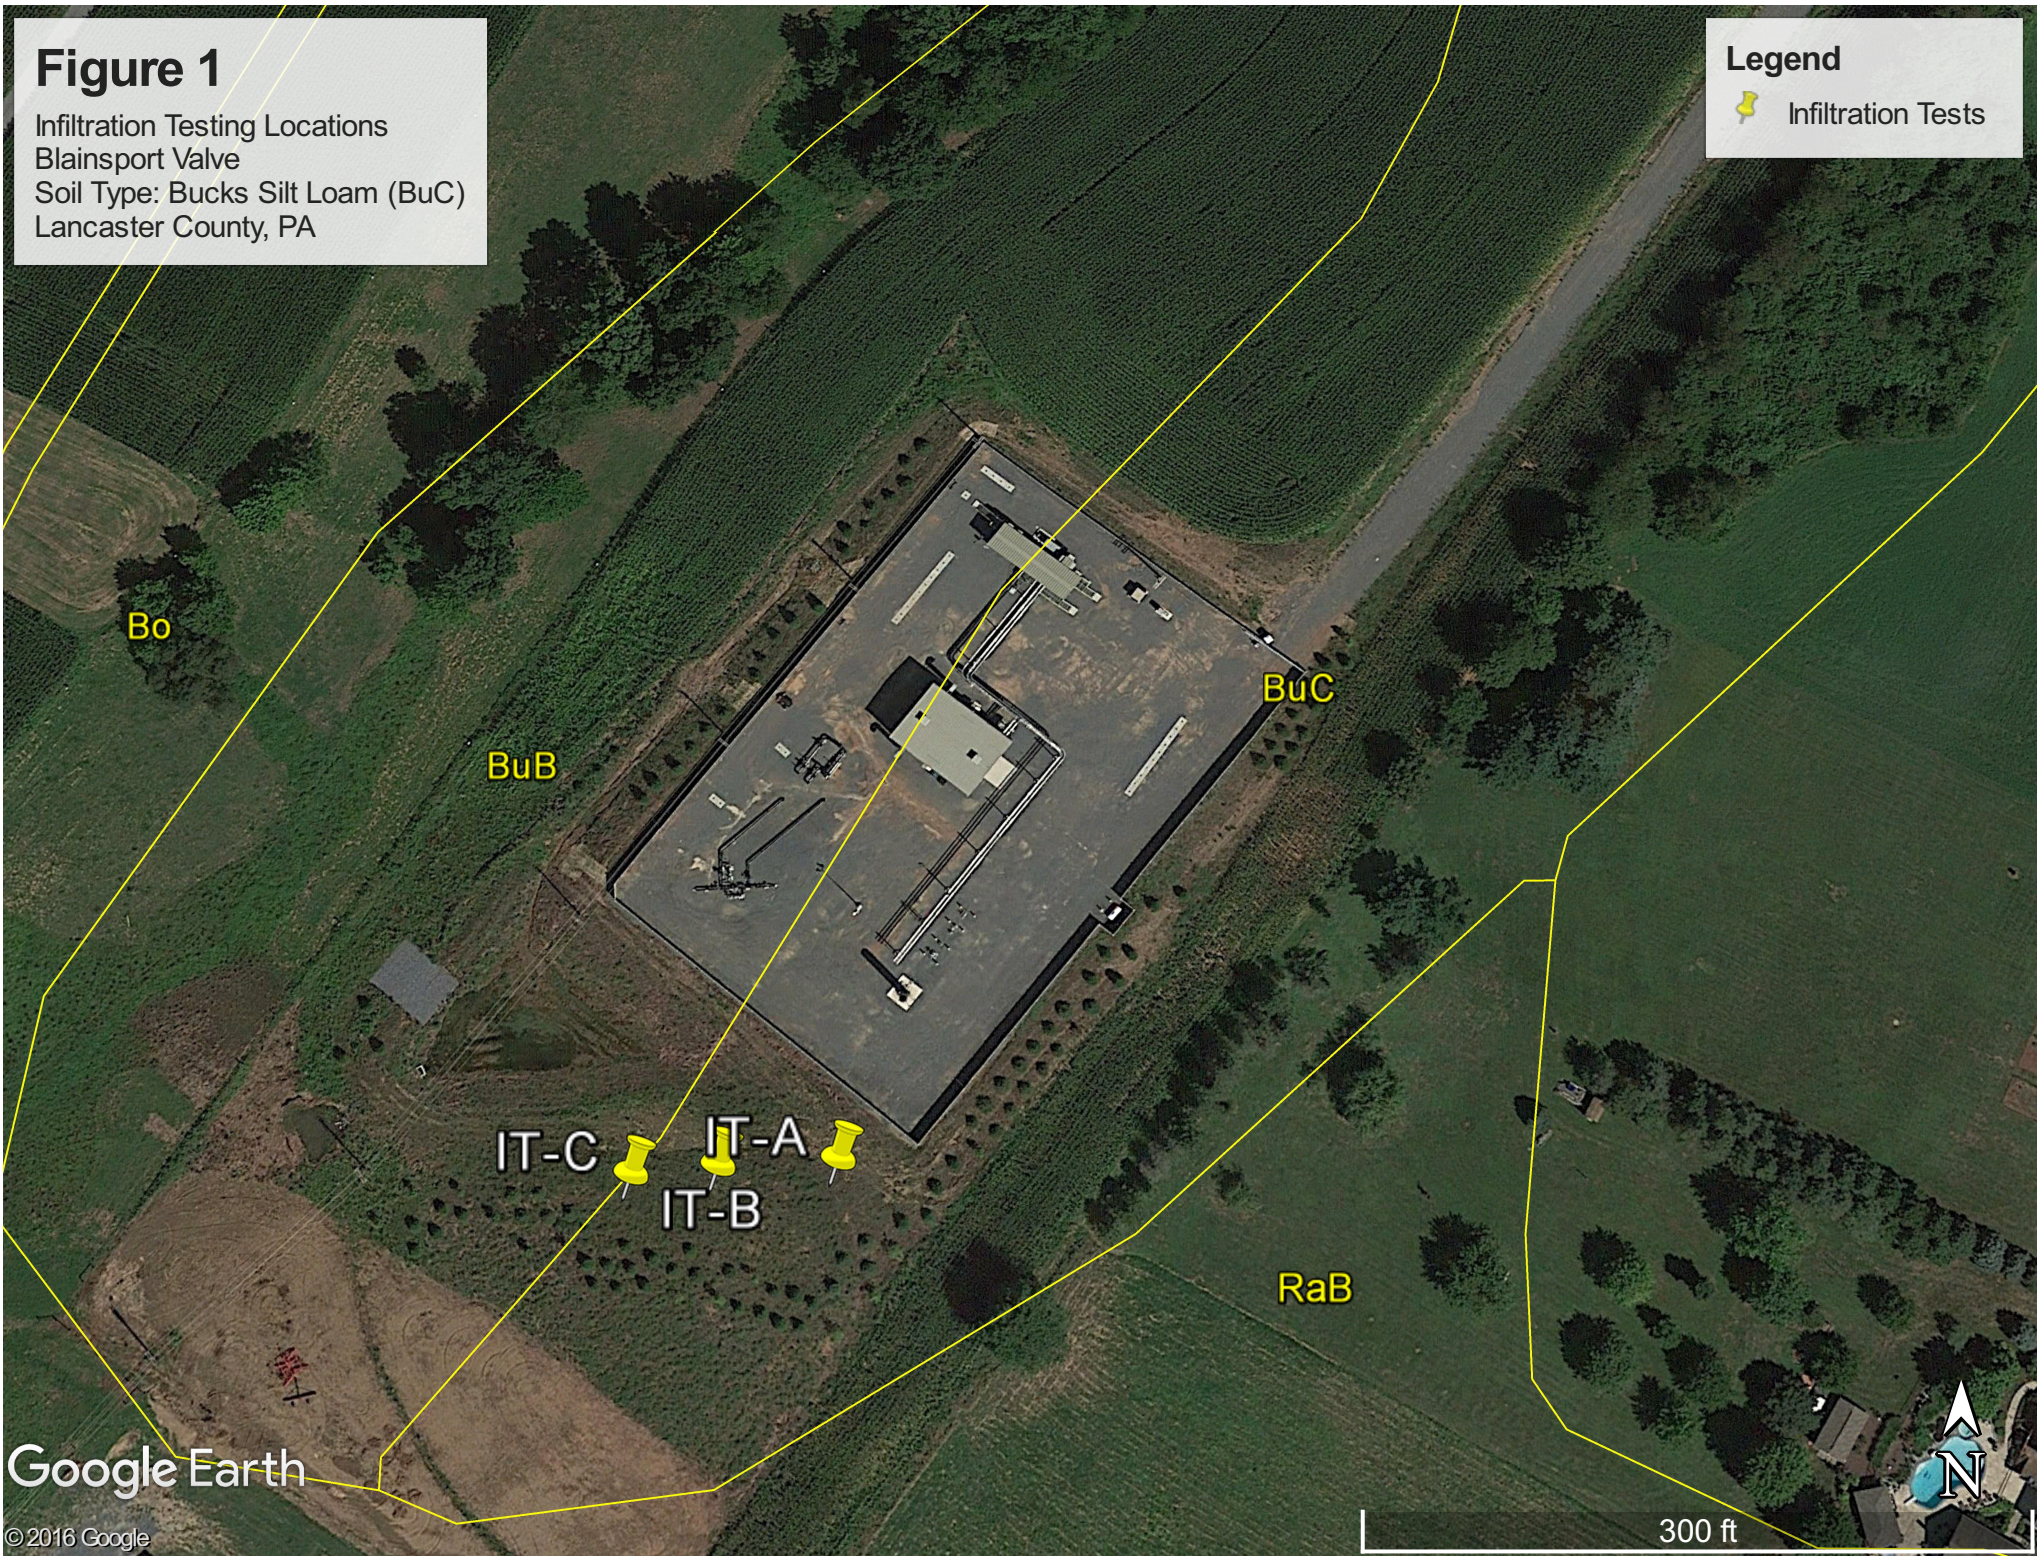
Figure 1

Infiltration Testing Locations
Blainsport Valve
Soil Type: Bucks Silt Loam (BuC)
Lancaster County, PA

Infiltration Tests

The infiltration tests were conducted by Mark Mengel and Kevin Schwab of Tetra Tech, Inc., on October 5, 2016. The test locations were positioned in the field using a handheld, WAAS-enabled GPS unit. Table 1 provides the coordinates of the test locations. All tests were located in a relatively flat grassy area, located between an existing valve site and an agricultural field.
